Cane River Creole National Historical Park
Magnolia Plantation
Overseer's House
Historic Structure Report

Hartrampf, Inc.

The Office of Jack Pyburn, Architect, Inc.

2004
Historic Structure Report
Overseer's House
Magnolia Plantation
Cane River Creole National Historical Park
Natchez, LA
LCS#: 091558

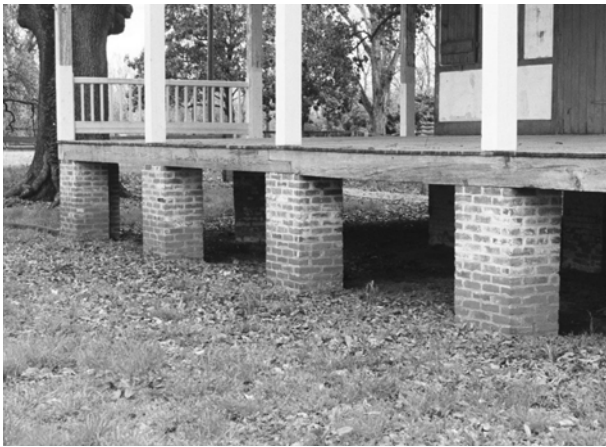
FIGURE 2. Foundation piers beneath southeast sill of southeast gallery.

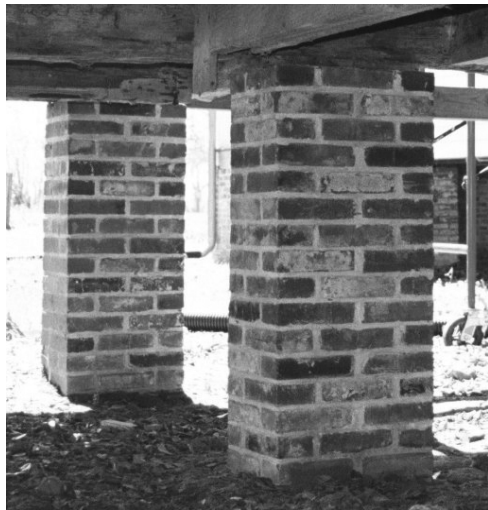
FIGURE 3. Foundation piers beneath Room 111 addition.

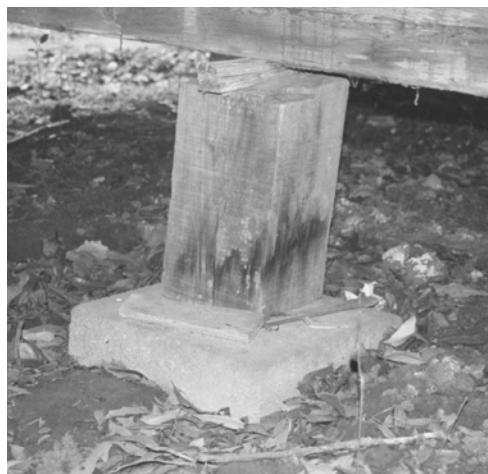
FIGURE 4. Odd pier beneath southwest sill of Room 110 addition.

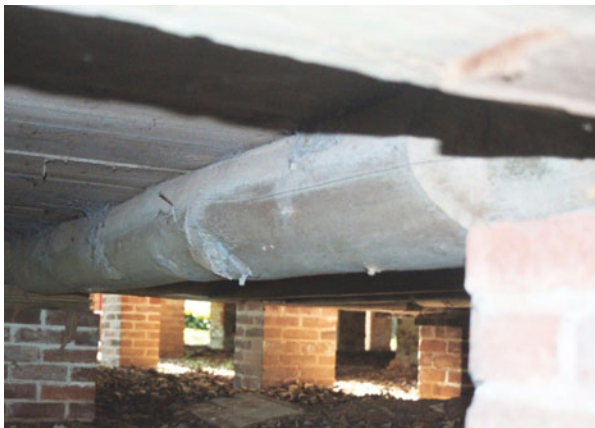
FIGURE 17. Log joist in floor framing of Room 110 addition.

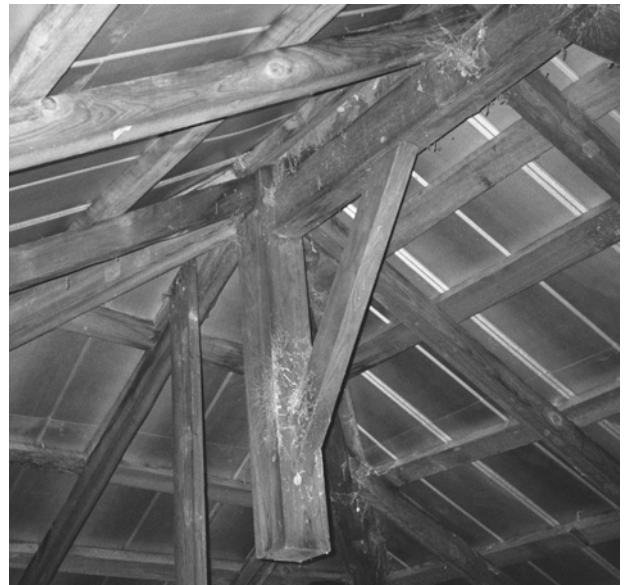
FIGURE 21. Framing at hip in roof. Note difference in end of king post.

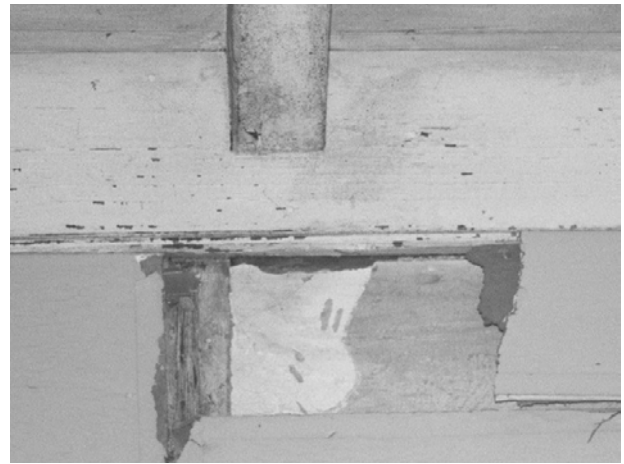
FIGURE 53. Room 104, ceiling joist (note bead), beam and exposed *bousillage* beneath gypsum wallboard.

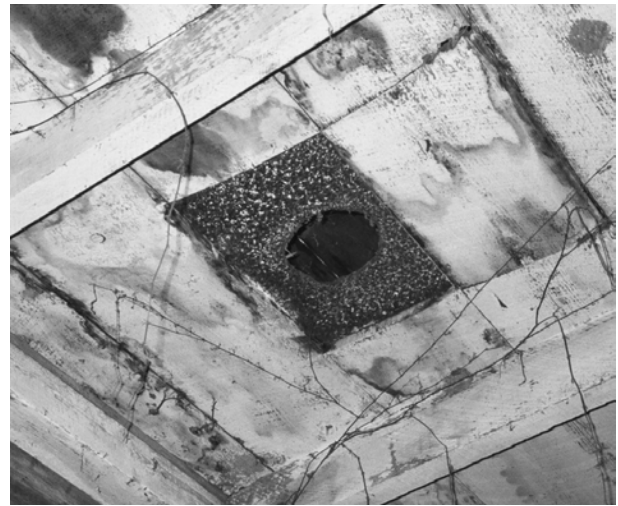
FIGURE 64. Ceiling, Room 110, showing stovepipe hole.
