Dry Tortugas Light Station

Lighthouse and Oil House

Historic Structure Report

2009

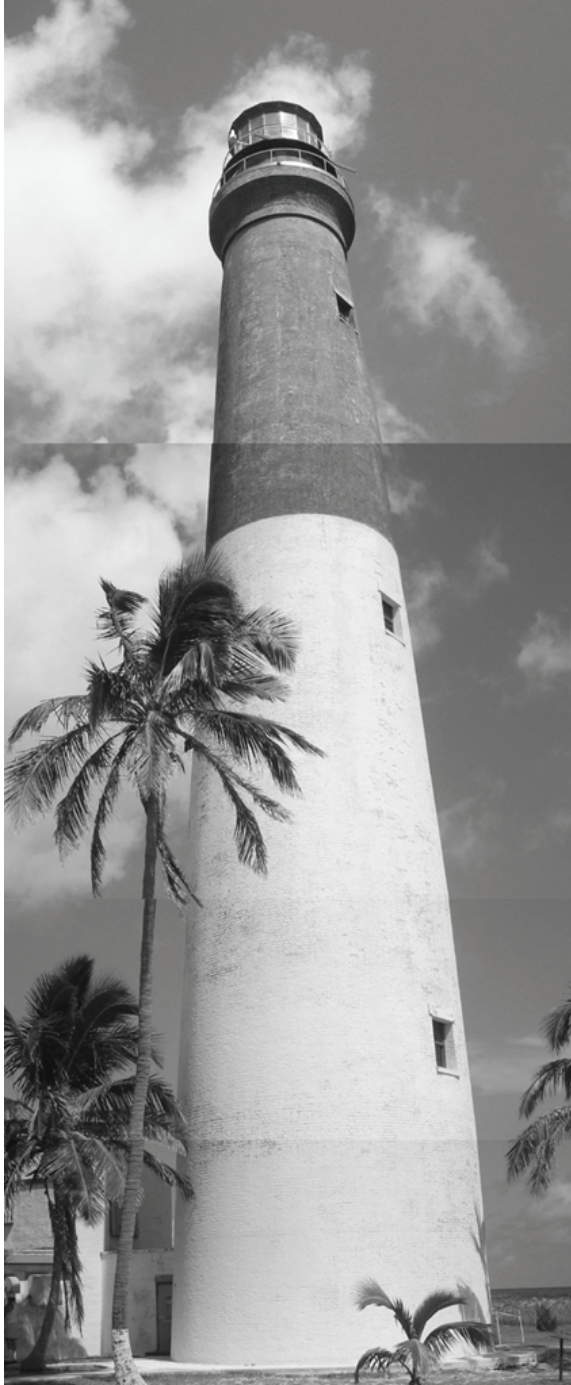
Figure 36. 2008 view of Lighthouse looking north. The painted finish of the tower is showing signs of weathering and deterioration. There is no discernable pattern to the paint loss.

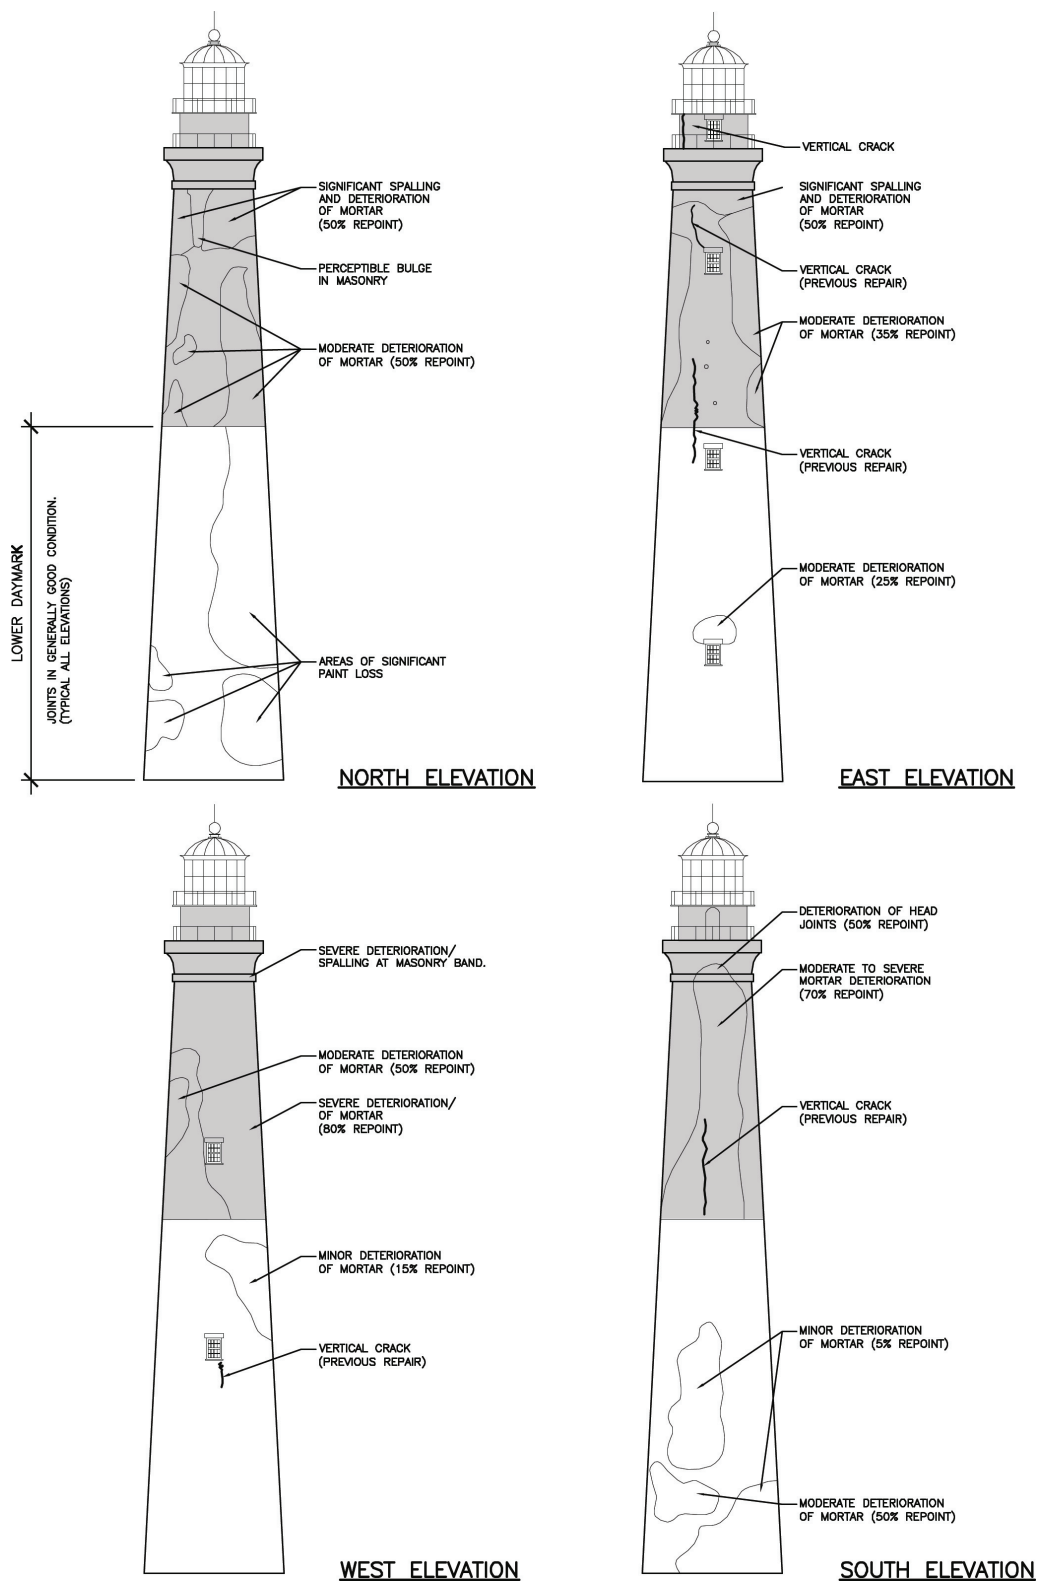
Figure 40. Exterior masonry conditions observed during site inspection conducted in 2009.

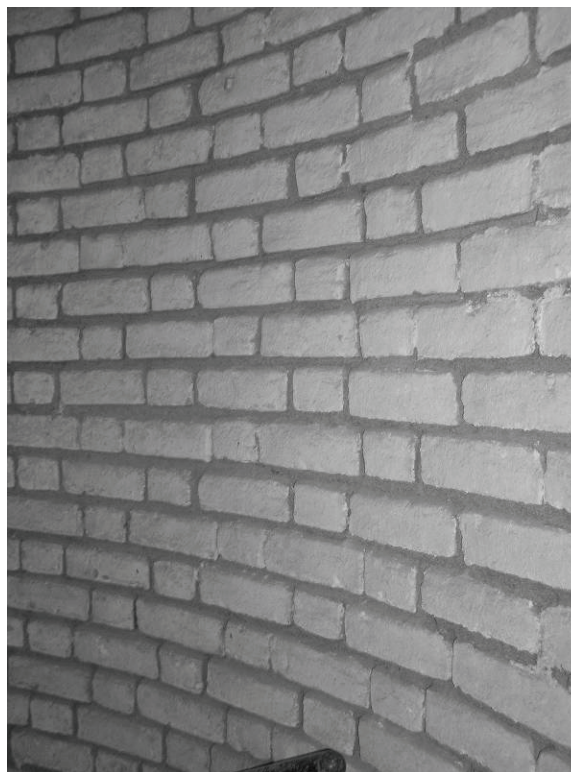
Figure 55. Typical view of interior wall surface showing deterioration of mortar. Note the paint is adhering well to the brick but has failed at the mortar joints.

- Abate lead-based paint and reapply interior finish.
- Quantify areas of mortar loss.
- At locations of critical mortar loss, conduct masonry repointing and repair of the Lighthouse interior.
- Repair vertical cracking with deep penetrating mortar.

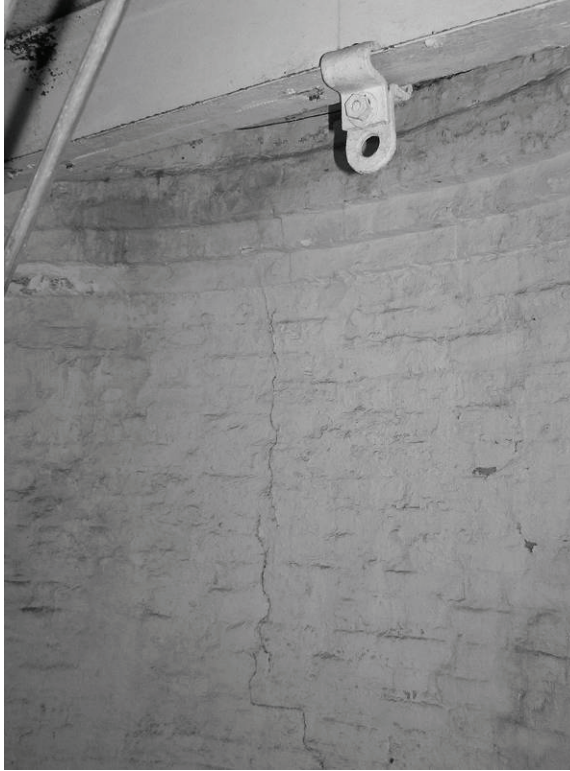
Figure 57. Vertical crack extending down from Watch Room level floor plate.

- Monitor vertical cracking below Watch Room level of Lighthouse.

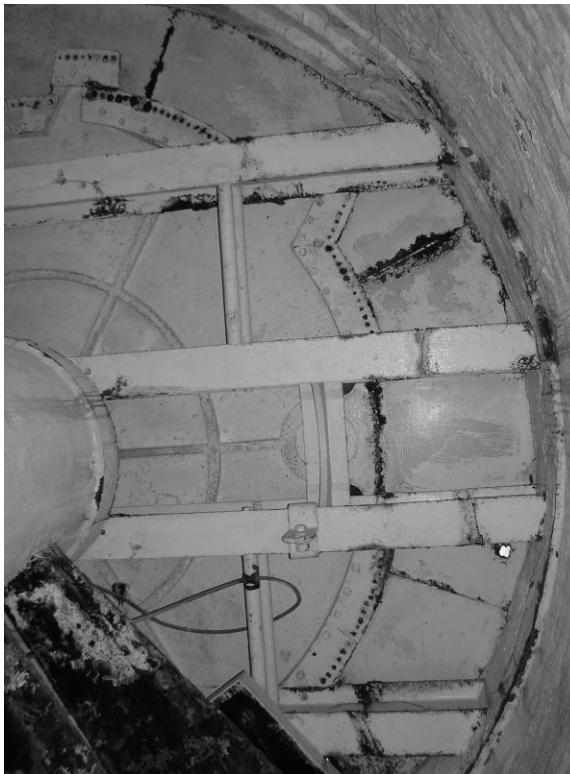
Figure 58. View looking up at the I-beams supporting the Watch Room level floor plate.

- If existing stucco finish requires widespread removal to accommodate repair of anchors, replace with a more compatible stucco finish system. If not, repair existing stucco as needed.
- Expose, remove corrosion and refinish I-beams and lintel supporting Watch Room level floor plate.

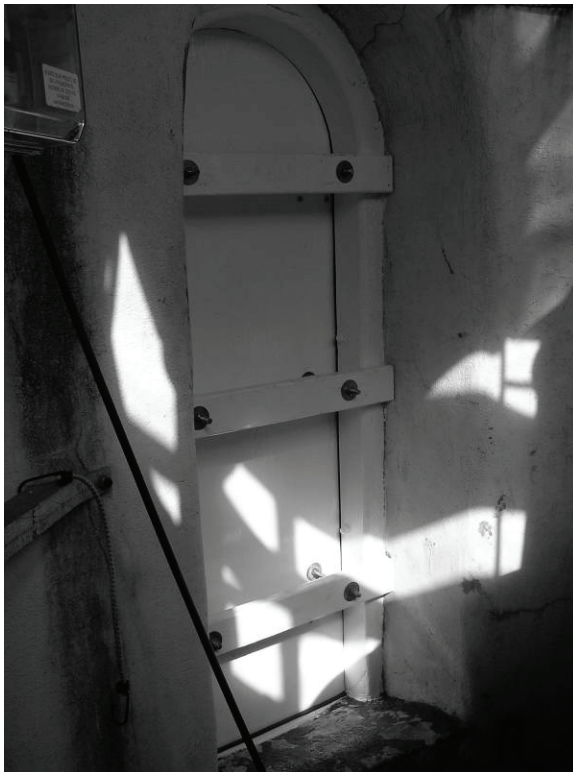
Figure 60. The original arched iron door has been recently removed and replaced with a plywood insert.

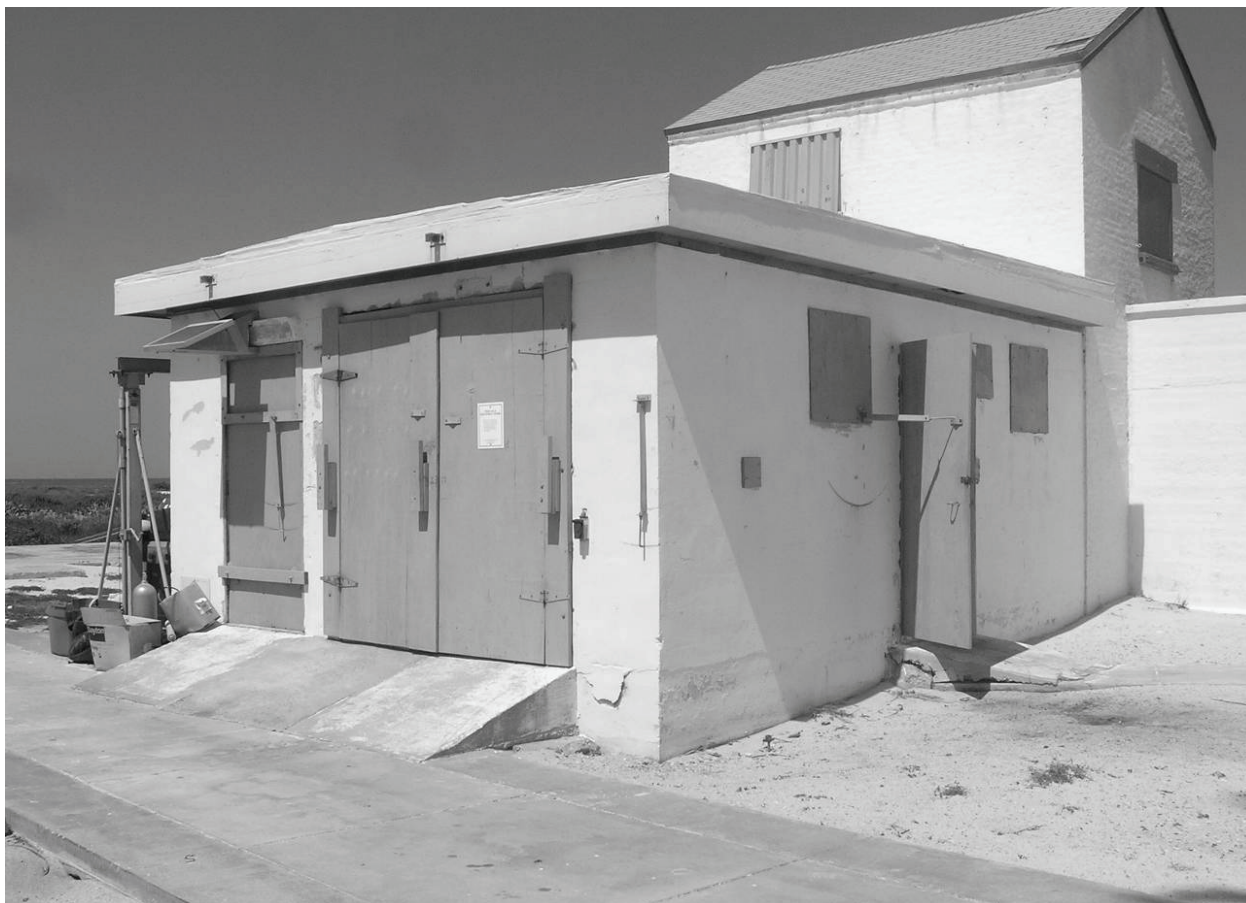
Figure 85. Concrete block addition constructed in 1982 by the crew of the USCG vessel *White Sumac*. When originally constructed the addition did not have any openings.

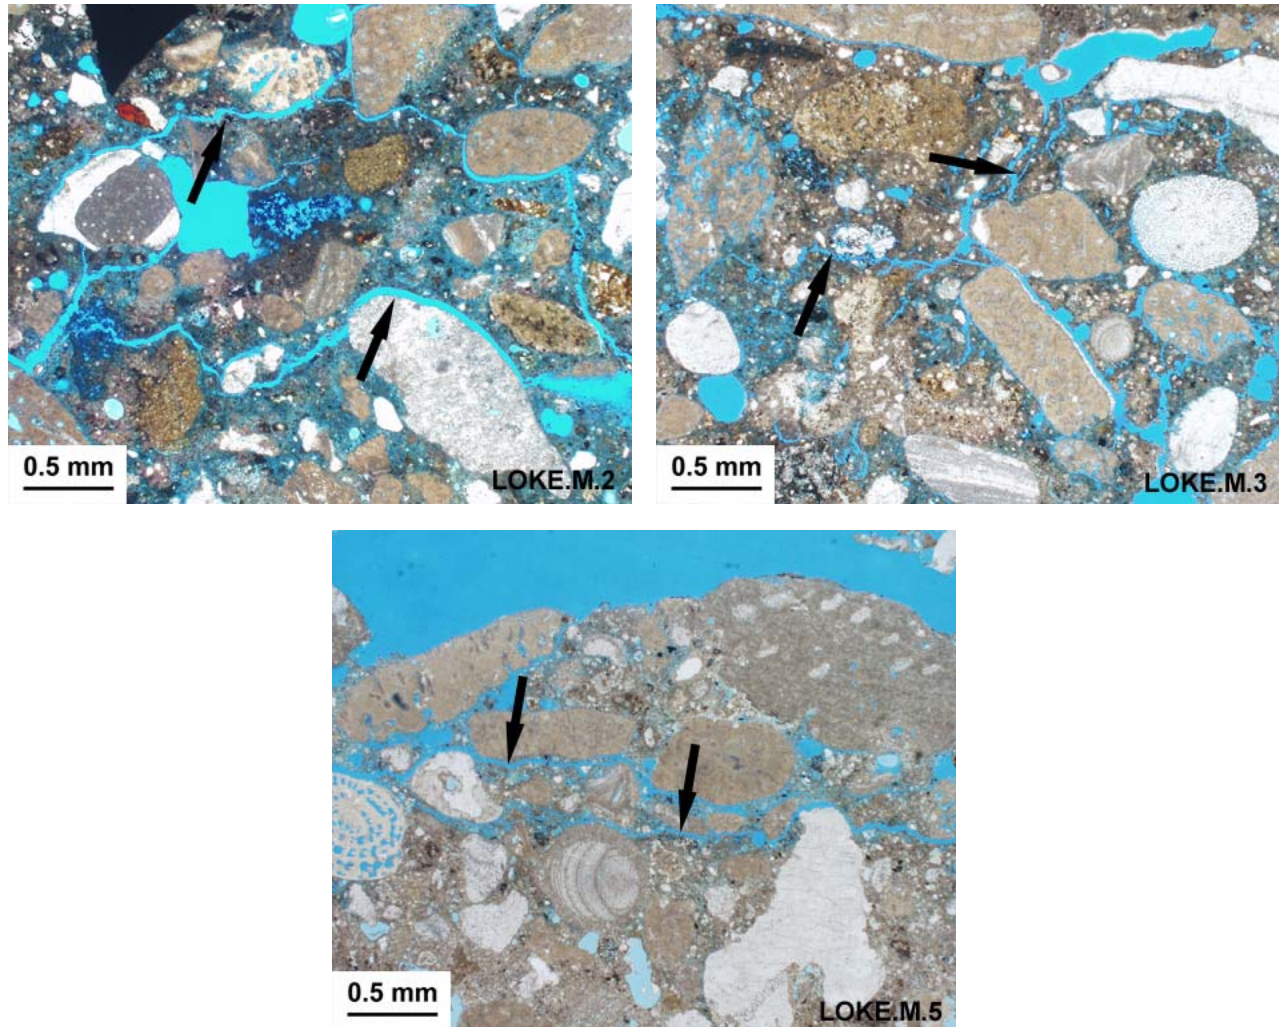
Figure 25: PPL photomicrographs illustrating microcracks in the cistern samples and one of the Lighthouse samples (arrows). These are minor and no sample in the examined suite exhibits any significant cracking distress.

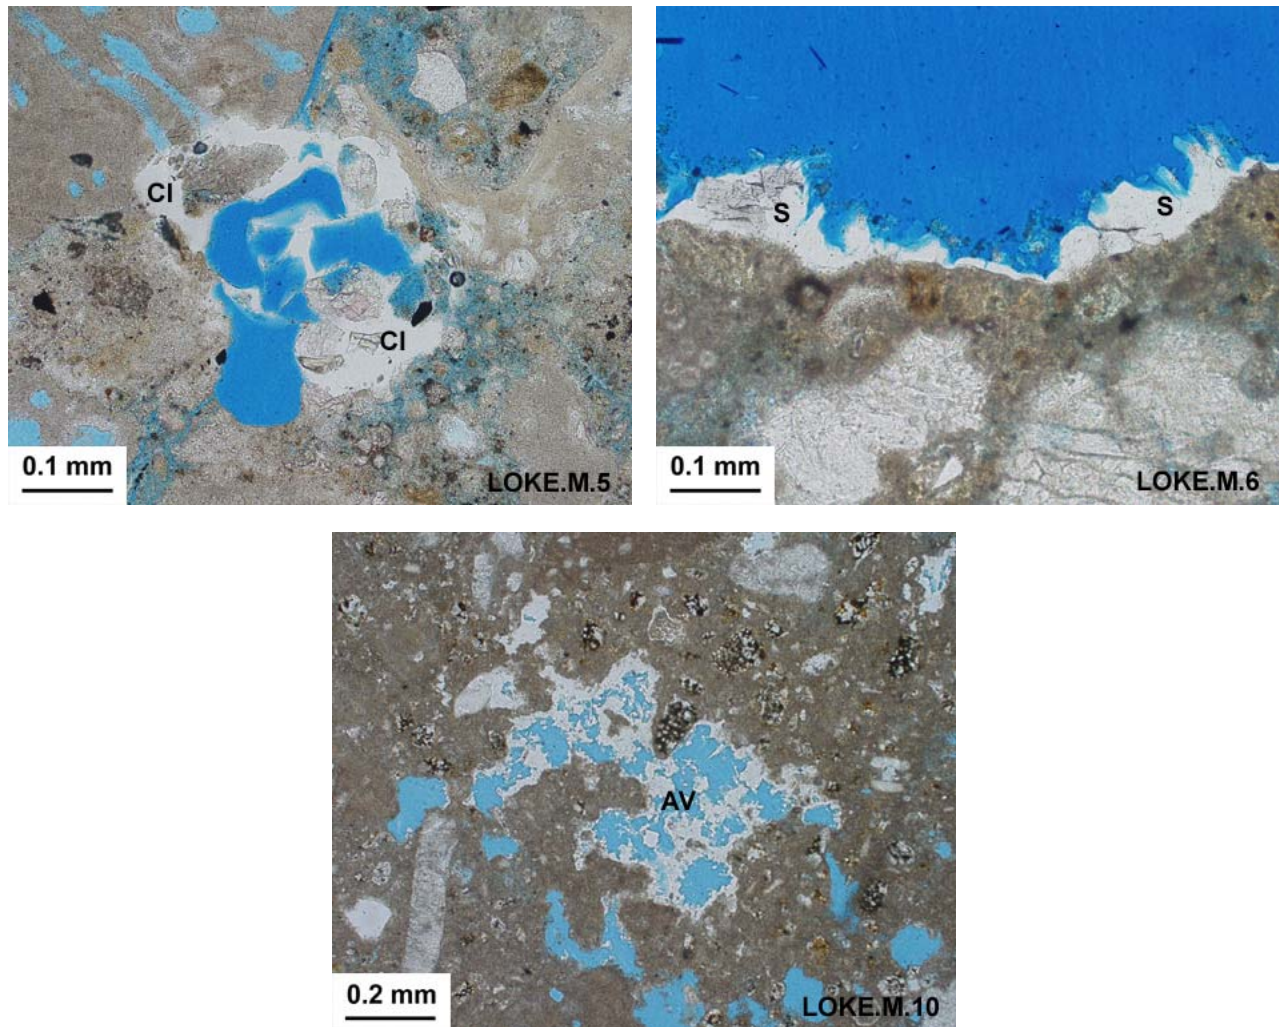
Figure 26: PPL photomicrographs illustrating the few secondary chemical deposits detected petrographically in the examined sample suite. No visible distress is associated with any of these deposits. (Top left) Isotropic mineral deposits consistent with chlorides (Cl) are found in low abundance in samples LOKE.M.5 and LOKE.M.6. (Top right) Fine secondary deposits consistent with sulfates (S) are quite rare. (Bottom) Some air-voids in the portland cement mortar of sample LOKE.M.10 contain linings of secondary gypsum but again, no associated distress is noted.

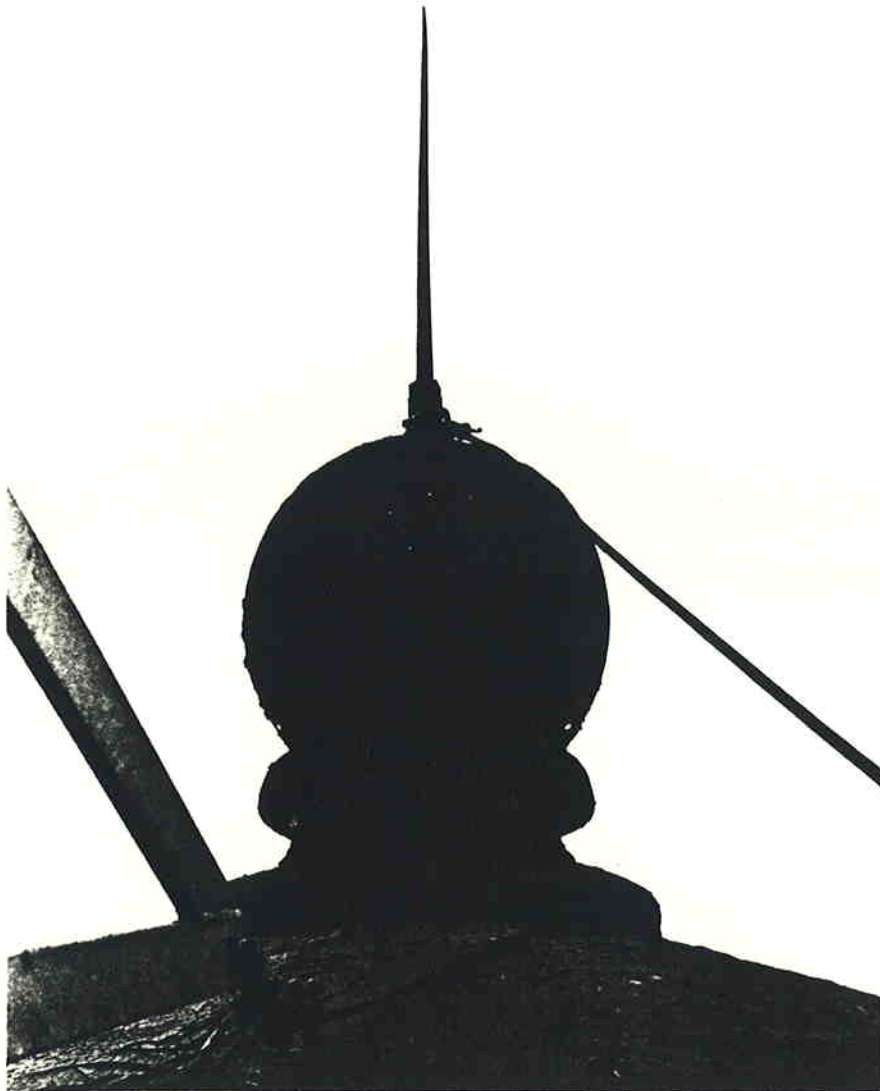
EXISTING CONDITION OF FINIAL AT DOME
I-5

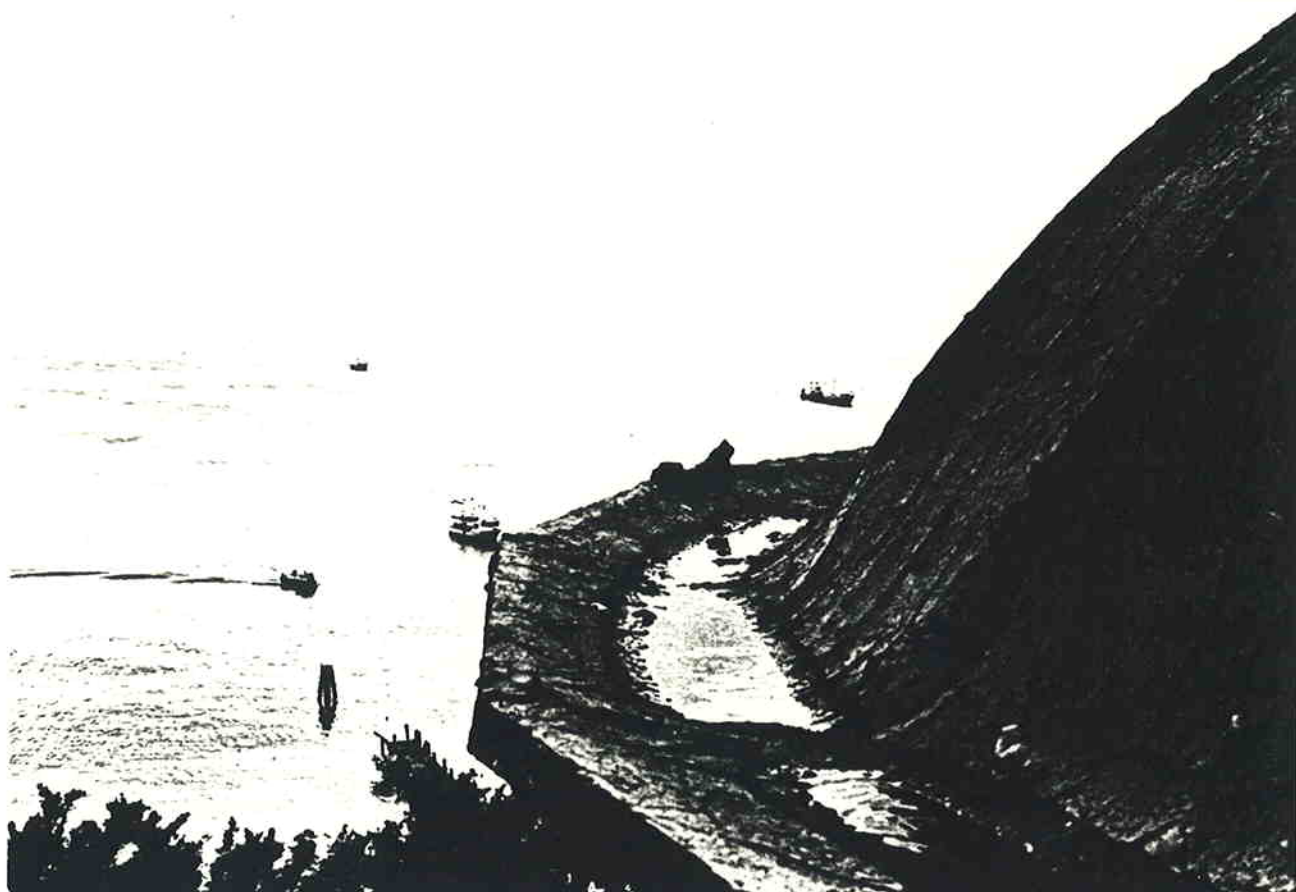
EXISTING CONDITION OF GUTTER AT DOME
I-6

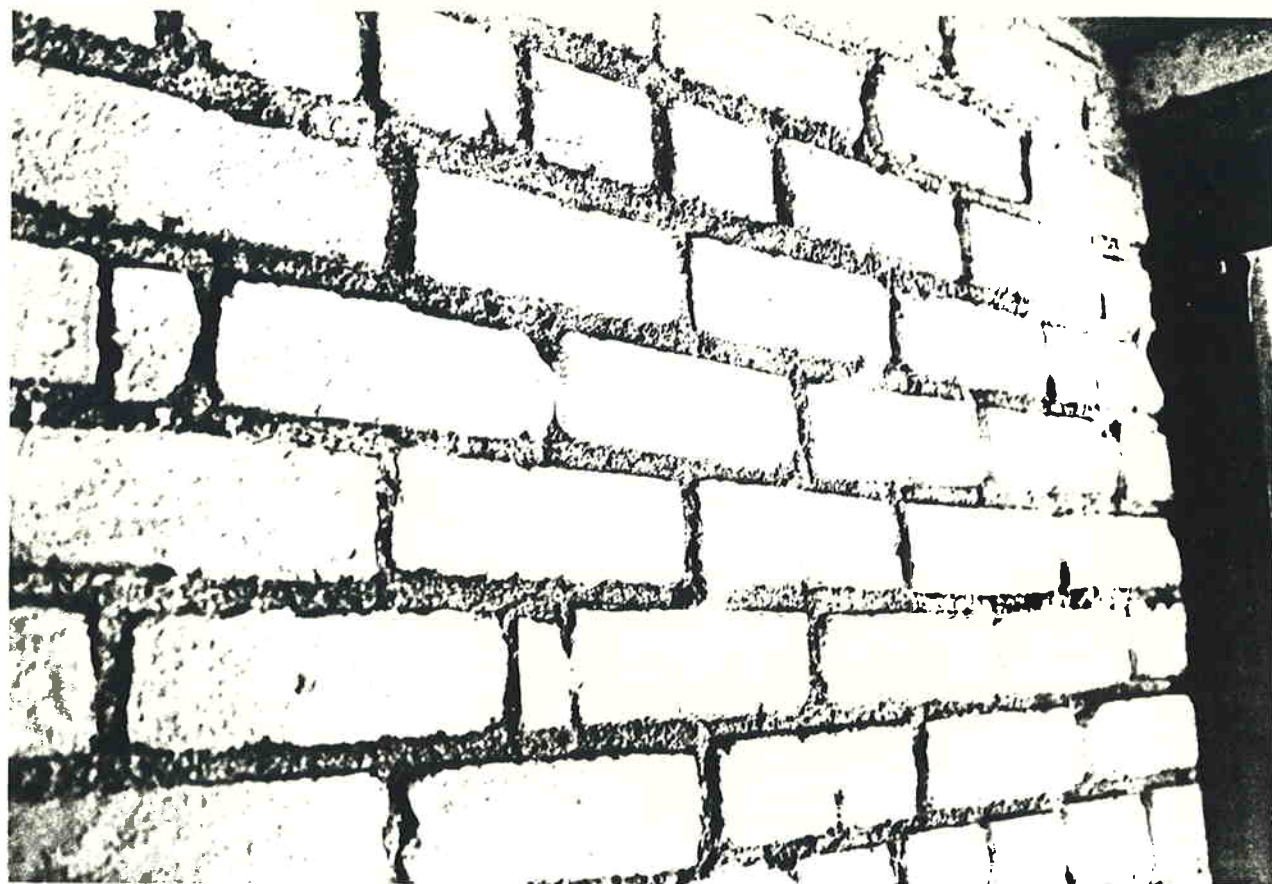
EXISTING CONDITION OF INTERIOR MASONRY WALL (TYPICAL)
I-7

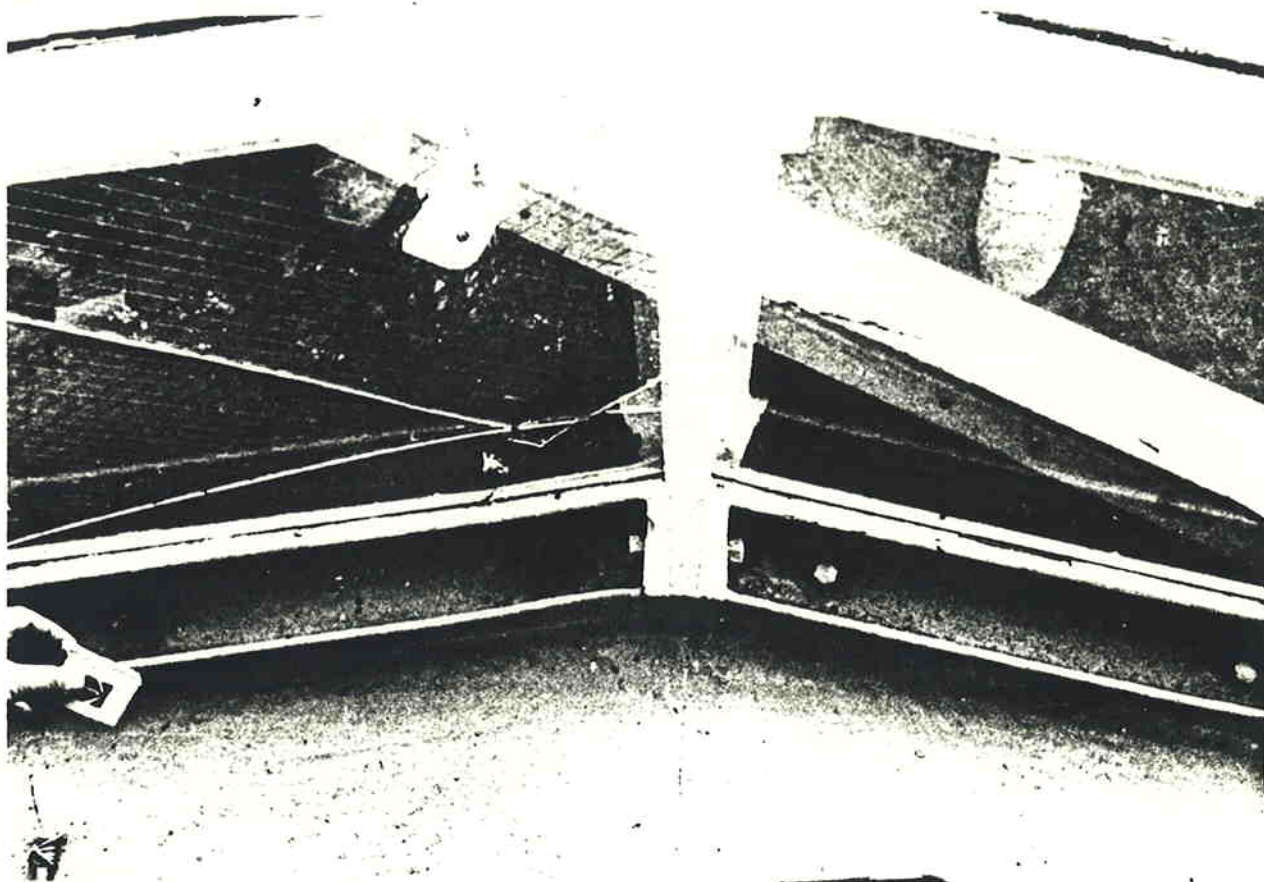
EXISTING CONDITION OF INTERIOR MULLION AT METAL LANTERN ROOM
I-8

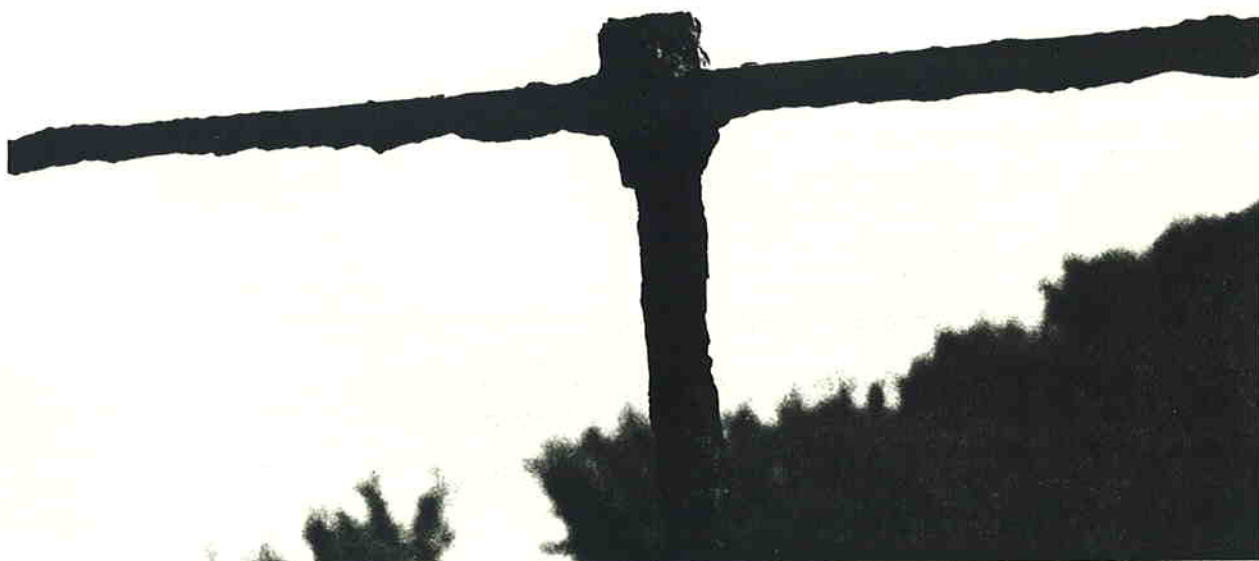
EXISTING CONDITION OF EXTERIOR RAIL AND PICKET
AT METAL LANTERN ROOM AND GALLERY I-9

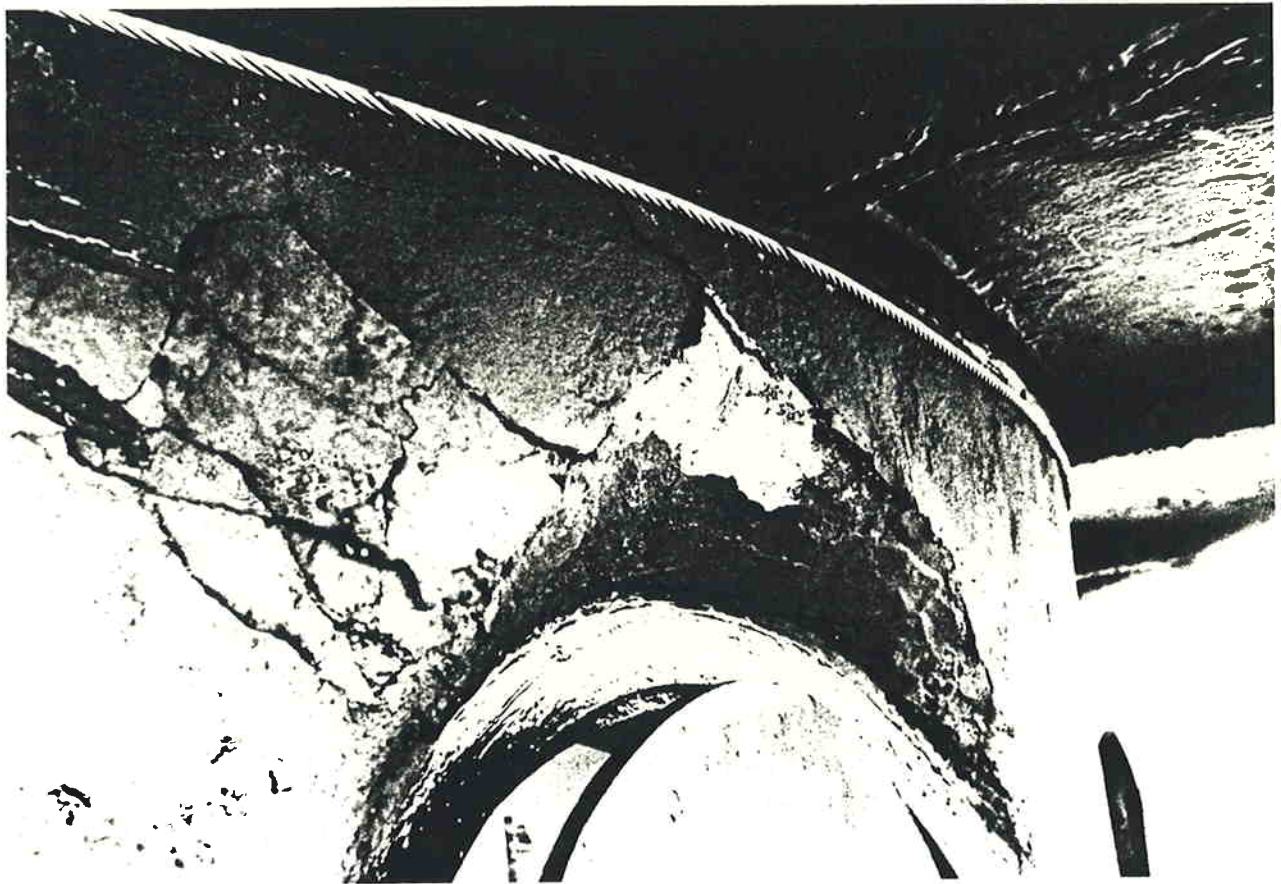
EXISTING CONDITION OF EXTERIOR STUCCO WALL AT GALLERY ROOM
I-10
