FIRE ISLAND LIGHTHOUSE AND KEEPER'S DWELLING

**HISTORIC STRUCTURE REPORT
Architectural Data Section**

**Fire Island National Seashore
Patchogue, New York**

Carole L. Perrault

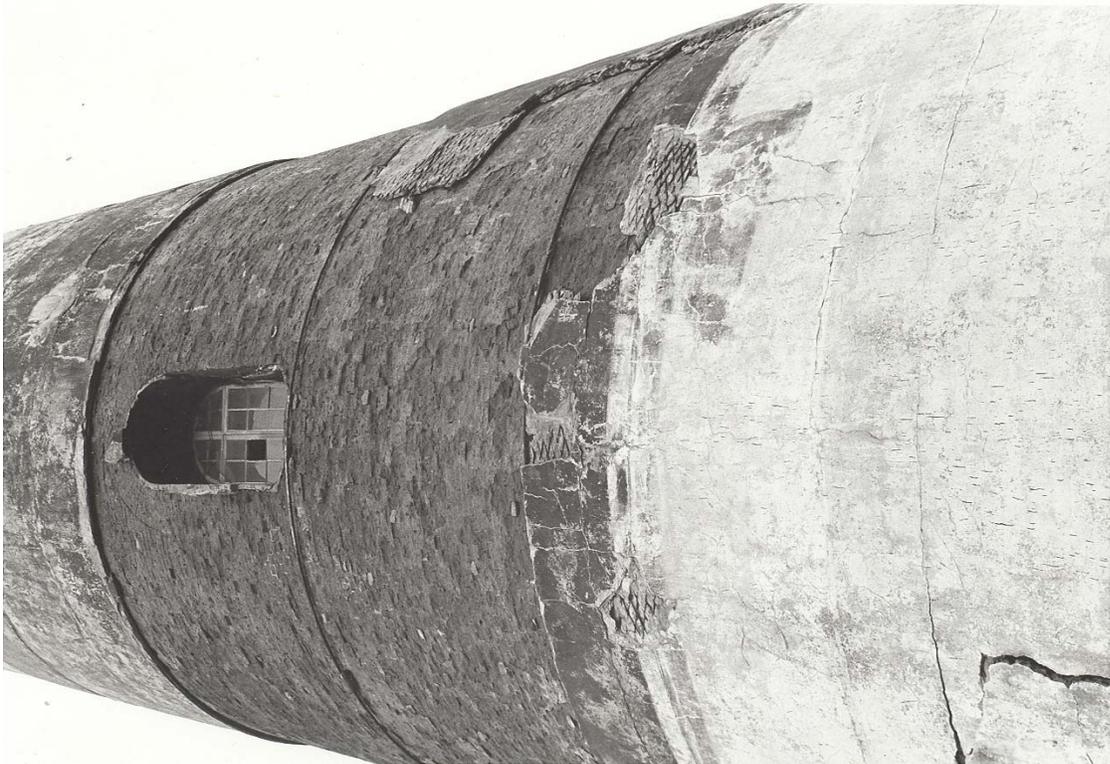
Figure 86. Tower exterior: deteriorated coating and exposed brickwork (1982).

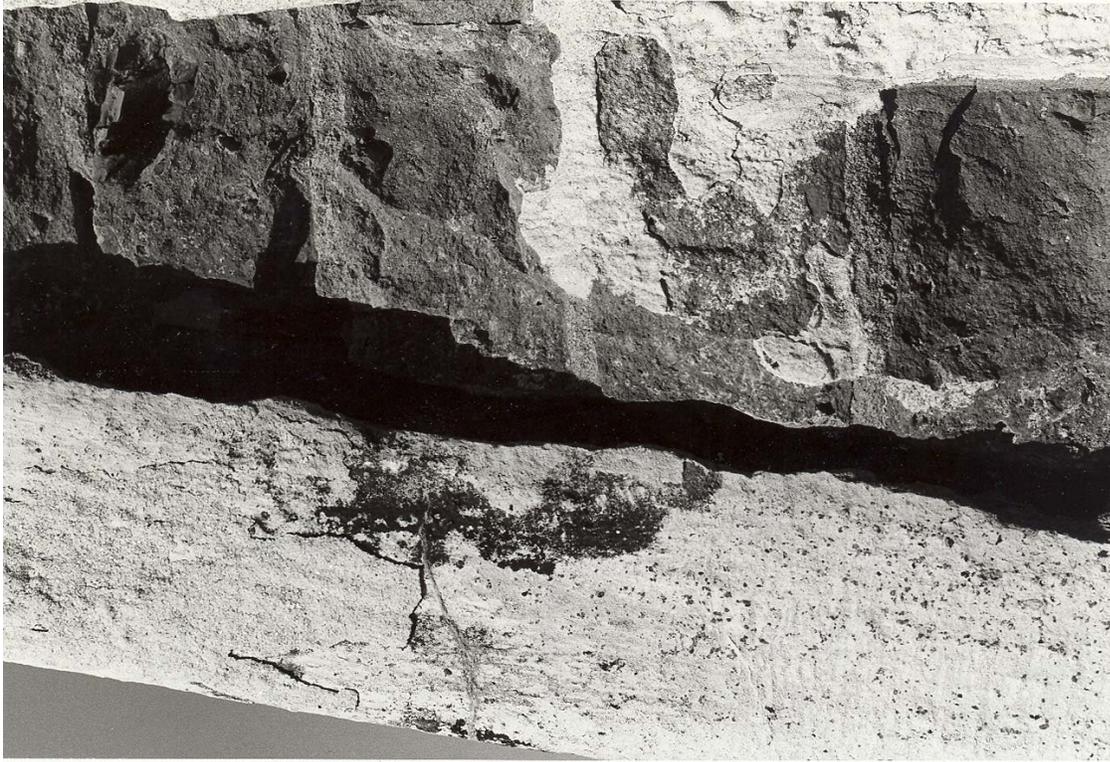
Figure 87. Tower exterior: coating separating from brickwork at entrance (1983).

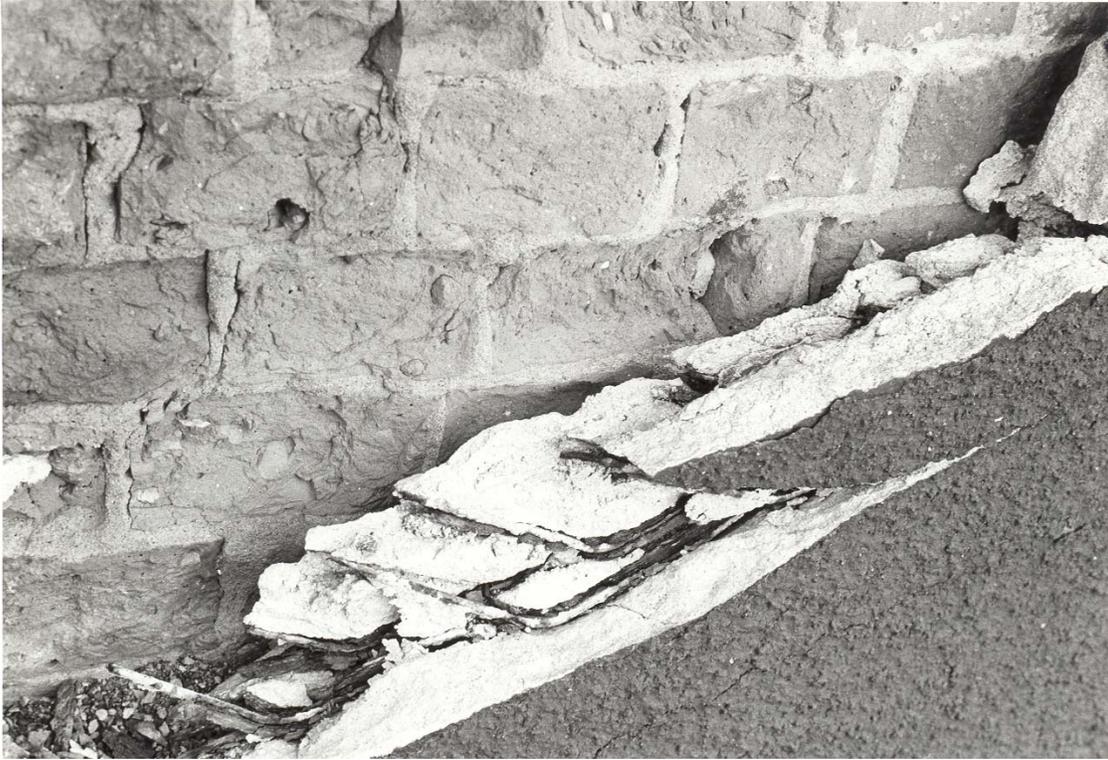
Figure 88. Tower exterior: deteriorated coating and exposed brickwork at Watch Room (1983).

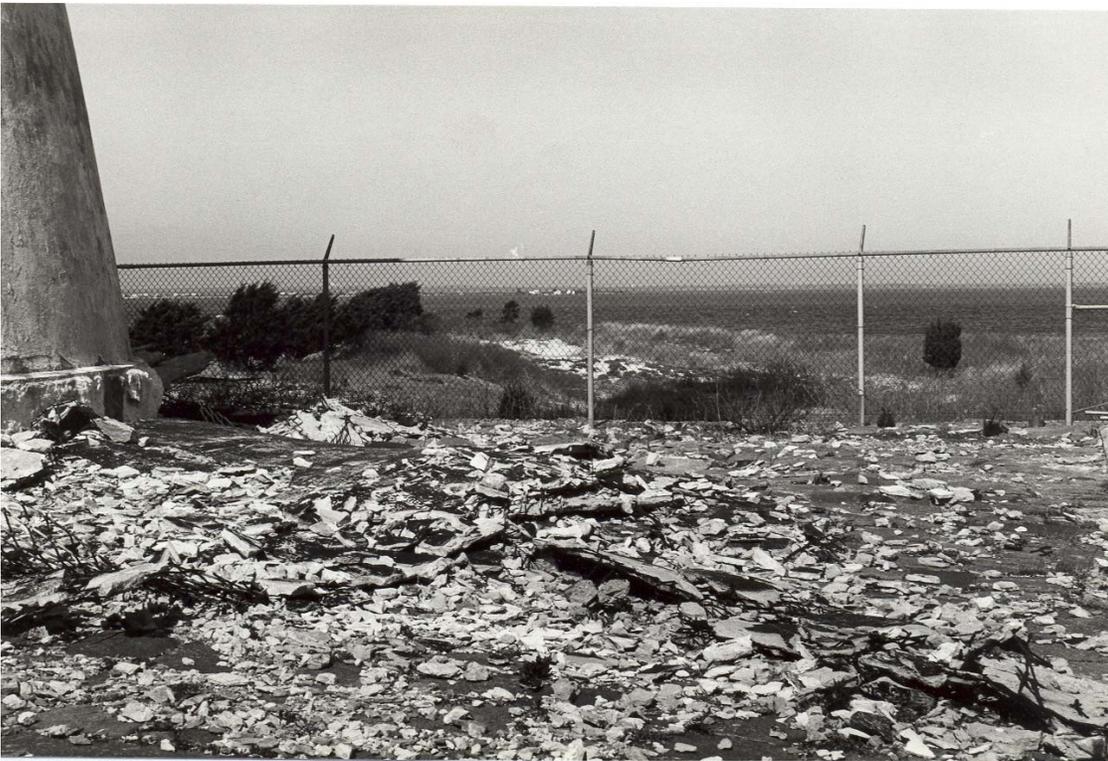
Figure 89. Tower exterior: protective coating debris at base of tower (1983).

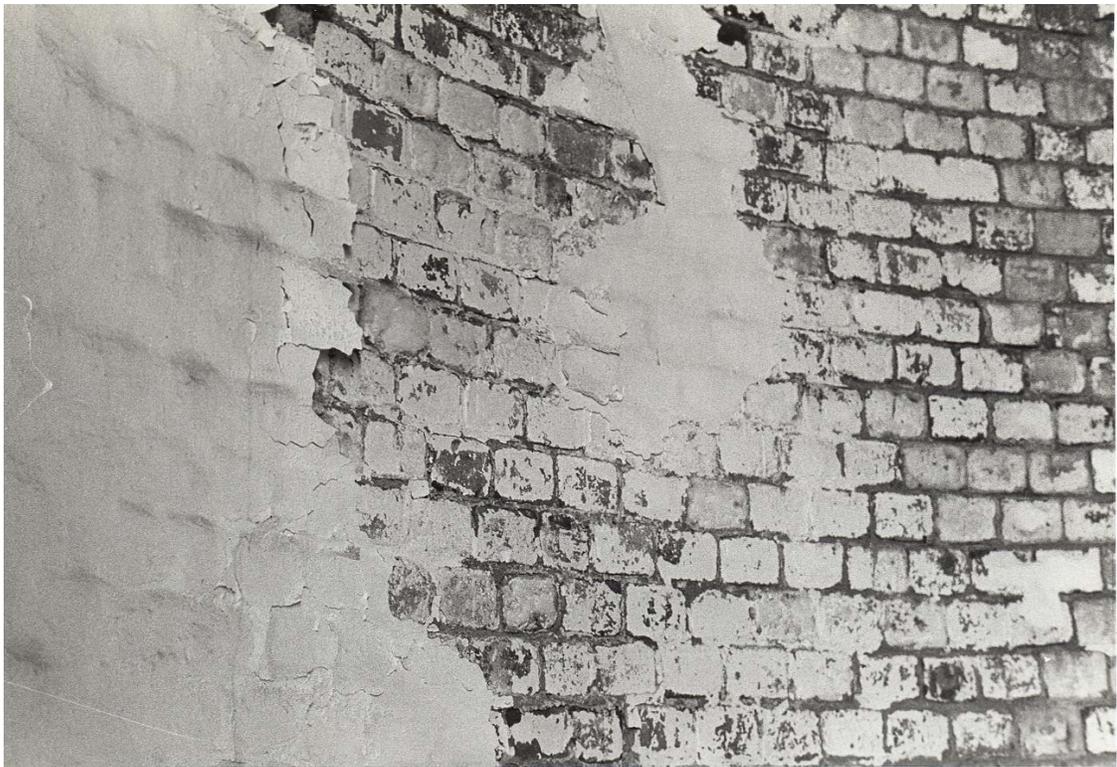
Figure 103. Tower interior: deterioration of wall whitewash (1982).

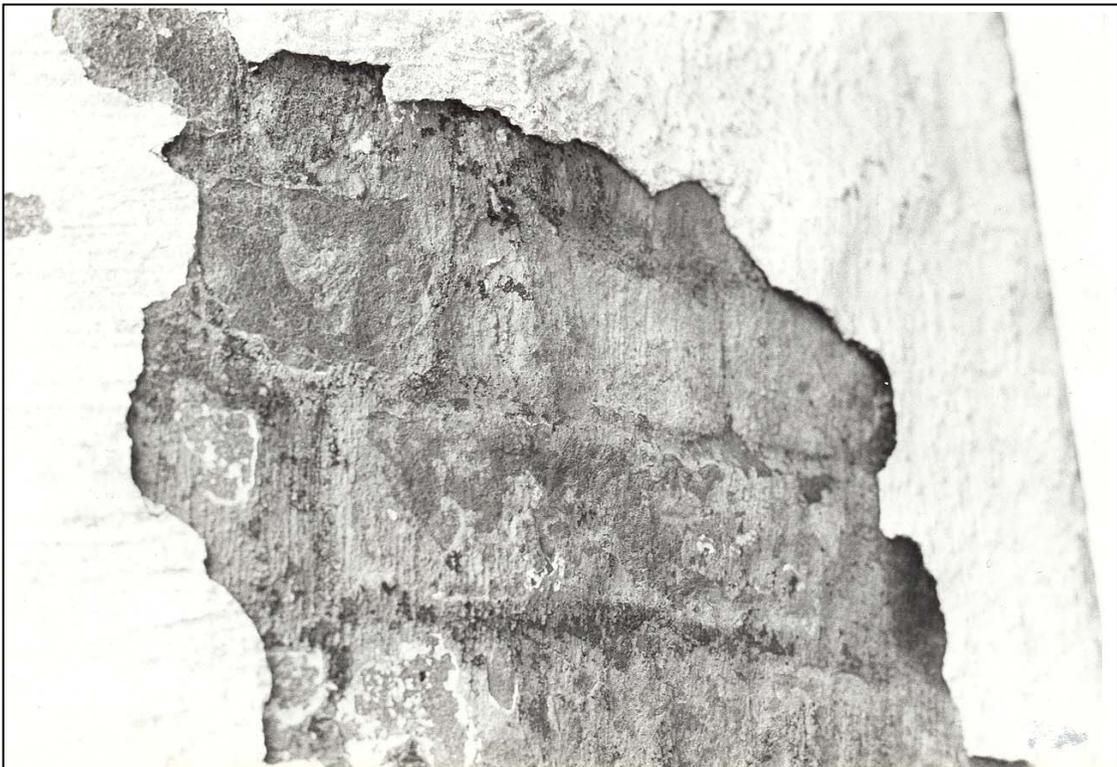
Figure 104. Tower interior: deterioration of wall whitewash (1982).

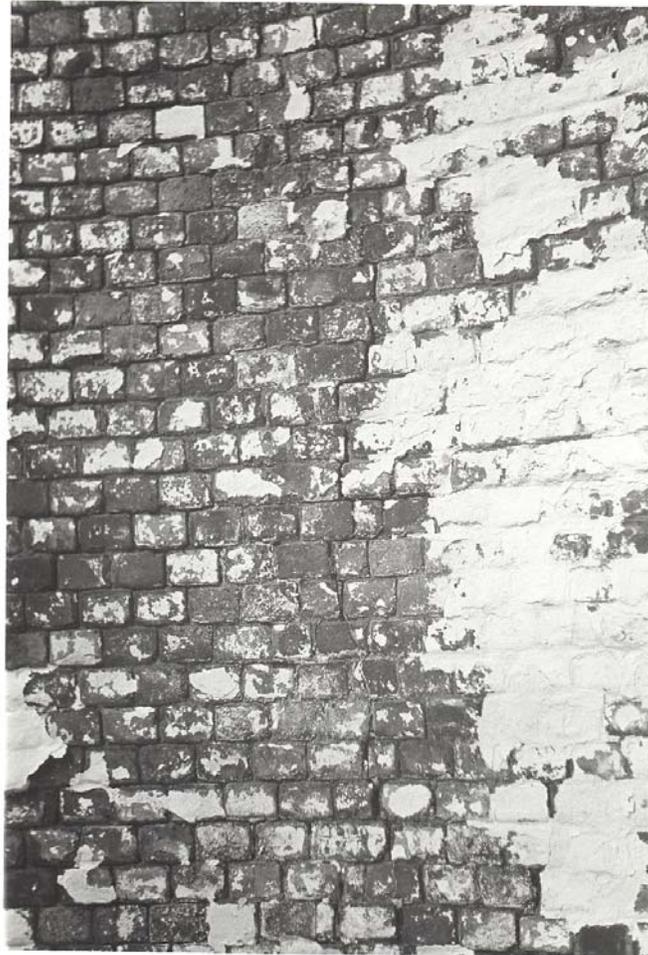
Figure 105. Tower interior: vertical crack in wall brickwork (1983).

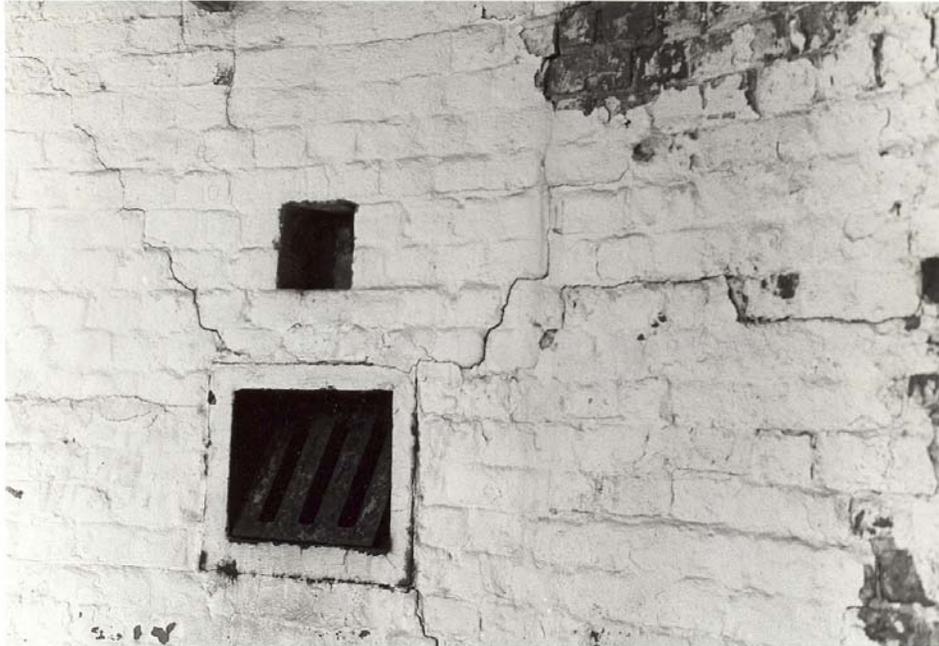
Figure 106. Tower interior: Watch Room, cracks in wall brickwork (1983).

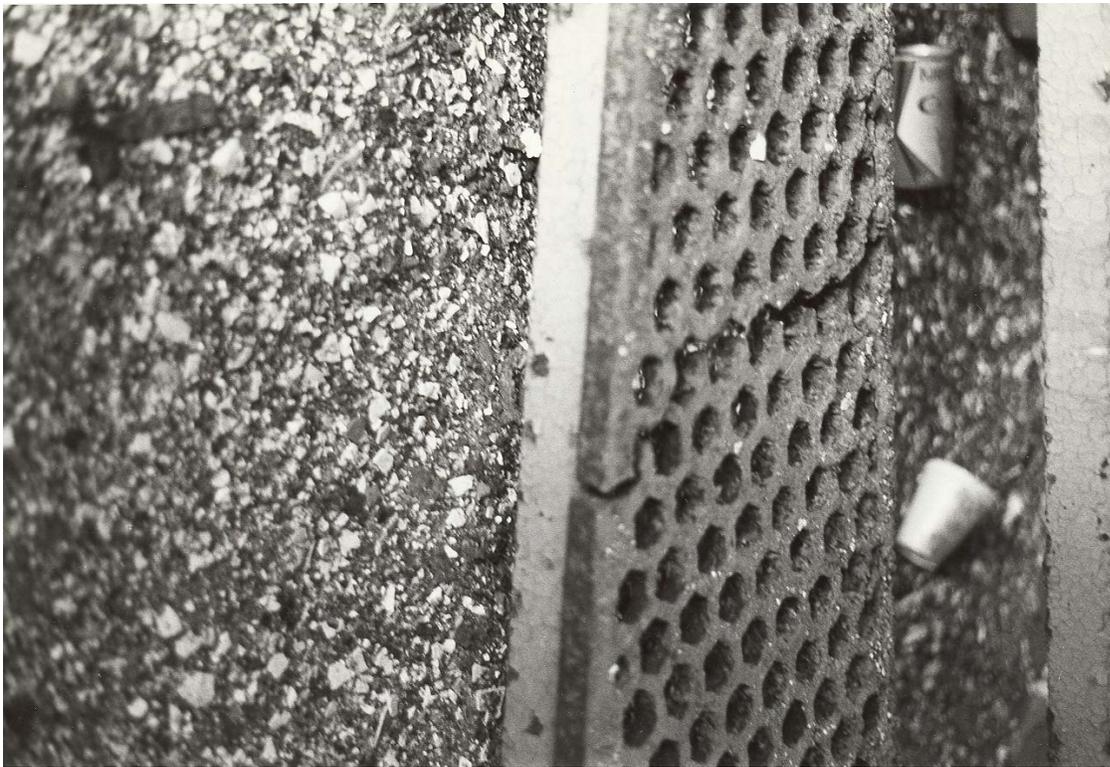
Figure 135. Tower interior: main stairway, deterioration of steps (1983).

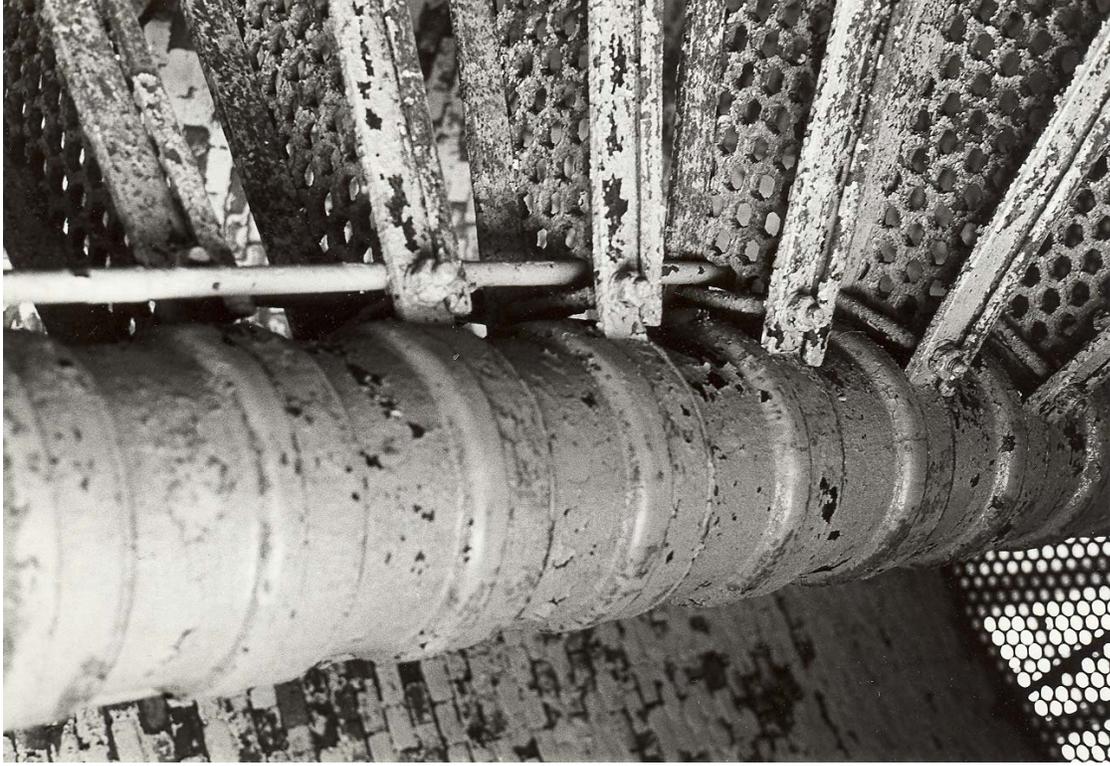
Figure 136. Tower interior: main stairway, deterioration of paint (1983).

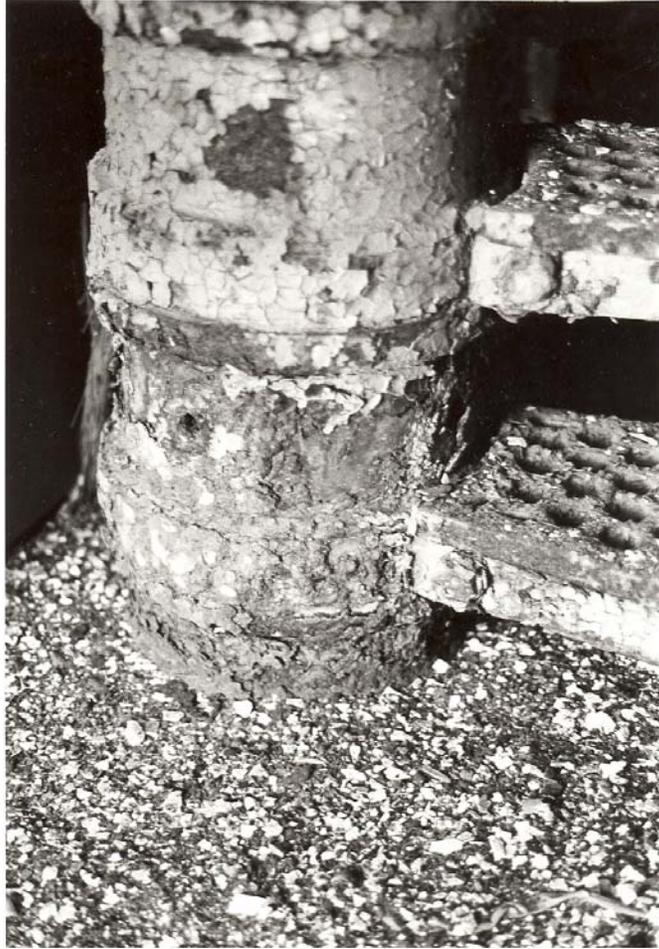
Figure 145. Tower interior: central column corrosion (1983).

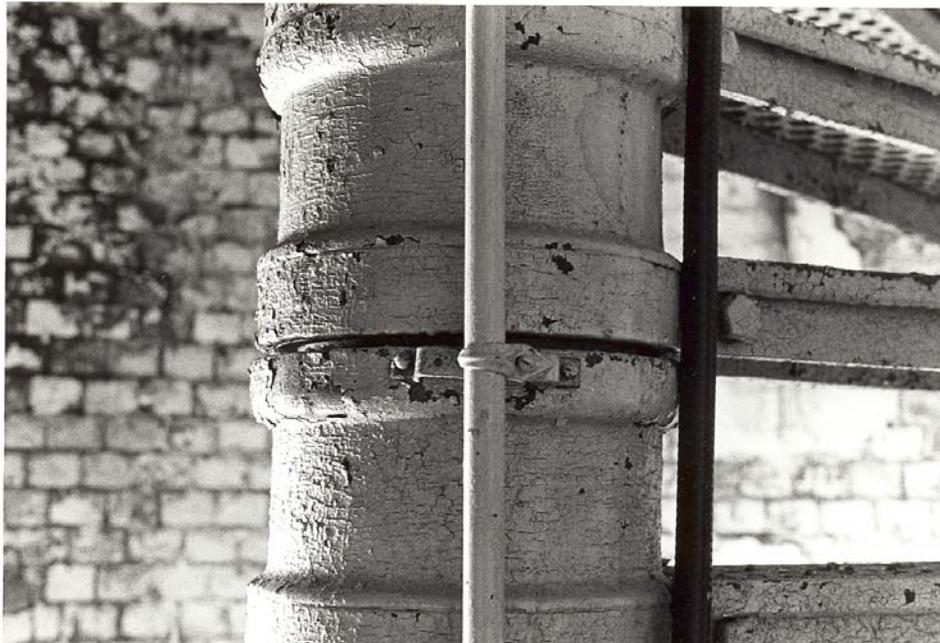
Figure 146. Tower interior: central column, seam separation (1983).

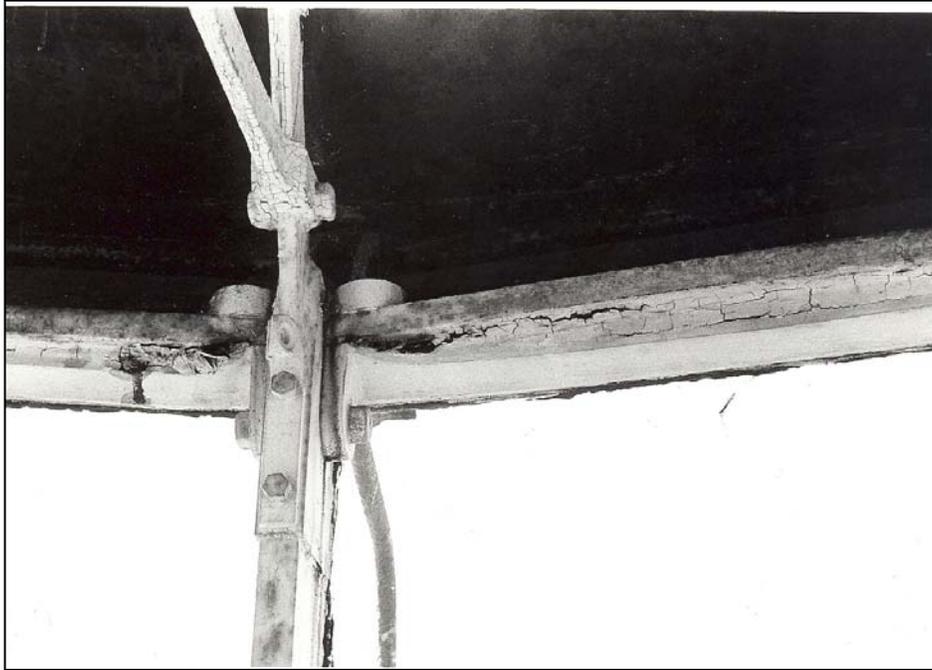
Figure 193. Tower interior: lantern cornice area, deterioration of fittings (1983).
