SPECIAL HISTORY STUDY
MASONRY FORTS
OF THE NATIONAL PARK SERVICE

Prepared by
F. Ross Holland, Jr.
Russell Jones

DENVER SERVICE CENTER
HISTORIC PRESERVATION TEAM
NATIONAL PARK SERVICE
UNITED STATES DEPARTMENT OF THE INTERIOR
DENVER, COLORADO

AUGUST, 1973

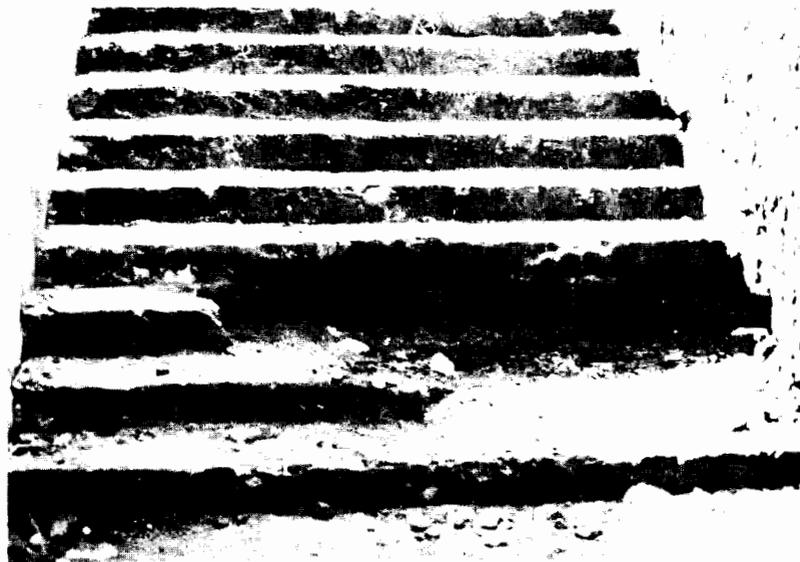
Conditions are hazardous to the visitor.

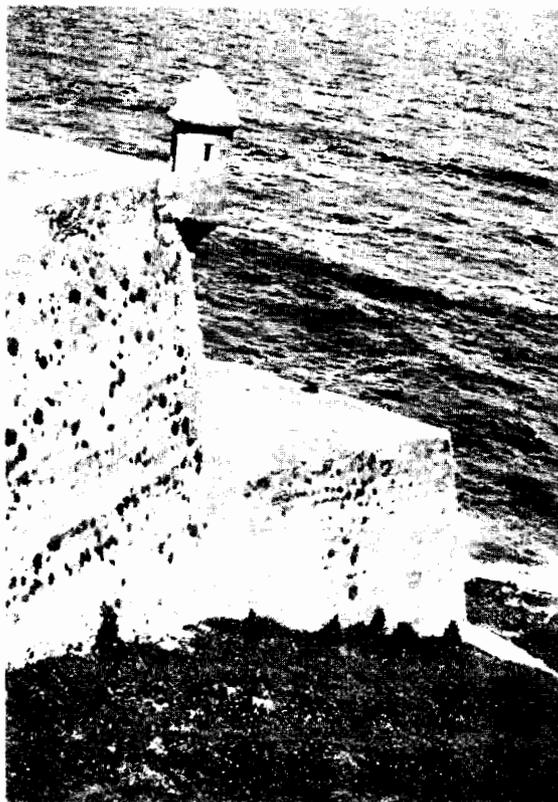
Erosion of the seaward side of San Cristobal is very evident in this photograph.

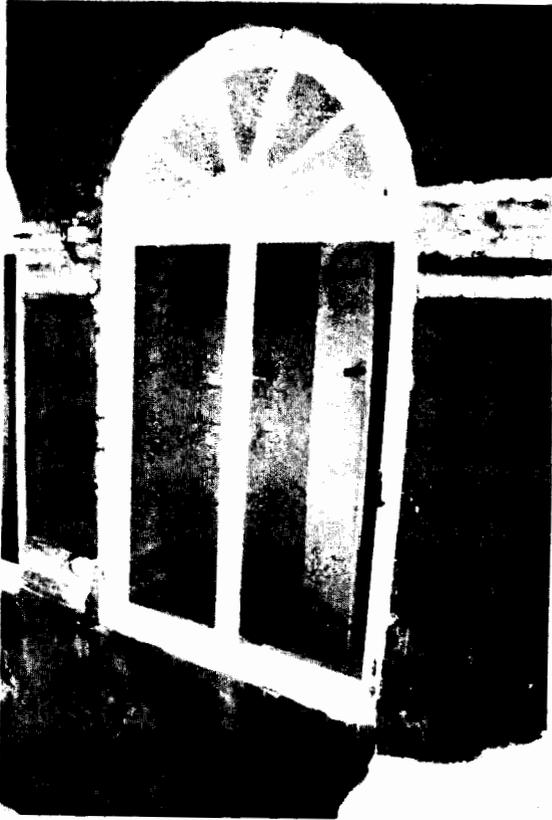
The windows, door and wood construction in general need repair and restoration.

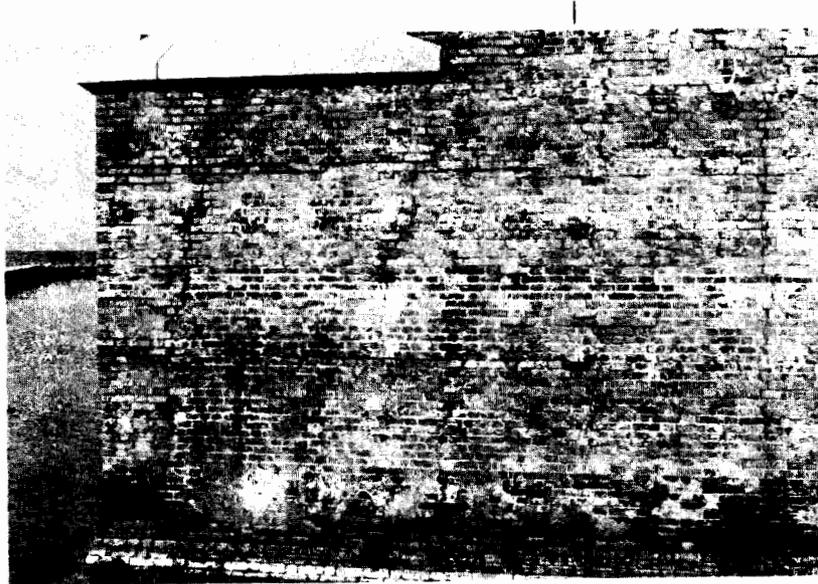
In places where the cracking of the walls is serious foundation repairs will probably have to be made. Other areas may only require minor wall repair and repointing of the cracks.

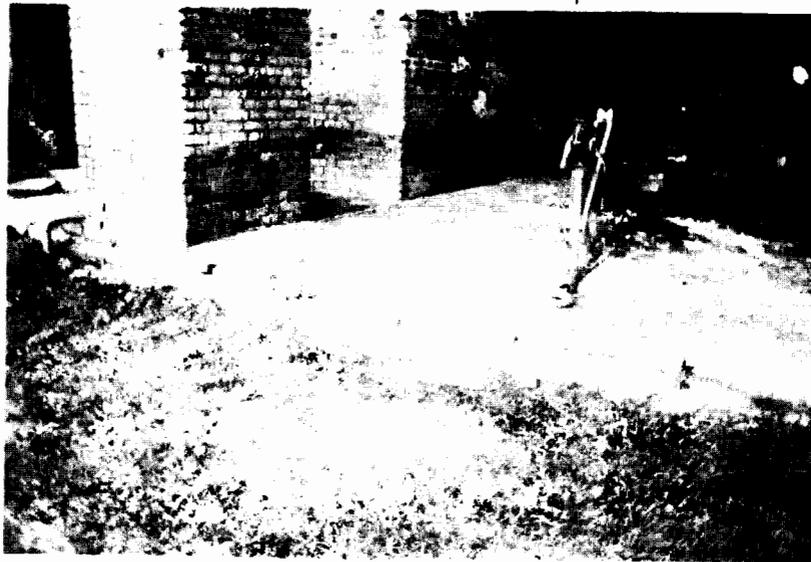
View of counterescarp showing condition and stabilization of the counterescarp.

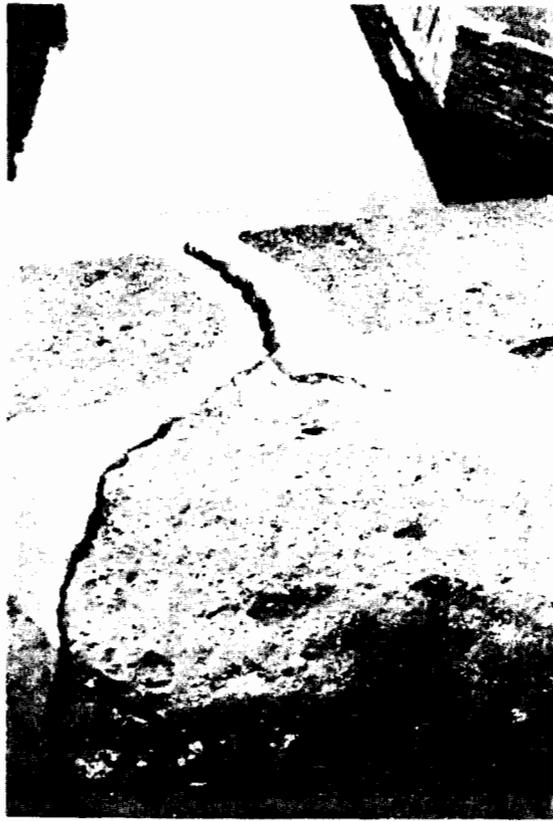
Cracks permit water to seep into walls and the rooms below.

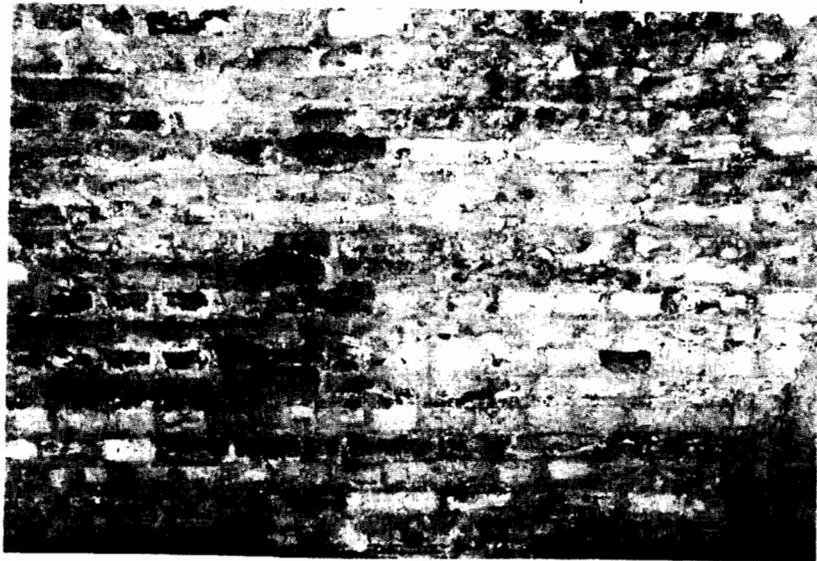
Some repair and repointing of the brick walling is required.

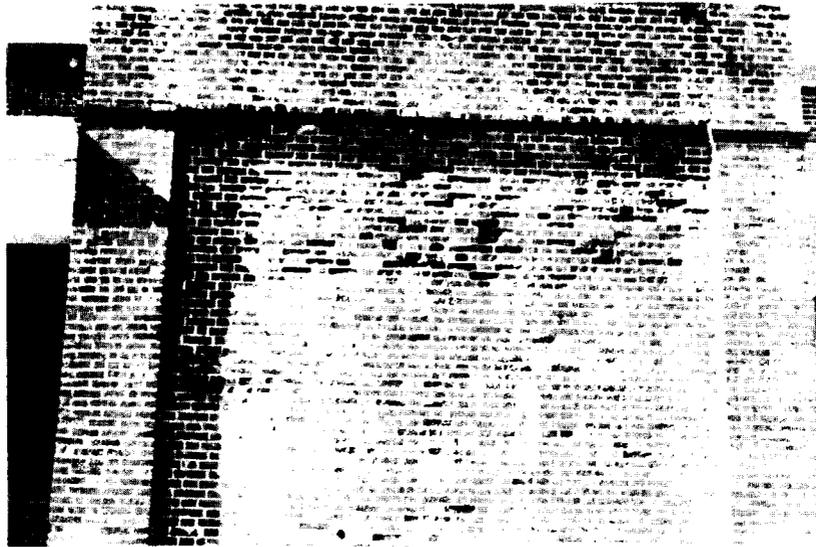
If some of the mortar joints should be replaced to stop the flow of water into the soot ways.

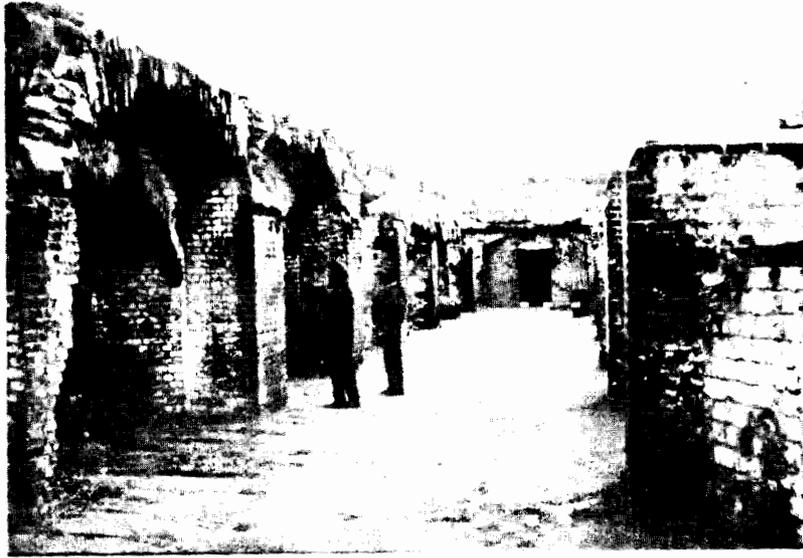
Extensive repair and repointing of the masonry remains is necessary to preserve the structure.

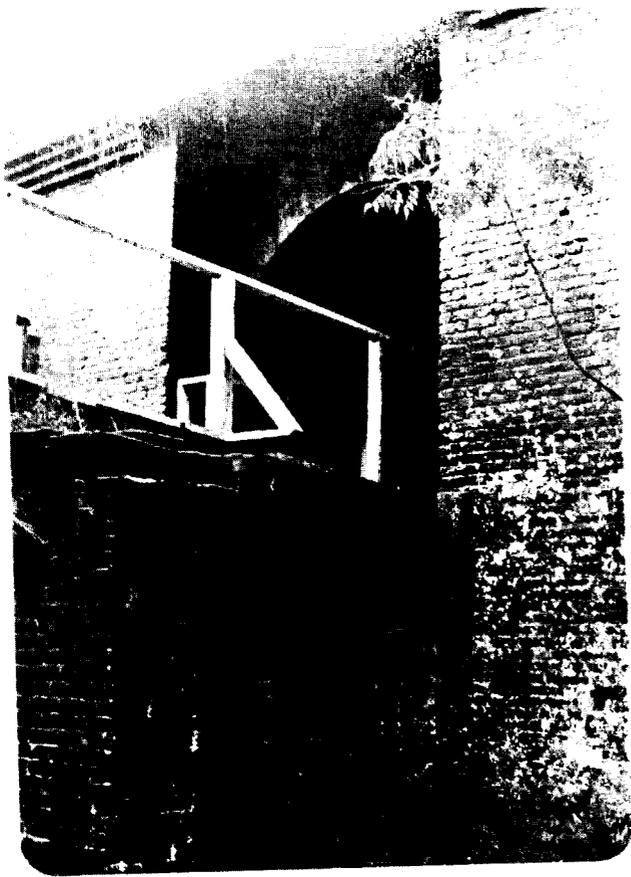
The condition of the wall in part will require the replacement of bricks, repointing and repair work with the reconstruction of drainage and gutters.

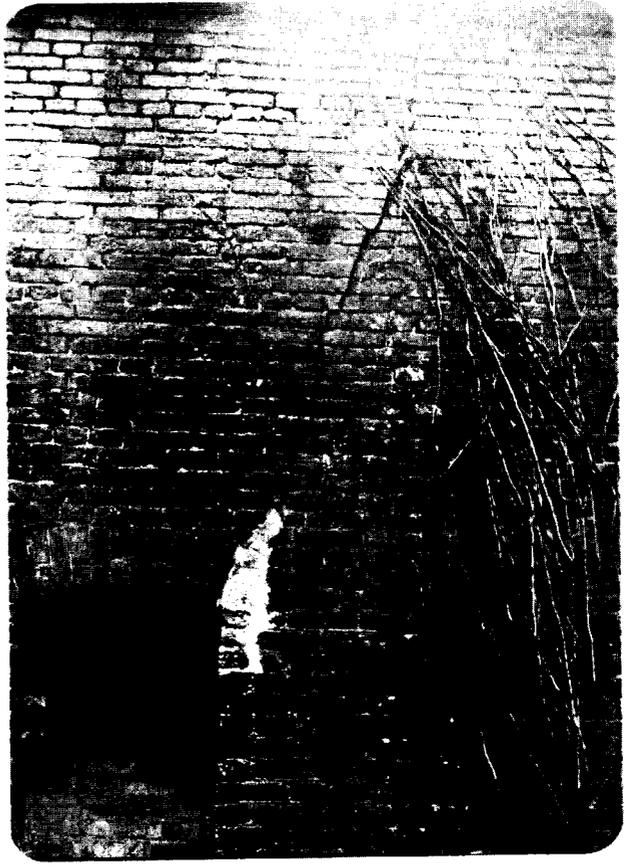
The foot walls are cracked in a number of places. In some cases corrective of this condition will require extensive stabilization. In others only grouting will be necessary.

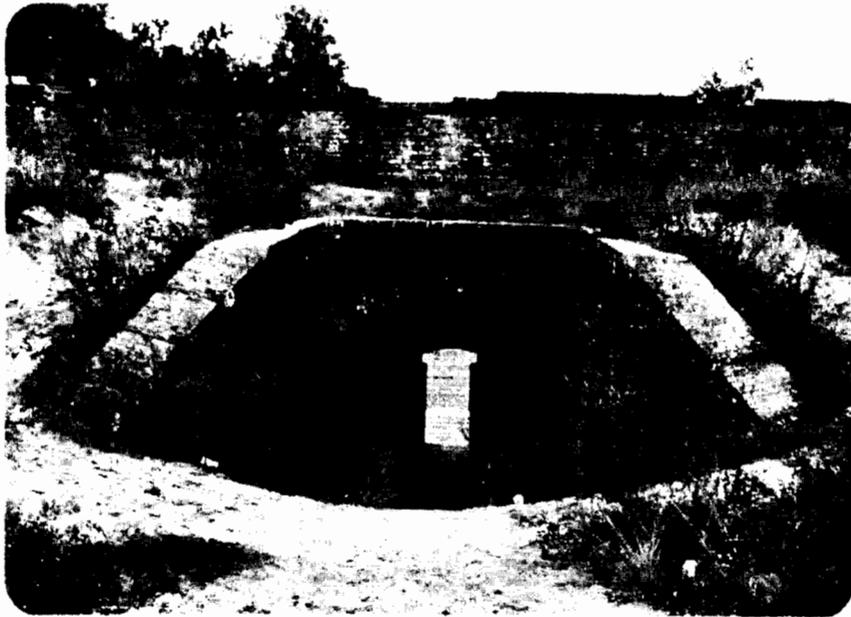
The interior of the fort is covered by vegetation which is not to be removed. The present ground level inside the fort must be excavated to the original grade.

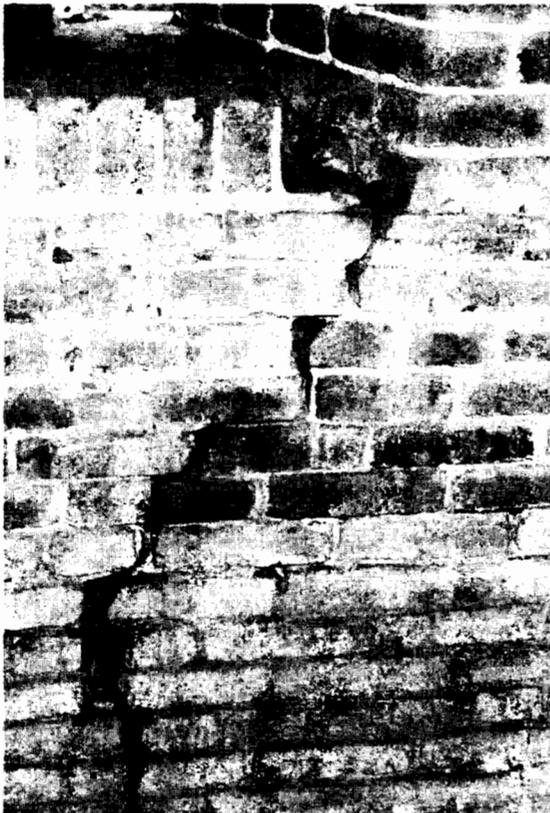
In several places wall cracks extend completely through to the interior face.

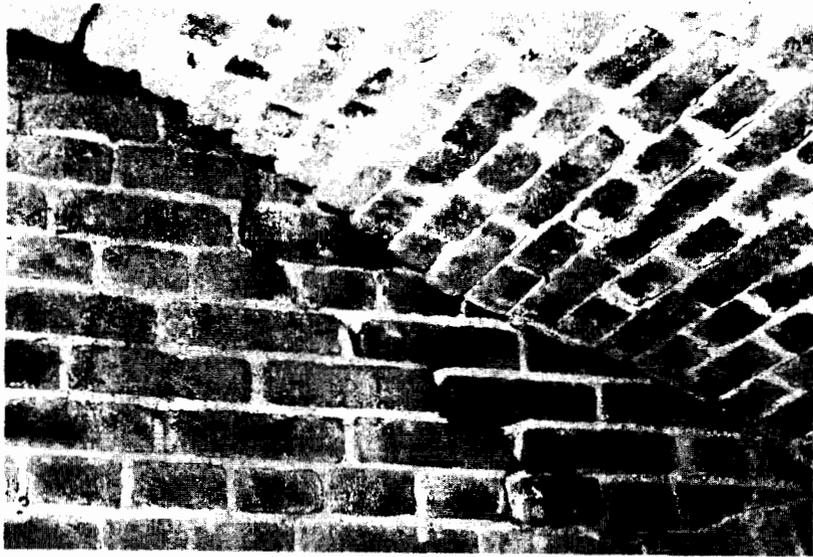
The curtain or exterior wall is not bonded to the vaulted ceilings of the gun rooms. It must be determined if this gap between the two surfaces was created by wall movement or construction error.

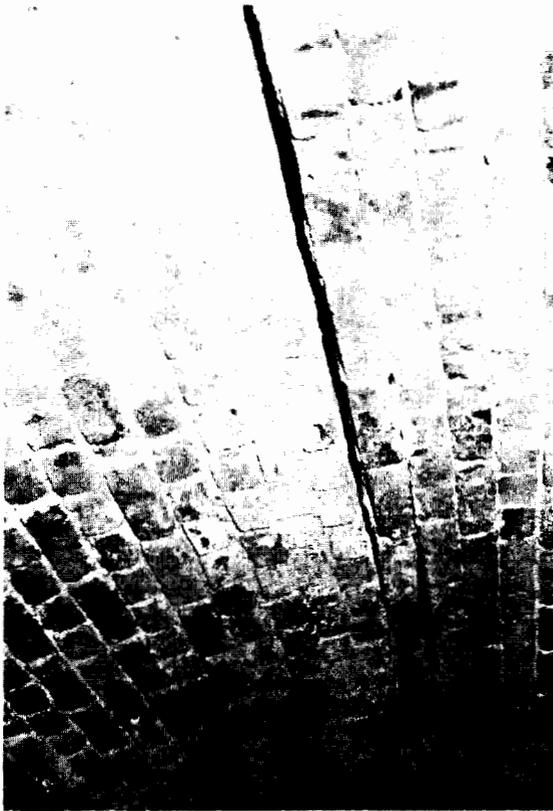
Repointing of the interior masonry will close the ceiling cracks such as this.

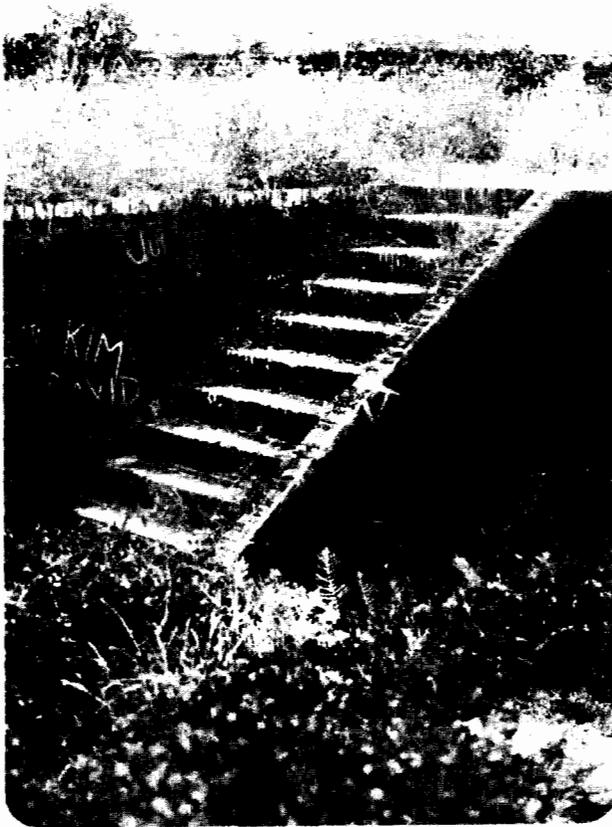
The interior of the battery is overgrown and must be cleared. Vandalism has caused as much damage to the masonry structure as the passing years.

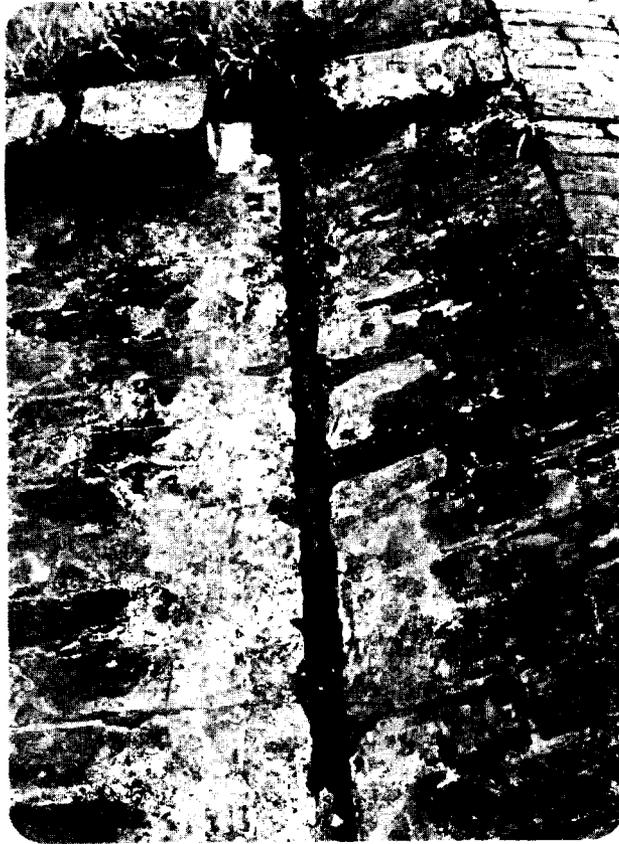
The upper deck and torseplate will require extensive repair and repainting.

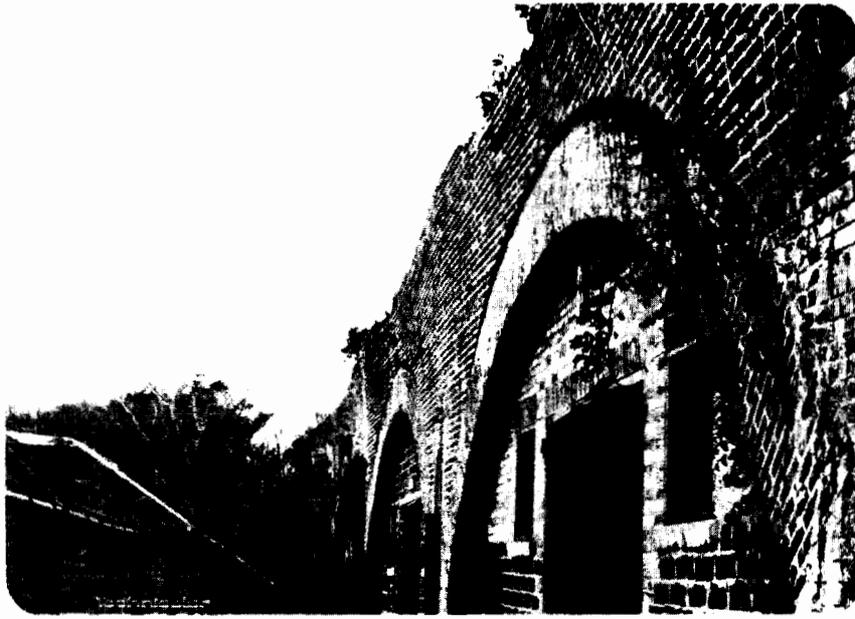
... on the interior our aim is separating from the main structure. The photo collapse can occur at any time. When this condition exists monitoring must be installed and repairs made to make the area safe for public visitation.

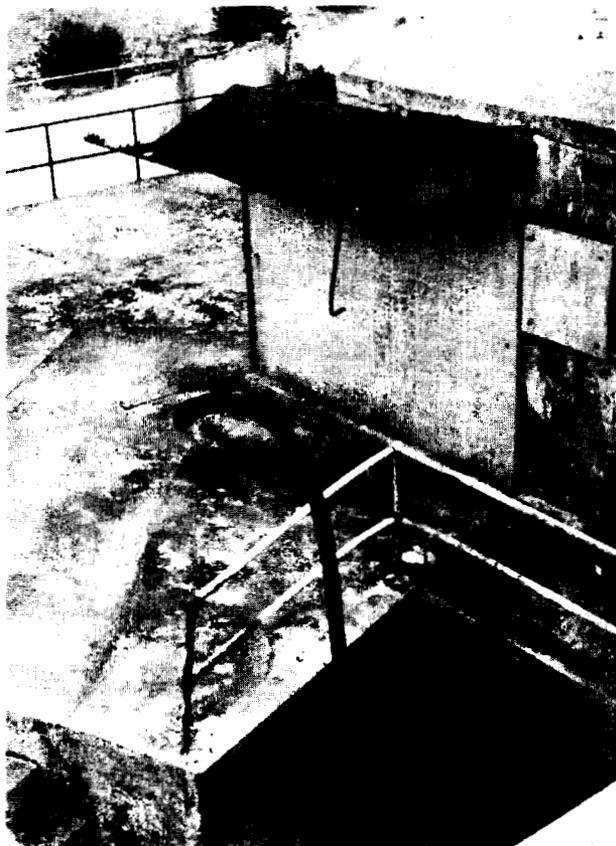
The miscellaneous ironwork has deteriorated to the point of being hazardous to the visitor. Much of it can be removed. When it is essential to the structure it will be restored.

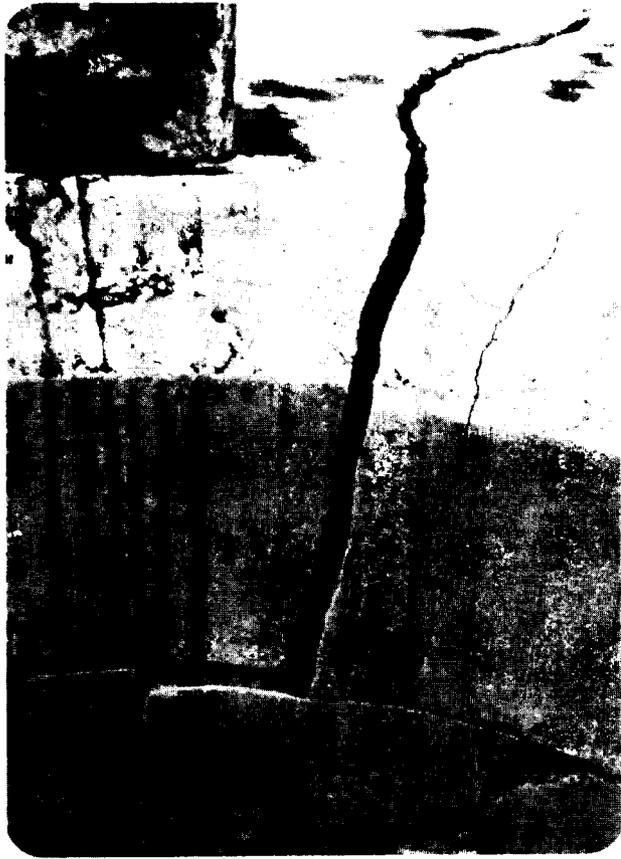
In locations where there are root cracks, such as this, can be grouted to stop the free passage of water.

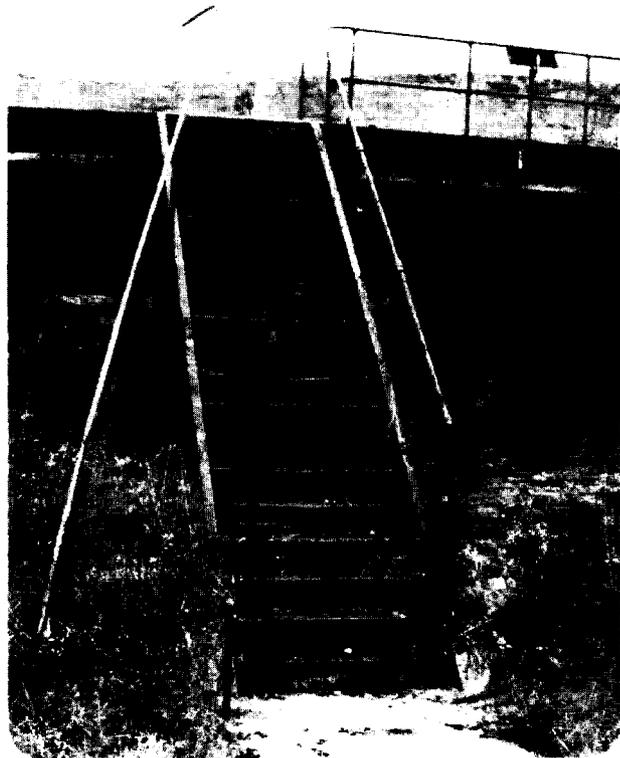
With stairs and railings rusted, they must be restored for the safety of the visitor.

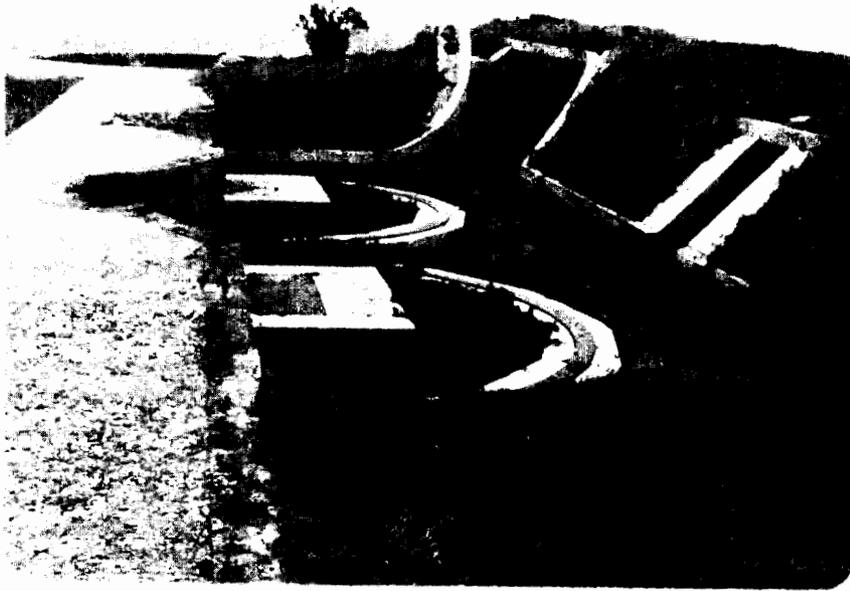
The earth surfaces of the temple are covered with vegetation which must be removed before any work can be done. Note the splendid condition of the gas points.

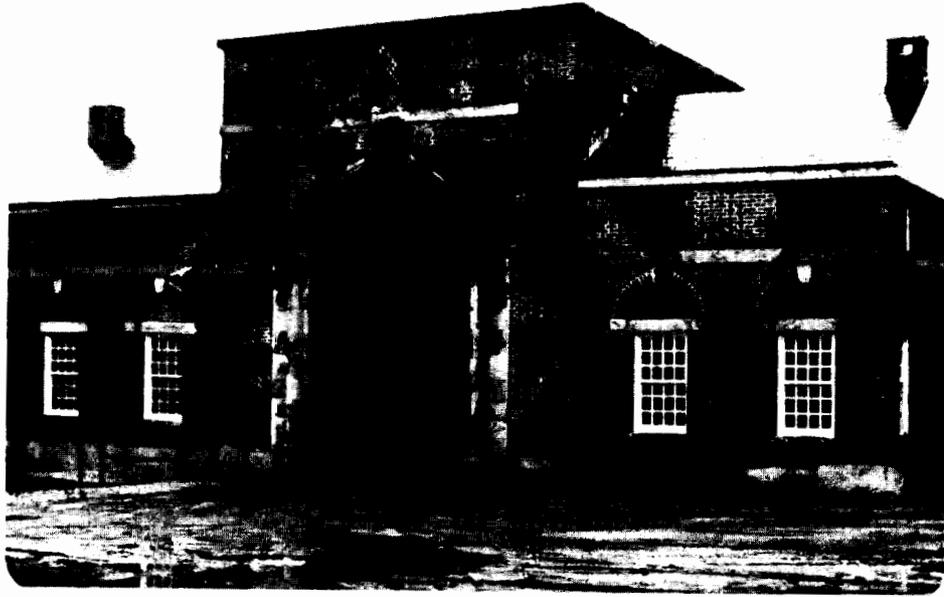
Sill's port, Fort Washington. Note the deterioration of the brickwork and the modern brick patches which must be removed and replaced with reproductions of the original brick.

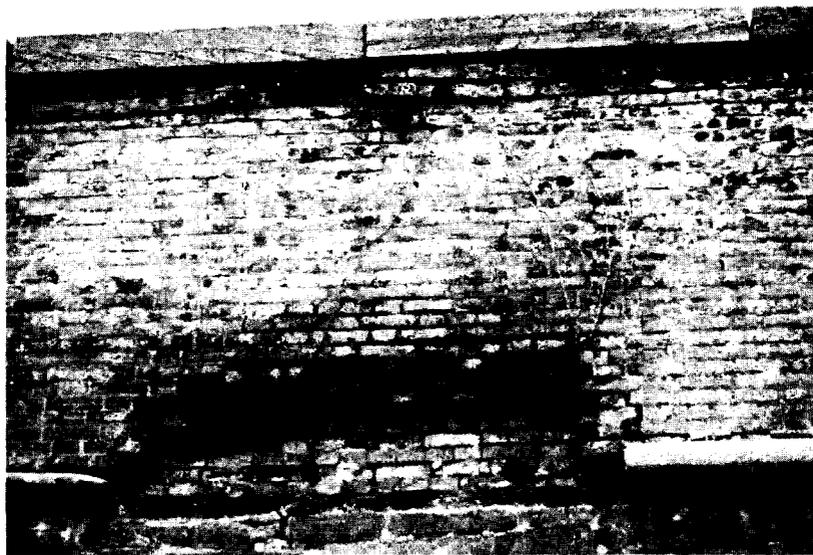
Deteriorating brick above coping in south wall of fort.

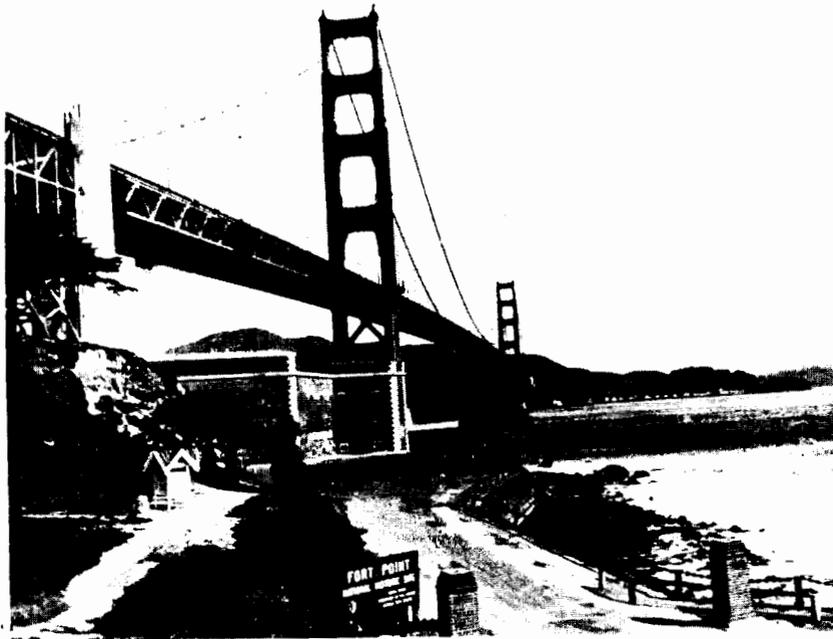
A general view of Fort Point showing its position relative to the older Gate Bridge. Falling or thrown objects from the bridge pose a serious hazard to the visitor.

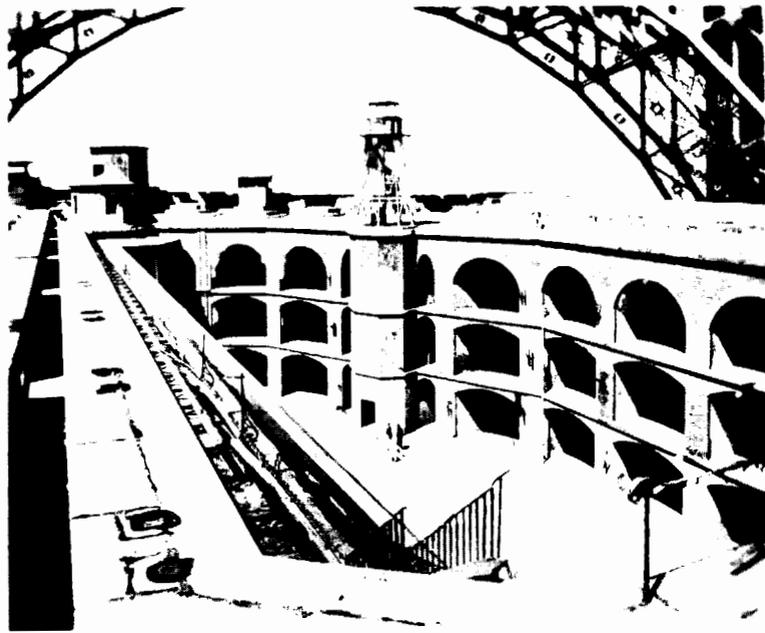
The metal stair and guard railings, seen in the foreground, have deteriorated beyond repair and will be replaced. Note the condition of the lighthouse before restoration. Deterioration of the brickwork can be seen on the face of the masonry.
