SPERMACETI COVE LIFE-SAVING STATION

Fort Hancock, New Jersey
Sandy Hook Unit, Gateway National Recreation Area

HISTORIC STRUCTURE REPORT

**James J. Lee III
Architectural Conservator**

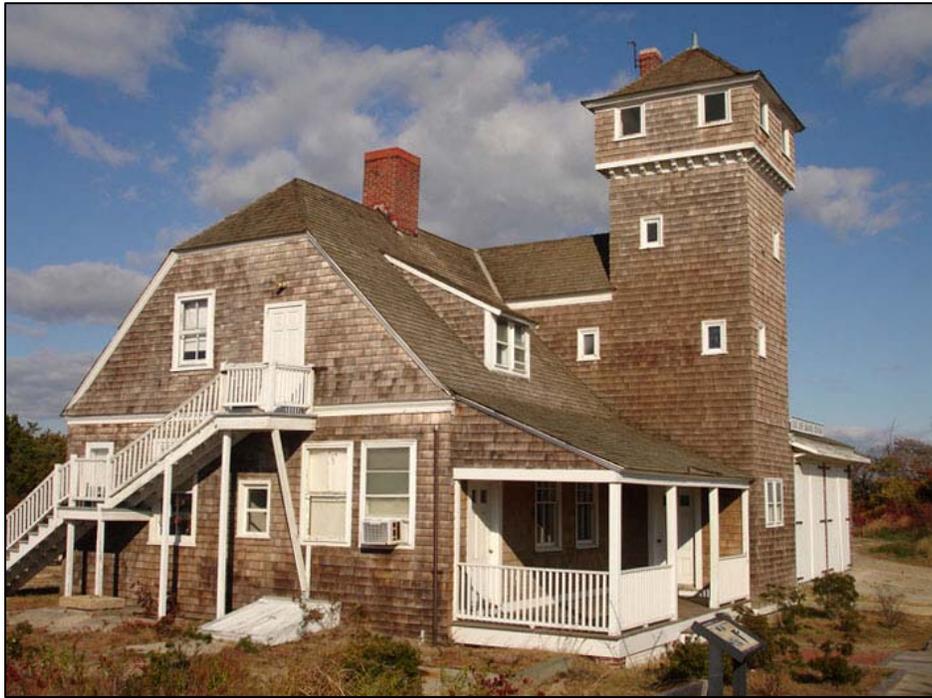
The exterior trim elements are currently finished with white paint that is degraded on some surfaces. This includes all cornice trim, window trim, and window sashes, as well as porch elements. Historic photographs indicate that these elements were historically painted but were probably finished in a different color. It appears as though the trim was painted with a light color and the sashes were painted with a darker color. Analysis of the exterior paint samples supports the documentary evidence.
