George Rogers Clark National Historical Park

*Cultural Landscape Report/
Environmental Assessment
January 2008*

George Rogers Clark National Historical Park
Vincennes, Indiana

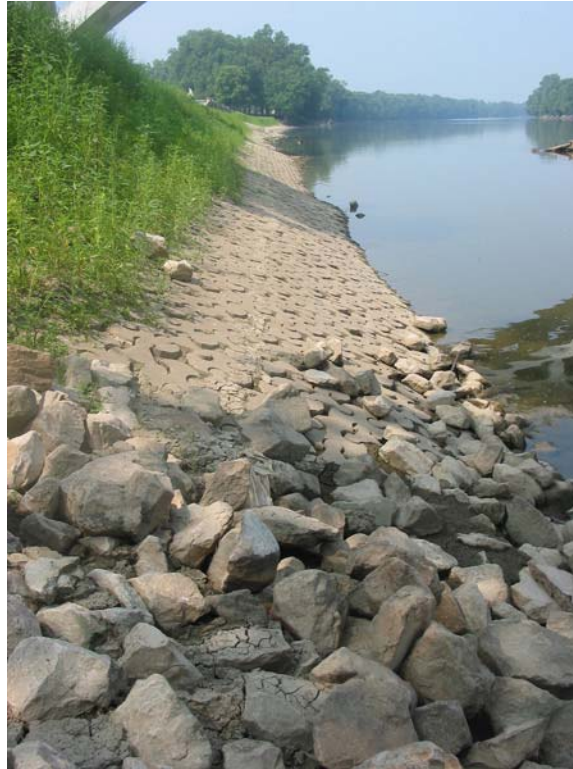
and a PMIS⁷ project has been created for this project in order to obtain funding and approval for these efforts. Since natural vegetation does not extend to the riverbank and erosion control measures are necessary, the condition of the riverbank is fair.

Figure 3.1: Tri-Lock and rip rap line the river edge within the park boundary, Photo by The Jaeger Company, 2005.

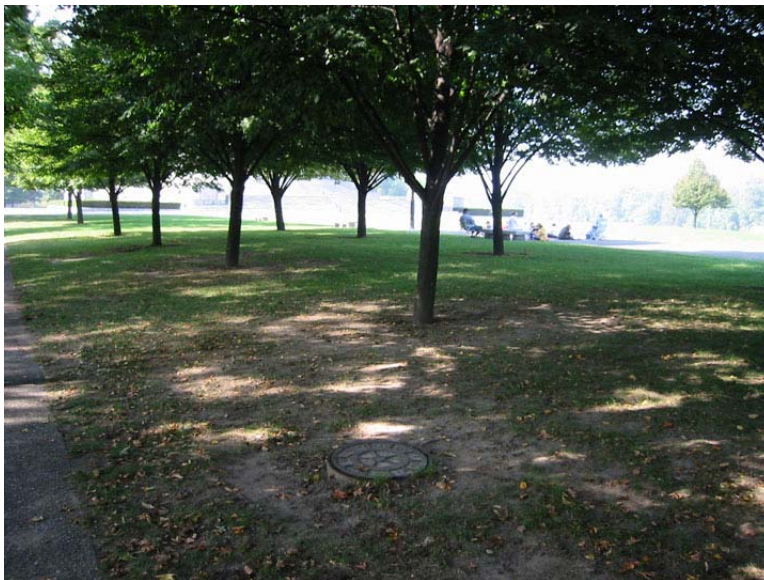
Figure 3. 4: Lawn beneath linden trees is in poor condition, Photo by The Jaeger Company, 2005.

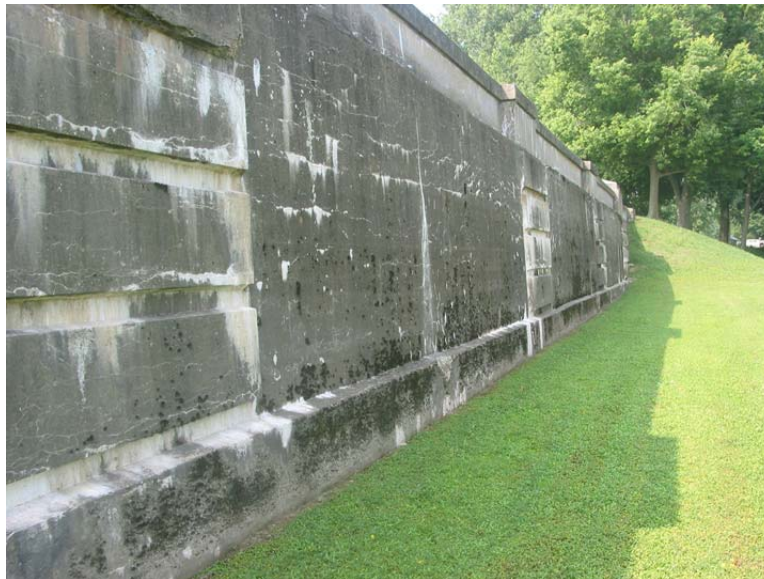
Due to the severity of the spalling and cracking of the Wabash River Floodwall (see Figure 3.16 – Figure 3.19), the condition of this element is poor. Existing conditions reports and repair plans for the Floodwall were conducted in 1989 and in 2005. Funding has been proposed to implement the 2005 plan.

Figure 3.16: Wabash River Floodwall, southern portion, Photo by The Jaeger Company, 2005.

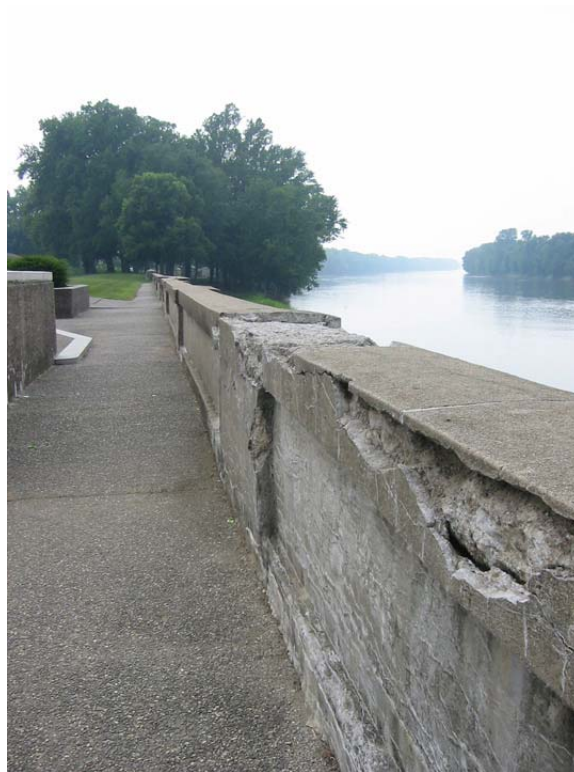
Figure 3.18: Wabash River Floodwall, view of spalling and cracking, Photo by The Jaeger Company, 2005.

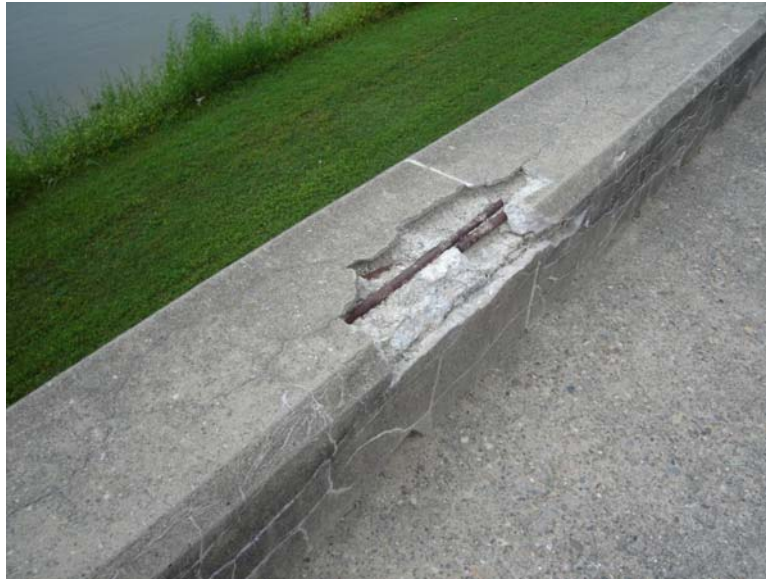
Figure 3.19: Wabash River Floodwall, view of exposed reinforcement, Photo by The Jaeger Company, 2005.

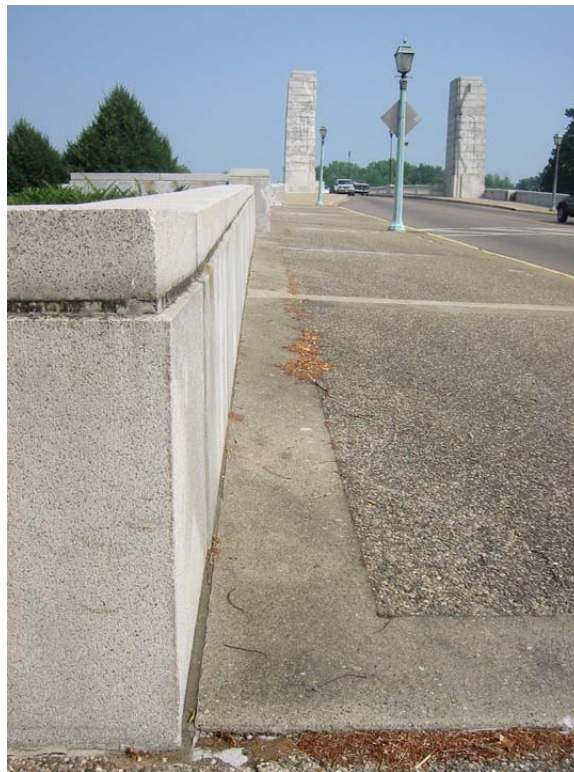
Figure 3.21: Detail of walls and sidewalk on Lincoln Memorial Bridge Approach, note cracking in mortar joints, Photo by The Jaeger Company, 2005.

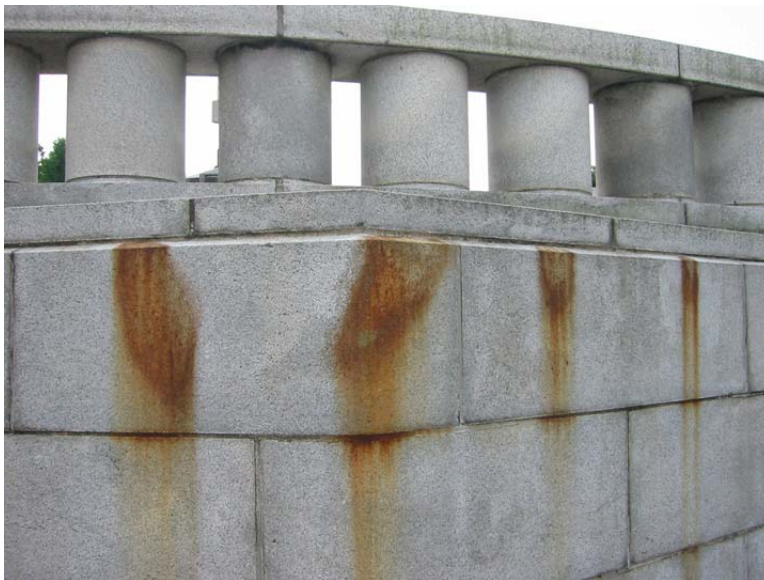
Over time much of the original fabric of the Memorial Grounds has degraded. Walkways have been replaced as necessary when concrete deteriorated. The Wabash River Floodwall is in a state of deterioration and needs to be repaired or replaced in-kind to prevent complete structural failure. The Memorial Terrace has had a history of leaking into the structure's basement causing degradation to the structure itself. The surface of the Terrace has been paved over and replaced several times since construction of the Memorial Building. Funding has been planned for repairs to the Memorial Terrace and Floodwall. Any construction in these areas will require proper staging and the removal/damage of any historic plant materials will have to be mitigated. The North and South Terraces of the Lincoln Memorial Bridge Approach show signs of damage caused by seepage which has been degrading iron reinforcing rods in the structures. Iron rust stains are evident on the facades of both terraces.

Figure 3.27: Detail of iron rust stains below balustrade of North Terrace, Photo by The Jaeger Company, 2005.

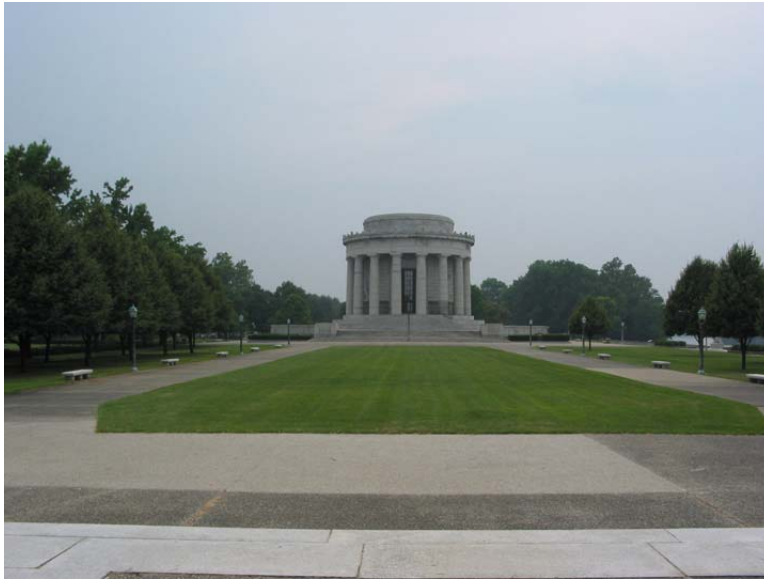
Figure 3.55: Views across the center lawn of the Mall remain unobstructed; however, the linear effect of the view has been diminished by loss of linden trees, Photo by The Jaeger Company, 2005.

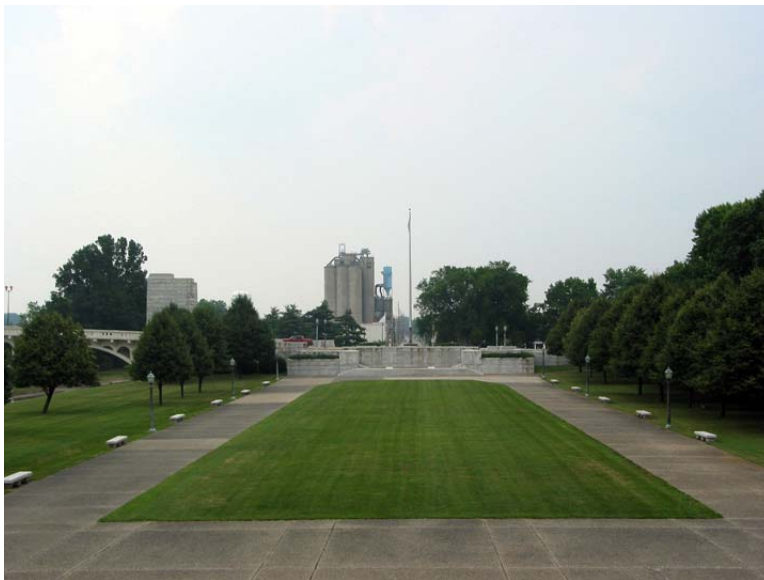
Figure 3.56: View across center lawn from Memorial Building remains true to historic conditions including the view of the grain elevator; however, linear effect of view has been diminished by the loss of linden trees, Photo by The Jaeger Company, 2005.

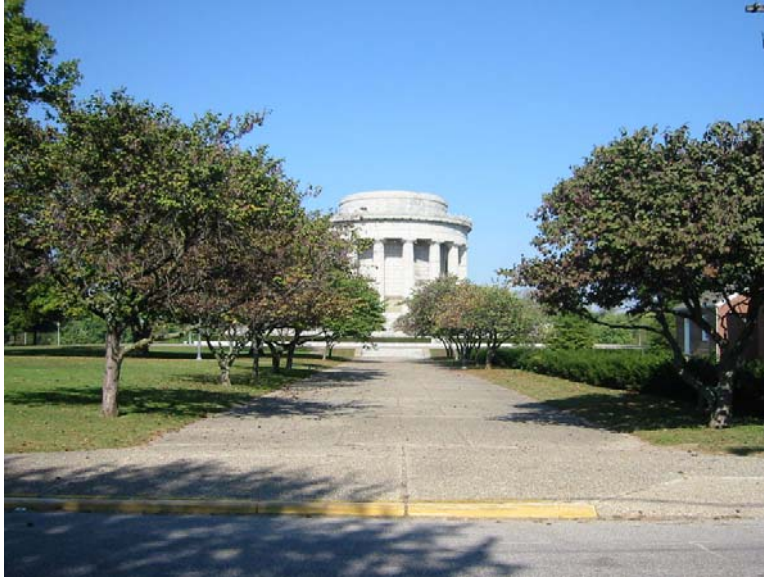
Figure 3.57: The allée of trees lining the Barnett Street Sidewalk is interrupted by missing trees, vista is not consistent with historic conditions, Photo by The Jaeger Company, 2005.
