SAN FRANCISCO  
PORT OF EMBARKATION  
HISTORIC STRUCTURE REPORT

Golden Gate National Recreation Area  
National Park Service

ARCHITECTURAL RESOURCES GROUP

February 1991

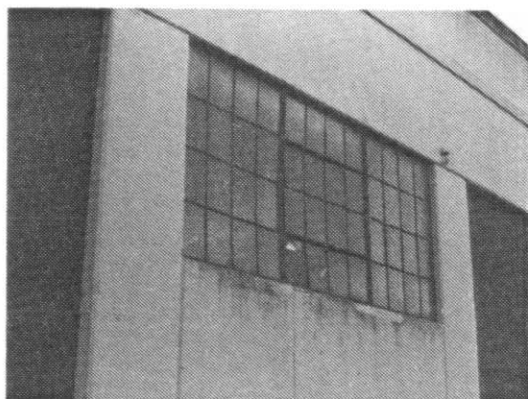
Factory sash in Pier Shed 3 with a bowed frame.

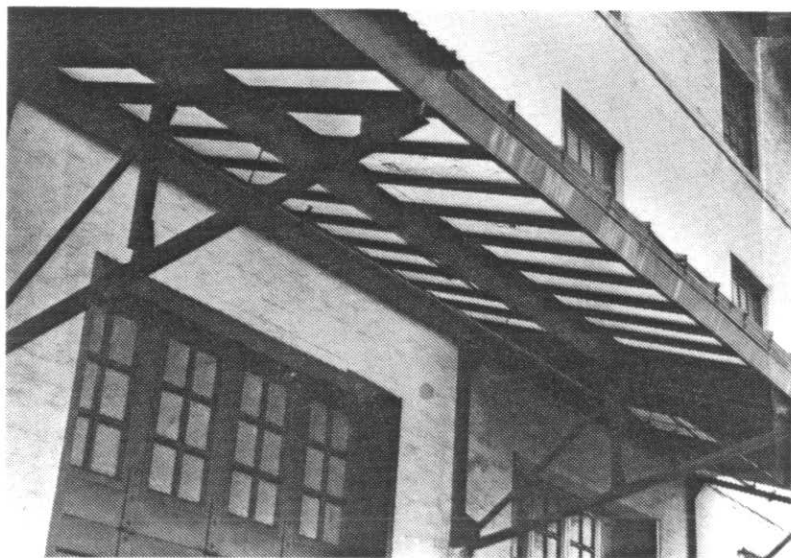
Damaged awning on  
Building 314

1. Repair or replace deformed awning components.
2. Scrape loose or flaking paint and remove all corrosion from metal by wire brush.
3. Prime bare metal and paint all metal using appropriate coating of the same system for use on exterior ferrous metals. Finish coat color should match existing.
4. Check all metal biannually for any areas of corrosion. Remove corrosion and re-coated surface.
5. Areas where birds roost should be covered with specially manufactured bird netting sensitively installed.

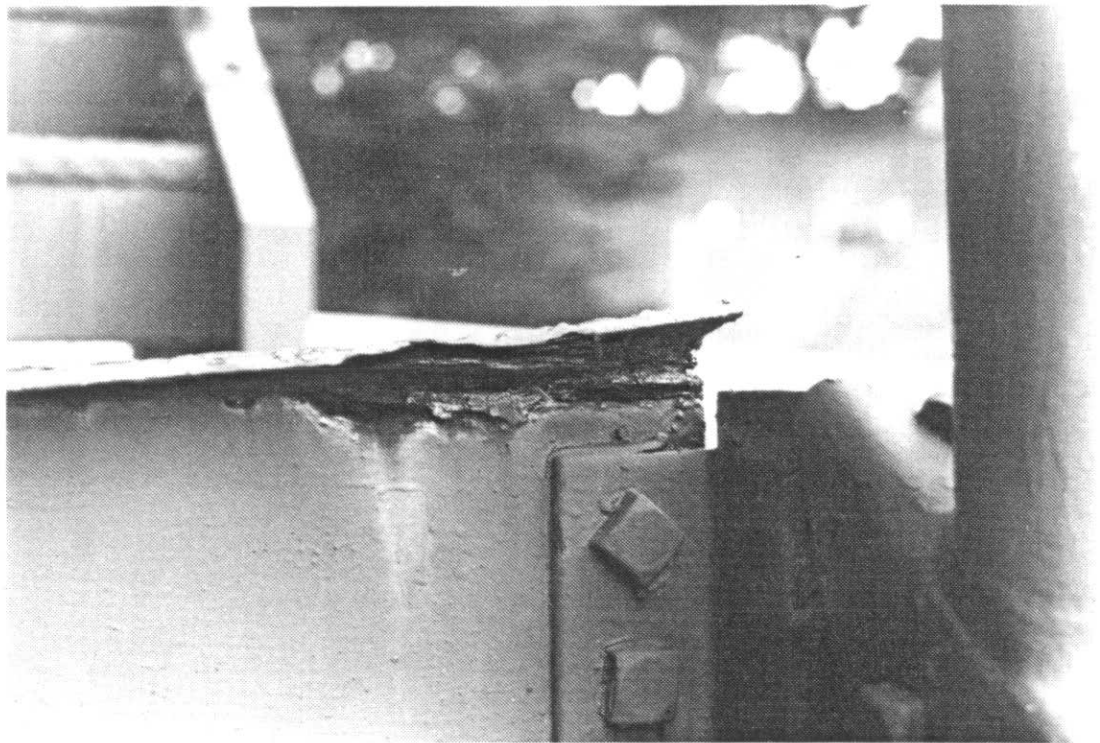
*Corroded section of  
exterior stair landing.*

Fire escape stairways should be surveyed immediately and severely corroded portions repaired. This will involve removing steel that has lost more than 25% of its original dimension and replacing it with new steel welded into place. In some cases it may be more economical to replace entire stair runs. New steel and portions affected by repairs should be coated as described below.

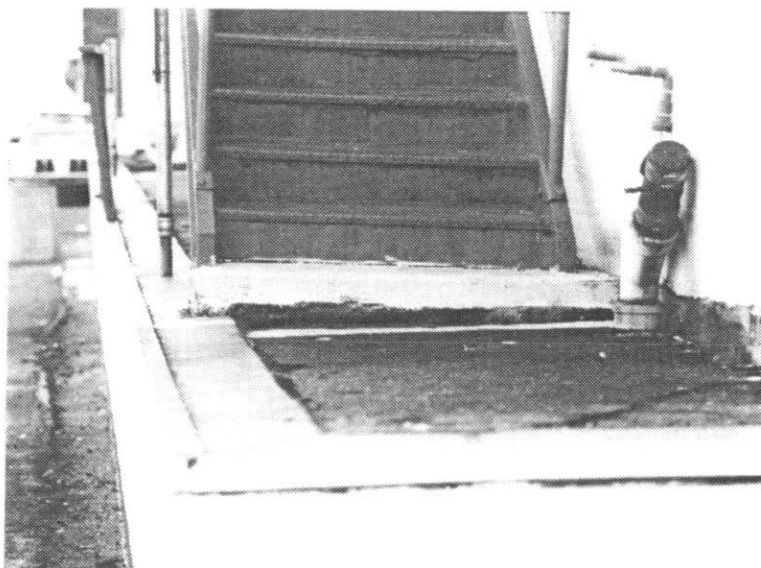
*Settling on a loading dock caused by the 1989 earthquake.*

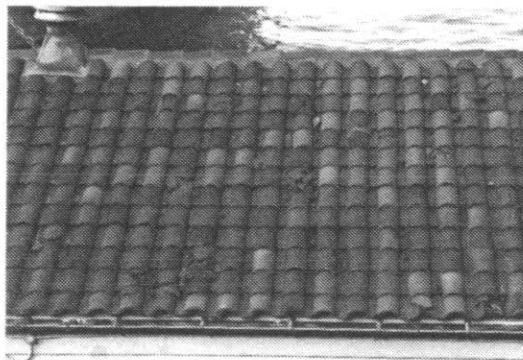
Tiles which no longer retain their original form due to cracking and displacement.

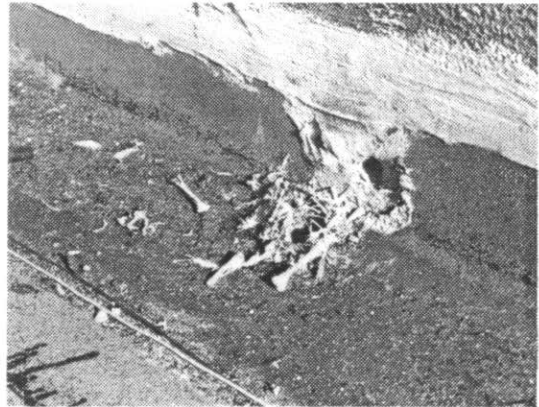
Drains in which debris restricts or stops normal rain water flow are designated as obstructed. Typical obstructions were feathers, bones, and pigeon droppings.

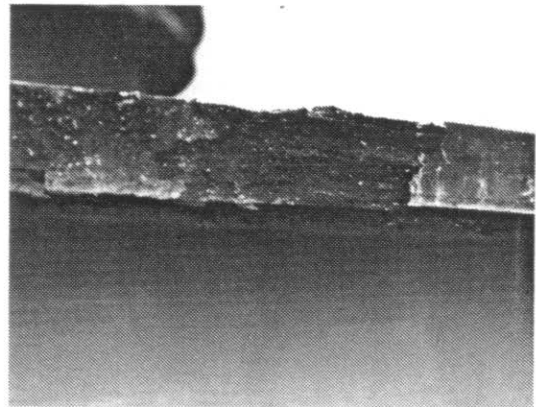
### *Failed Membrane*

Failed Membranes are identified by bubbles, cracks, and areas of loose material.

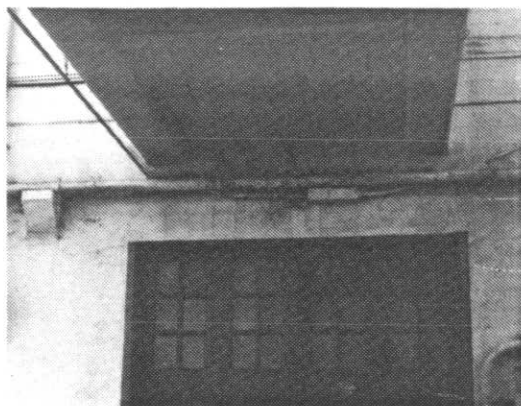
Bird debris is defined as any material which has produced soiling on adjacent materials due to the presence of pigeons. This may include, but is not limited to nests, bones, feathers, and pigeon droppings.

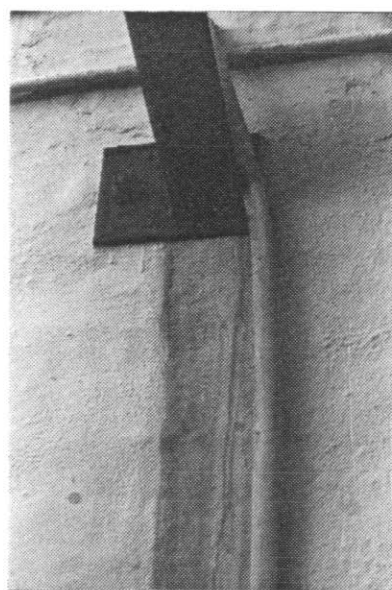
*Biological Staining*

Biological growths producing dark green to black stains on the concrete.

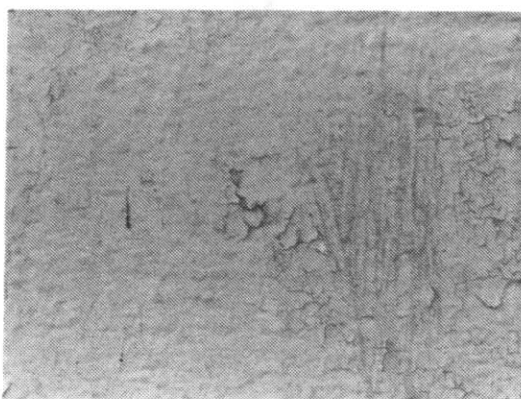
*Ferrous Staining*

Ferrous staining is staining of the concrete surface due to the oxidation of ferrous metal adjacent to, or imbedded in the concrete.

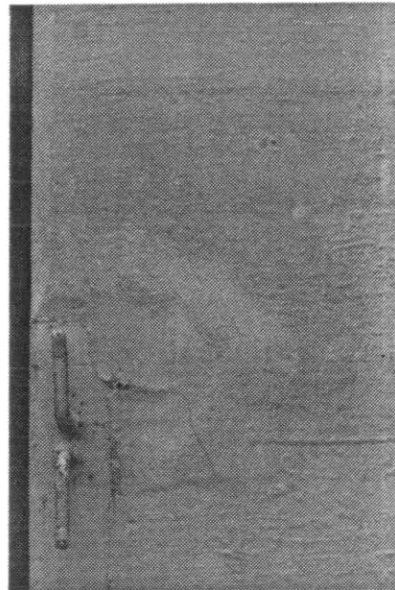
Patches which are of a plastic consistency when applied, and are composed of a cementitious material together with aggregate and a liquid are termed cementitious patches.

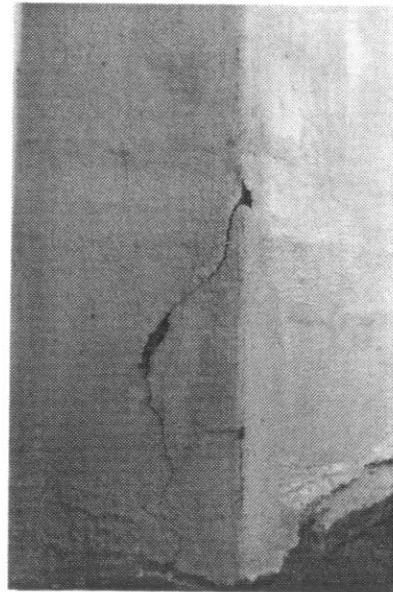
**CRACKS, INCIPIENT SPALLS AND SPALLS** are three conditions typically caused by corrosion jacking of reinforcing bars or imbedded steel anchors. Corrosion jacking is the increase in dimension that ferrous metals undergo during oxidation due to the presence of moisture. Iron oxide (rust) may expand up to eight times the thickness of the original metal. The increase in size exerts great pressure, leading to the rupture of the surrounding materials.

Cracks are fissures in the material of random width and length. A limited number of cracks were observed which varied in severity, and typically ran parallel with the building edges and window and doorway openings.

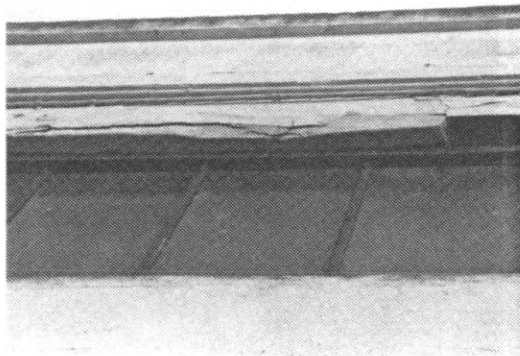
### *Incipient Spalls*

Incipient spalls were noted on all elevations of the pier buildings, and at random locations on other structures primarily at window and door openings.

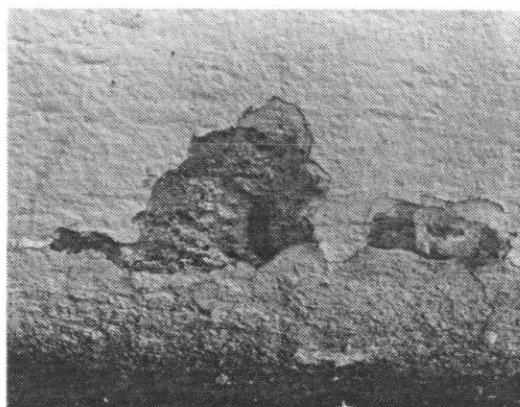
### *Spalls*

Spalls are losses in the concrete surface. Frequently, exposed reinforcing bars are visible in the spall area. Although spalls were observed on all elevations of the buildings, the most severely affected area was on the west elevation of Building 319.

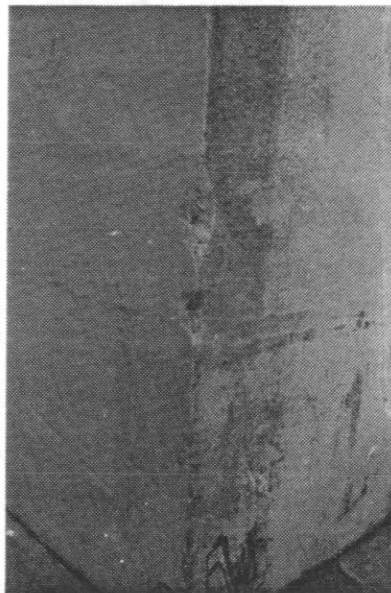
### *Impact Losses*

Losses due to objects striking building, primarily at corners.

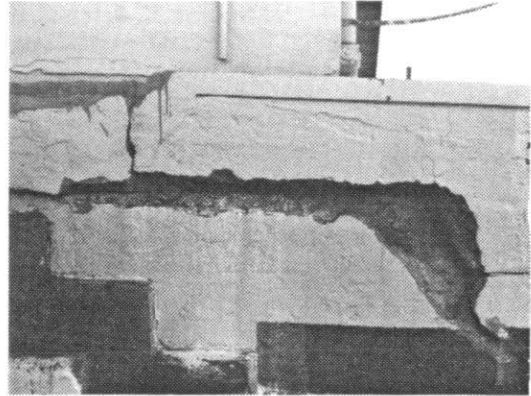
*Displacement*

Large cracks with corresponding displacement of walls and sinking of decks were noted in the porch walls. This damage may have been caused or exacerbated by the October 1989 earthquake.

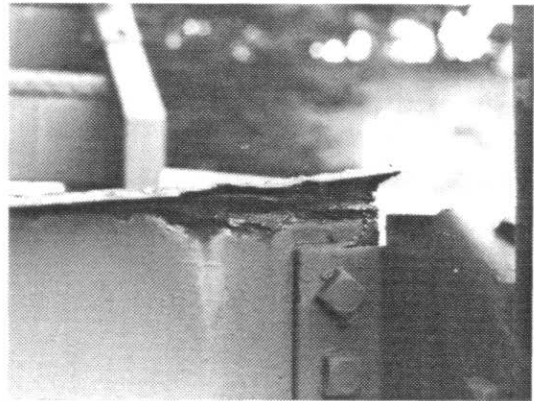
The deterioration of metal by chemical or electrochemical reaction resulting from exposure to moisture, chemicals or other agents.

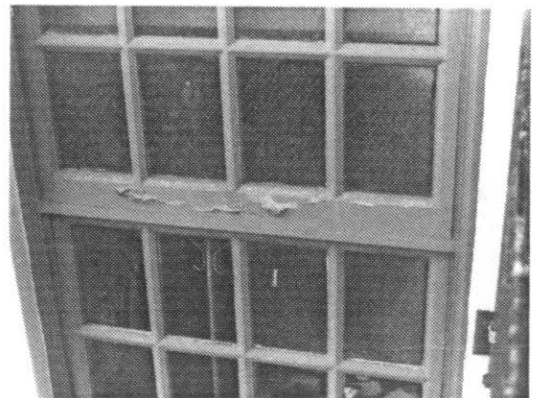
*Failed Paint Coatings*

Failed paint coatings are characterized by flaking and loss of adhesion.

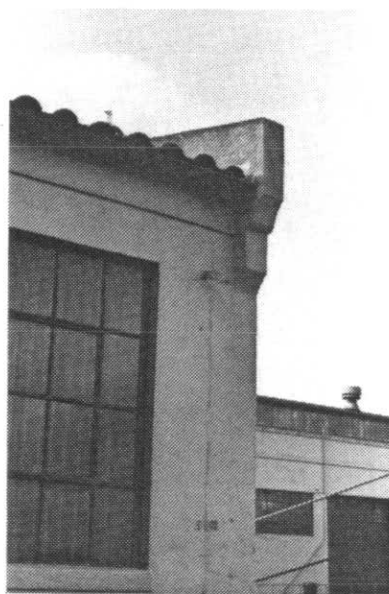
MISSING  
FEATURES

Absence of original features as judged by  
incompleteness of form or decoration.
