Historic Maintenance and Warehouse Complex

Historic Structure Report for 11 Buildings

Grand Canyon South Rim Historic Maintenance and Warehouse Complex

February 1, 2008

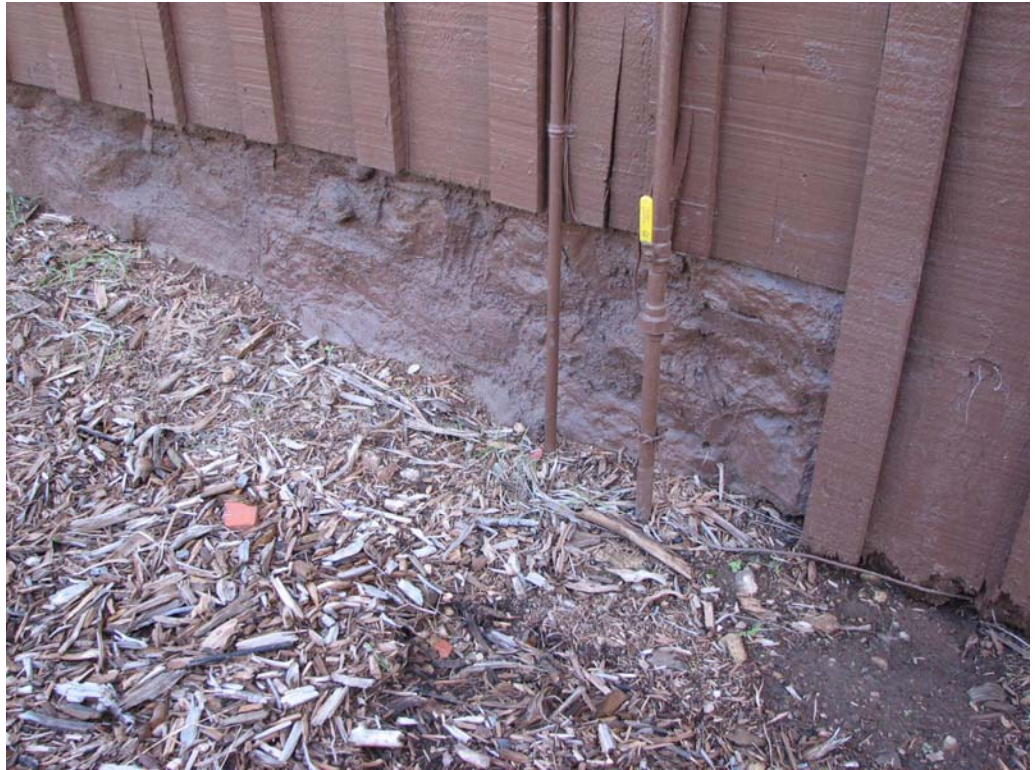
Painted Stone Foundations on North Side 0069-114

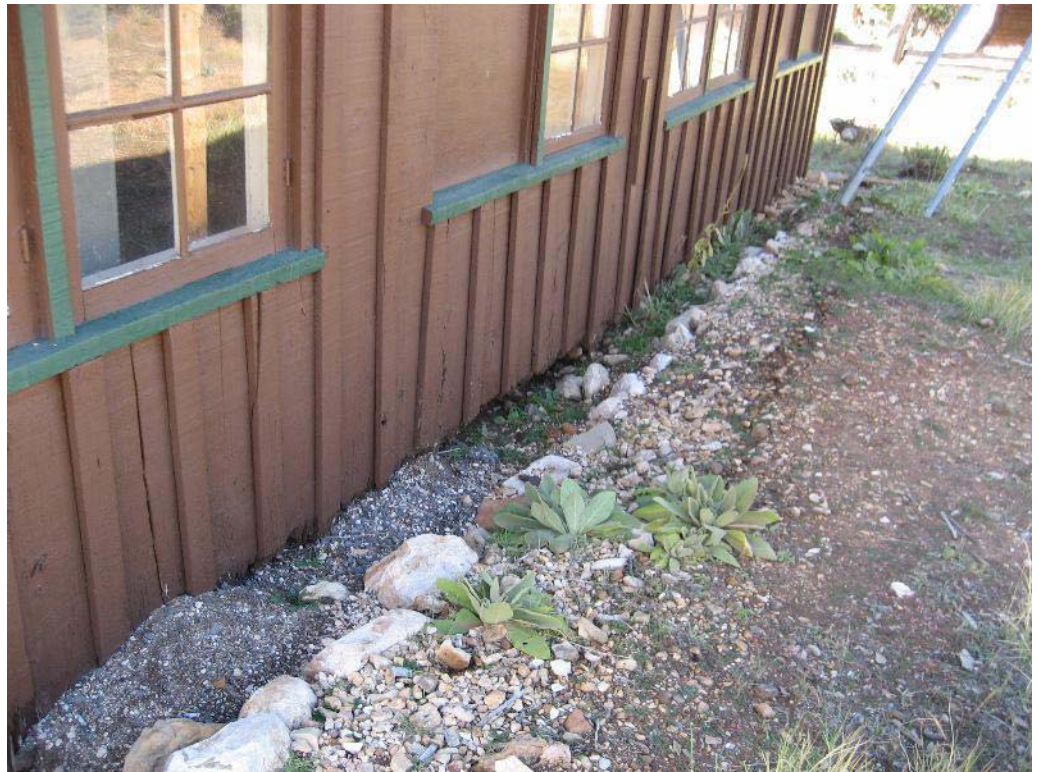
East Wall: Note Lack of Foundation 0069-130

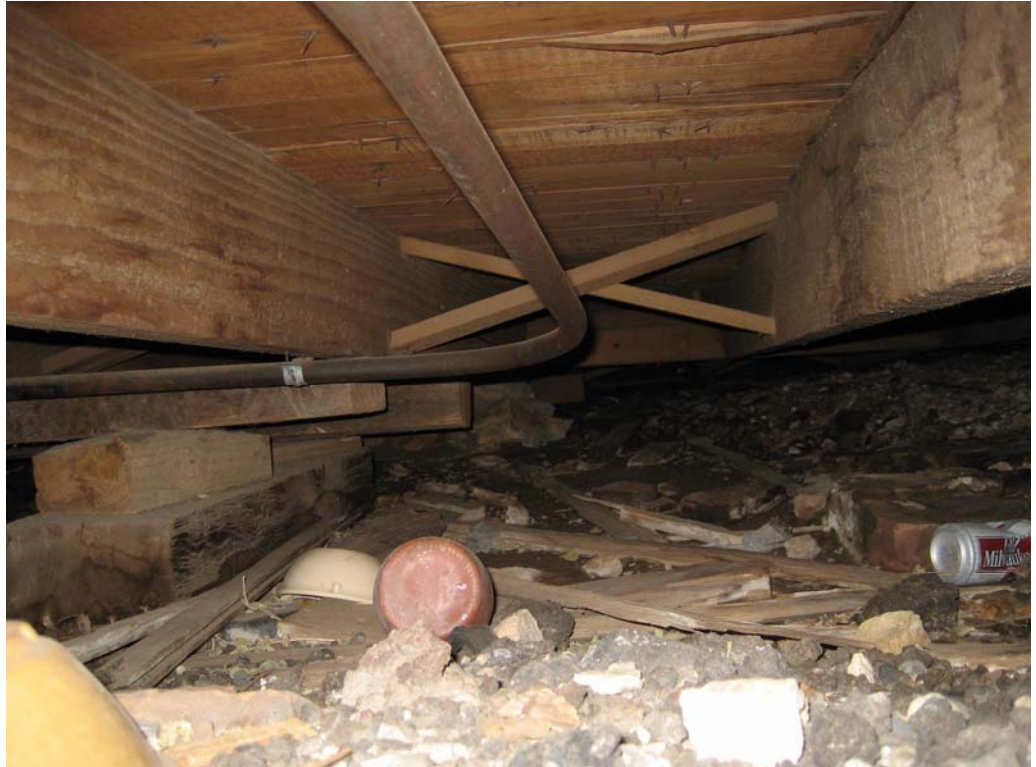
0069-221

Deteriorated Wood Foundation Under East Side

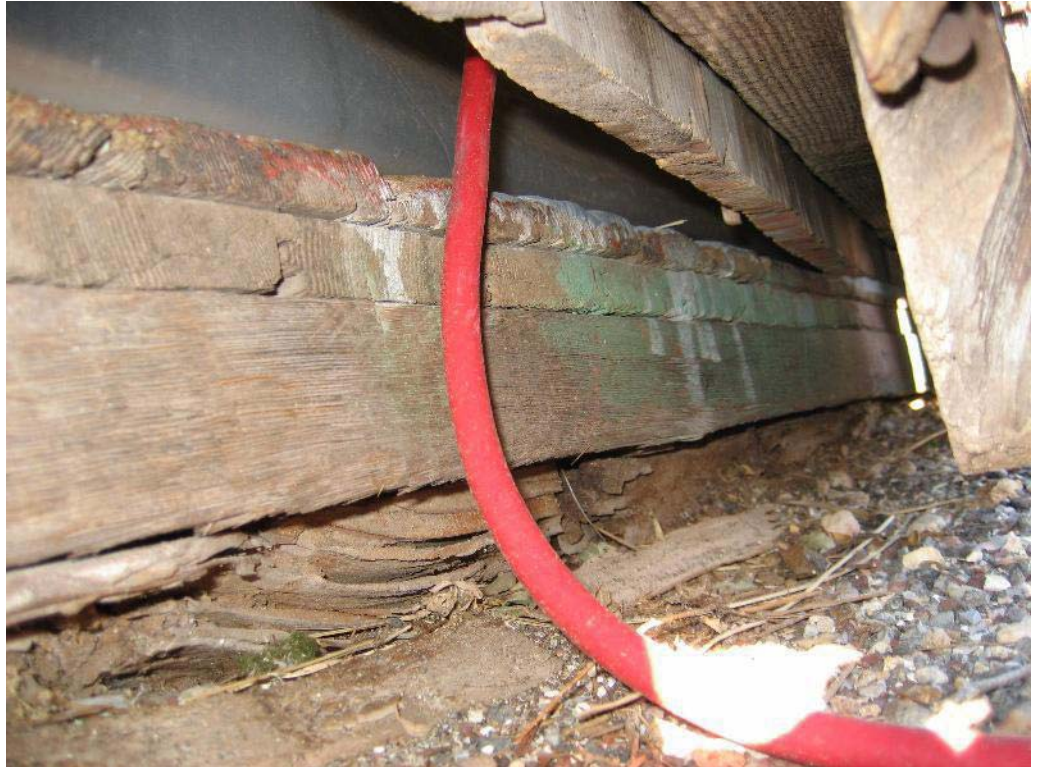
0069-223

Deteriorated Rim Joist at South Wall

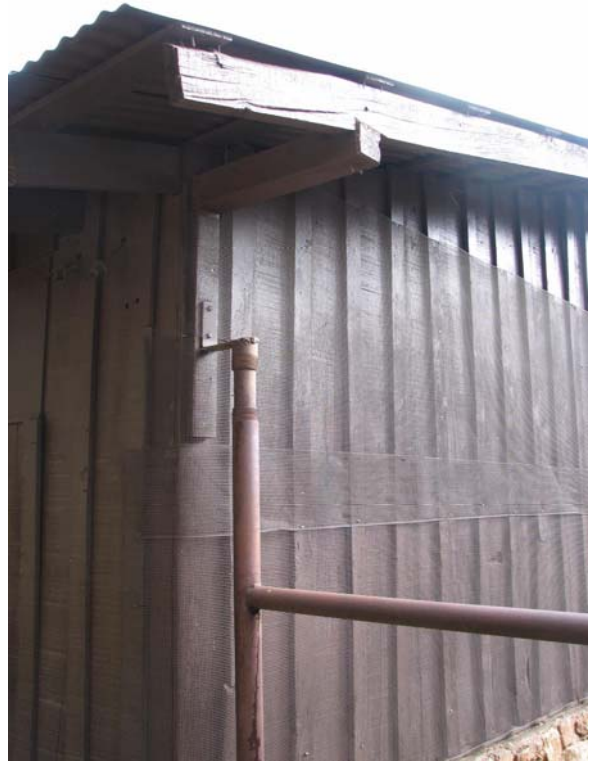
Bracket in Southwest Corner showing Missing Brace 0074-107

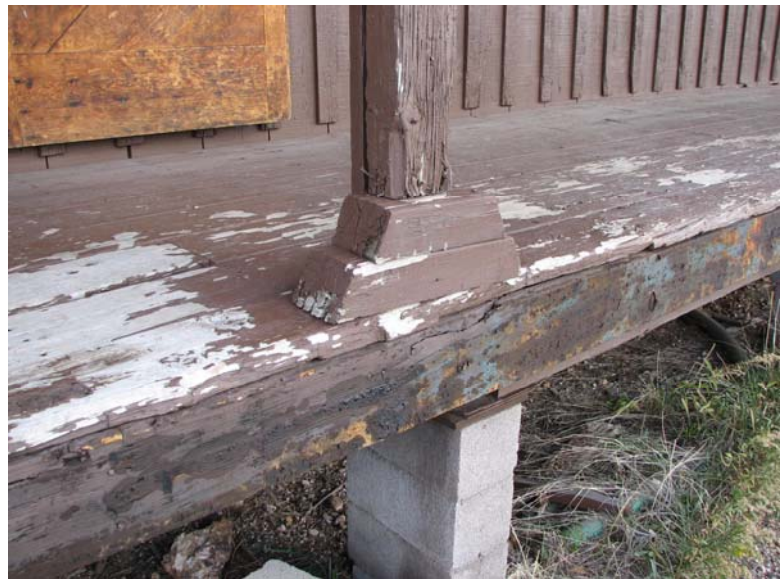
Porch Supported on Loosely Stacked 8x16" CMU 0078-118

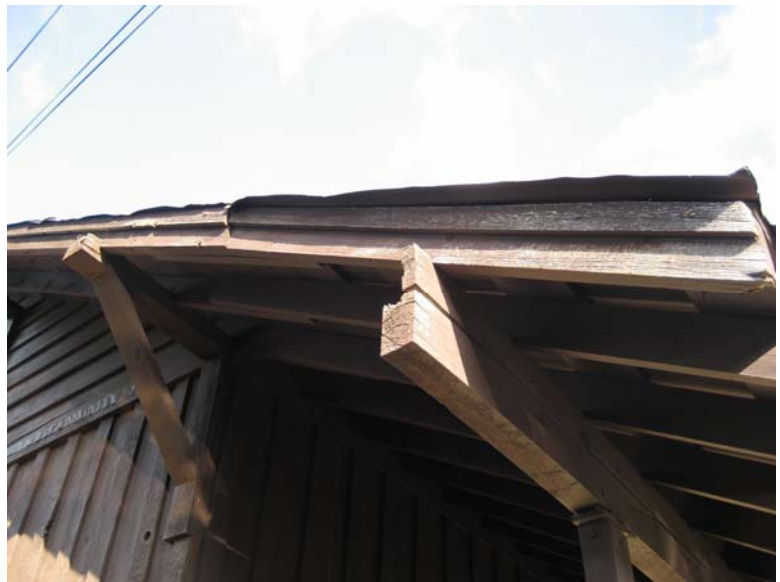
Porch Framing. Deteriorated Edge Beam and Rafters 0078-159

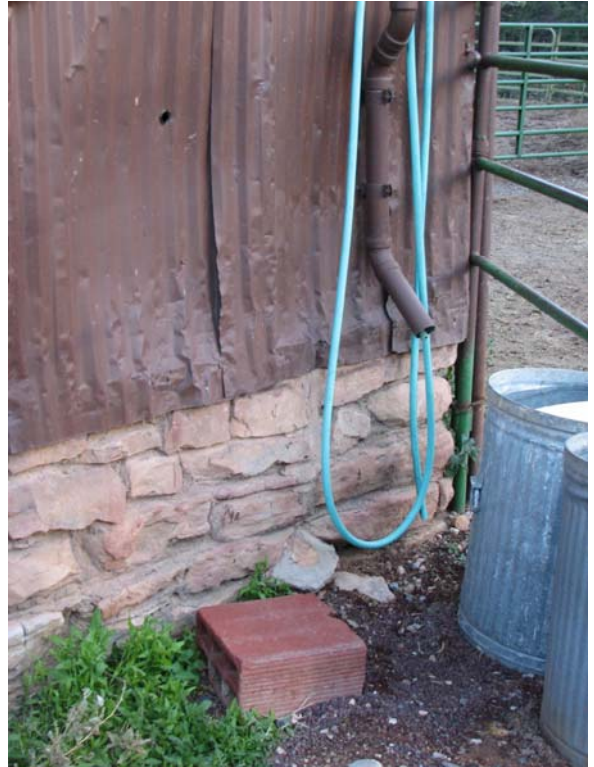
Siding Extends Over Stone Foundation 0080-109

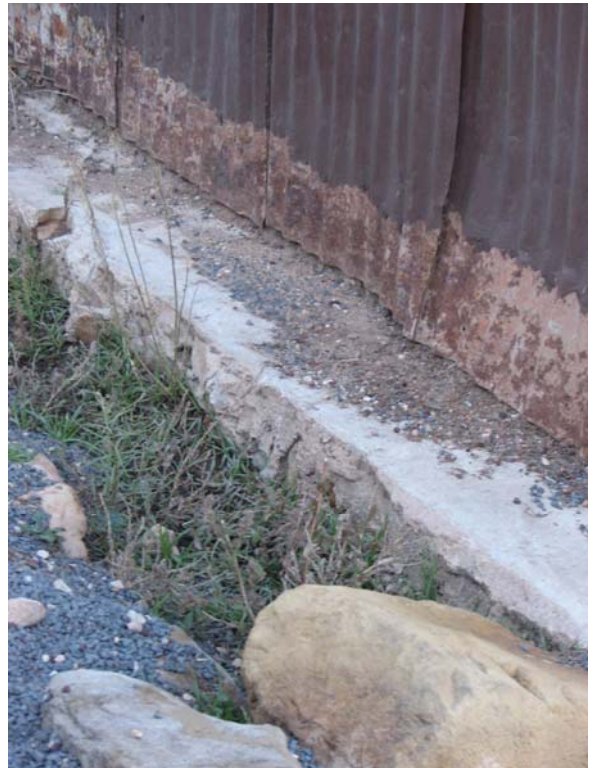
Siding Extends to the Top of the Concrete Ledge 0080-110

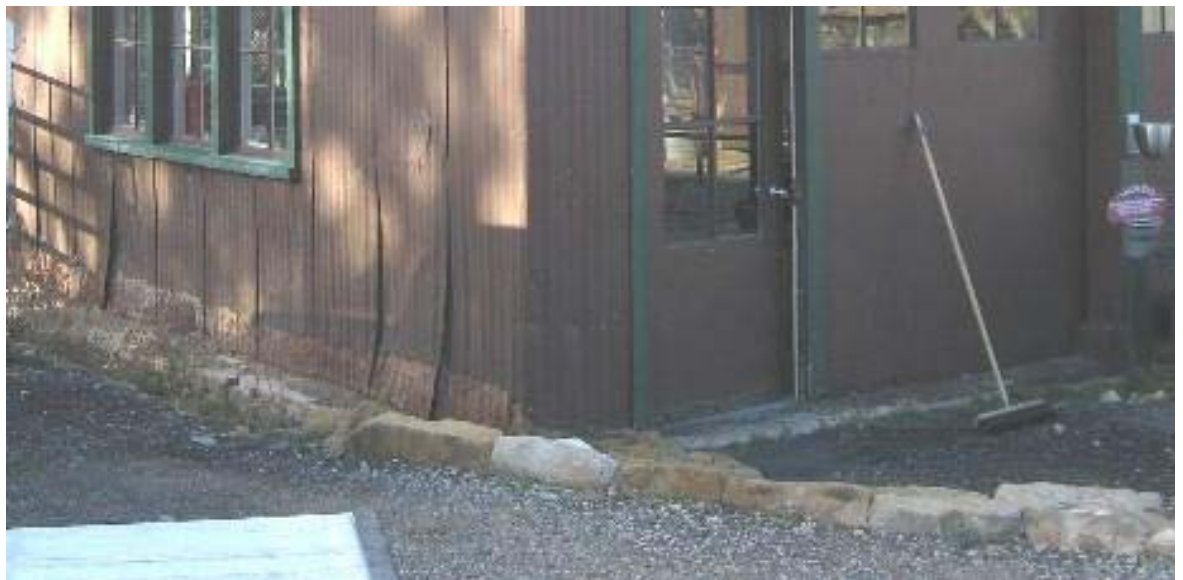
East Wall: Deteriorated Sill and Stud 0080-224

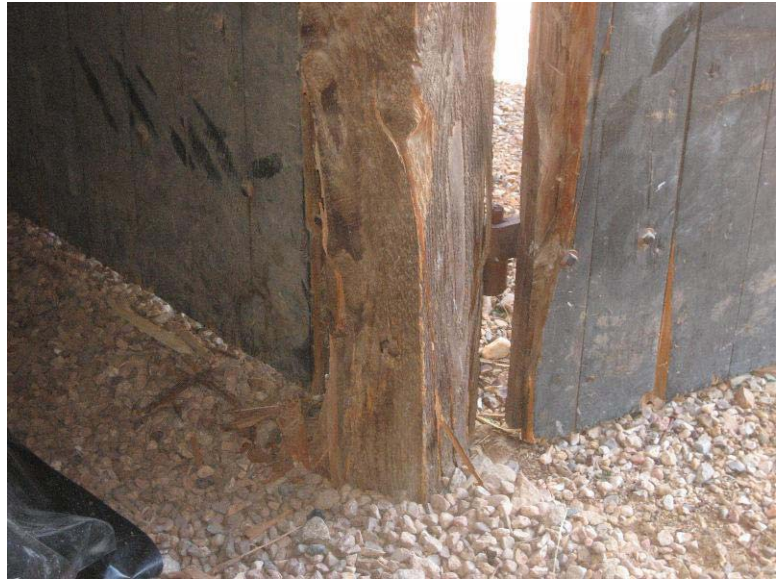
Damaged Post at South Wall 0099 - 209
