Lamar Bathhouse

Historic Structure Report

HOT SPRINGS

National Park • Arkansas

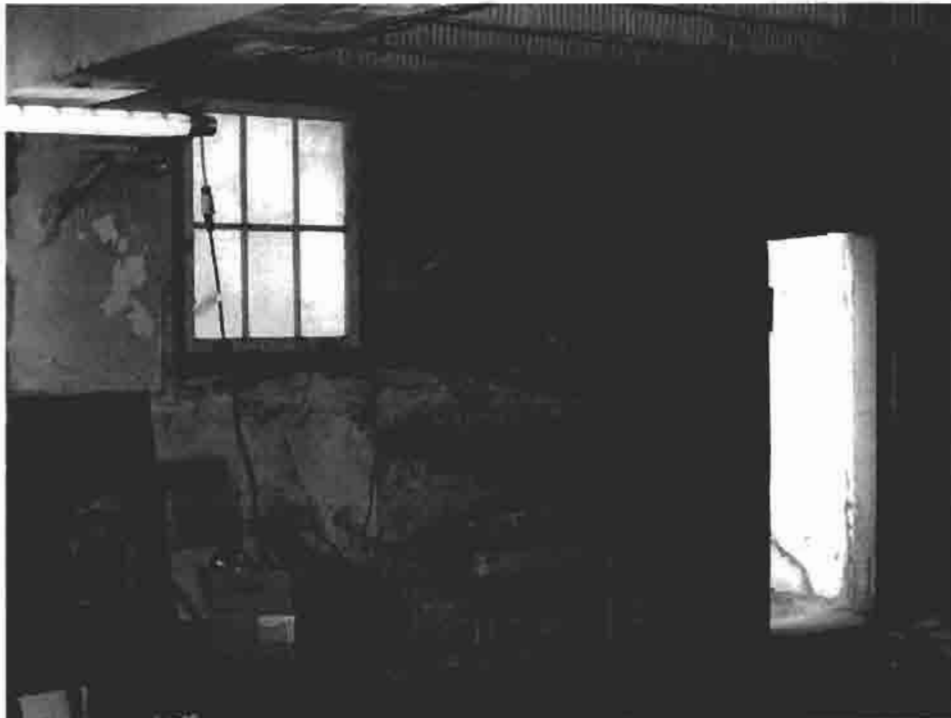
1C-52: Boiler & Machinery Room, Room 02: North Wall. Note: fan has replaced windowpanes. Window: 03. Door: B02. 11/2003

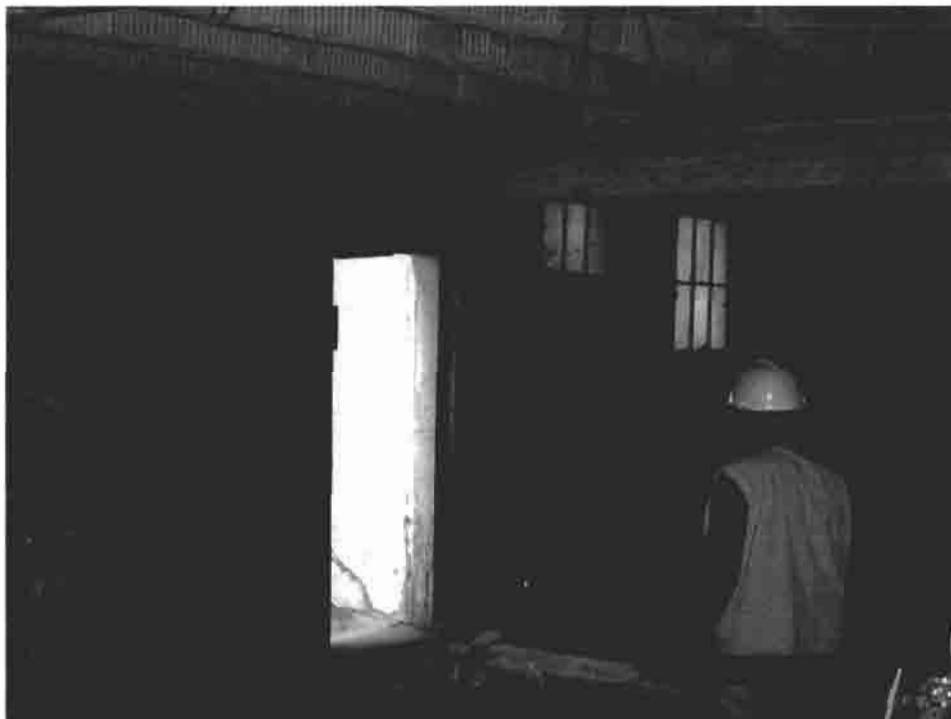
1C-53: Boiler & Machinery Room, Room 02: North wall to northeast corner. Note: exposed structure. Door: B02. Windows: 04, 05. 11/2003

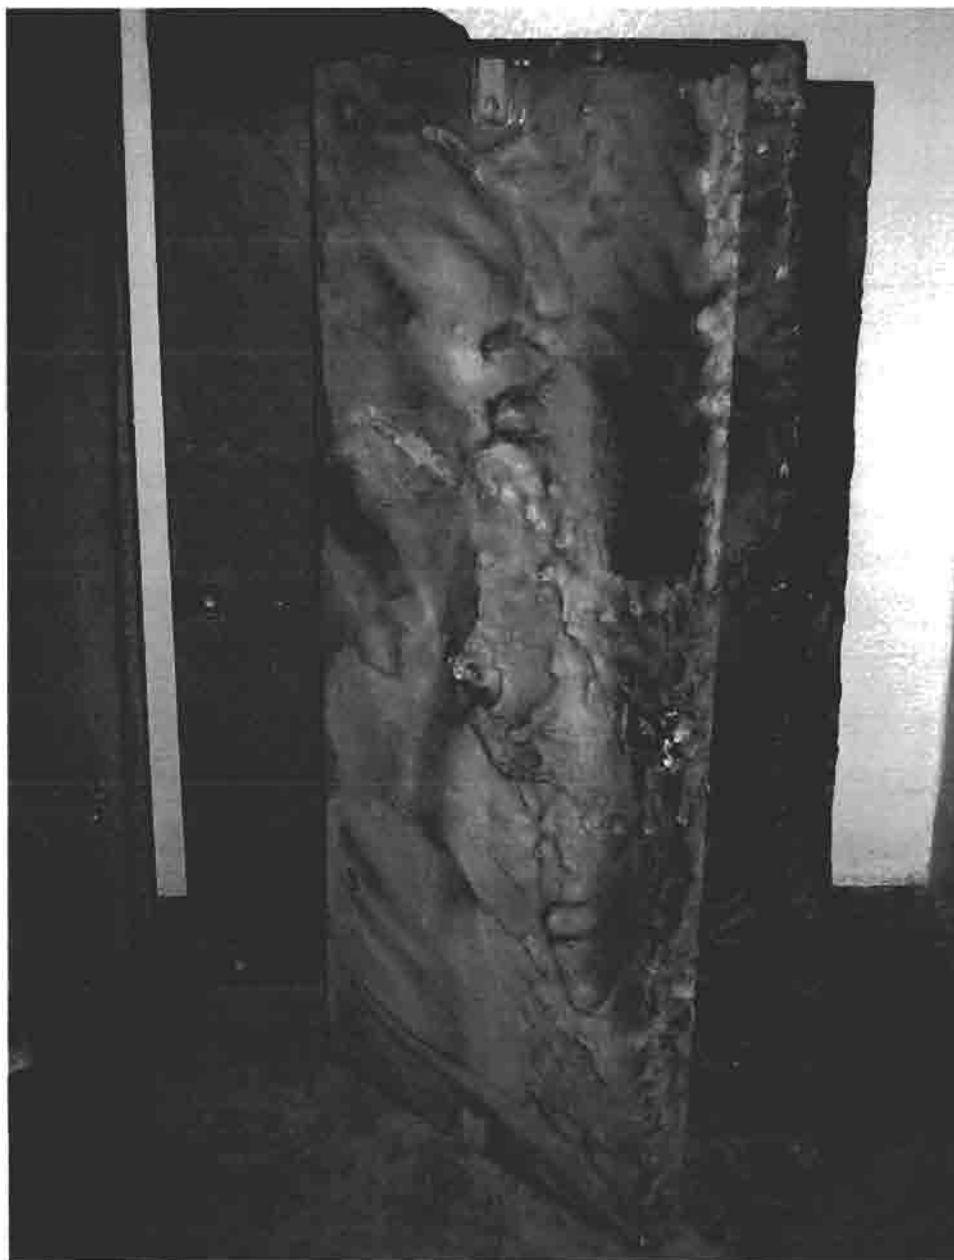
1C-88: Room 109, Women's Pack Room: Marble panel found stored in room 109.
Deterioration due to exposure to spring water and steam. 11/2003

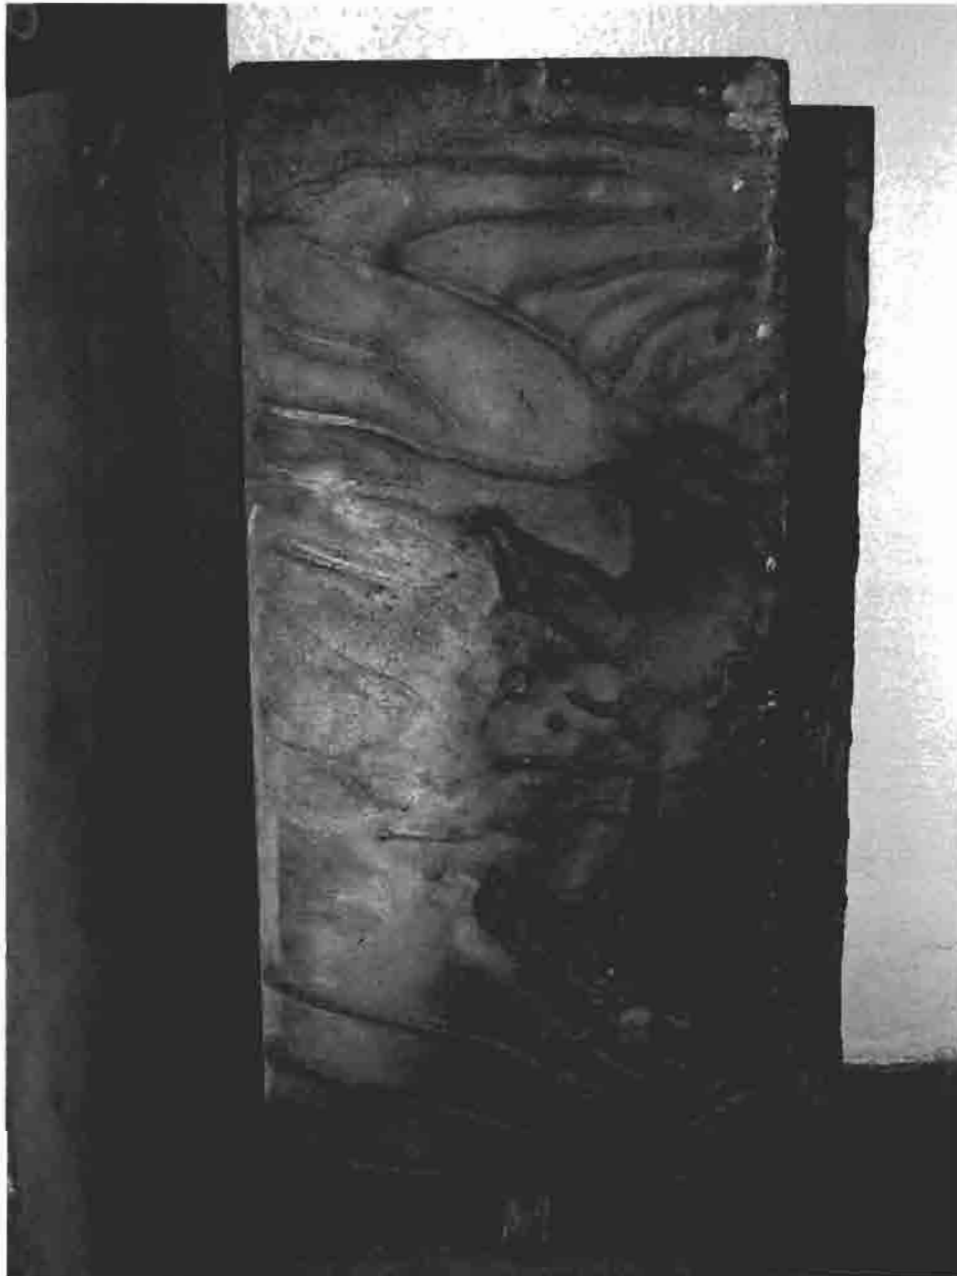
1C-89: Room 109, Women's Pack Room, Marble Panel. Deterioration due to exposure to spring water and steam. 11/2003

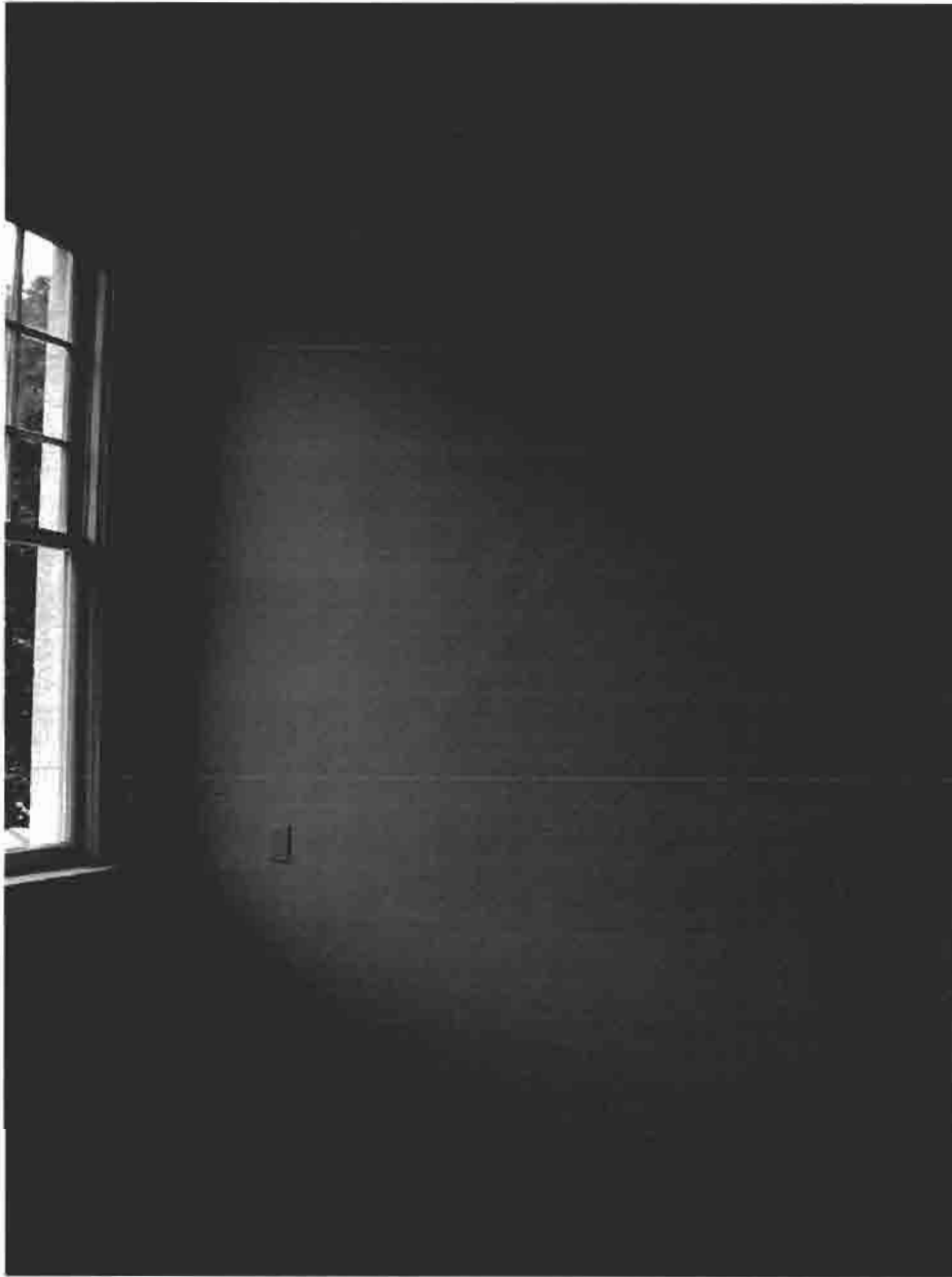
ROOM NUMBER:	209
ROOM NAME:	Women's Massage
FLOOR FINISH:	Concrete slab
WALL BASE:	None
WALLS:	Plaster with white paint
NORTH:	
EAST:	
SOUTH:	
WEST:	
OTHERS:	
CEILING:	Plaster with white paint
WINDOWS:	
DOORS:	
SPECIAL FEATURE:	
KEY CONDITIONS CONCERNS:	
<ol style="list-style-type: none"> 1. Slab cracks, general minor. 2. Cracks in north wall, next to window.

IC-147: Room 209, Women's Massage Room: North Wall at Northwest Corner: Note: Crack next to window. Window: 231. 11/2003

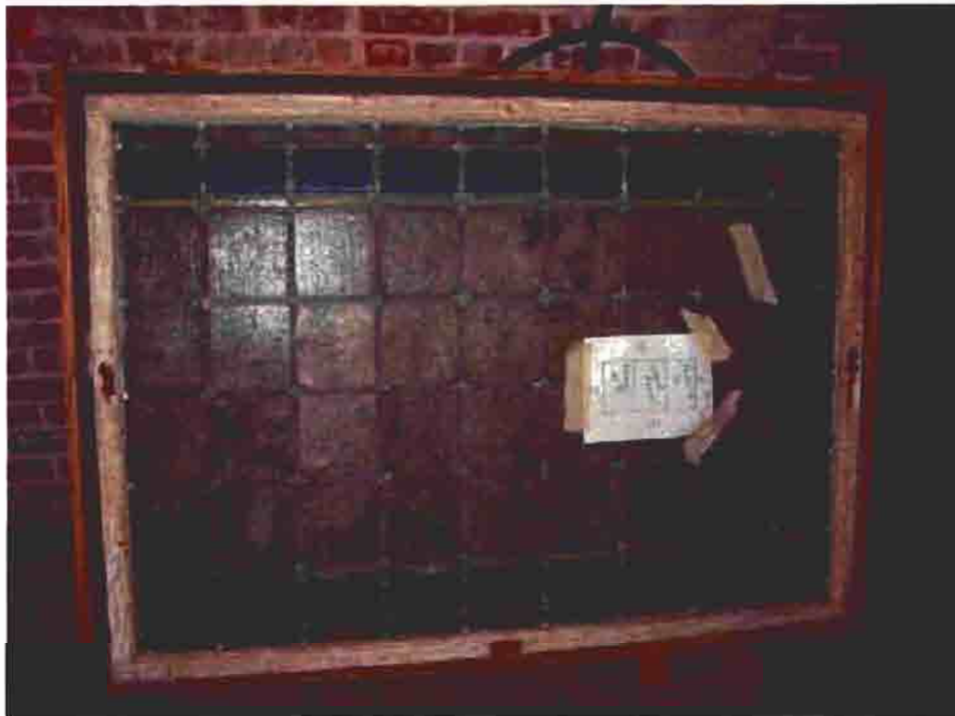
WOOD FRAMED PANEL: NOTE THAT THIS IS AN END PANEL, & EXHIBITS A TYPICAL LAYOUT DIAGRAM TAPED TO THE PANEL. THIS IS AN EXAMPLE OF A REPAIRABLE PANEL; IT IS IN GOOD CONDITION.

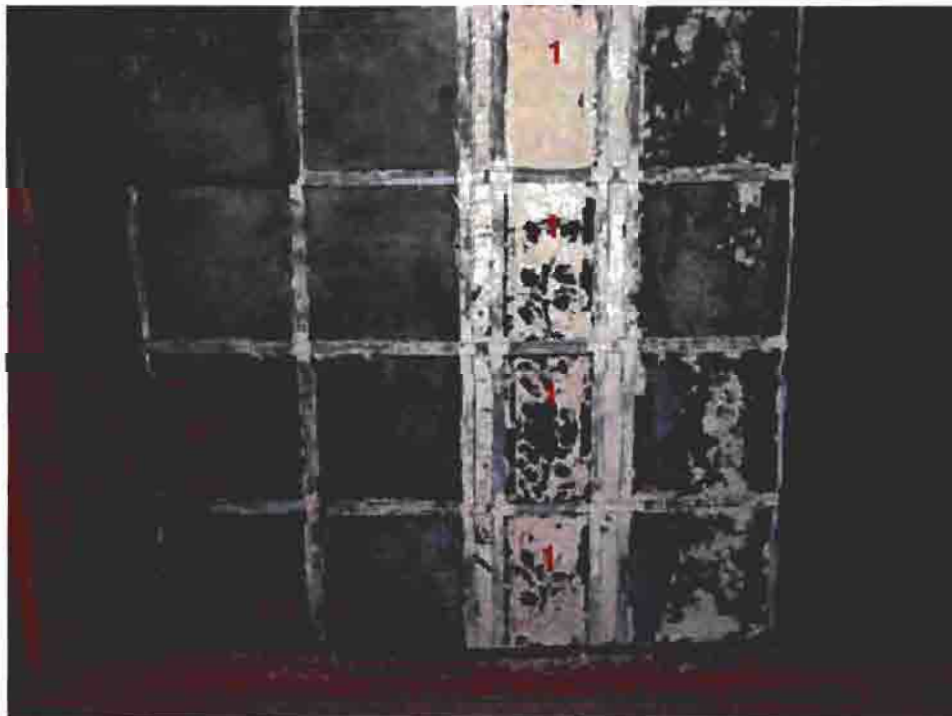
SOME TYPICAL
CONDITION PROBLEMS:
LOSS OF PAINTED
FINISH (1), LOOSE CAME
(2); CORROSION OF
CAMES (TYPICAL).

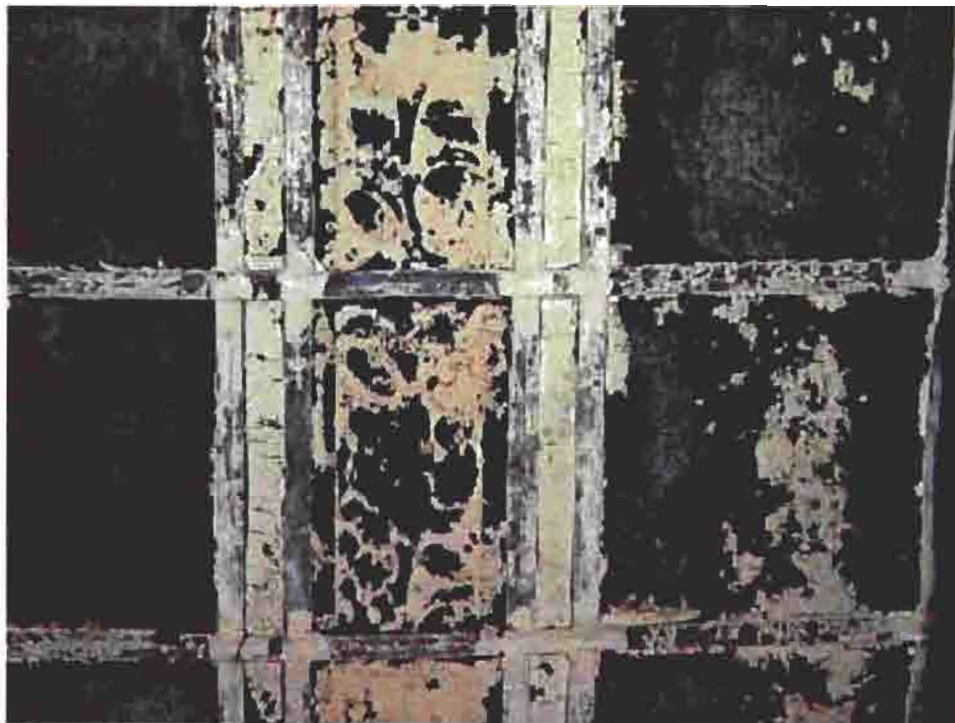
DETAIL OF PAINTED
FINISH LOSS

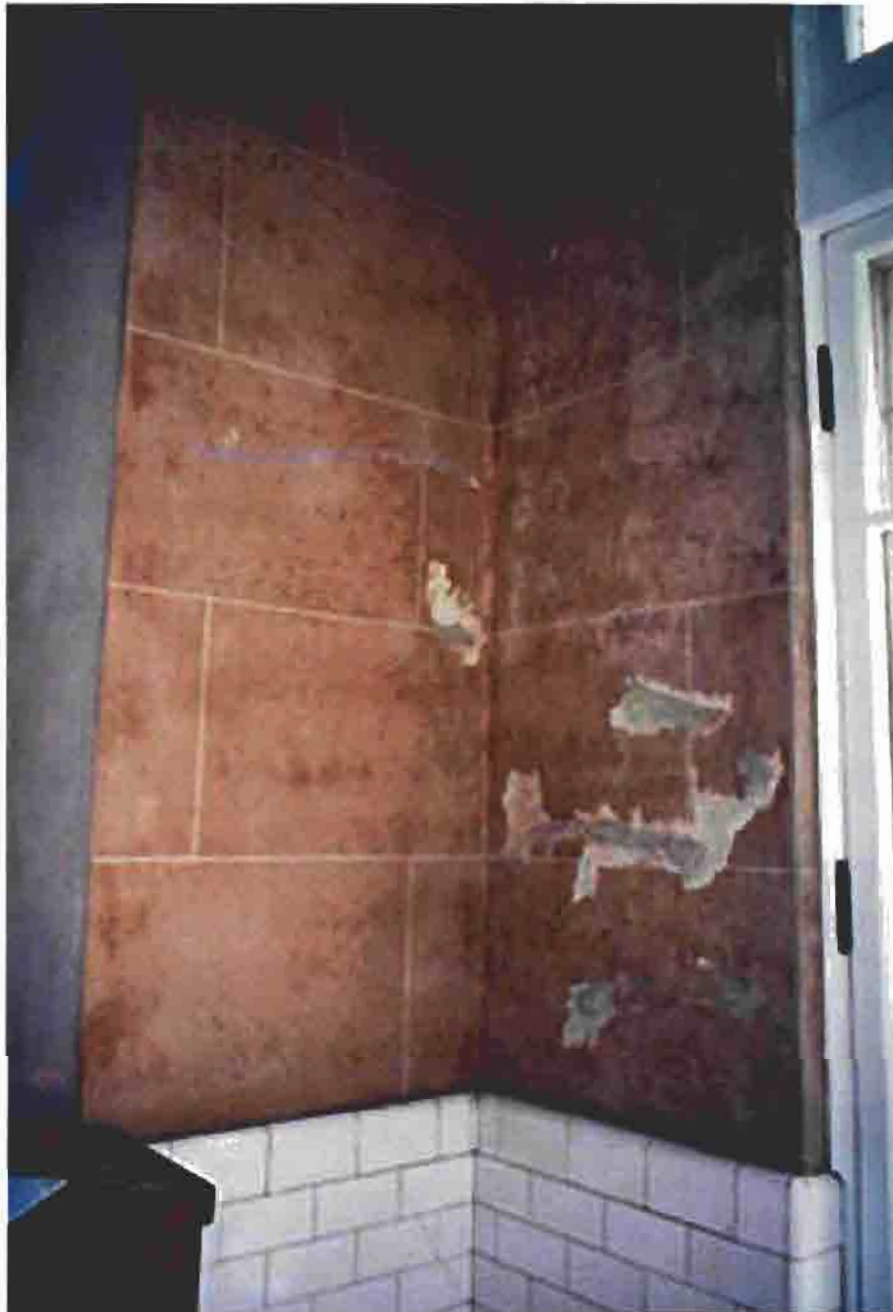
PLASTER/DECORATIVE PAINT JUNCTION: EAST & SOUTH WALLS AT
SUN PORCH, LOCATION WHERE LOOSE PAINT WAS REMOVED TO
REVEAL UNDERPAINTING.

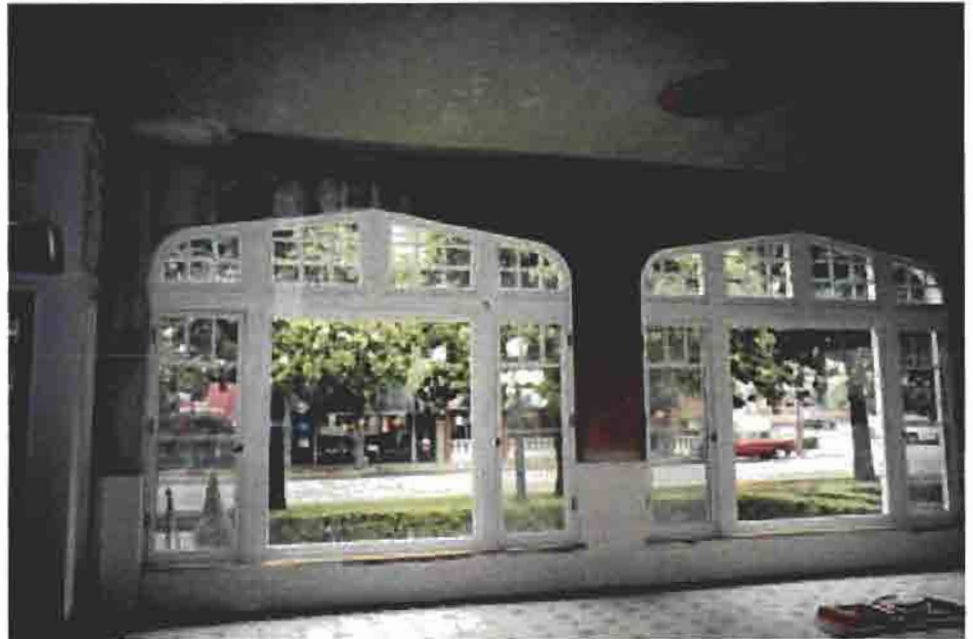
PLASTER: SUN PORCH,
WEST WALL (NORTH END),
HAS SLIGHTLY LESS
DAMAGE THAN SOUTH
END.

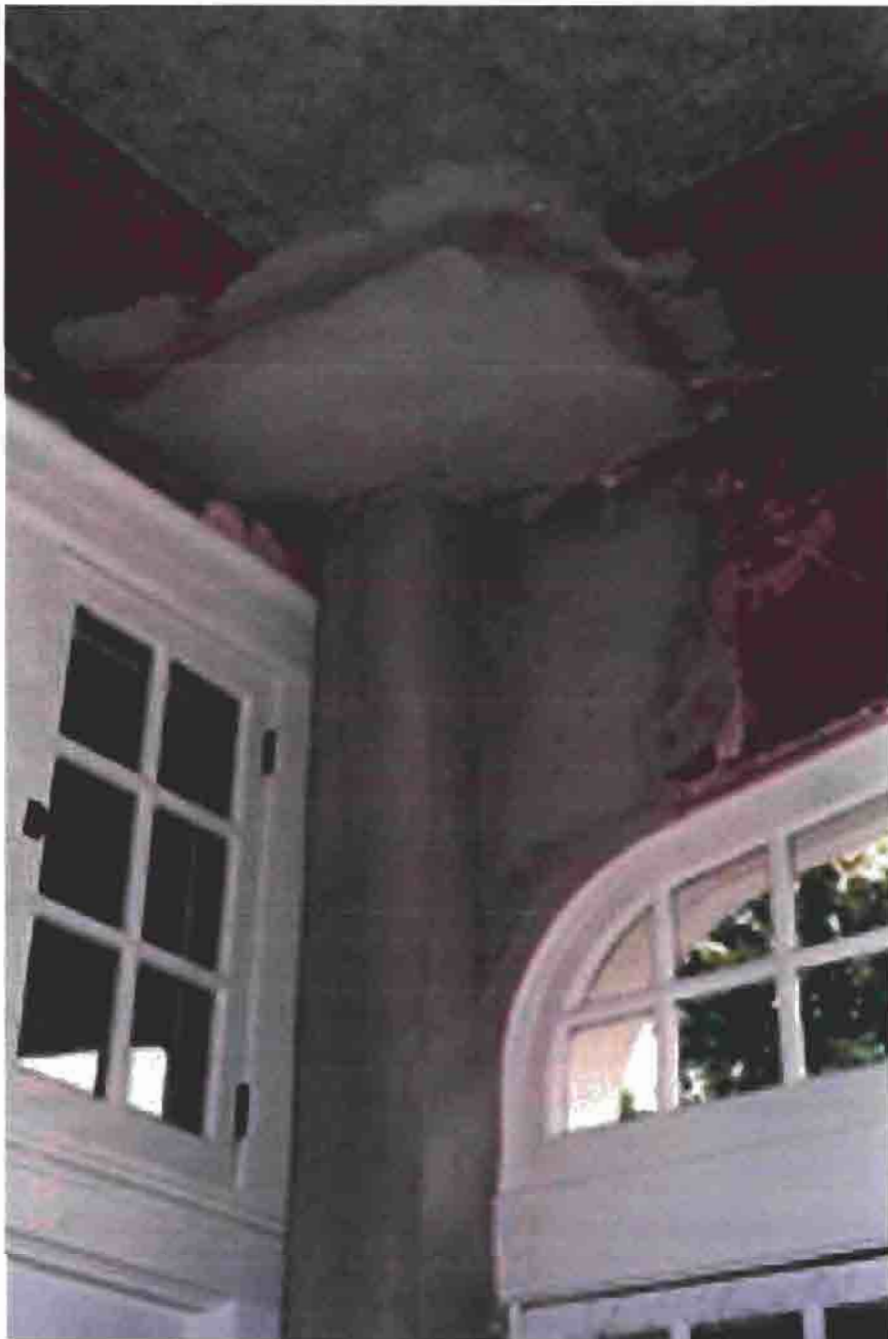
PLASTER: SOME PREVIOUS REPAIRS MAY NEED TO BE REDONE.

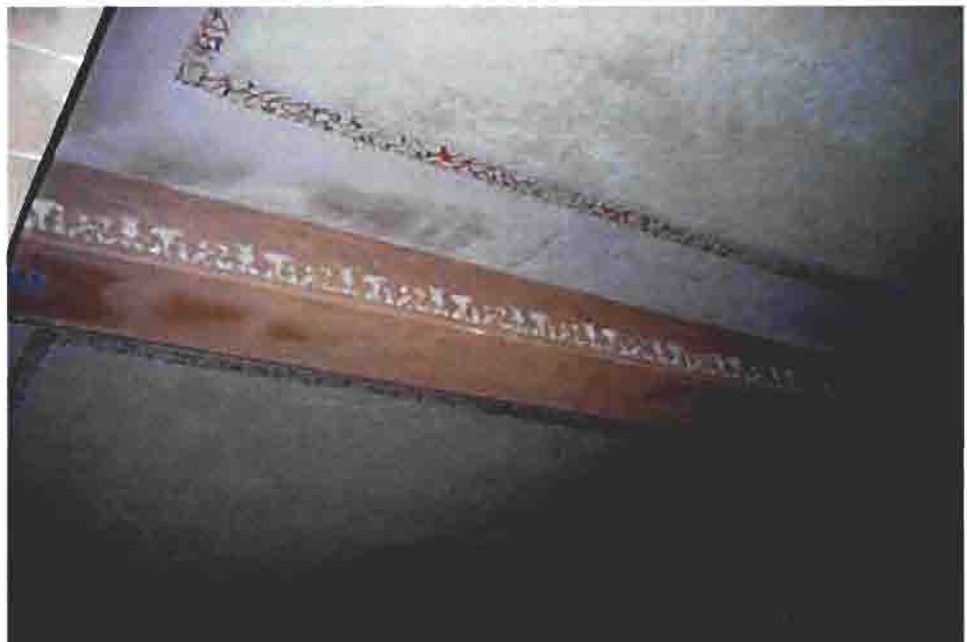
DECORATIVE PAINT: EXTENSIVE
STAINING AT EDGE OF EAST CEILING
PANEL.

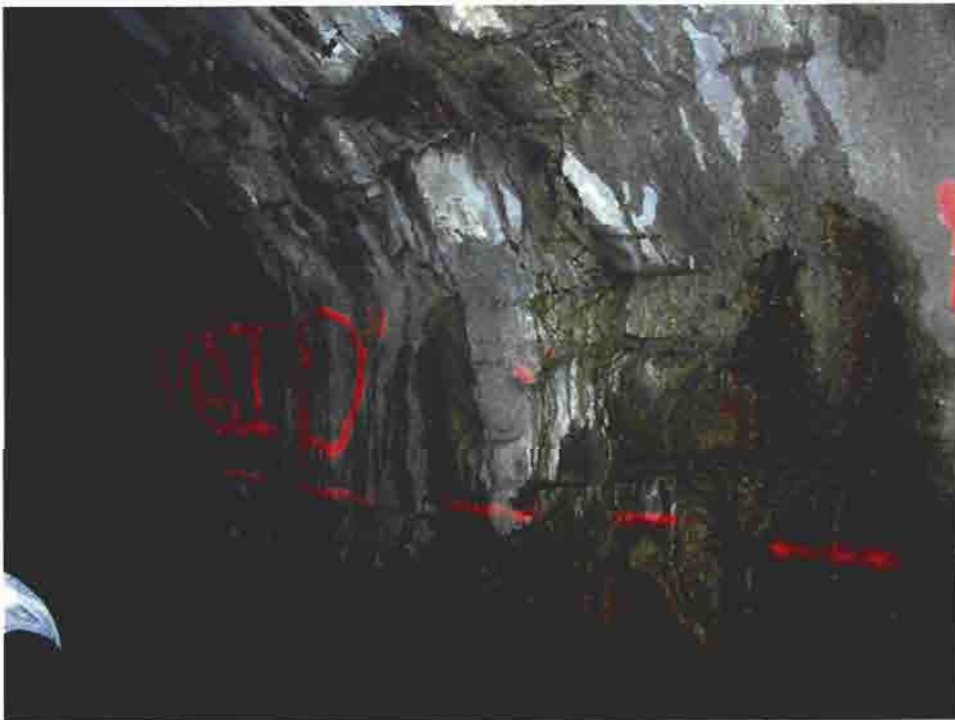
CA-9: The Creek Arch. The "void" designation was the only one found, but it did coincide with areas of mortar loss deep within the joints.

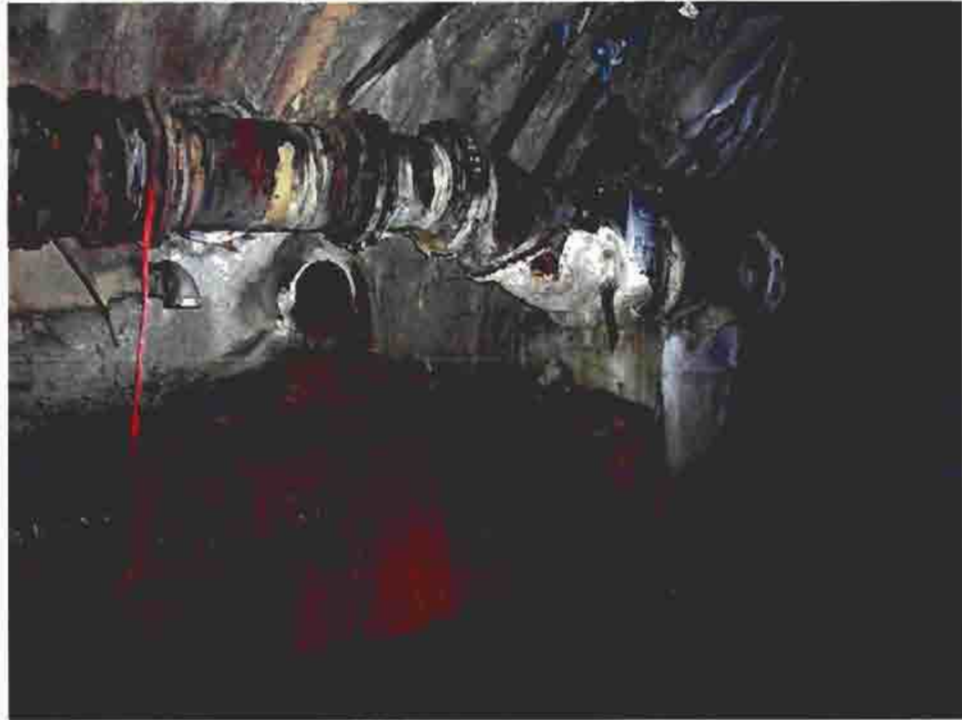
CA-11: The Creek Arch. Note the abundance of faded and overlaid markings on the wall beside this part manhole. These markings make location of problems difficult.
