Jean Lafitte National Historical Park and Preserve

Chalmette National Cemetery

Superintendent's Lodge

Historic Structure Report

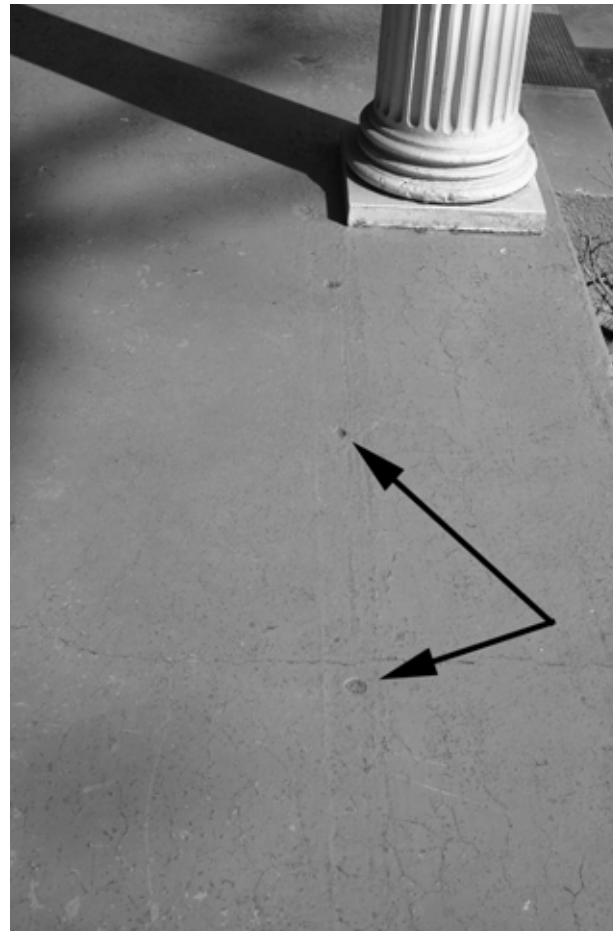
FIGURE 13. View of front porch floor with arrows indicating where screen framing was attached to the floor.

porch. The front porch screening was removed around 1979 when the residence was rehabilitated for offices.

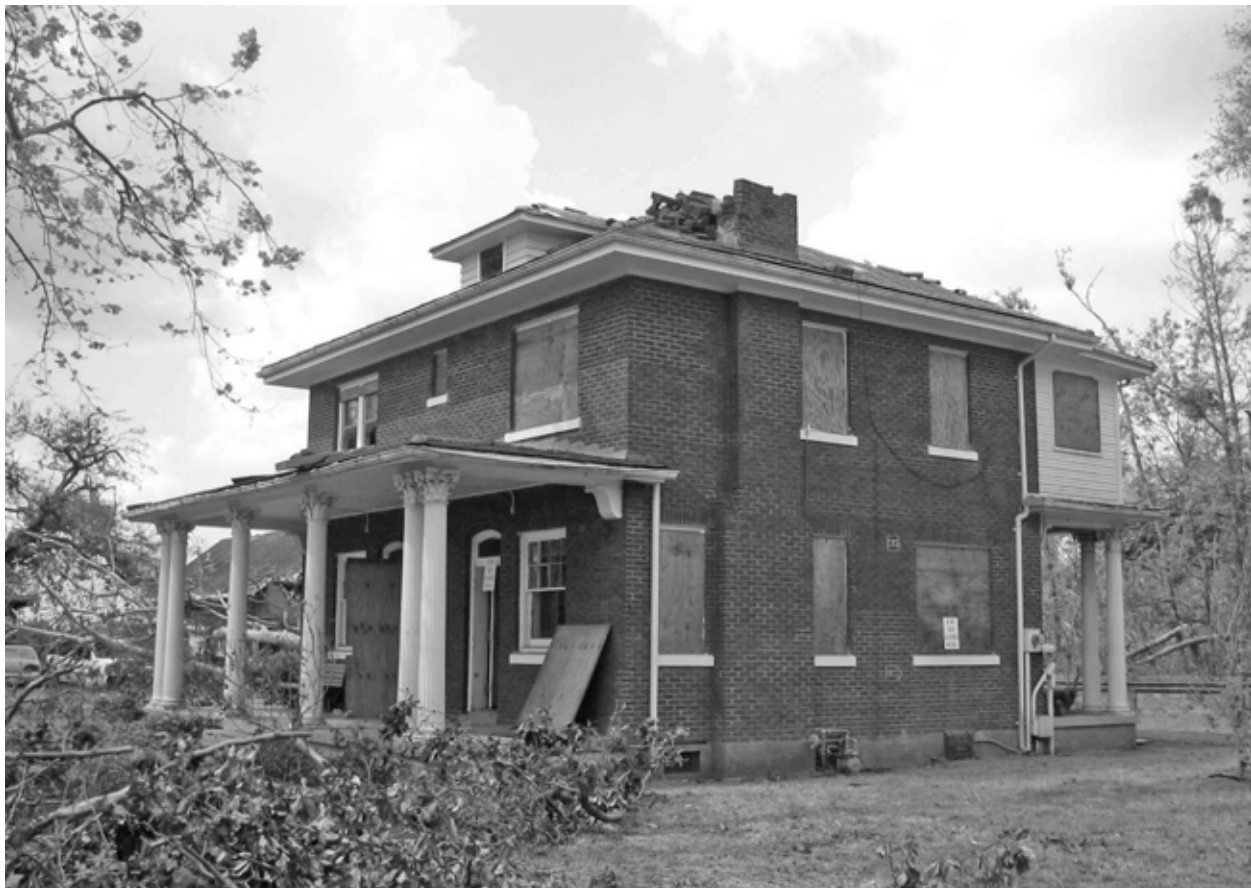
FIGURE 19. View of Lodge after Katrina, fall 2005. (NPS, SERO-CRD.)

offices. Flooded to a depth of eight feet in September 2005, the building underwent emergency stabilization but remained vacant in February 2006. This physical description is based on a survey and non-

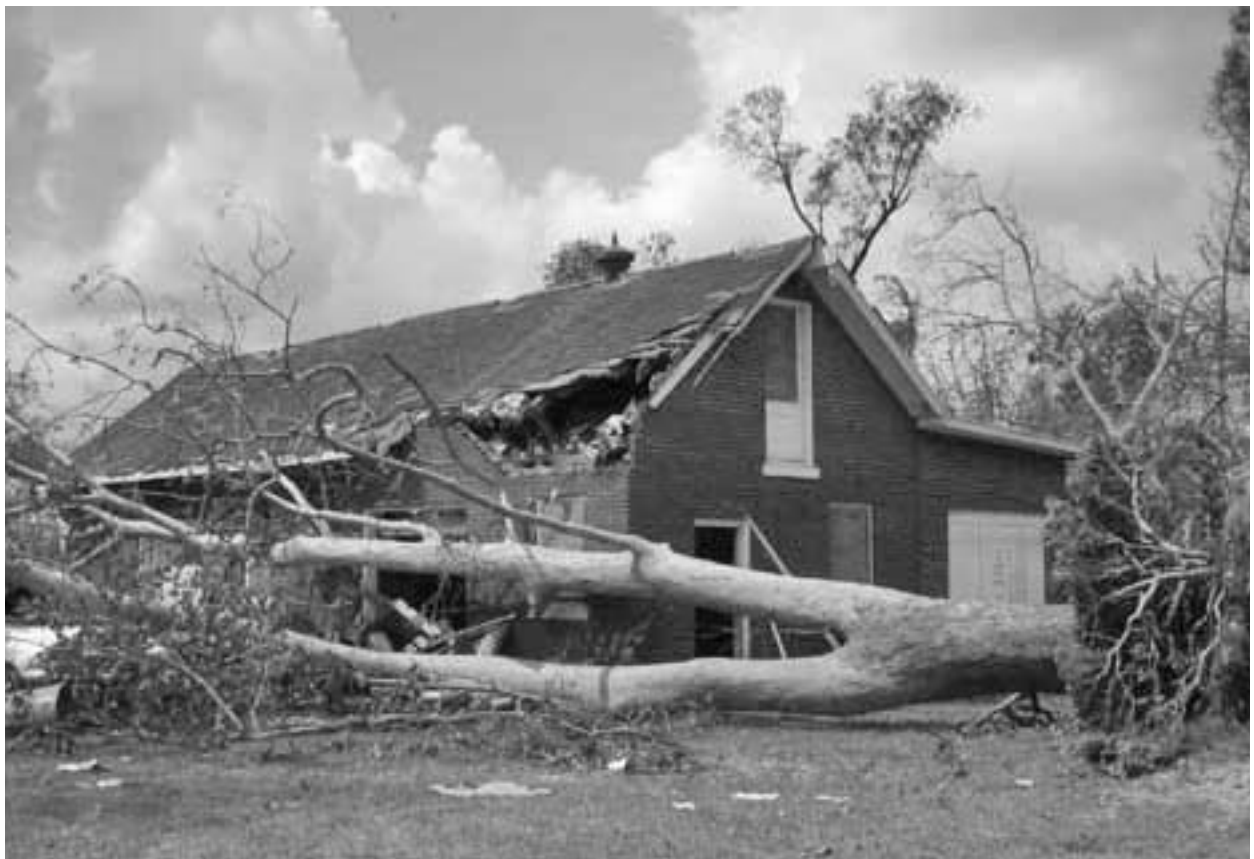
FIGURE 20. View of garage after Katrina. (JELA Coll.)

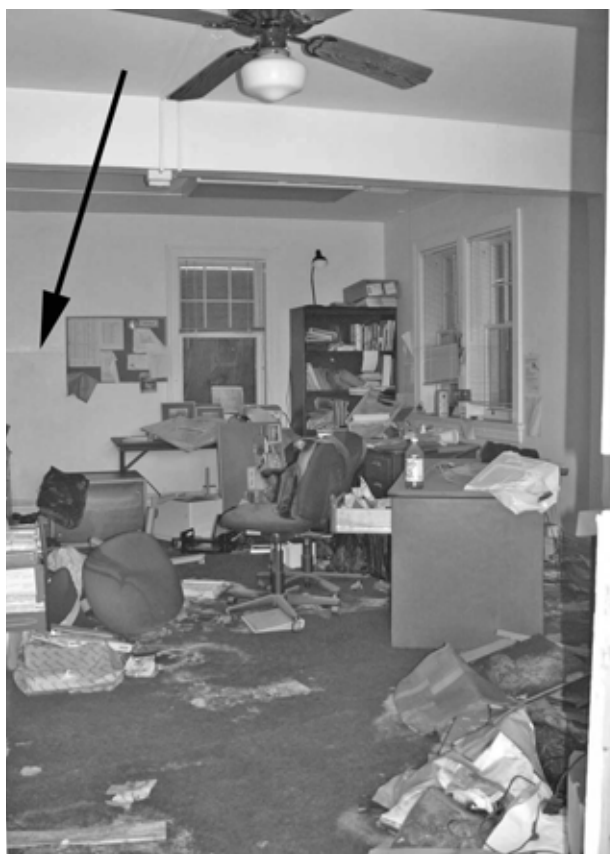
FIGURE 21. View of Rooms 101 and 104 in the Lodge after Katrina. Arrow denotes high-water line. (JELA Coll.)

- Reinstate wall between Rooms 101 and 104 if that would benefit the park's use of the building

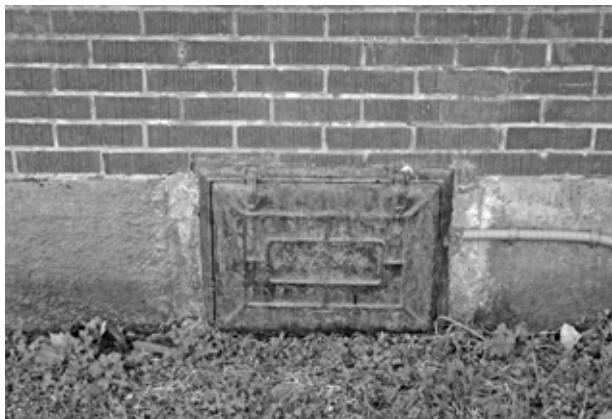
FIGURE 30. View of altered foundation opening on northeast side of house.

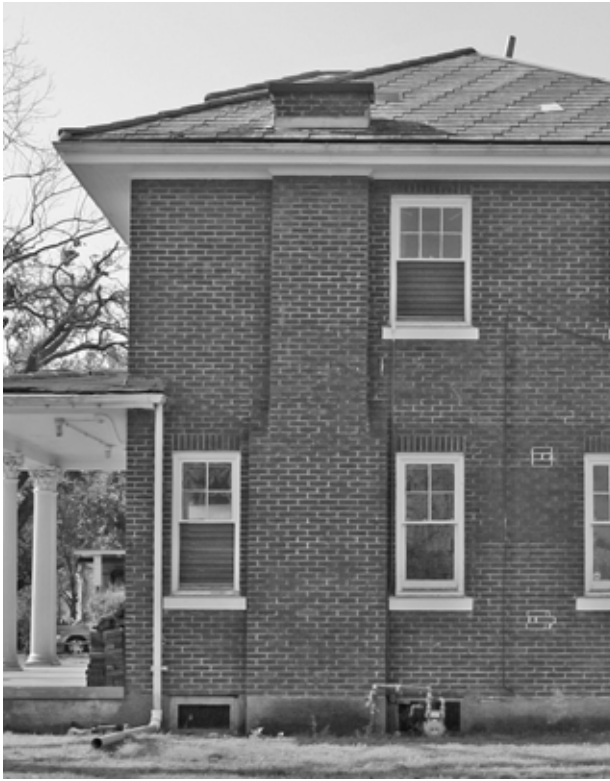
FIGURE 50. View of northeast chimney.

- Reconstruct east chimney
- Repair roofing
- Replace gutters with 6" or larger gutters
- Install permanent drainage system from downspouts
- Reinstall original doors and windows

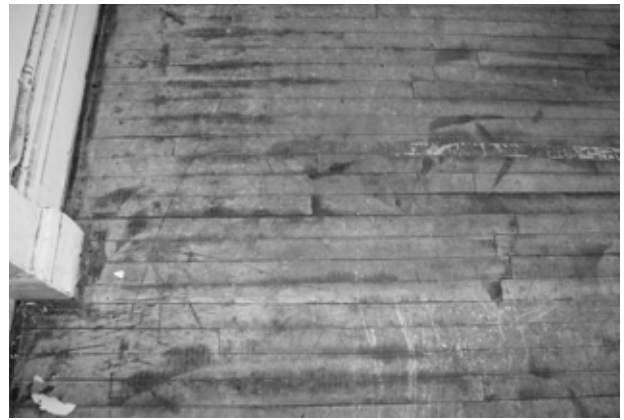
FIGURE 52. Oak flooring at location of former wall between Rooms 101 and 104.

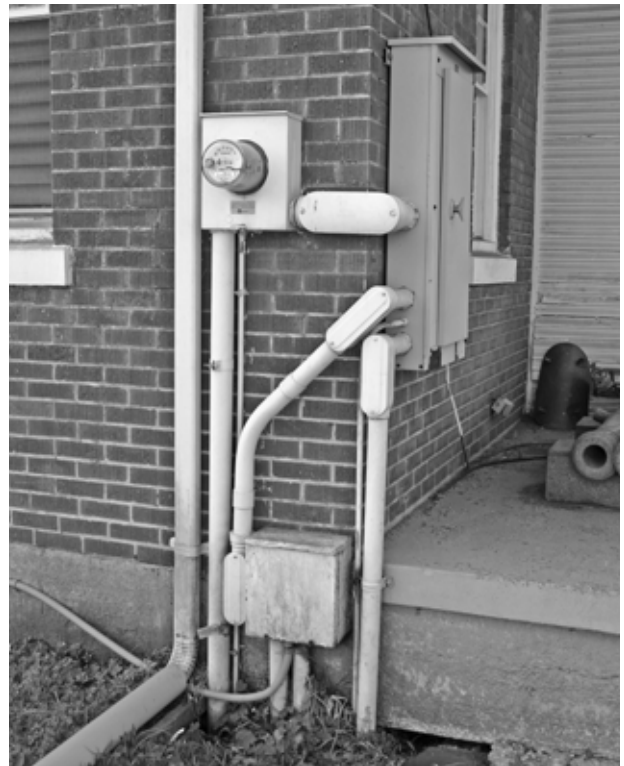
FIGURE 63. View of electrical service at north corner of house.

Existing Condition. Although some components might be suitable for re- use, most of the building's mechanical and electrical systems are either missing or in poor condition.

- Replace all HVAC, electrical, and plumbing
- Repair plaster walls and ceilings

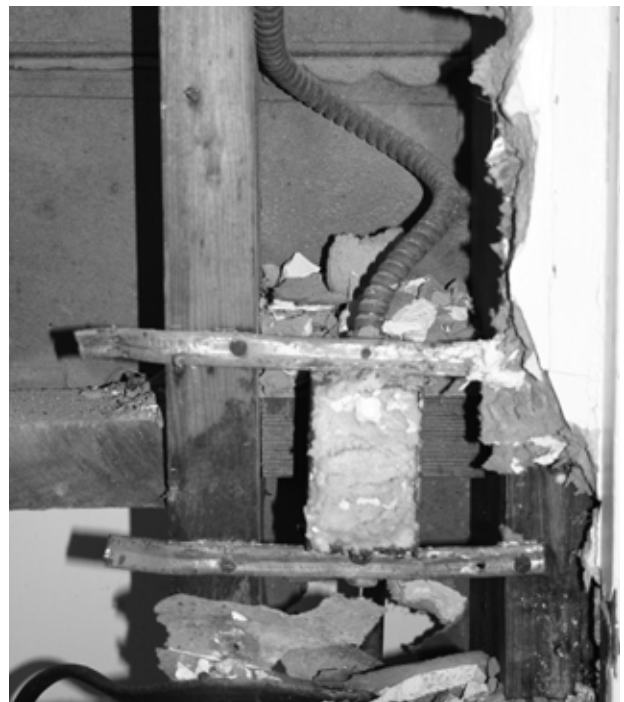
FIGURE 64. View of original switch box and BX electrical cable, abandoned in 1965.

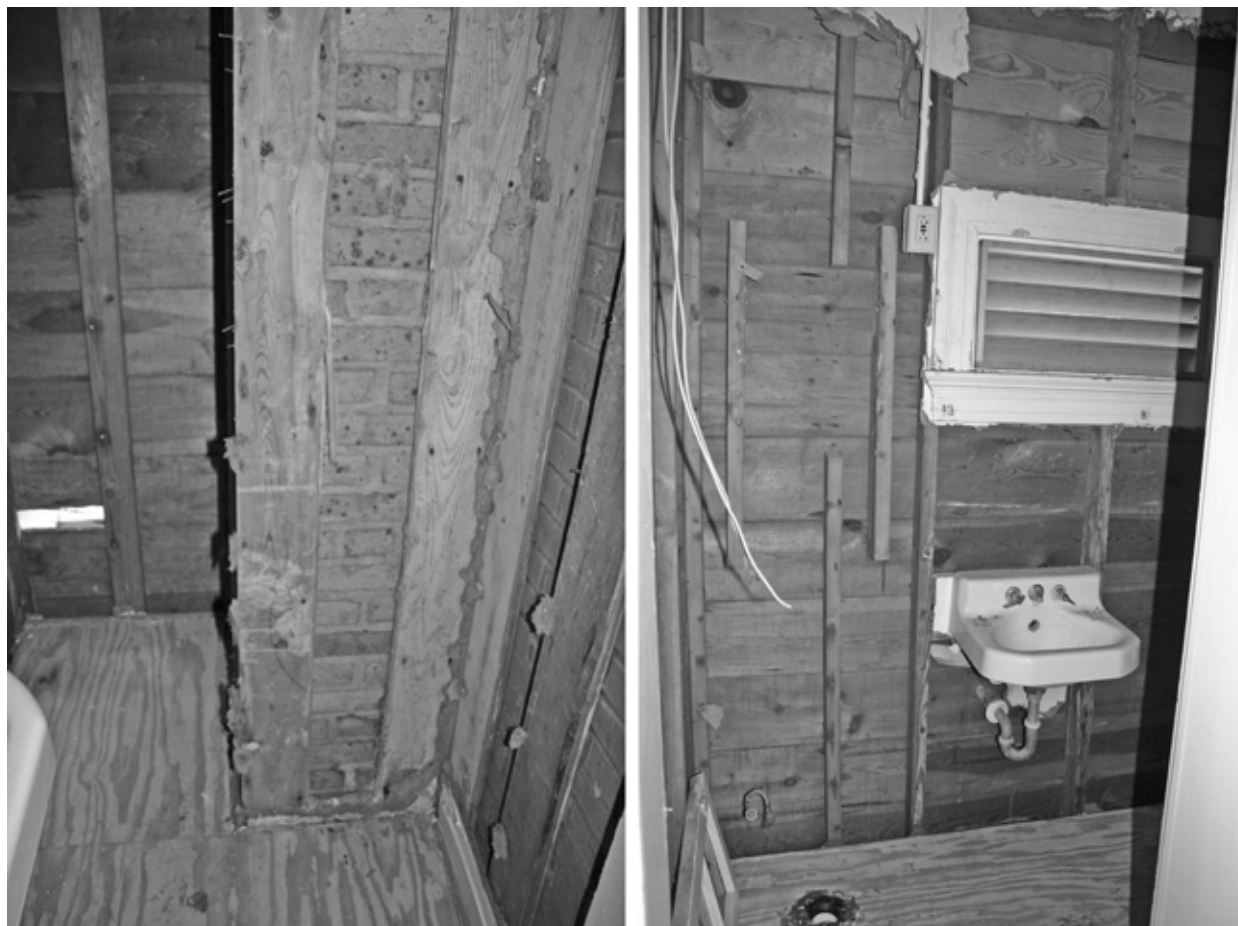
"Powder Room" (105)

FIGURE 71. View northeast (left) and north (right) in Room 105. The odd framing visible in the right-hand image was probably to accommodate a wall-hung toilet tank.

- Remove laundry room, half bath, and chimney from first floor of back porch
- Close opening for half bath door
- Widen back door and door between Rooms 103 and 104 to provide handicapped access
- Remove closets and chimney from sleeping porch
- Install ramp to back porch along southwest side of house
- Install fire detection and suppression systems

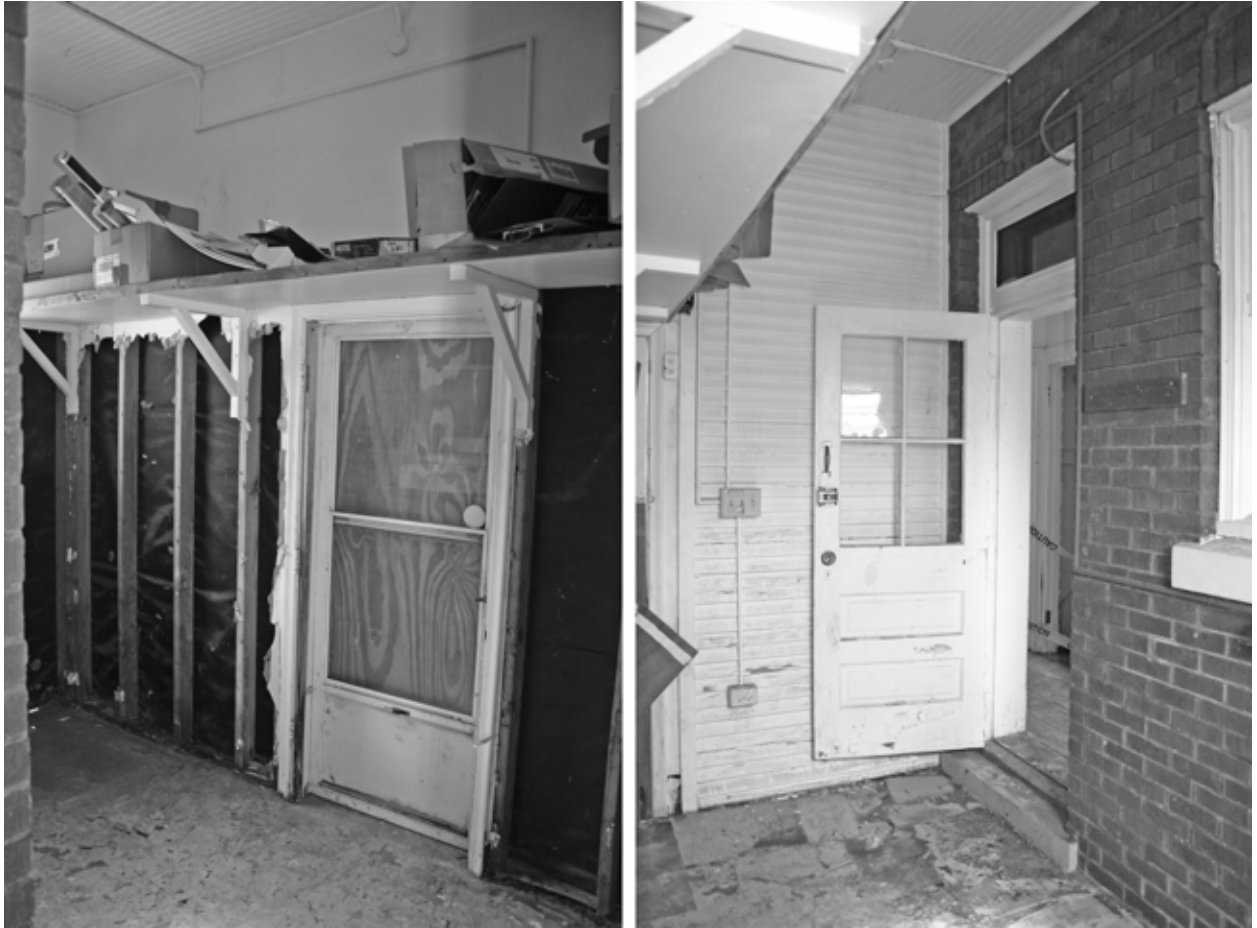
Laundry or Utility Room (106)

FIGURE 72. View west (left) and east (right) in Room 106.
