# KALAUPAPA

HISTORIC STRUCTURE REPORT

ST. PHILOMENA CATHOLIC CHURCH  
(FATHER DAMIEN'S CHURCH)

January 1985

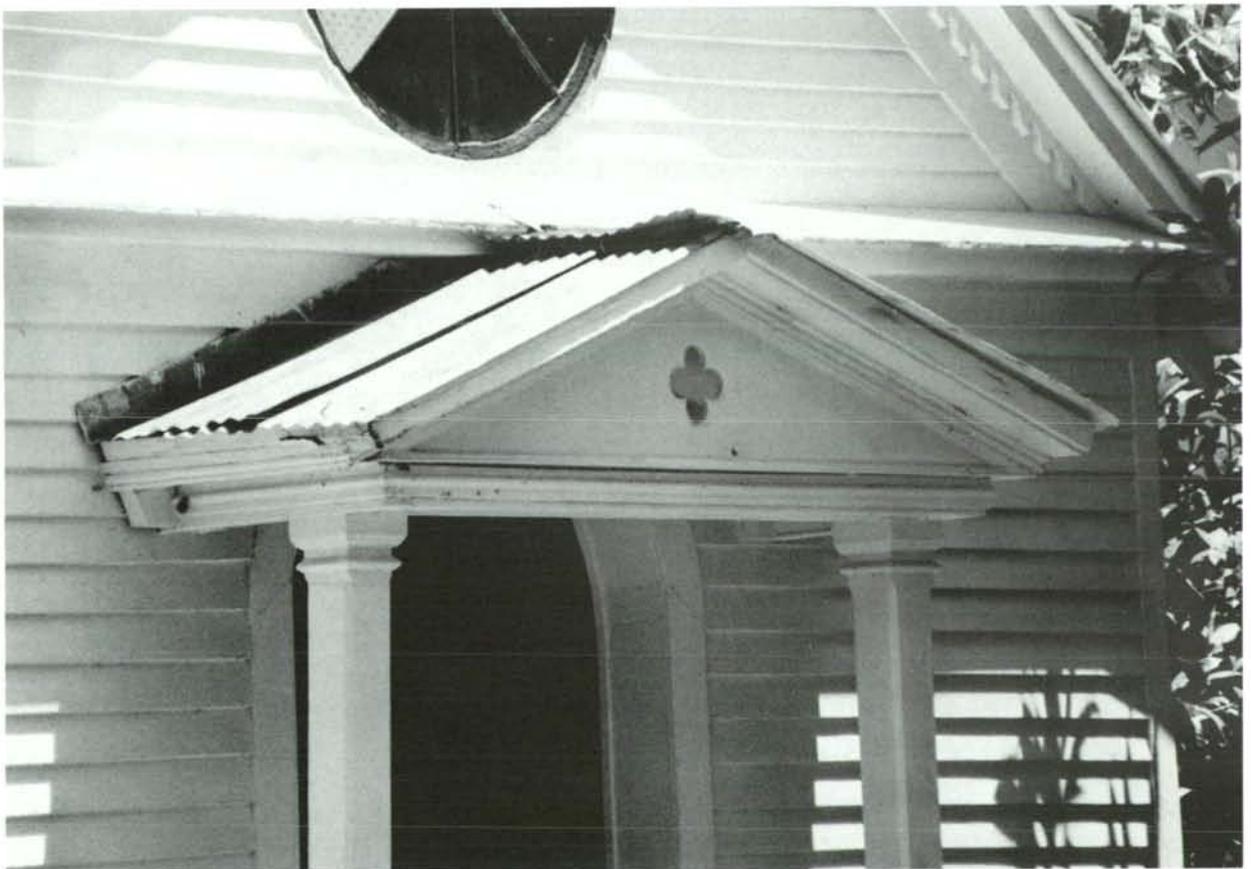
Illustration A14.

Detail of portico roof at 'west' entry of 1876 nave. Deterioration of the framing and sheathing no longer will hold the roofing nails. 6/84. R.L.C.

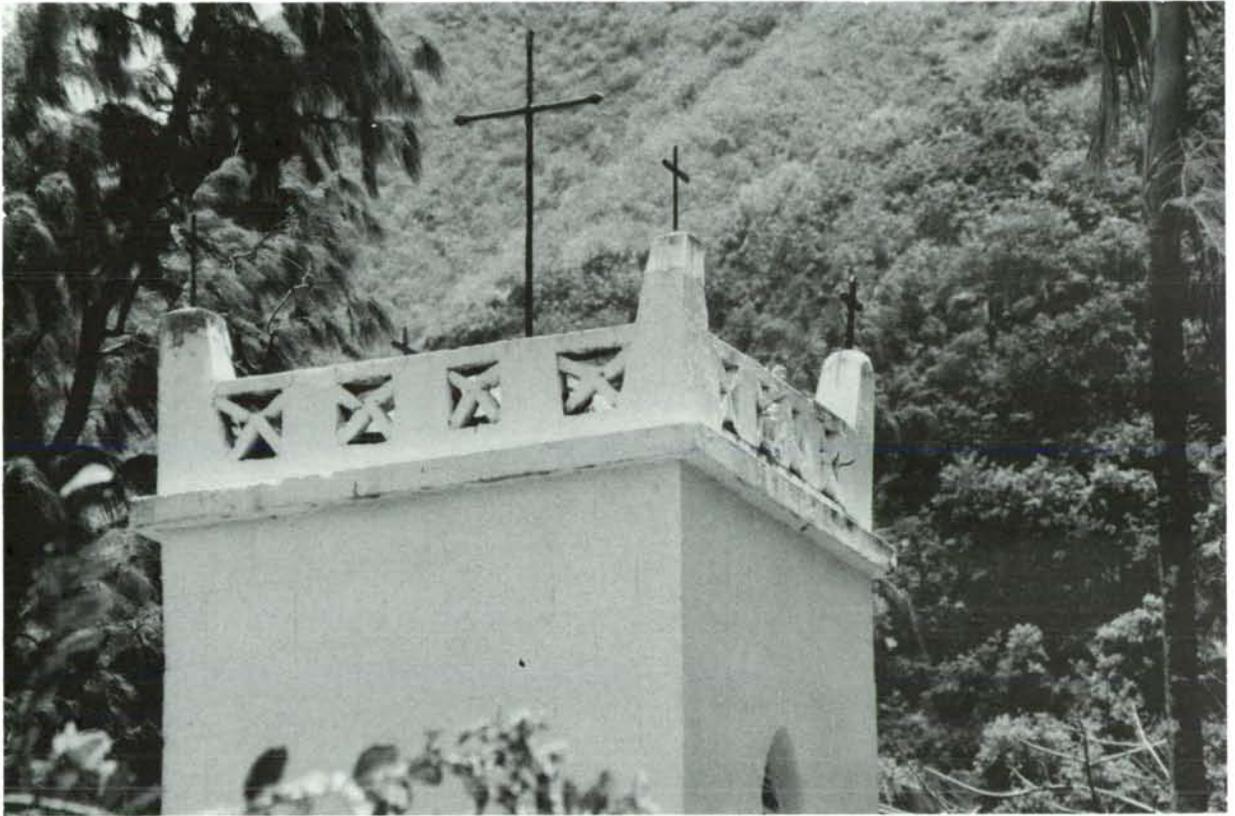
Illustration A25.

'North' and 'west' parapets of bell tower. Note repair caps on pinnacles resulting from replacement of crosses. 6/84. R.L.C.

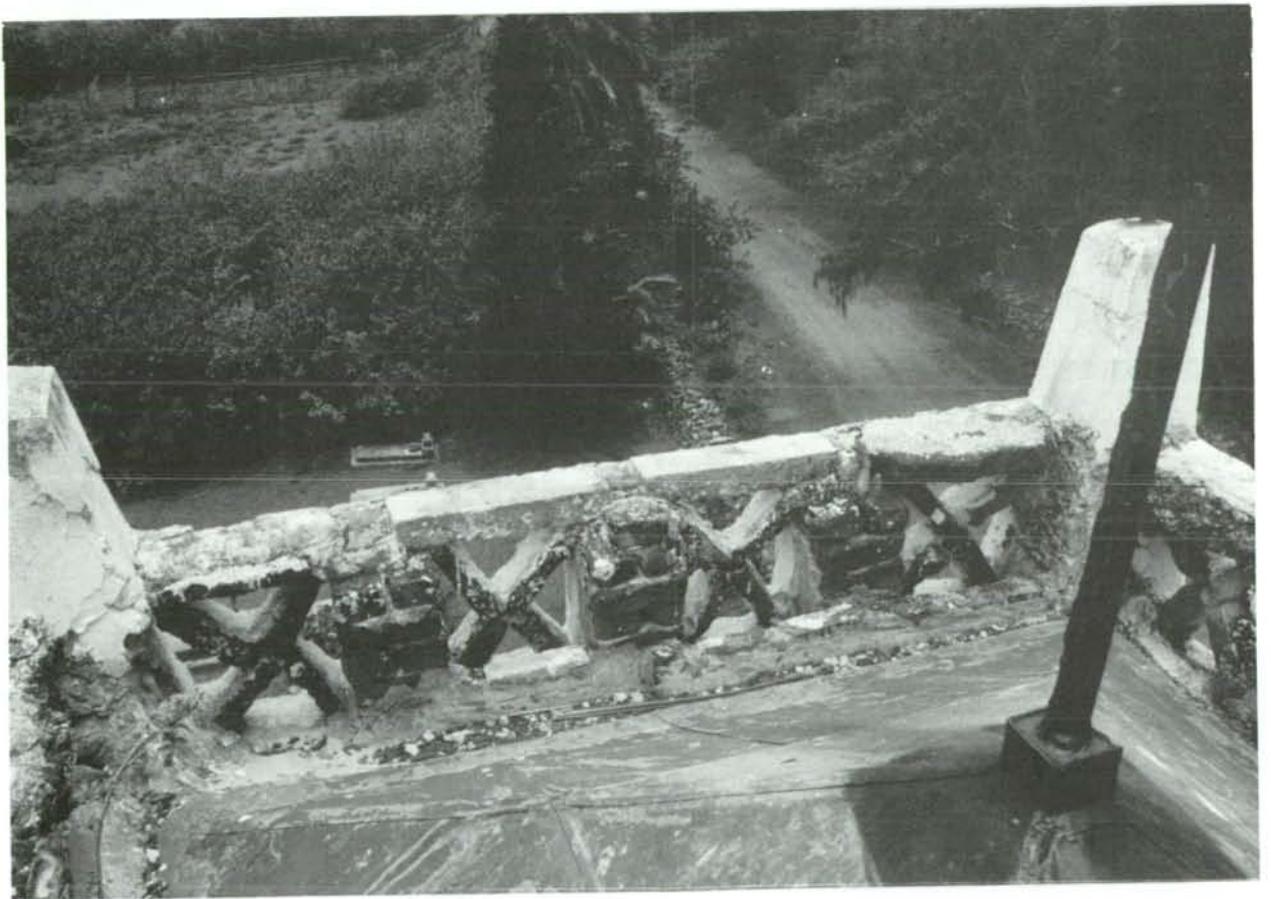
Illustration A29.

'East' parapet. Note concrete masonry units used for repairs. The copper roofing is in reasonably good condition but the drainage gutter around the base of this square pyramidal roof does not drain well and the base plate of the roof framing is rotted. All crosses are rusted and exfoliated. 5/84. H.G.L.

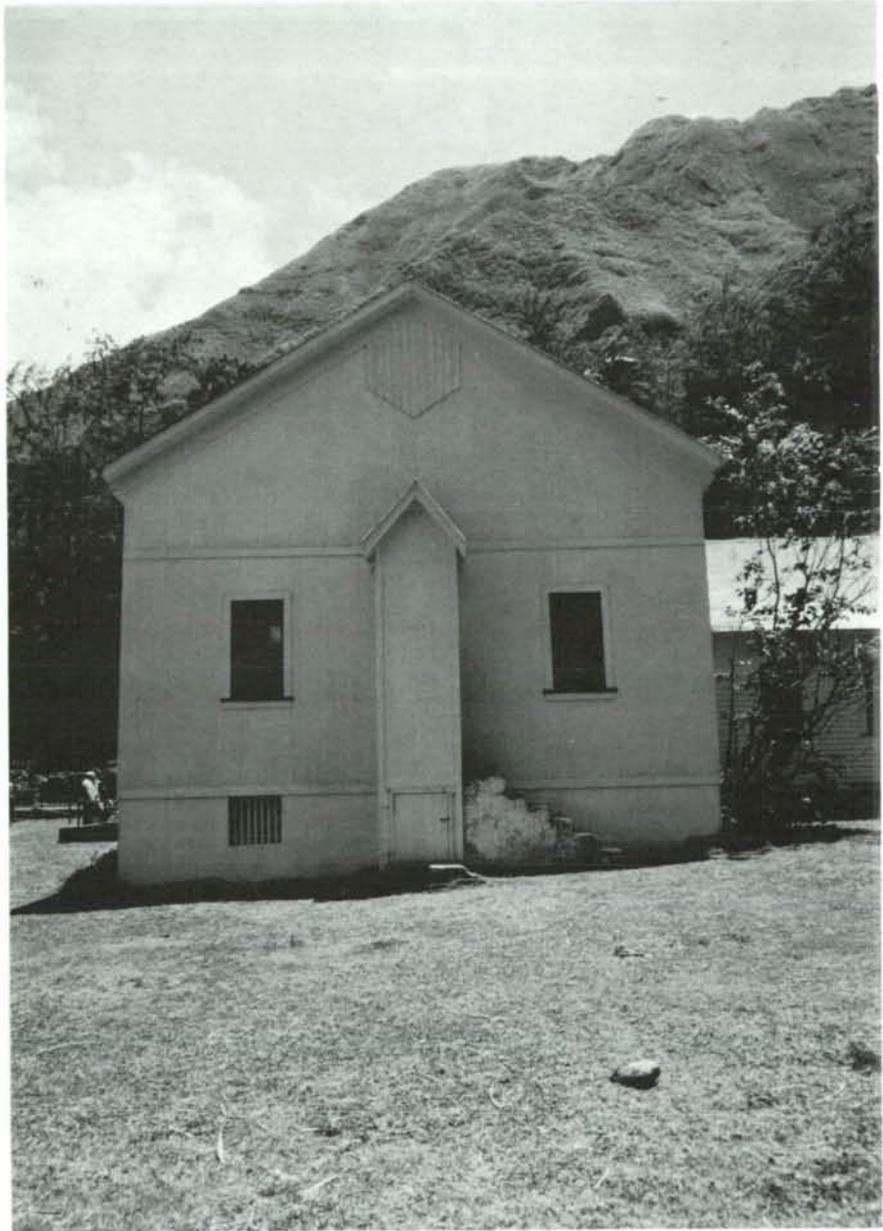
Illustration A33.

Rear ('north') elevation of 1888-89 portion of building. This wall was replaced after collapse during a storm. The sand density in the paint on this wall does not match that of the other siding of the building. 6/84. R.L.C.

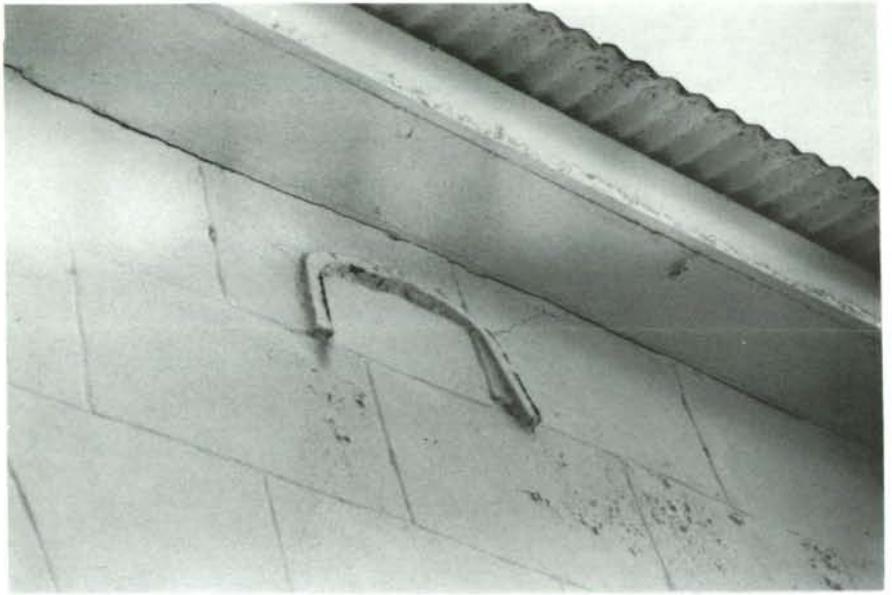
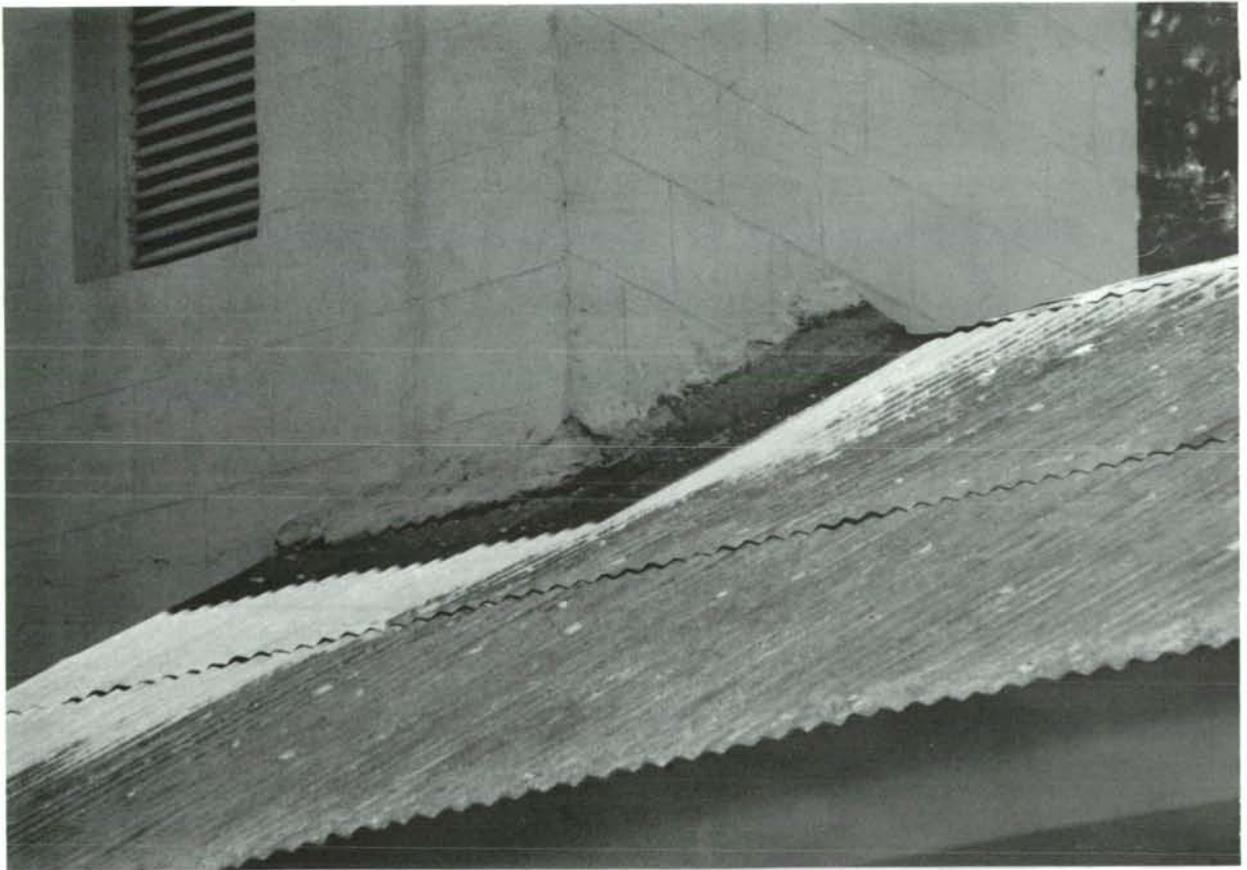
Illustrations A39 and A40.

Detail at juncture of main roof and bell tower. Numerous attempts to seal this joint are evident. Leakage here is the cause of damage to the stations of the cross. 6/84. R.L.C.

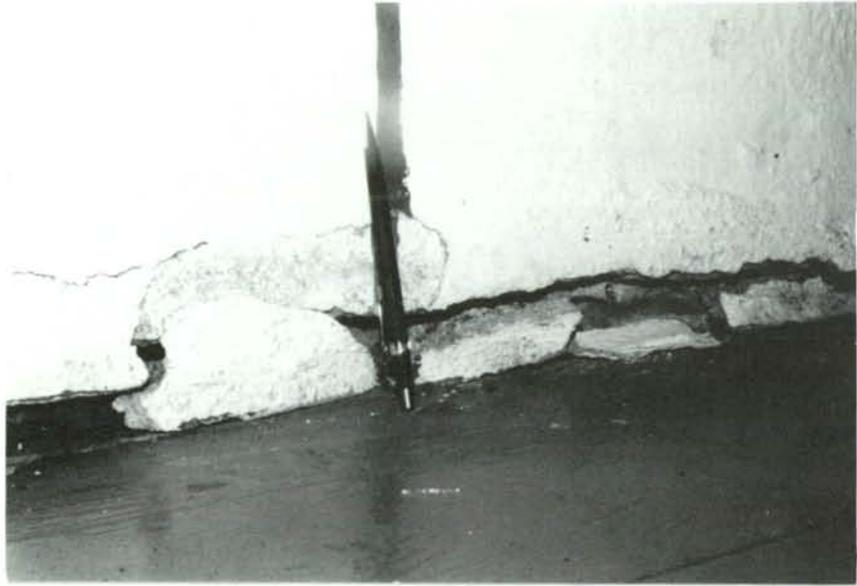
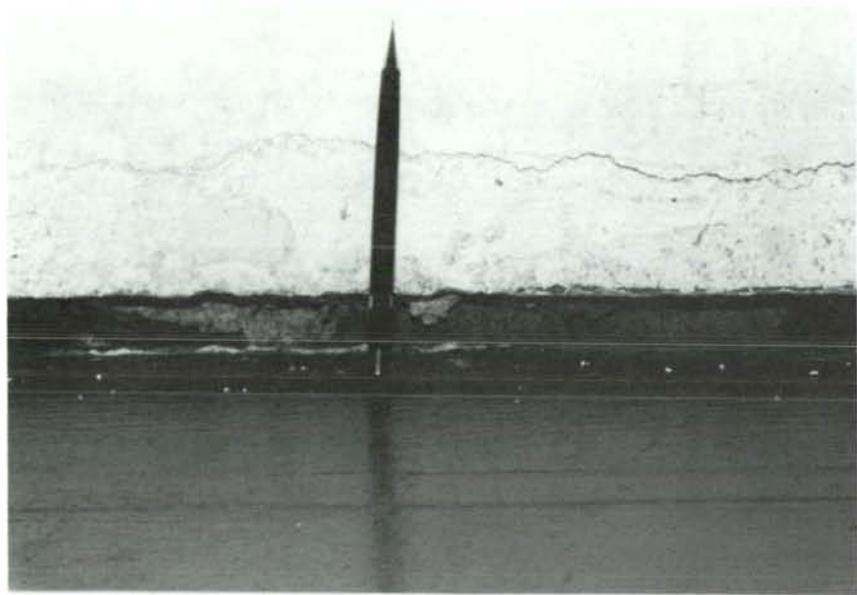
Details showing subsidence of floor of 1888 nave. The greatest settlement occurred in the area of the two 'southern-most' columns. Repairs to the wall plaster have failed as the cement plaster mix did not bond to the earlier lime plaster. 8/84. P.C.C.

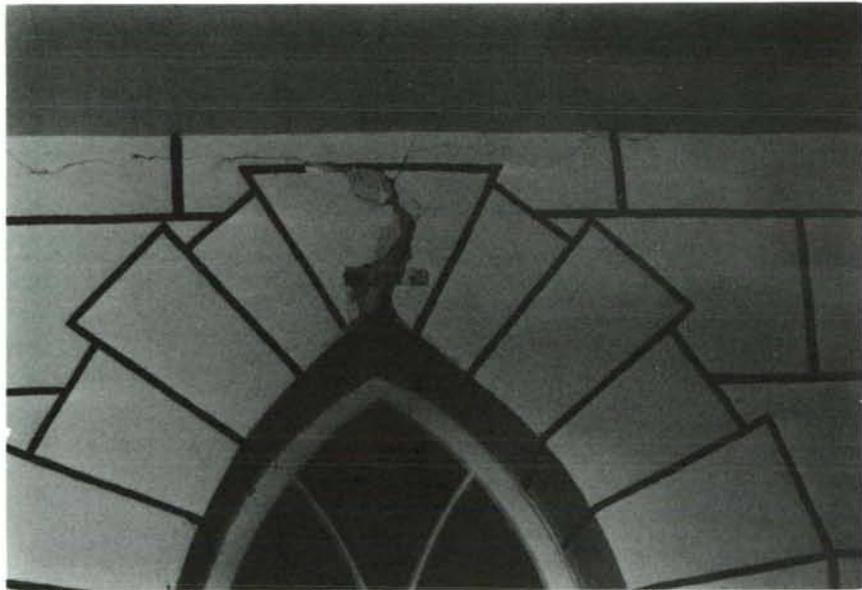
Illustration A52. Earthquake damage at 'south' window of 1888 nave, west wall. Similar damage occurred at the window on the opposite side of the building. There has been no movement recorded since the tell-tale was installed. 8/84. P.C.C.

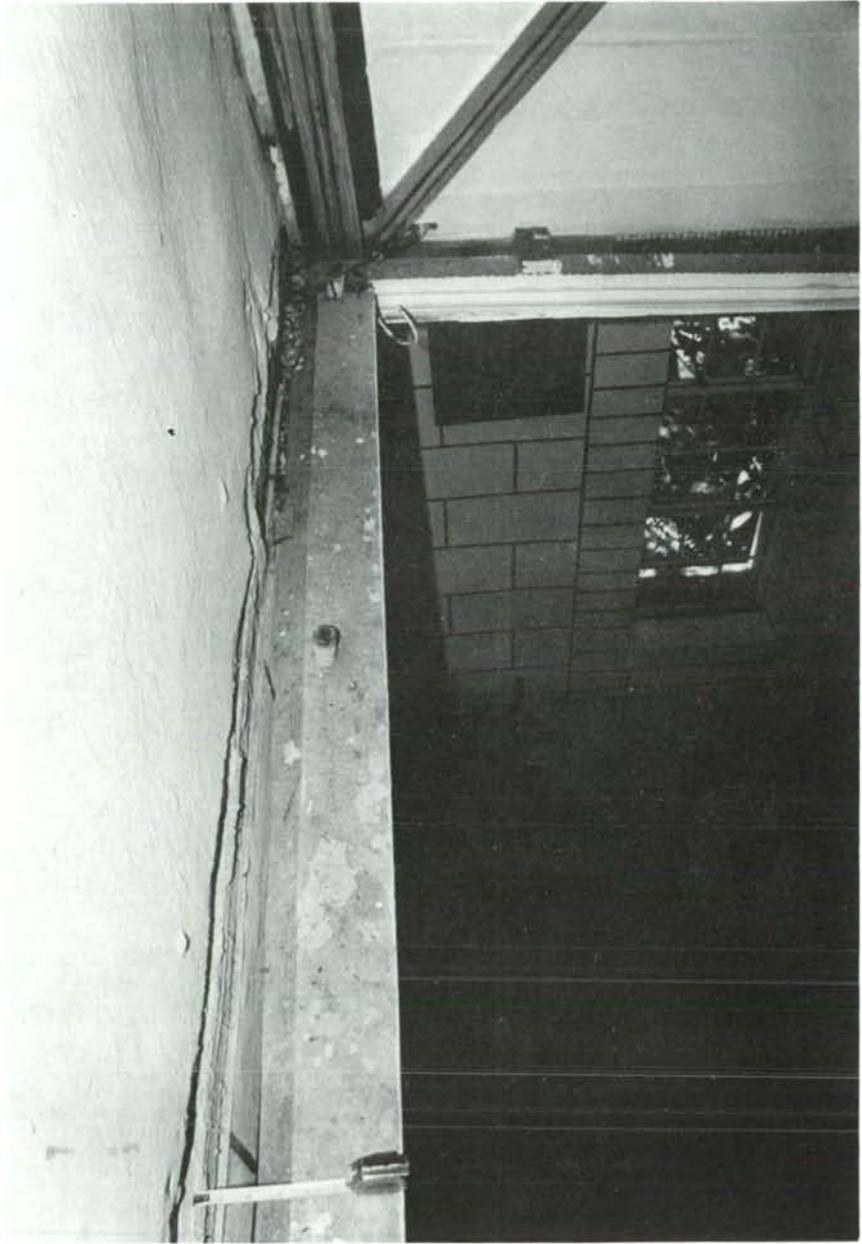
Illustrations A54 and A55.

Top of cornice at 'south' wall of 1888 nave. The nails which formerly secured it to the wood nailer set in the masonry wall are completely rusted away, and it is held in place only by the ends of the cornice members at the base of the vault. 8/84. P.C.C.

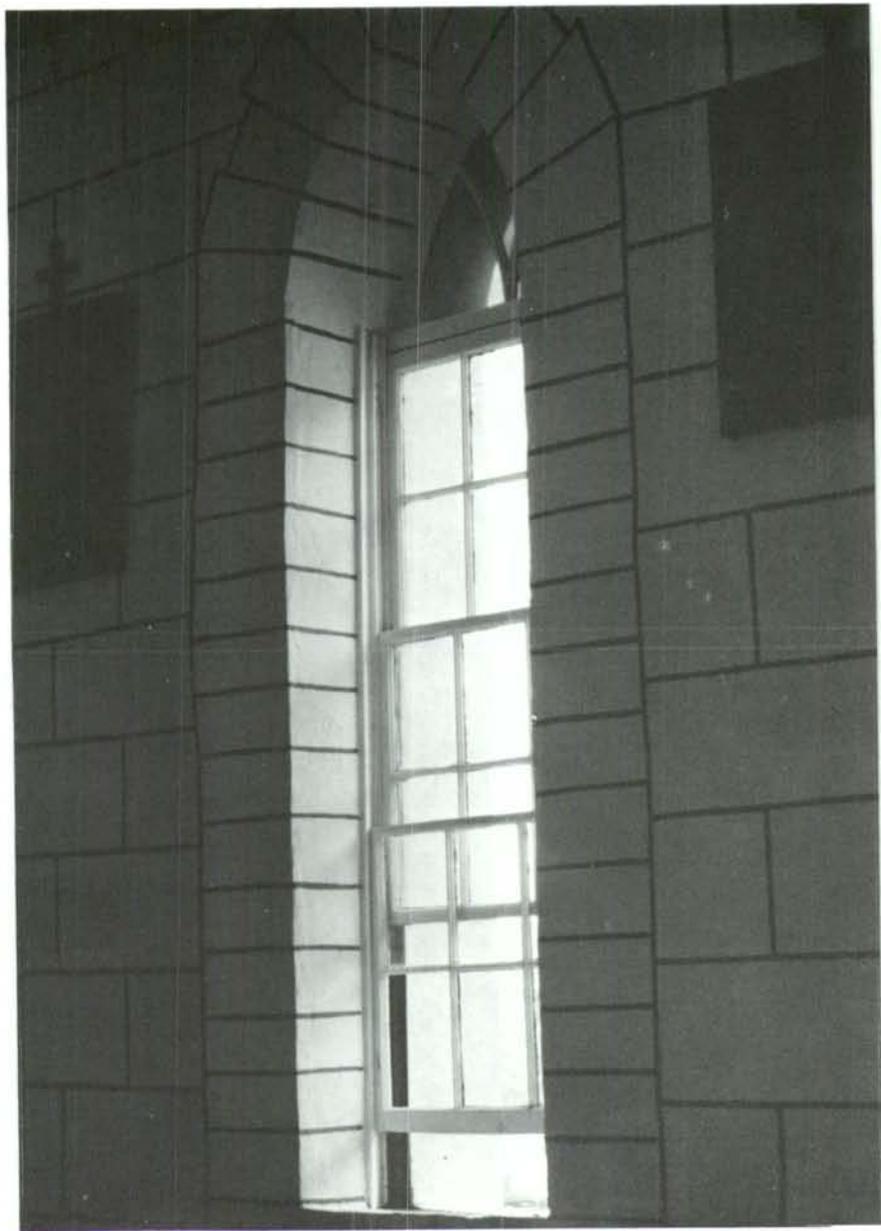
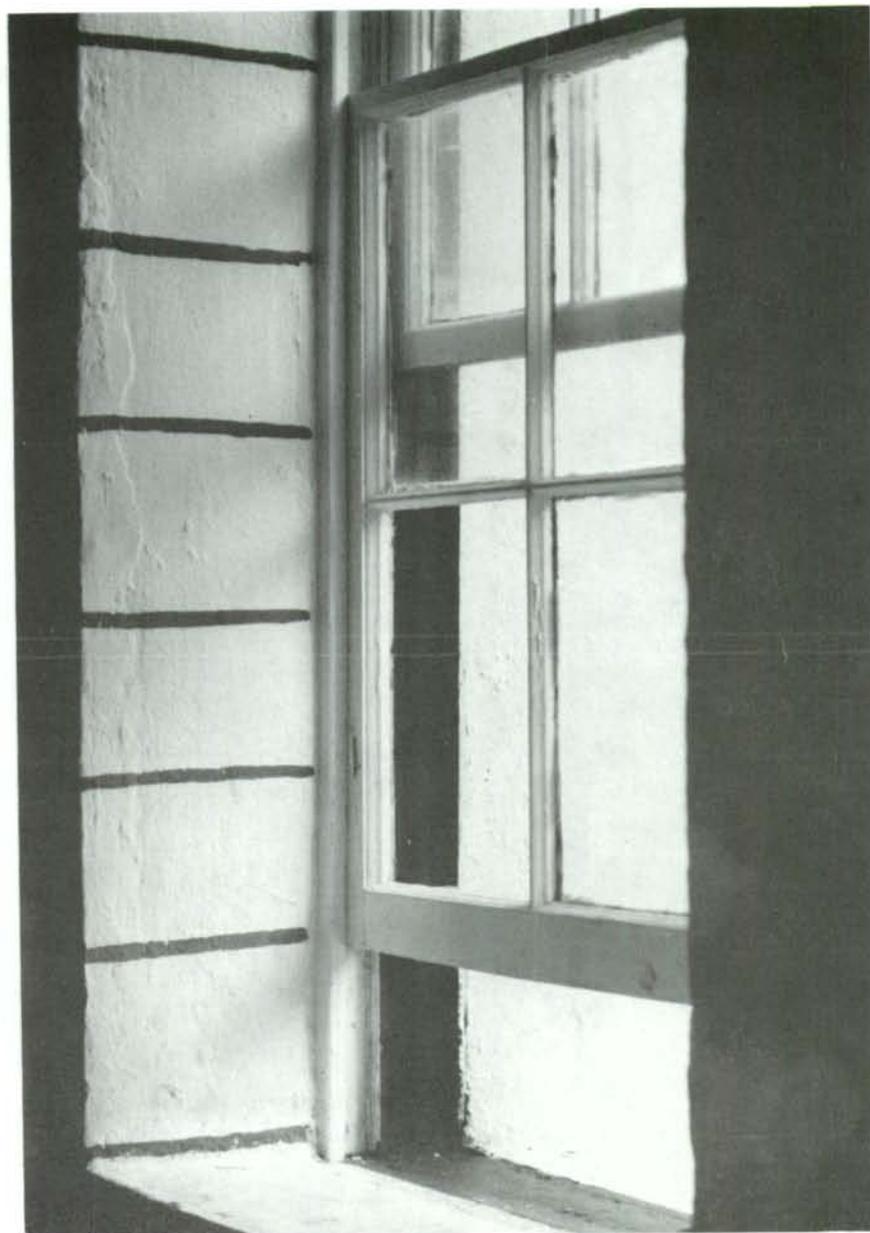
Illustration A56.

Window details, 1888 nave. Only the lower sash units of these windows are operable. There is no hardware, nor does it appear that there ever was, so they must be propped open. Some glazing is missing, as illustrated here, or broken. Sash, sash guides, wood jambs and sills need refurbishing, and in some cases, elements need replacement. 6/84.  
R.L.C.

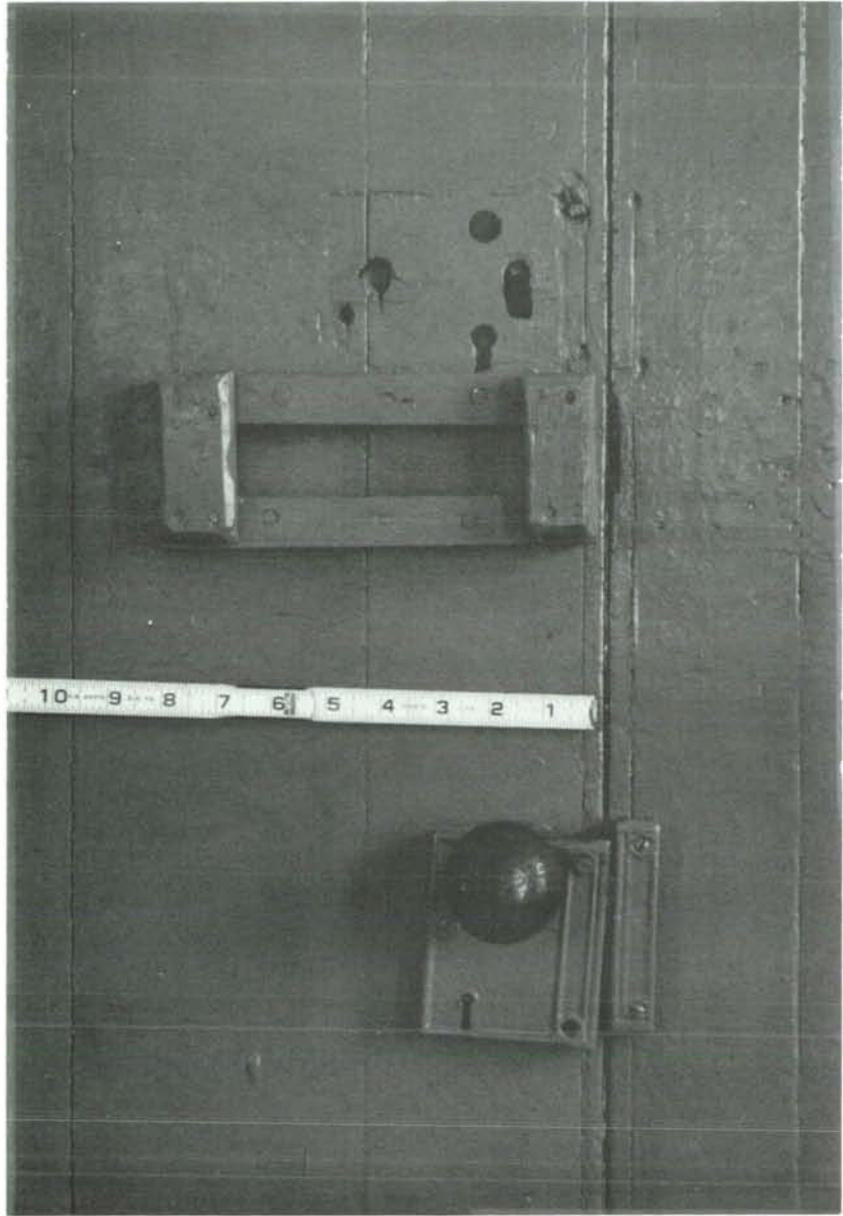
Illustration A58.

Hardware detail, interior of 'west' entry door, 1876 nave. Three periods of hardware are evident, the missing rim lock probably the intermediate set. Part of the wood slide-latch is obviously missing. 8/84. P.C.C.

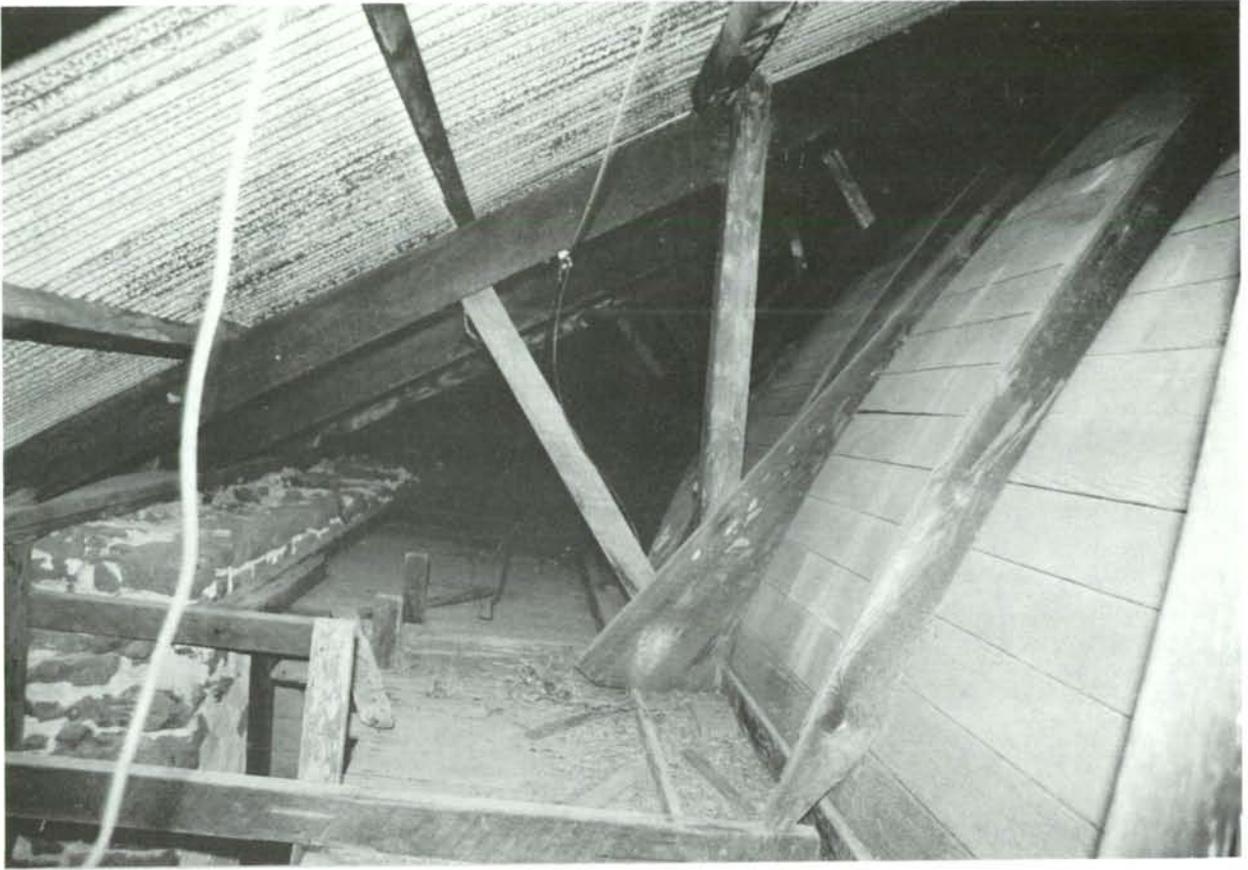
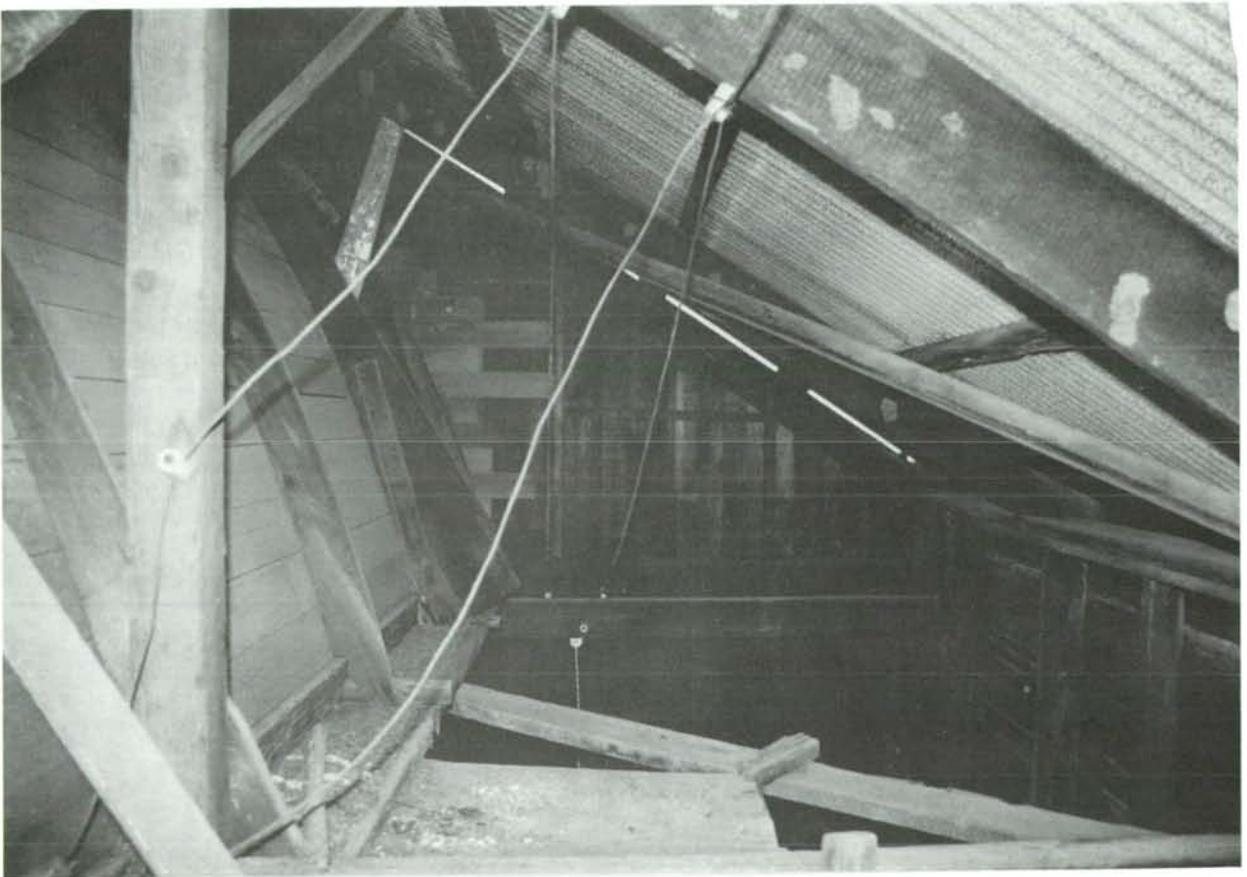
Illustration A65.

Attic along 'east' side of 1888 nave vault, view toward 'north', showing wood frame portion of building, open to the east sacristy below. The deteriorated vault base plate is at lower left. 8/84. P.C.C.

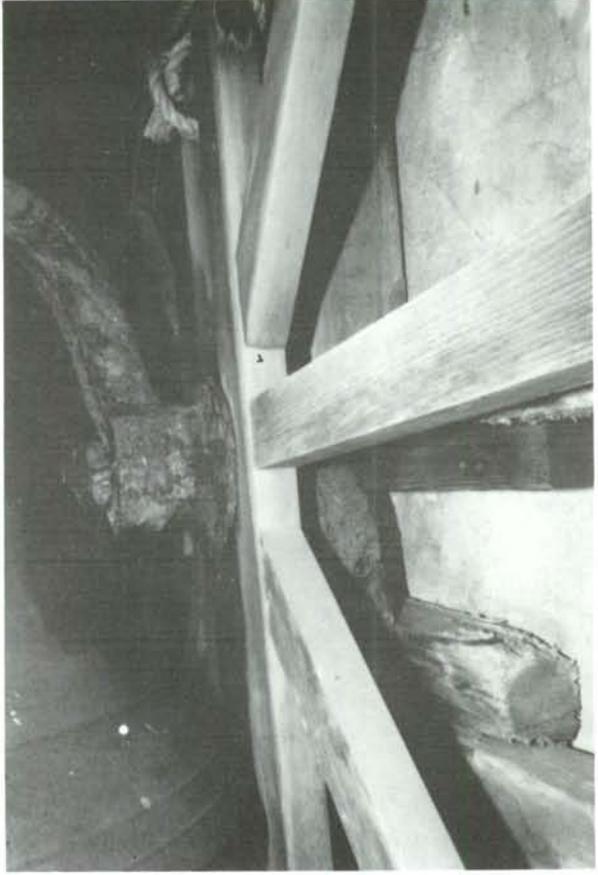
Illustration A72.

Details of the deteriorated bell yoke. The bell is frozen because of the rust and exfoliation of the iron. 6/84. R.L.C.

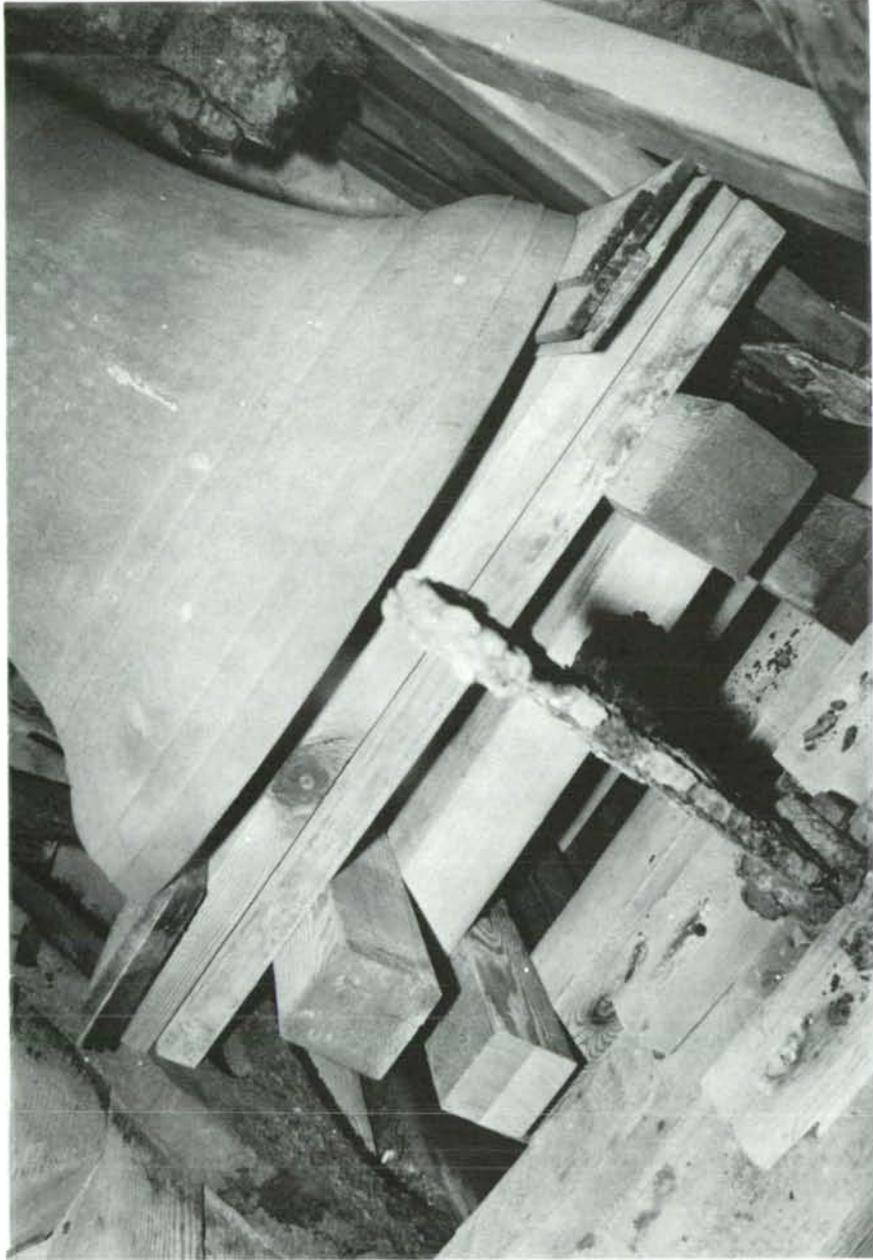
Illustration A73.

Detail showing cribbing installed in August, 1984 as a safeguard against failure of the deteriorated shafts and connections of the bell yoke. 8/84. P.C.C.

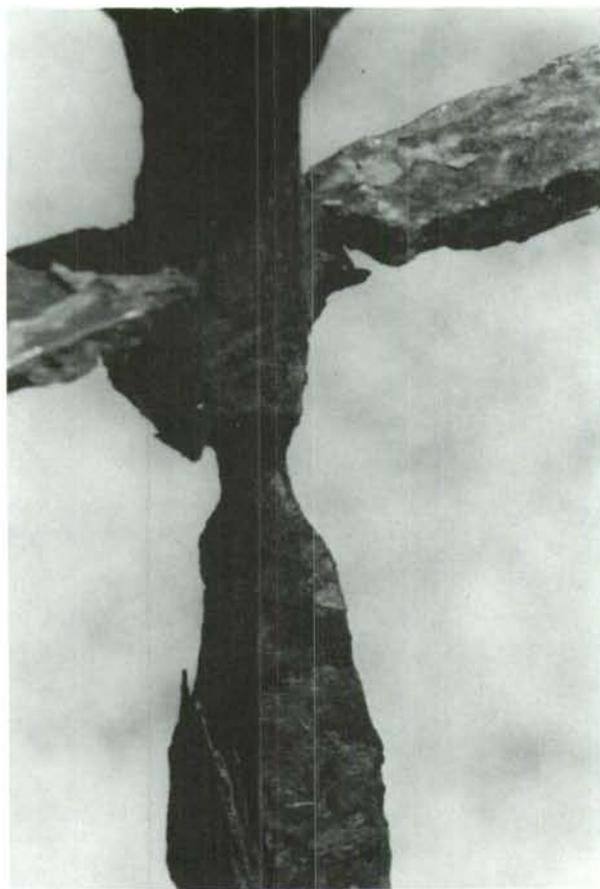
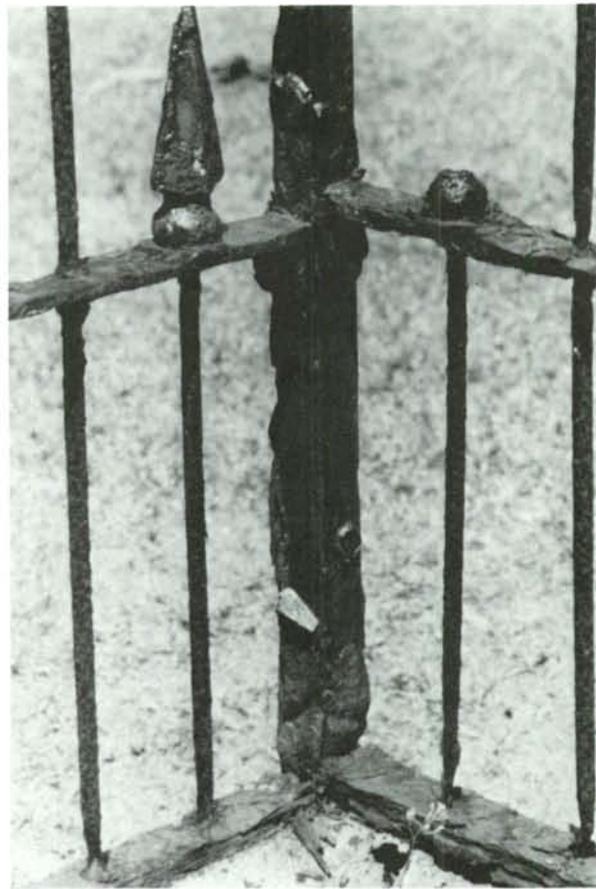
Illustrations A117 and A118.

Details of railing, Fr. Damien's grave, showing deterioration of metal. 6/84. R.L.C.

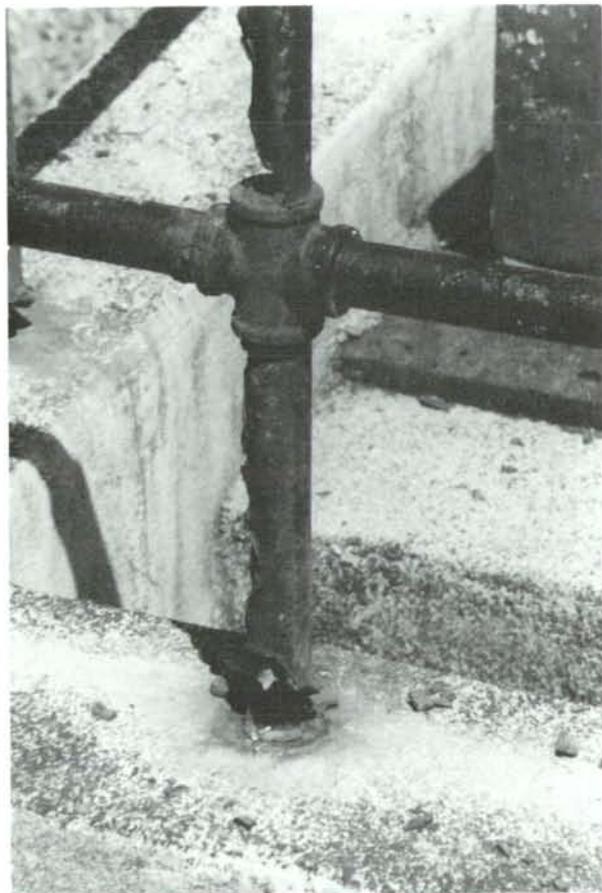
Illustration A124.

Detail of deteriorated pipe railing of Br. Dutton's grave. 6/84. R.L.C.
