STRUCTURE REPORT

ARCHITECTURAL DATA SECTION - VOLUME I

LINCOLN HOME

Lot 8 - Block 10 Lincoln Home National Historic Site Springfield, Illinois

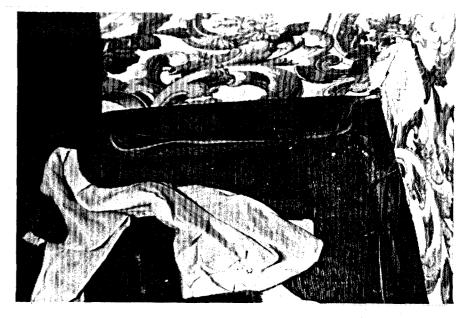
202 - P1

(By using a mirror, viewing up wall between studs)

1) vertically sawn studs
2) stains due to water damage
3) end of Second Floor joist extending into wall cavity (typical balloon framing detail)

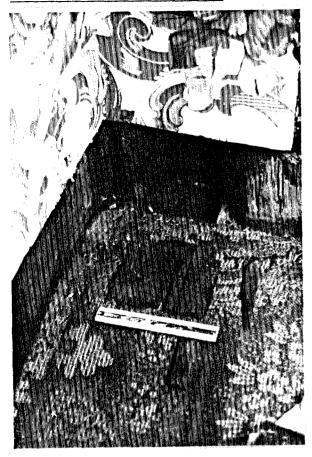
202 - P9

- 1) pieces of original siding or boxing removed from inside wall
- 2) decayed 4 x 4 next to window3) discontinuous stud

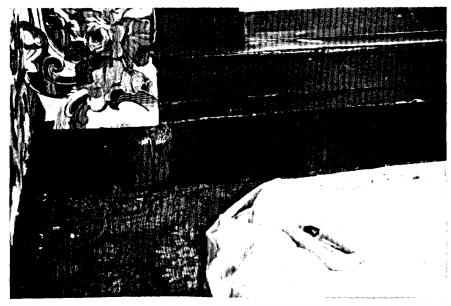
202 - P10

1) 4×4 stud along each side of window (same at south window of Robert's Bedroom, 207)

2) clapboards directly on studs with no "boxing"
3) strip below window sill apron is paper painted brown
4) air infiltration through wall very noticeable

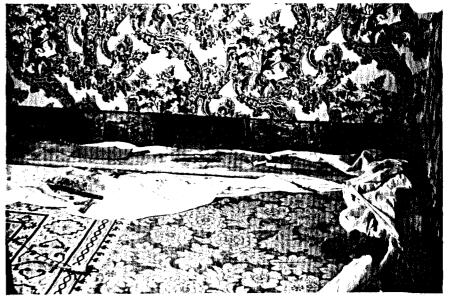
201 - P3

NOTE:
1) Closeup of corner

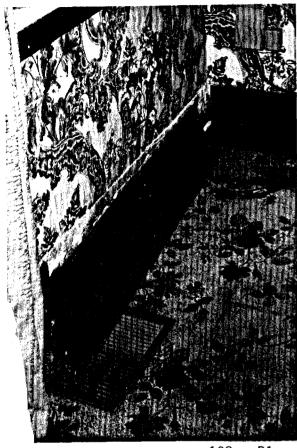
108 - P1

- 1) brick "nogging" starting + 8" above floor on up to second floor
- 2) the bottom 2 or 3 courses may have been removed when wood sill plates were replaced in the 1950's (no record of brick "nogging" at that time)
- 3) baseboard extension into south wall was cut off during Fabric Removal in order to reinstall baseboard (LHNHS staff has walnut piece)

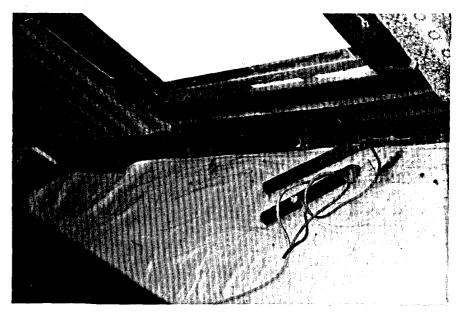
207 - P1

- 1) floor joists run north/south and bear on wall plate
- 2) window weights not in use different style from ones found in Front Parlor on First Floor (LHNHS staff has the weights)

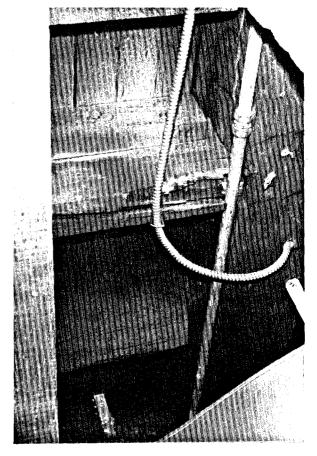
Base - 27

- 1) original hewn beam under north wall of Entrance Hall
- 2) original hewn joists deteriorated3) joist ends supported by new beam and column

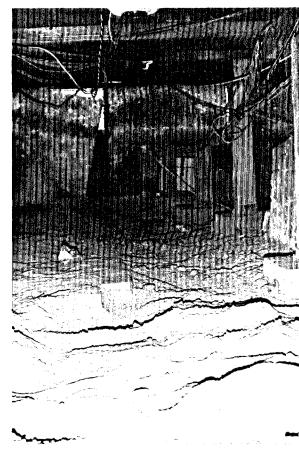
Crawl - 10

- NOTE:
 (Looking due west)
 1) outline of former brick foundation wall
 2) brick foundation wall ends approximately
 two feet further east of where it stops

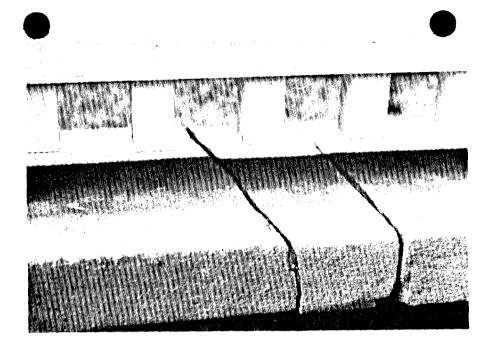
Cracks in coping on top of south brick wall
