Henry House
Historic Structure Report
Final Revised Edition

Manassas National Battlefield Park
National Capital Region
Manassas, Virginia

Historic Preservation Training Center
U. S. National Park Service

August 2003

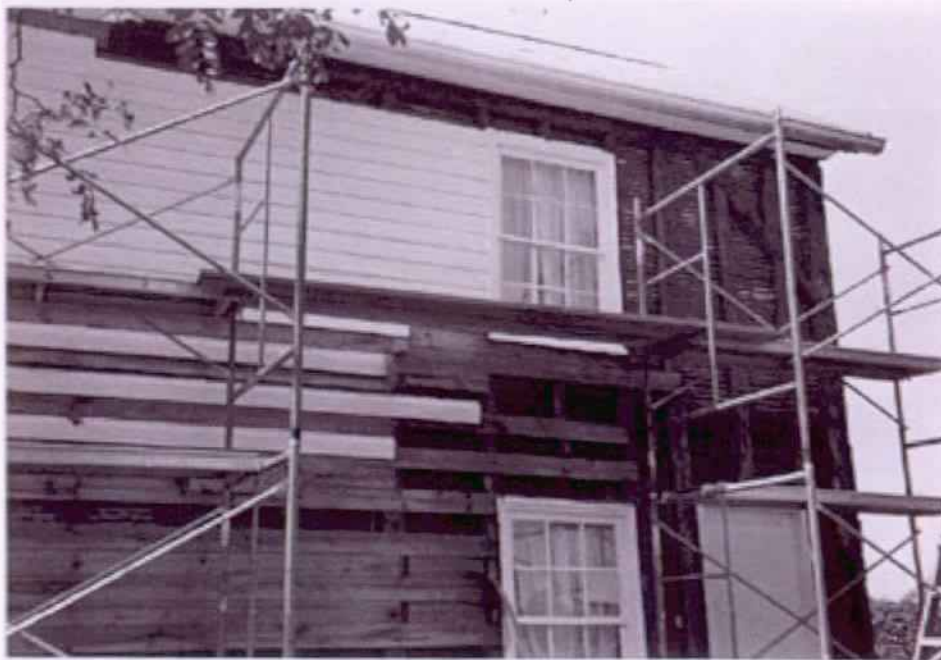
Figure 1. Siding and sheathing boards being removed to investigate extent of termite damage to the wall framing system at the NE corner (north block).

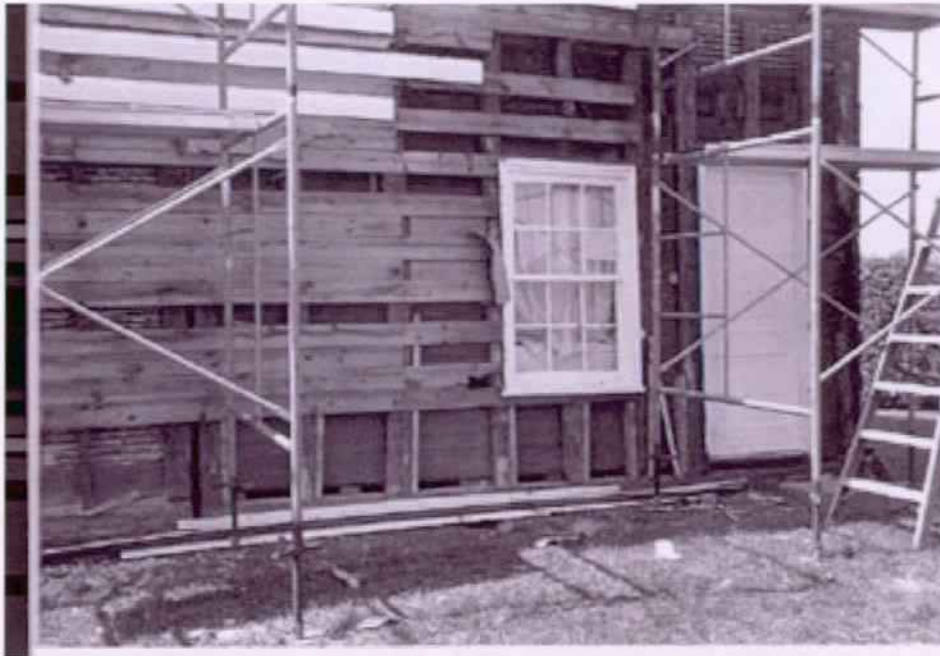
Figure 2. Siding and sheathing boards removed to investigate extent of termite damage to sill plate and wall framing system at NE corner (north block). This photo also documents repairs that have been made to the wall framing – modern dimensional lumber is seen in the wall cavity at the base of the vertical framing members to provide additional support to the wall framing surface in lieu of replacing historic framing members.

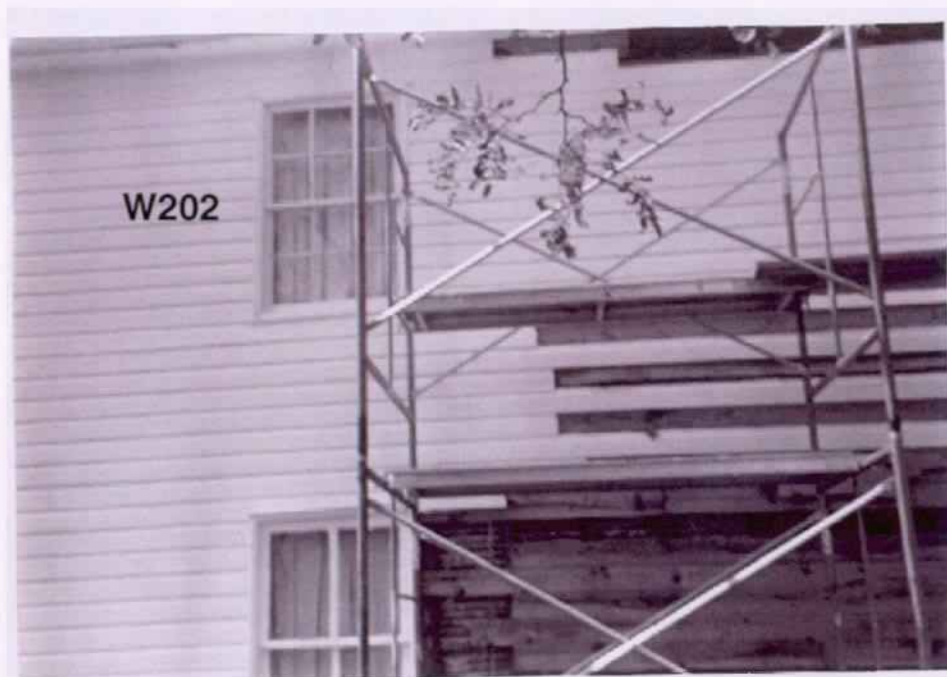
Figure 3. Documentation of extent of removal of exterior siding to investigate condition of wall structure and range of termite damage.

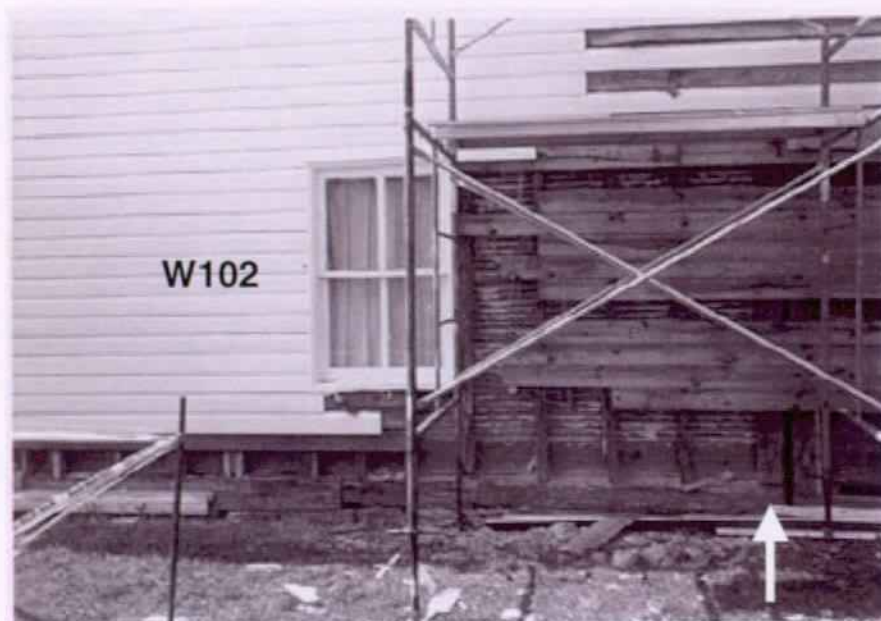
Figure 4. Removal of siding and sheathing boards continues to reveal extent of termite damage to house framing system. Adjacent double corner posts (arrow) are exposed (lower far right) at junction of south (L) and north (R) blocks of house.

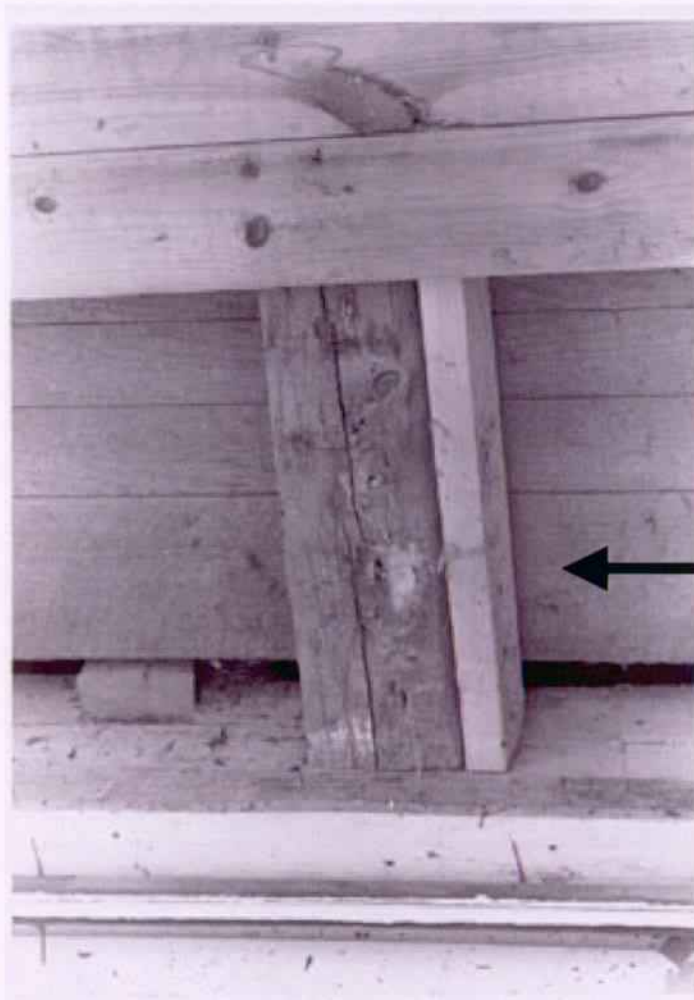
Figure 9. This view of a vertical wall post also shows the installation of a supplemental framing member (arrow) to help support the historic framing member. This is a non-destructive method of structural preservation and is recommended by the National Park Service. It is not known what condition these members are in at the time of this report (04/2003).

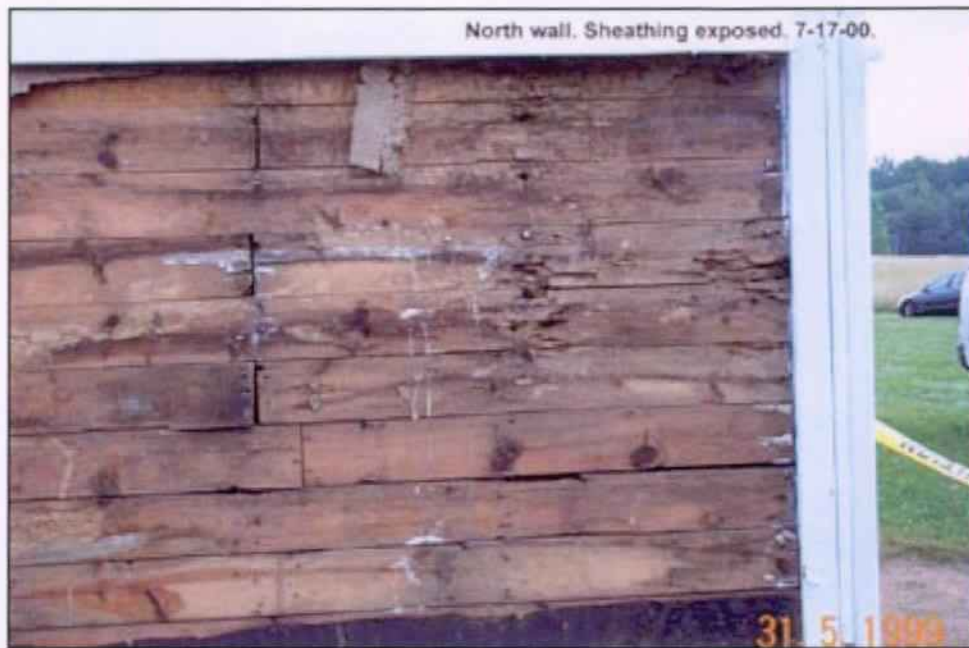
Figure 5. North Elevation with T&G sheathing boards exposed after exterior siding has been removed. 07/11/00

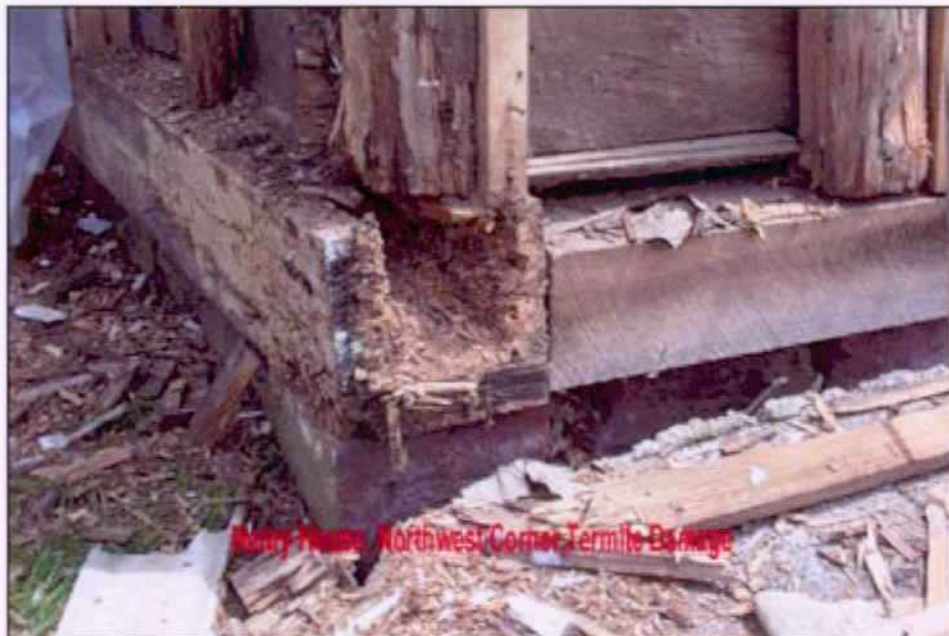
Figure 10. Northwest corner of building with north sill plate exposed with damage.

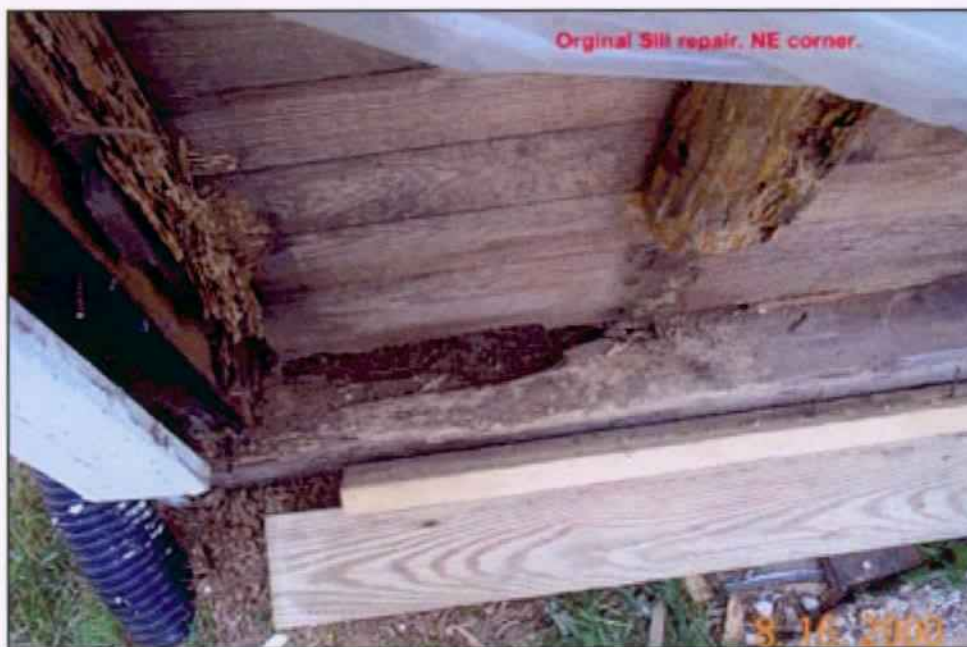
Figure 6. View of NE corner of building showing damage to original sill plate and vertical framing members. 08/16/2000.

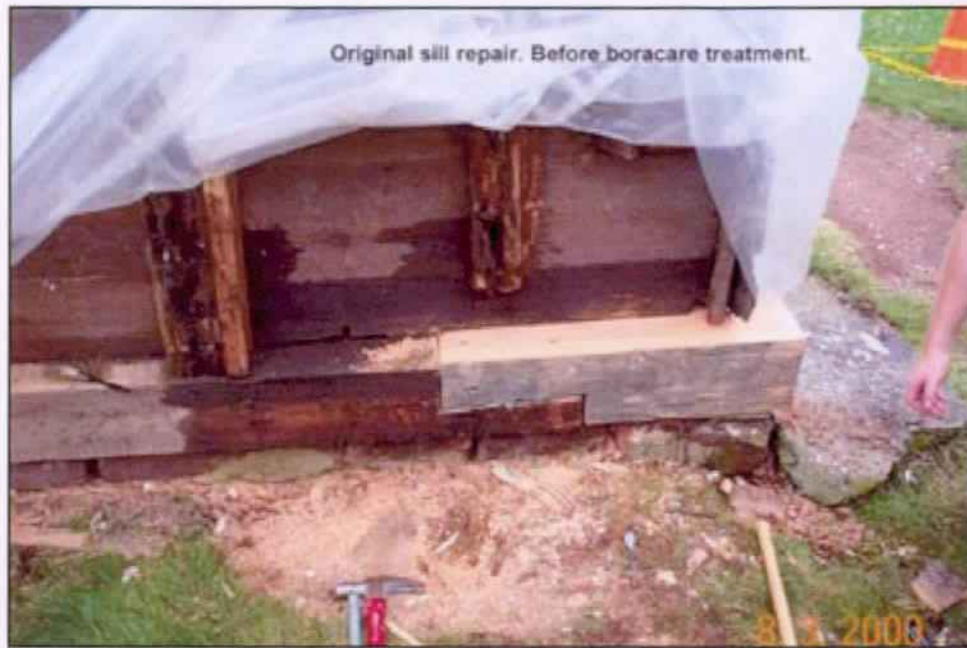
Figure 7. Repairs made to original sill of north elevation gable end at NW corner. Note corner post is not seen in this view. 08/03/2000

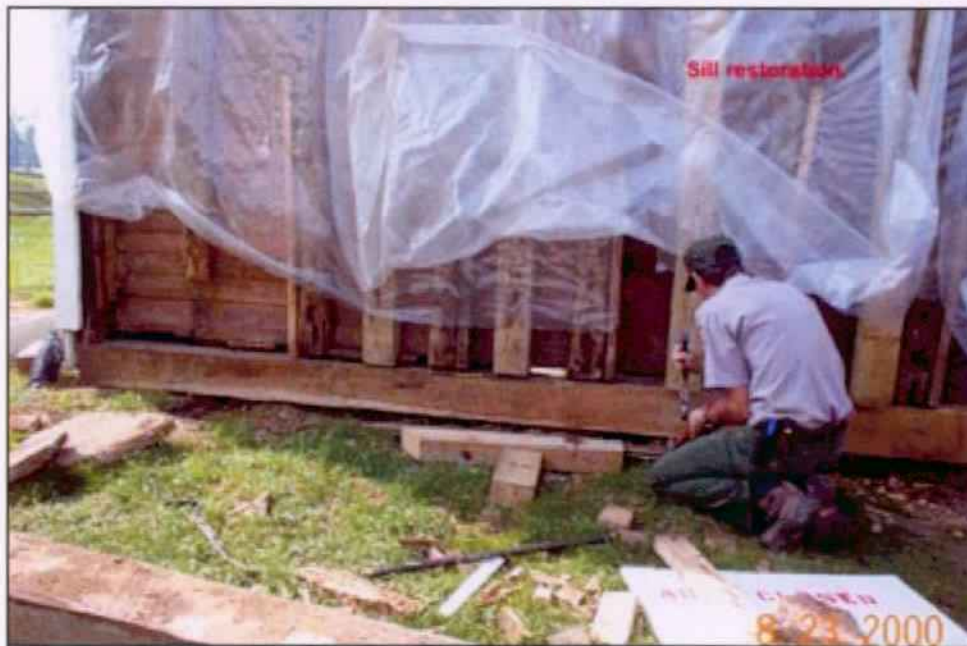
Figure 8. North Elevation Gable End replacement sill installed. 08/23/2000

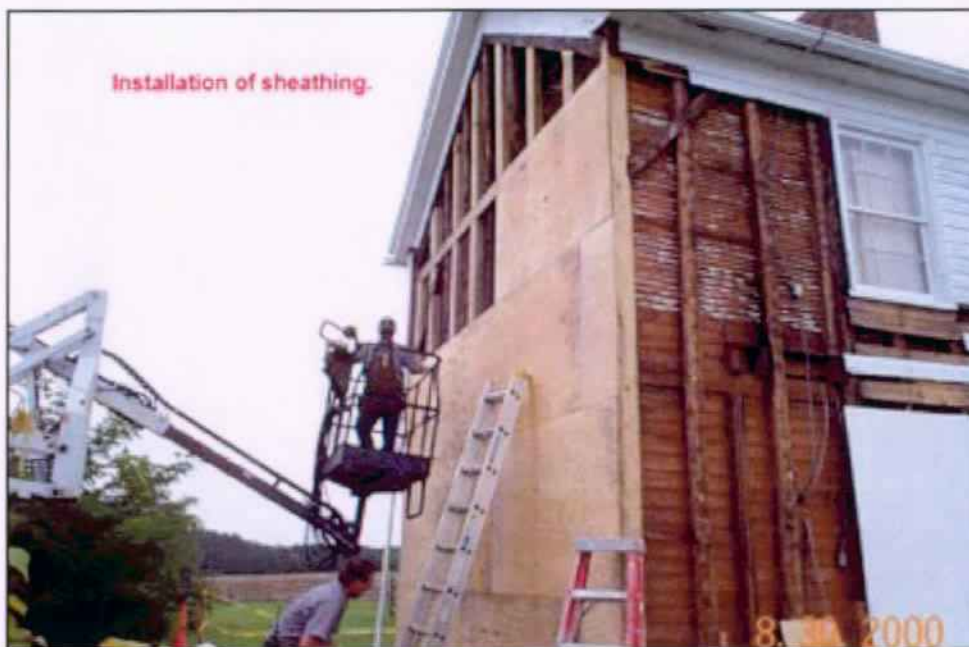
Figure 9. Installation of $\frac{3}{4}$ inch CDX plywood wall sheathing at north elevation gable end over new pressure treated wall framing system and sill plates. 08/16/2000

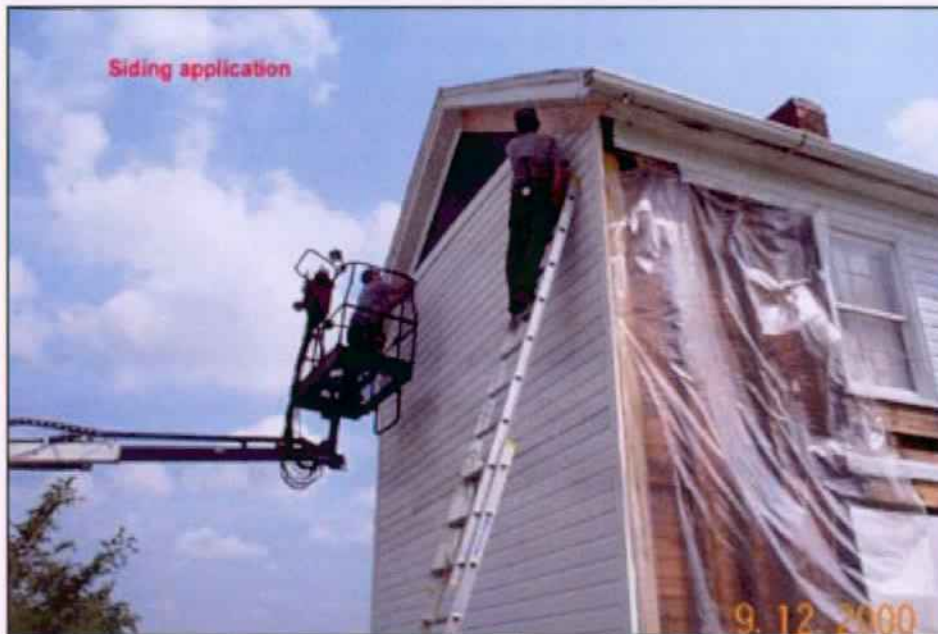
Figure 12. Installation of third generation replacement exterior siding at north elevation gable end almost completed, 09/12/2000.

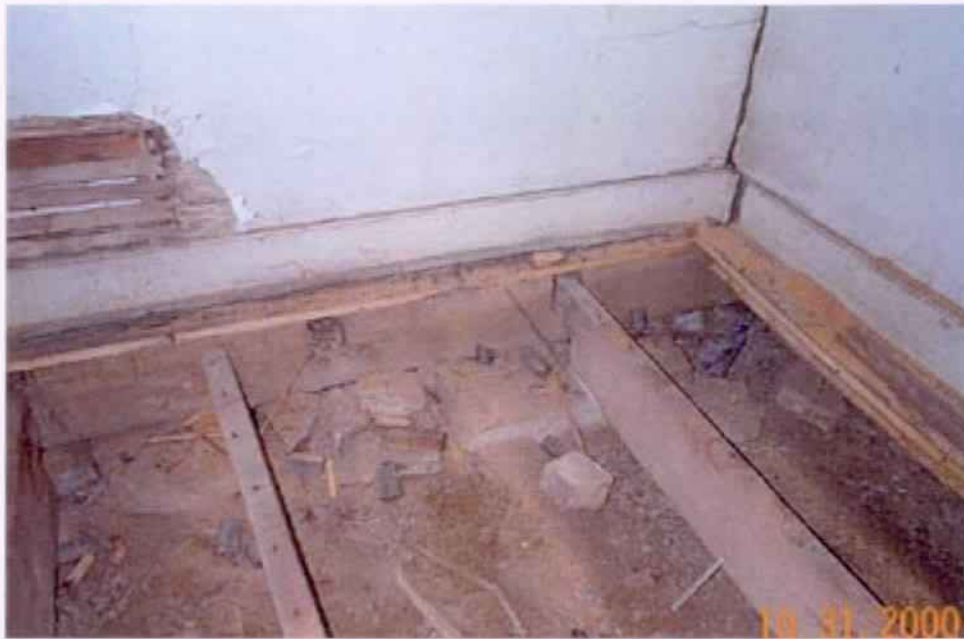
Figure 13. ESE Quad and SE Corner with crack.

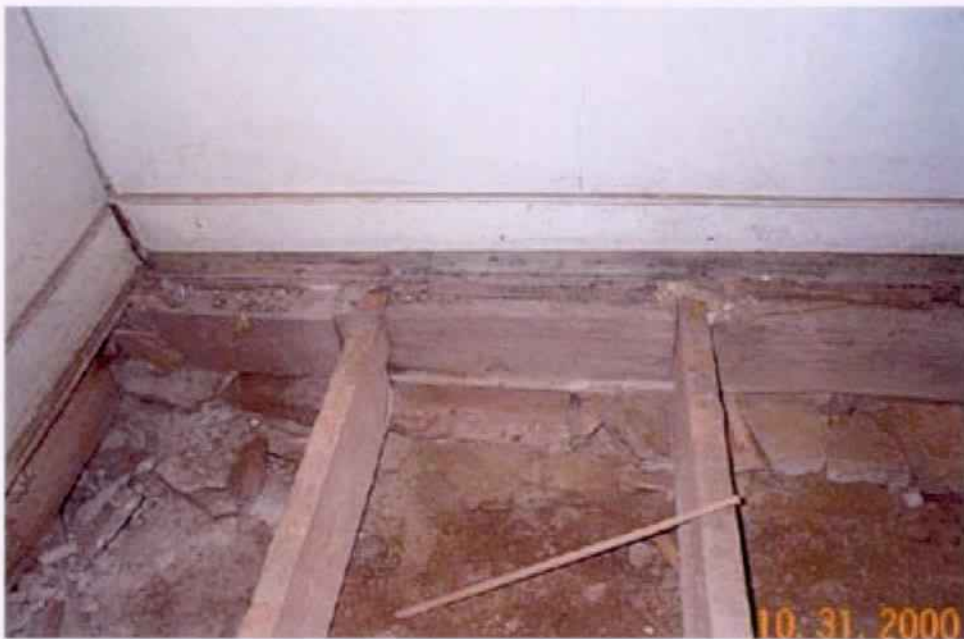
Figure 14. SSE Quad and SE Corner with crack.
