THE HISTORY AND PRESERVATION
OF THE COMMUNITY AUDITORIUM-GYMNASIUM
Historic Structure Report

MANZANAR
NATIONAL HISTORIC SITE

HISTORIC STRUCTURE REPORT

December 1998

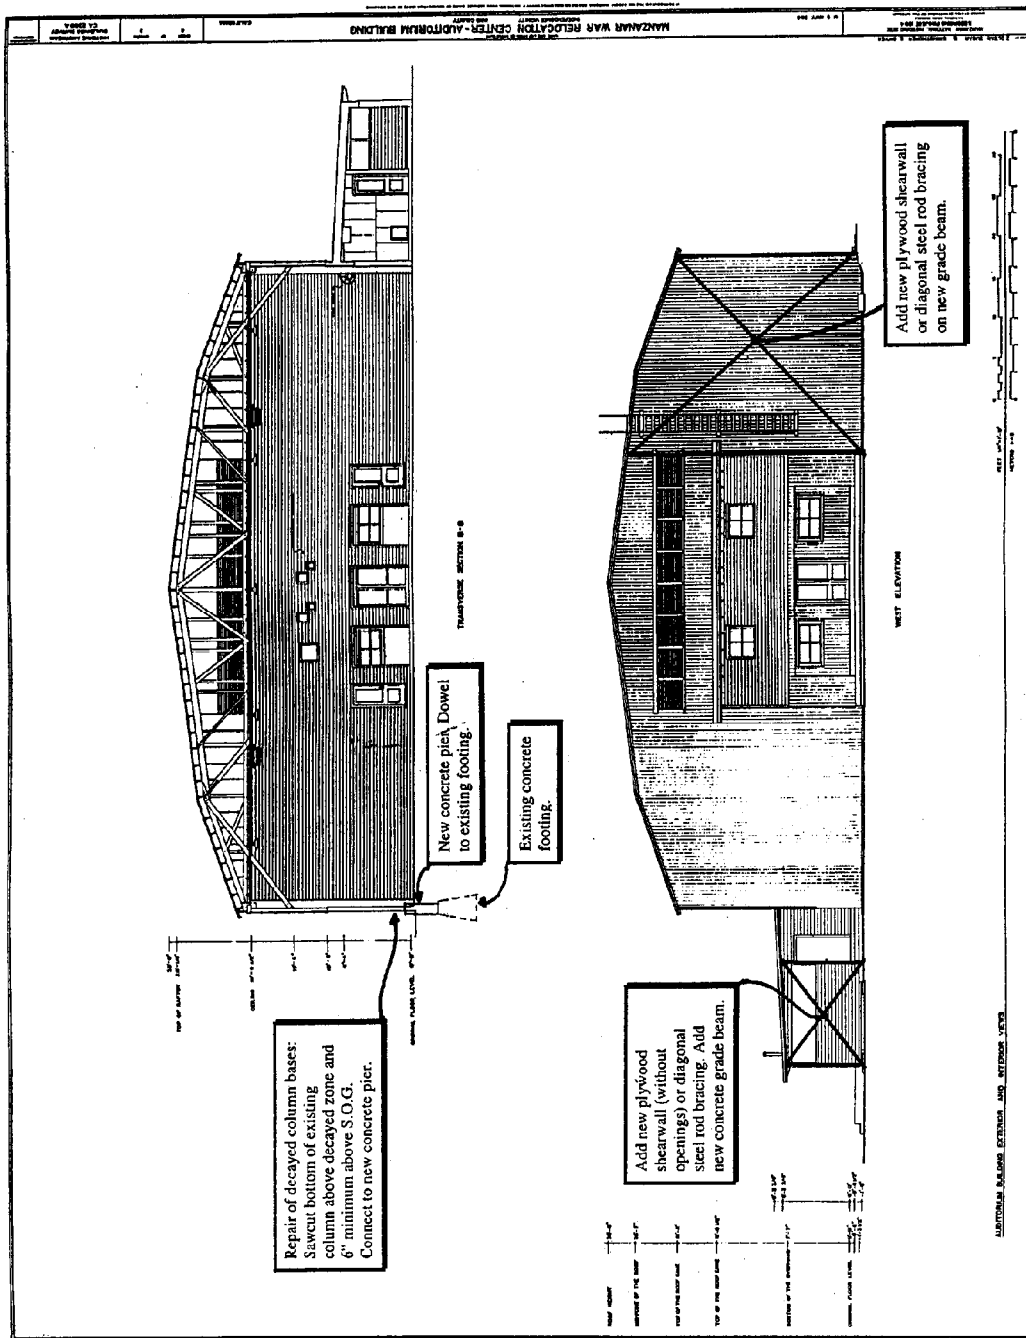
Sheet No. F5

Figure 7 West Elevation Added Bracing & Repair of Decayed Columns

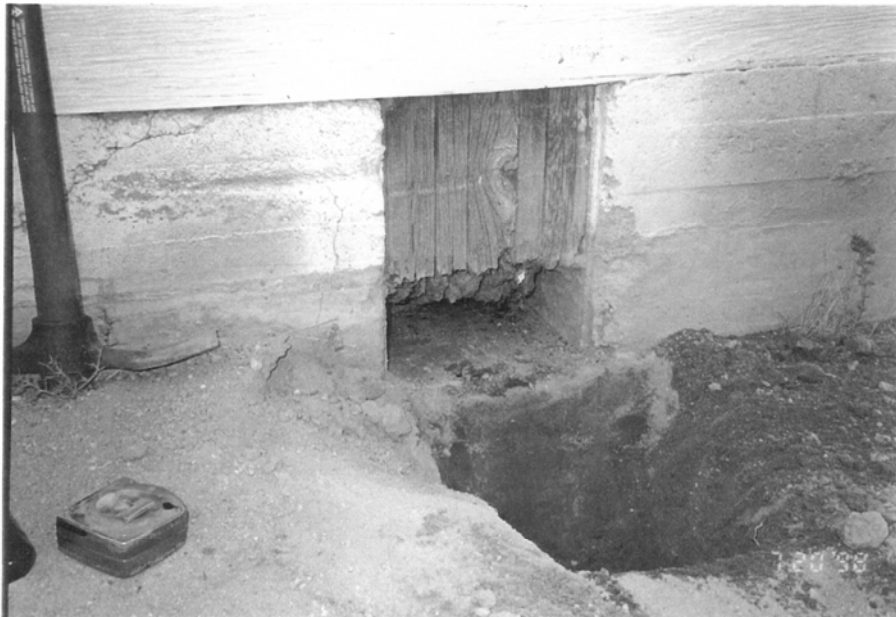
Photo No. 14
Decayed Bottom of Column

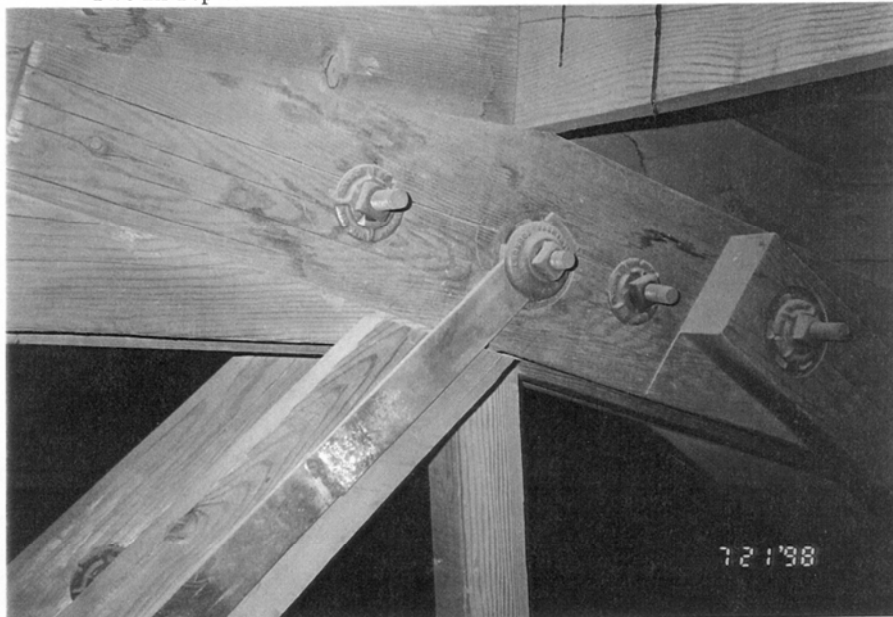
Photo No. 20
Cracked Truss Top Chord at Diagonal Connection
