historic structure report
architectural data section
volume 2: appendixes
june 1985

HISTORIC STRUCTURE REPORT

Architectural Data Section

MARTIN VAN BUREN NATIONAL HISTORIC SITE

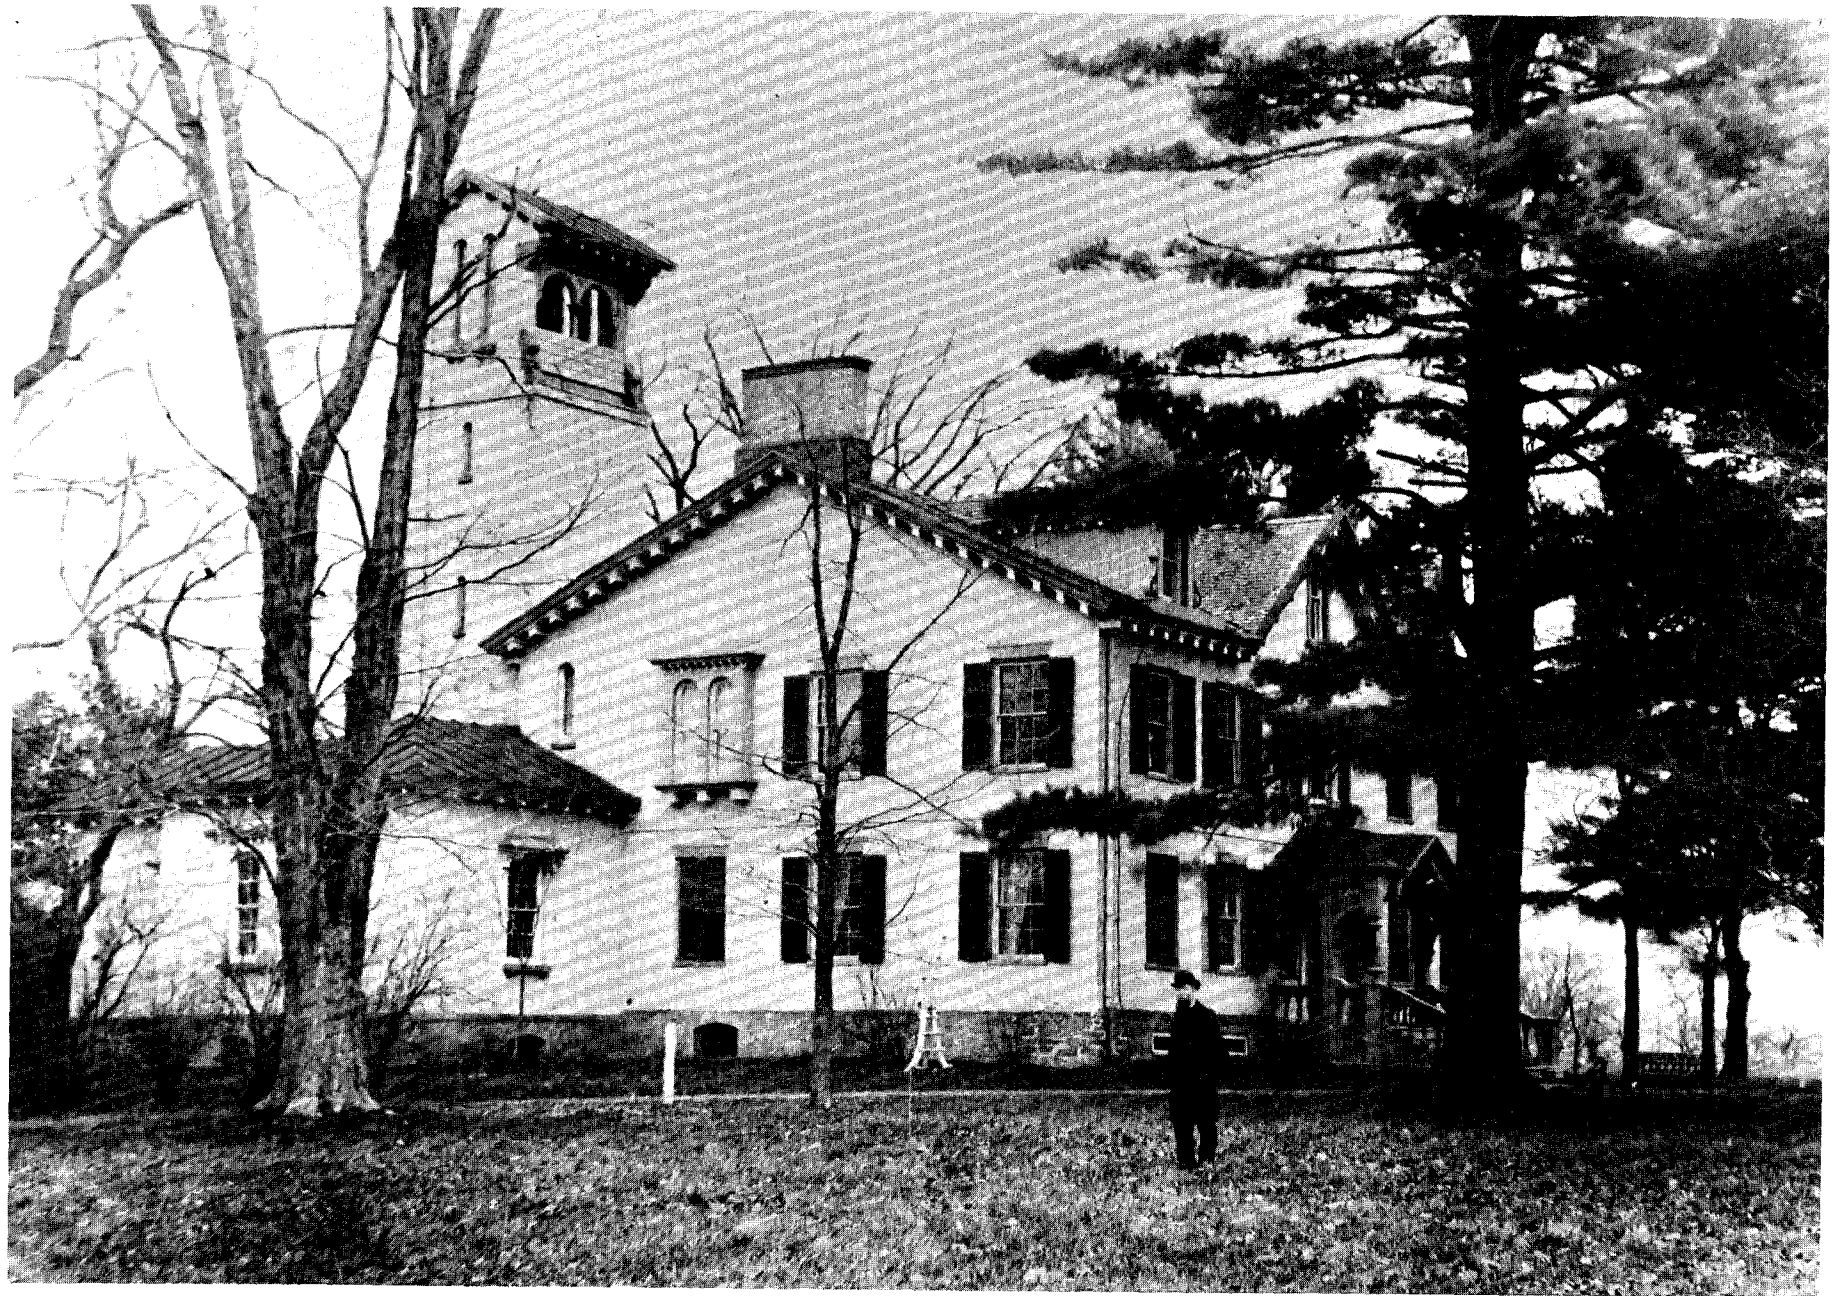
HP5. Lindenwald, ca. 1890-1900. This photograph of the south and east sides is dated ca. 1890-1900 on the basis of recollections of the donor, Hazel Whitbeck, a long-time resident in the vicinity. The following details should be noted:

The southeast corner of the foundation appears to have been repointed.

Visible lawn furniture consists of a cast iron-bench, a rustic chair, a tripod trellis, and a hitching post.

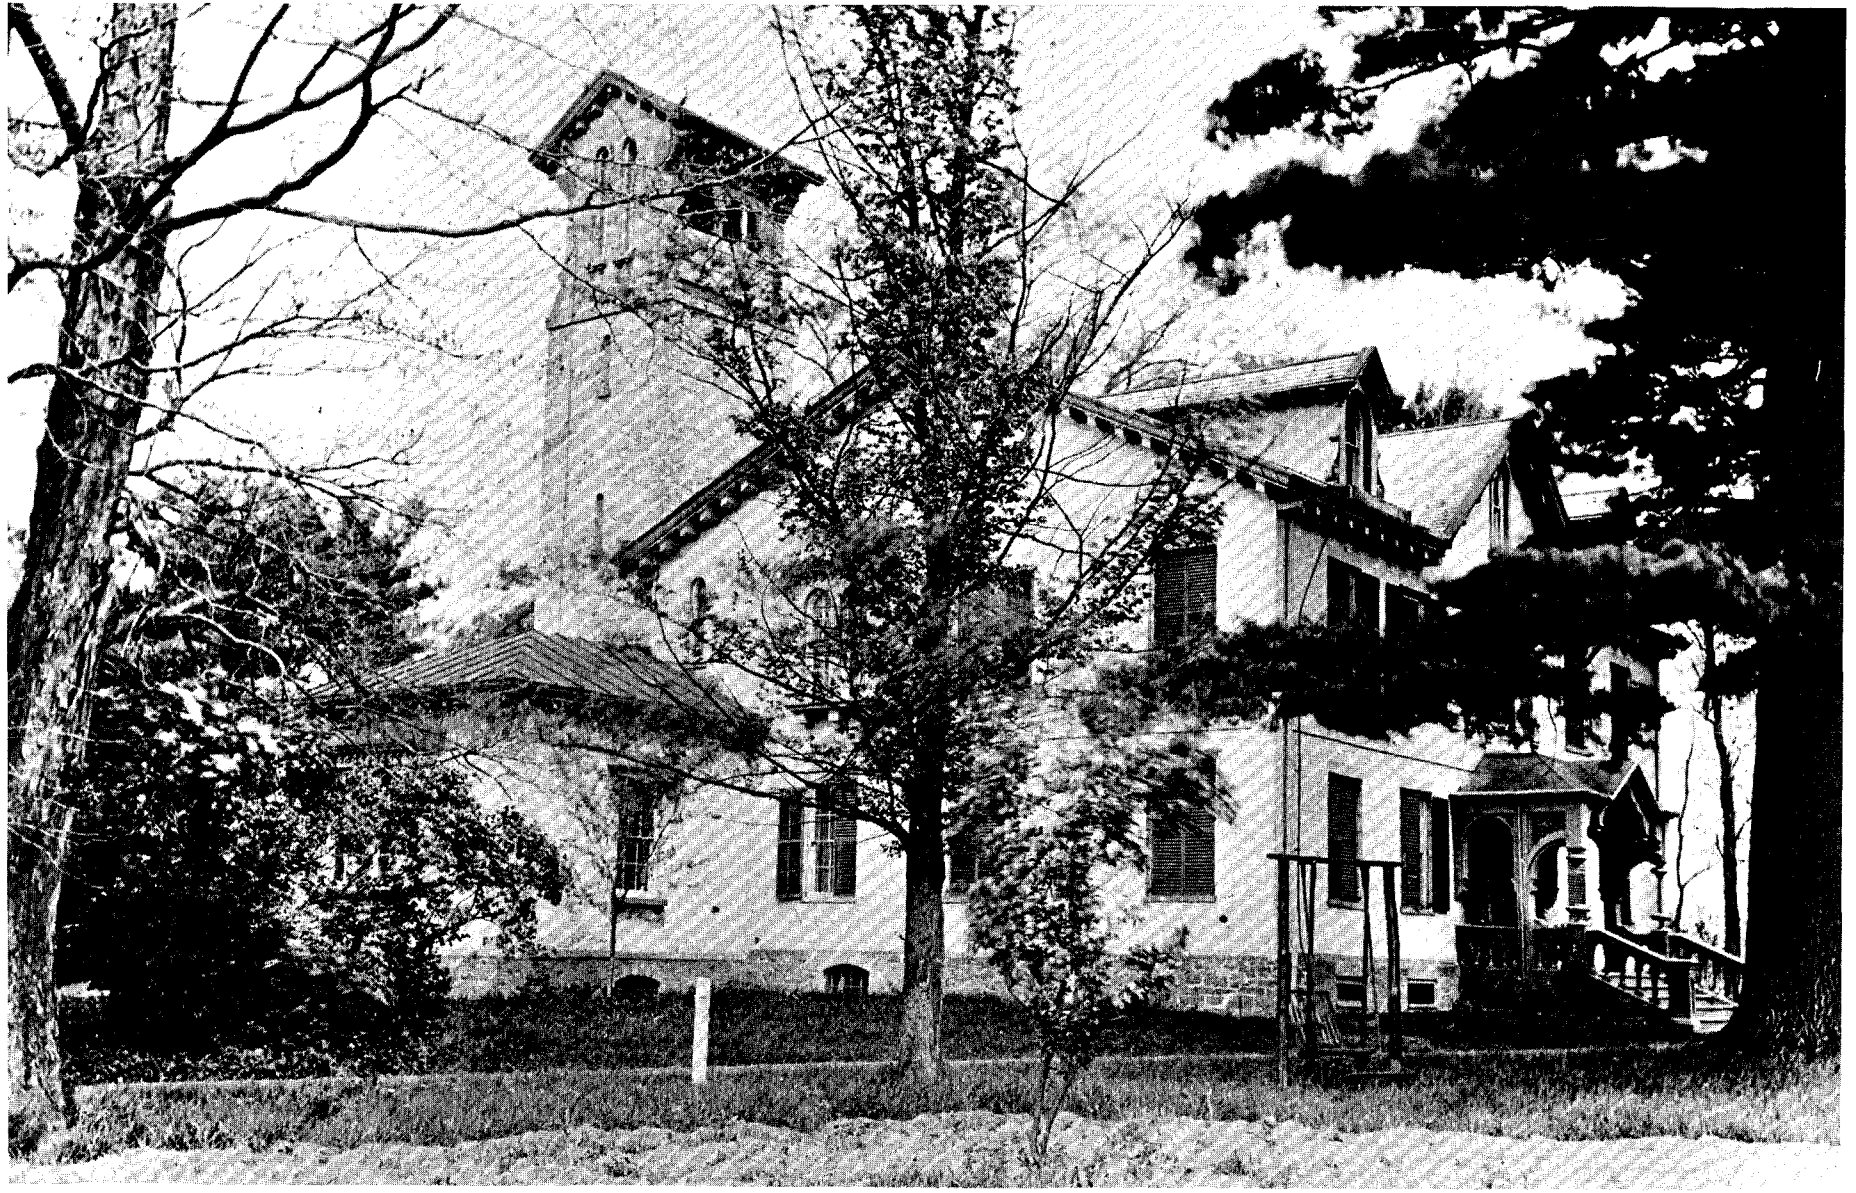
HP6. Lindenwald, ca. 1900. The date of this photograph is approximate because it is based on the growth of the small tree in the foreground compared to its size in HP5. The following details should be noted:

The dormer sill return is missing.

Basement window frames are painted a dark tone.

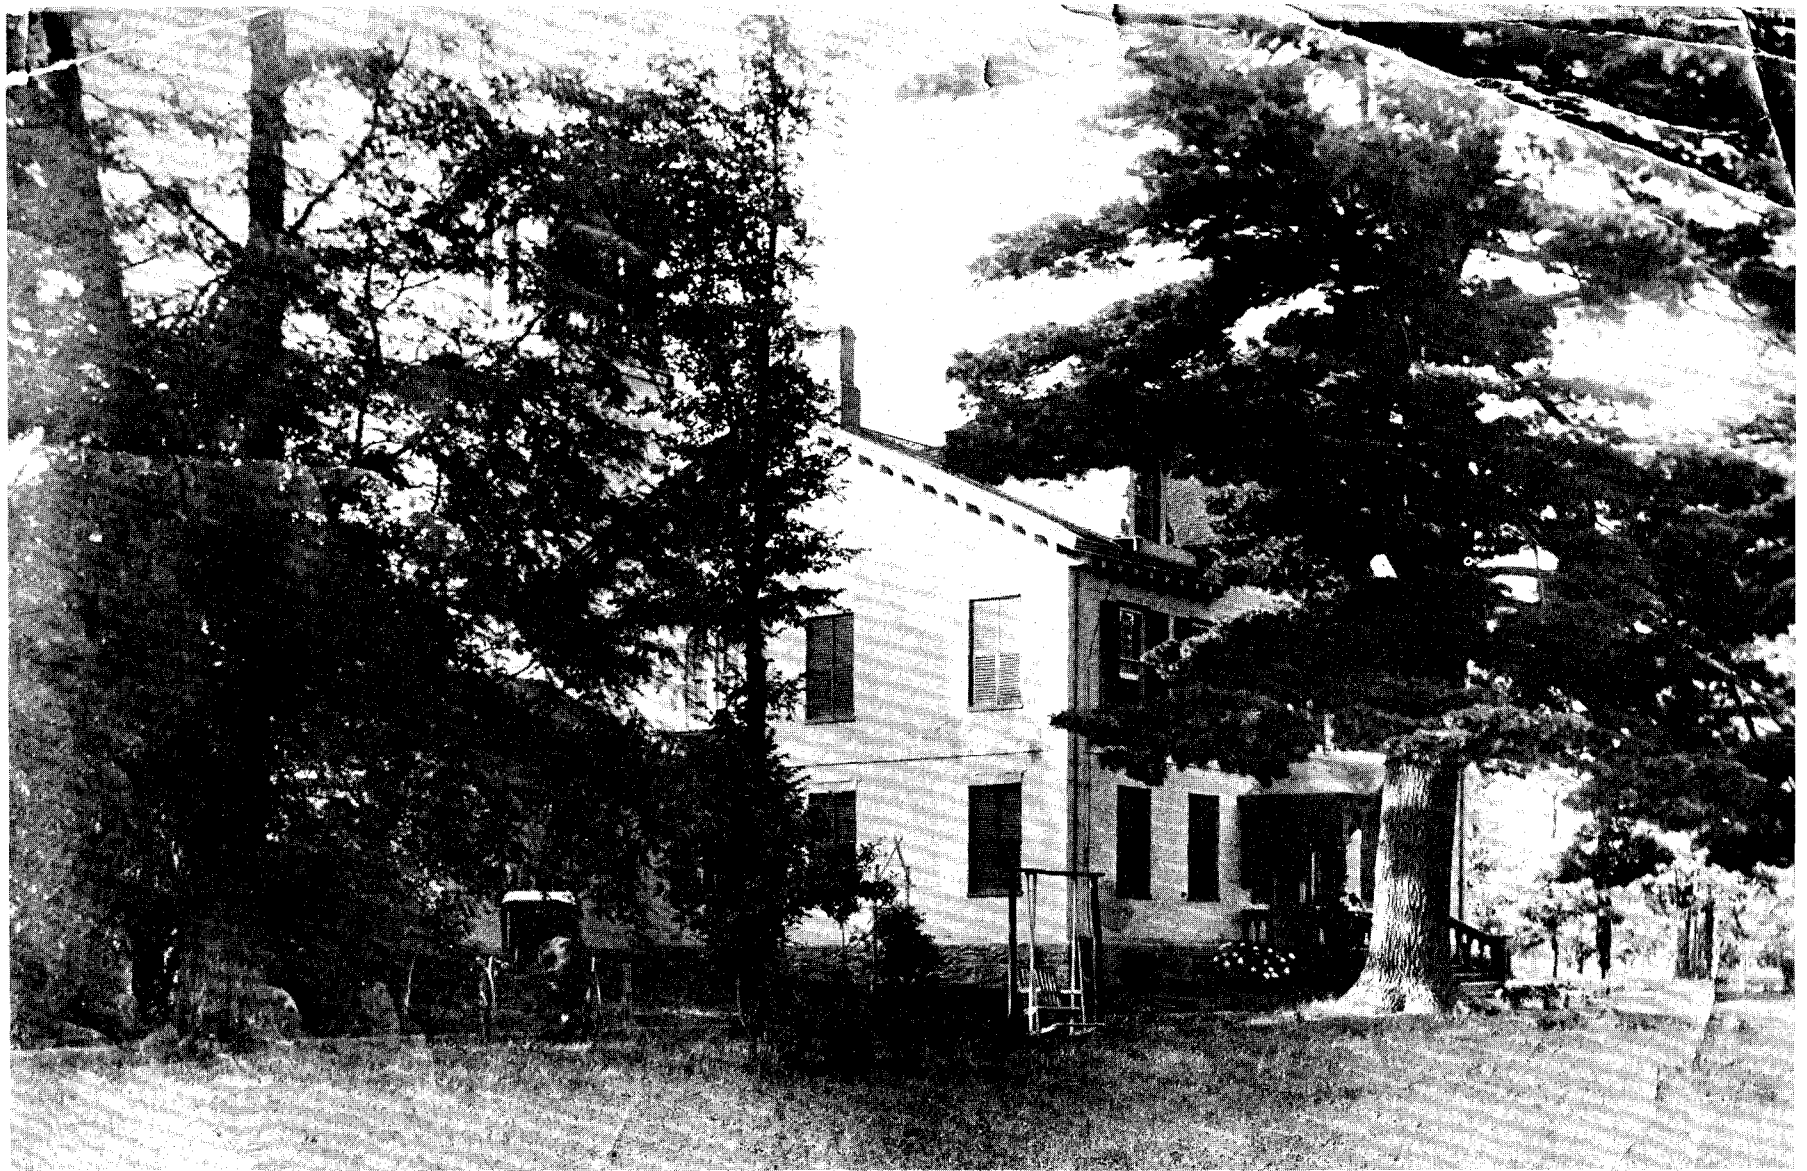
HP8. Lindenwald, ca. 1910-1917. This photograph is dated ca. 1910-1917 on the basis of the growth of the small foreground tree compared to HP6 and the presence of lightning rods compared to HPI8. Note also the following details:

The foundation has been painted so that repointing at the southeast corner is no longer visible. The shutters, window frames, porch, and foundation are a dark tone. The bricks and cornice are painted a lighter tone.

Some of the bricks are loose in the flat arch over window 127.

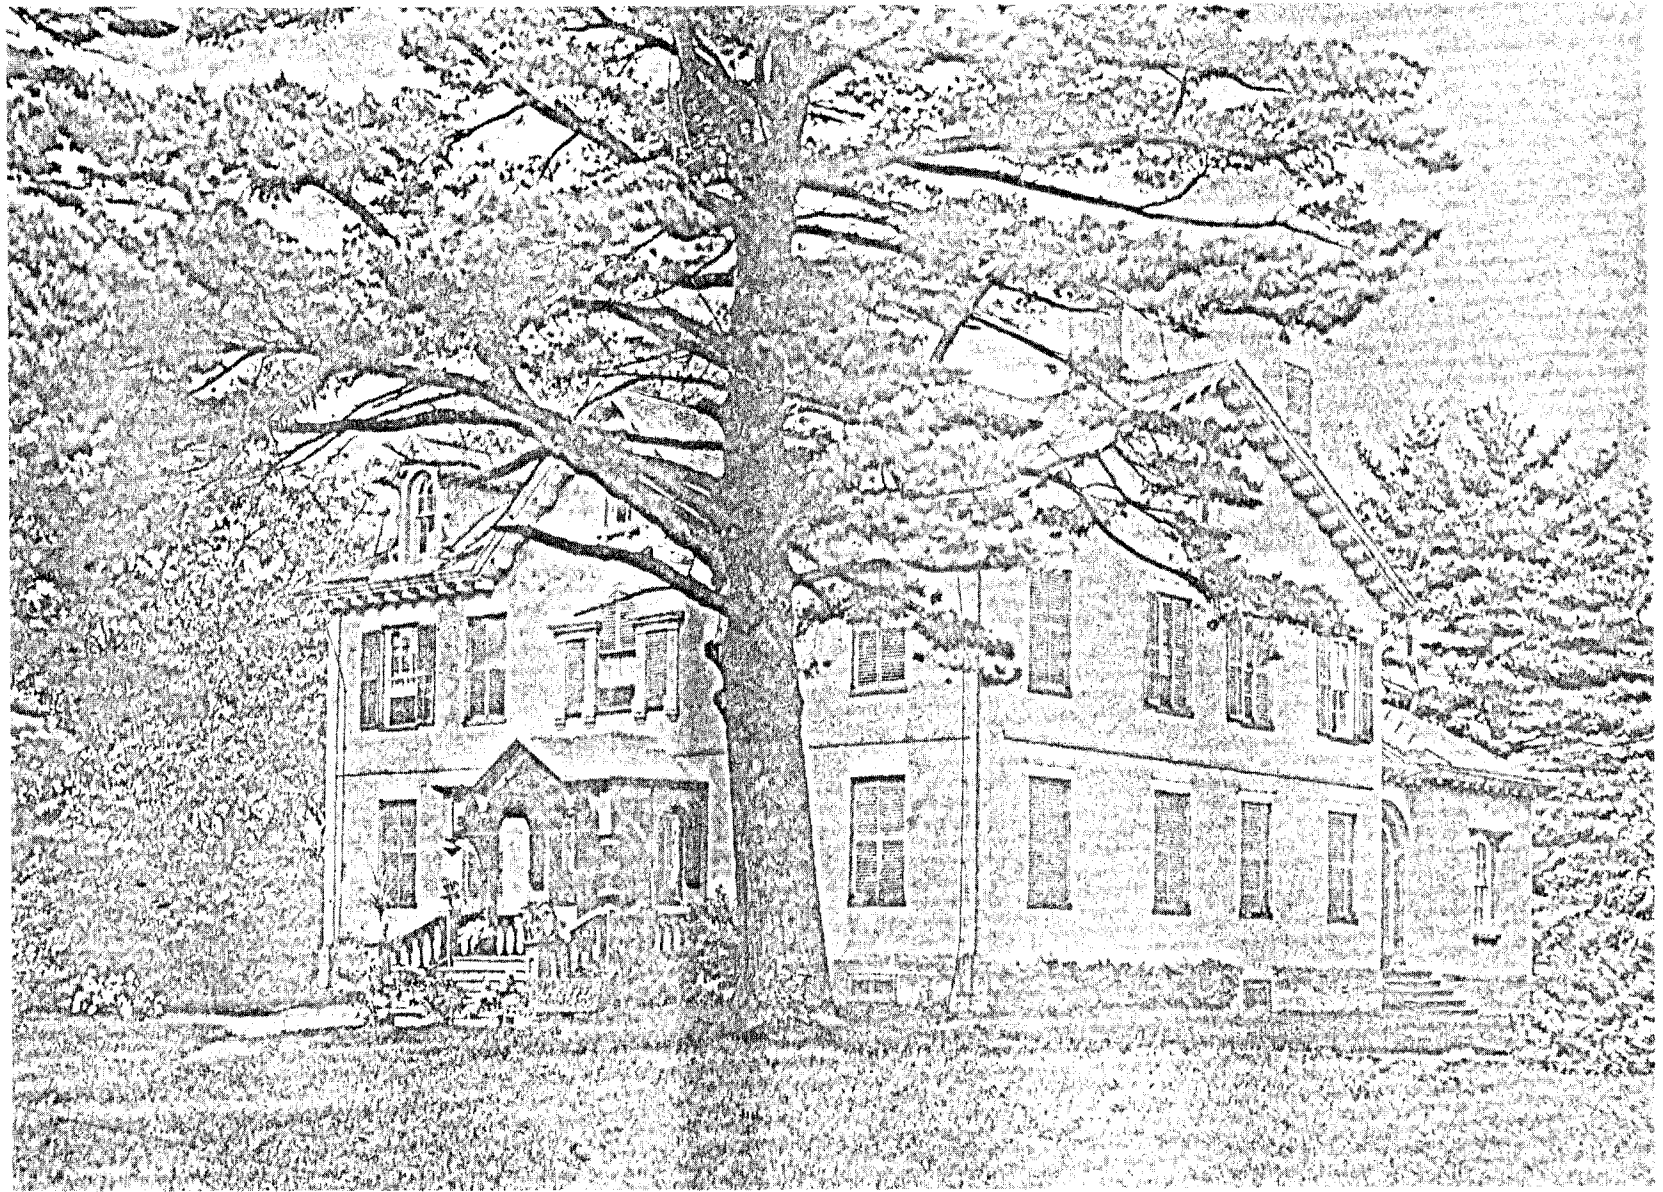
HP9. Lindenwald, ca. 1910-1917. The assigned date is based on similarities with HP8. The following details are noteworthy:

The foundation, window frames, shutters, and front porch seem to be painted a dark tone. The bricks and cornice are painted a lighter tone.

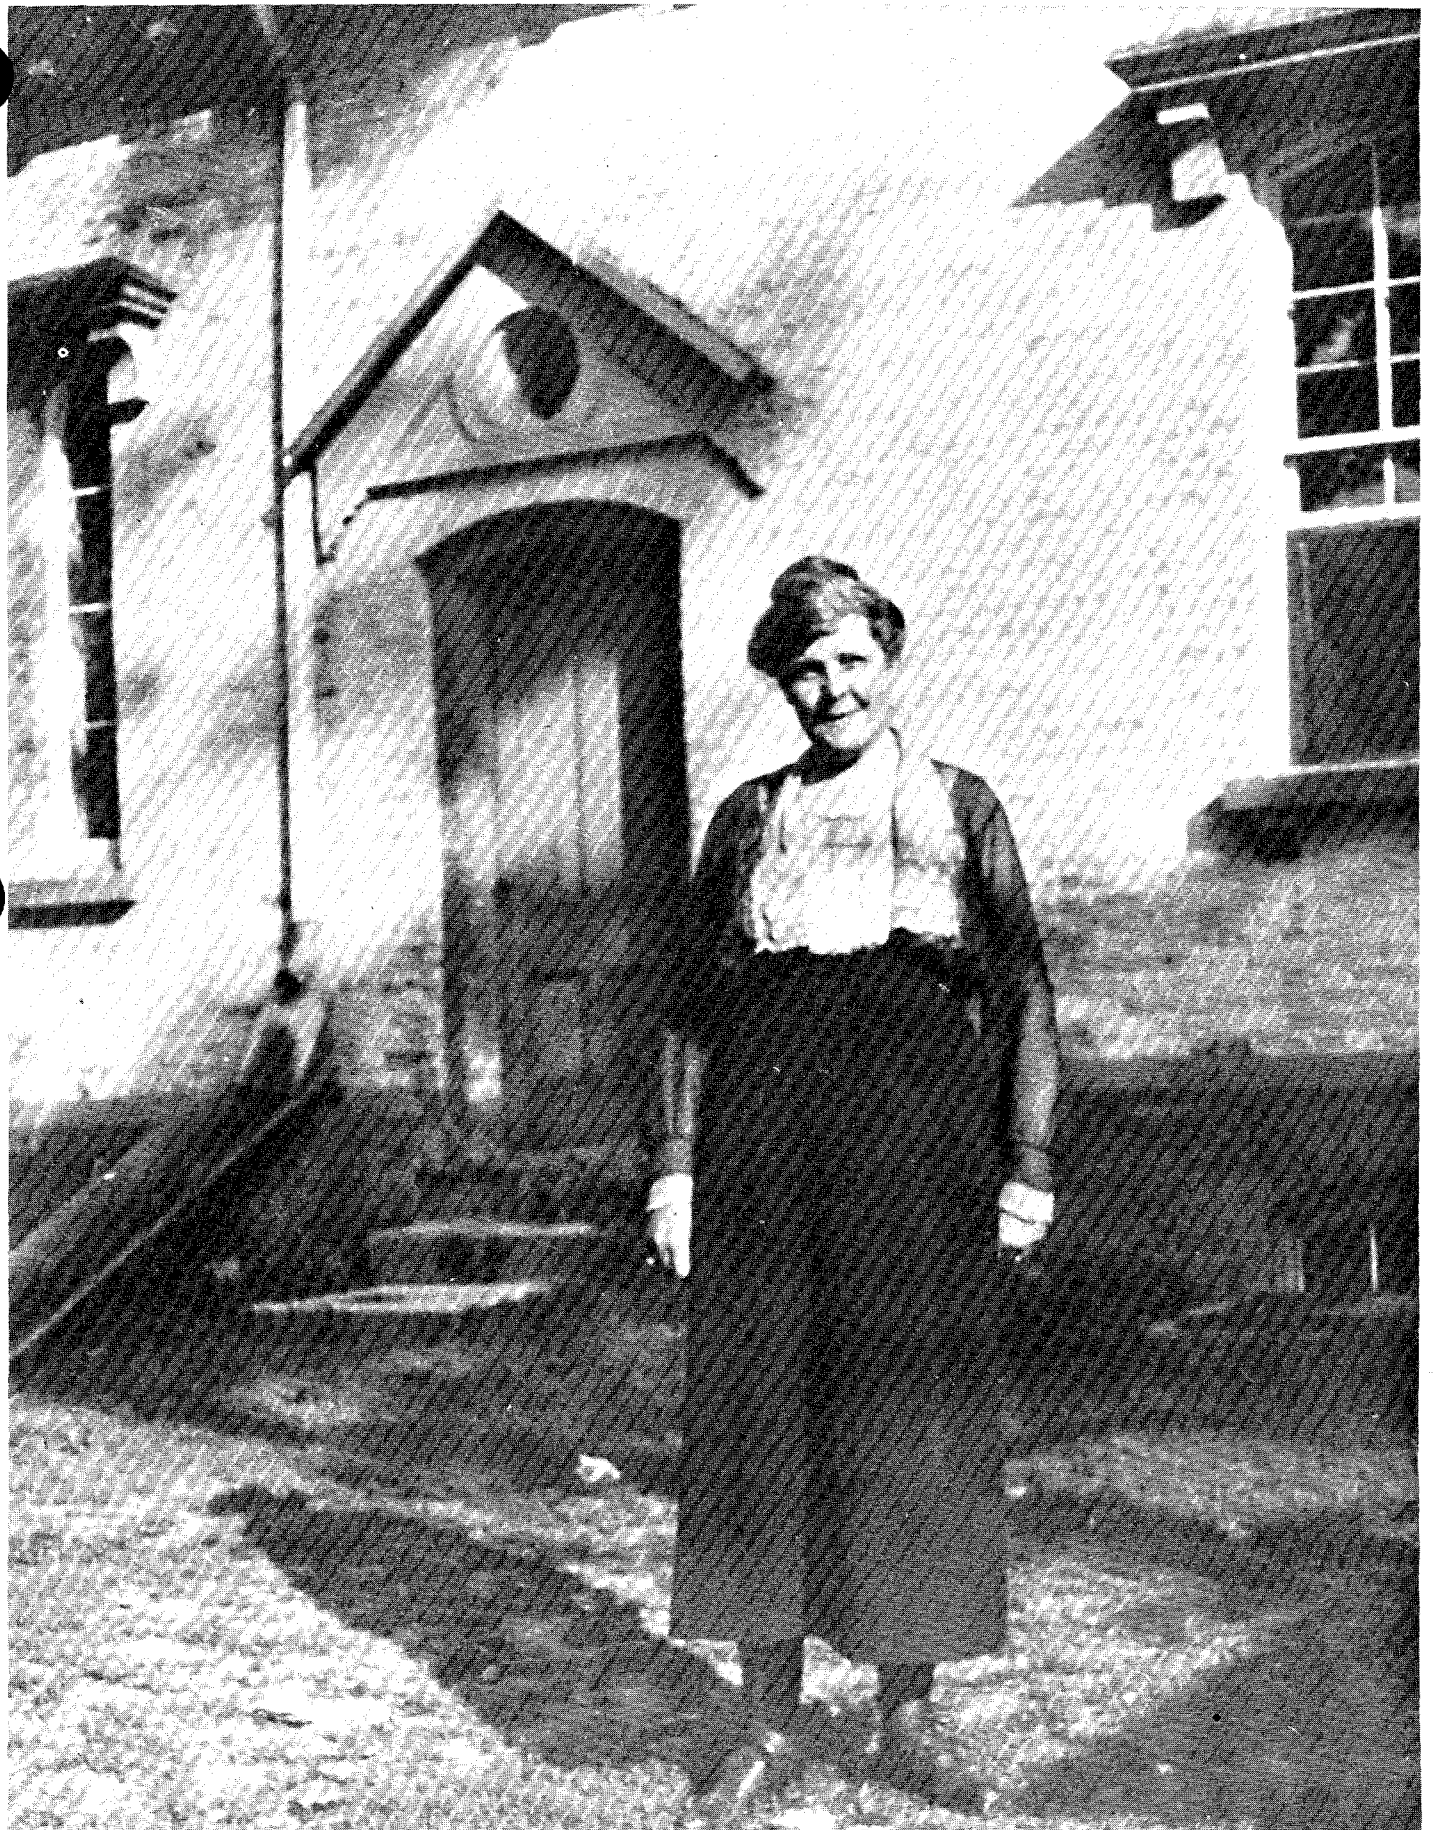
HP12. Mrs. Bascom Birney at Lindenwald, after 1917. This photograph was probably taken after the Birneys' acquisition of Lindenwald in 1917. The following details should be noted:

The foundation and trim appear to be painted a dark tone. Brickwork has been painted a light tone but is now quite weathered. Window frames are painted a lighter color.

The downspout appears to be a replacement consisting of lengths of stock corrugated pipe and a wooden board and trough to direct rainwater away from the foundation.

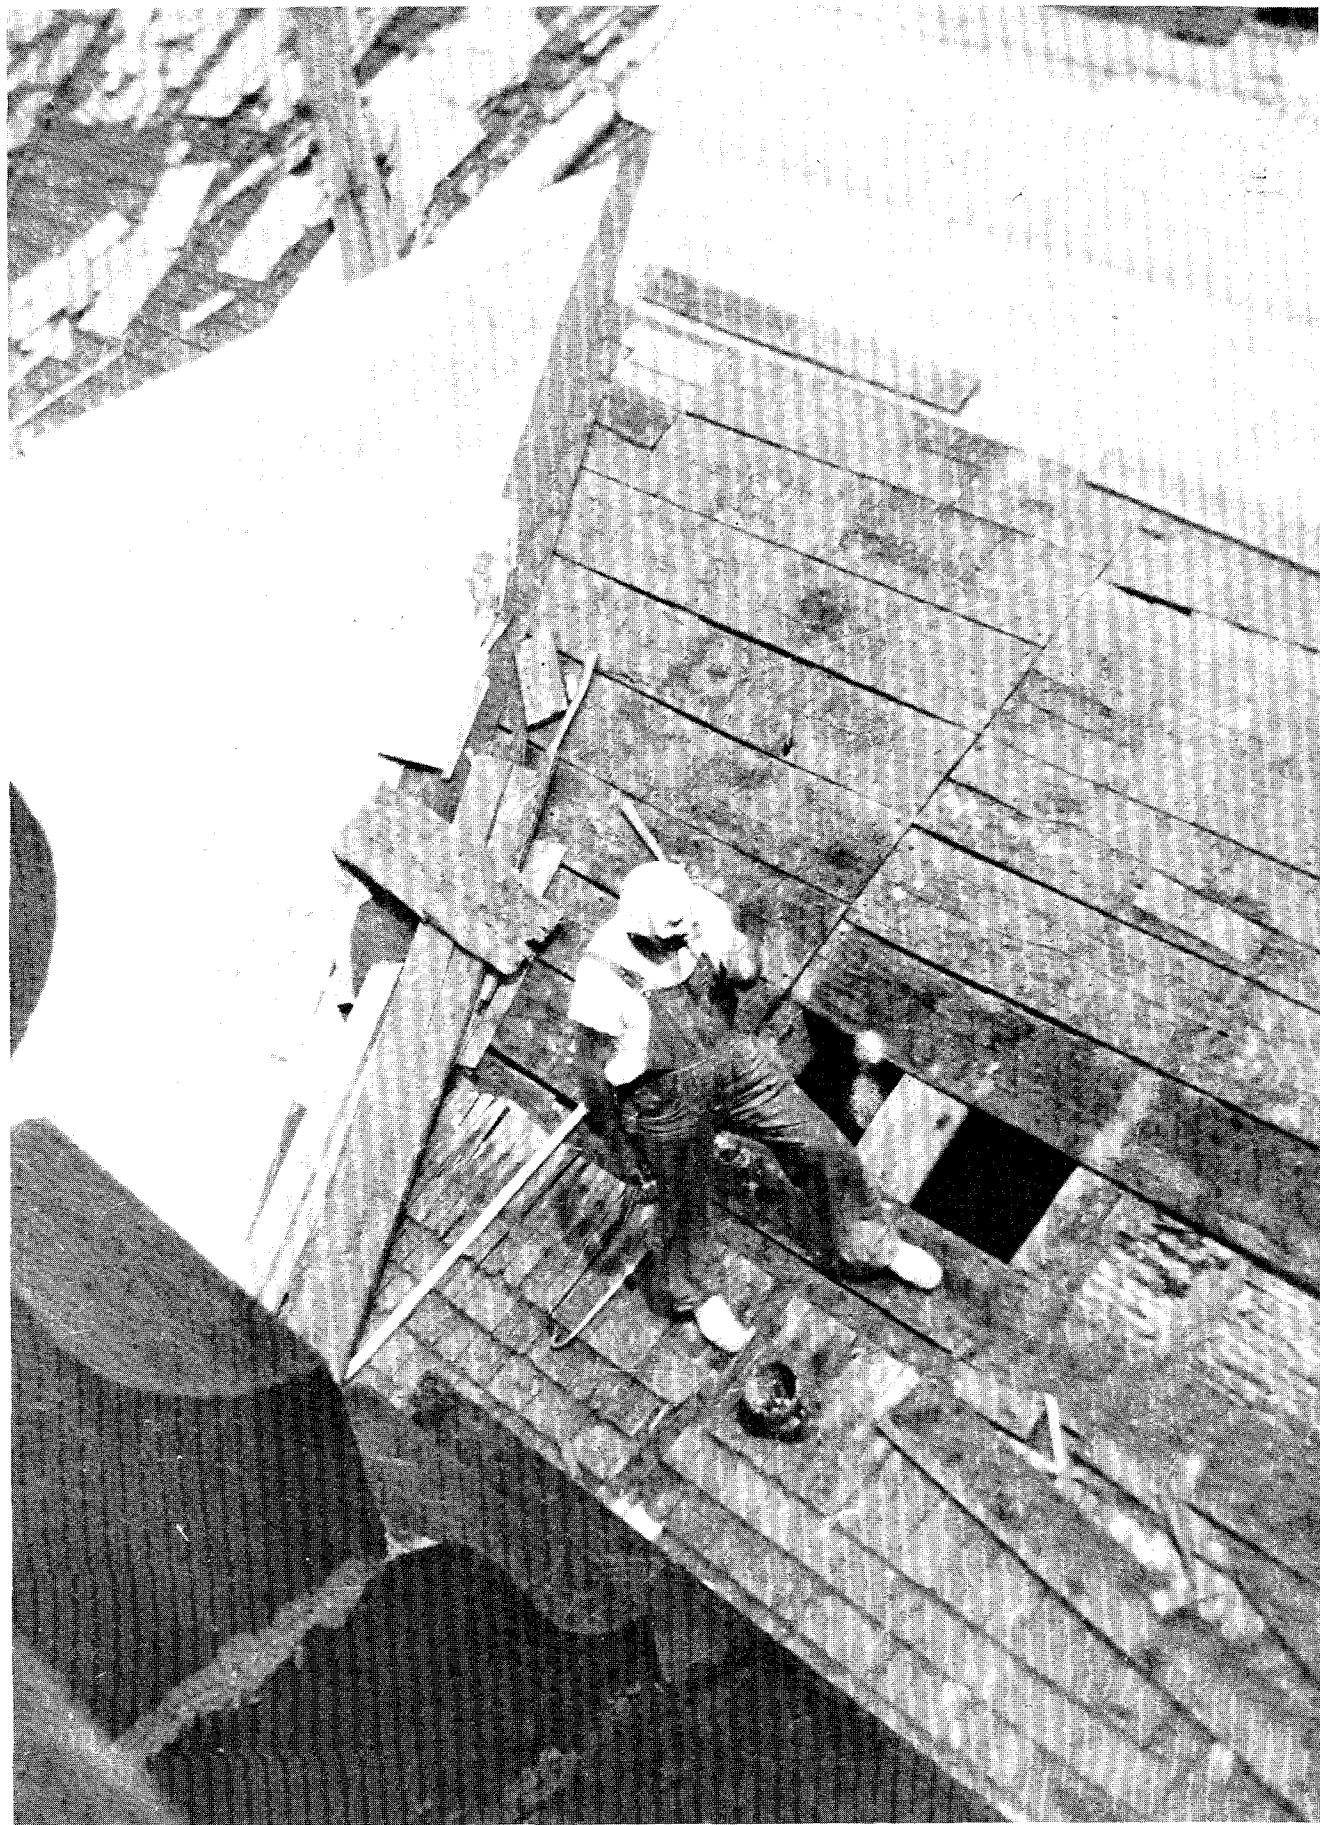
HP14. West Slope of ca. 1797 Roof, ca. 1918-1920. This photograph shows Dr. Bascom Birney removing wood shingles in preparation for the slate roof. Family tradition dates this event to the early years of their ownership of Lindenwald, probably before 1920. Note the following details:

condition of sheathing boards

missing and broken plaster keys over room 307

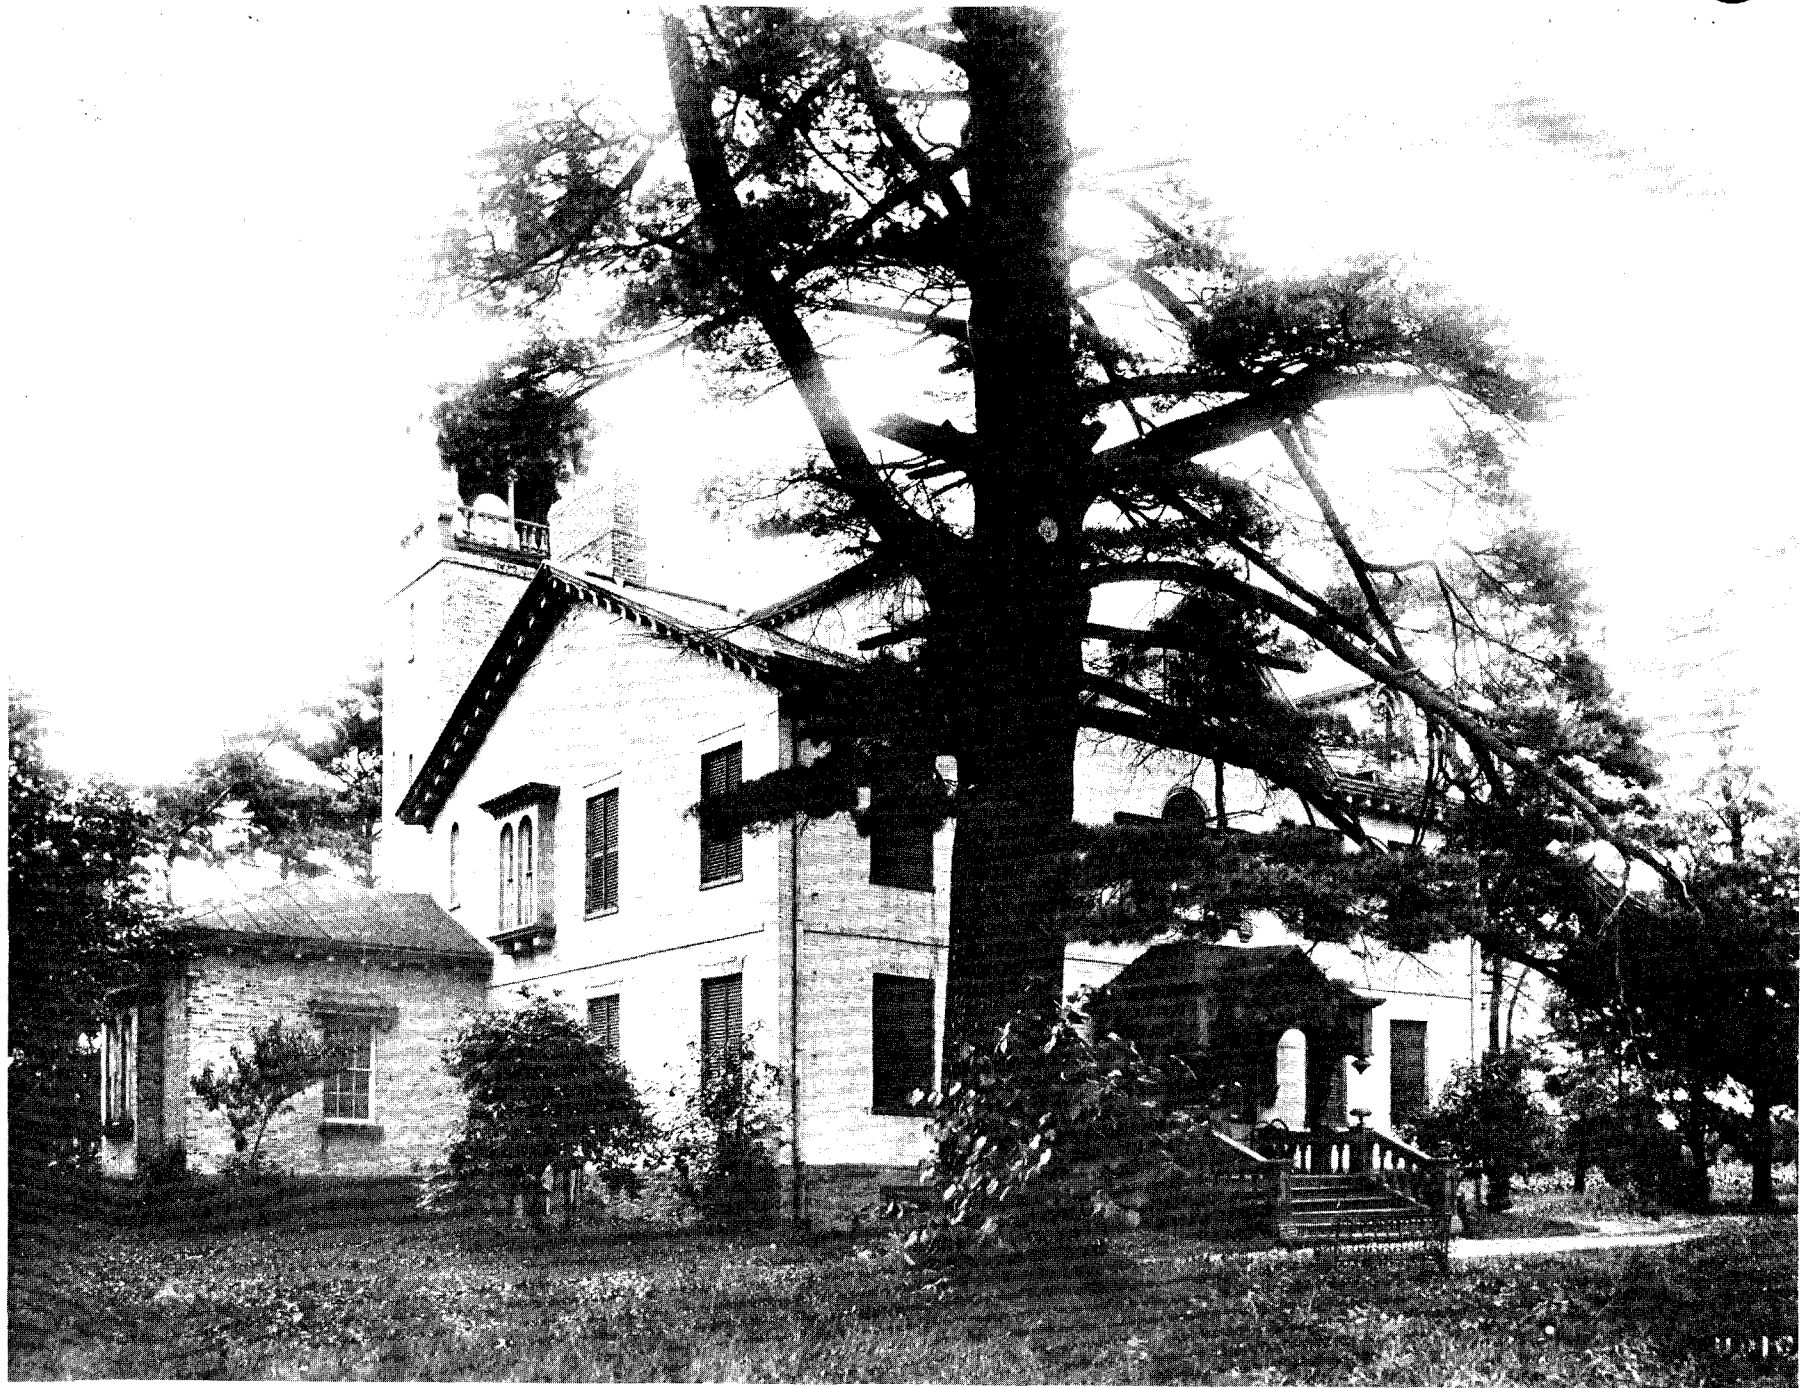
HP18. South and East Facades of Lindenwald, ca. 1917-1925. This photograph is considered to postdate 1917 because the lightning rods are missing from the front of the house and because roofing brackets and a plank are still attached to the roof (indicating that roofing work is still in progress). It is considered to predate 1925 because the tie rod is still in place on the front porch, and shutters are still in place on the Venetian window (see HP22). This photograph was taken by Rowles Studios. The following details should be noted:

The return for the sill at the north dormer is missing.

Bricks are loose in the flat arch over window 127.

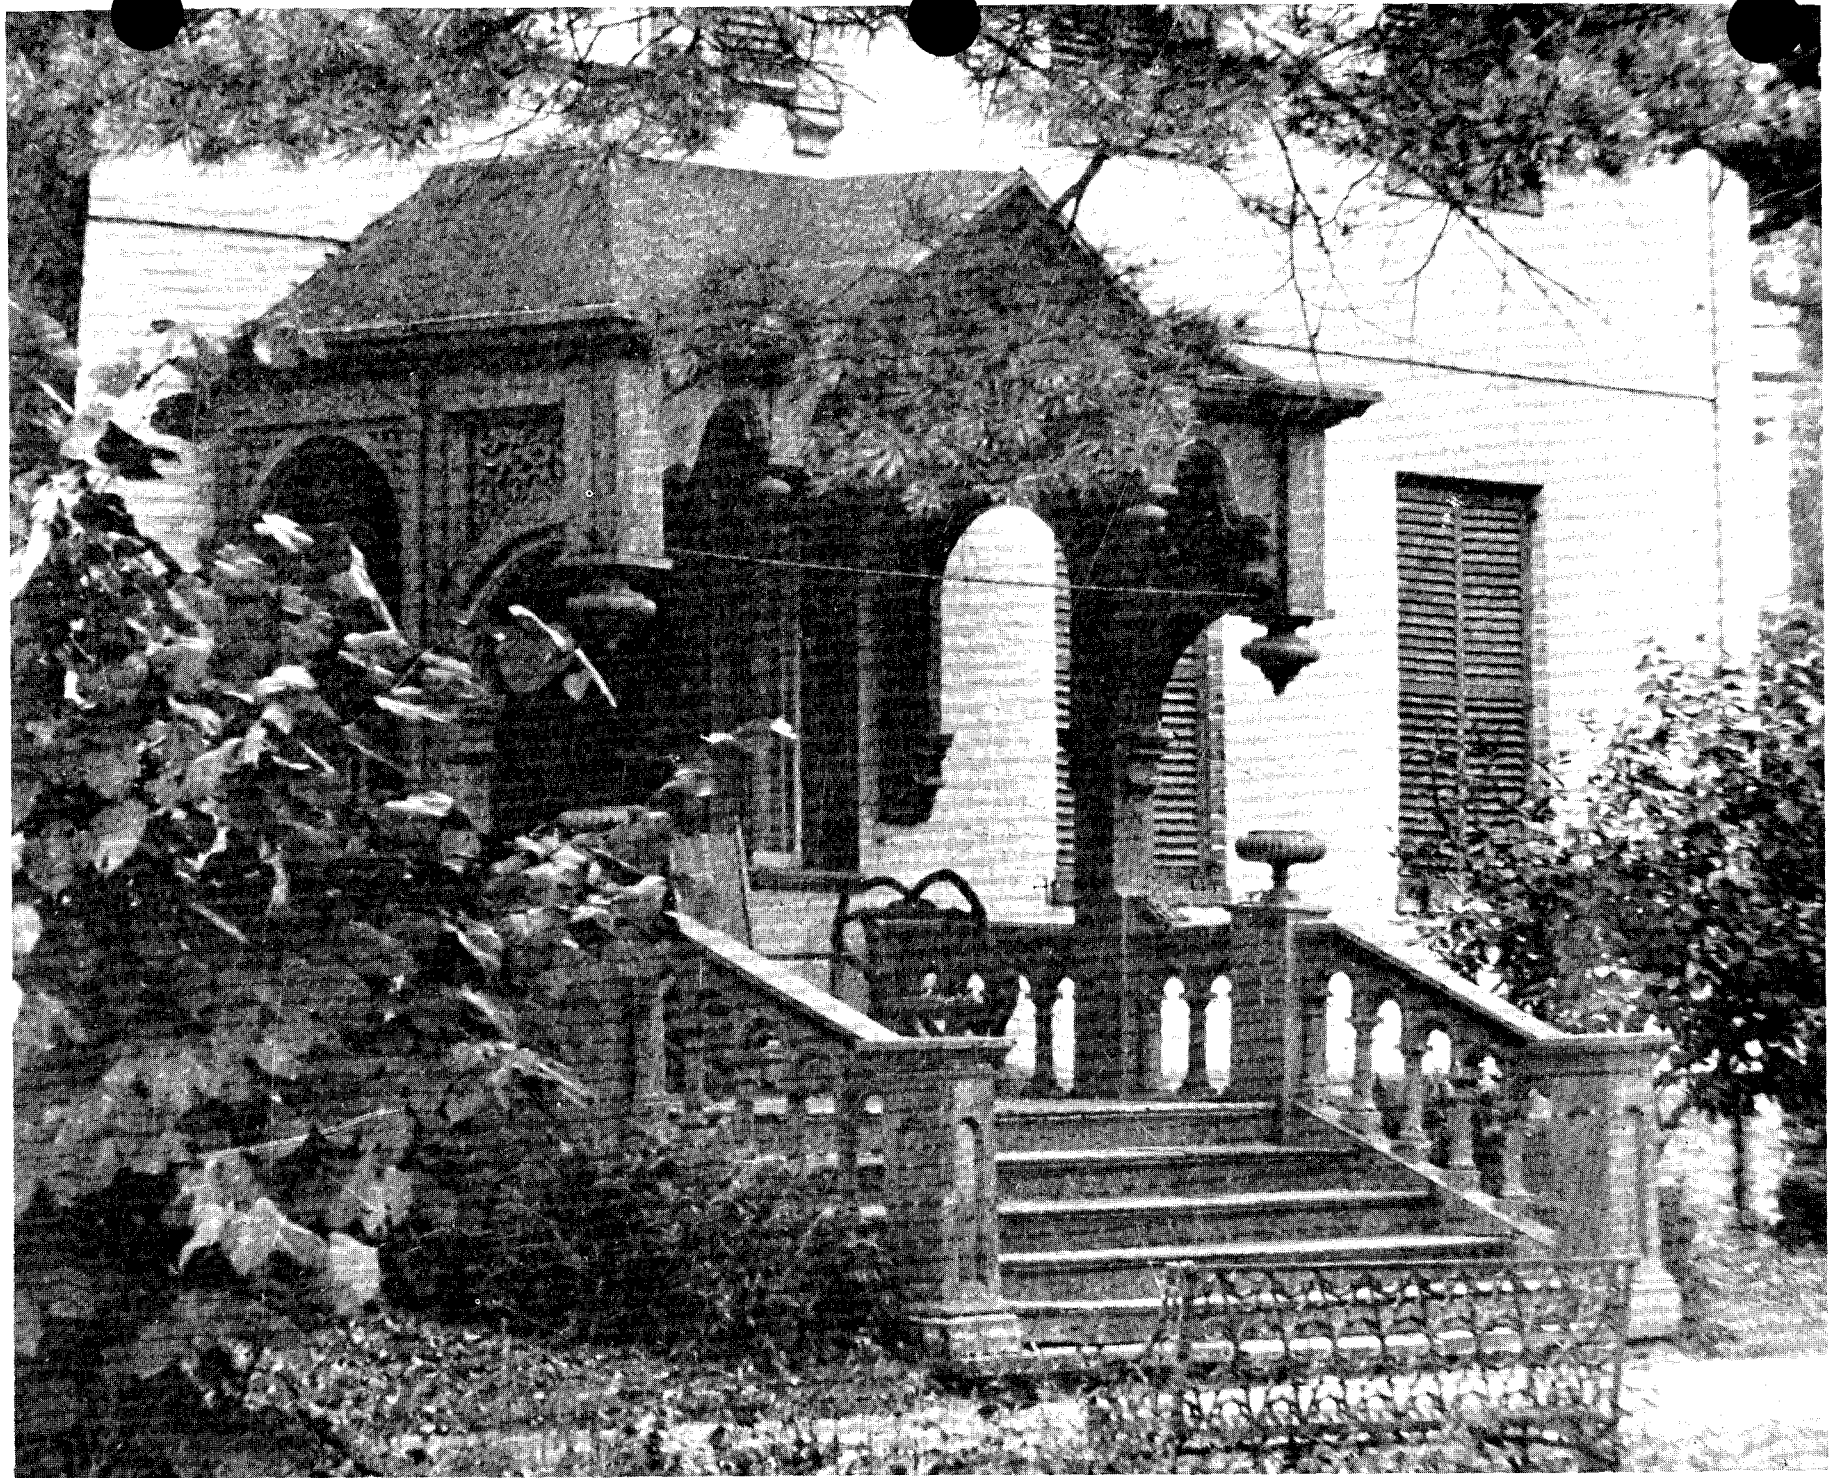
HP20. Lindenwald, ca. 1917-1925. Because of the absence of front lightning rods and the presence of roofing brackets and planks, the tie rod on the front porch, and the shutters on the Venetian window, this photograph is associated with HP18 and assigned the same range of dates. The following details should be noted:

The front board of the sill box under the south dormer is missing.

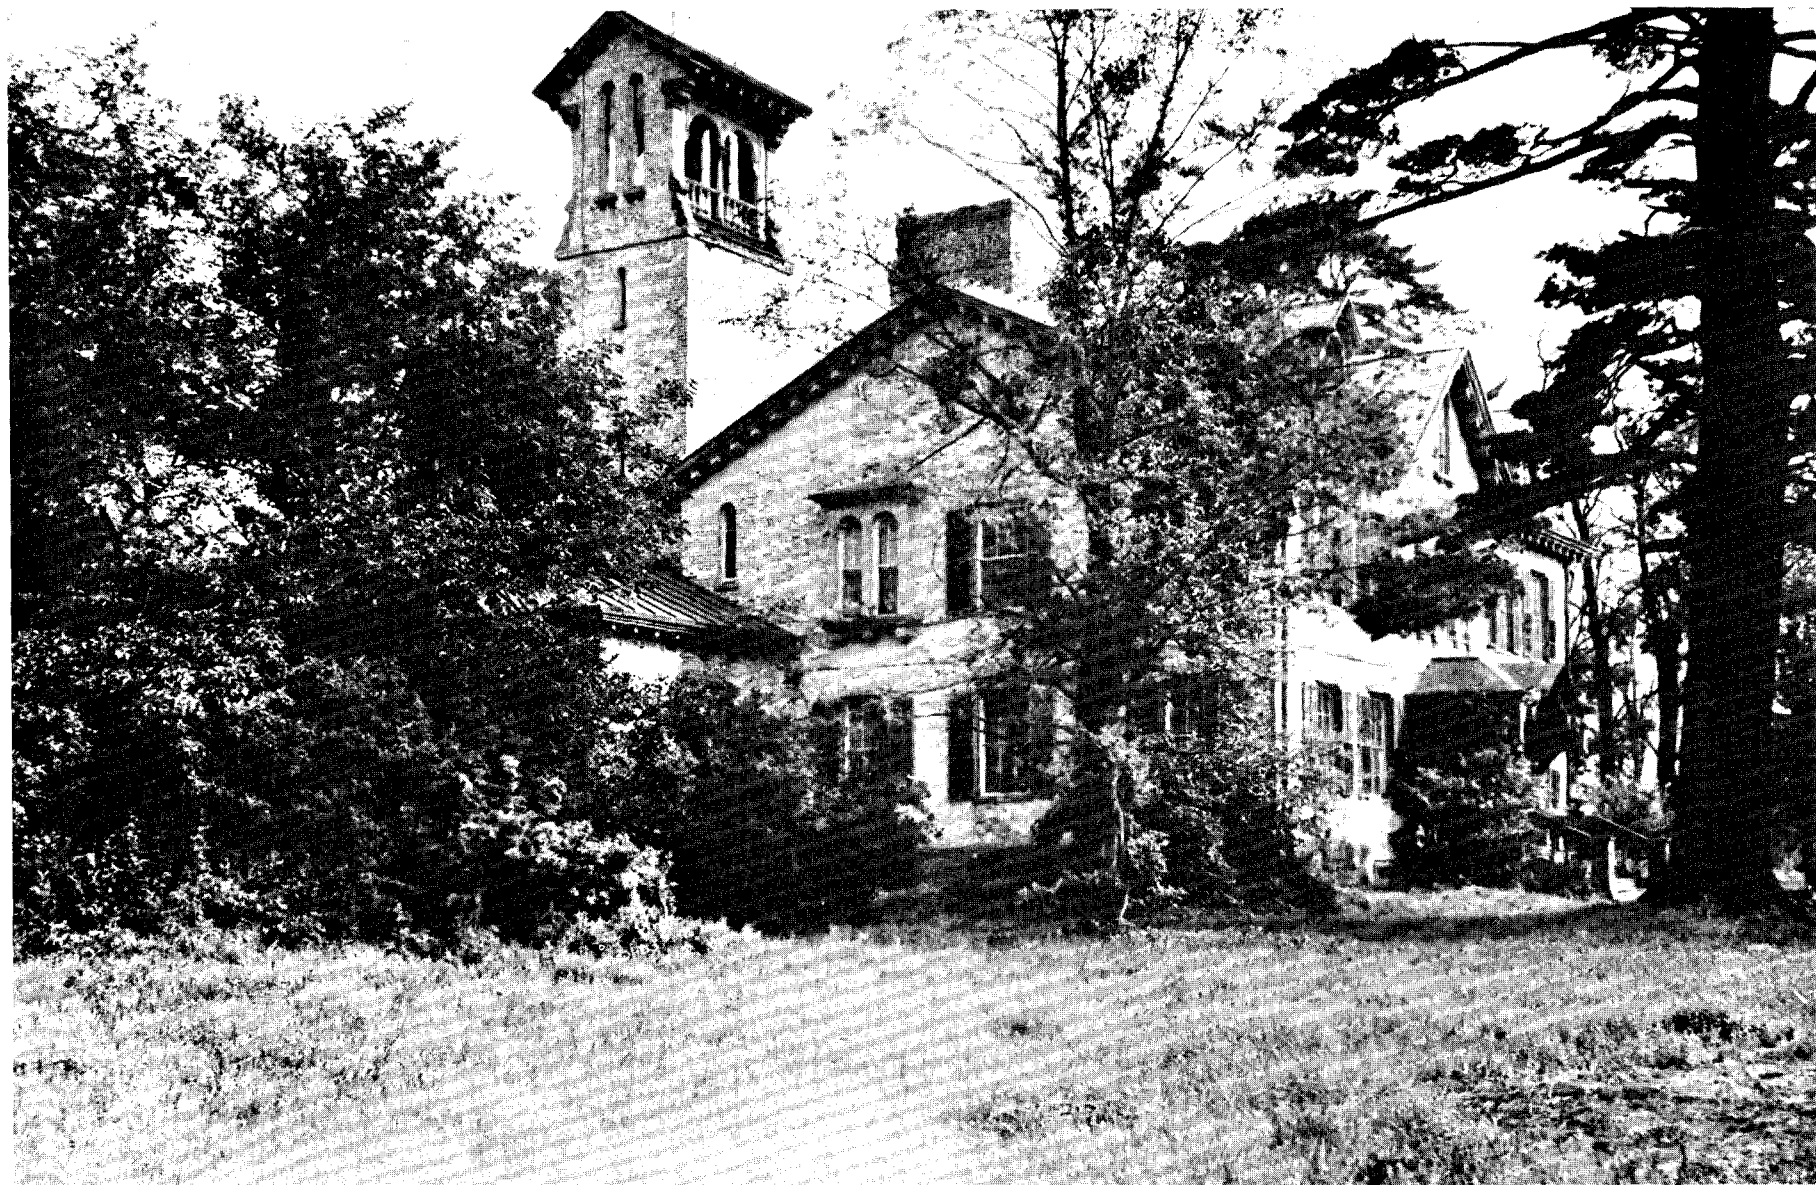
HP23. South and East Sides of Lindenwald, 1936. This photograph was taken by Melvin Weig, National Park Service historian, on August 3, 1936. This date is documented in the captions of all the photographs in his report "'Lindenwald,' the President Martin Van Buren Homestead, near Kinderhook, New York" dated November 3, 1936. The following details should be noted:

Some bricks are missing from the cap of the south chimney.

The light paint on the brickwork is very weathered and most brick courses on the south elevation can be seen. Sash has also been painted a light tone, but now the cornice appears to be a dark tone. Foundations, window frames, and the front porch are painted a dark tone. Shutters appear to be painted an even darker tone.
