historic structure report
architectural data section
volume 2: appendixes
june 1985

HISTORIC STRUCTURE REPORT

Architectural Data Section

MARTIN VAN BUREN NATIONAL HISTORIC SITE

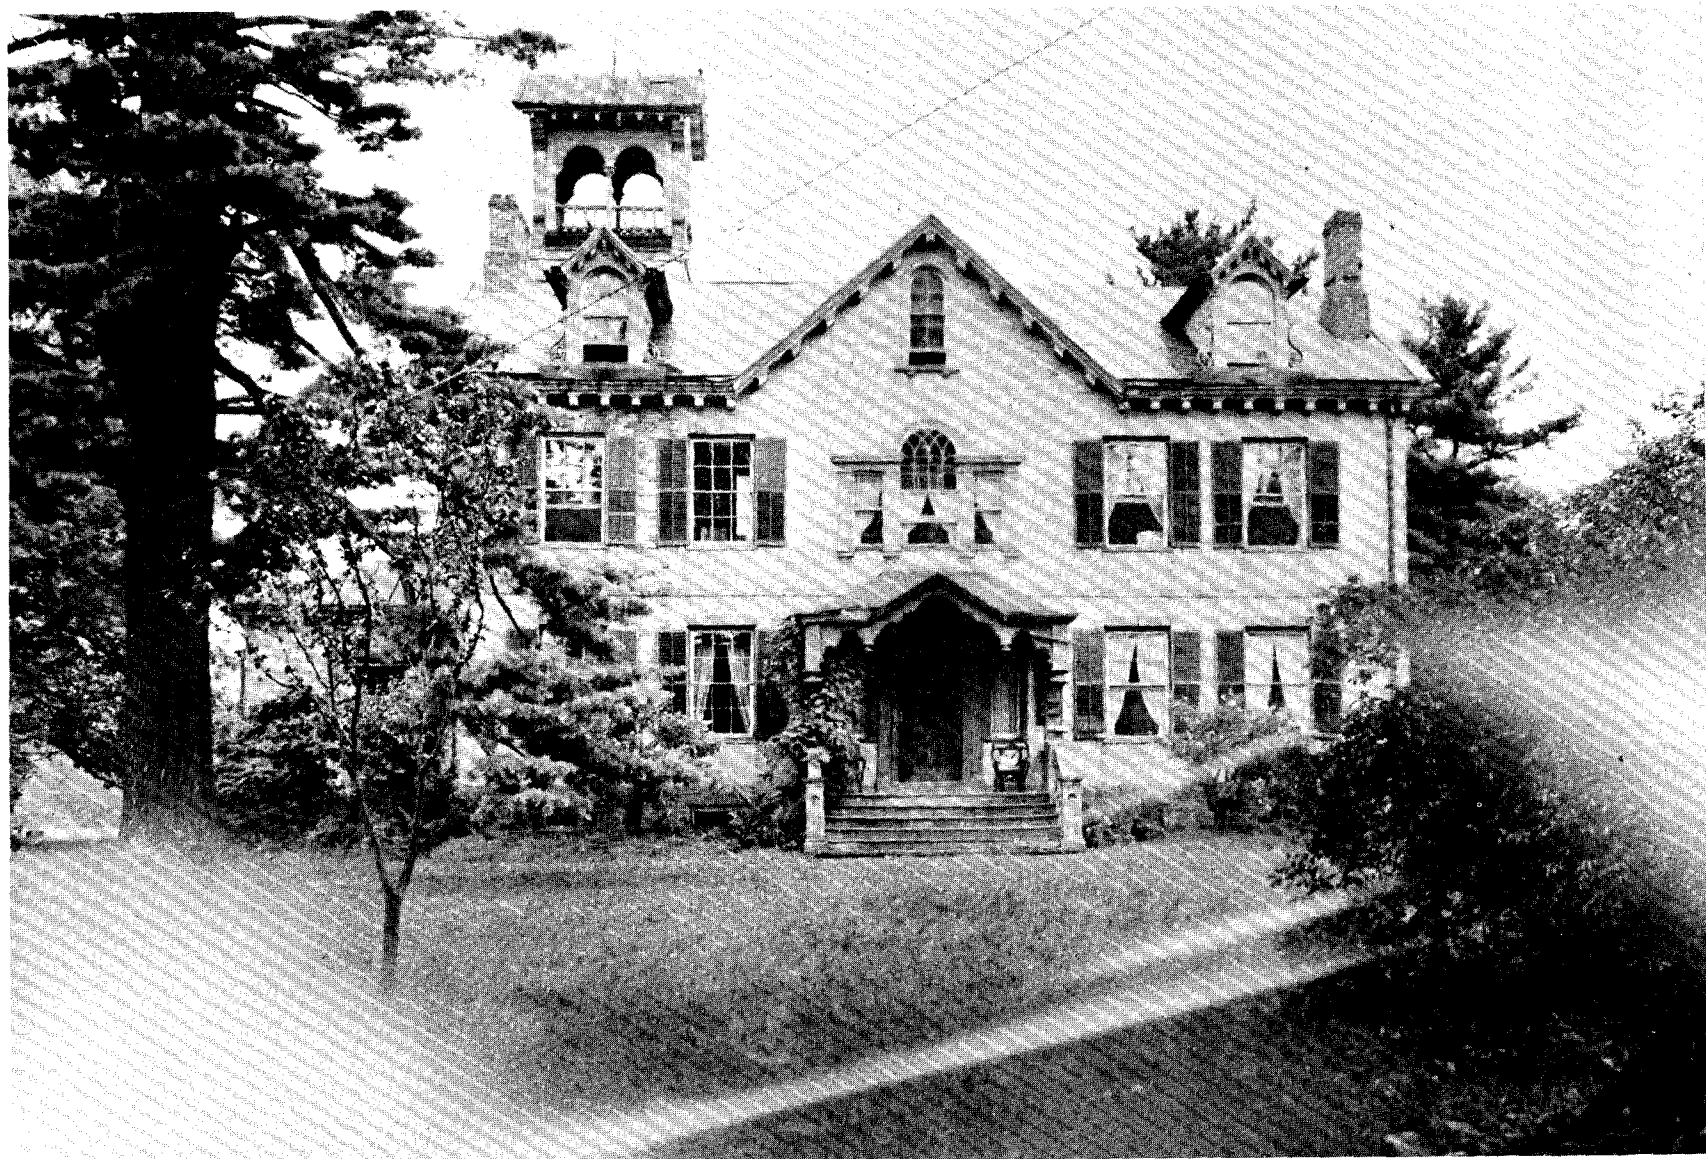
HP24. Lindenwald, East Elevation, 1936. This photograph was taken on August 3, 1936, by Melvin Weig. This date is also documented in his report, "'Lindenwald,' the President Martin Van Buren Homestead, near Kinderhook, New York." The following details should be noted:

Some bricks are missing from the cap of the south chimney.

The light paint on the brickwork is very weathered, and most brick courses on the east elevation are discernible. Sash has also been painted a light tone, but now the cornice appears to be a dark tone. Foundations, window frames, and the front porch are painted a dark tone. Shutters appear to be painted an even darker tone.

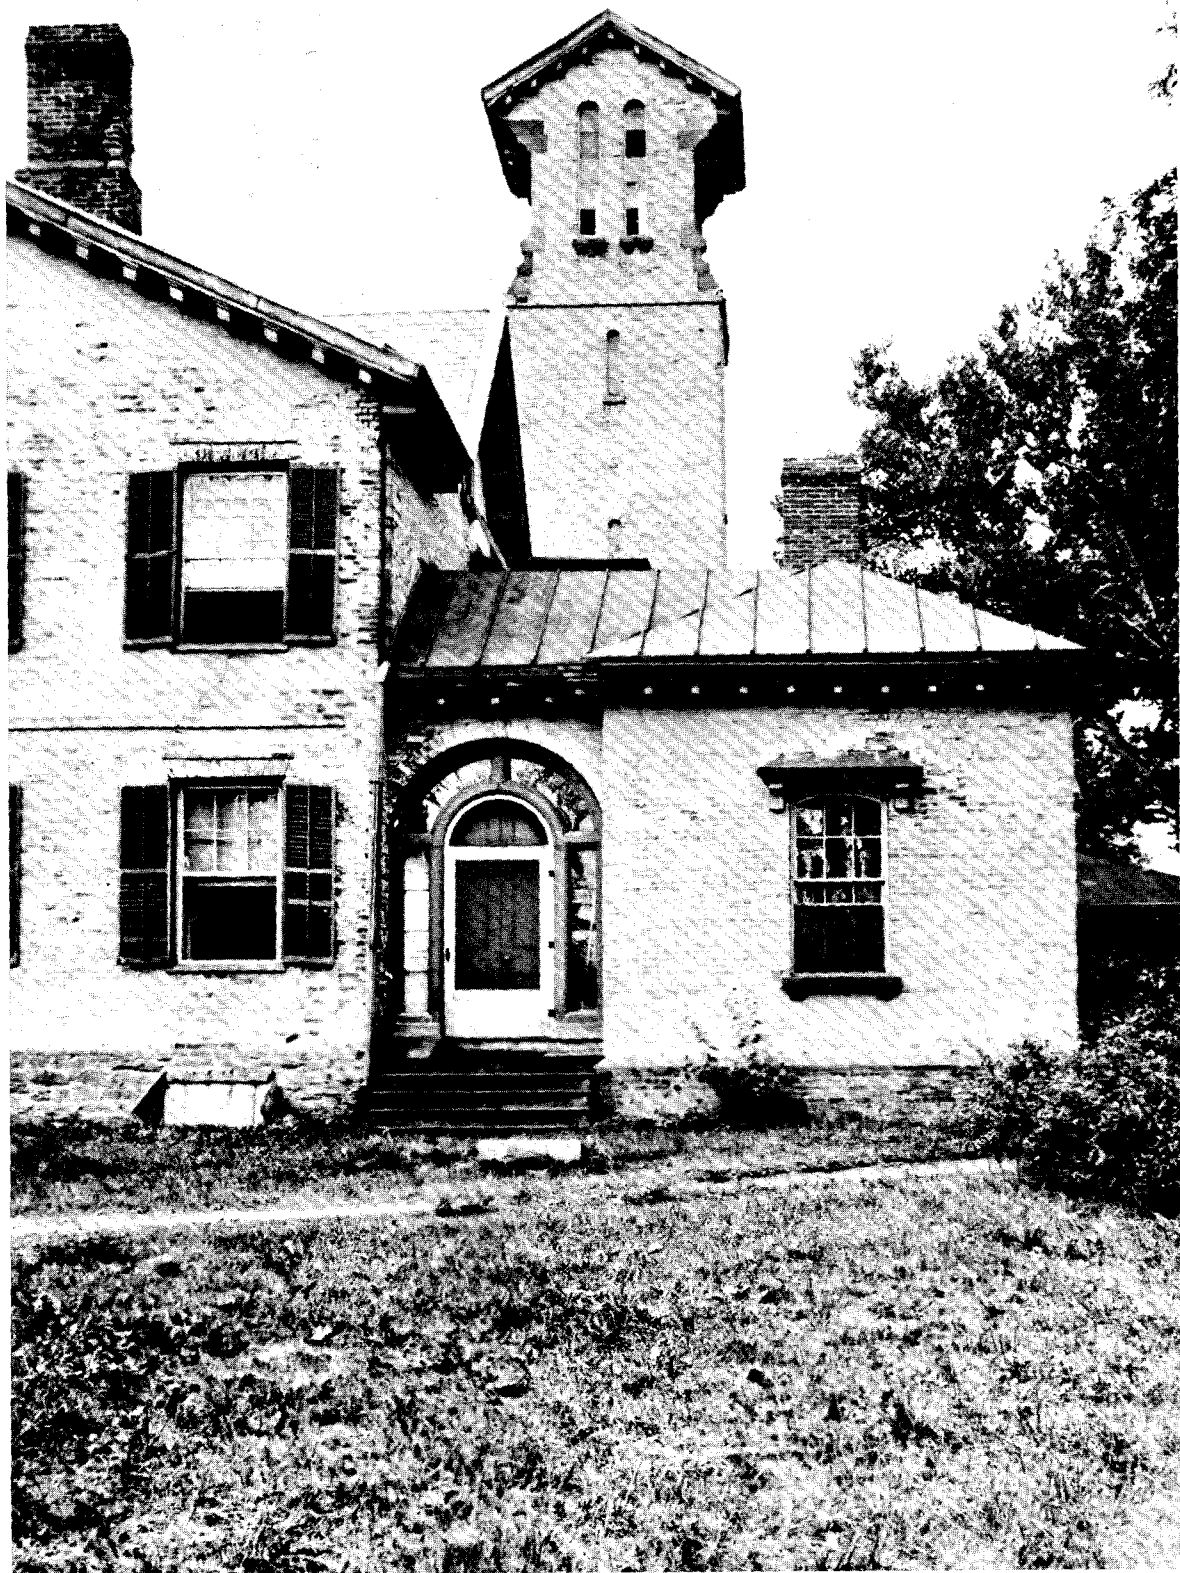
HP27. West End of the North Elevation of Lindenwald, 1936. This photograph was taken by Melvin Weig on August 3, 1936. The following details should be noted:

The belvedere windows are missing lights.

The lower section of the downspout is stock corrugated sheet metal (replacement).

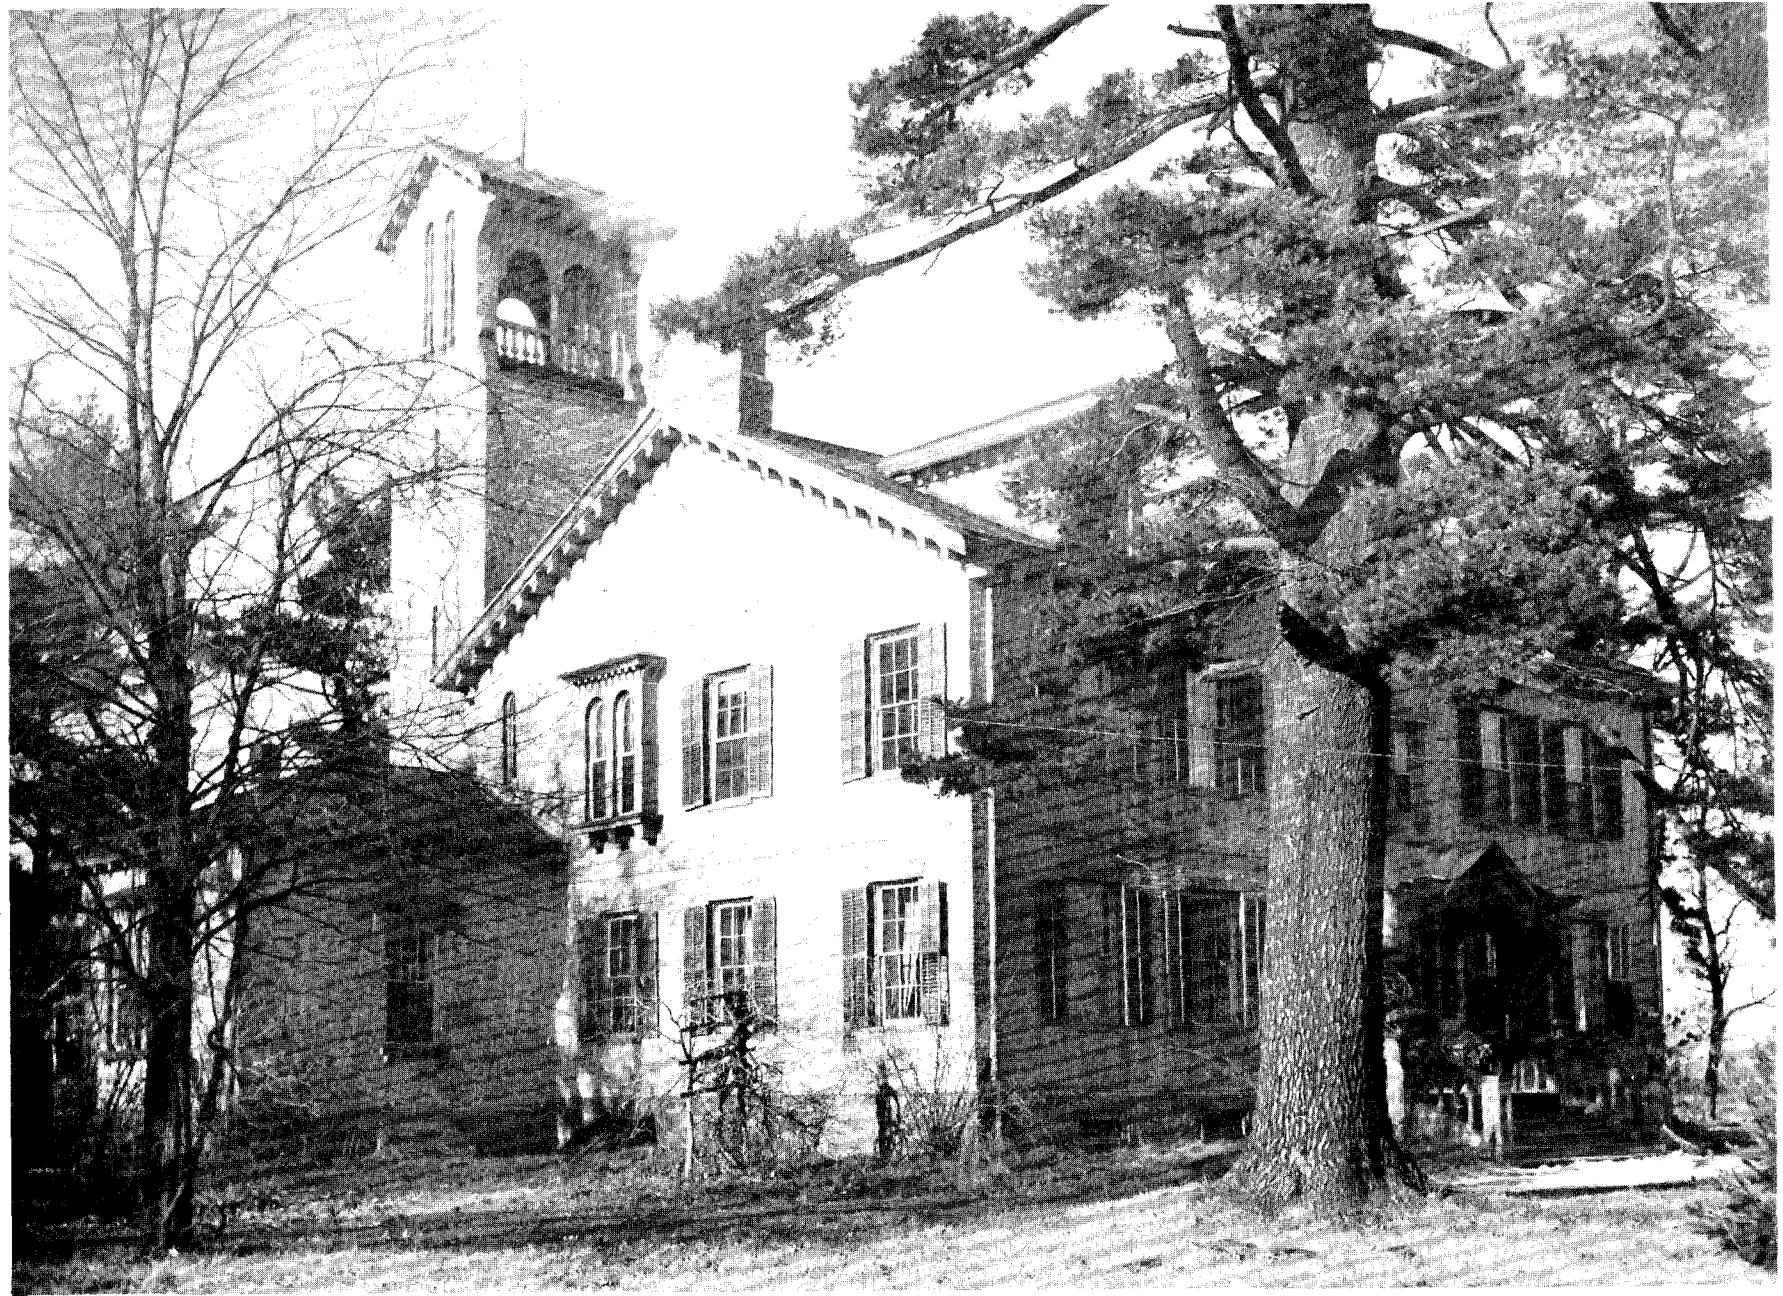
HP33. Lindenwald, 1937. This and the three following photographs were taken by Historic American Buildings Survey photographer Nelson E. Baldwin in January 1937. The following details should be noted:

loose bricks over window 127

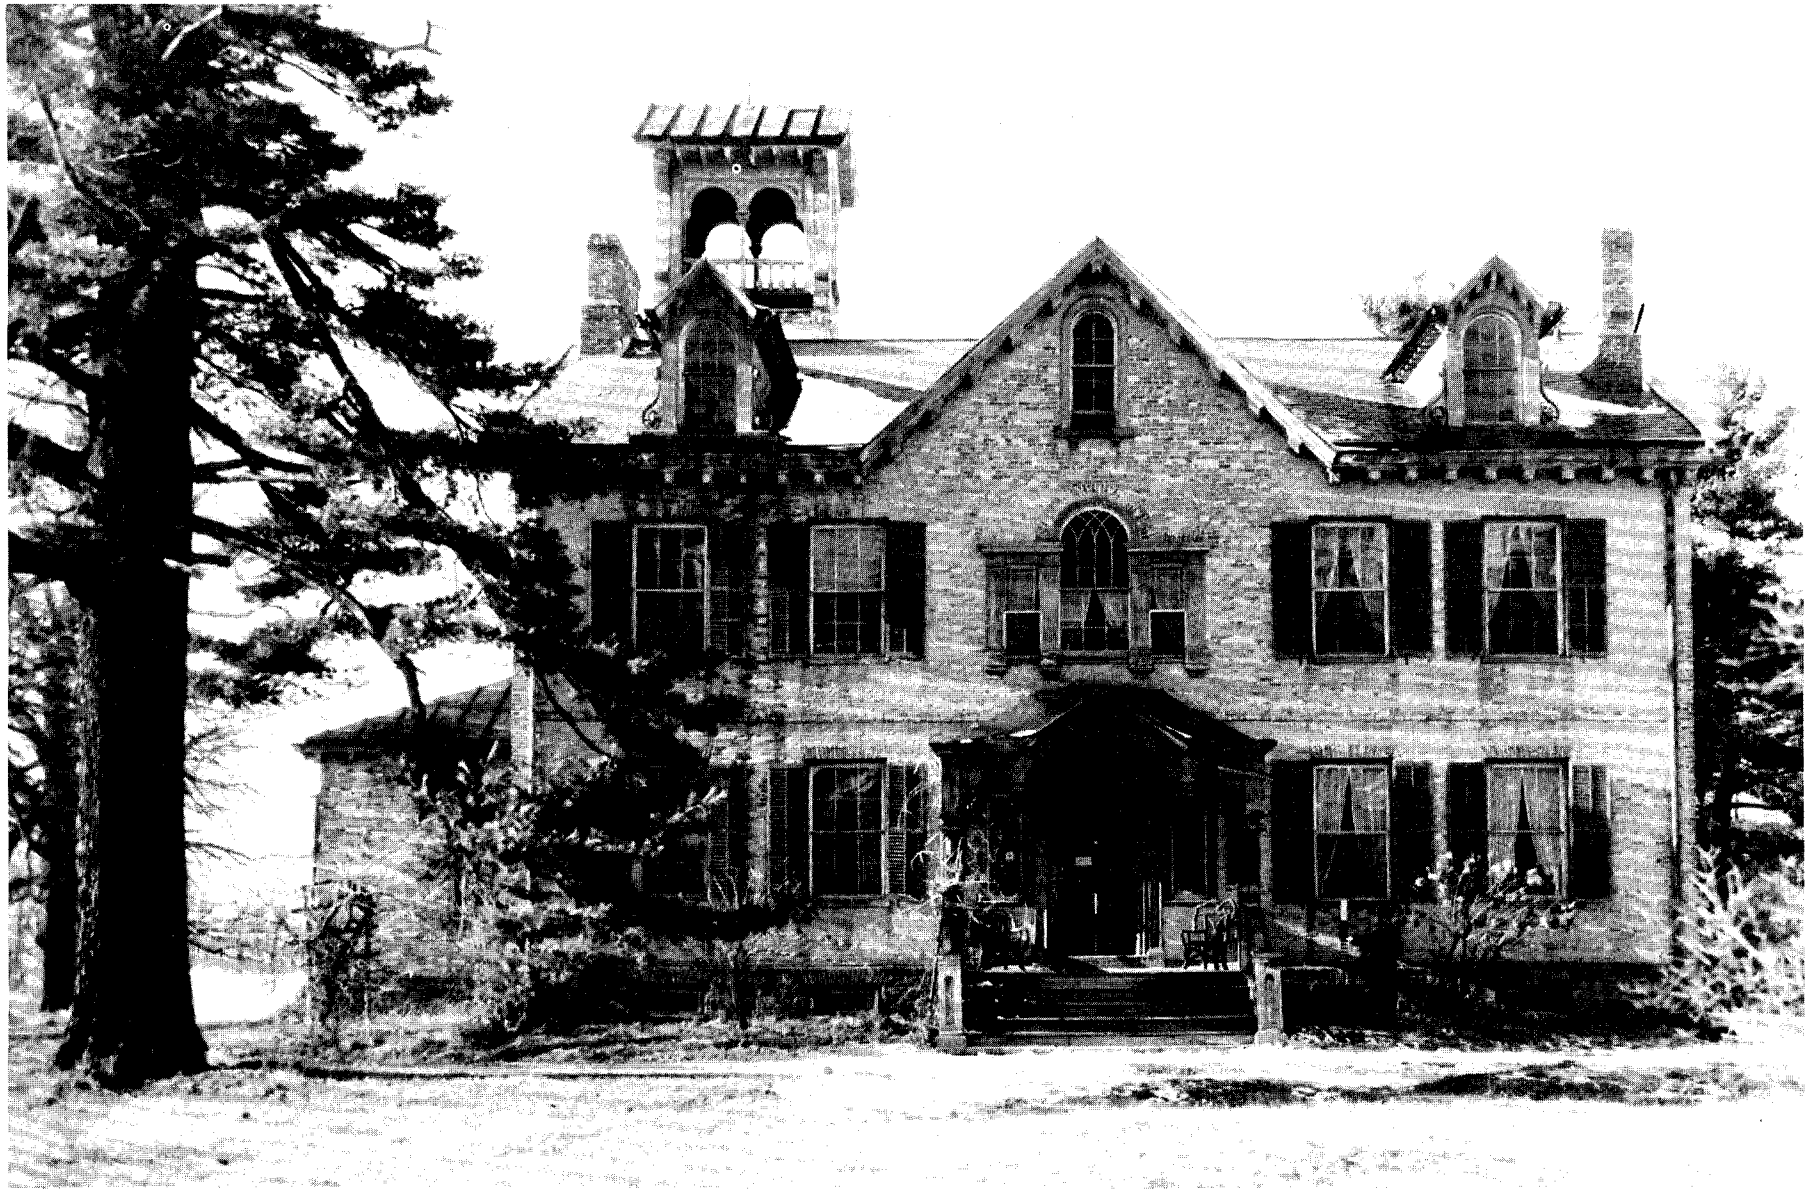
HP34. Lindenwald, East Elevation, 1937. This photograph was taken by Nelson Baldwin in January 1937. The following details should be noted:

The main cornice crown molding is deteriorating at the joints.

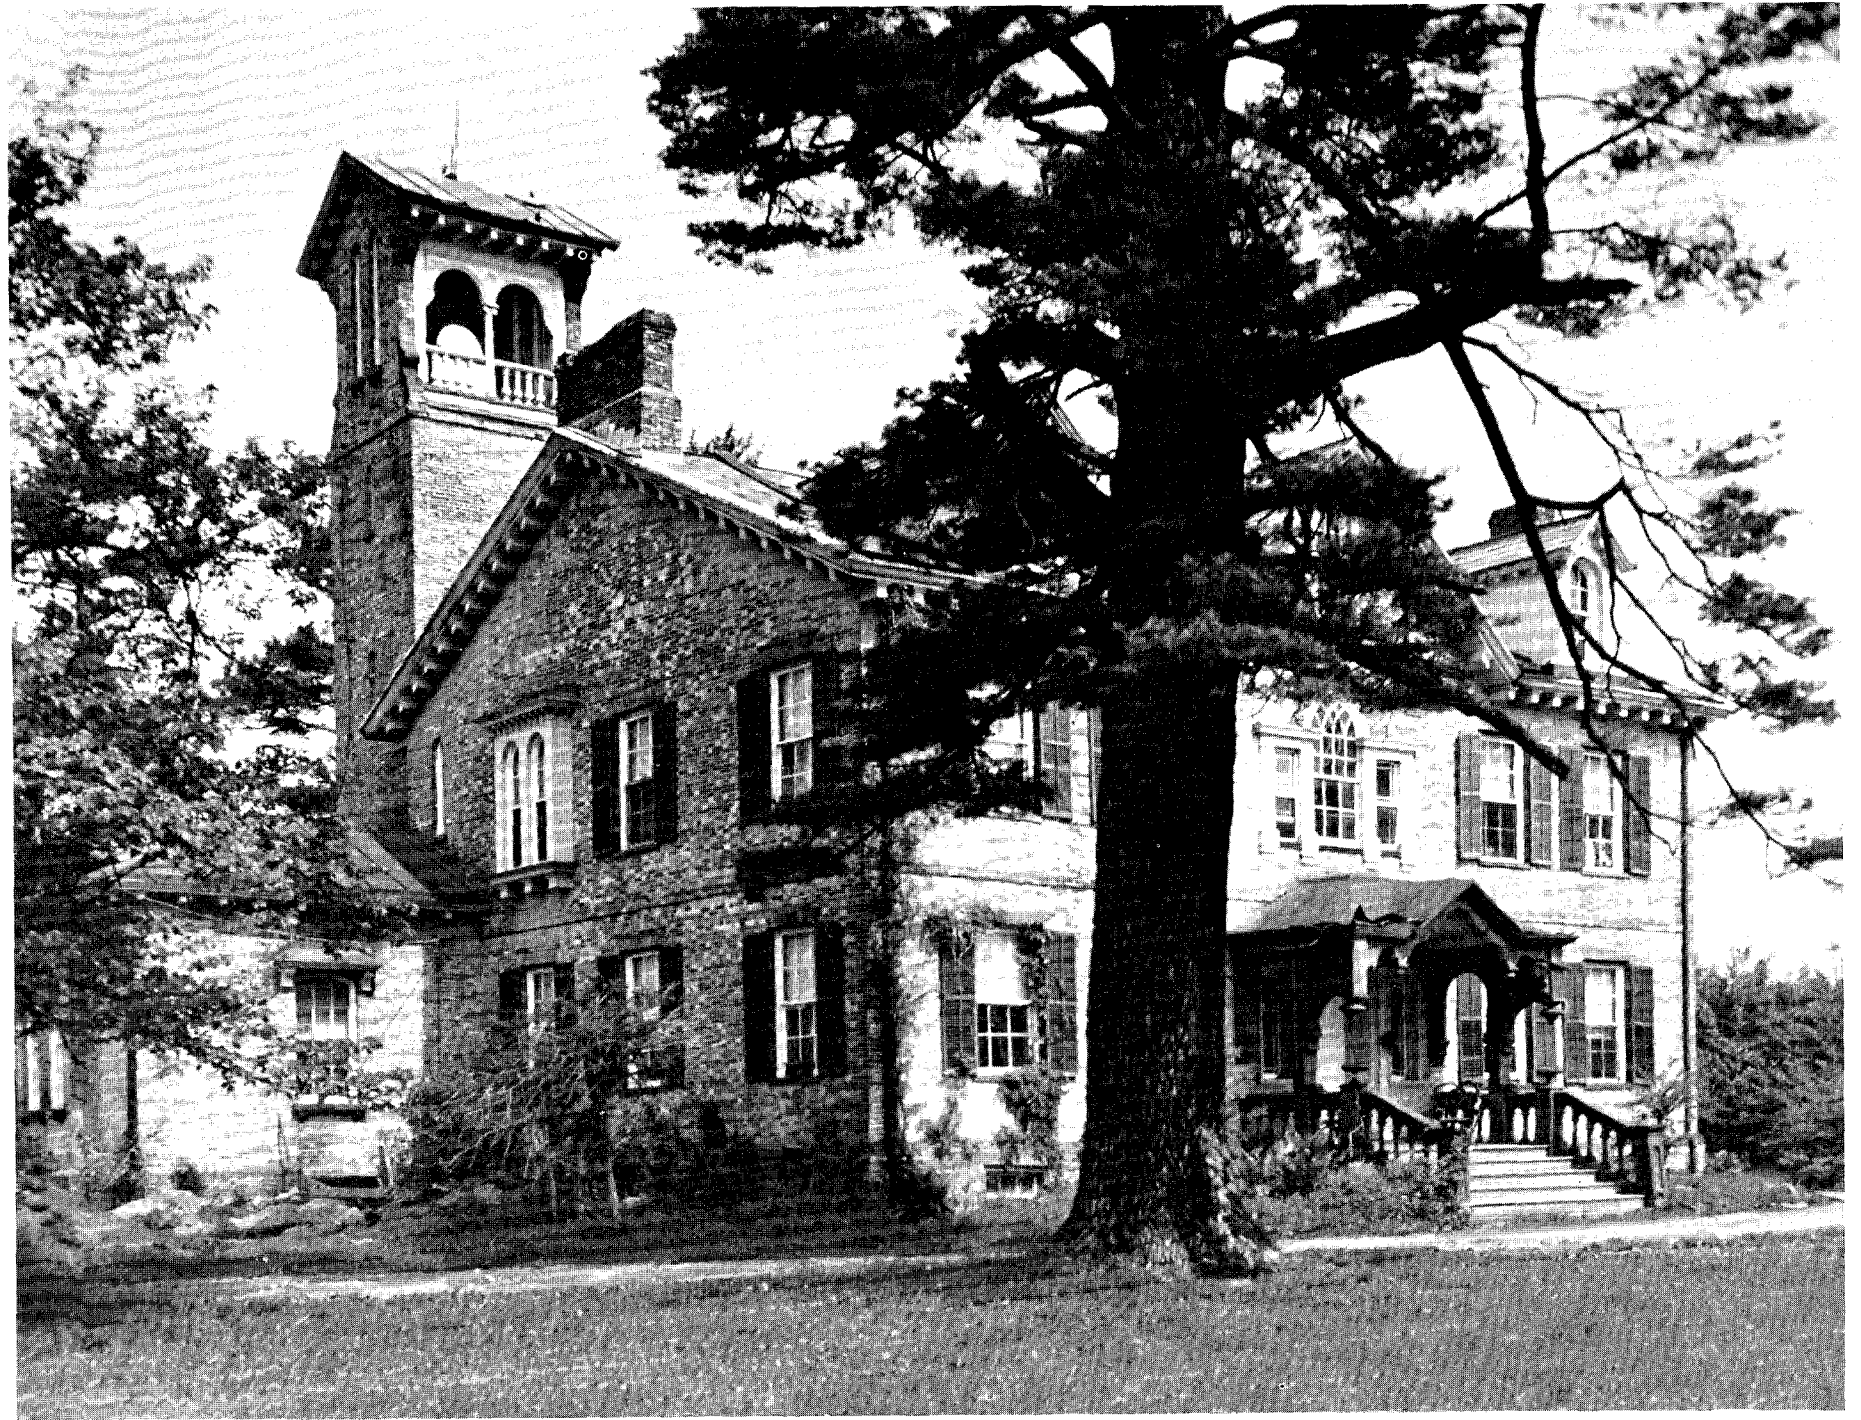
HP41. Lindenwald, ca. 1946-1950. This color photograph of the south and east facades of Lindenwald was donated to the National Park Service by the DeProsse family. It has been assigned a date between ca. 1946 and ca. 1950 on the basis of two DeProsse family recollections (W.N. Jackson, "Oral History Report," September 5, 1979). The painting of windows and doors is reported to have been done in 1946. The front porch is reported to have been removed in 1950. The following details should be noted:

repairs to tower roof

missing scrolls on north dormer

condition of porch roof

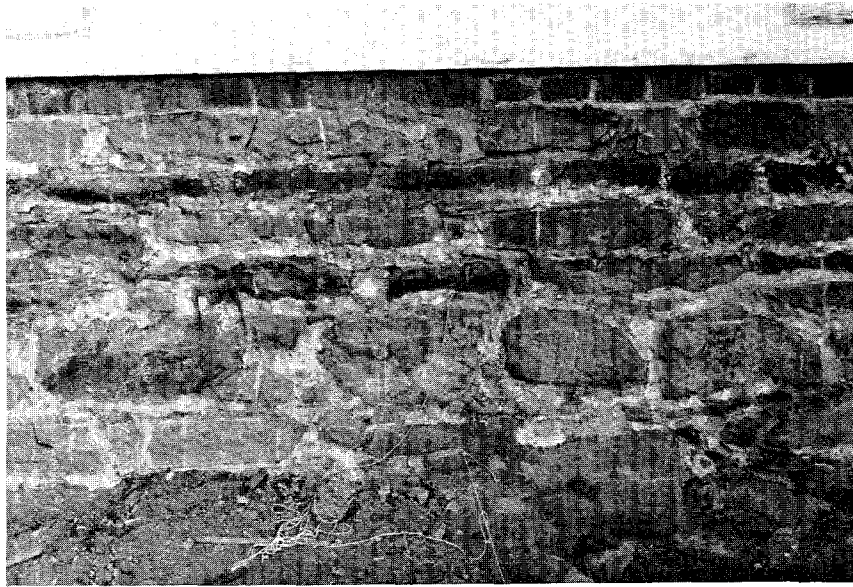
IP001, N002-04. Ca. 1797 foundation below door 101.

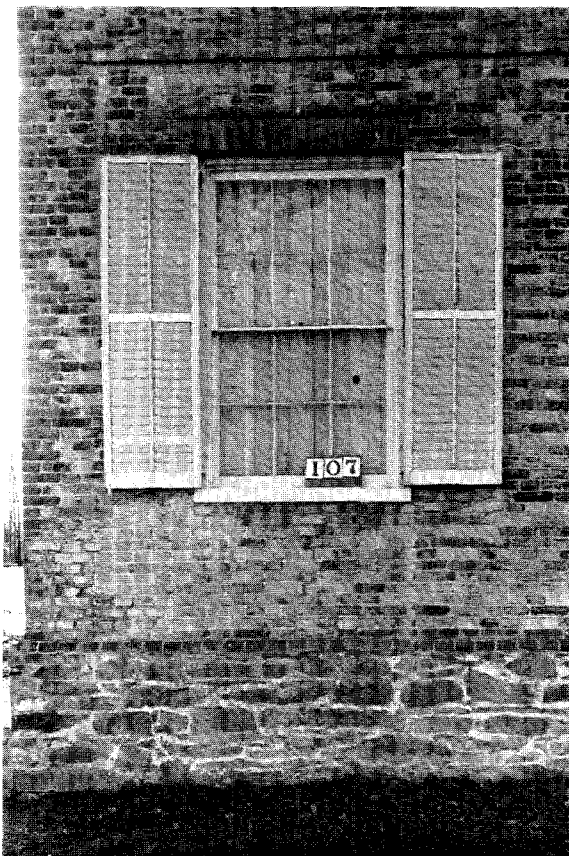
IP002, N012-14. Closure pattern at east corner of north wall.

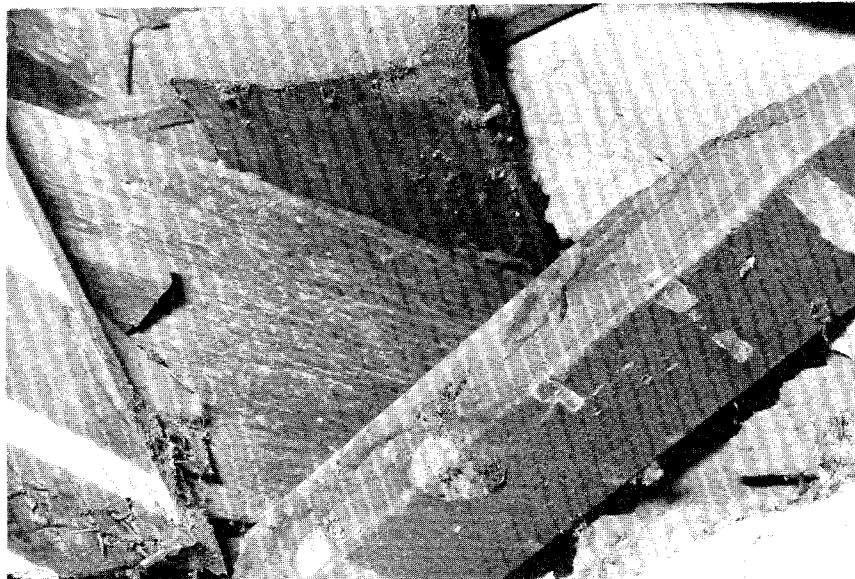
IP072, N028-35. Window 011. Note water penetration and dislodged masonry at lower left corner.

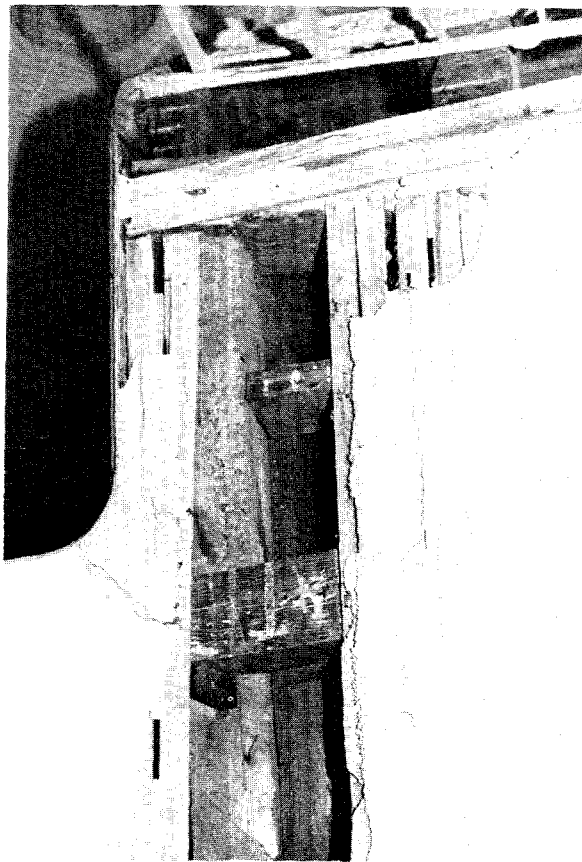
IP073, N041-12. Typical condition of cantilever joist wedged into masonry pocket.
