**THE BARN
AT THE FARWELL JONES HOUSE
STRUCTURAL ASSESSMENT REPORT**

**Minute Man National Historical Park
Concord, Massachusetts**

September 2004

Draft Historic Structure Report

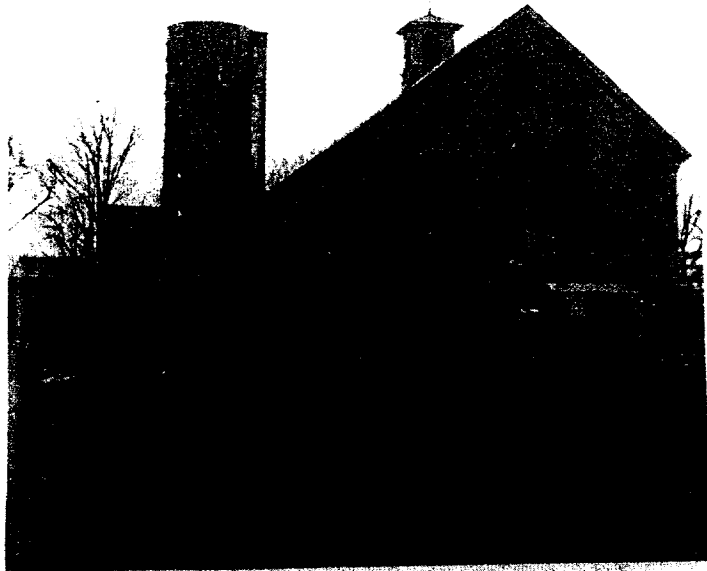
Figure 9. Rear elevation of the barn and silo, April 1963.

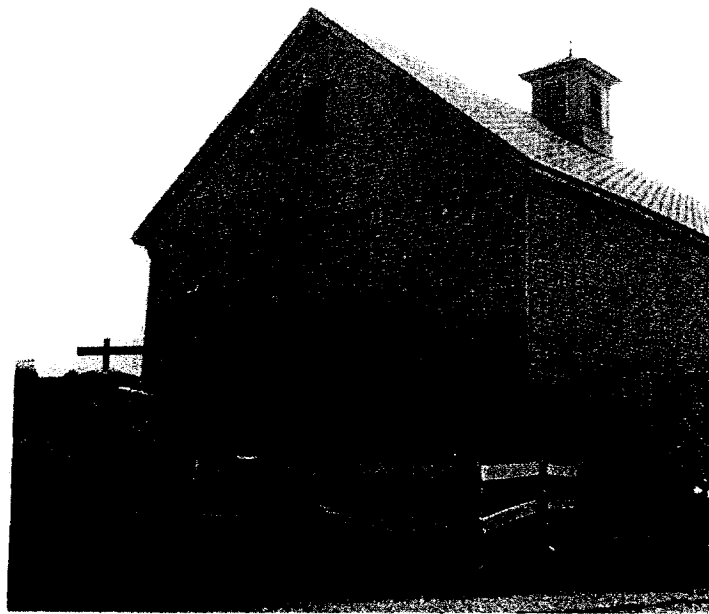
Figure 10. Rear and west elevations of the barn, April 1963.
