THE MINUTE MAN TREATMENT REPORT, 2007

Prepared by Carol Warner, Conservator
Northeast Museum Services Center,
Collections Conservation Branch

CONDITION & TREATMENT REPORT
MIMA, The Minute Man

Object : The Minute Man
Artist : Daniel Chester French, 1875
LCS # : 006545
CCS treat : on-site, 6/11-15/2007
Material : Cast bronze on 7' high granite base
Dimensions : H.18.5' W 11.5'
Park : Minute Man NHP
174 Liberty St.
Concord, MA 01742
Curator : Terrie Wallace, Ph.D.
978-318-7841

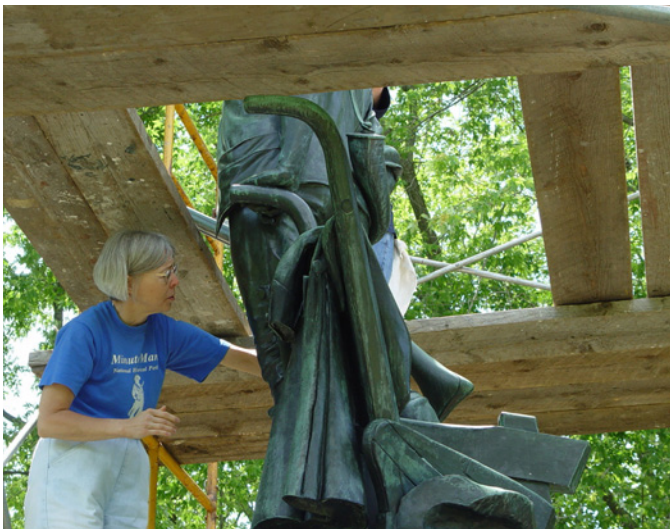
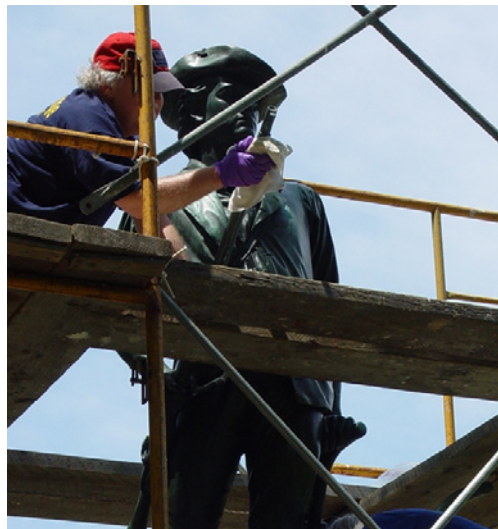
Terrie Wallace and Steve Neth of the MIMA curatorial staff apply a protective coat of clear paste wax in the spring and the fall.

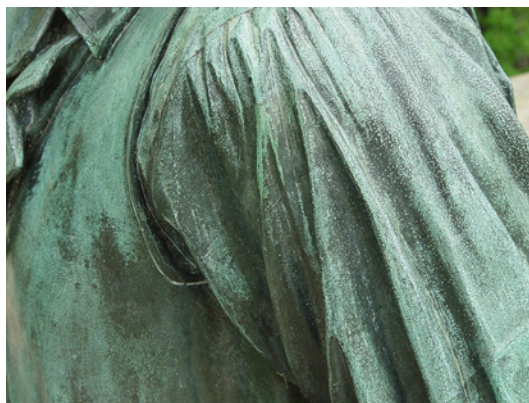
Weathered patina is black in recesses and light green on exposed areas.

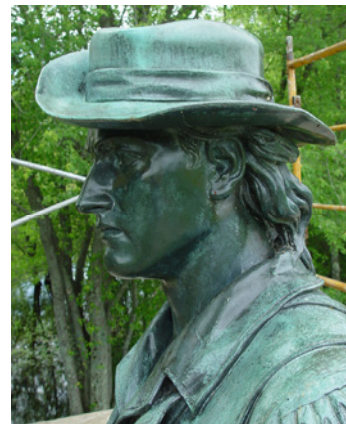
Face, hair and neck have even dark green patina.

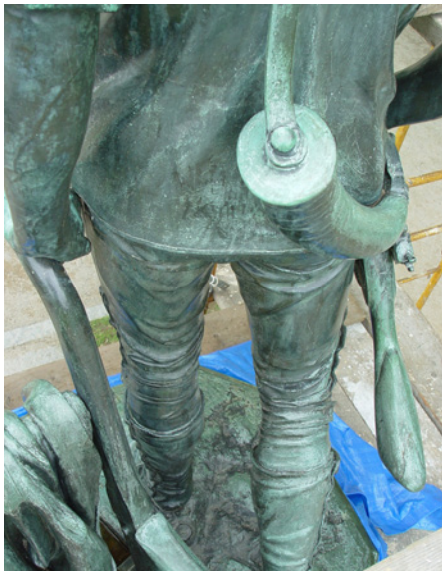
Top planes such as the top of the hat, powder horn and proper left hand, rifle in the right hand and toes of the boots are more weathered and appear light green/turquoise. These upper planes receive deposition of air-born particulates such as pollen and dirt. Acid rain and wind along with deposition wears protective coatings exposing the original patina and metal surface to the elements. Chemical reaction of the copper component of the bronze alloy with acid rain can result in color alteration to the turquoise and black tones presently seen on the Minute Man Statue. This weathered patina is stable and can be maintained indefinitely if protective coatings are maintained. If coatings are not maintained, the run off pattern of acid rain will result in a more pronounced streaky appearance of light green and black and ultimately will result in etching, and erosion of the bronze surface and loss of original sculptural detail.

Weathered patina on powder horn.

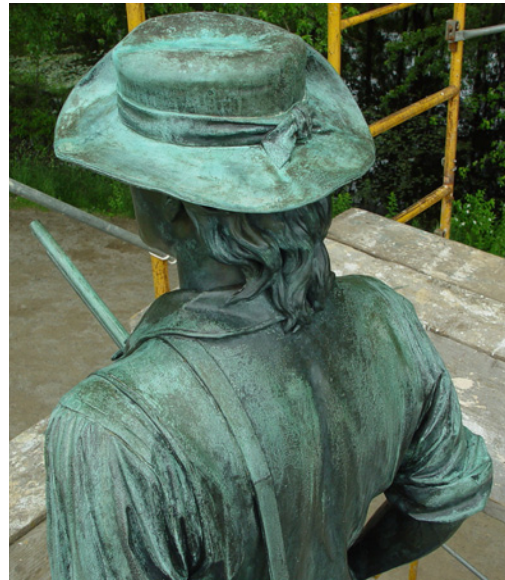
Weathered patina on crown and brim of hat.

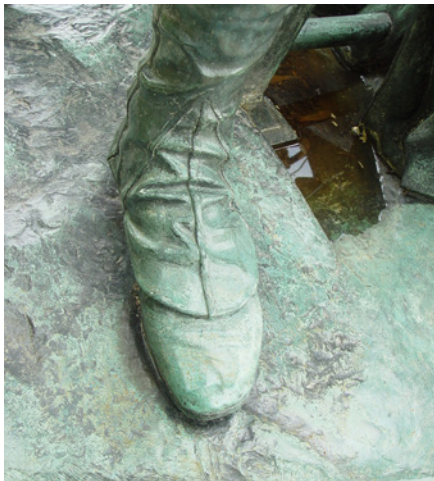
Weathered patina on shoe and base.

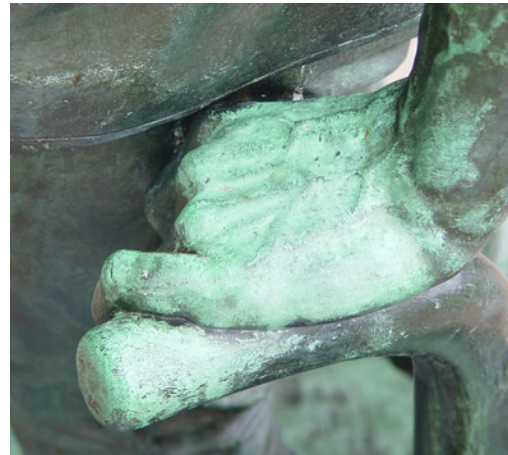
Weathered patina on left hand and plow handle.

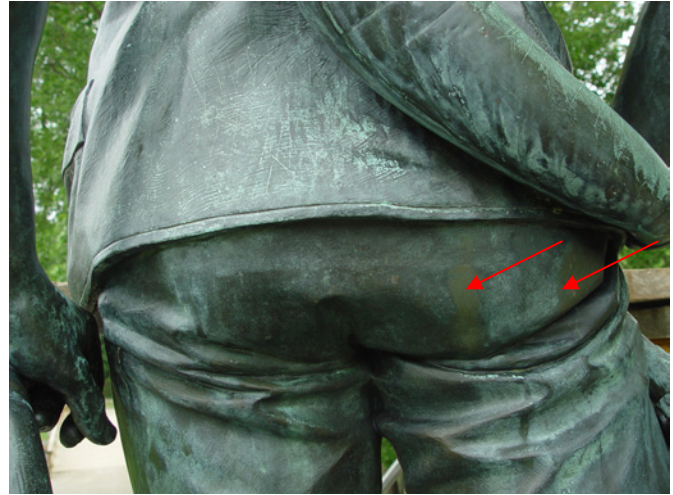
Anomalies in the surface appearance of the patina are present in several locations and are assumed to be the product of manufacture such as the location of casting faults or sprue sites patched with an alloy that weathered differently than the casting bronze.

Graffiti on back, bottom of jacket near jacket.
Anomalies in patina on pants seat

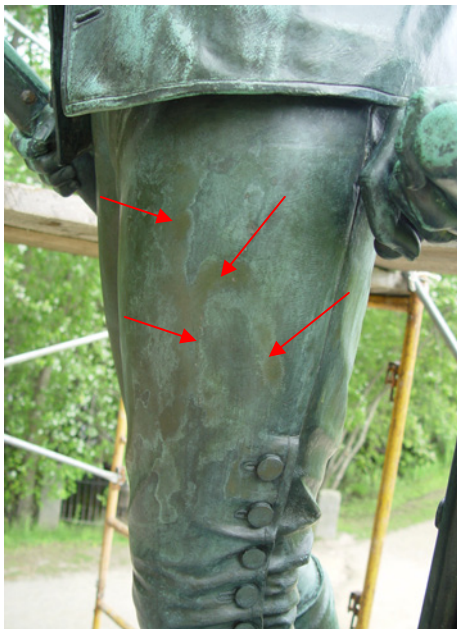
Anomalies in patina on front of left thigh.

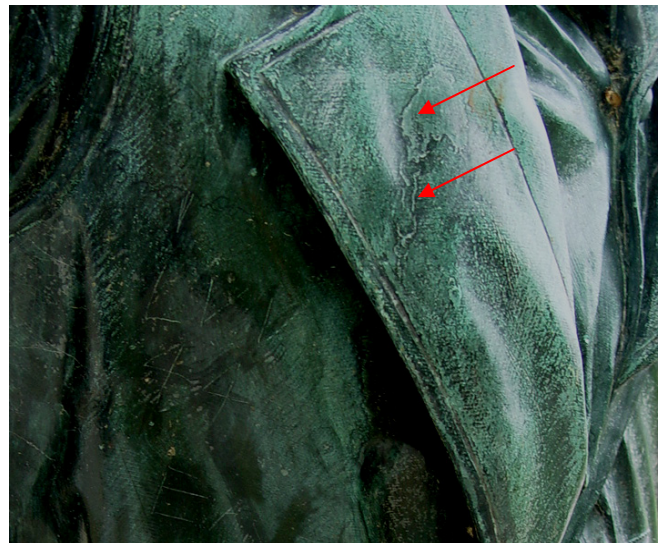
Anomalies in patina on right lapel.

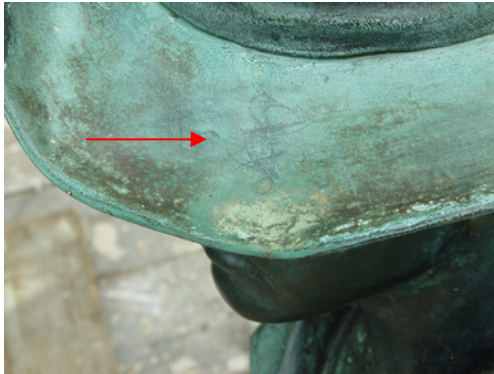
The statue has many small areas of graffiti and scratches resulting from vandalism. These were present at the time of the 1994 treatment and are documented in slides from that treatment. Scratches and graffiti are located on the top and brim of the hat, on the back below the shoulders, in the middle of the back above the powder horn, the proper right front of the jacket beside the lapel, butt of the rifle, and back of proper right thigh.

Graffiti on brim of hat

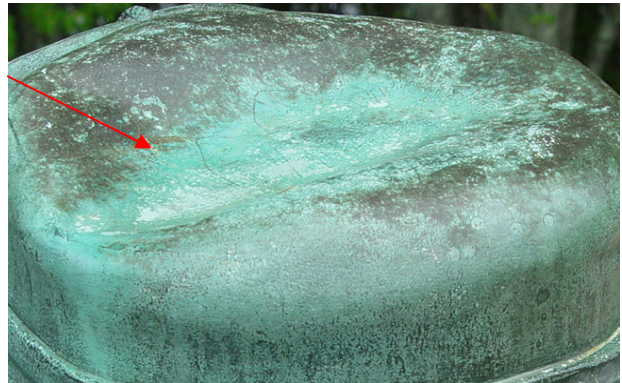
Graffiti on top of hat

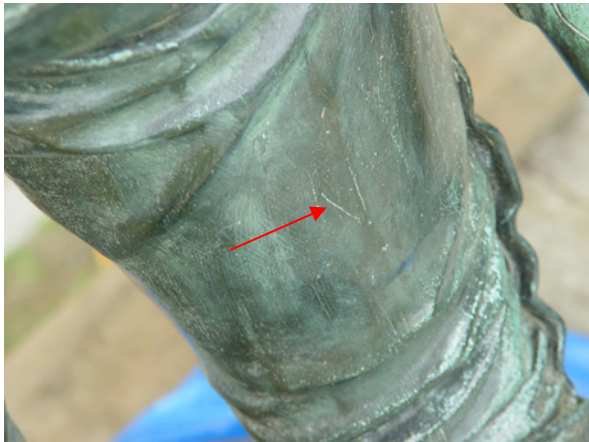
Graffiti on proper right leg.

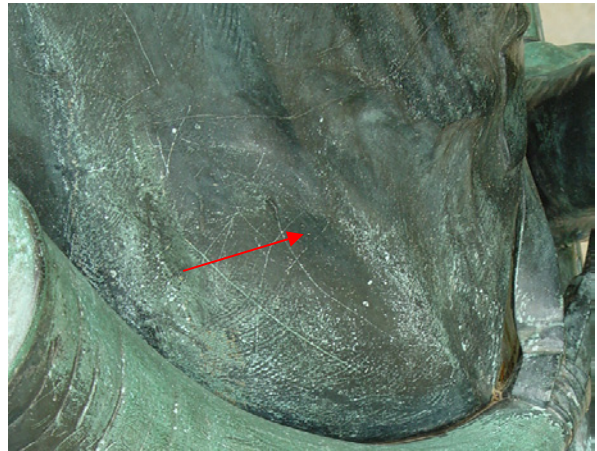
Graffiti on back of jacket above powder horn.

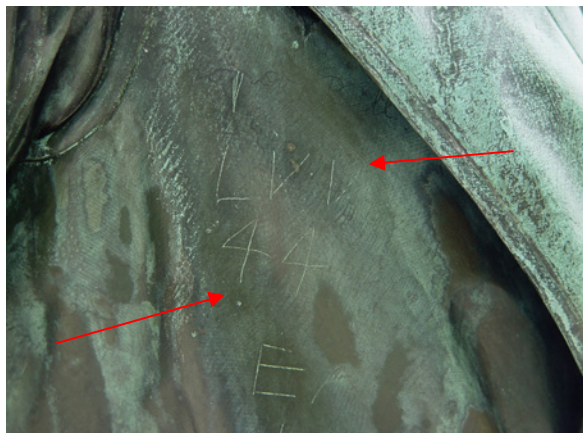
Graffiti on the jacket, front right, near lapel.

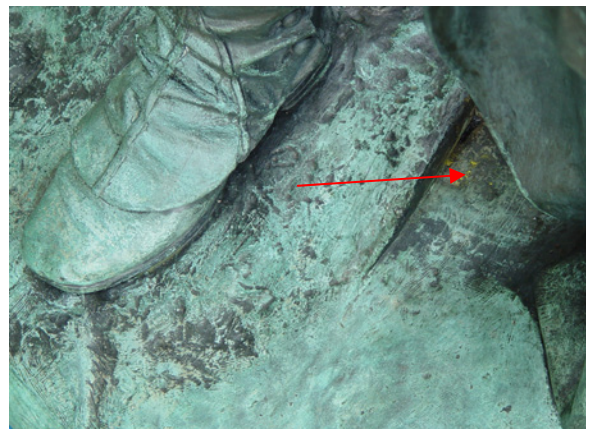
Insoluble yellow paint spatters are present on the base in front of the plow by the left foot.

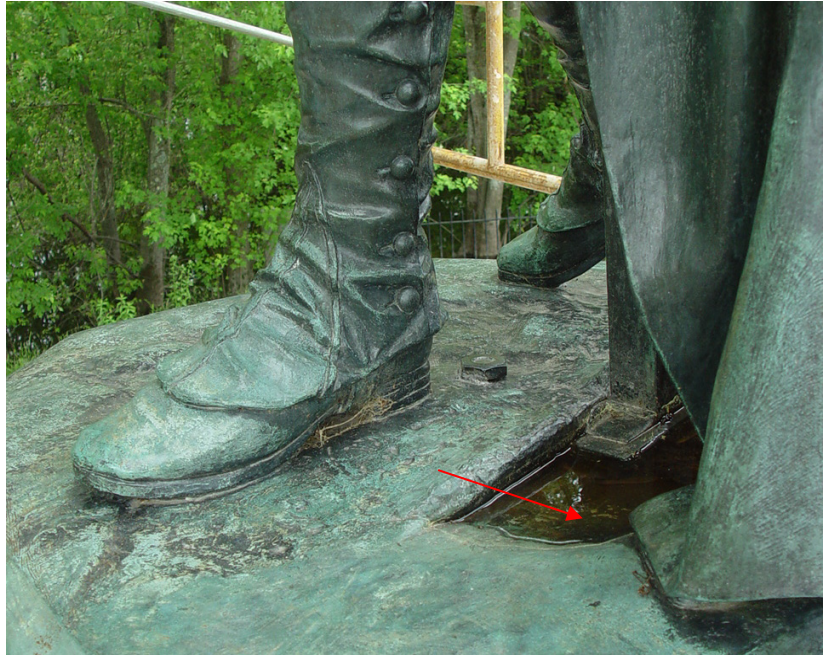
Standing water was present in the concave depression in the base in front of the plow at the time of the site visit for treatment. This occurs every time it rains but does not appear to be an issue if the coatings are properly maintained and intervention to provide drainage is not recommended at this time.

Standing water in recess of base.

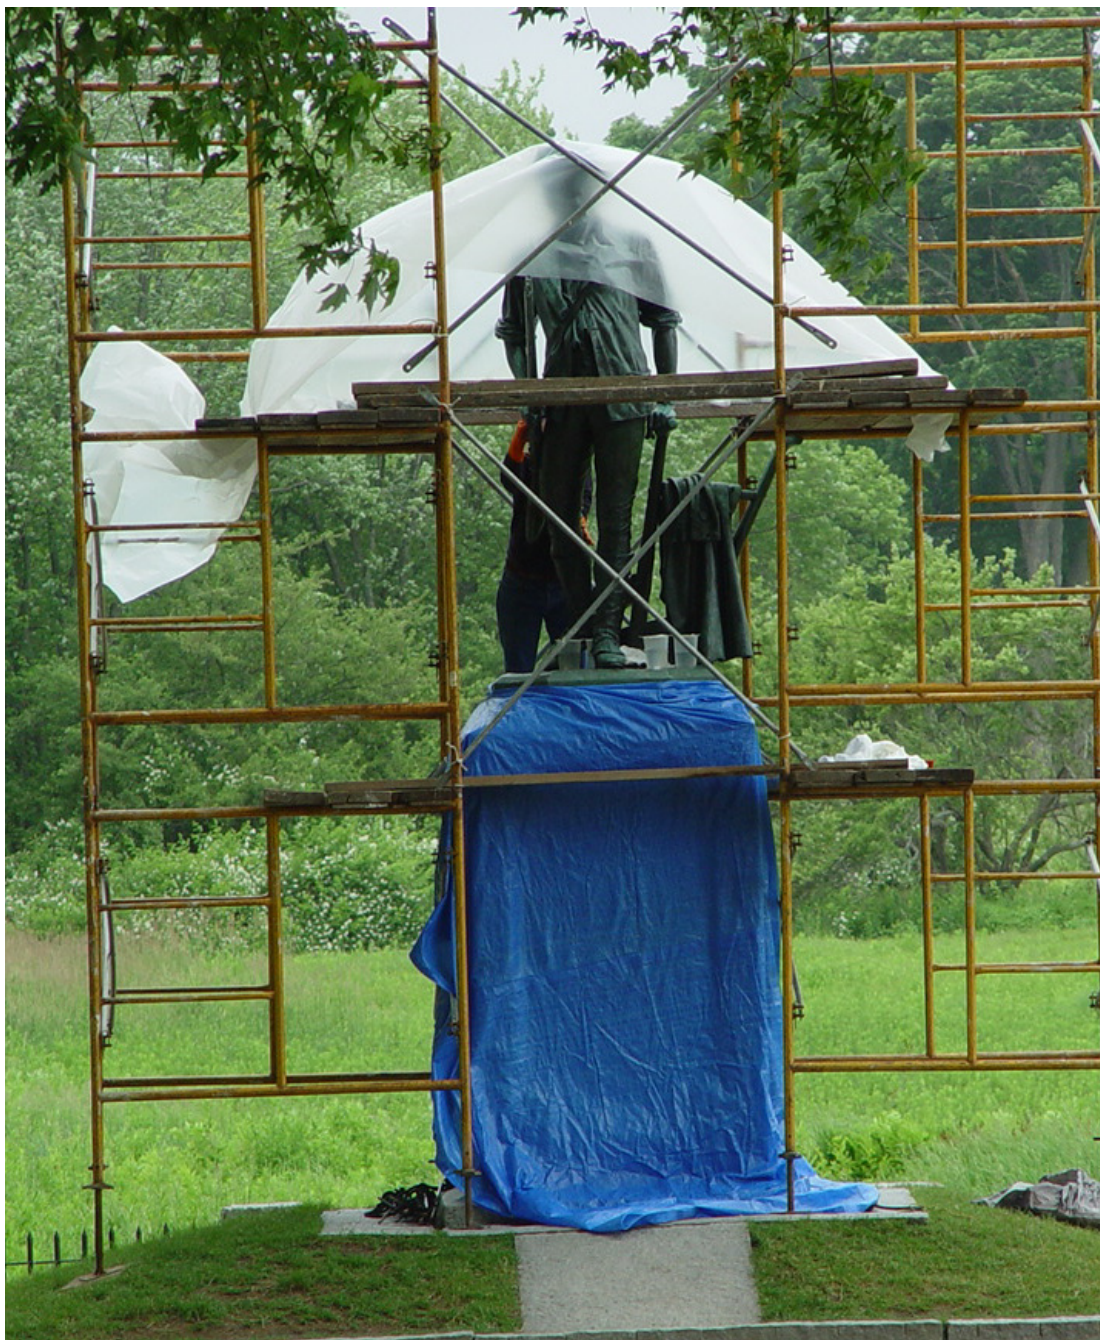
During Treatment, CCB Conservators stripping coatings.

- Brush coats of benzene and cotton rags were employed to remove the existing wax coating on top of the existing Incralac coating. Several cycles of applying solvent and wiping did not appear to be affective in removing all of the wax. This procedure was repeated with xylene which was effective. It is likely that the partial stripping, reforming and recoating done in 1999 resulted in less discreet and continuous layers than a treatment involving complete stripping and replacement of coatings. Both Incralac and wax are soluble in xylene.

- Brush coats of acetone/toluene, 1/1 and cotton rags were employed to remove existing Incralac coatings. Repeated cycles were required to remove the resin coating to the level of the metal surface.

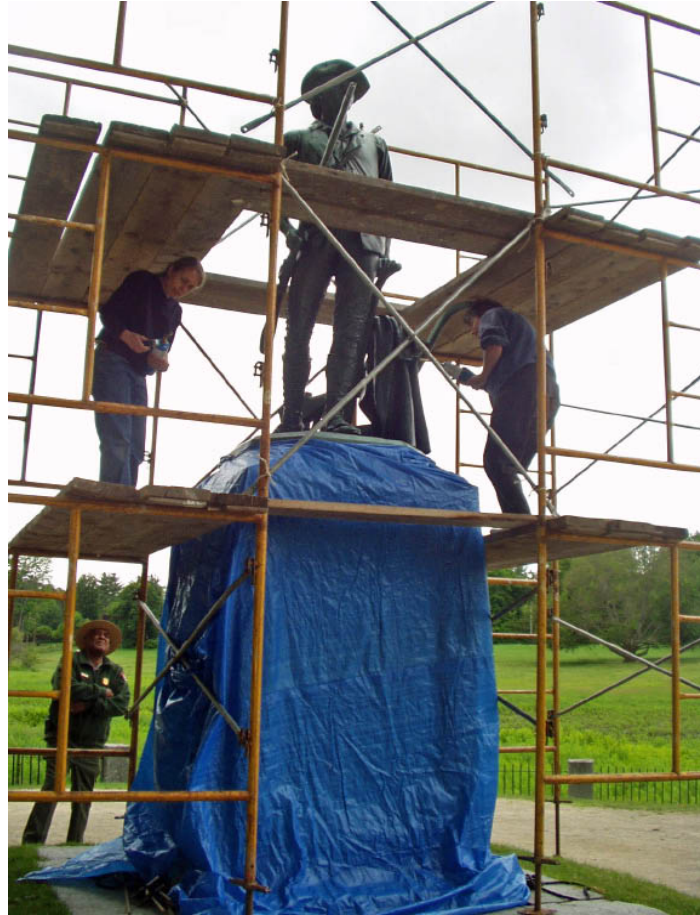
During treatment, CCB conservators apply heat with propane torches to drive off moisture before applying Incralac coatings.

- Moisture in the surface of the bronze was driven off with heat from propane torches.
- Acetone was applied by brush and the statue was wiped down with cotton cloths to degrease it and remove any residual coating before application of a new Incralac coating.

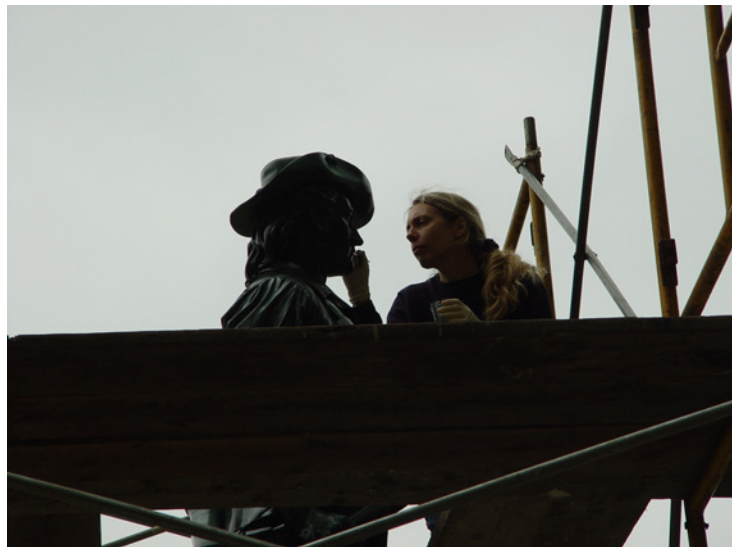
After brush coat of Incralac was applied, weathered areas in the patina are toned with pigmented Incralac.

- First coat of Incralac™/ toluene, 1/1 was applied by brush. (Incralac is acryloid B-44S methylmethacrylate copolymer with benzotriazole sold 15% solids in toluene.)
- Pigmented Incralac was applied by small brush on weathered areas in the patina.
- Second coat of Incralac™/ toluene, 1/1 was applied by air gun.
- After the Incralac™ coating had dried, Park Curatorial staff applied Butcher's™ Bowling Alley Paste Wax and buffed it with cotton cloth.

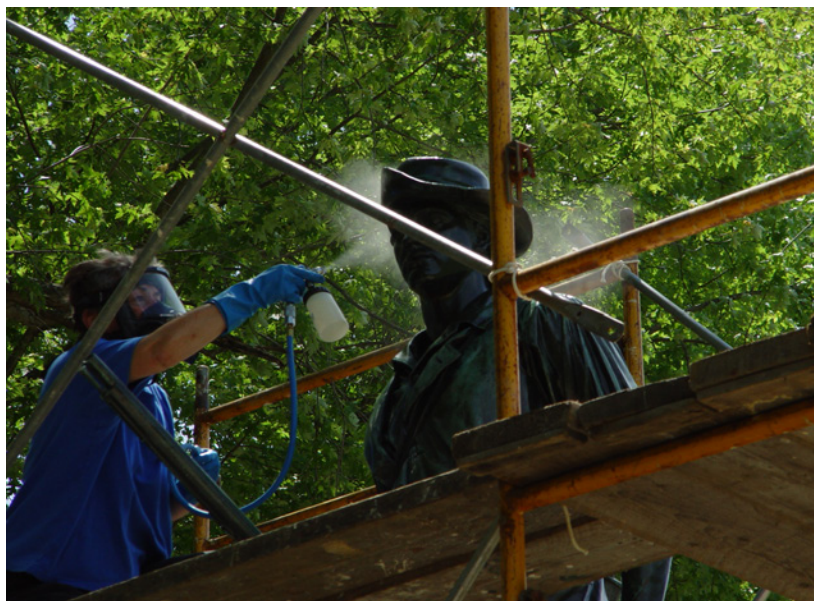
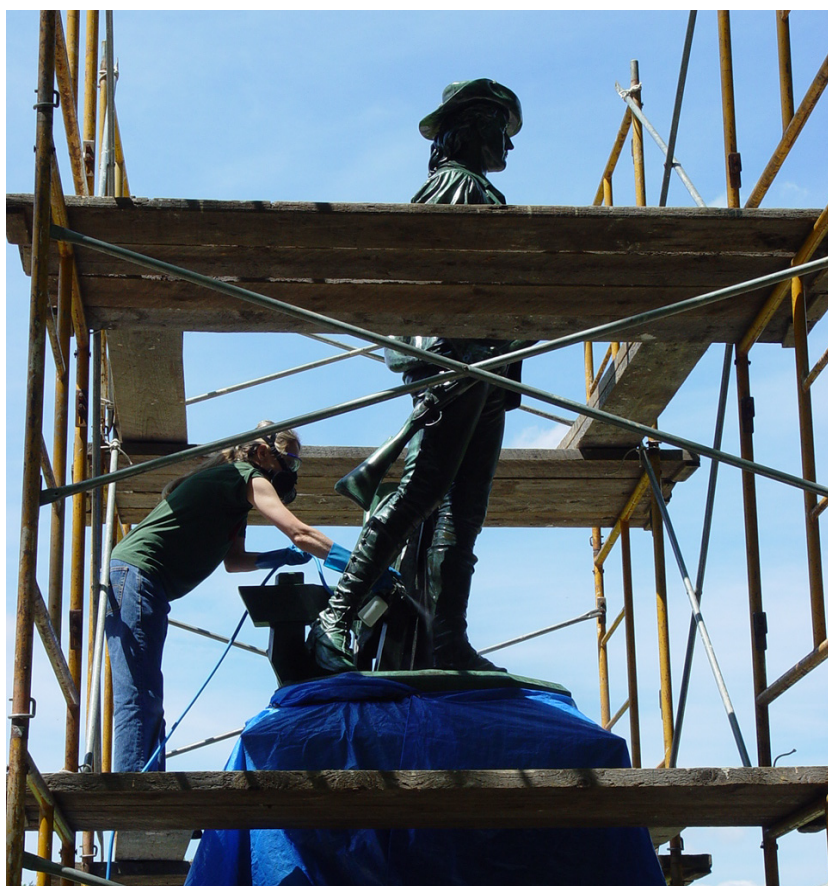
CCB Conservators Carol Warner and Margaret Breuker apply spray coats of Incralac.
