CAPTAIN WILLIAM SMITH HOUSE

Minute Man National Historical Park
Lincoln, Massachusetts

Historic Structure Report

December 2007

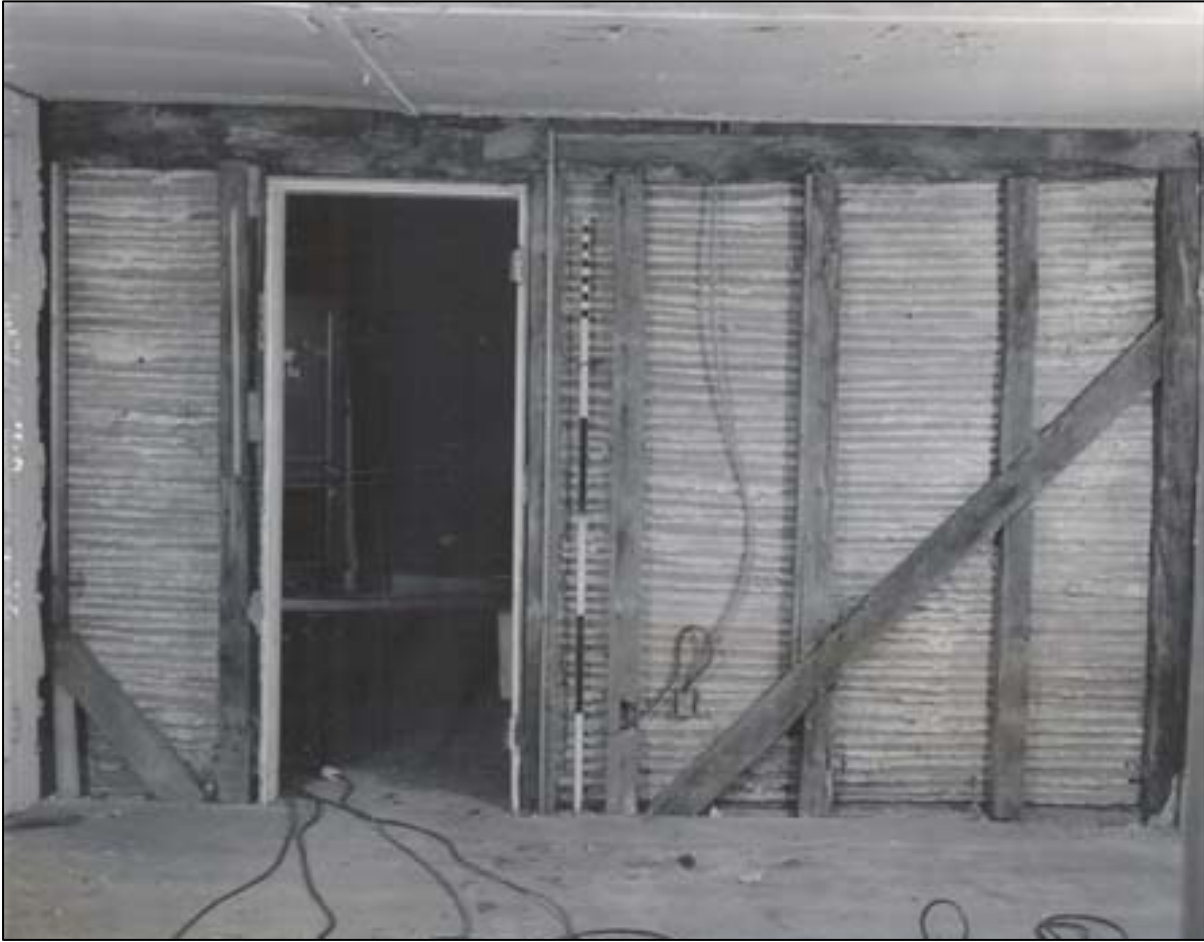
Figure 42. Main House: West gable end, after removal of ca.- 1956 clapboards during architectural investigation; window opening is not original.

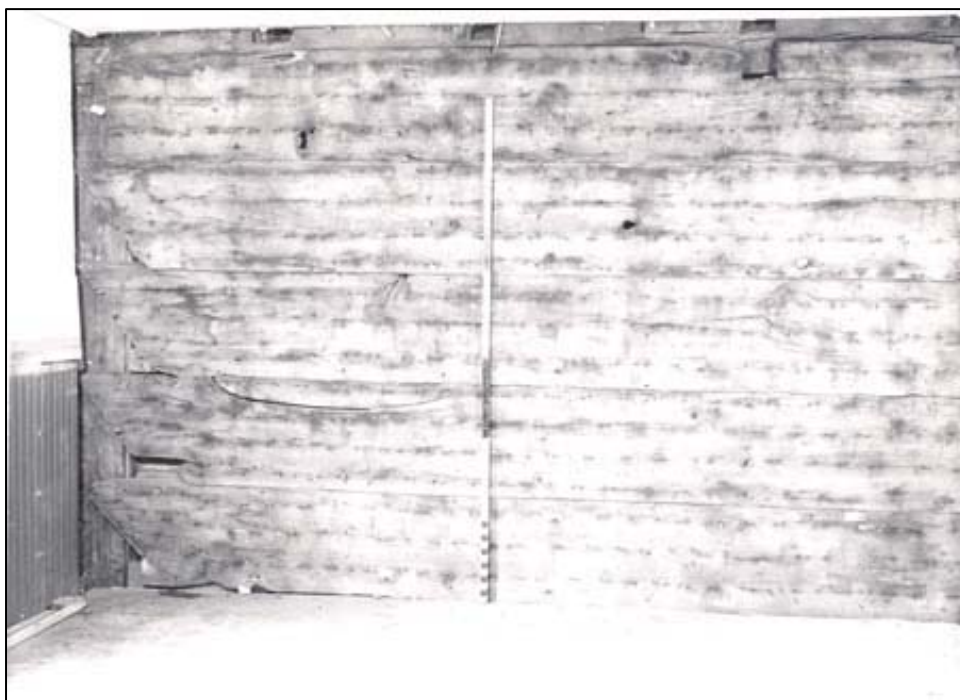
Figure 43. Ca.- 1900 Addition: Second- story east room, looking south at north (formerly exterior) wall of main house, showing original wall boards removed ca. 1900 and replaced in 1980.

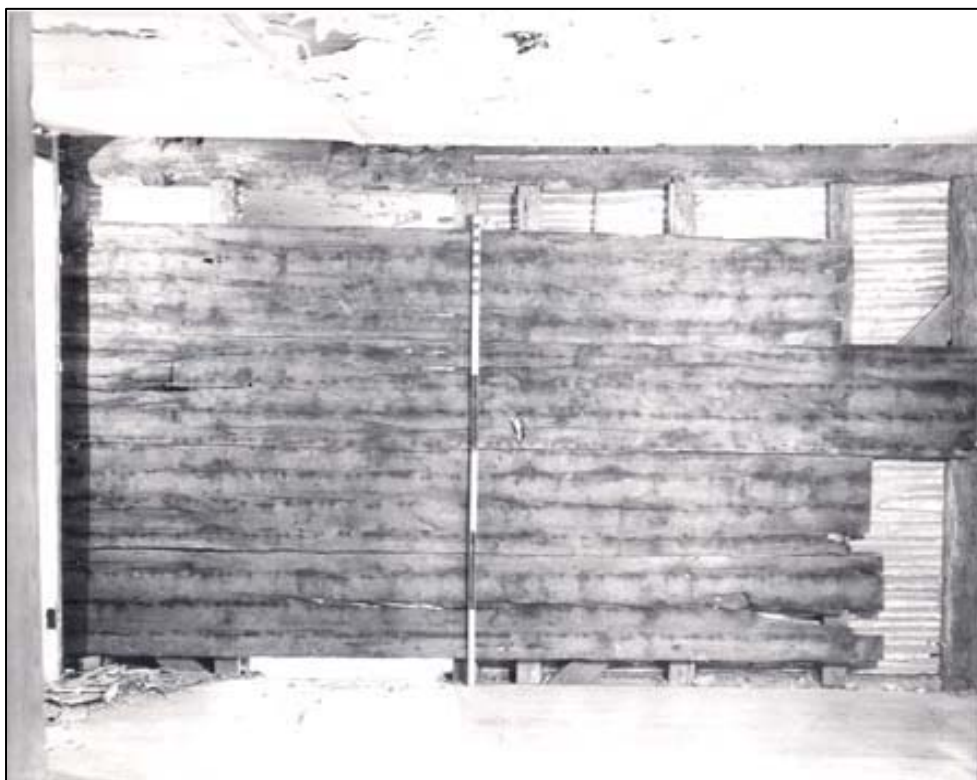
Figure 44. Ca.- 1900 Addition: Second- story west room, looking south at north (formerly exterior) wall of main house, showing original wall boards removed ca. 1900 and replaced in 1980.

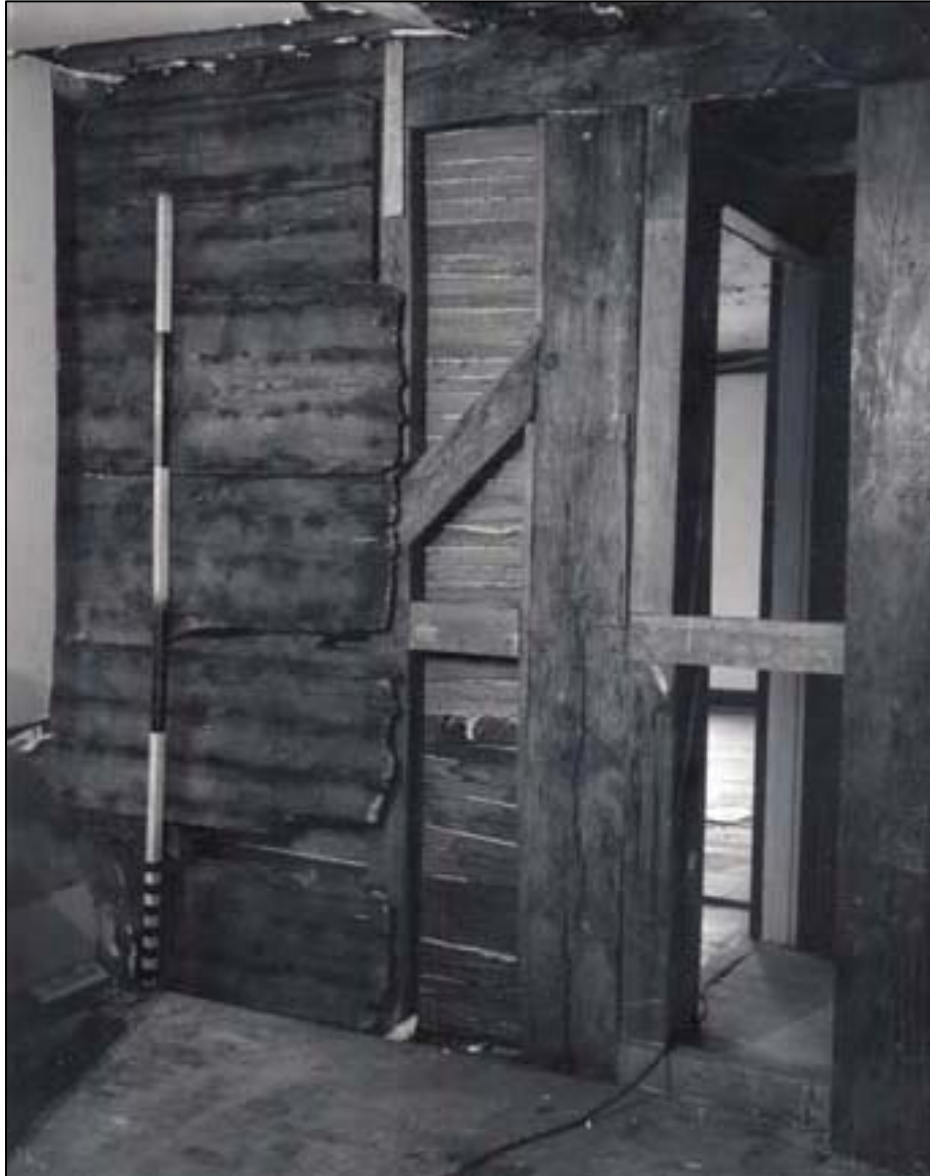
Figure 45. Ca.- 1900 Addition: Second- story center room, looking south at north (formerly exterior) wall of main house, showing original wall boards with lapped ends, removed ca. 1900 and replaced in 1980.

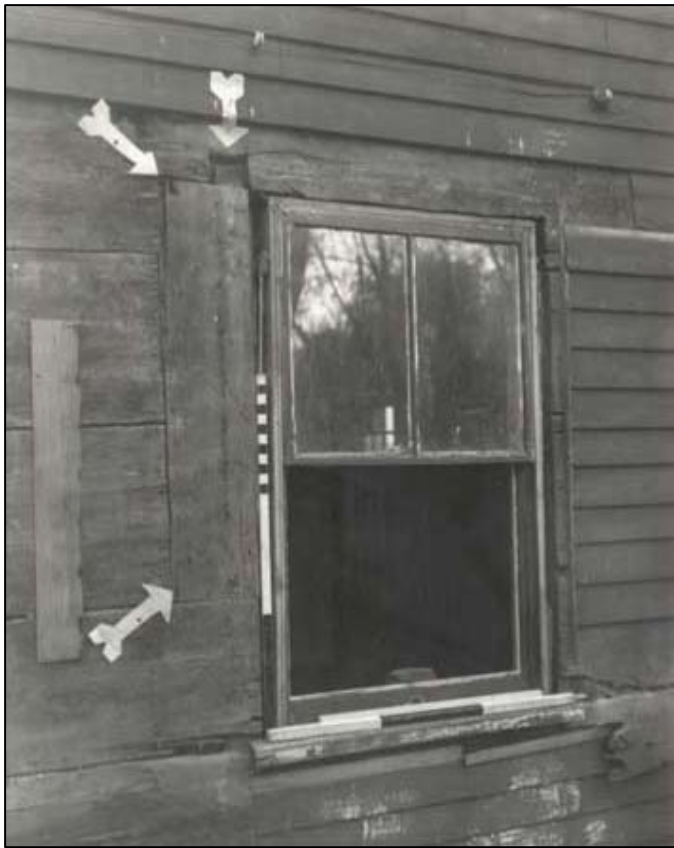
Figure 46. Main House:
West exterior wall, showing
West Parlor window; arrows
point to head and sill of ca.-
1692 window opening.

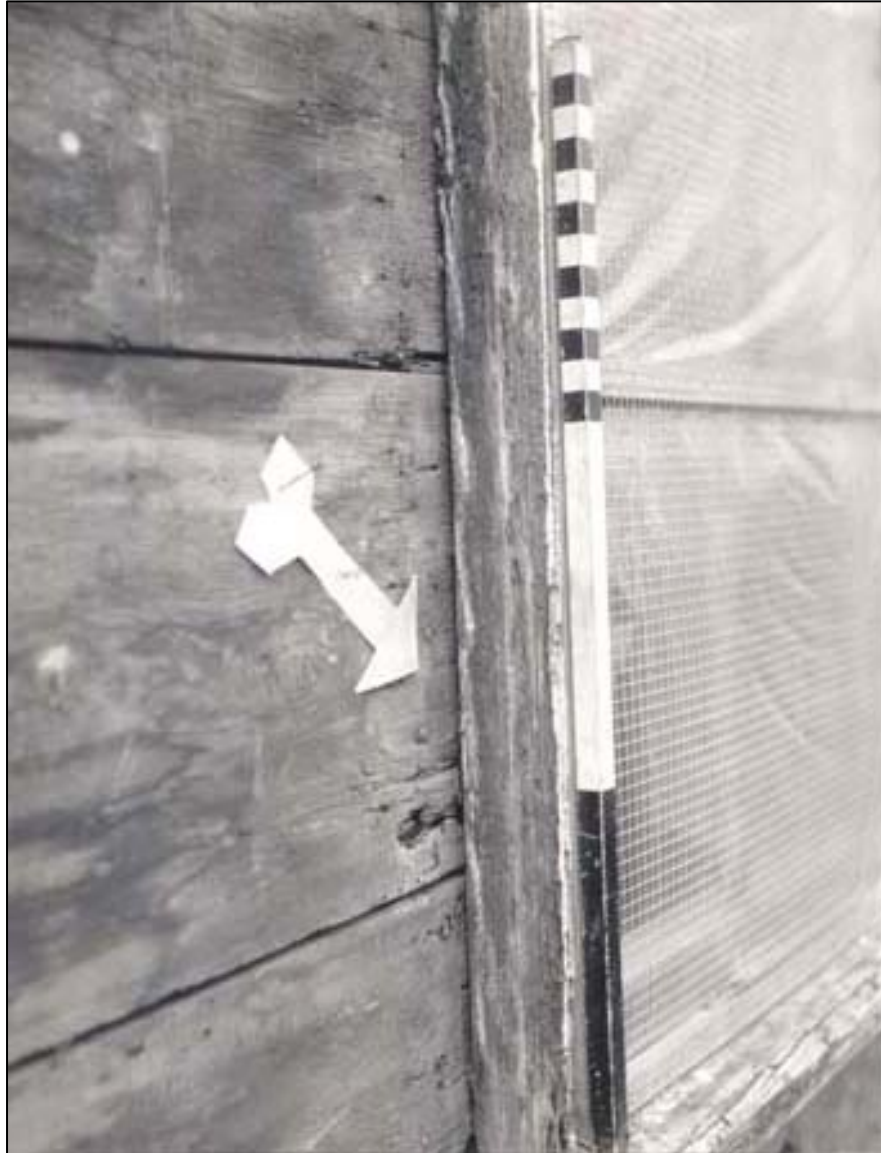
Figure 50. Main House: East exterior wall, showing East Chamber window; arrow points to outline of ca.- 1692 window sill, jamb.

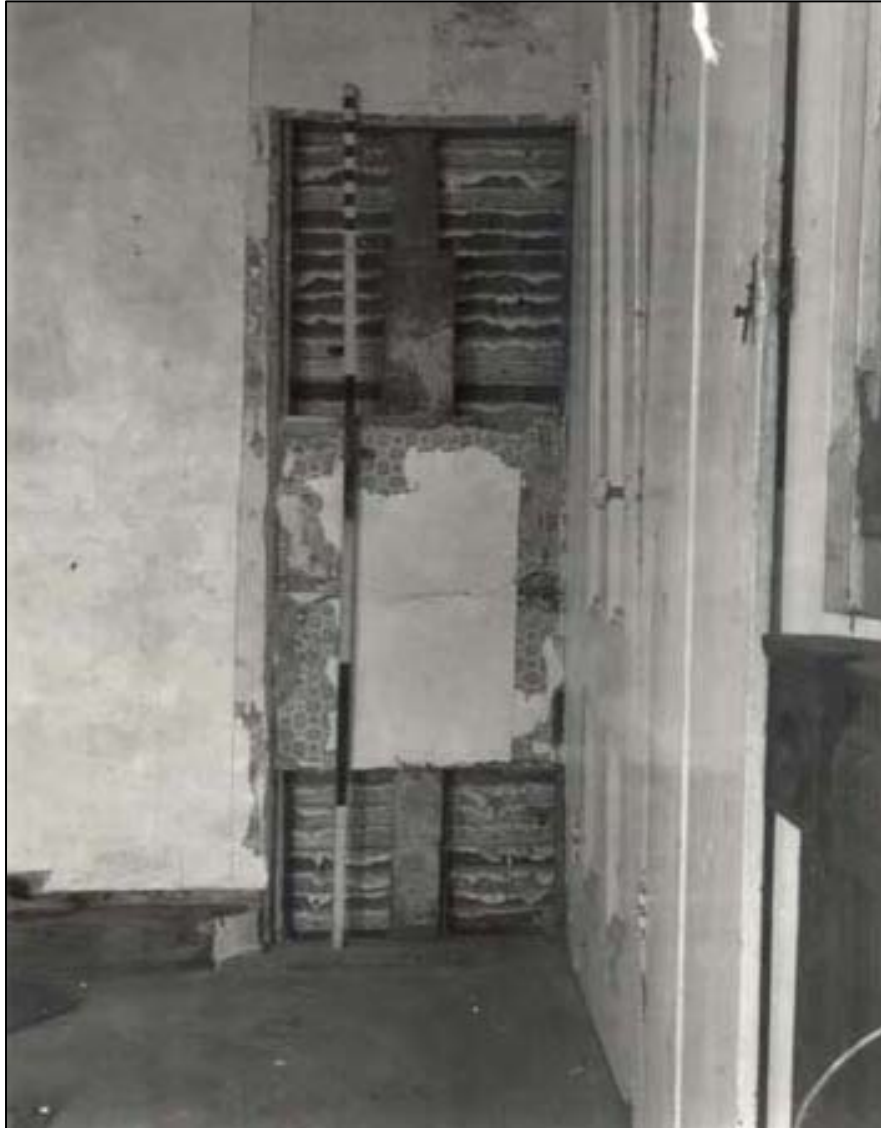
Figure 55. Main House: West Parlor, north wall, former doorway to ca.-1730 lean- to.

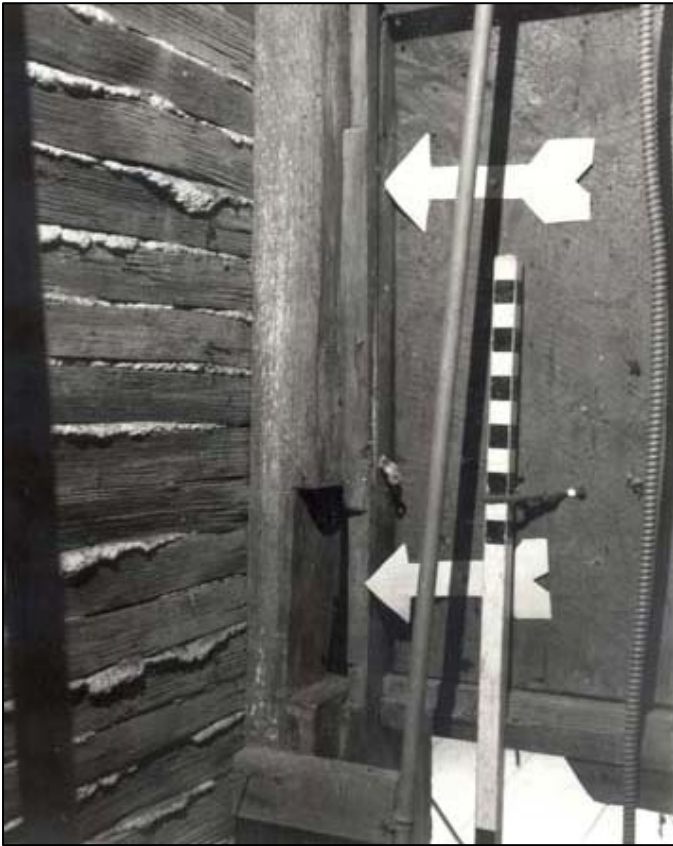
Figure 60. Main House: Former central chimney area, looking east at backside of fireplace wall of West Chamber; arrows point to evidence of missing, possibly original cove soffit (top) and mantelshelf (bottom).

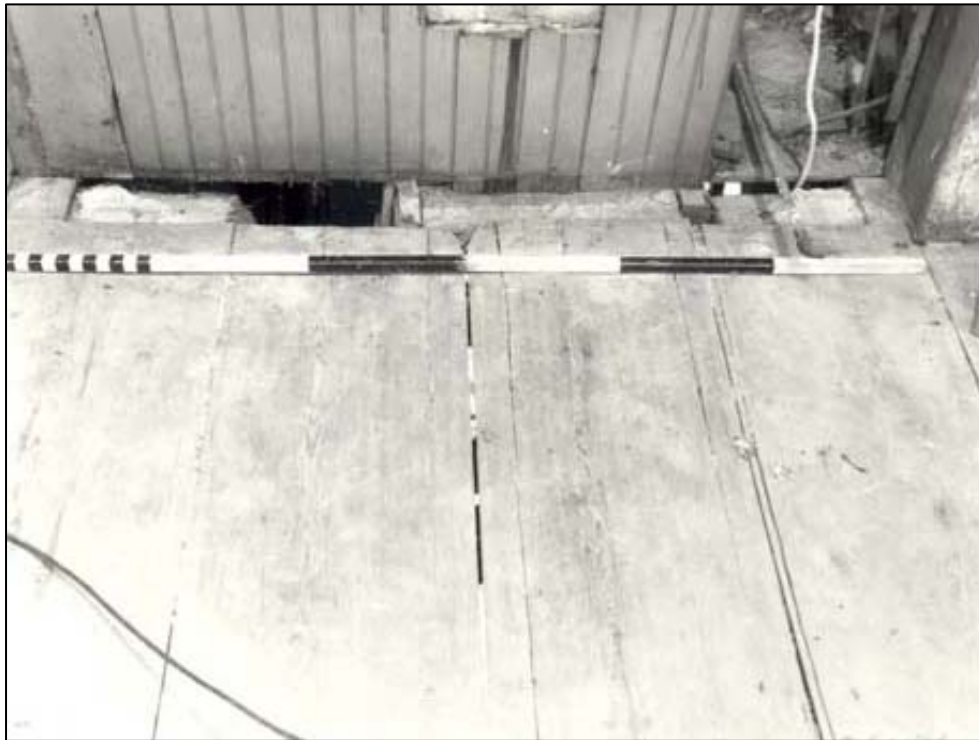
Figure 61. Main House: West Chamber, east wall, evidence of the ca.- 1692 hearth.

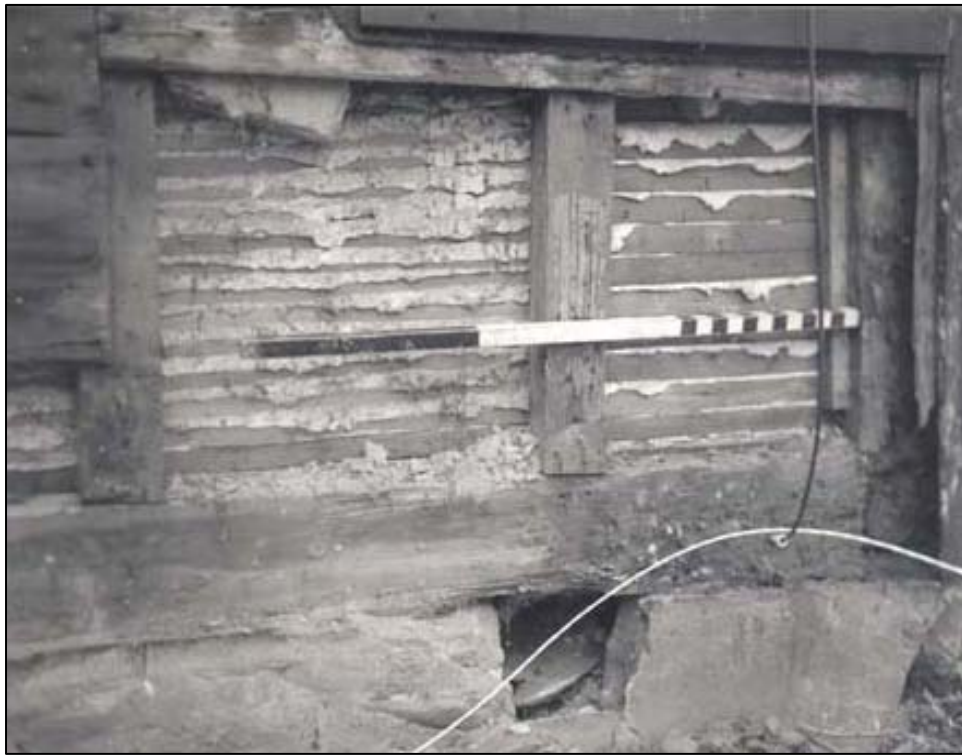
Figure 78. Main House: West wall, south corner, showing west sill replaced ca. 1825.

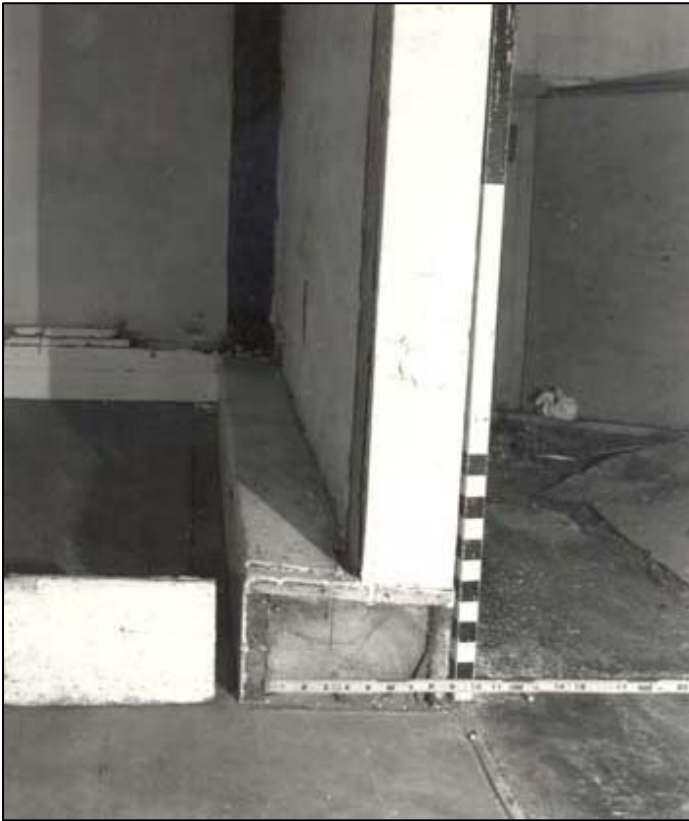
Figure 82. Main House: West Parlor, north wall, foundation sill cut out for ca.- 1910 doorway to ca.- 1900 addition.

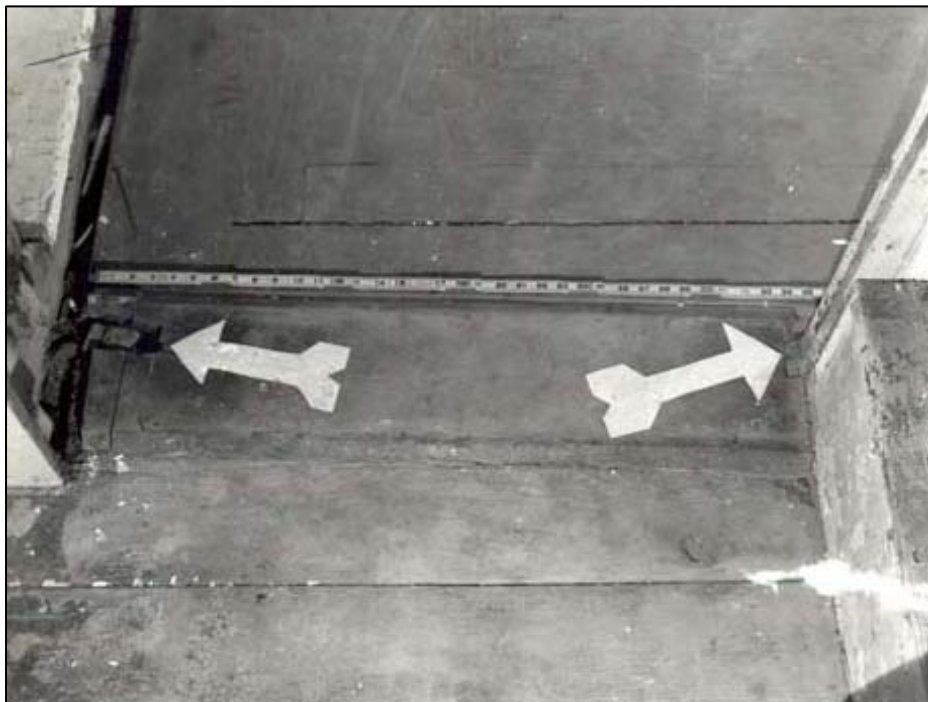
Figure 83. Main House: Entry Hall, threshold of ca.- 1910 doorway to West Parlor, showing probable location of original doorway; arrows point to locations of former vertical boards forming doorway jambs and stops.
