## Historic Structure Report

### Thurmond Commercial Buildings **NEW RIVER GORGE** National River • West Virginia

Historic Structure Report  
August 1992

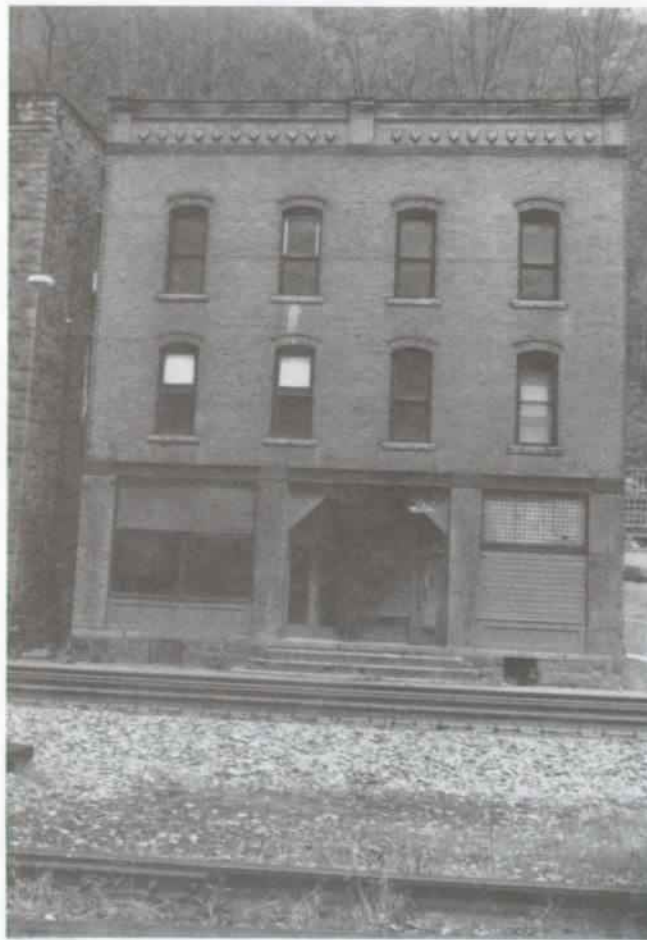
The Mankin-Cox Building is a three-story brick building, constructed in 1904 (figure 11). The track, or west, elevation is faced with yellow brick and topped by an ornately corbelled parapet. The foundation is constructed of rusticated ashlar with a smooth stone water-table course level with the first floor. A door leading into the cellar area is located to the north of the main entry into the building, with a cellar window to the south. The wooden frames, door, and sash for these openings no longer exist. The fenestration pattern at the second and third floors consists of four bays of double-hung wood windows, each headed by a brick arch. Brick piers support the iron lintel across the first-floor storefront bays. Decorative rosettes are applied to the web of the beam periodically along its length, and decorative metal panels fill in between the flanges at the top of each pier.

**Figure 11**  
Mankin-Cox Building, April 1991  
(NPS Photo)

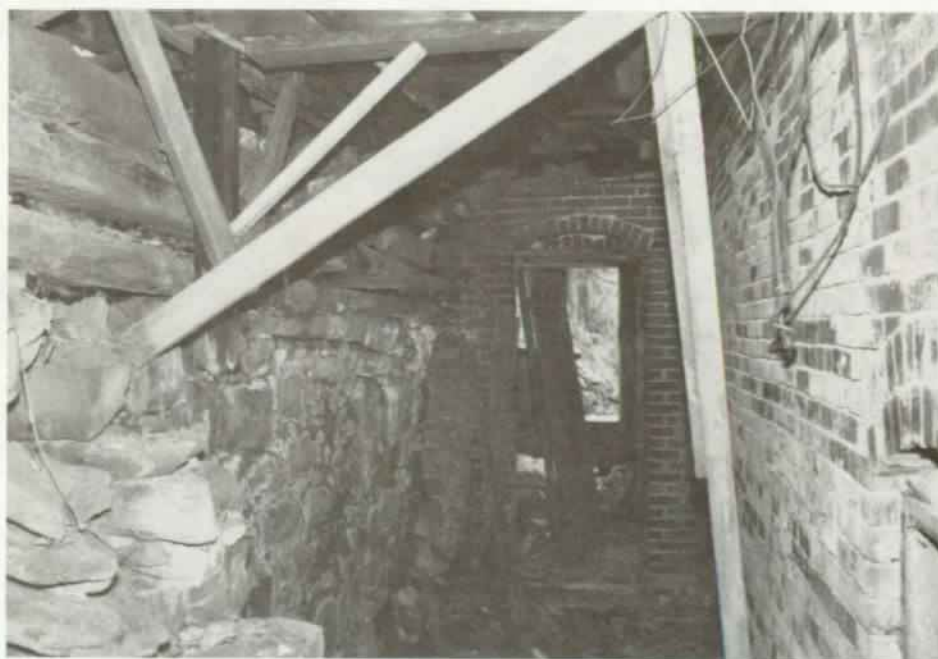
**Figure 18**  
Area Under Rear Porch, Looking South, Mankin-Cox Building, April  
1991  
(NPS Photo)

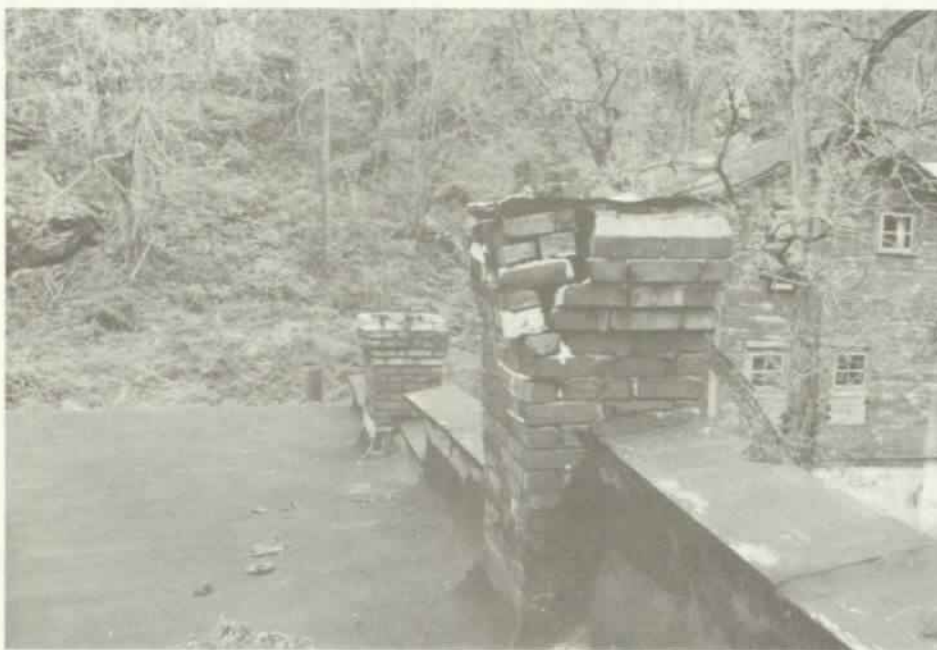
The chimneys are in very poor condition. Typically, the chimneys are constructed of red brick, with the top five courses, including three courses of corbelling, of yellow brick. The top of the northeast chimney has already collapsed, and the bricks have been laid on the coping stones of the adjacent parapet. The other three chimneys and the remaining courses of the northeast chimney are very short on mortar to the point that several courses of brick can be removed easily by hand. The northwest corner of the southwest chimney is beginning to cave in (figure 19), and the collapse of at least the top of the chimney is imminent. All of the chimneys lean or are rotating out of square.

**Figure 19**  
Southwest Chimney, Mankin-Cox Building, April 1991  
(NPS Photo)

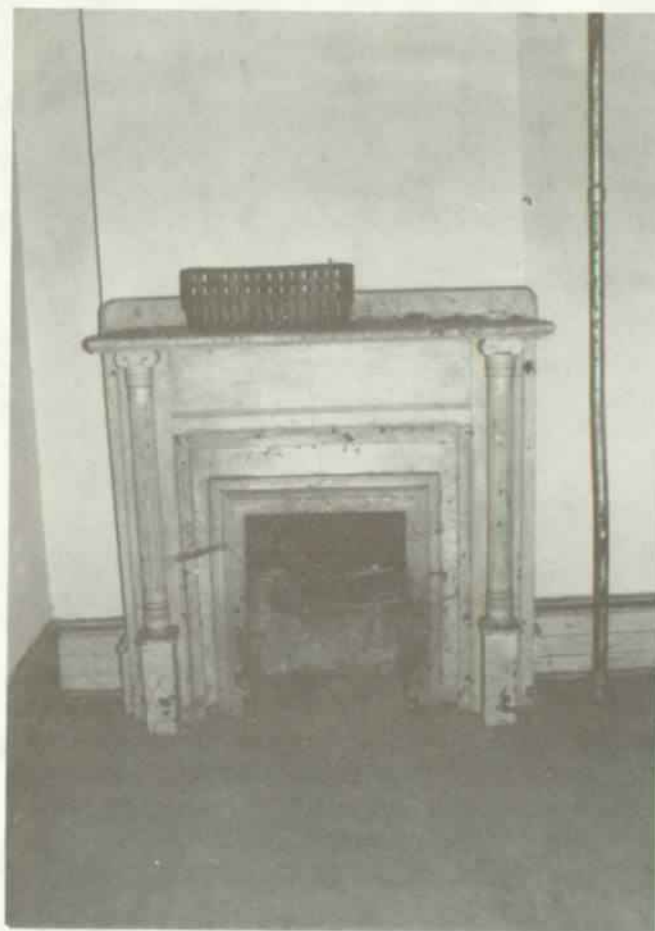
The wood mantle and decorative metal firebox surround are both in place (figure 31) and in fair condition. Several bricks in the firebox have fallen out, and the hearthstone has cracked in half and settled slightly. The metal grate exists but is not in place in the firebox.

**Figure 31**  
Mantle, Room 203, Mankin-Cox Building, May  
1990  
(NPS Photo)

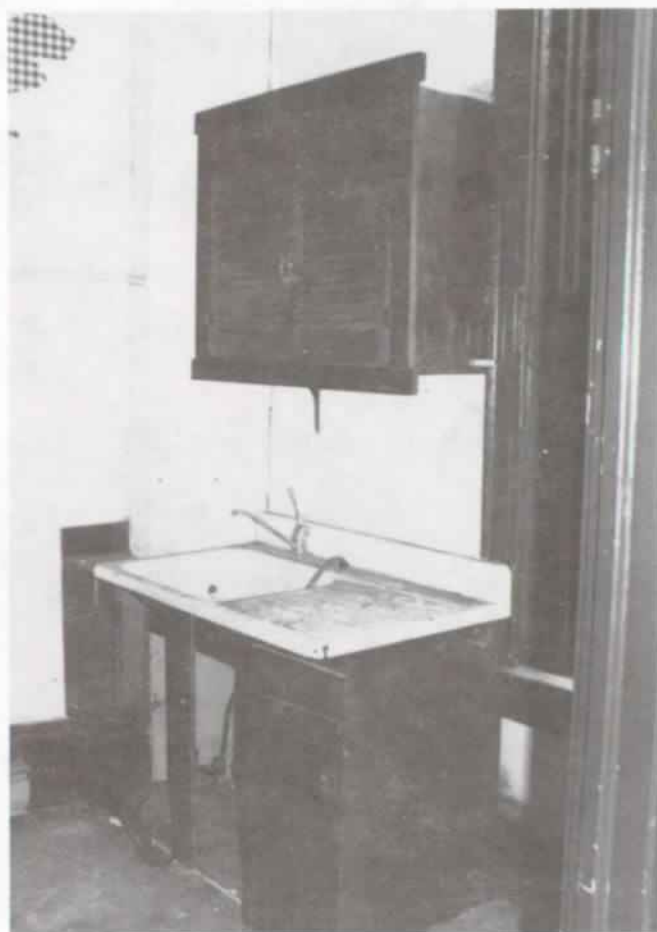
**Room 210.** This room served as a kitchen, although the stove and refrigerator were removed by the park in May 1990. The floor is covered in linoleum, so the exact condition of the tongue and groove underneath is unknown. The shoe molding of the baseboard is missing, but the baseboard is in good condition. The plaster walls are in fair condition with a gypsum board wainscot at the north, south, and east walls. Behind the present sink, the plaster at the west wall contains the ghost of a former sink. The current sink and cabinet are located along the west wall in the southwest corner of the room (figure 35). A gypsum board-covered pipe chase is located in the same corner and extends to the third floor. A wood cabinet with louvered doors, stained dark, hangs on the wall above the sink. The ceiling is a 2' x 4' acoustical panel suspended ceiling. The condition of the original plaster ceiling above is unknown.

**Figure 35**  
Cabinets in Room 210, Mankin-Cox Building,  
May 1990  
(NPS Photo)

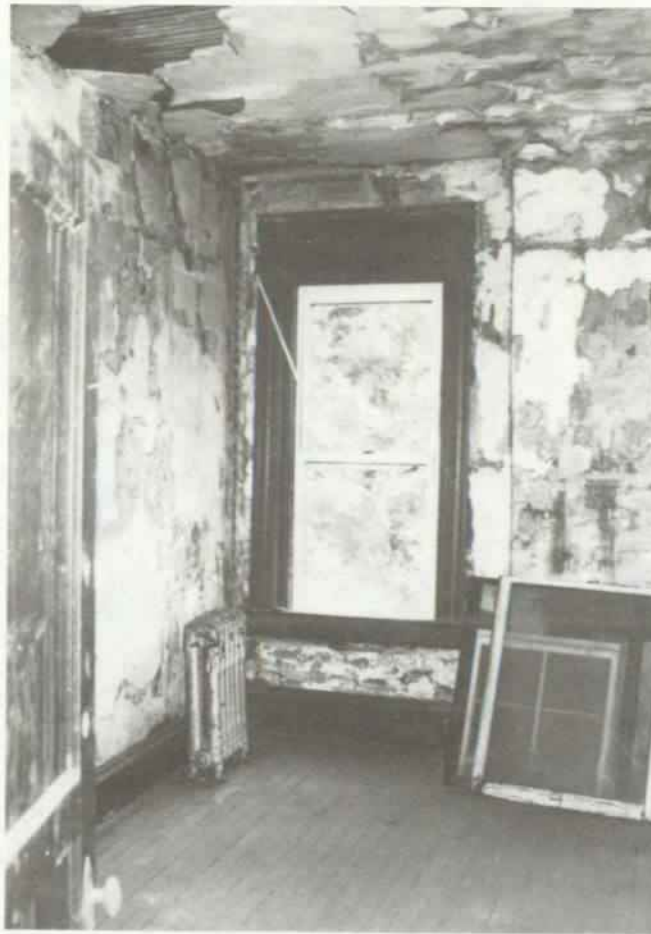
Approximately 15 layers of wallpaper cover the plaster walls, which are painted colonial blue. Most of the wallpaper is intact, and there is no indication of problems in those areas. There is a small area of plaster in poor condition at the top of the north wall in the northwest corner, and there is another area of loose plaster in the southeast corner. Other areas of poor plaster occur under window 311 and at the top and south corner of the west wall. A hole has been punched in the east wall. The interior walls have separated from the exterior as the building settled. A section of plaster at the bottom of the west wall in the southwest corner

**Figure 45**  
Southeast Corner, Room 309, Mankin-Cox  
Building, May 1990  
(NPS Photo)

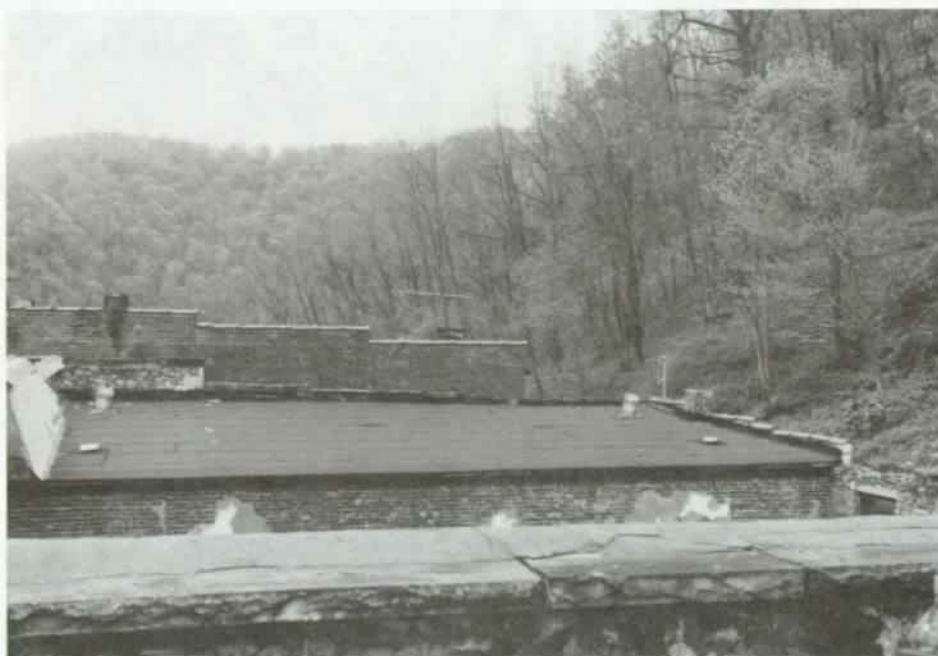
The roof itself appears to be in good condition. It is finished with mineral-surfaced asphalt roll roofing. The western parapet is protected with mineral-surfaced asphalt roll roofing and is also capped with sheet metal flashing that extends over the entire width of the parapet cap for the width of the roof covering the northern third of the building. Two sheet metal turbines, in the northeast and northwest corners, vent the attic.

**Figure 56**  
Roof, Looking North, Goodman-Kincaid Building, April 1991  
(NPS Photo)

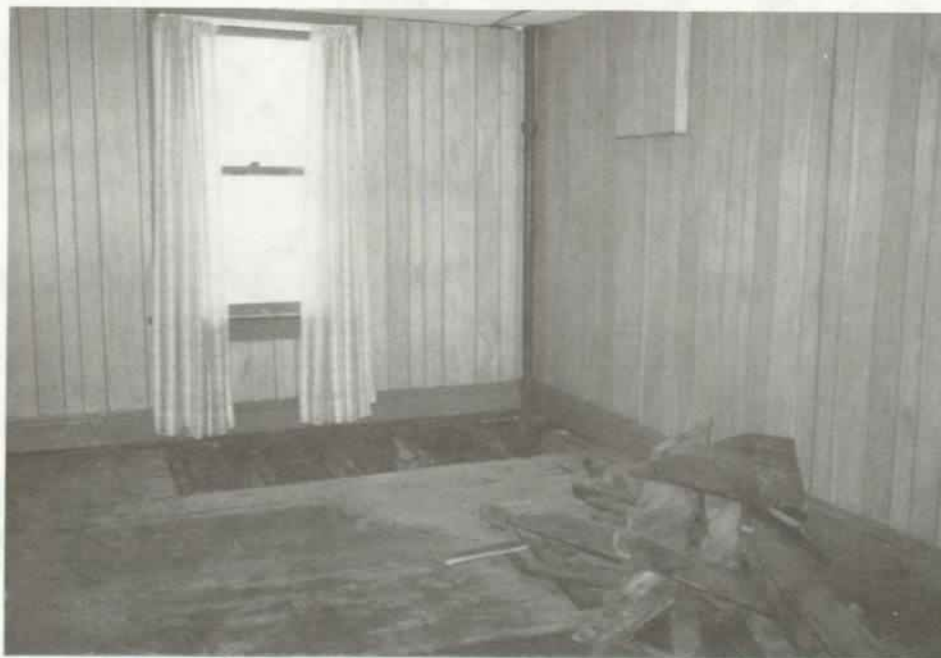
**Room 401.** In the winter of 1991, a section of carpeting and flooring in the northwest corner of the room was removed to expose the floor framing (figure 84).

**Figure 84**  
Northwest Corner, Room 401, National Bank of Thurmond, April 1991  
(NPS Photo)

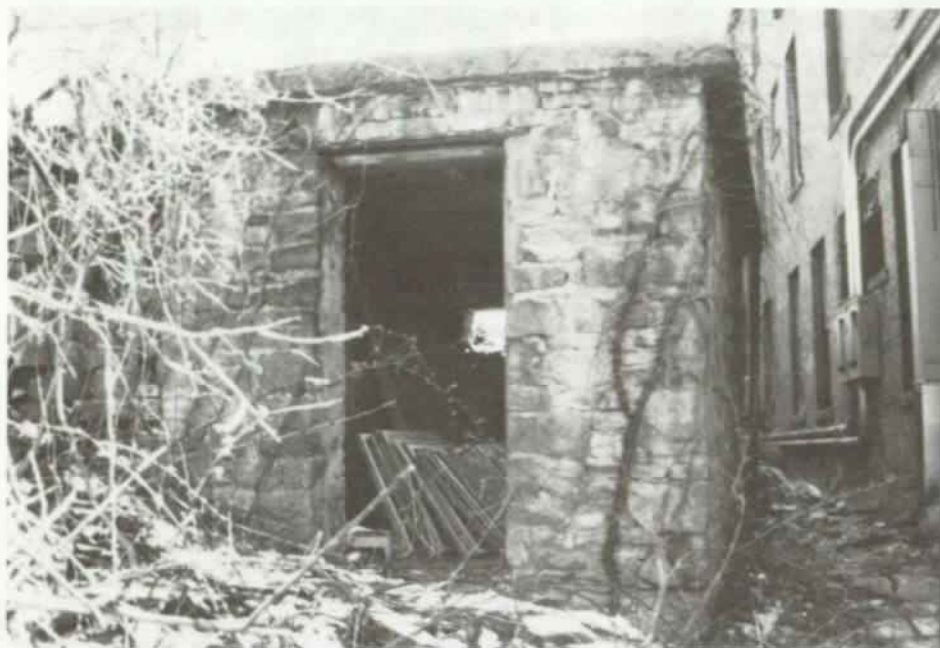
This one-room structure is constructed of split fieldstone with a sloping concrete roof and located to the east of the northeast corner of the National Bank of Thurmond (figure 90). A single door is located in the center of the north wall, and two small windows are located in the south wall. The roof slopes downward to the south and is cracked in numerous places. Moss and other vegetation are growing on the roof, and vines cover much of the building.

**Figure 90**  
North Elevation, Stone Structure, March 1990  
(NPS Photo)

No use has been identified for this structure. The stonework inside and out should be repointed as necessary. A new wood door and windows, including frames, should be installed to match the historic ones. New metal lintels should be installed to replace rusted and missing ones. Cracks in the masonry walls should be repaired. The debris and stored material should be removed from the interior in order to perform the restoration work and determine the condition of the floor slab. Vines and other vegetation should be removed from the walls and roof.
