**OREGON CAVES CHATEAU  
OREGON CAVES NATIONAL MONUMENT  
CAVE JUNCTION, OREGON**

**CHATEAU ACCESSIBILITY  
AND SAFETY STUDY**

**PREPARED BY  
ARCHITECTURAL RESOURCES GROUP**

**JUNE 2006**

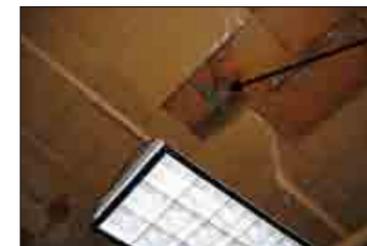
**Figure 4.9:** Missing Ceiling Panels Exposing Framing at First Basement

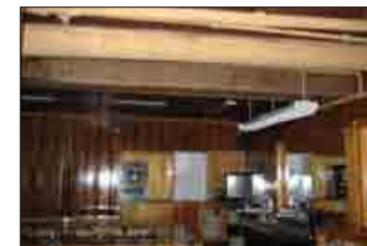
**Figure 4.10:** Lack of Fire Separation between Kitchen and Coffee Shop at First Basement

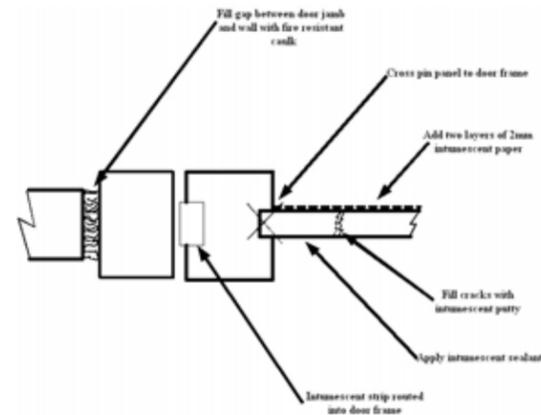
**Figure 5.1:** Recommended Guest Room Door Upgrade (based on information provided by English Heritage).

- Adding 2-mm intumescent paper on the room side (assumed fireside) of the door. This paper can be purchased with a wood veneer facing that is similar to current finishes.
- Adding intumescent mastic between the door boards and pinning them together to prevent an individual member from failing.
- Adding intumescent fire and smoke strips around the edge of doors.
- Providing fire sealants between the door jamb and wall structure.

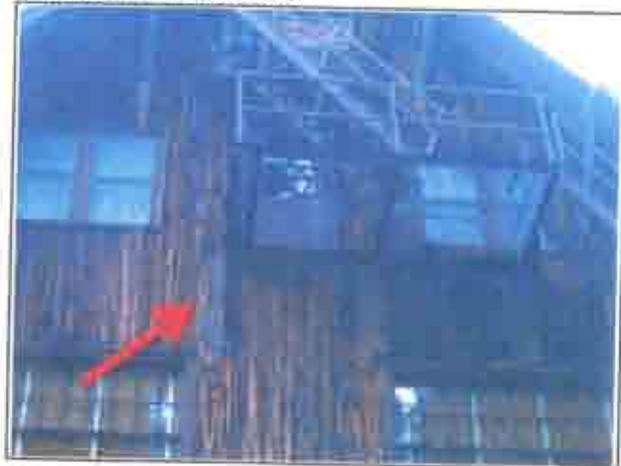
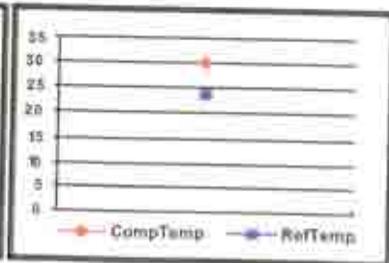
**Photo File:** IMG\_2371.JPG

**Component:** Small temp difference around north 2nd floor mounting bracket of fire escape, possible moisture problem or other anomaly.  
**Probable Cause:** Possible moisture or other anomaly

Instances Subreport										
Inst #	Prob #	Date	Comp Temp	Ref. Temp	Temp Rise	Sev. Code	Load	%Load	Wind Sed.	Amb. Temp
1	1	12/2/2004	30	24	6	0	N/A	N/A		22

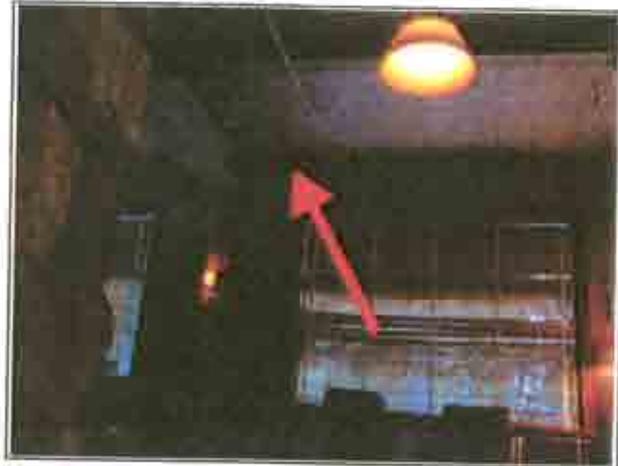
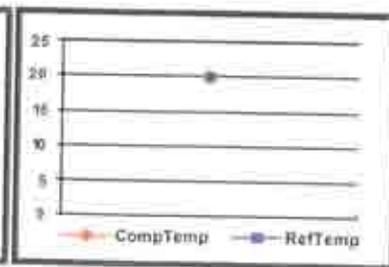
**Photo File:** IMG\_2381.JPG

**Component:** Same problem as item #1 just taken from the inside instead of the outside.

Rep #	Prob #	Date	Comp Temp	Ref. Temp	Temp Rise	Sev. Code	Load	%Load	Wind Spd	Amb. Temp
1	2	12/2/2004	20	20	0	0	N/A	N/A		20

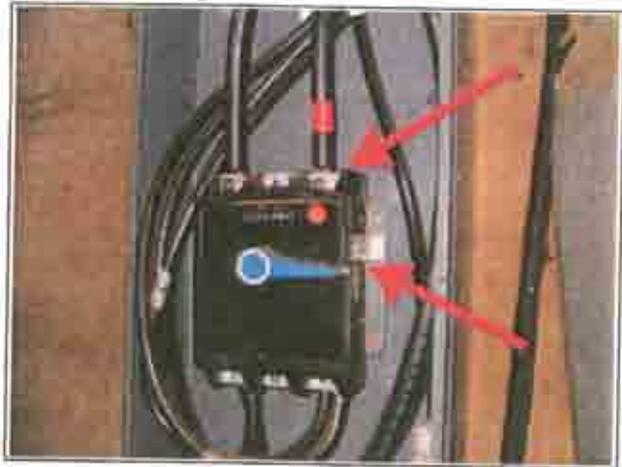
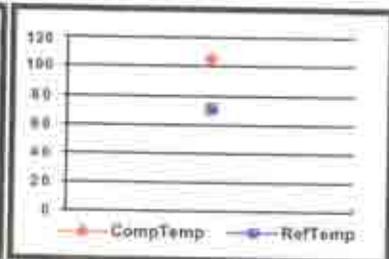
**Photo File:** IMG\_2382.JPG

**Component:** Right phase line side wire lug connections or internal problem in circuit breaker

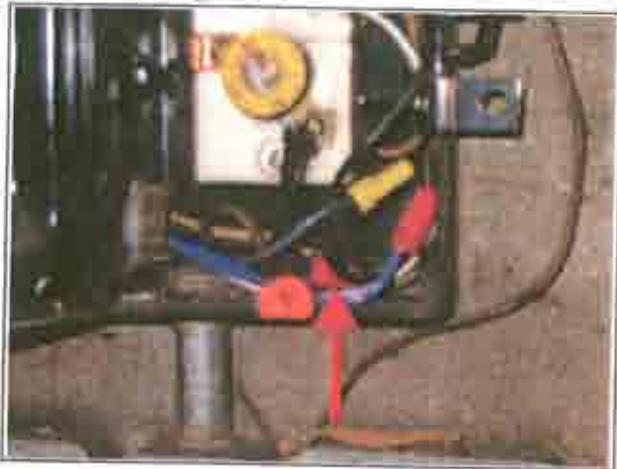
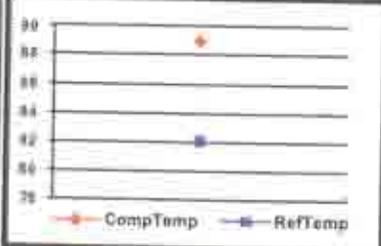
**Photo File:** IMG\_2383.JPG

**Component:** Load side red wire nut connection on purple wire below fused disconnect switch.

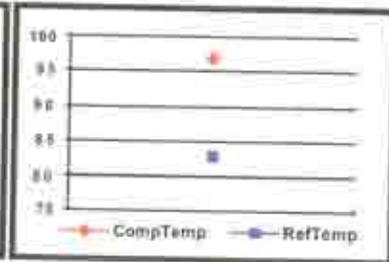
**Photo File:** IMG\_2385.JPG

**Component:** Upper phase heating possible internal problem in circuit breaker #24,26,28,30 sub pnl upstairs.
