**Appendix G. 1983 Stabilization Work.**

Images from Mac Watson, February 1983 report, prior to the collapse of the back wall,  
Courtesy Marc Simmons.

**D. Traylor, April 15, 1983, Field sketches and notes of foundation prior to work on new foundation and back wall. Original in Pigeon's Ranch File, SR-92, Historic Preservation Division, State of New Mexico, Santa Fe.**

**May 1983 repair work. Photos courtesy Marc Simmons**

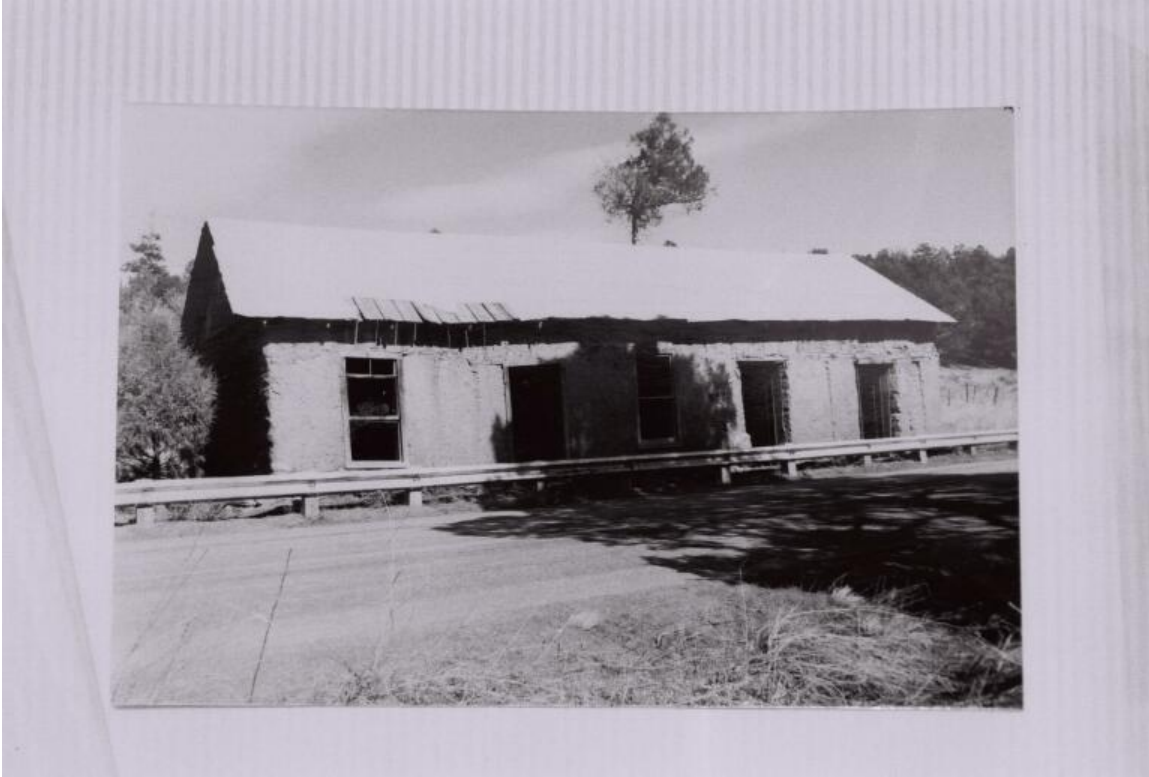
Front of building showing need for roofing and weatherproofing, February 23, 1983.

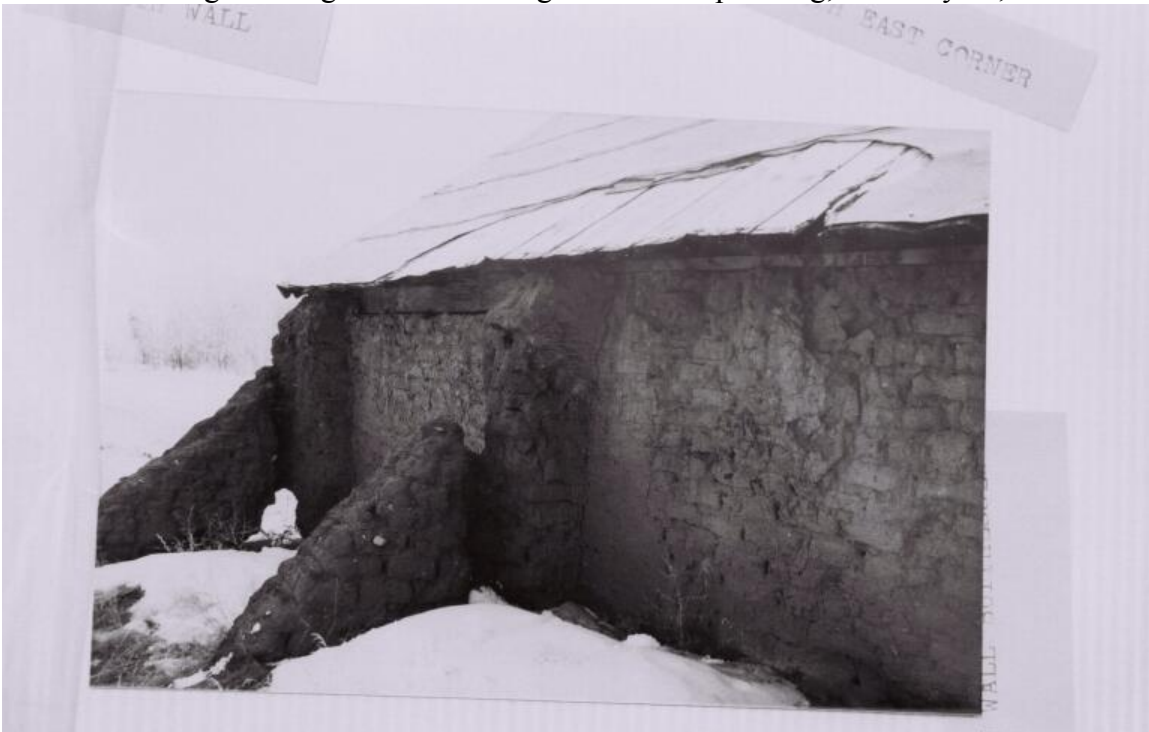
Rear, northeast corner, showing wall before collapse, February 23, 1983.

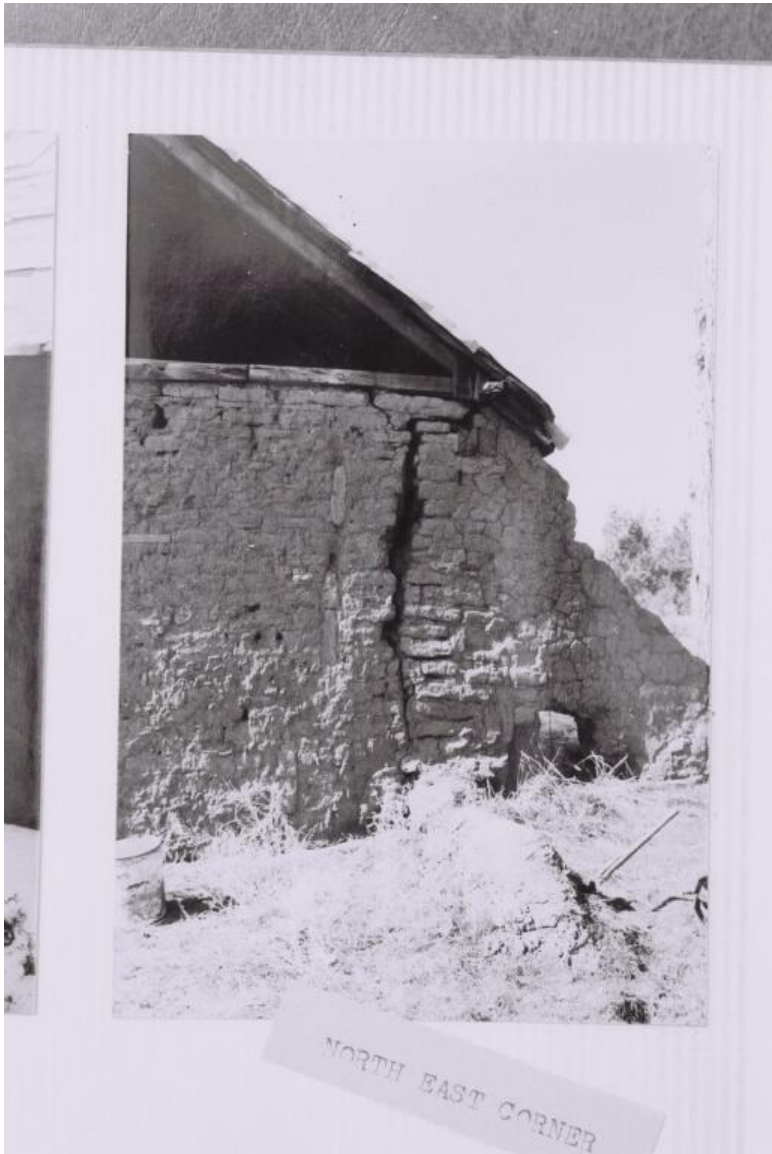
Northeast corner before collapse showing separation of wall from main building, February 23, 1983.

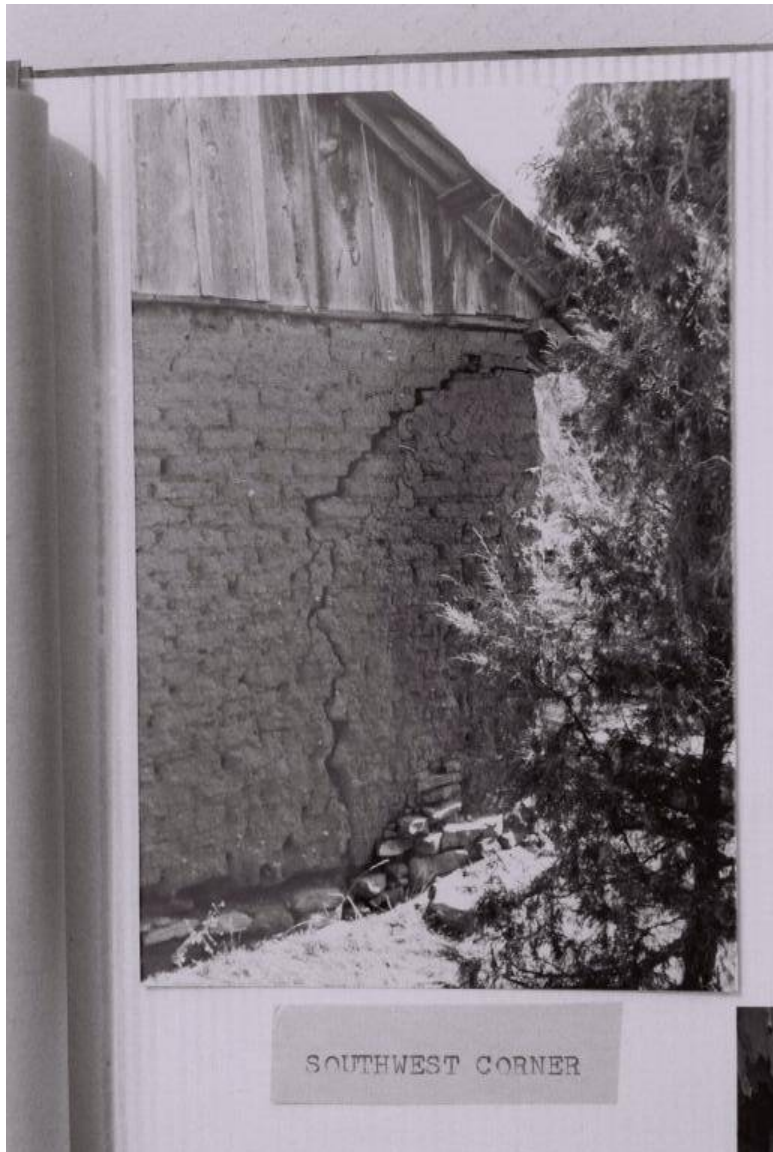
Southwest corner showing structural problems, February 23, 1983.

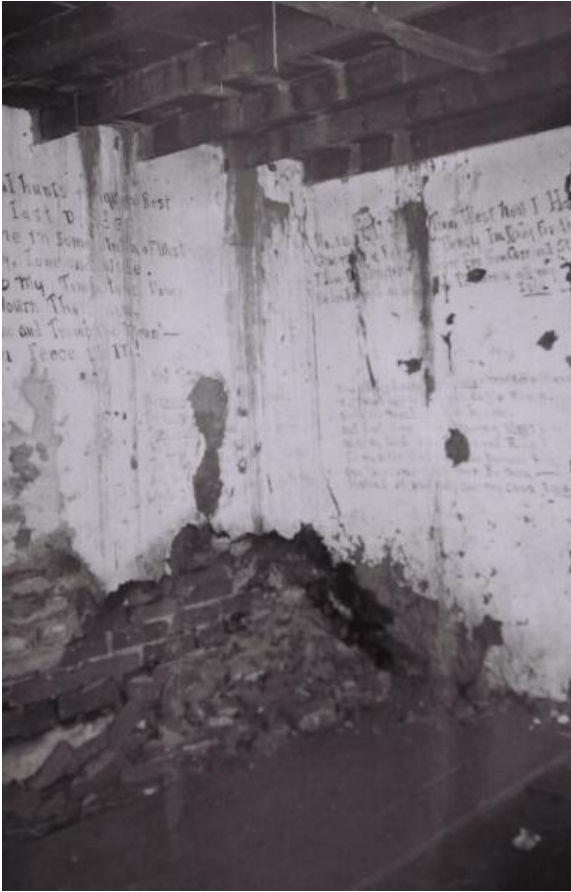
Interior northwest corner before collapse, February 23, 1983.

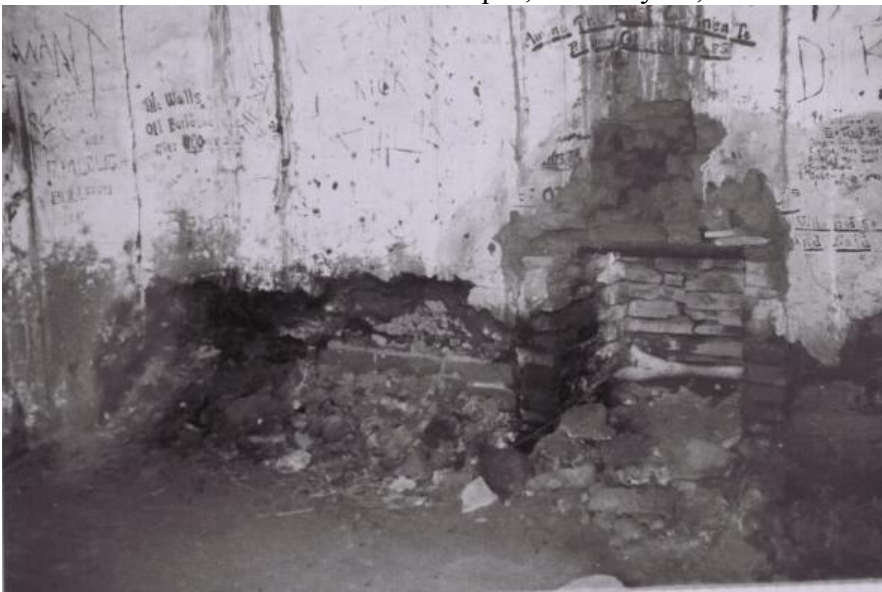
Interior view of back wall and fire place prior to collapse. February 23, 1983.

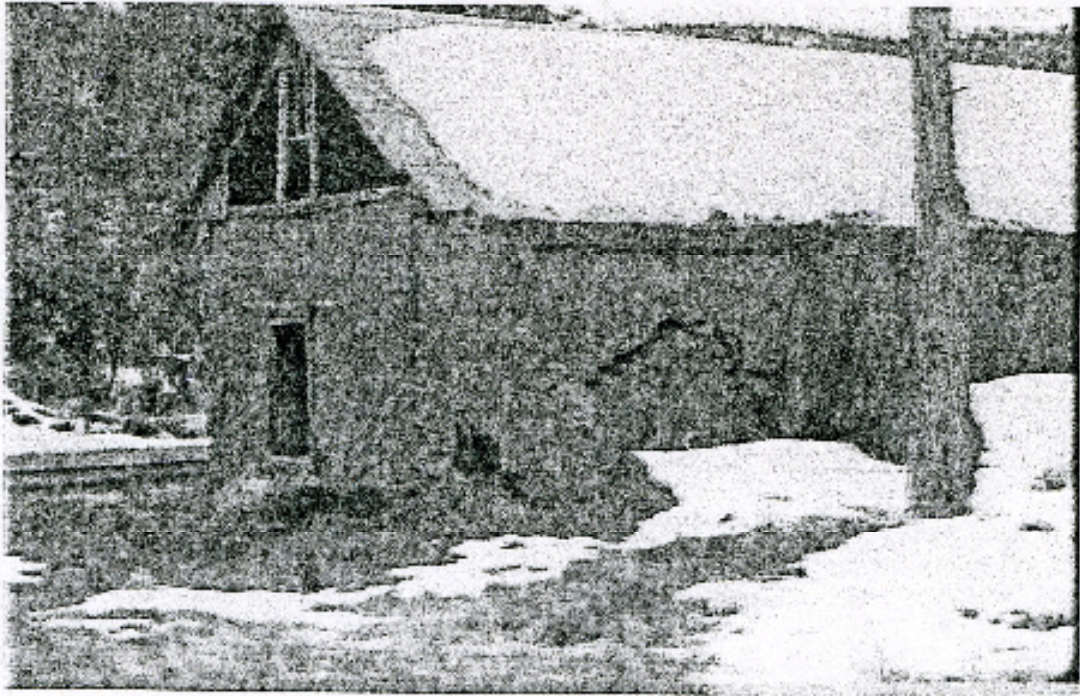
Figure 18: The north wall of the adobe from the northeast, ca. 1983. This image is scanned from a slide in the Park collection.

A slide from the park file shows the beginning of the collapse of the back wall, east end. The infill from the 1970s, which filled in the former breezeway and later entrance hall to Greer's museum, can be seen separating and in impending collapse. Copy from Anthony Crosby's *Conditions Assessment Report*, NPS, 2002.

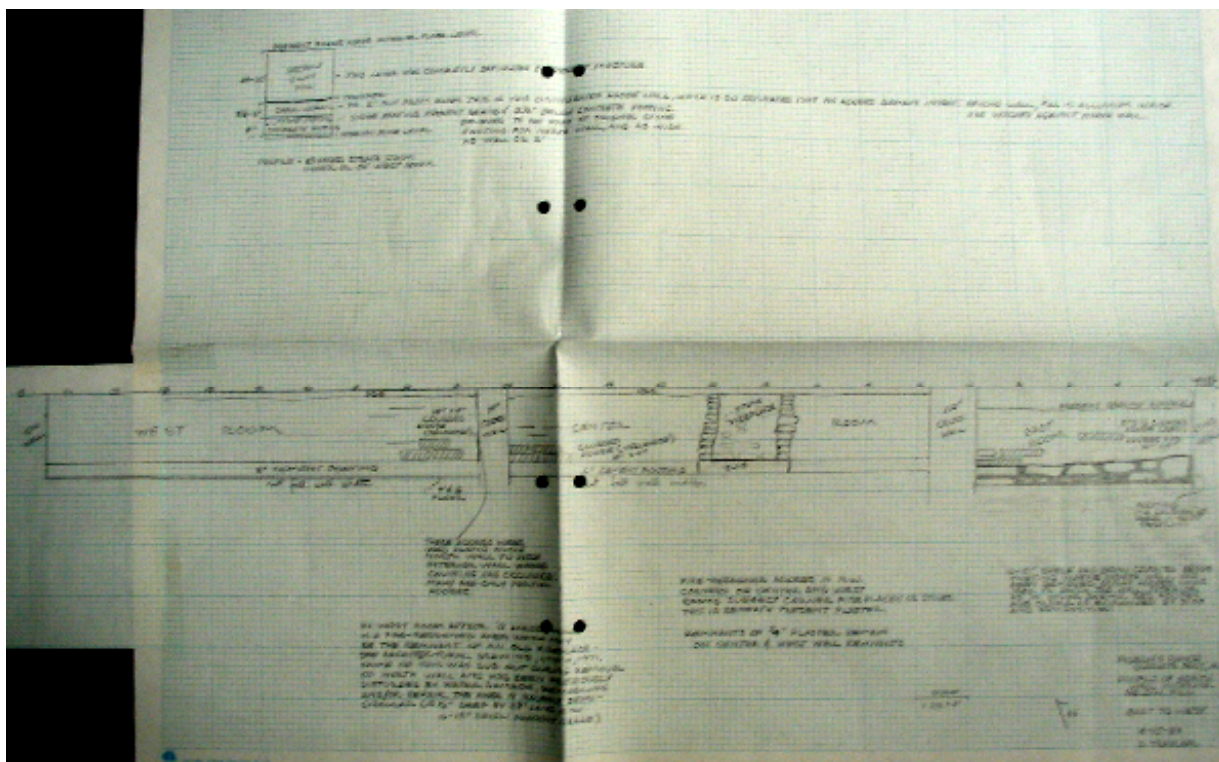
The overall sheet above is reproduced and blown-up in the following pages. They note the poor condition of the back wall in 1983.

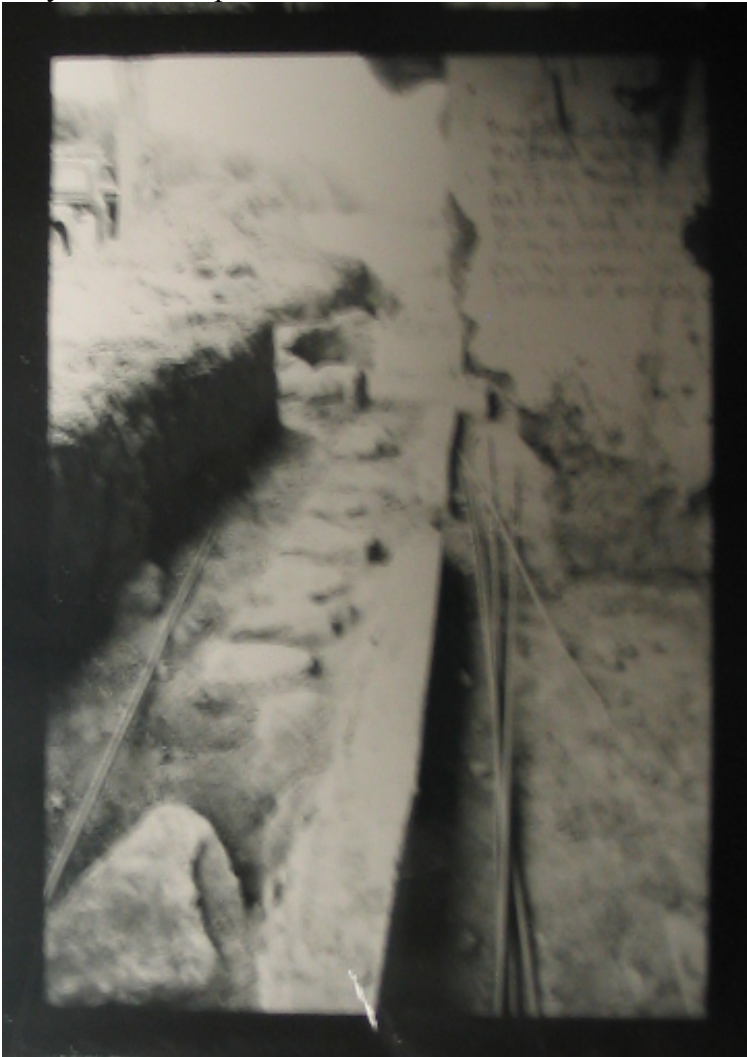
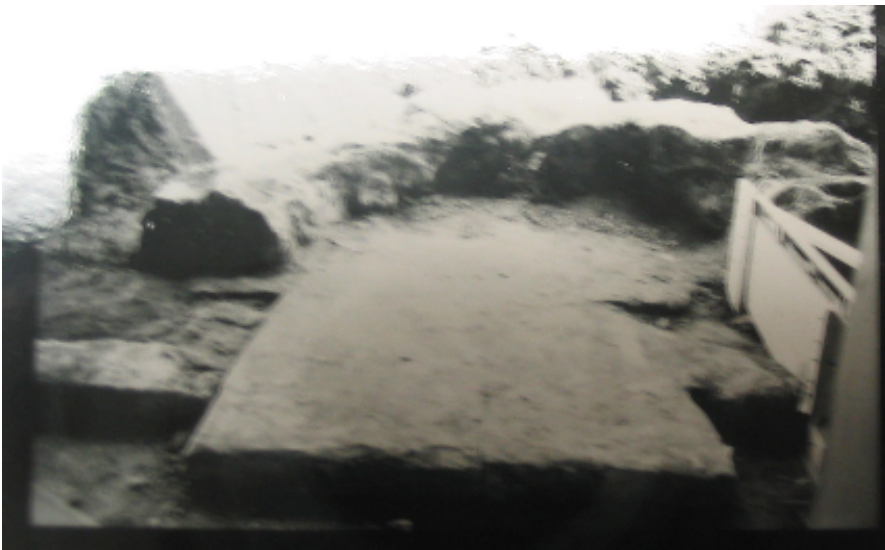
Traylor field snap shots. Note rock foundation
