CULTURAL LANDSCAPE REPORT MONTROSE PARK

Cultural Landscape Report

August 2004

Part I: Site History, Existing Conditions, and Analysis & Evaluation

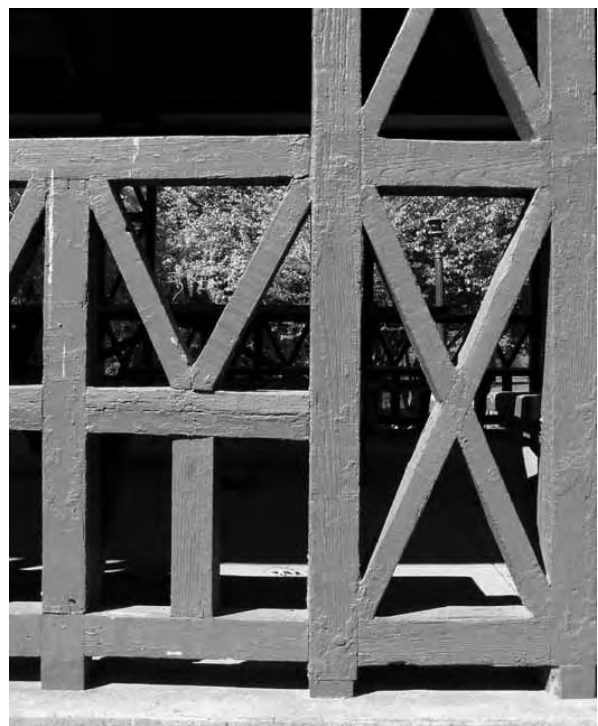
Figure 135. Summerhouse railing pattern. Some of the vertical members sitting directly on the concrete base have been replaced with dutchmen. (Architrave, 2003).

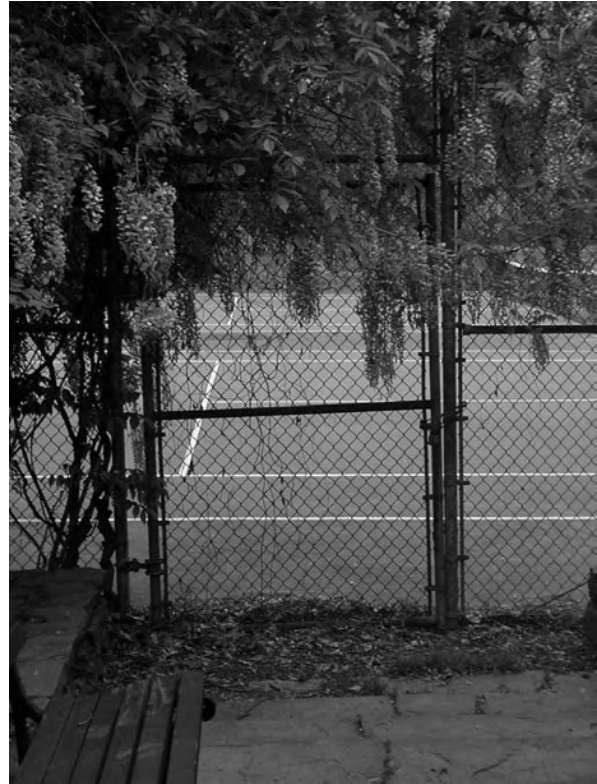
Figure 166. 2nd gate at Summerhouse tennis courts (locked). The wisteria visible here and in Figure 165 may be a remnant of the Burnap planting plan. (Rhodeside & Harwell, April 29, 2003).

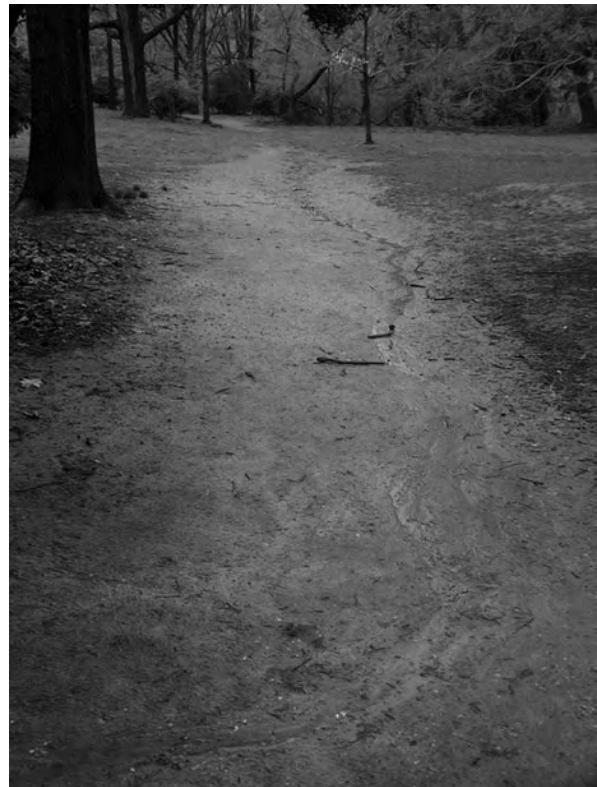
Figure 222. Path leading west from the end of the Ropewalk to the Circle, showing drainage problems. (Rhodeside & Harwell, April 9, 2003).

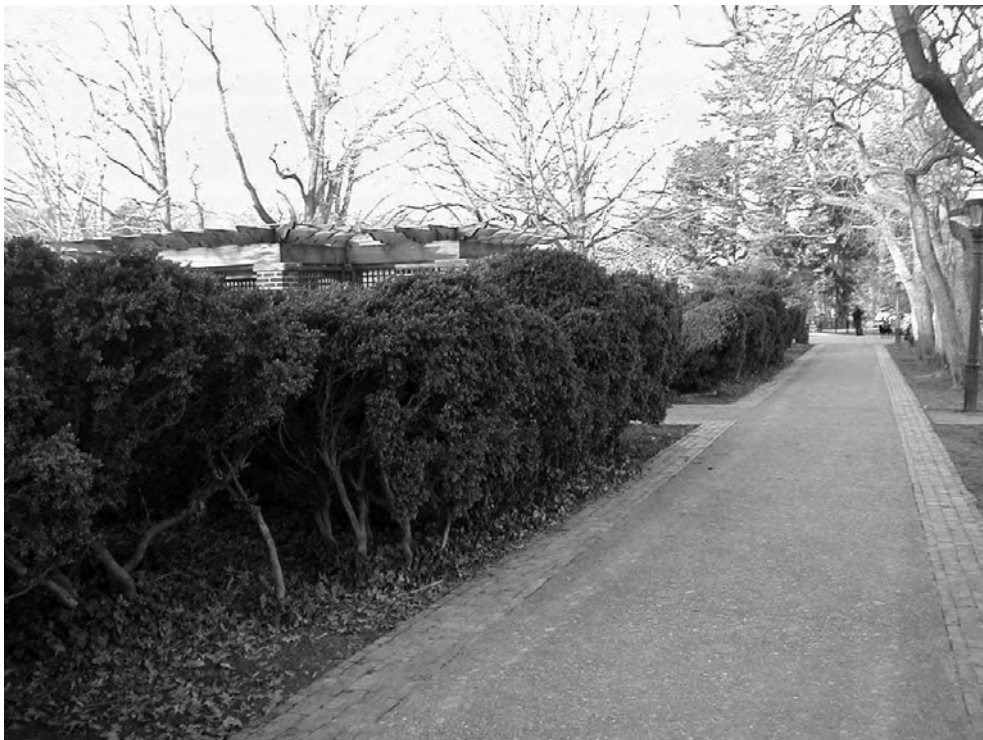
Figure 231. Current view of the Boxwood Gardens and Pergola (2003). Boxwood plants are so large that the Pergola can barely be seen. (Rhodeside & Harwell, December 22, 2003).

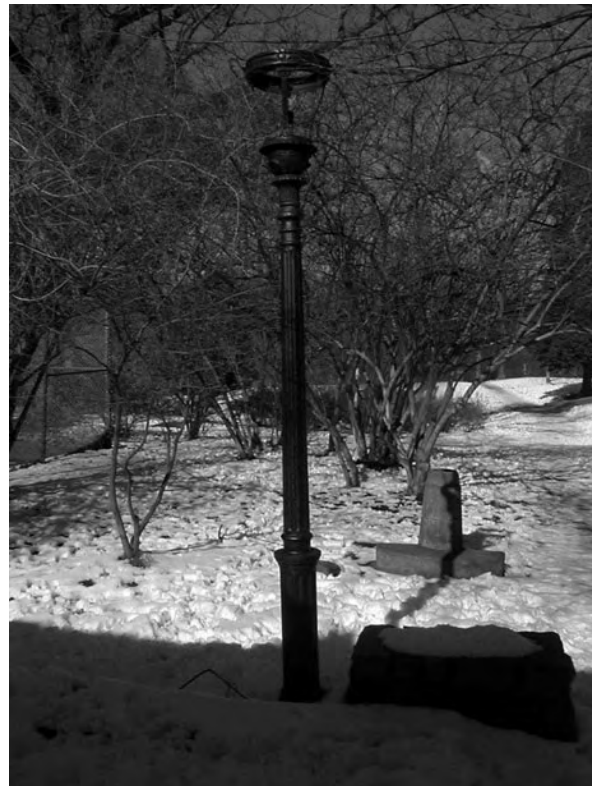
Figure 254. Light pole with missing globe north of Summerhouse. (Rhodeside & Harwell, March 12, 2003).
