Historic Structure Report
Update

**ASPET
and
LITTLE STUDIO**

**Saint- Gaudens National Historic Site
Cornish, New Hampshire**

Judith Q. Sullivan
Architectural Conservator

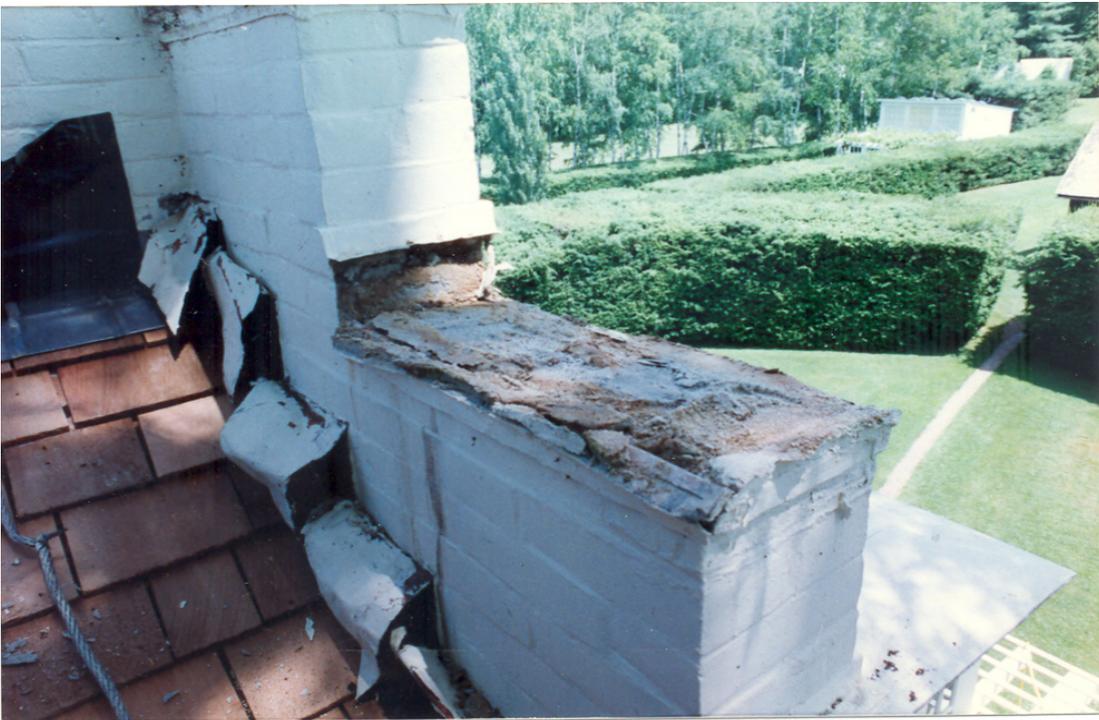
Figure 58. Aspet, deteriorated condition of brick parapet caps, 1993.

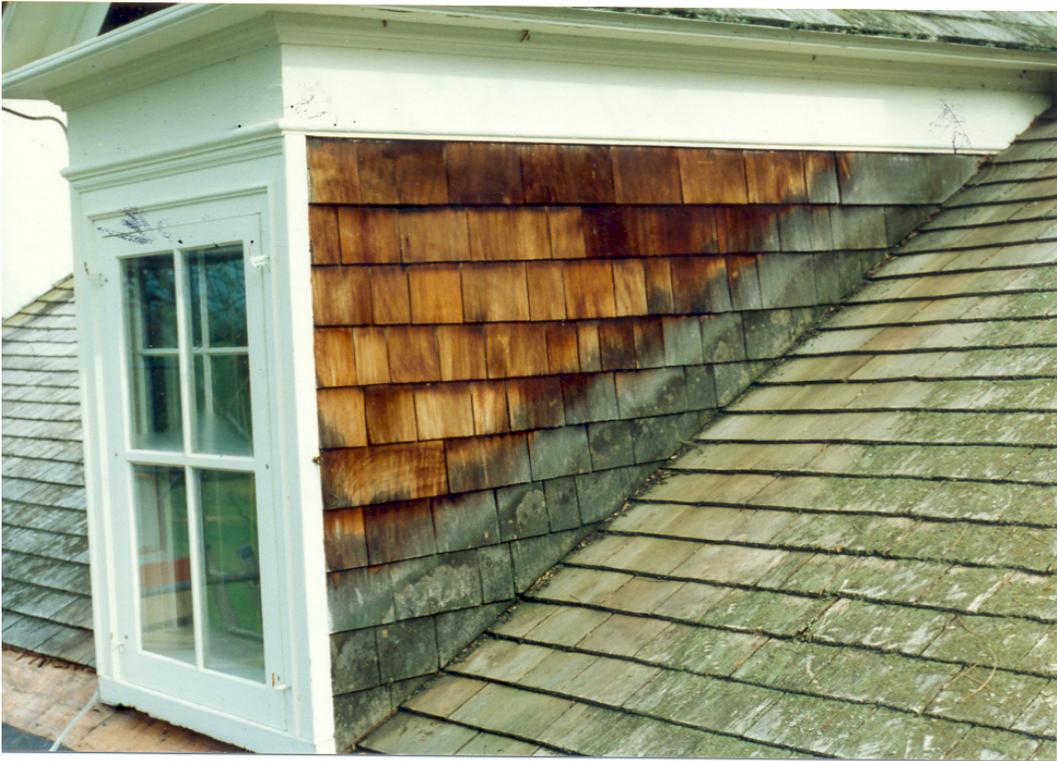
Figure 59. Aspet, dormer showing mold and water damage to shingles; mold and moss also covers adjacent roof shingles, 1993.

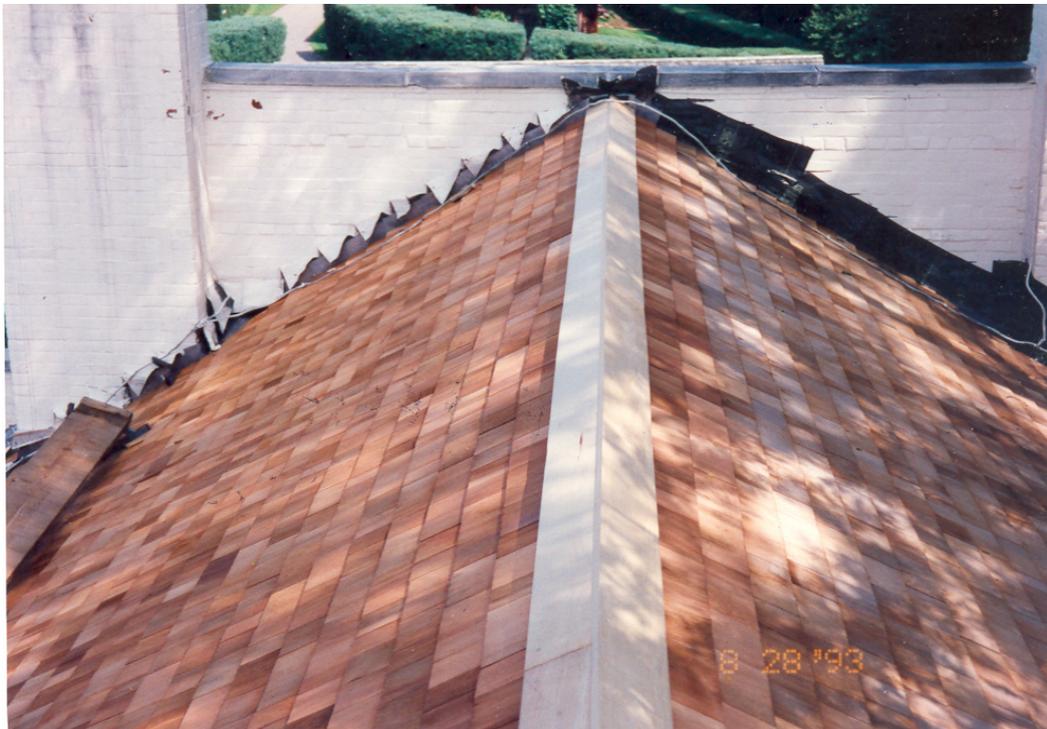
Figure 60. Aspet, new roof ridge, flashing, and shingles, 1993.

DATE	DETAILS OF WORK	SOURCE
<p>May 1993 – Aspet Roof Replaced</p>	<p>Emergency project requested by SAGA March 1992. Needed due to the following findings:</p> <p>Ca. 1970- 72 cedar shingle roof prematurely deteriorated.</p> <p>Poor condition of shingles, lack of integrity of flashings, numerous active leaks.</p> <p>Problems with ice dams, entrapped moisture, chronic leakage (especially along parapet walls).</p> <p><u>Scope of Work included the following:</u></p> <ol style="list-style-type: none"> 1. Remove existing wood shingles and associated ridge boards and flashings on north and south main slopes, and on roofs and cheeks of north and south dormers. Temporarily remove all lightning conductor cable retainers. 2. Patch and selectively replace as required existing plywood over sheathing. Lay bituminous polyethylene membranes along eaves, roof- wall intersections, valleys, and ridges. 3. Install new strapping on main roof slopes, parallel to respective eaves, for each shingle course. 4. Install new lead- coated copper base flashings and crickets at brick parapet walls. Install new lead- coated copper hidden step flashing at intersections of main roof and dormer cheeks, and install bare copper open valleys at intersections of main and dormer roofs. Install new lead- coated copper plumbing vent stack flashings at two locations. Repair, repaint, and reinstall historic galvanized plumbing vent stack and apron. Underlay all flashing with rosin paper. 	<p>LaBonte and Fortin, <i>Completion Report, Aspet – Reroofing</i></p>

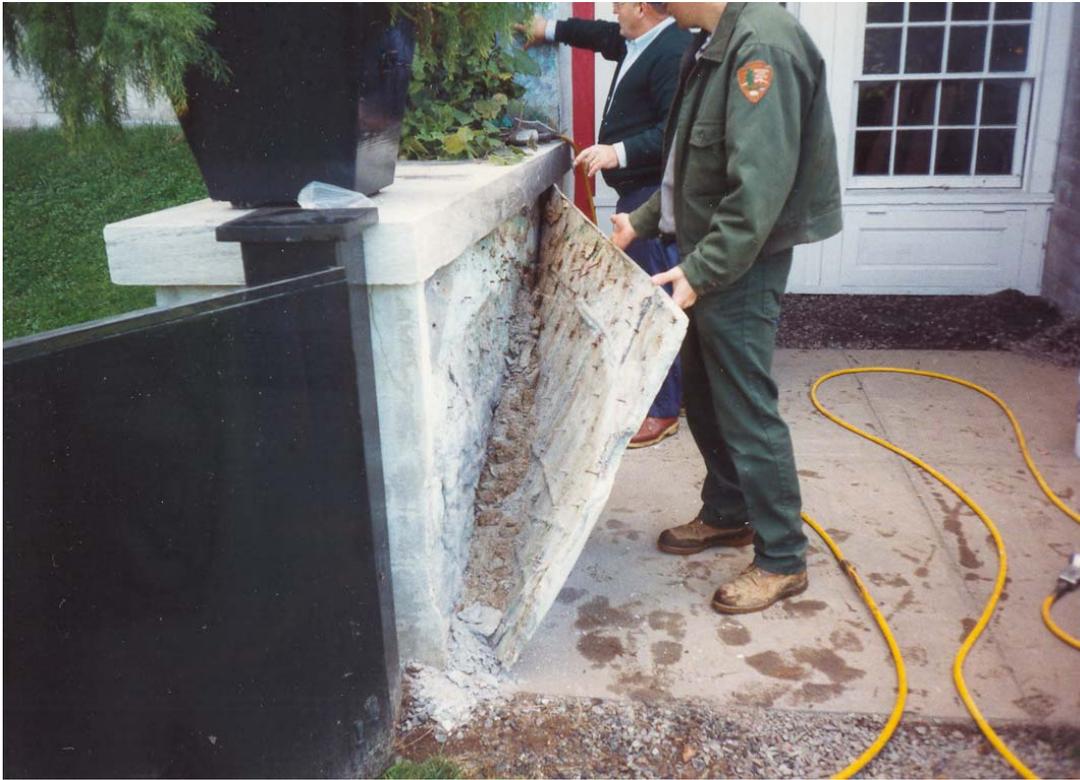
Figure 104. Little Studio, west elevation, wall repairs at basement entryway, September 1994.

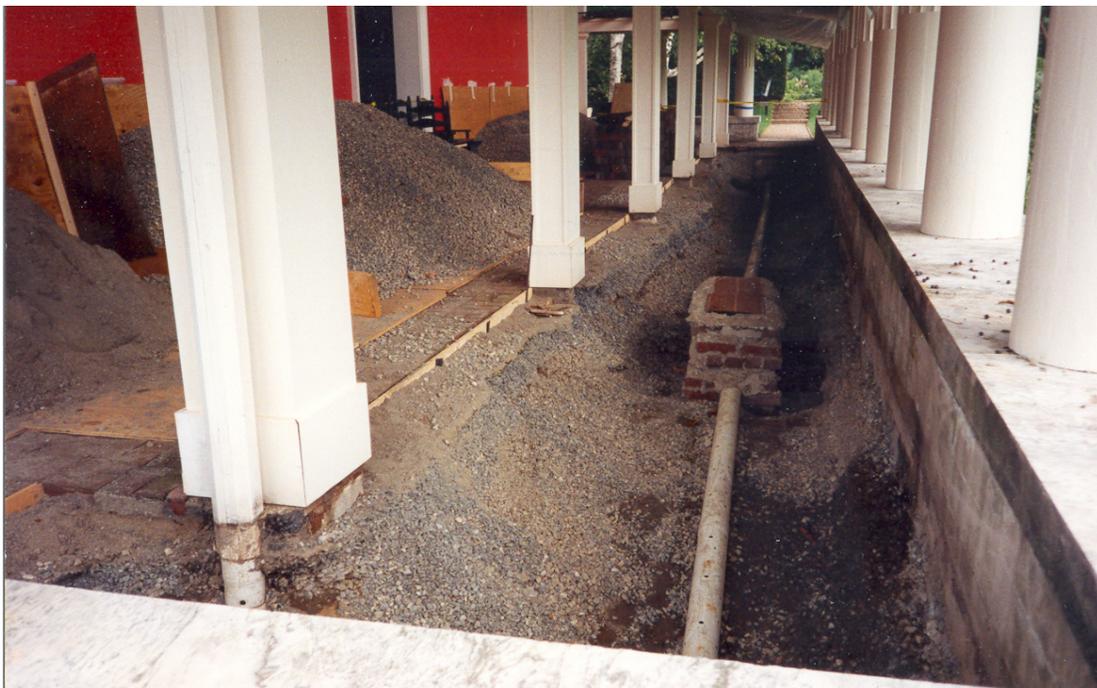
Figure 105. Little Studio, drainage project at south elevation: brick and rock removed to prepare for drain, 1994.
