THE FARM BUILDINGS at SAGAMORE HILL

Sagamore Hill National Historic Site
Oyster Bay, New York

Historic Structures Report

James J. Lee III
Architectural Conservator

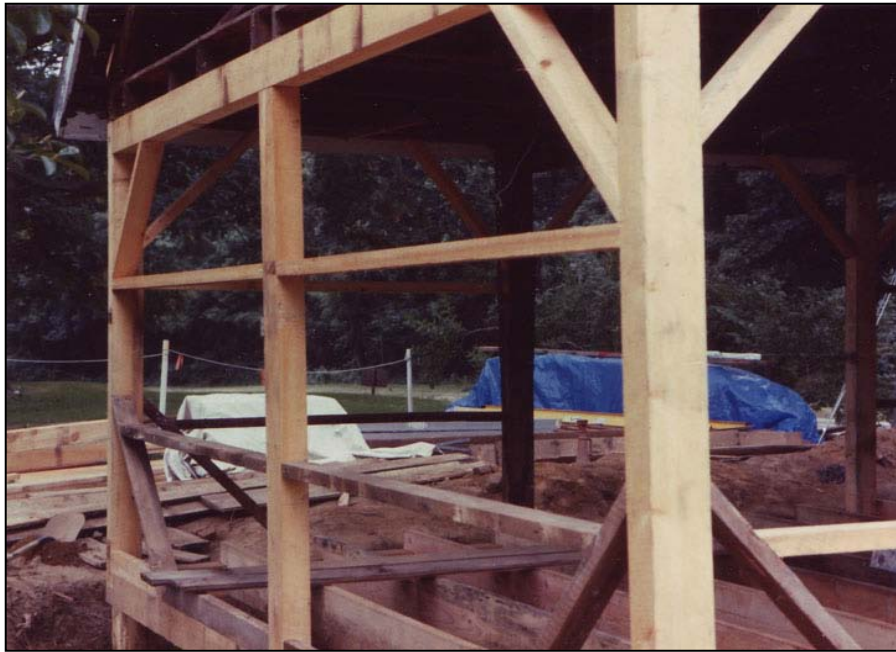
Figure 25. Gardener's Shed: South elevation showing in-kind replacement framing, 1986.

During the rehabilitation and stabilization of the Gardener's Shed, all materials that were deteriorated were replicated and replaced in-kind.

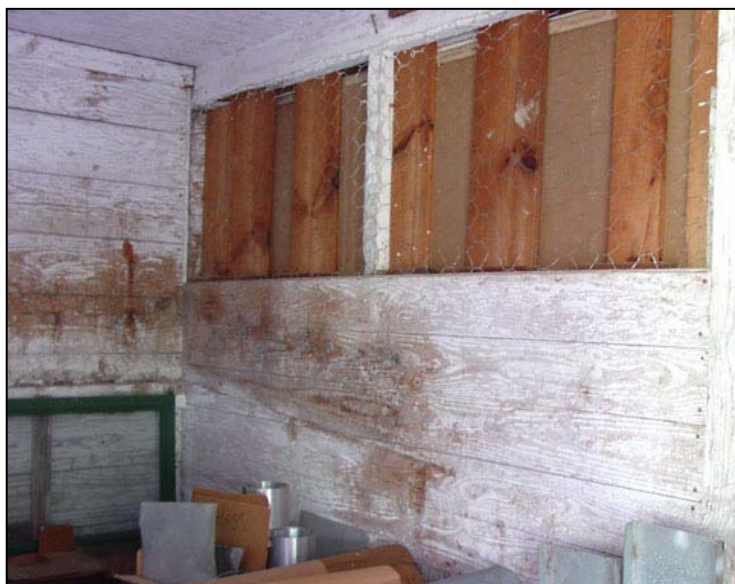
Figure 49. Chicken House: Room 102, east partition wall and evidence of roost on both the north and east walls, 2007.

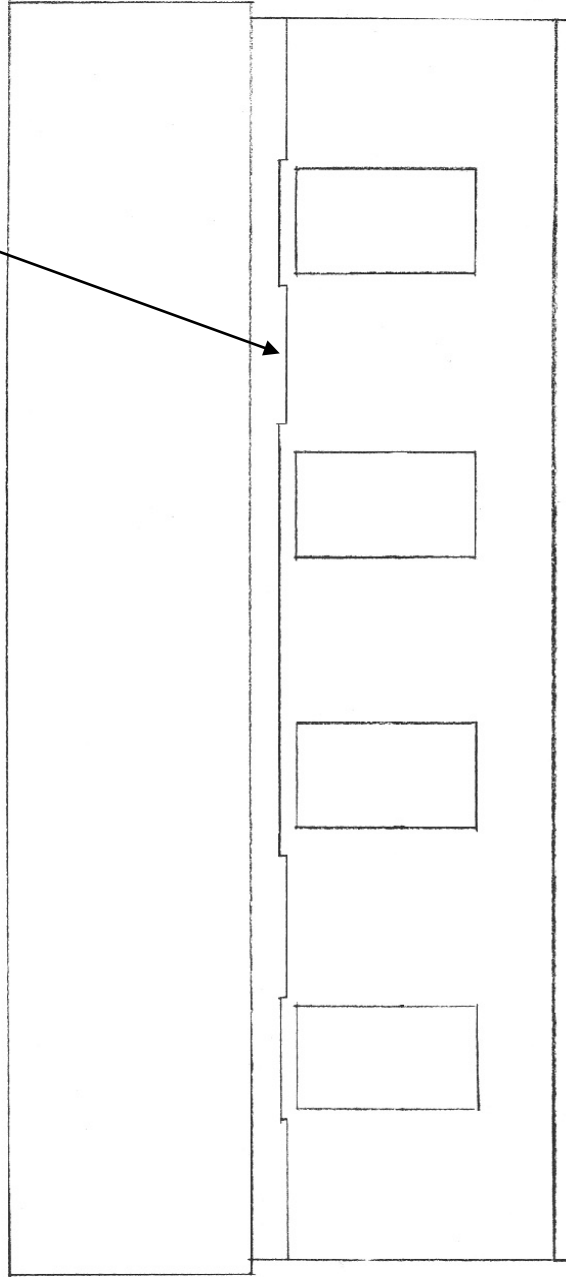
Figure 51. Chicken House: South elevation illustrating anomaly in siding that may represent evidence of earlier openings (not to scale), 2007.

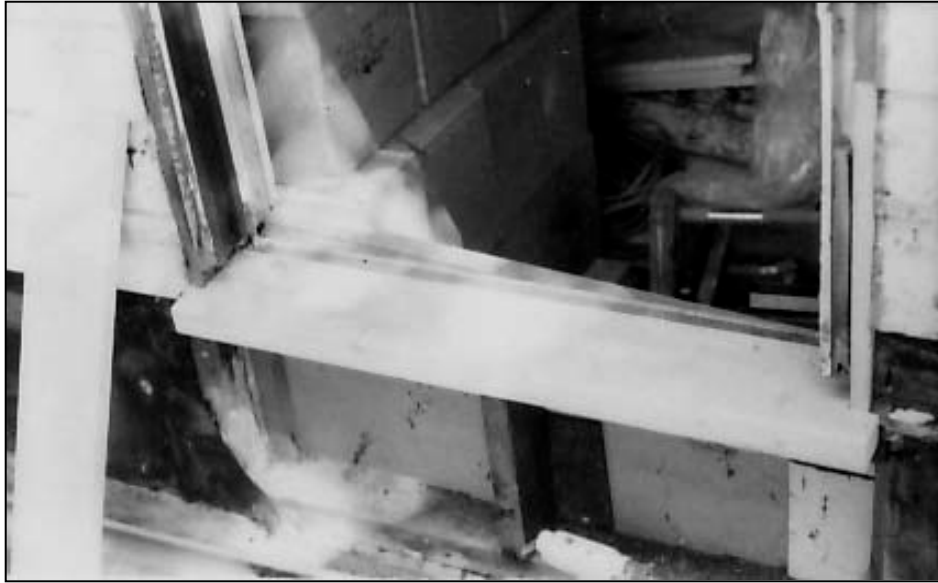
Figure 56. Chicken House: South elevation, west window. Repairs to the sill, frame, and rails, 1986.

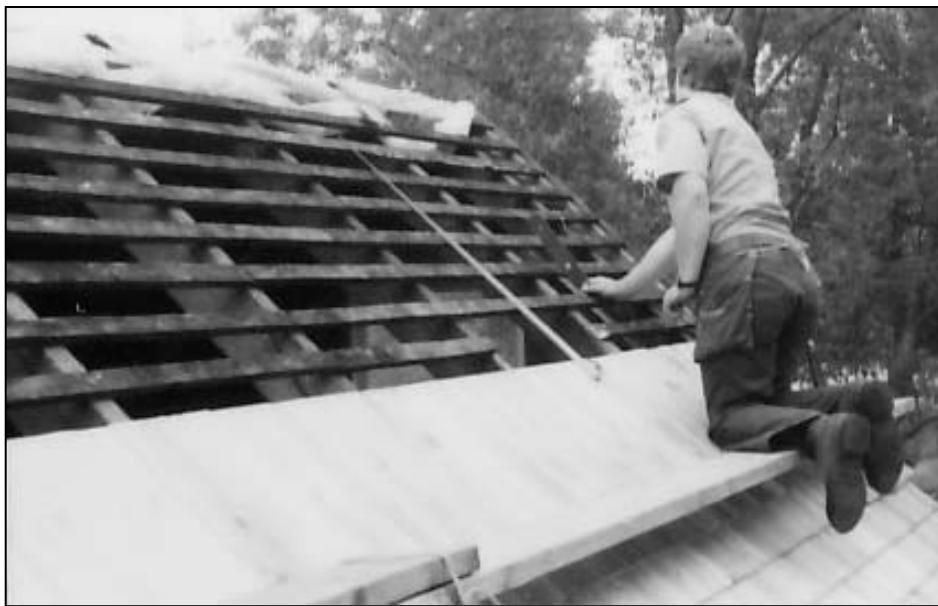
Figure 57. Chicken House: Repairs to roof, including replacement of wood lath and installation of wood shingle roof, 1986.

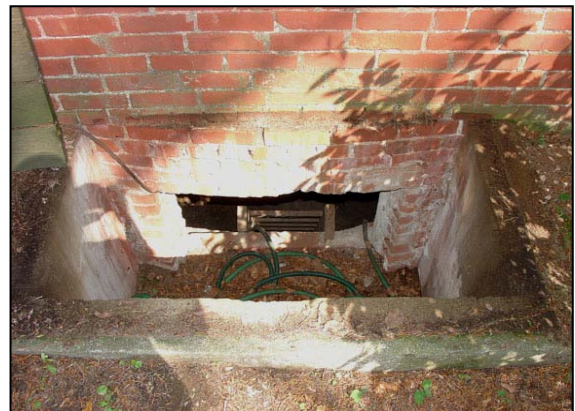
The window opening is surrounded by a poured concrete window well, which was previously

Figure 76. Ice House: Window well on southeast elevation, 2007.

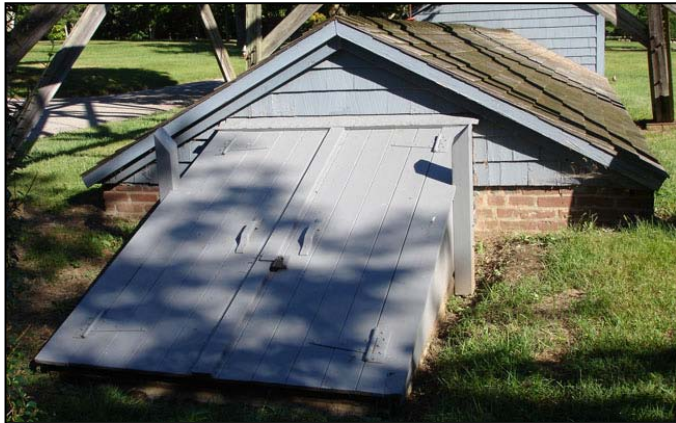
Figure 93. Pump House: South elevation with new bulkhead cover, 2007.
