THE NEW BARN

HISTORIC STRUCTURE REPORT

Sagamore Hill National Historic Site
Oyster Bay, New York

2005

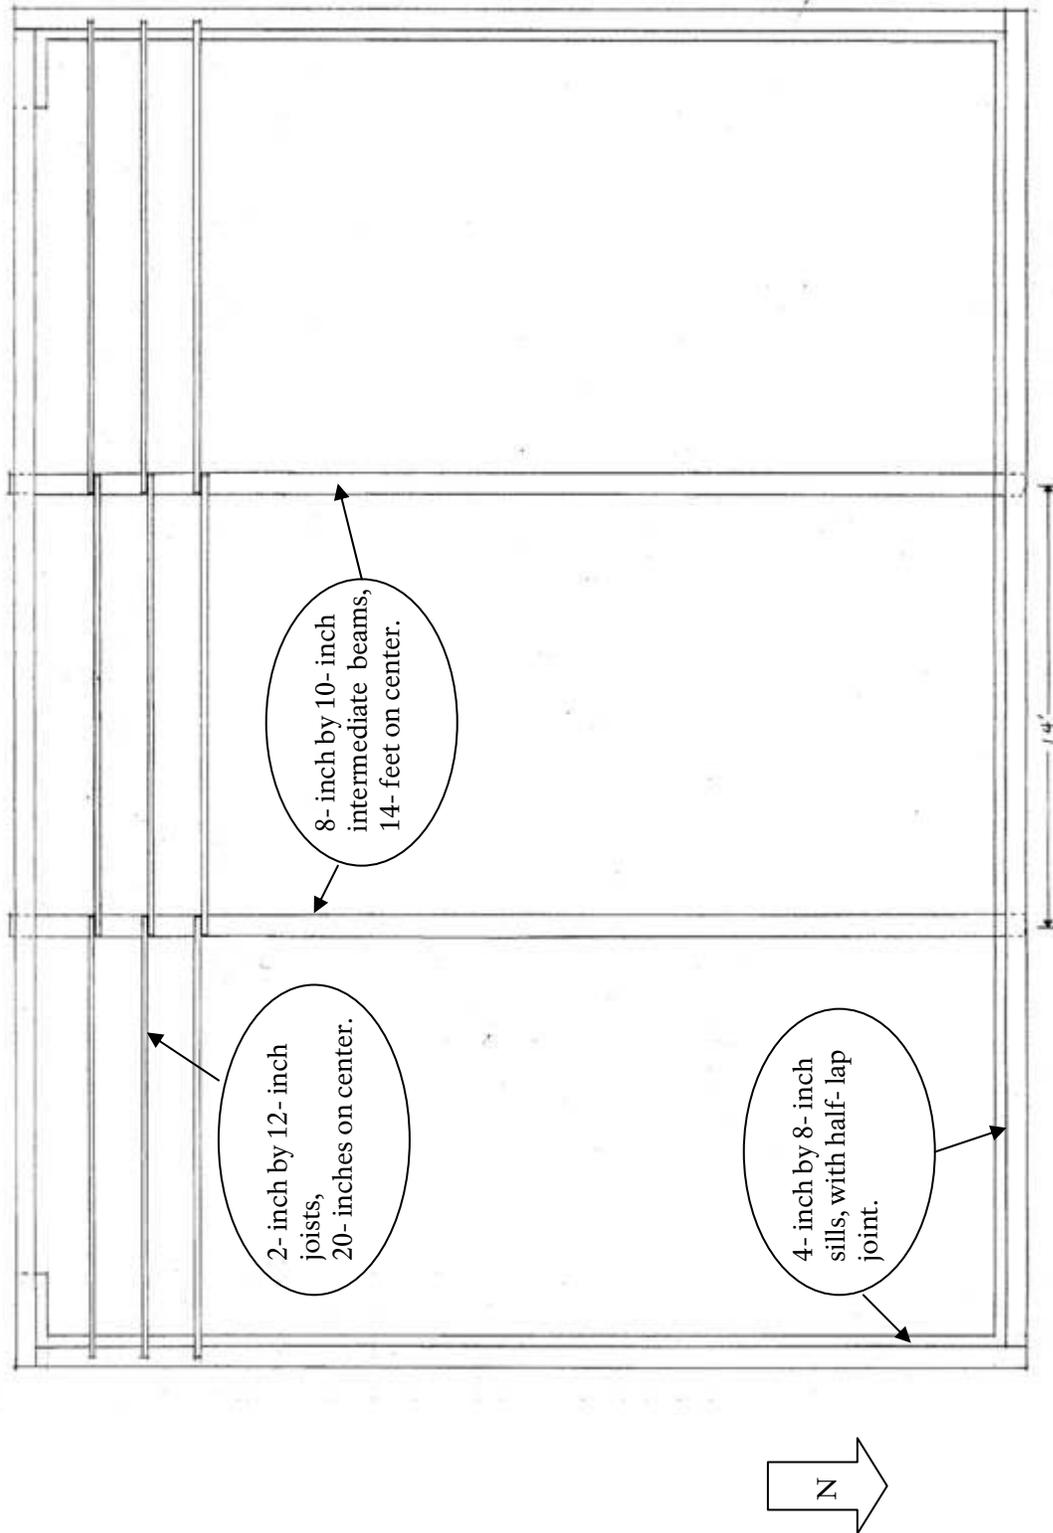
Along the north, east, and west elevations, the concrete foundation formed the support for the structure above. Two intermediate beams measuring 8 by 10 inches were set 14 feet apart on center. These extended from the north wall of the foundation to the south elevation of the barn, where they were supported by rough- hewn posts (fig. 16). Interestingly, the intermediate beams were placed evenly east- to- west, such that they did not align with the barn bays above.

Though limited access and later materials obstructed investigation of most of the sills, observations during the stabilization project did note that 4- by 8- inch sills were extant in 2002, and they may have been used in the construction of the barn.⁴⁷ The sills were laid flat on the concrete foundation and were half- lapped at the corners. The 4 by 8 sills and half- lap joinery were consistent with other extant framing in the barn, especially the plate, and were most likely from the original construction. Along the north and south sills, 2- by 4- inch members set on edge were installed on the inside edge of the sills to act as floor nailers.⁴⁸ Blocking was installed between the top of the intermediate beam and the sill to match the height of the foundation and make the sill level.

The framing for the first story consisted of 2- by 12- inch joists running east- west. Starting from the east elevation, the 2 by 12s ran to the first intermediate beam; another 2 by 12 joist was staggered next to it and spanned the two intermediate beams; and another joist then ran from the second intermediate beam to the west foundation wall (fig. 16). The joists were notched at the foundation walls and the sills, as well as at the intermediate beams, and were fastened with nails to the sills and intermediate beams. The spacing between the joists varied from 18 ½ inches to 20 ¼ inches.

Figure 16. Schematic plan of New Barn basement framing, depicting foundation, summer beams, sills and typical joist construction, not to scale, drawn by James Lee, September, 2005.

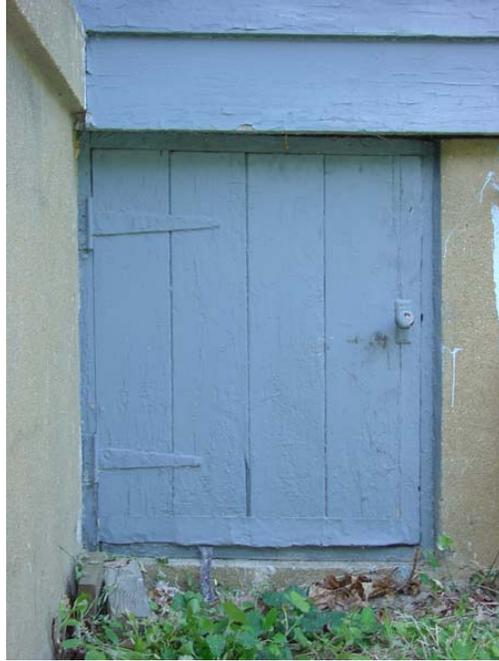
Figure 26. New Barn, south elevation, access door to crawlspace (2005).

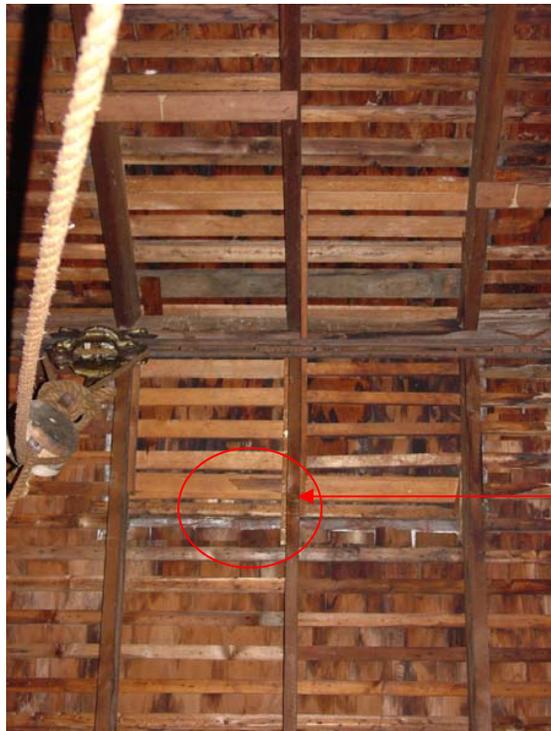
Figure 29. New Barn, interior view of roof framing and extant evidence of barn cupola, note change in sheathing and extant cupola flashing (2005).

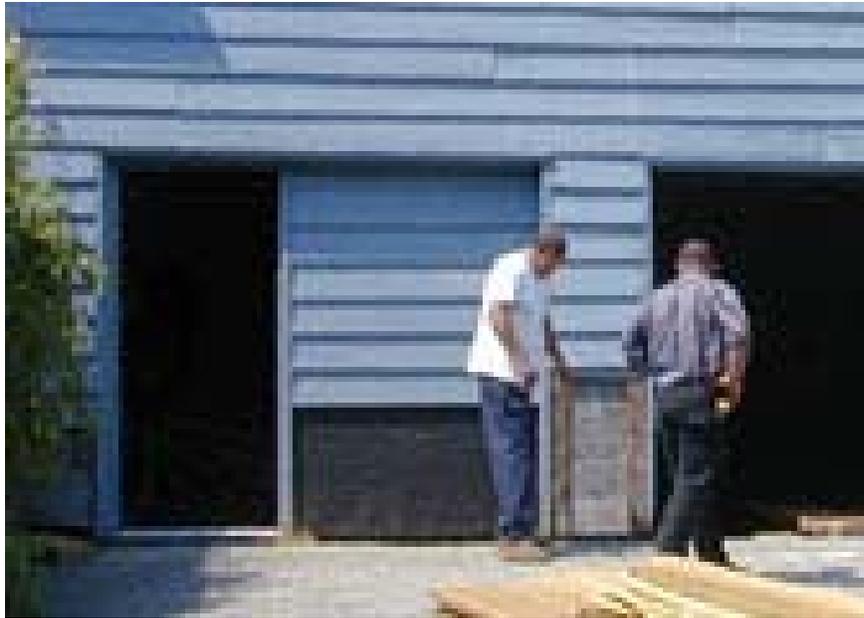
Figure 36. New Barn, east elevation, southeast garage bay doorway (2002).

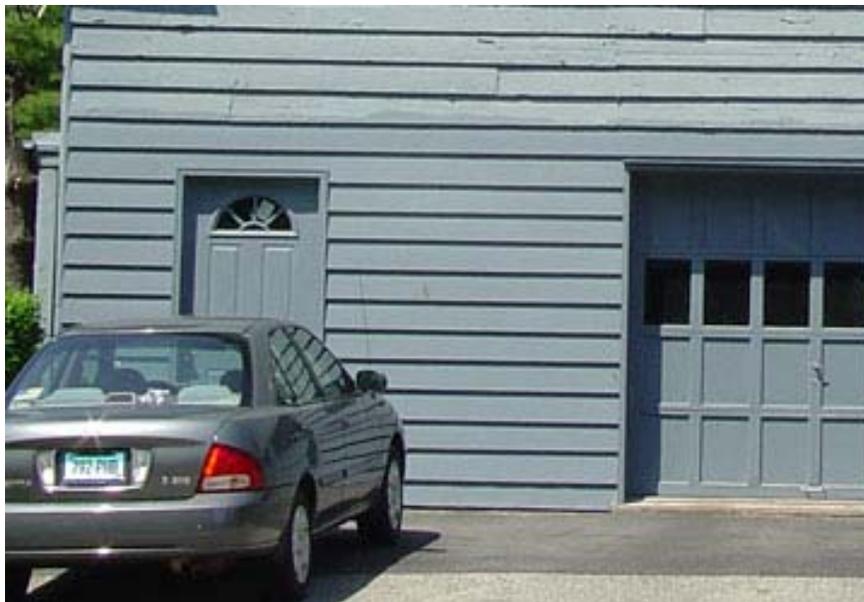
Figure 37. New Barn, east elevation, southeast garage bay doorway (2005).
