THE FORTIFICATIONS OF SAN JUAN NATIONAL HISTORIC SITE

HISTORIC STRUCTURE REPORT

Summaries
Conditions Survey
Recommendations
Glossary
Bibliography
Selected Historic Drawings
Appendices

1991

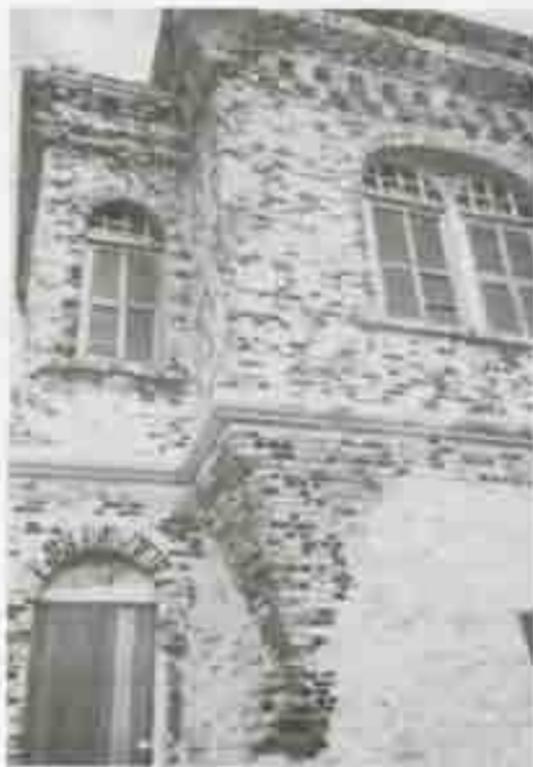
One of the most dramatic examples of differential erosion is found at the lighthouse on el Morro (fig. 9). The lighthouse was constructed in two different years; the upper (and newer) portion has deteriorated to a much greater degree than the lower. "Honey combing" is the phenomenon where brick become severely eroded and the mortar joints remain intact. (This will be discussed to a greater extent later in the text.)

Figure 9. El Morro, lighthouse. (Photo by W. Bedovic, 1980.)

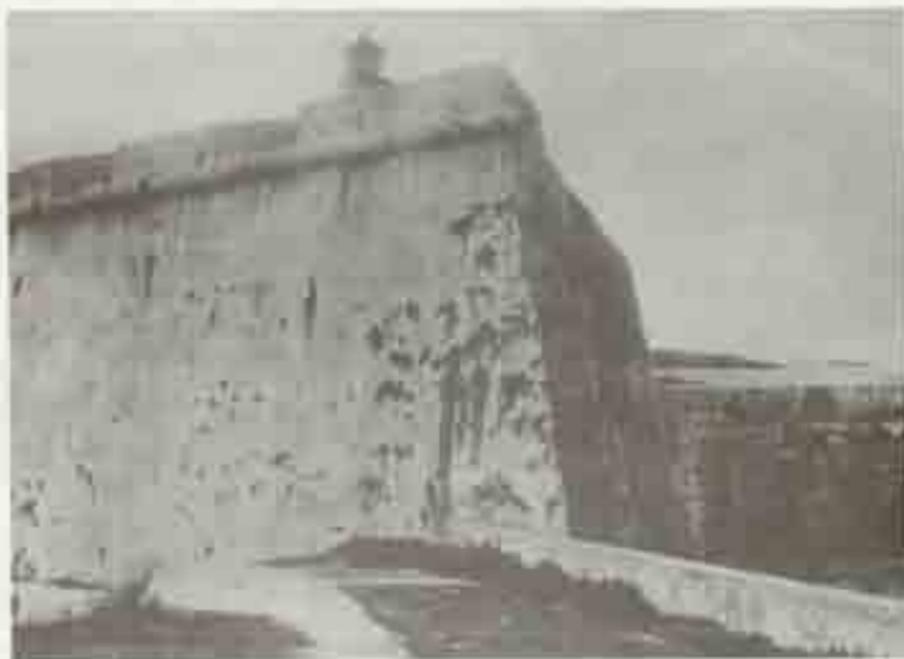
The apparent streaking of the finish may in fact be surface stains resulting from biological growth. A photograph dated 1900 shows the salient angle of Ochoa Bastion (fig. 20). The southeast wall still has most of its original surface stucco and finish. The black splotches designating deterioration and biological organisms all have, to a greater or lesser degree,

Figure 18. Dehus Bastion, salient angle. (Photographer unknown, ca. 1900. San Juan NMS Archives.)

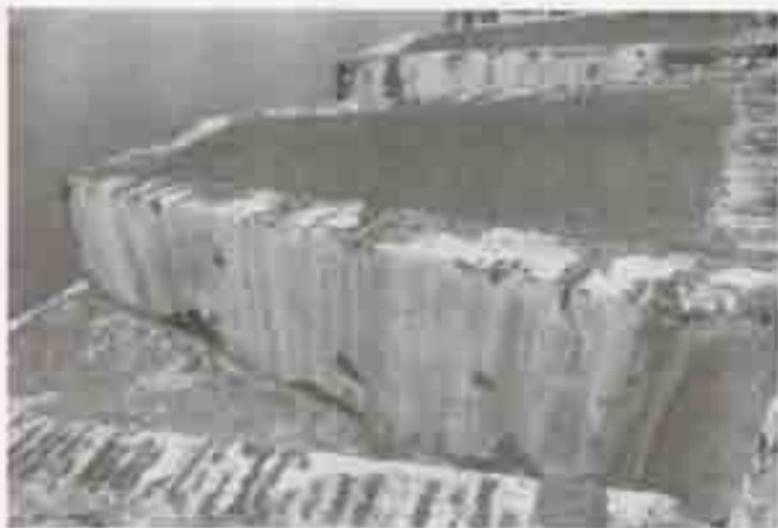
Brick dating to the Spanish tenure is primarily found edging banquettes and merlons and was originally covered with stucco (fig. 23). Where stucco has worn away on tops of merlons, brick remain in good condition with the mortar exhibiting loss. Exposed brick on banquettes is eroding due to heavy pedestrian traffic.

Figure 23. Santa Barbara Battery, western on the south side. (Photo by J. Jacob, 1989.)

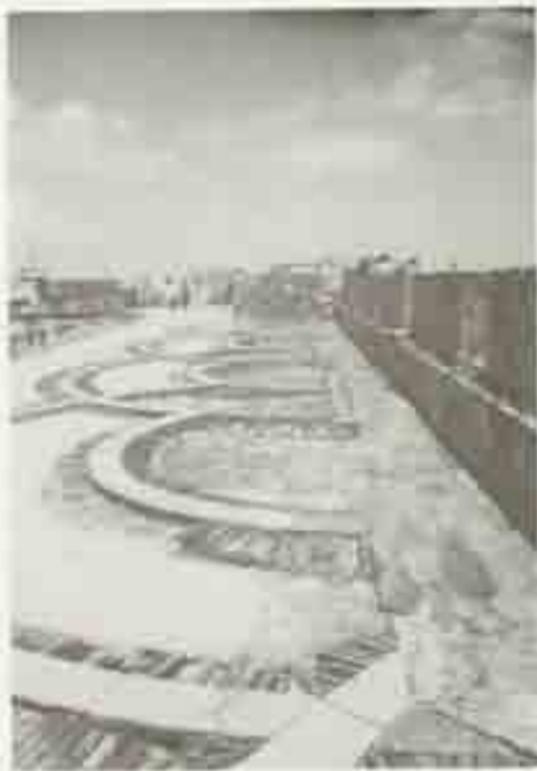
Figure 24. Santa Barbara Battery, gun tracks on the north side. (Photo by W. Sedovic, 1988.)

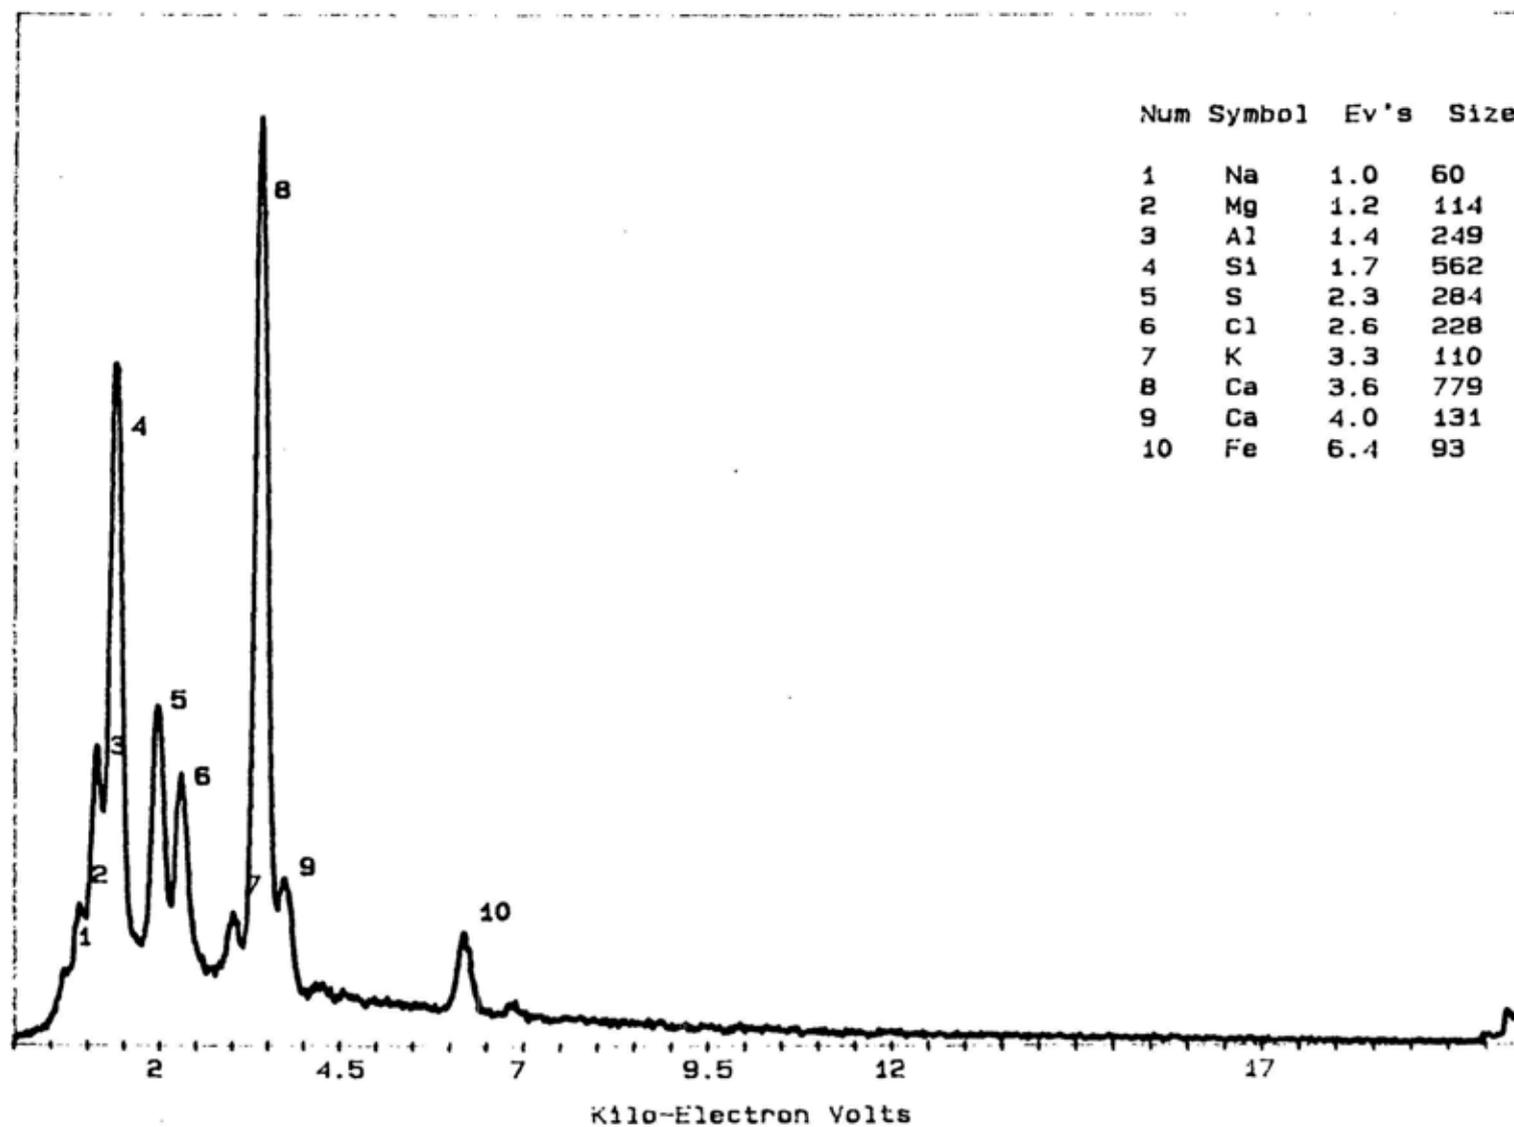
Figure 2. X-ray spectrum from the damaged surface of a stucco sample.
