# THE FORTIFICATIONS OF SAN JUAN NATIONAL HISTORIC SITE

## HISTORIC STRUCTURE REPORT

El Fuerte de San Cristóbal

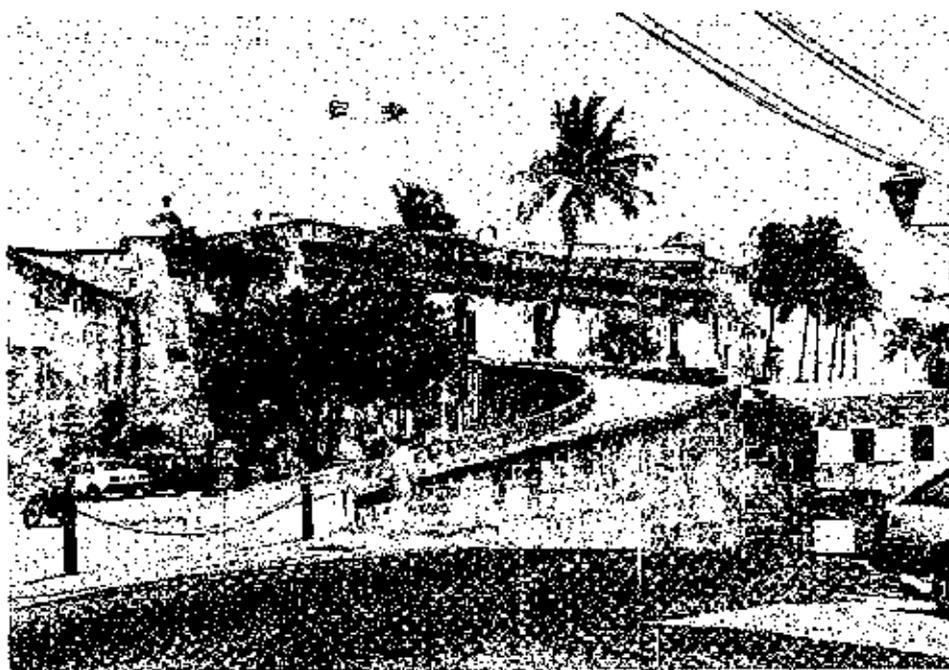
1.1. Main Gate and entrance ramp to San Cristóbal. (Photo by CPR, 1986.)

The present condition of the ramp walls is poor with problems that will accelerate their deterioration. The ramp surface is in good condition although its central section shows differential weathering, general surface cracking and isolated areas of patching repairs. As with other structures throughout this site, all problems seem to be associated with water infiltrating into the masonry walls. Because the ramp walls are completely unprotected from the weather, erosion of building materials is a typical problem. Conditions seem to be most severe at the northern elevation; probably because it is exposed to the open sea.

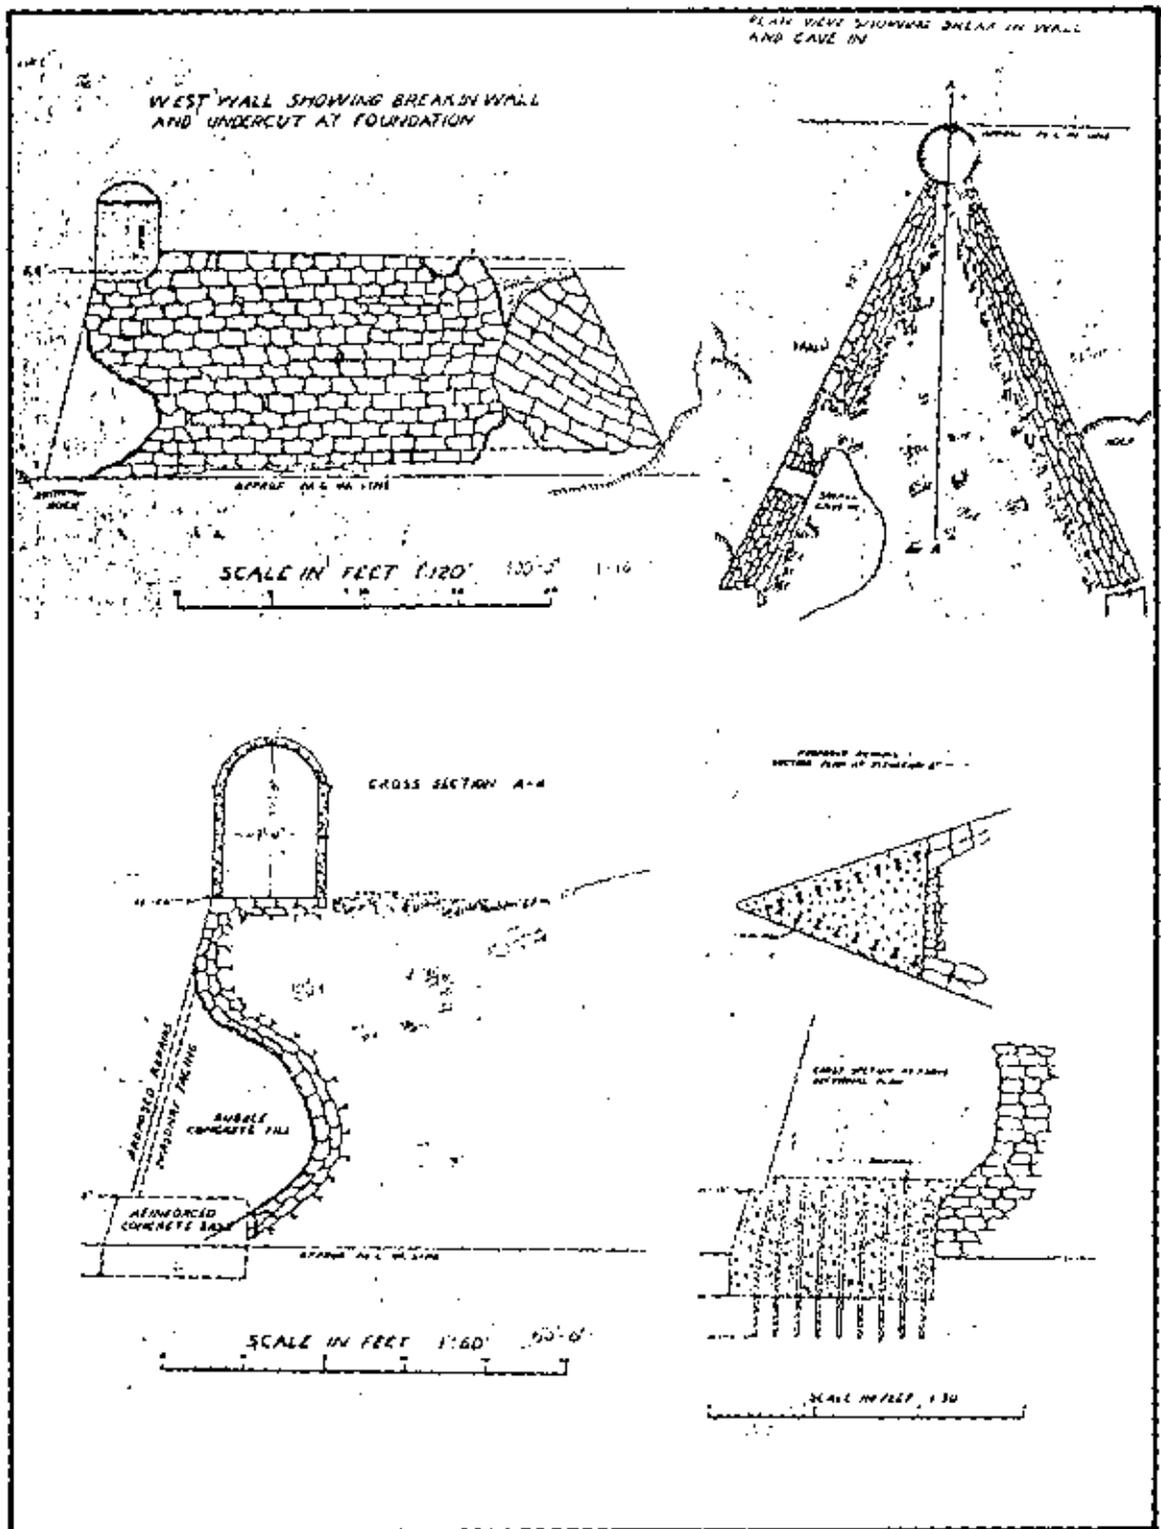
Figure 11.10. Proposed repairs to el Espigón, 1938-39. U. S. Engineer Office, War Department. (San Juan NHS Archives.)

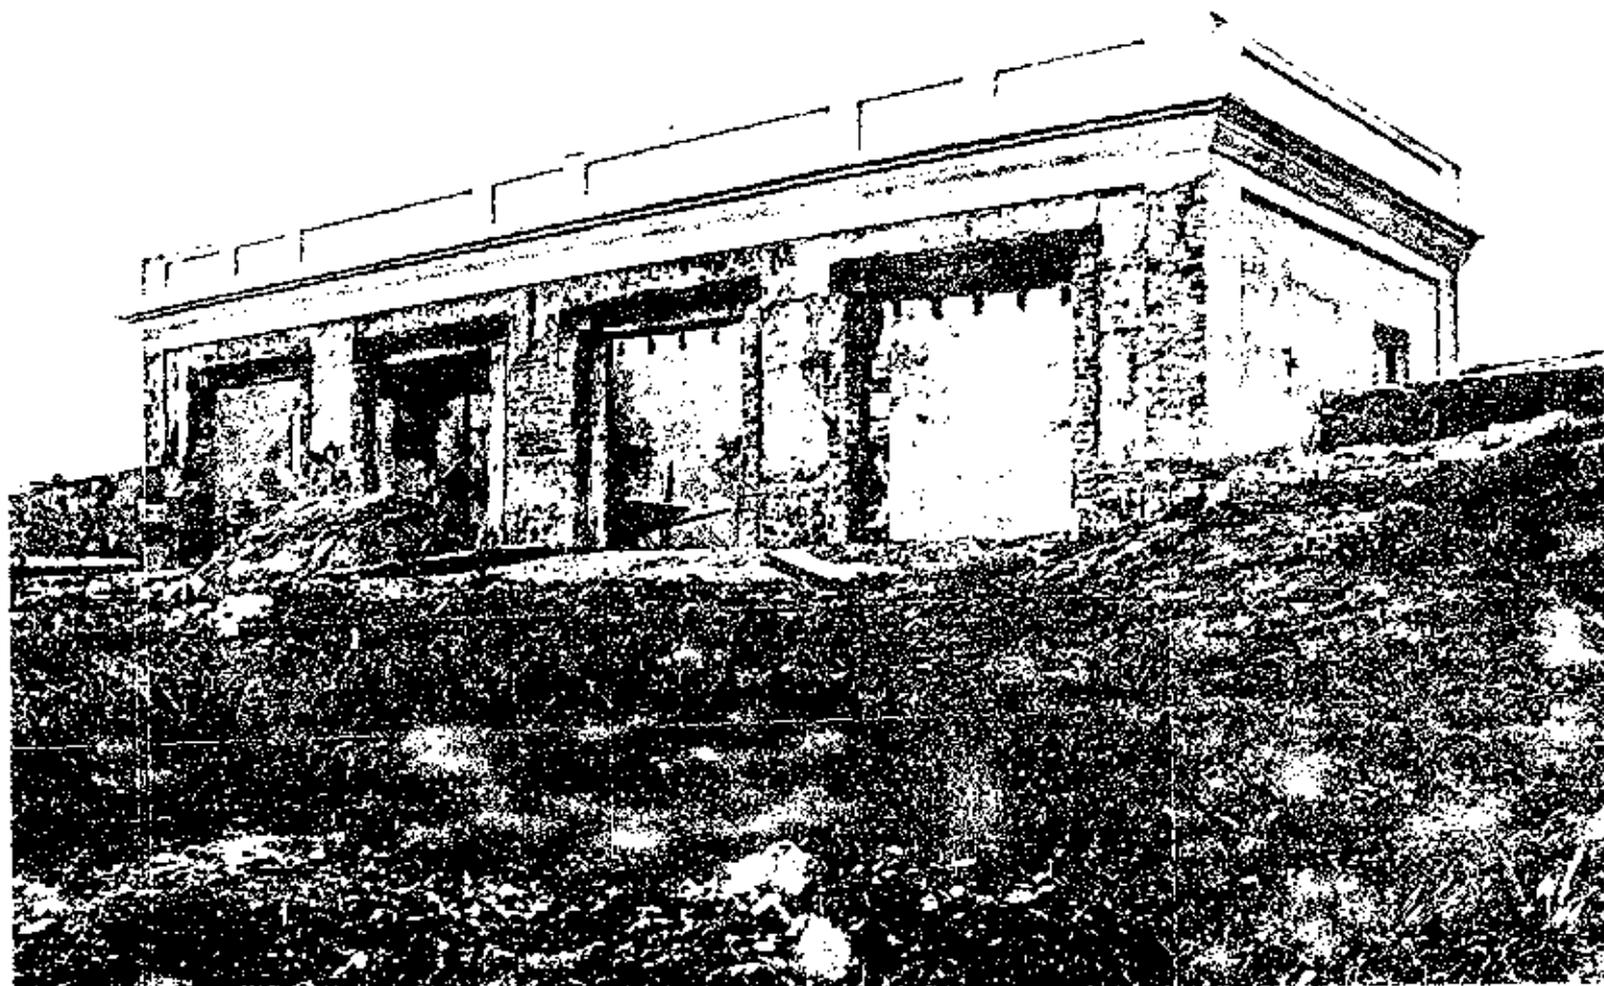
Figure 17.8. North and west elevations of the Guardhouse in the process of restoration, October 29, 1981. (San Juan NHS Archives.)

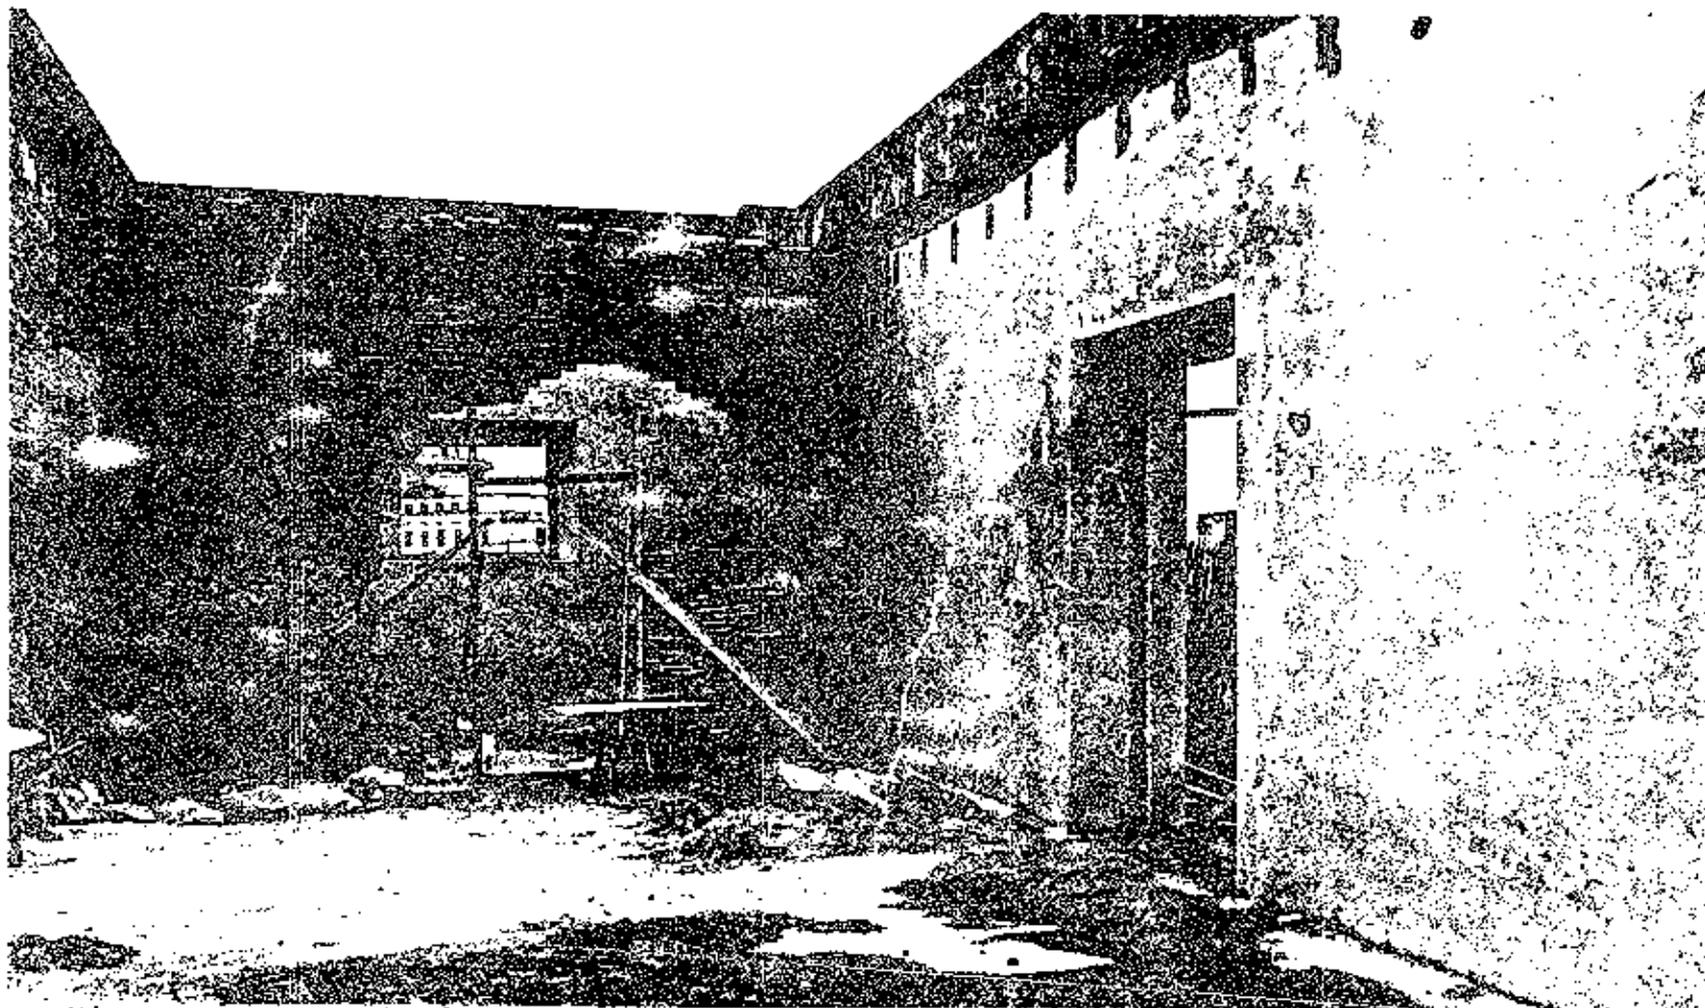
Figure 17.9. Interior of the Guardhouse looking southeast in the process of restoration, October 29, 1981. (San Juan NHS Archives.)
