## historic structure report

TUSKEGEE INSTITUTE  
THE OAKS

NATIONAL HISTORIC SITE / ALABAMA

HISTORIC STRUCTURE REPORT

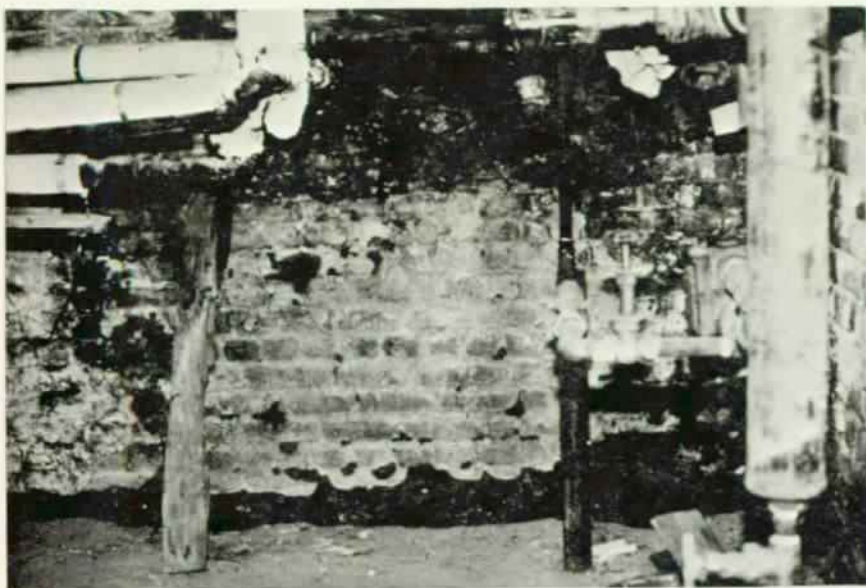
Room 001 — Stair — East Wall  
Note Deterioration

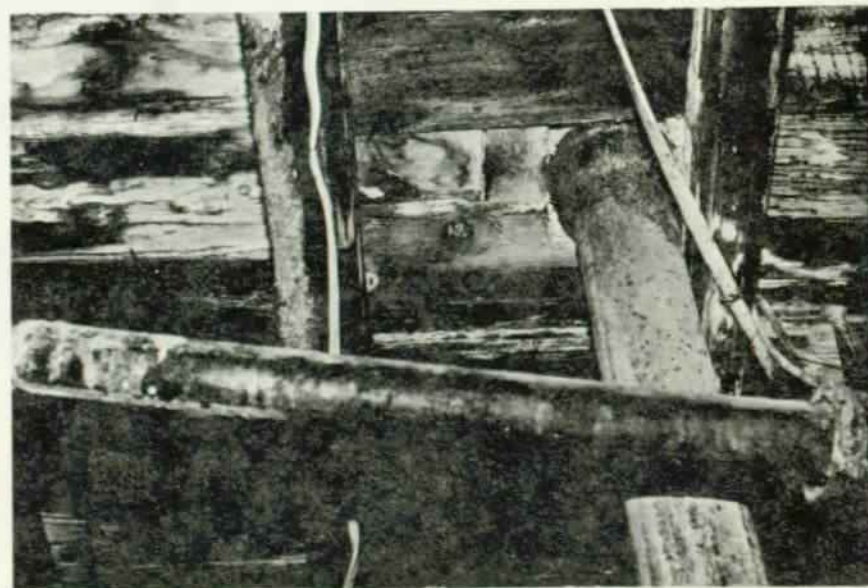
Crawlspace 004 — Under Bathroom  
Note Rotting
