STIRLING'S QUARTERS AT VALLEY FORGE NATIONAL HISTORICAL PARK
HISTORIC STRUCTURE REPORT

PREPARED BY:
JOHN MILNER ARCHITECTS, INC.
104 LAKEVIEW DRIVE, CHADDS FORD, PA 19317

JANUARY 2006

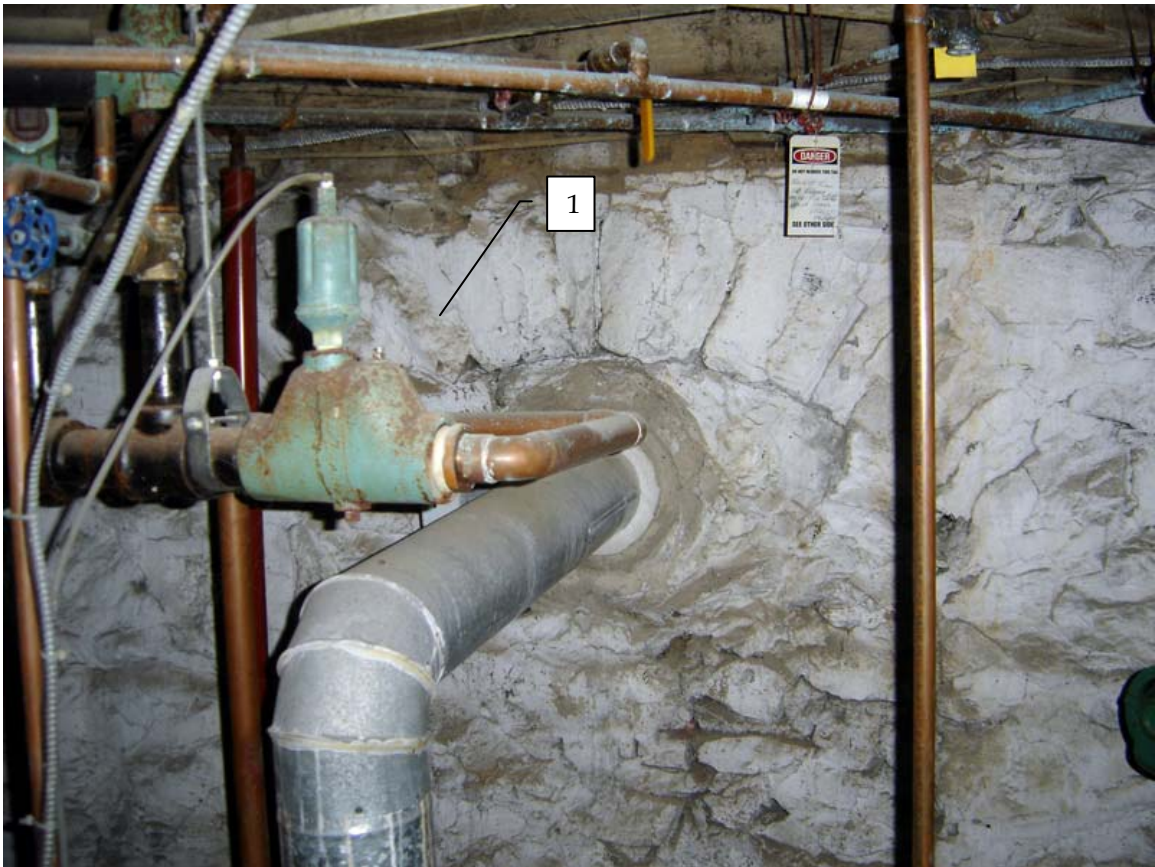
Photo 002a – Detail view of north fireplace foundation arch, Room 002, looking southeast. Alcove beneath arch has been infilled with stone and an exhaust flue from the current heating system has been introduced.

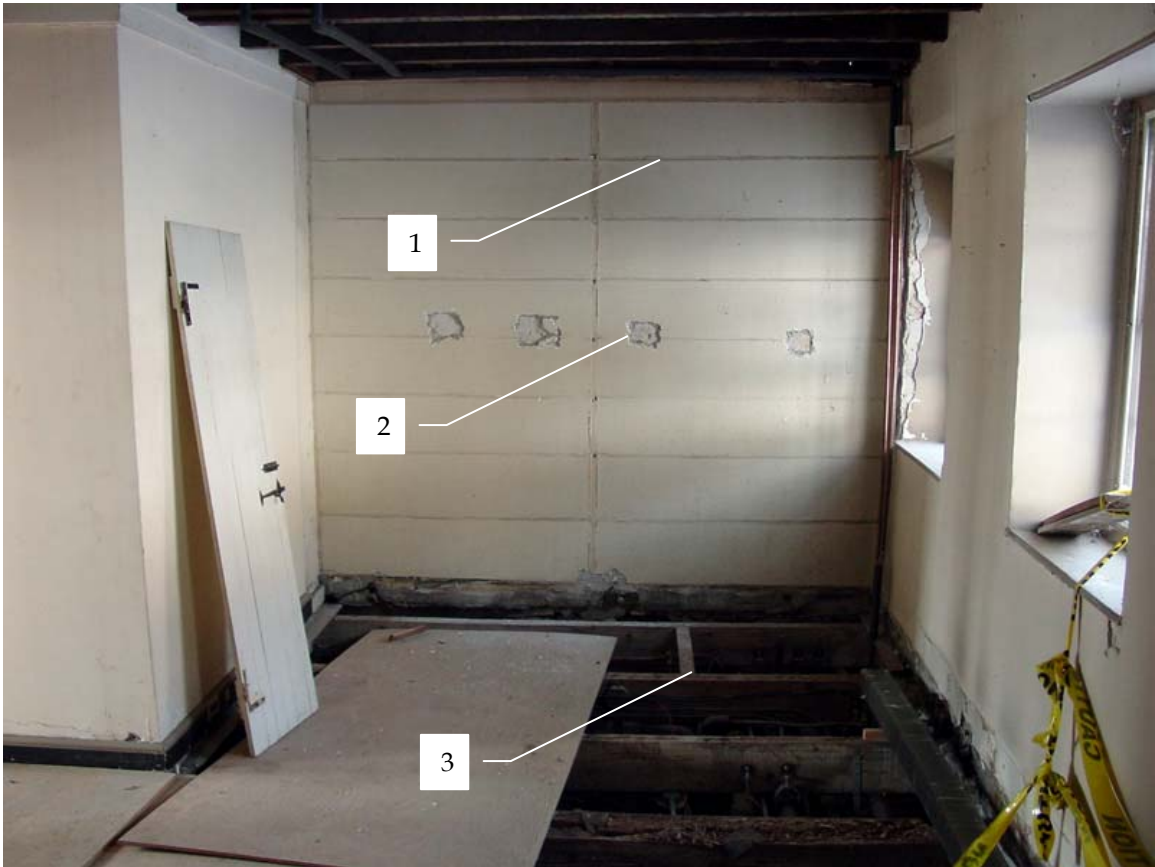
Photo 102a – View of west wall, Room 102.

1. Evidence in plaster finish of recent built-in shelving.
2. No evidence of former opening at west wall.
3. Wood flooring removed; wood joists severely rotted.

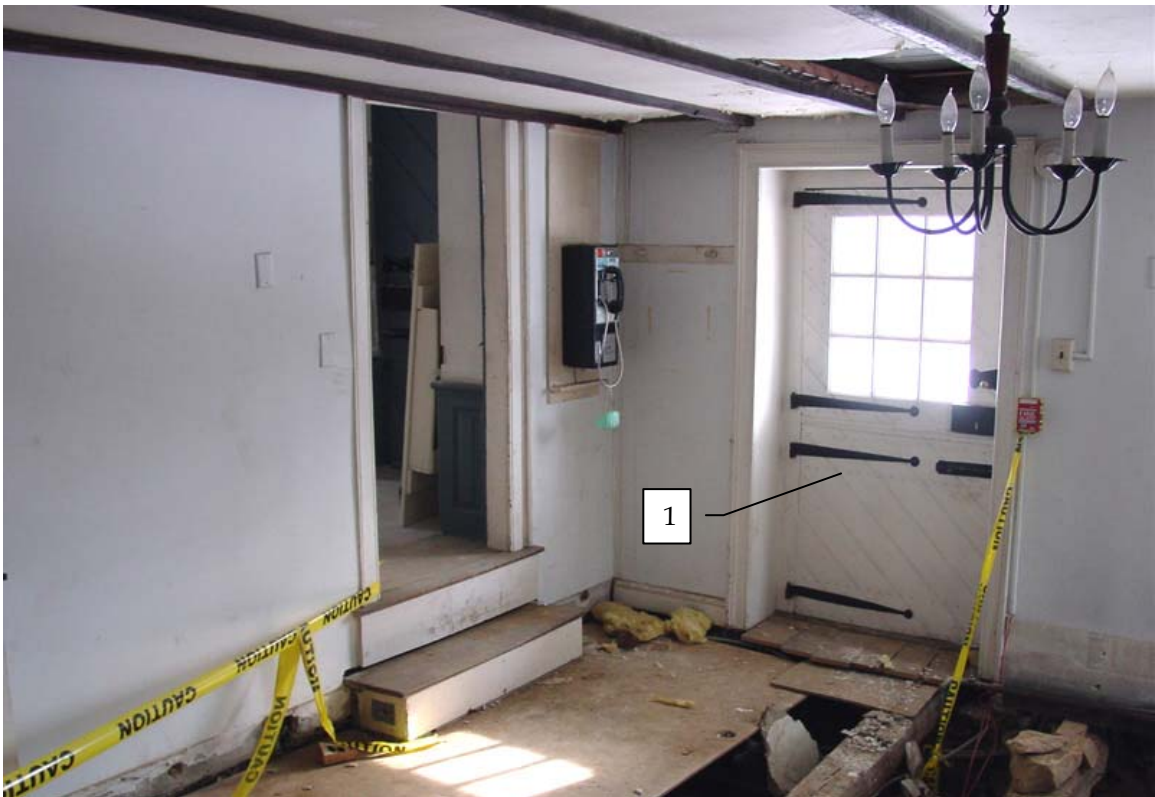
Photo 104c – Interior view of Room 104, looking southeast.

1. Replacement Dutch door set in original c. 1769 wood frame.

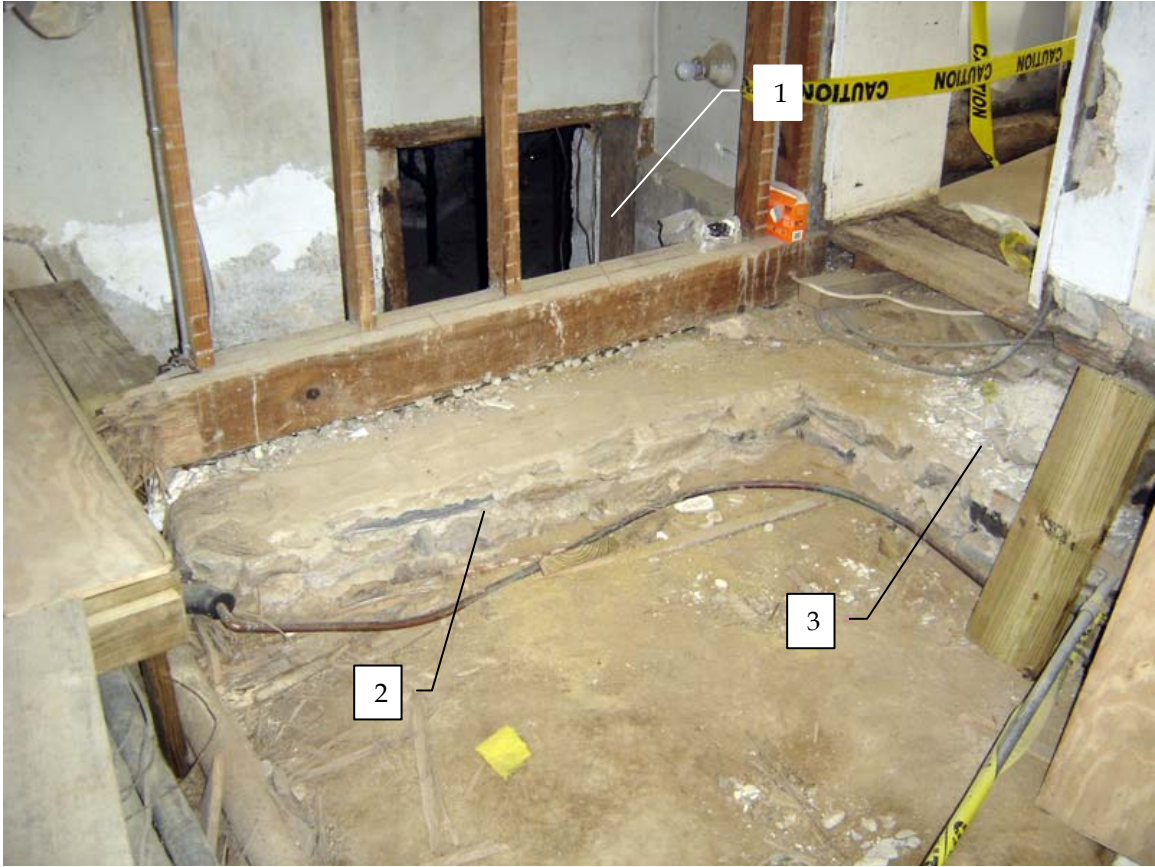
Photo 106c - General view of floor in Room 106, looking southeast.

- The east end of the room was heavily modified in 1926 by the addition of an interior basement stair. The wood stair has been removed due to deterioration, but the stone retaining wall forming the stair areaway is intact and in good condition. (Photo 106c, Note 9/106)

1. New stair (missing) to basement introduced c. 1926.
2. Stone retaining wall for areaway.
3. Stone shelf.
