# VICKSBURG NATIONAL MILITARY PARK

## PEMBERTON'S HEADQUARTERS

(WILLIS-COWAN HOUSE)

# HISTORIC STRUCTURE REPORT

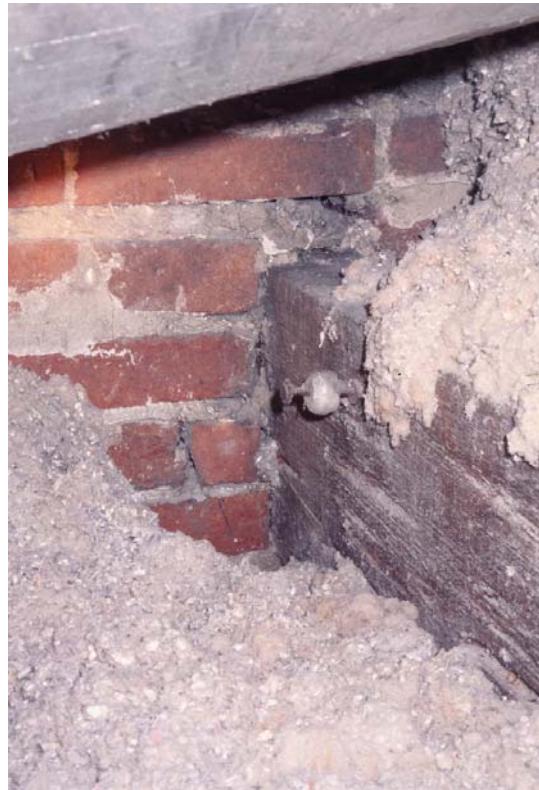
**Figure B - 3** Ceiling joists above the original L-shaped porch are resting in formed joist pockets in the brick wall, indicating they are an original feature

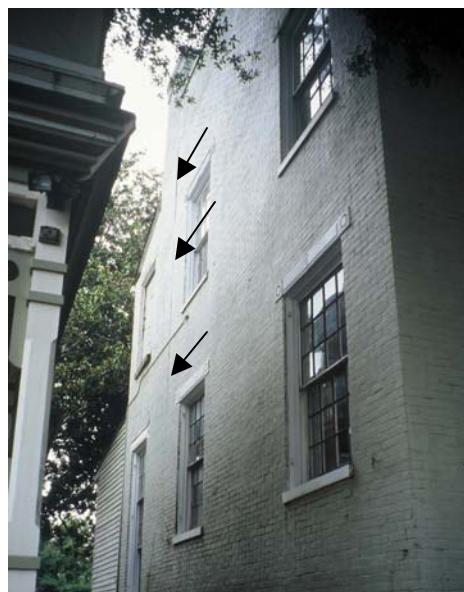
**Figure C – 1** Stack joint on east elevation

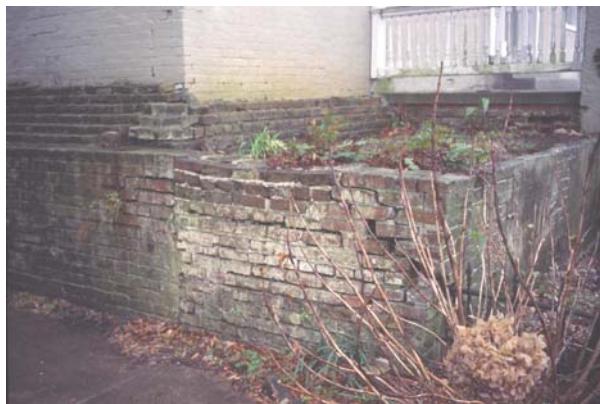
lintels. The cracks appear to be active. The outward thrust of the east wall is the result of the cutting back of the grade along the east elevation. This was done to construct the corner house in the later nineteenth century. A low brick wall that separates these two property lots acts as a retaining wall of the higher grade of the Willis-Cowan House property, but it clearly is inadequate as evidenced by the numerous extensions, repairs and current poor condition.

**Figure C – 2**      *Retaining wall*

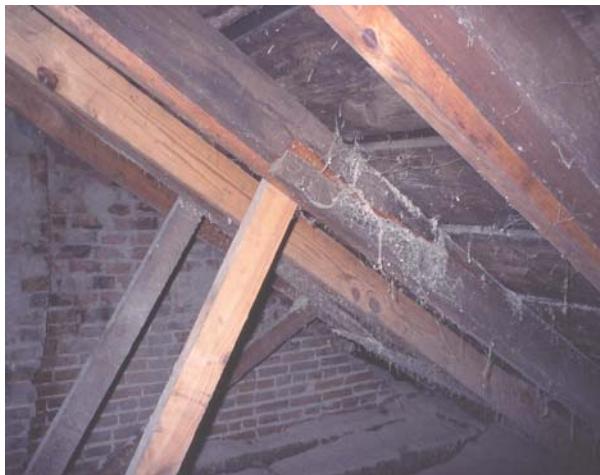
judging from the amount of discoloration and dirt at the split, open wood. It is damage caused by a distributed load applied from above, probably the collapse of the adjoining, southwest chimney. Additional framing dating to the twentieth century now sister and provide post support to the damaged rafters.

**Figure C – 3**      Split rafters

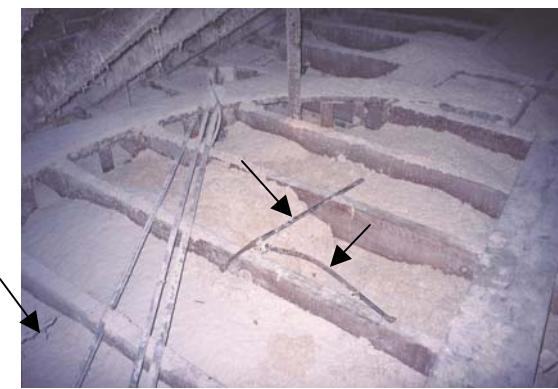
Figure C - 48 Early gas lines in the attic

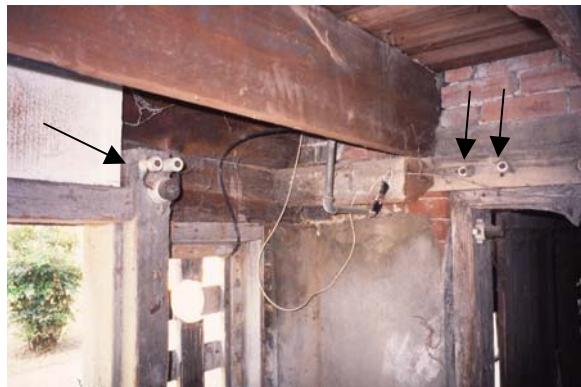
basement, Room 002, of the frame addition and in the attic of the original house. The previous owner reported that the house was largely rewired in the 1970s and completed in 1997-99 when the current lighting fixtures were installed. Nothing was observed to contradict those statements.

*Figure C - 50 Knob and tubing*

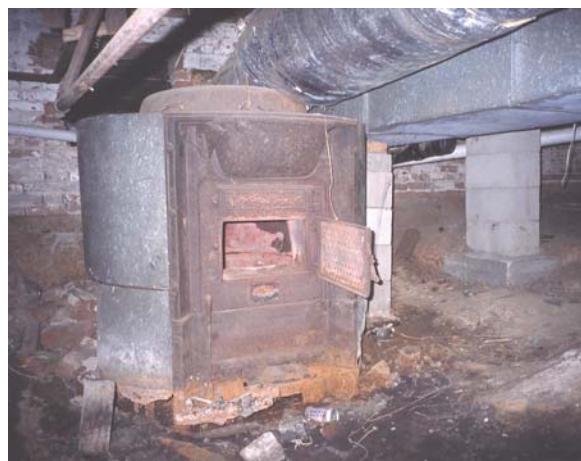
*Figure C - 51 Abandoned furnace*

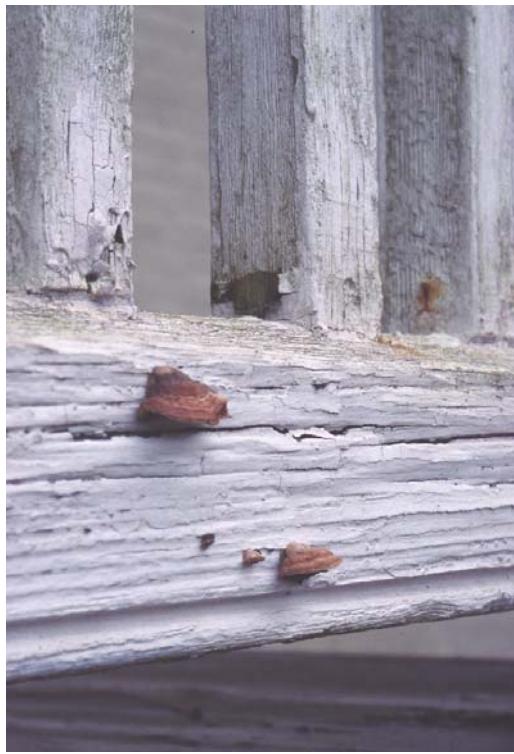
**Figure C – 52** Fungus growing on the west porch balustrade
