# CARETAKER'S HOUSE AND GARAGE

## Weir Farm National Historic Site Wilton, Connecticut

Historic Structures Report

Volume II- B

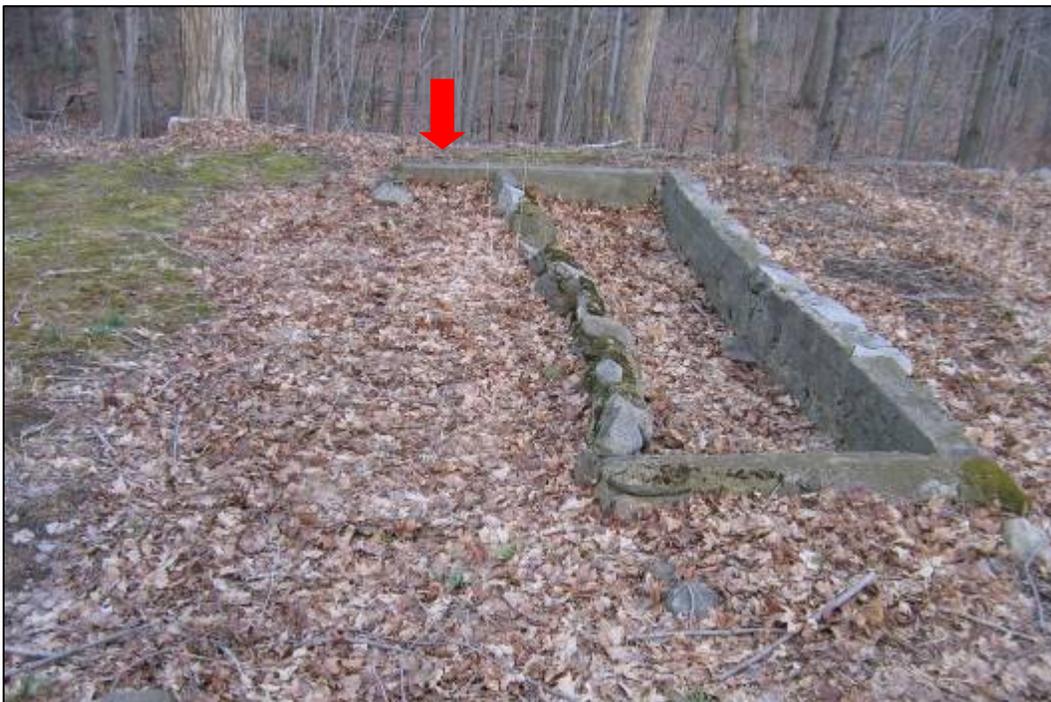
**Figure 3.2.** Original carriage house, rubble foundation wall and abutting concrete greenhouse foundation with partial rubble facing (2006). Red arrow indicates extension of greenhouse foundation under southeast corner of the carriage house.

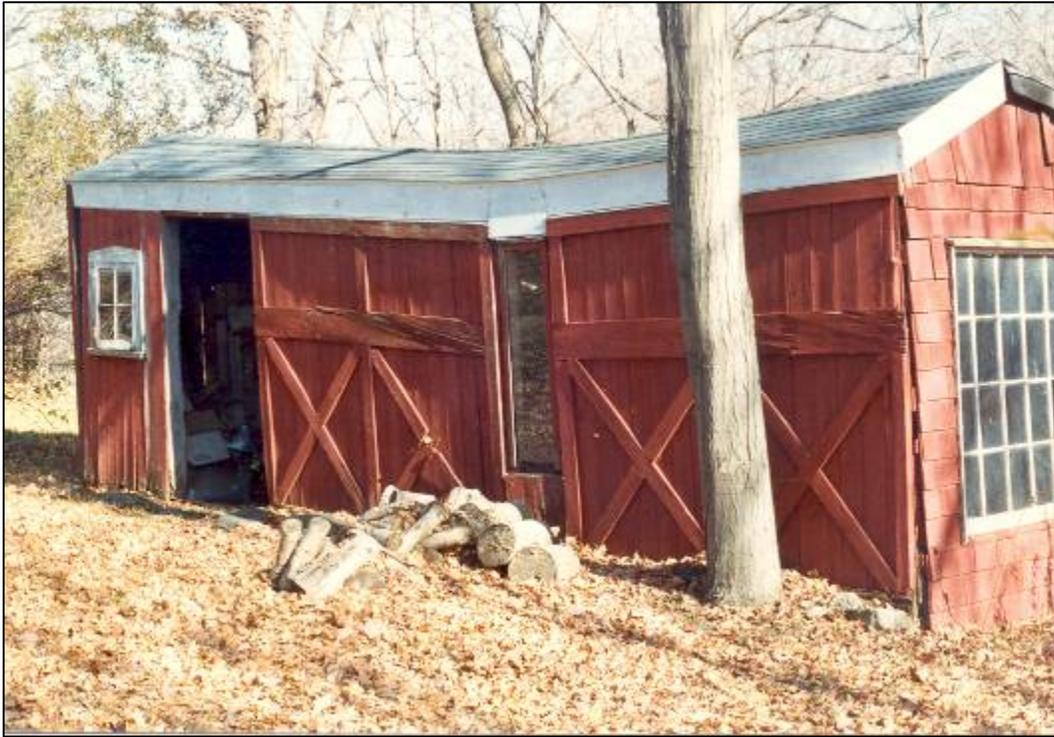
The roofing on the front roof slope consists of 1- inch- thick, square- edge boards of various widths, covered by asphalt shingles with white (vinyl or aluminum) drip edges. All of the asphalt shingles are eroded, brittle, and curled (see figs. 3.3 - 3.4).

Figure 3.3. Caretaker's garage: West facade (1993).

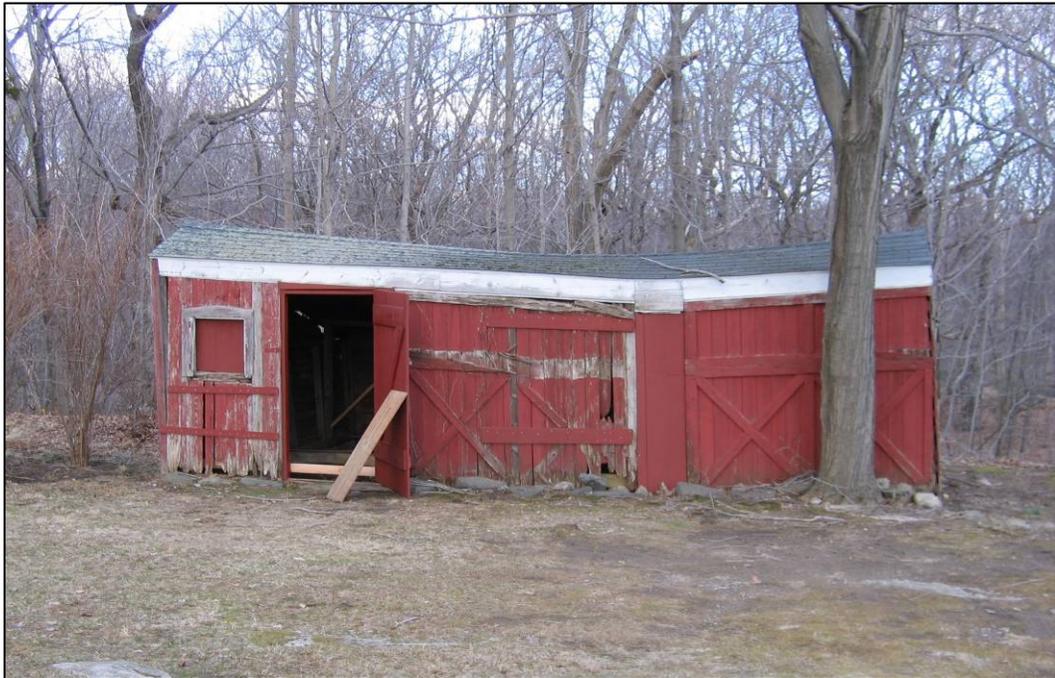
Figure 3.4. Caretaker's garage: West façade (2006).

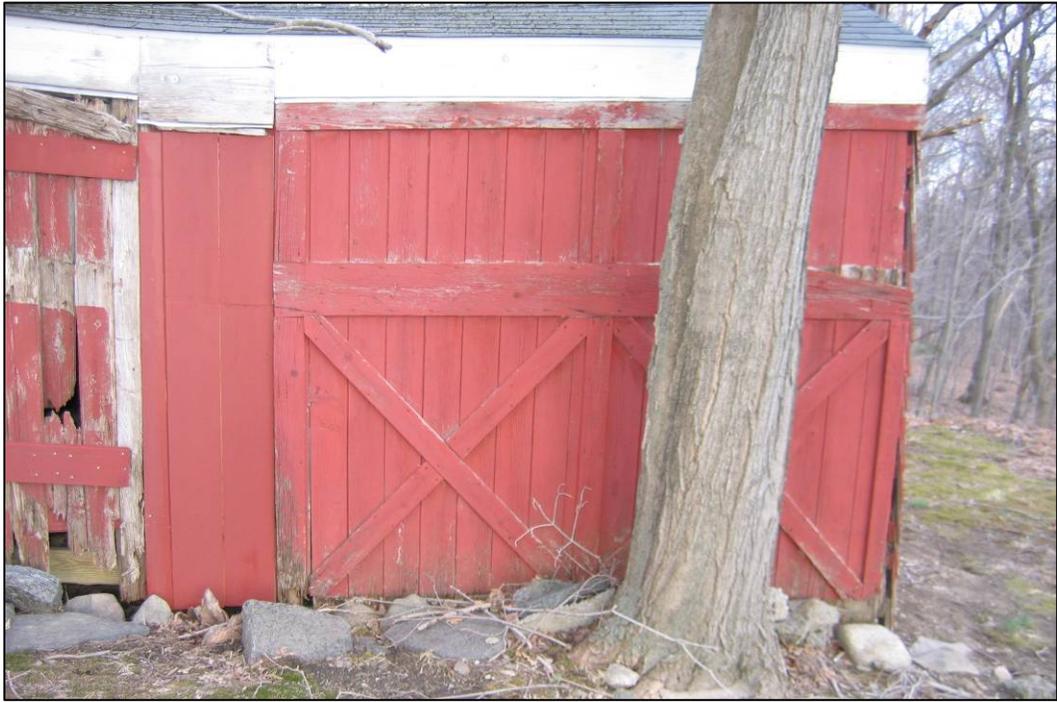
Figure 3.5. Caretaker's garage: West façade, showing reused carriage- house door (2006).

- Replicate the original carriage house's gable front as seen on historic photographs.
- Restore or replace in- kind the original carriage house doors (presently installed upside- down on the garage), including original hardware, as seen on historic photographs.

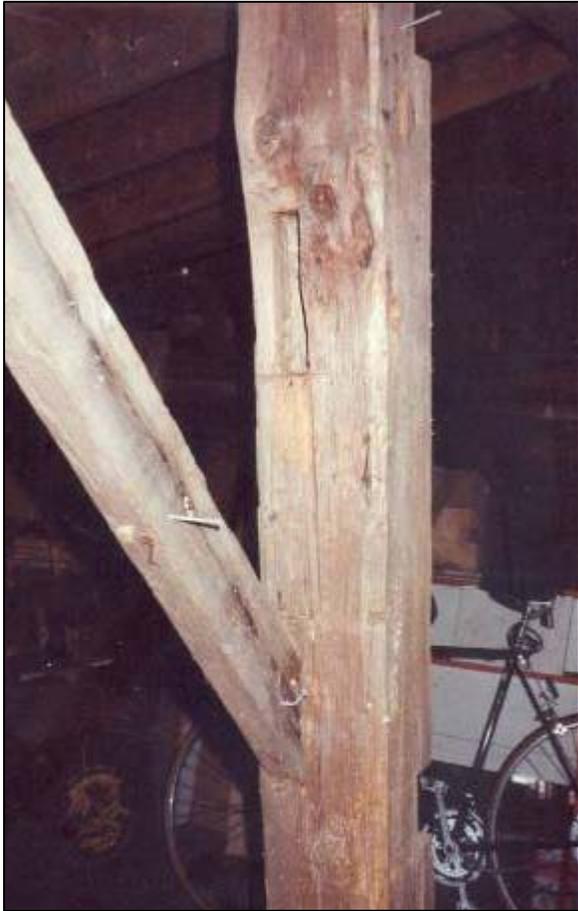
**Figure 3.11.**  
Caretaker's garage:  
Interior view,  
showing reused  
post with empty  
mortises (1994).

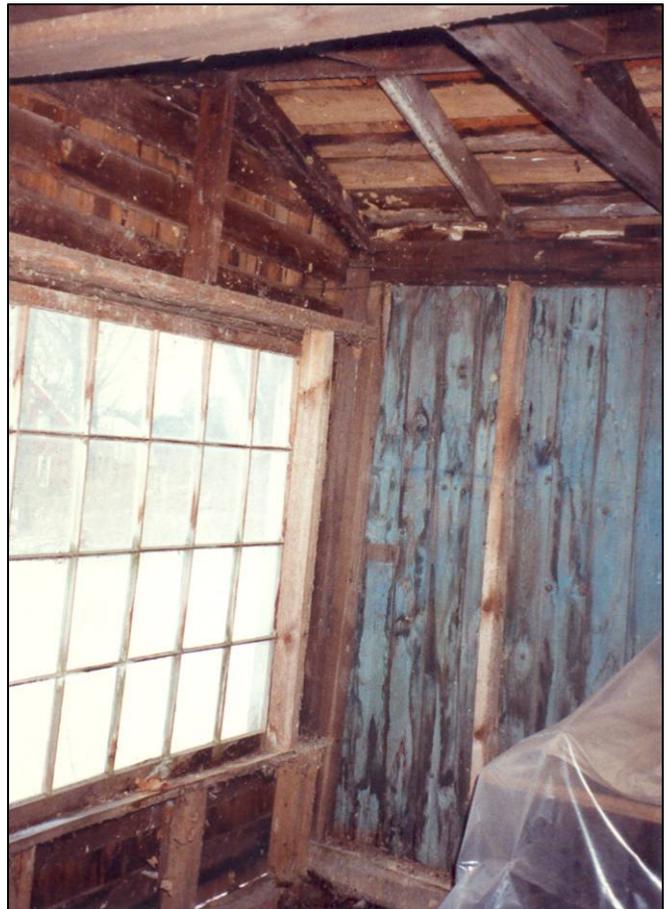
**Figure 3.12.**  
Caretaker's garage:  
Interior view of  
southwest corner,  
showing reused  
carriage- house door  
(1994).
