M'CLINTOCK HOUSE

**Women's Rights
National Historical Park**

Historic Structure Report

THE M'CLINTOCK HOUSE
HISTORIC STRUCTURE REPORT

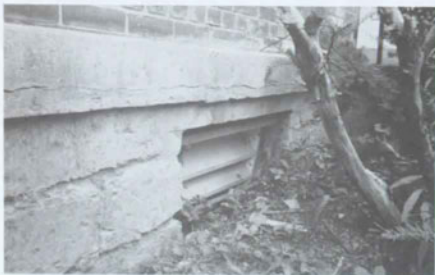
Figure 42. M'Clintock House: North (Front) Foundation [1988].

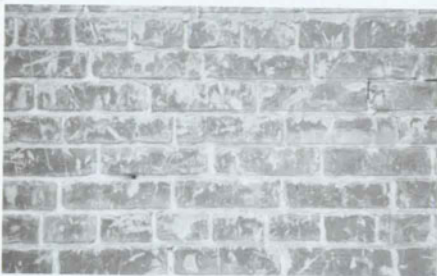
Figure 45. M'Clintock House: Damaged Bricks at Former East-Wall Trellis [1988].

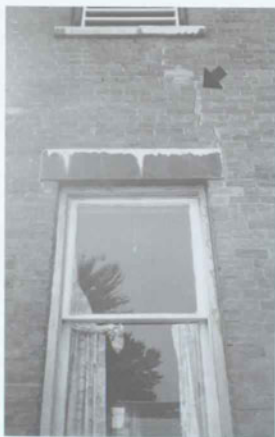
Figure 46. M'Clintock House: Vertical Crack Between Windows in the East Wall [1988].

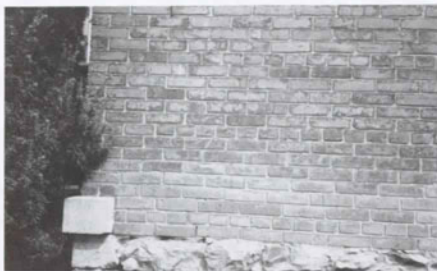
Figure 52. M'Clintock House: West Foundation and Wall, North End [1988].

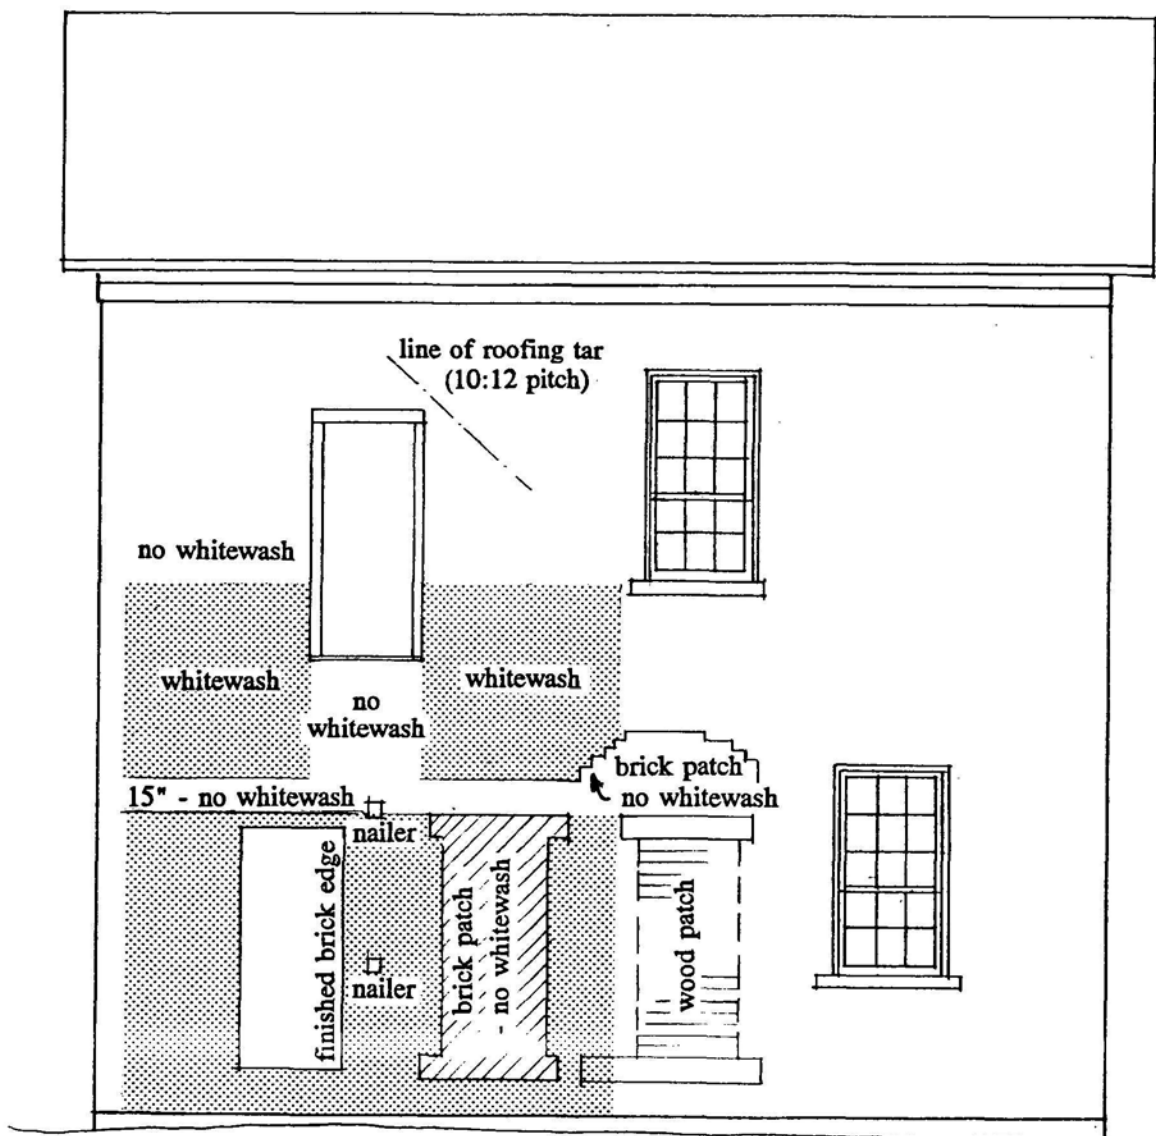
Figure 54. M'Clintock House: Physical Evidence Discovered on South Wall of Main House in May 1990.

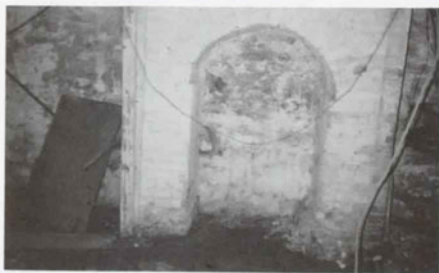
Figure 60. M'Clintock House: Cellar, East Chimney Foundation [1988].

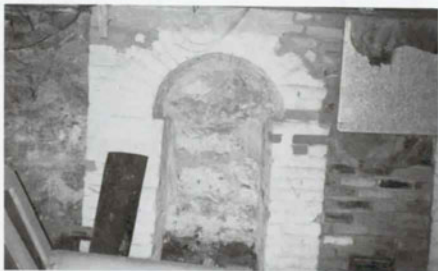
Figure 61. M'Clintock House: Cellar, West Chimney Foundation [1988].

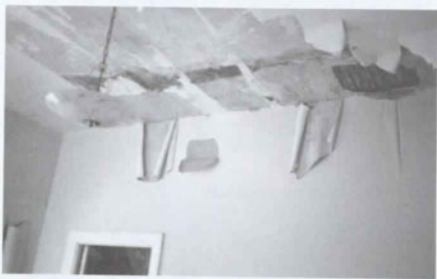
Figure 82. M'Clintock House: Room 103 (Southeast Room), Ceiling at West Wall [1988].
