THE STANTON HOUSE

Women's Rights
National Historical Park

Historic Structure Report

HISTORIC STRUCTURE REPORT

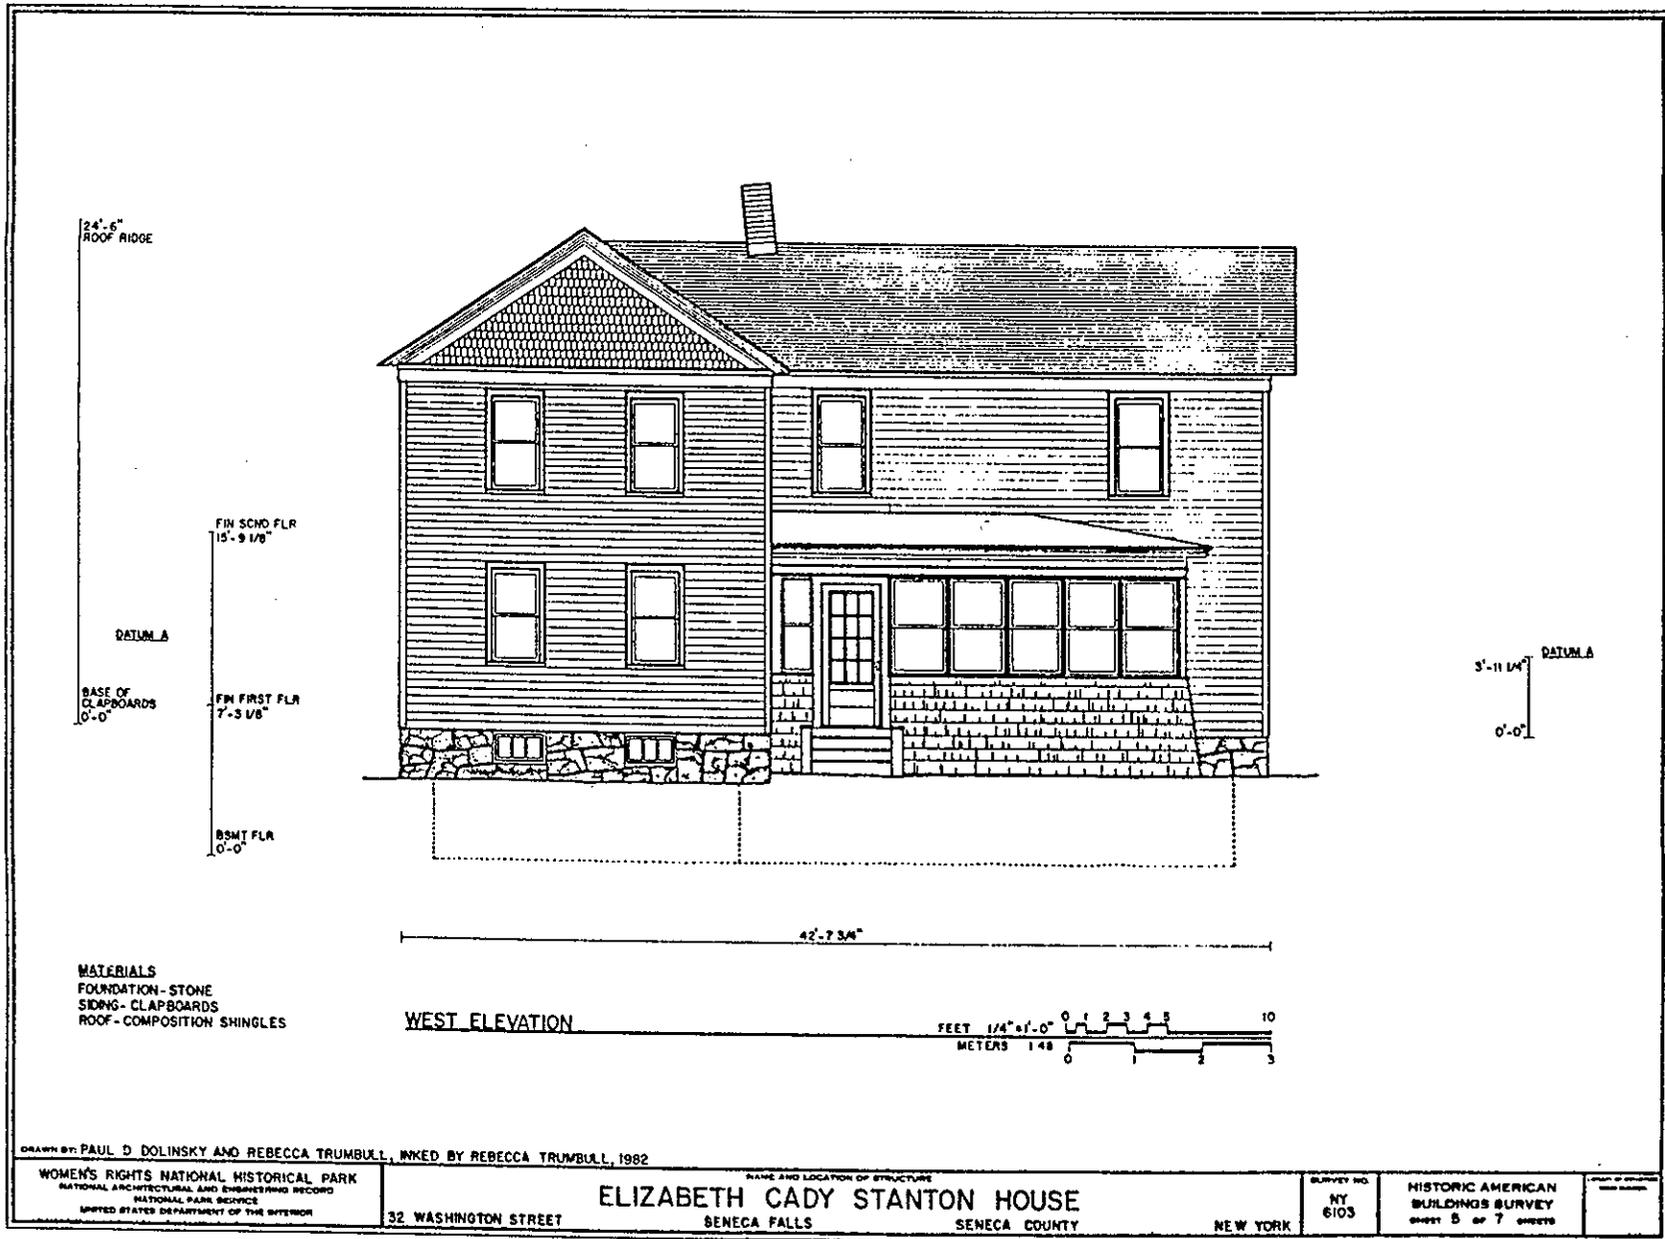
Figure 25. Stanton House: west elevation, summer 1982.

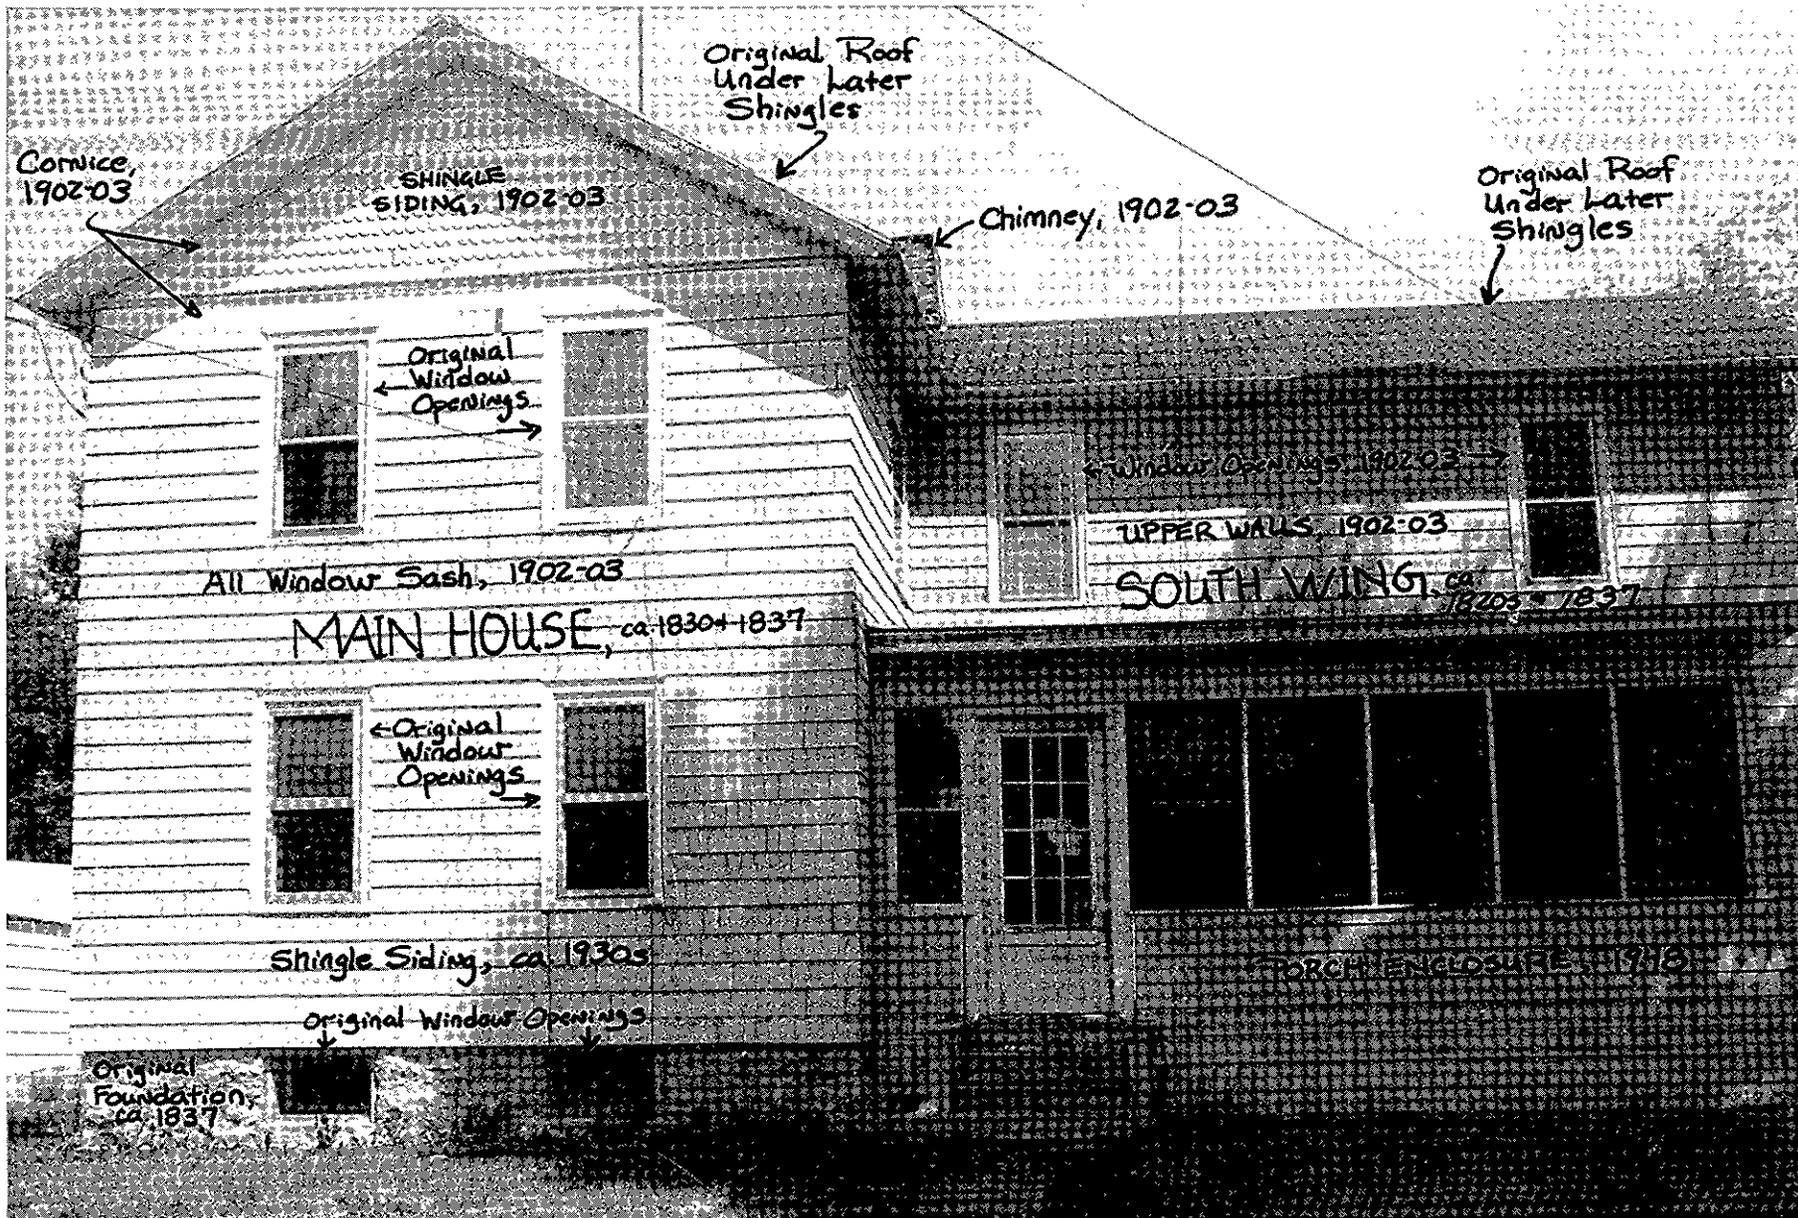
Figure 26. Stanton House: west elevation, June 1982.

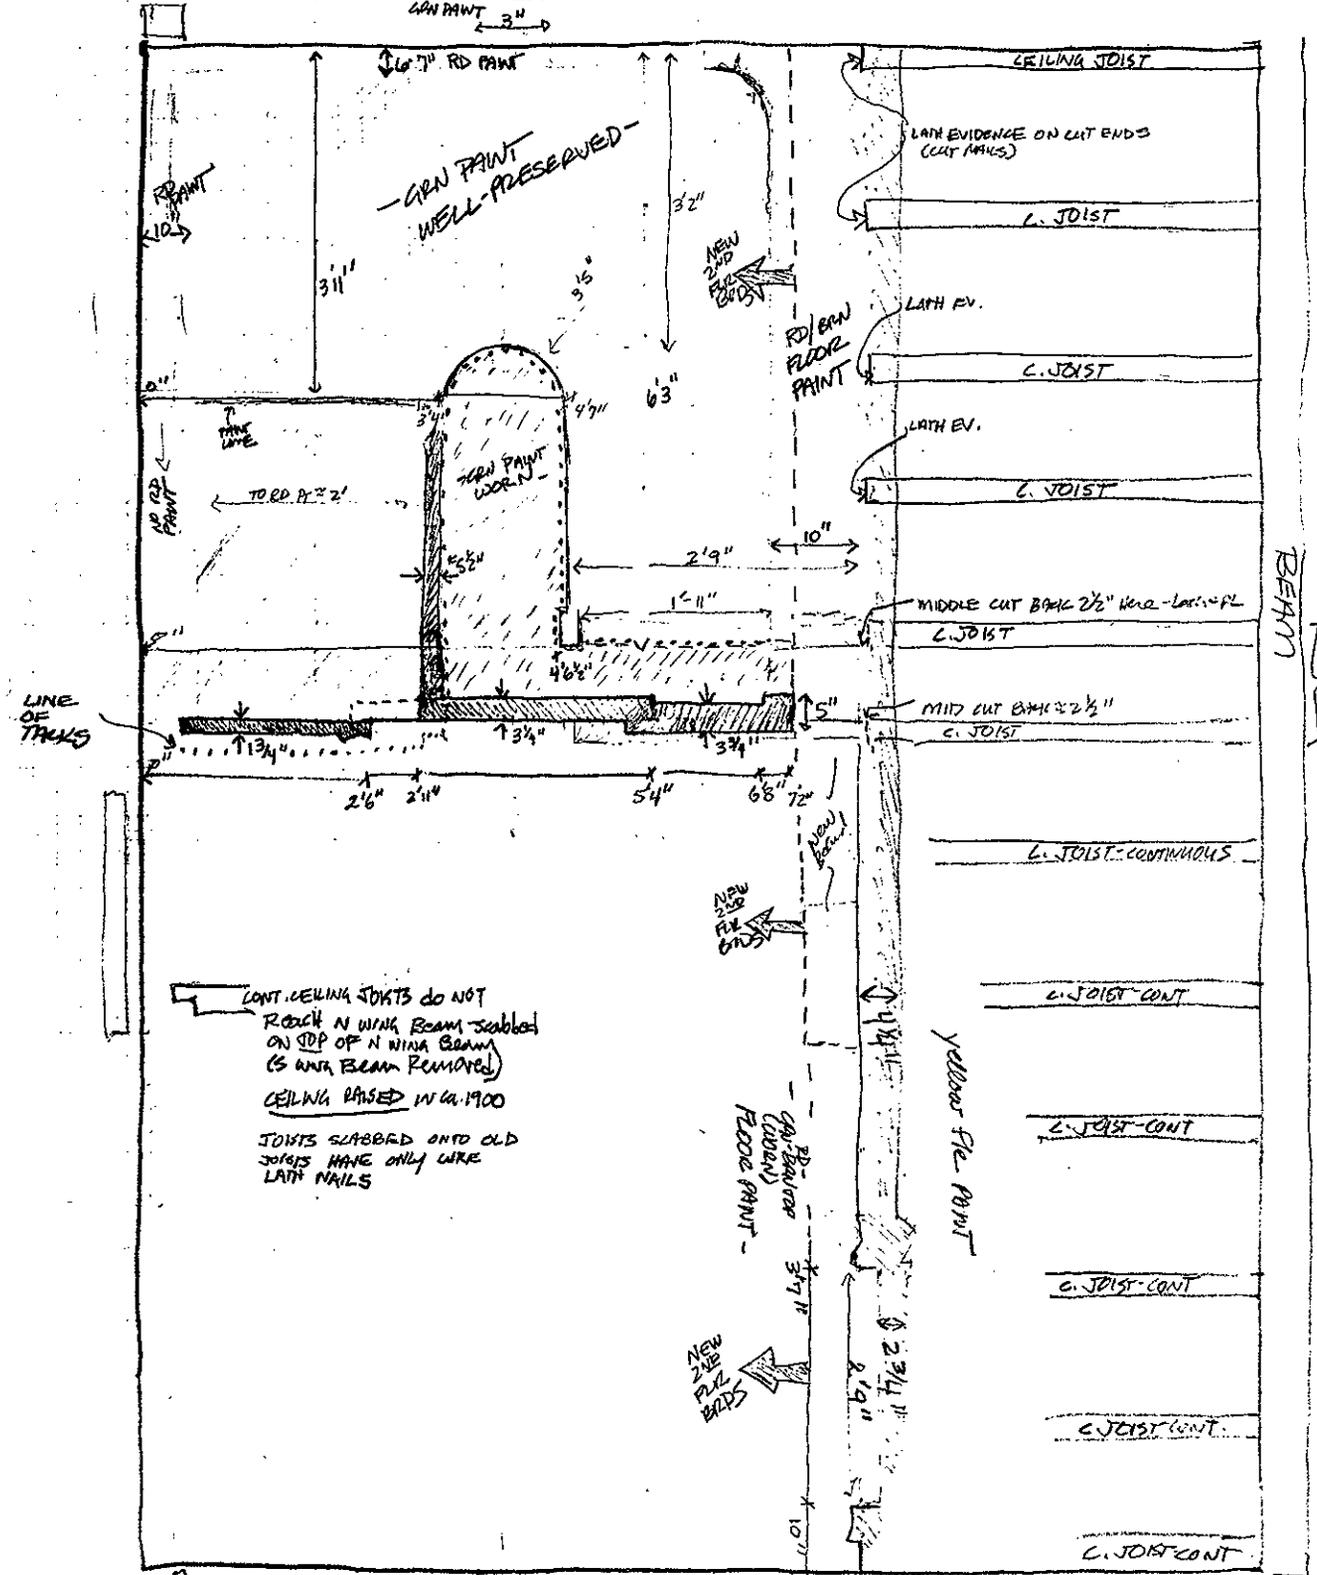
15 SEPT '82
 RM 103
 FLOOR

CONT. CEILING JOISTS DO NOT
 REACH N WING BEAM SCABBED
 ON TOP OF N WING BEAM
 (S WING BEAM REMOVED)
 CEILING RAISED IN CA. 1900
 JOISTS SCABBED ONTO OLD
 JOISTS HAVE ONLY WIRE
 LATH NAILS

↑ Reused scabbled JOIST w/ lath
 marks - may have been associated w/
 former stairs

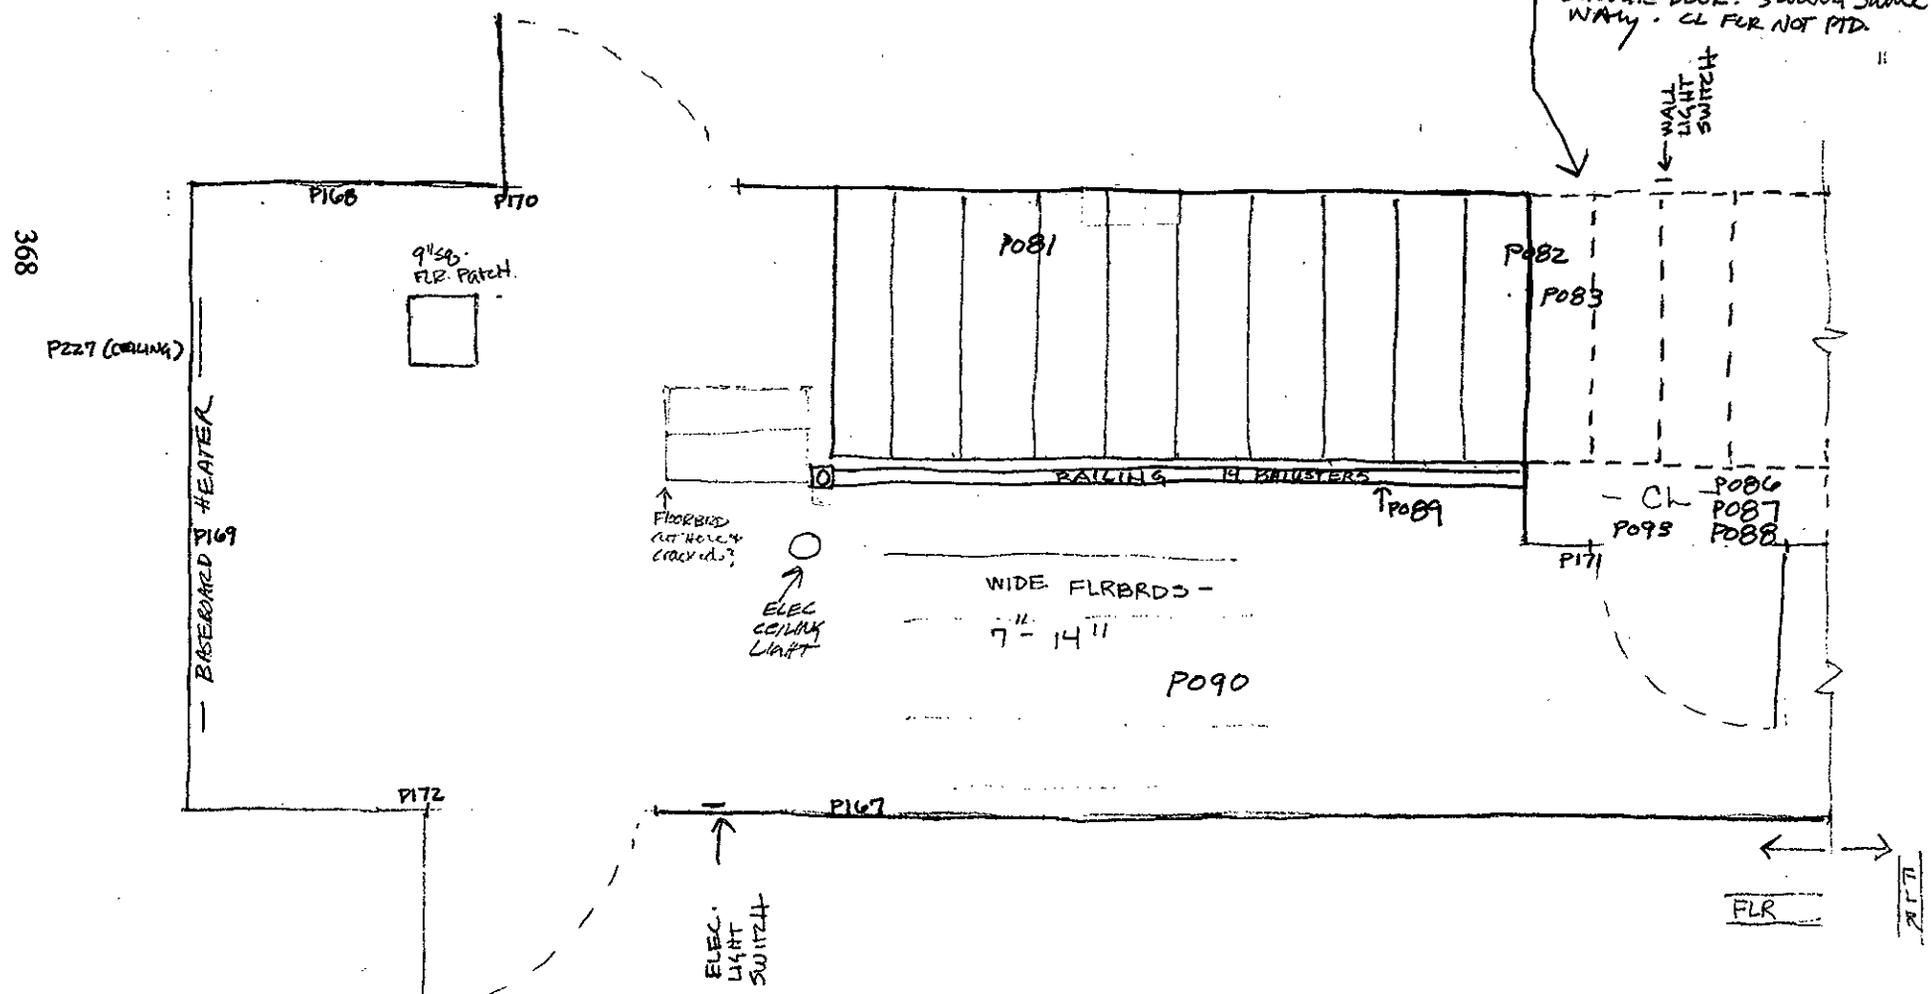
P114 (ceiling)
 P228 (UNDER FRONT PORCH)

ELEC. LMT IN CL. CEILING
CLOSET INT. PLASTERED. H2O
DAMAGE SE CORNER. EVIDENCE
FROM INT. OF EARLY DOOR FRAME -
3 HWTS. DOOR SWUNG SAME
WAY. CL. FLR NOT PTD.

FURBEDS IN THIS RM LESS
 WIDE THAN THOSE IN
 NE RM & HALL
 ~5"-9" W
