The History and Architecture of the **POINT REYES LIFEBOAT STATION**

Historic Structure Report

by
DEWEY LIVINGSTON
HISTORIAN, POINT REYES NATIONAL SEASHORE
and
STEVEN BURKE
HISTORICAL ARCHITECT, DENVER SERVICE CENTER

POINT REYES
NATIONAL PARK SERVICE
1991

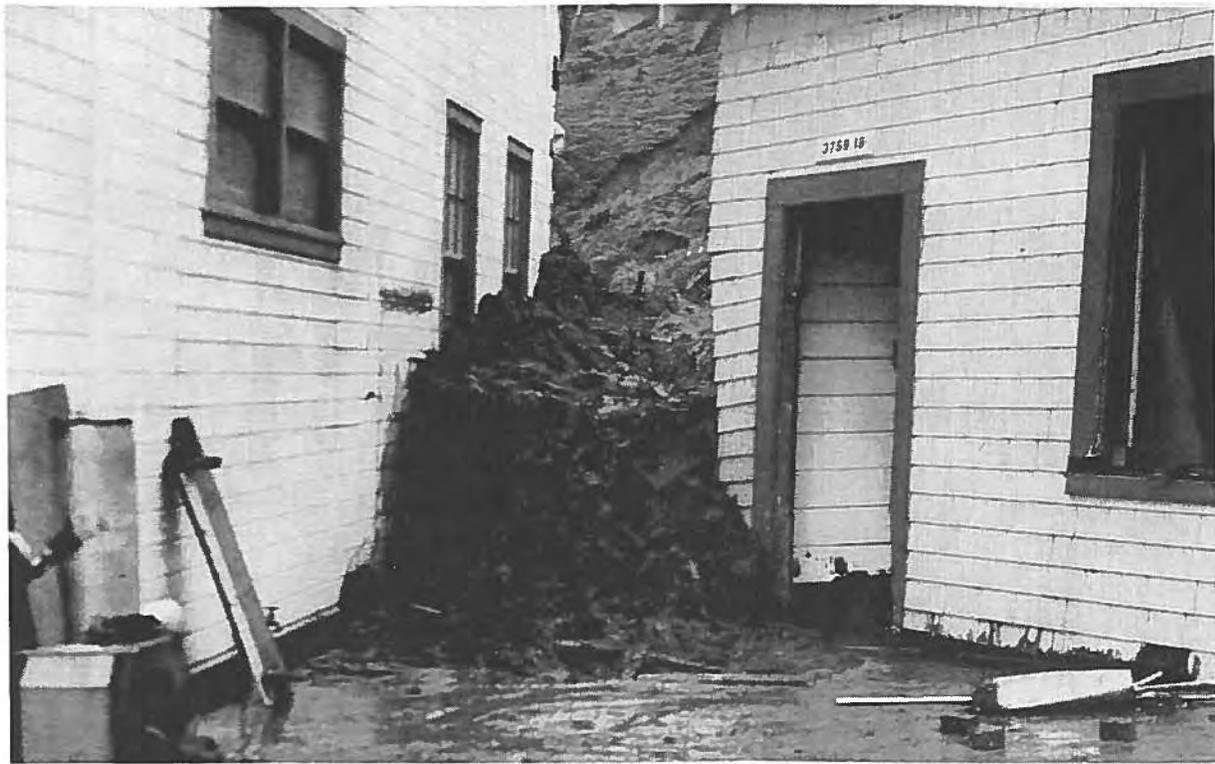
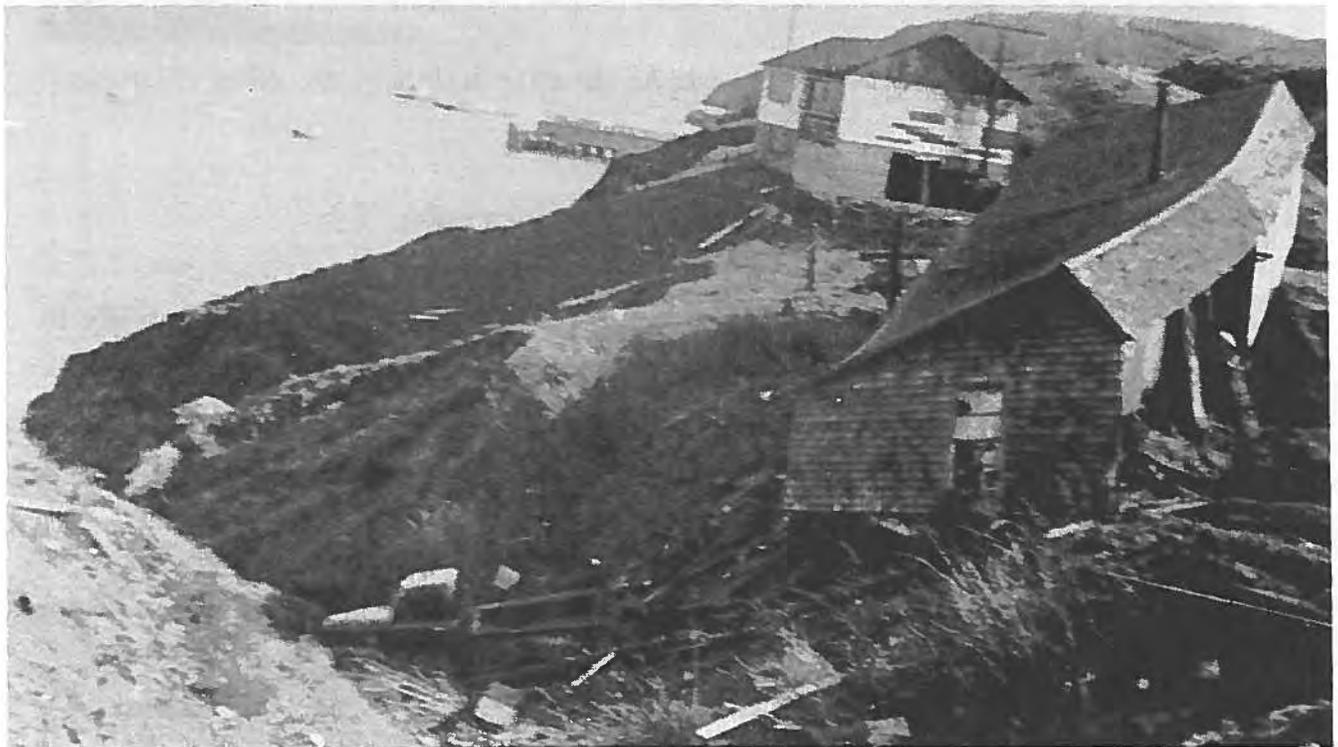
Top photo shows how the mud pushed the entry room off its foundation (National Park Service). Below, Mendoza's garage was damaged in a separate slide near the Officer-in-Charge quarters. (Charles Riedmuller)

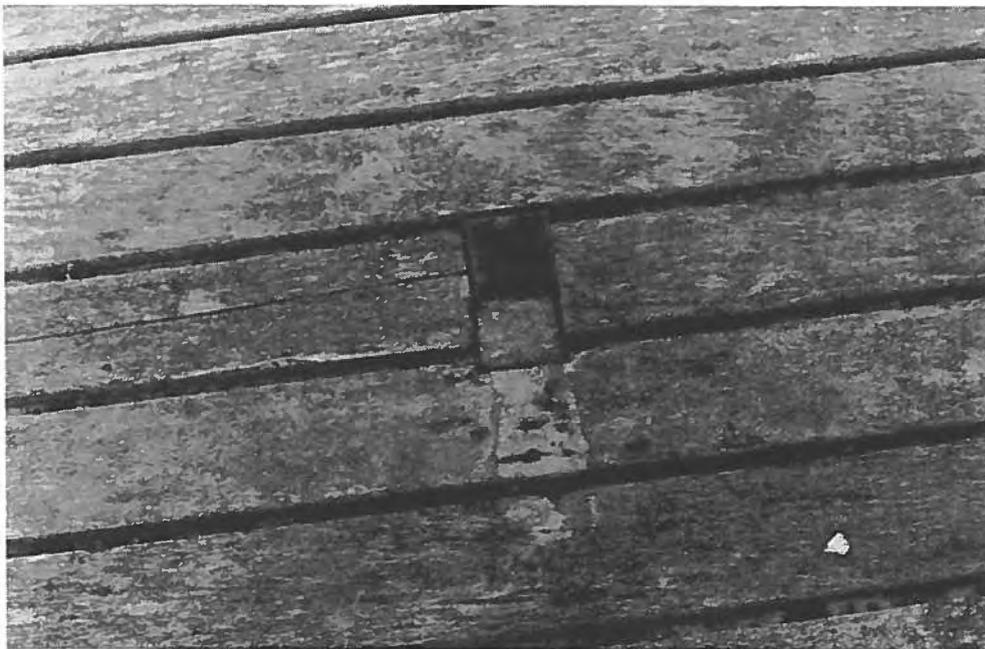
Figure 9 - Original location of door hold now cut off level with deck.

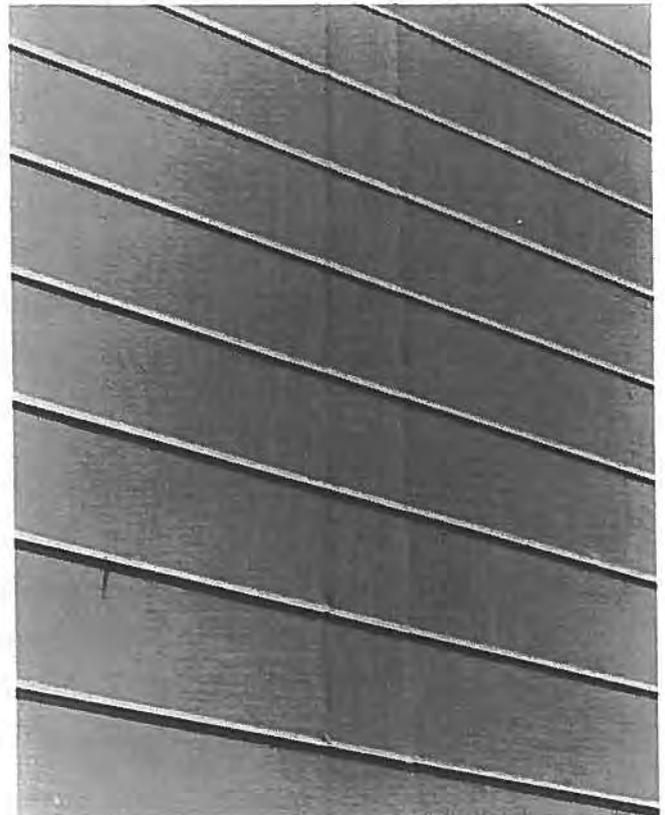
*Figure 11 (above) - Detail of 1956 photo showing metal gutters (U.S. Coast Guard).
Figure 12 (right) - Indentation in siding from old downspout.*

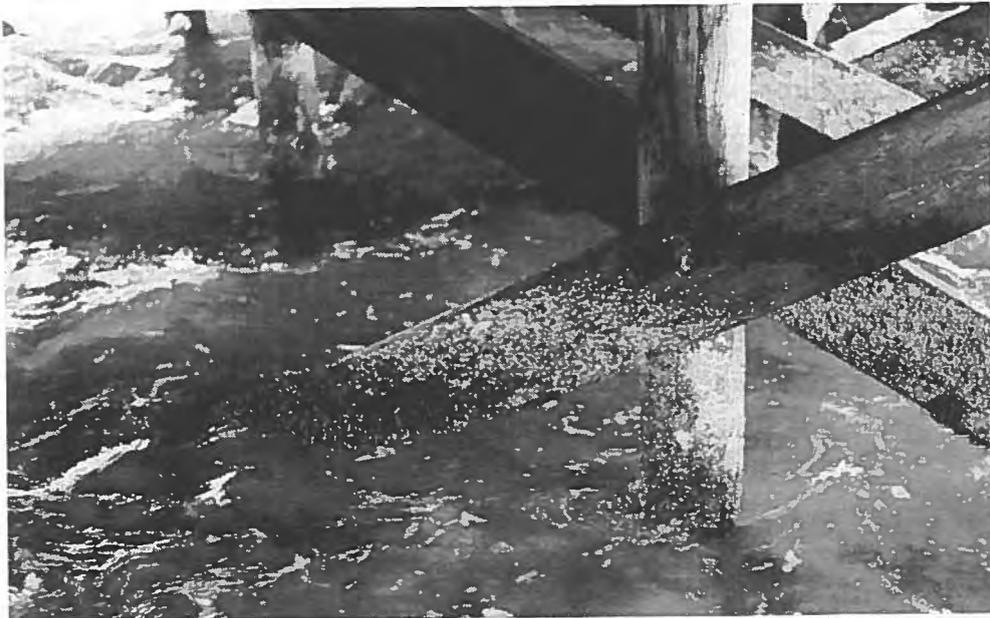
Figure 15 - Underside of launchway showing bolted connections and deteriorated cross-bracing.

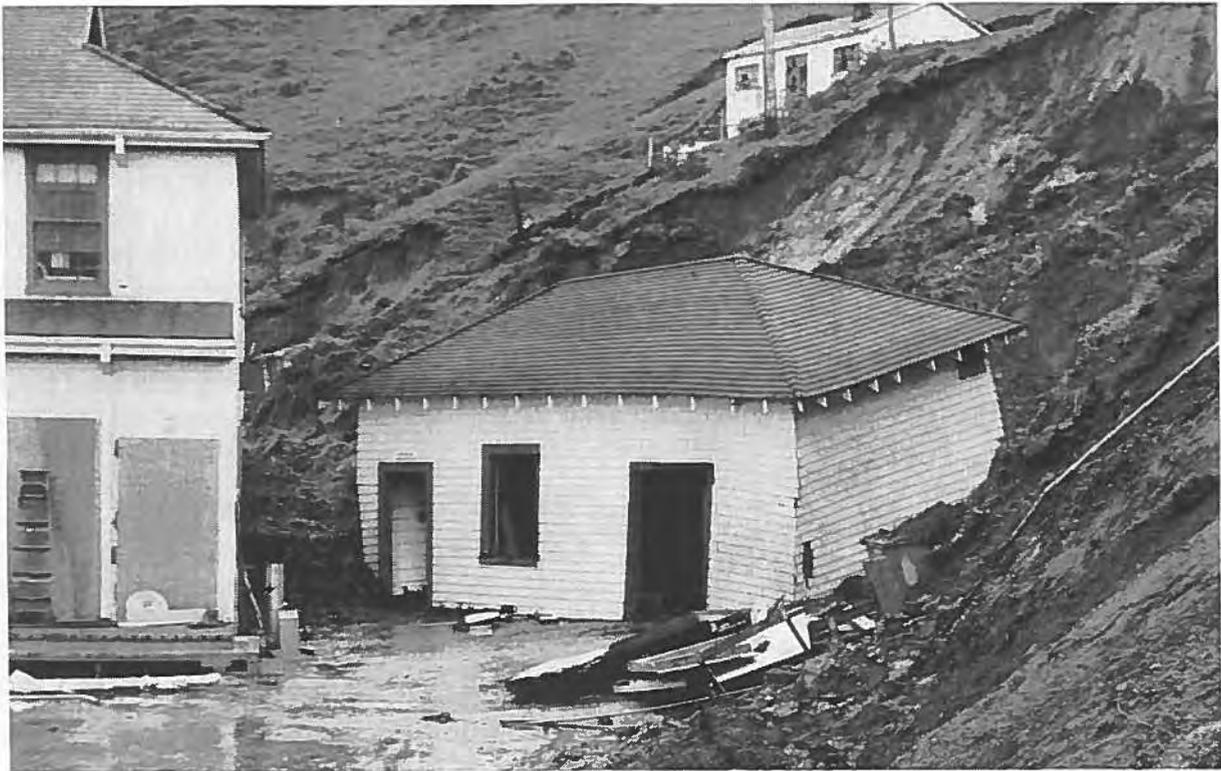
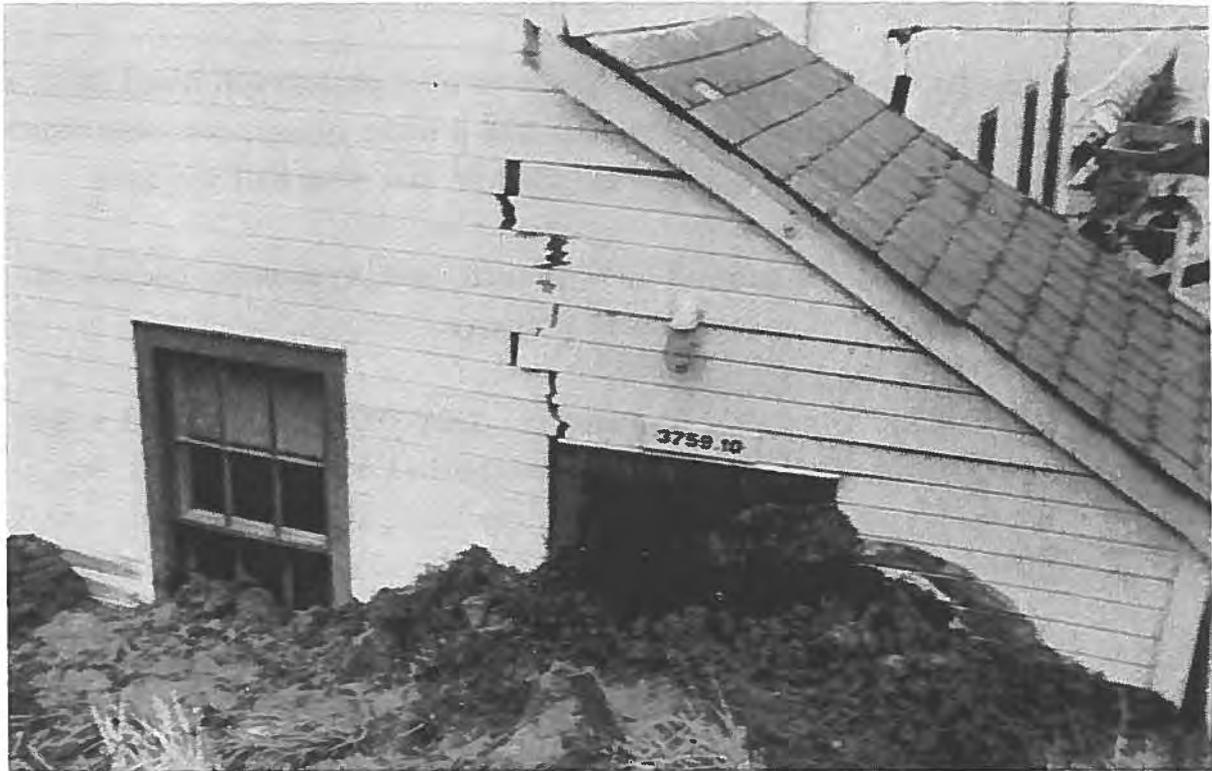
Figures 35 and 36 - Slide damage at boathouse, 1956. (NPS, Charlie Riedmuller)

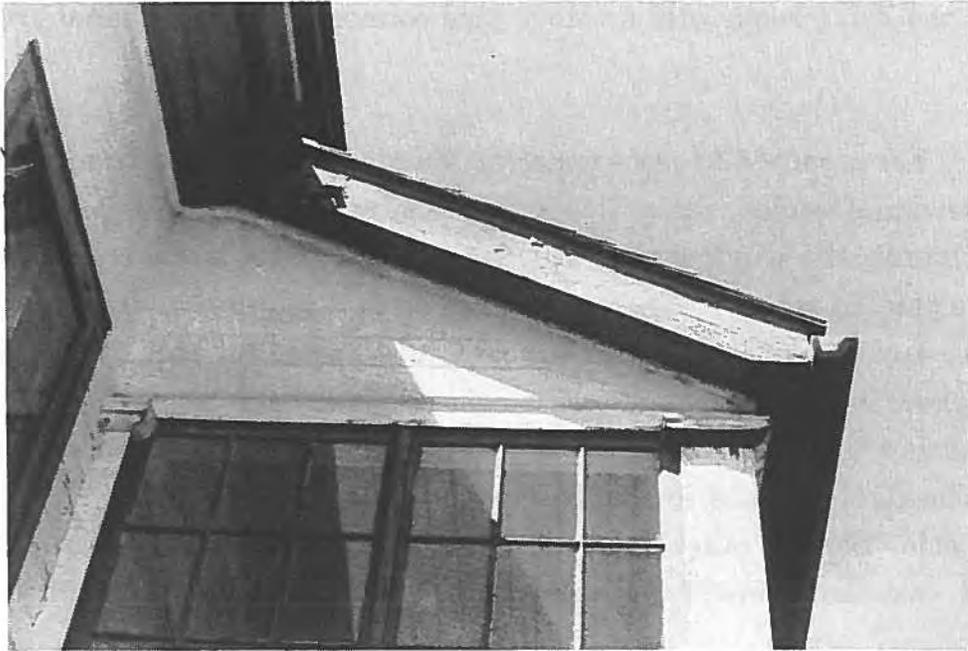
Figure 4 - Exterior detail, residence. Note the missing wood trim and need for paint.

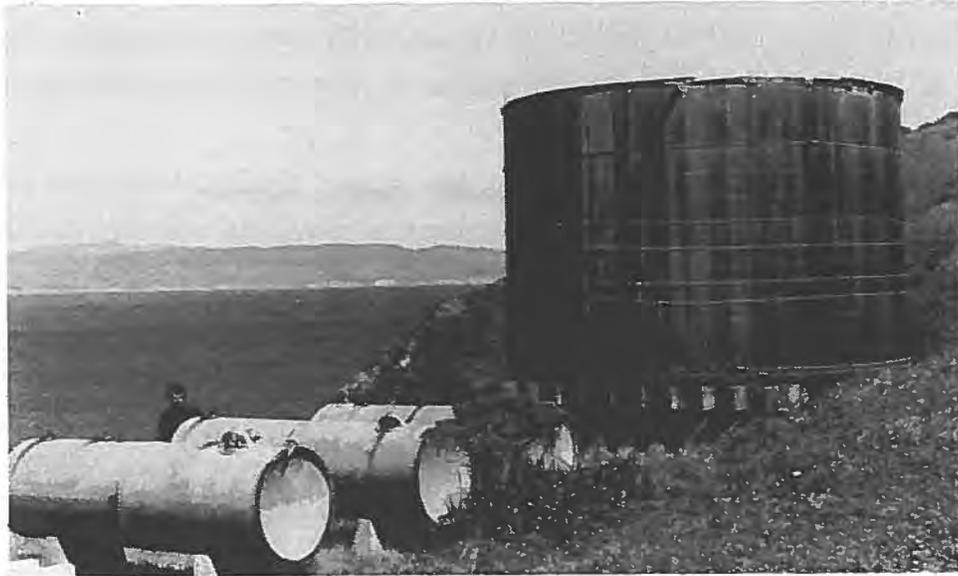
Figure 21 - Large deteriorated water tank and three smaller steel fuel tanks above boathouse.
