VIRGIN ISLANDS NATIONAL PARK
Cruz Bay, St. John, U.S. Virgin Islands

CANEEL BAY
STRUCTURAL ASSESSMENT REPORT

NATIONAL PARK SERVICE (NPS)
SOUTH EAST REGION (SER)

July 2025

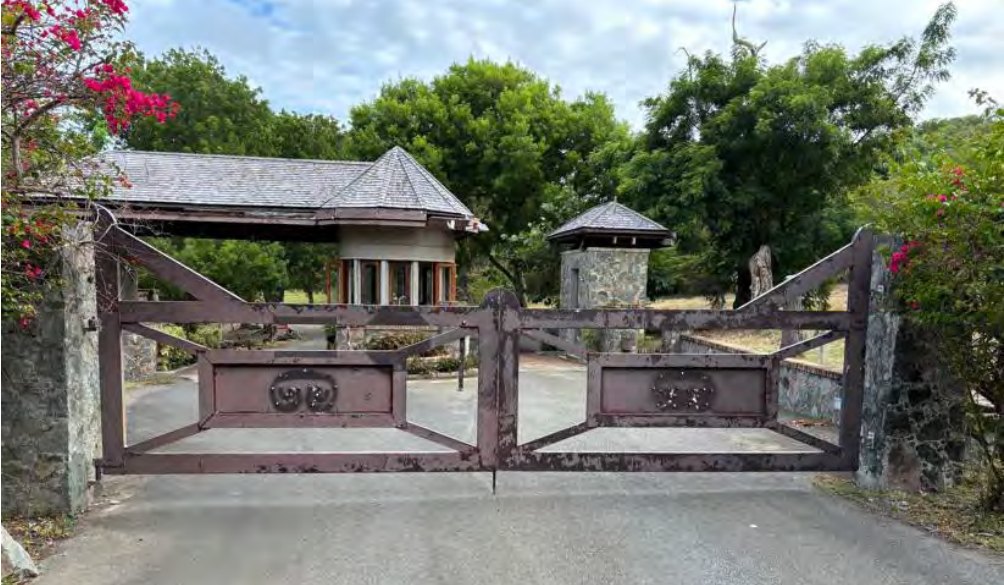
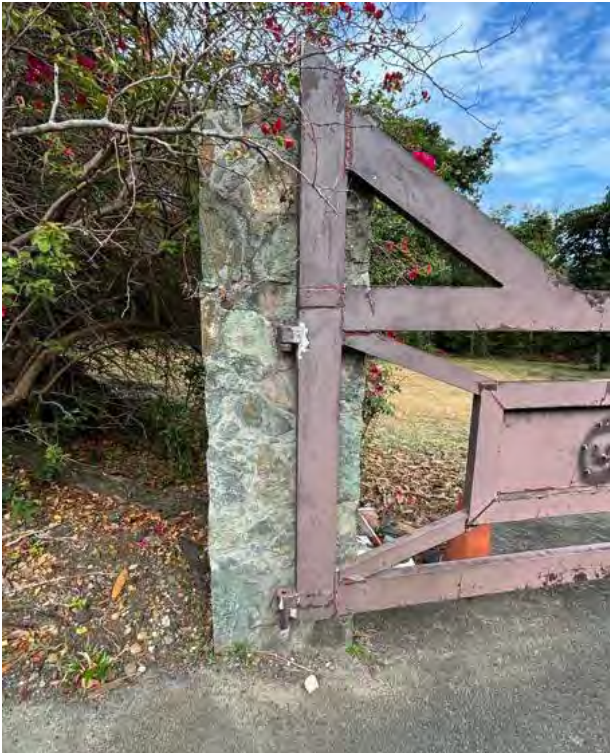
Building: 88 Welcome Center Gate

| Component | Material | Notes |
|---|---|--|
| Gate | Aluminum | Each gate leaf is approximately 116" wide by 78" tall and constructed with 2" deep painted aluminum tubes. The east gate has damage to one of the vertical leaf sections |

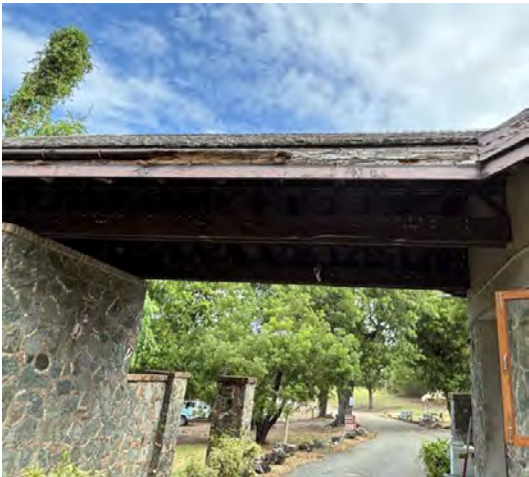
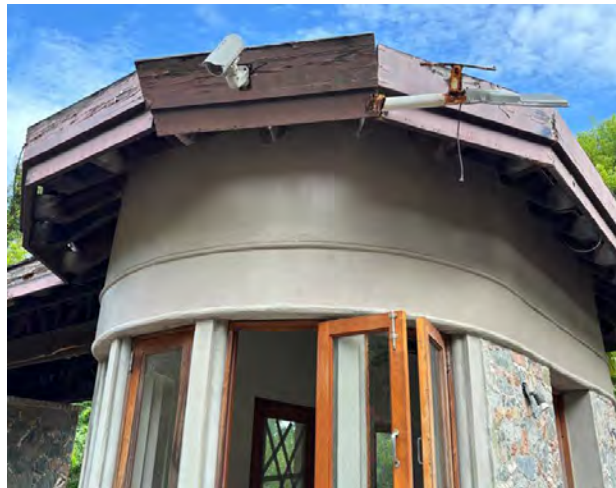
Building: 88 Welcome Center

| Component | Material | Notes |
|---|--|--|
| Roof | Timber Truss / Timber Rafters / Wood Shingles | Signs of termite activity. Impact damage bottom chord of truss. The secondary framing rafters showed signs of excessive termite and water damage in select areas. Damage was especially prevalent at the hip rafter over the storage room and comfort station. |

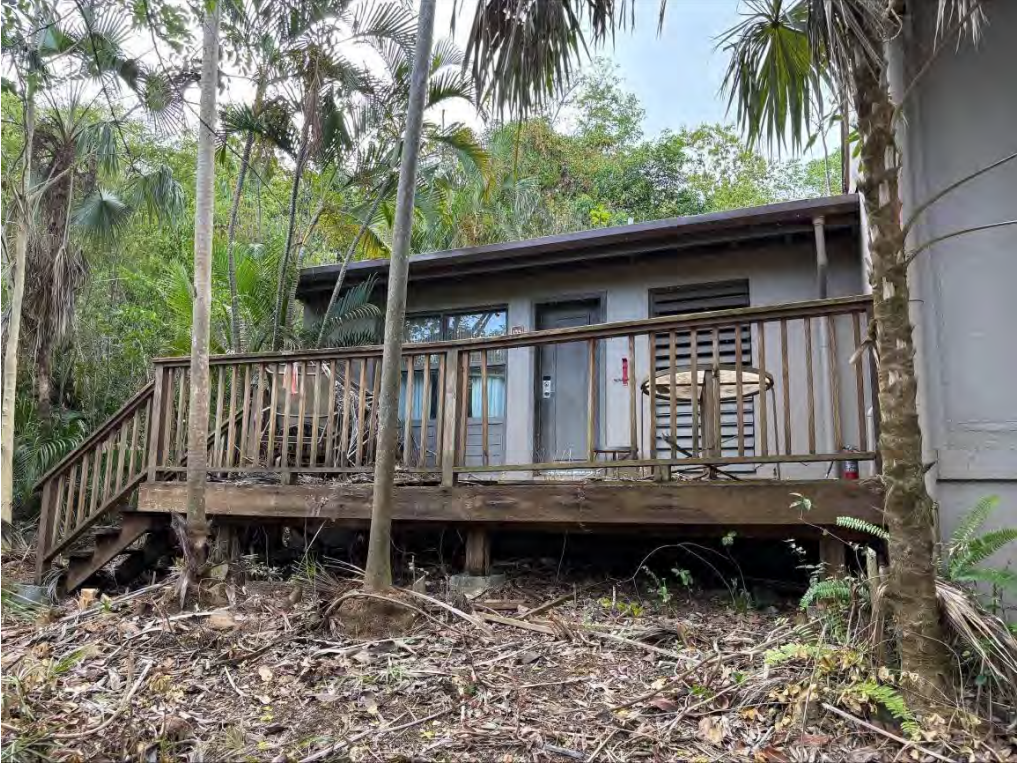
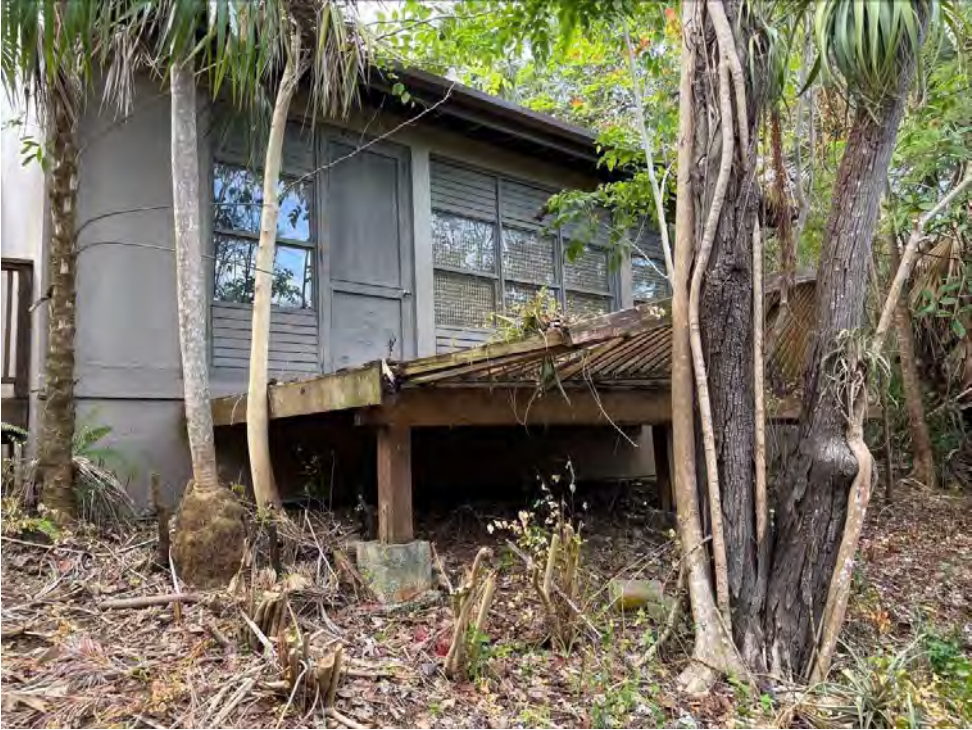
Building: 57 Garden View Units 132-133

| Component | Material | Notes |
|---|---|--|
| Walls (Structural) | Concrete | Cracks at NE wall corner, NW foundation of 132, and vertical crack in dividing wall between 131 and 132. |
| Roof | Wood framed/ Metal Roof | Vegetation growing in gutter, termite damage potential |
| Deck / Railings | Wood | Decks and railings have failed. |

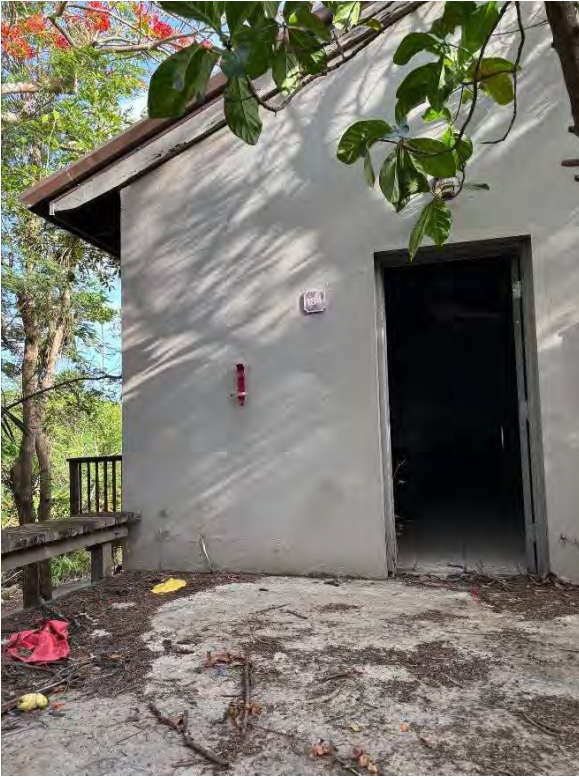
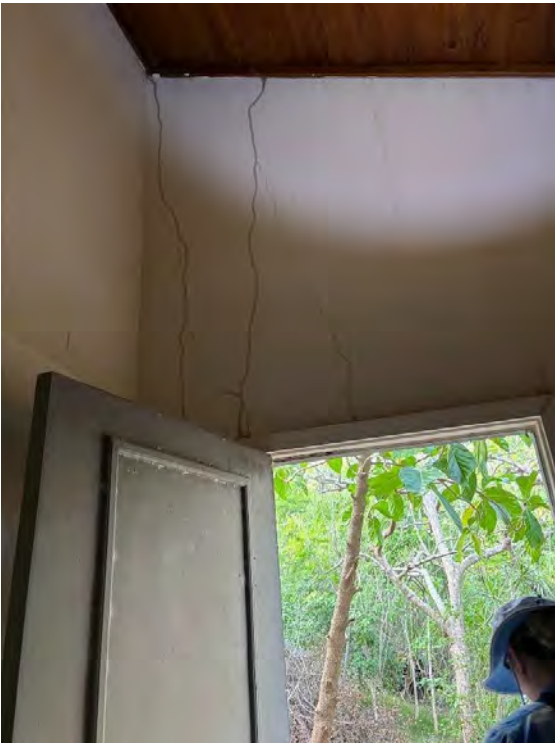
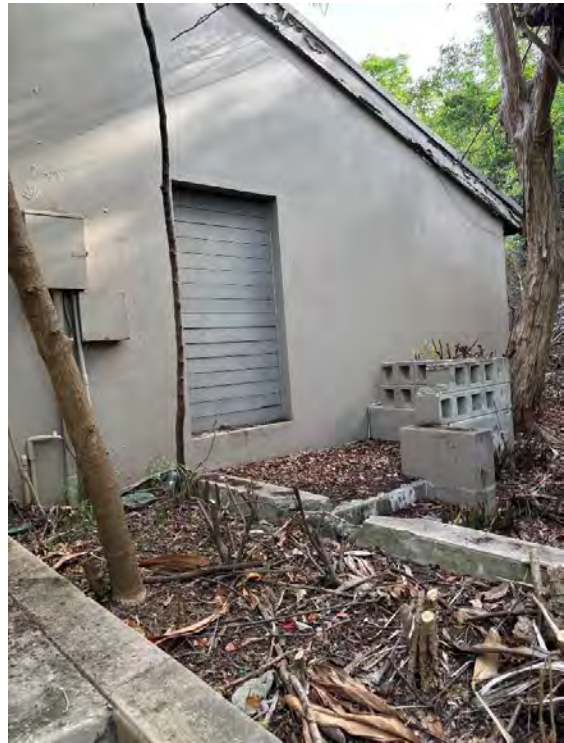
Building: 50 Garden View Units 134-135

| Component | Material | Notes |
|---|---|---|
| Walls (Structural) | Concrete | Moisture infiltration at north side of 135. |
| Roof | Wood framed/ Metal Roof | Vegetation growing in gutter. Potential termite damage. |
| Deck / Railings | Wood | Decks and railings have failed. |

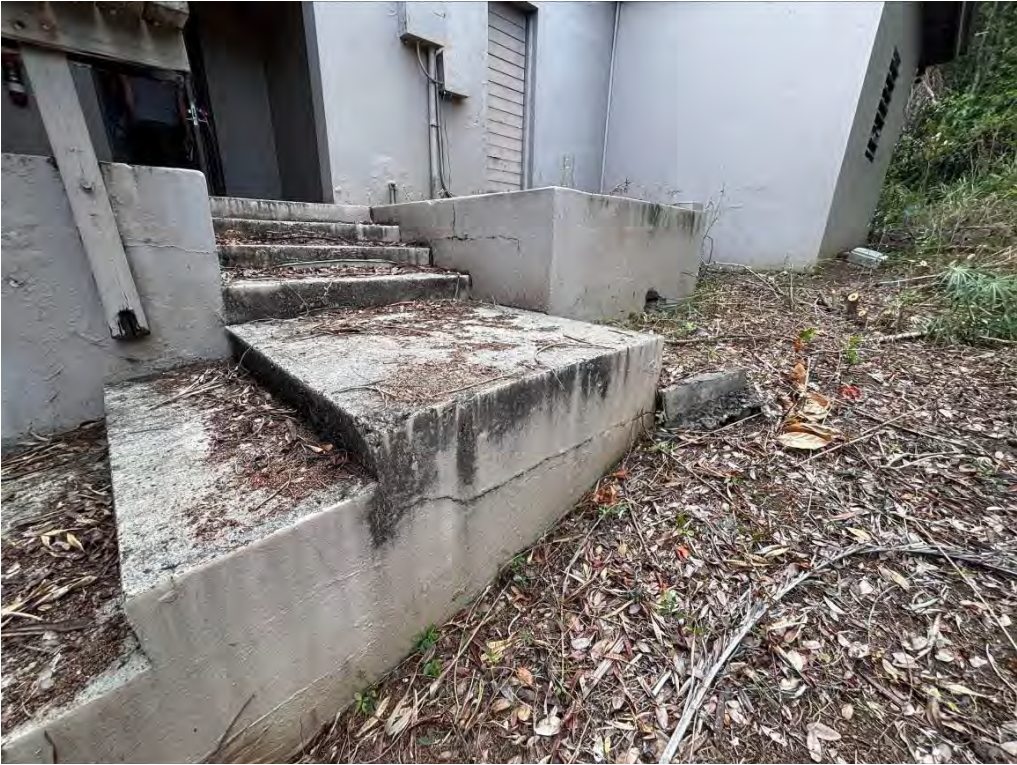
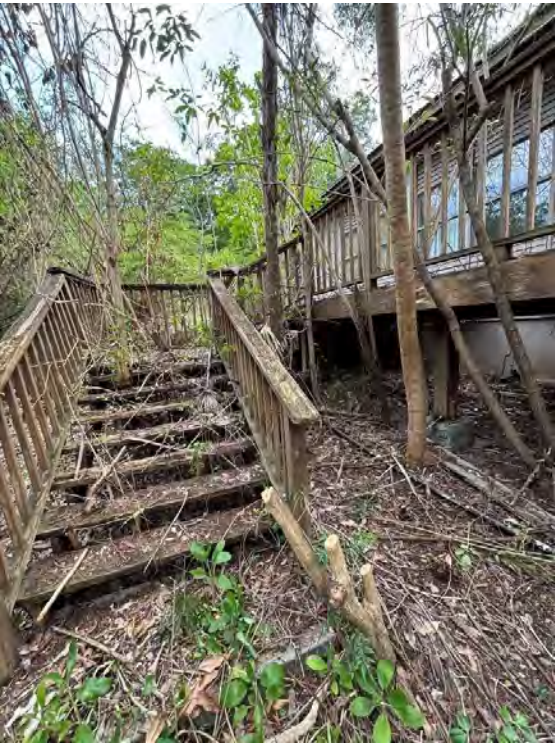
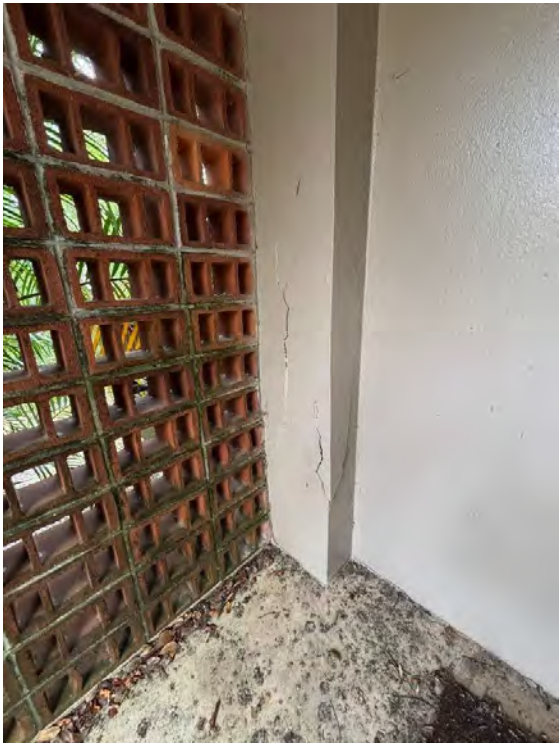
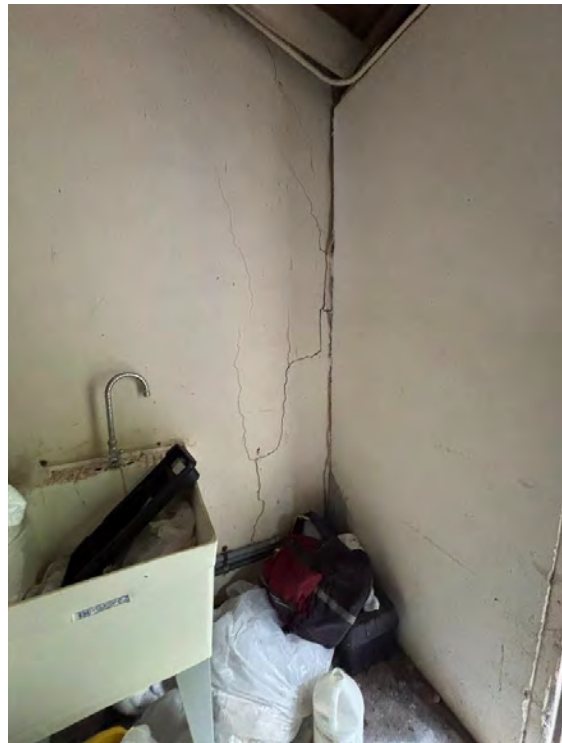
Building: 49 Garden View Units 136-138

| Component | Material | Notes |
|---|---|---|
| Walls (Structural) | Concrete | Cracks observed in walls running north-south. Crack in north wall of custodial closet. Widening gap between custodial closet and main building. Cracks observed in concrete column and concrete wall near entrance of 136. |
| Walls (Non-Structural) | Concrete/ Wood | Cracks observed in concrete partition walls running north-south. |
| Roof | Wood framed/ Metal Roof | Vegetation growing in gutter. Potential termite damage. |
| Deck / Railings | Wood | Decks and railings have failed. |

- Recommend further investigation to identify underlying problems causing wall cracking. There is evidence of previous repairs at cracks that have failed. Wall cracks indicate that there may be differential foundation movement.

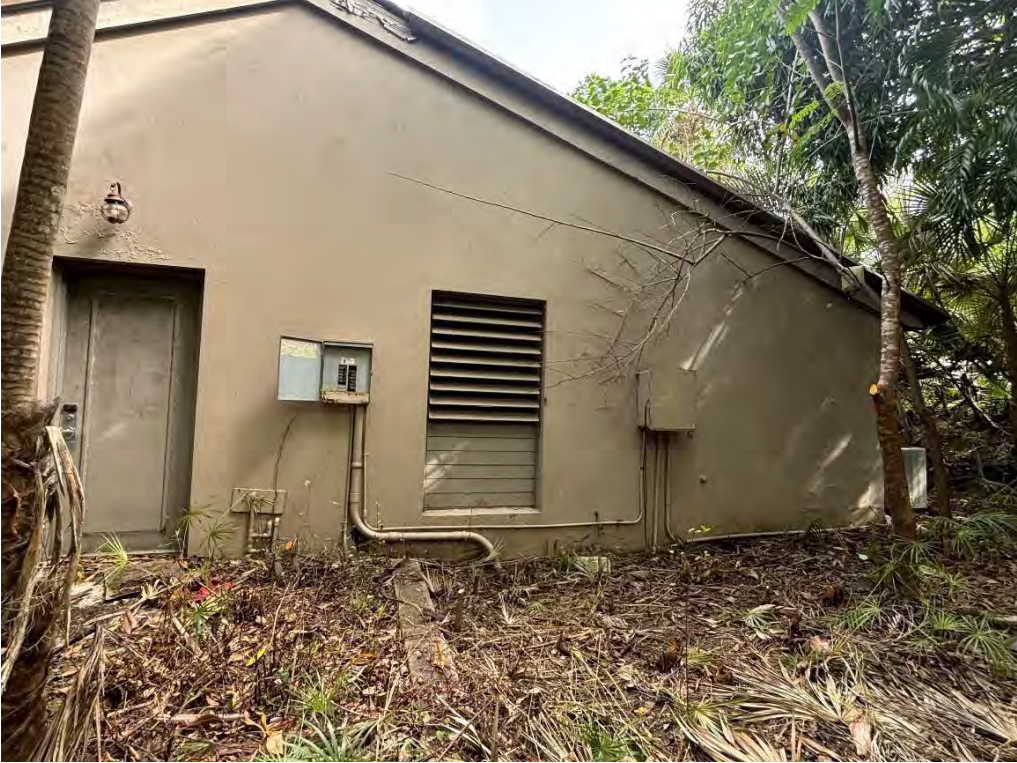
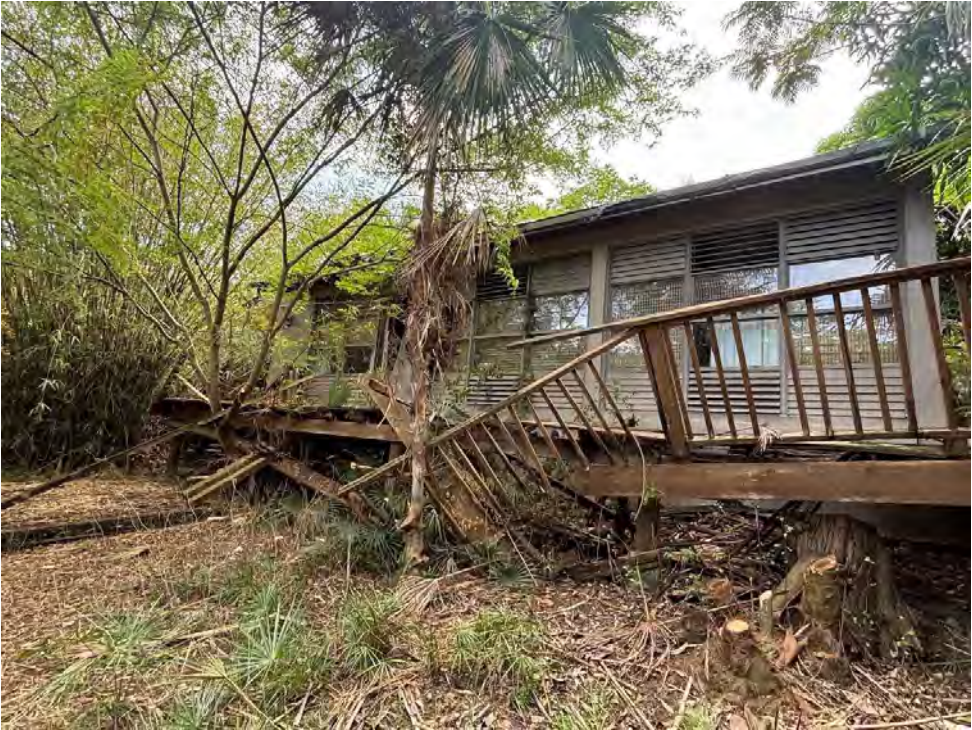
Building: 51 Garden View Units 139-140

| Component | Material | Notes |
|---|---|--|
| Walls (Structural) | Concrete | Vertical crack in south wall of 140. Vertical crack with signs of previous repair on north wall of 139, water infiltration and spalling of parging on interior face of wall. |
| Roof | Wood framed/ Metal Roof | Vegetation growing in gutter. Potential termite damage. |
| Deck / Railings | Wood | Decks and railings have failed. |

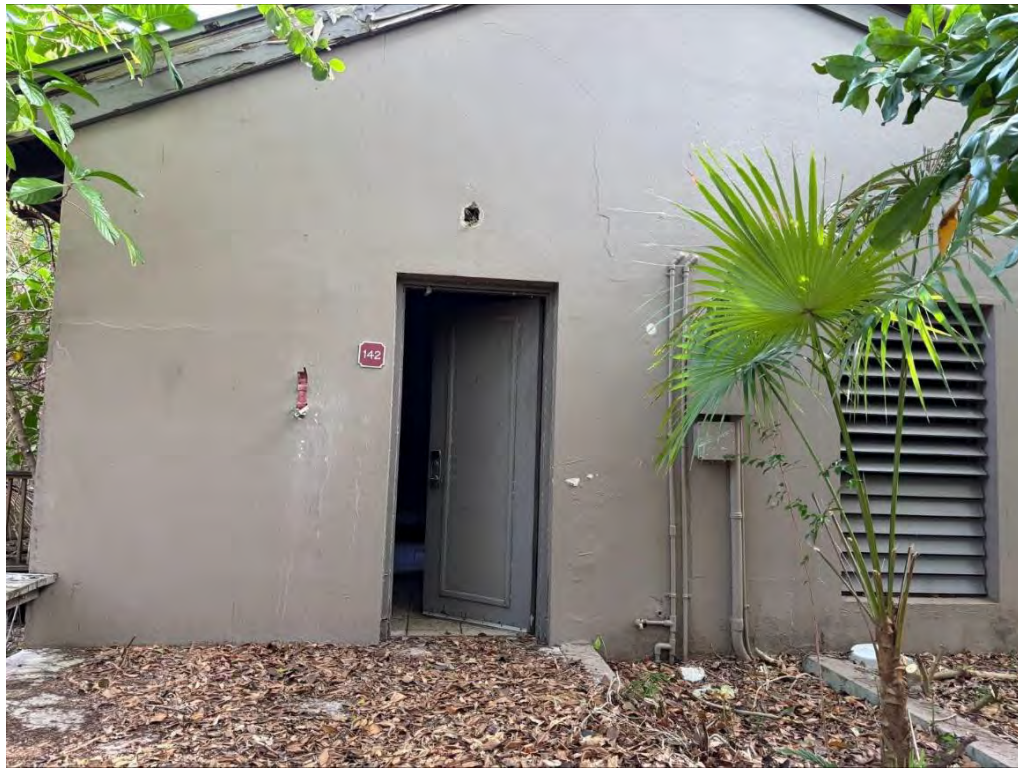
Building: 52 Garden View Units 141-142

| Component | Material | Notes |
|---|---|--|
| Walls (Structural) | Concrete | Cracked column on east side of building. |
| Roof | Wood framed/ Metal Roof | Vegetation growing in gutter. Potential termite damage. |
| Deck / Railings | Wood | Decks and railings have failed. |

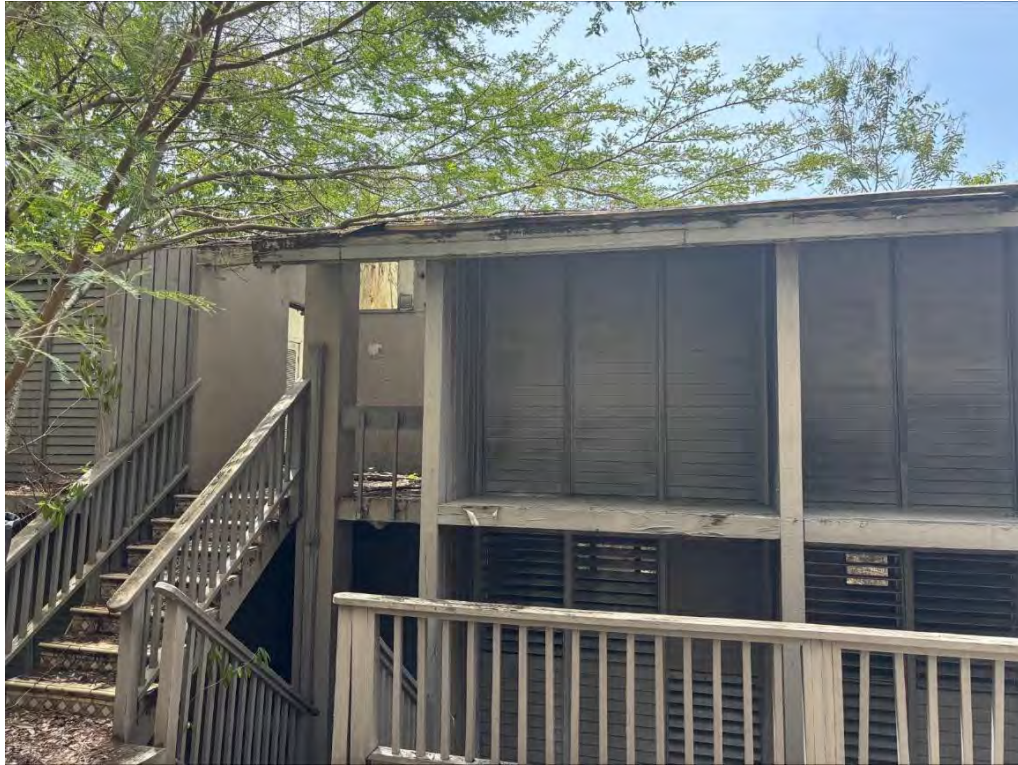
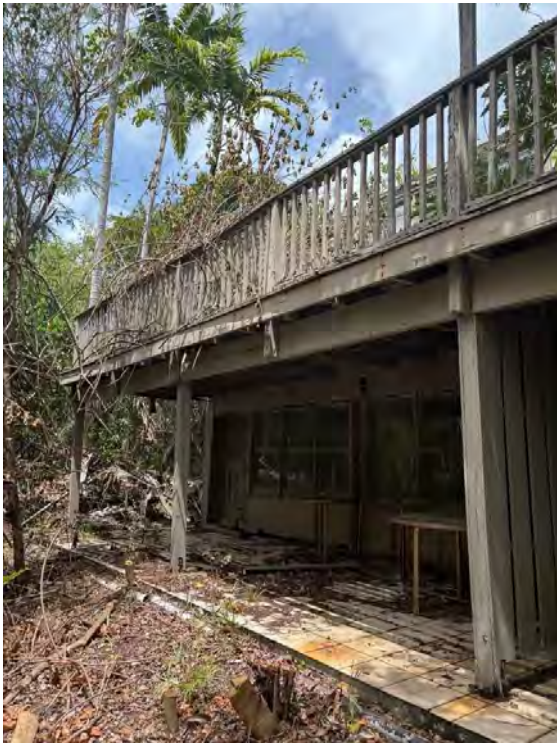
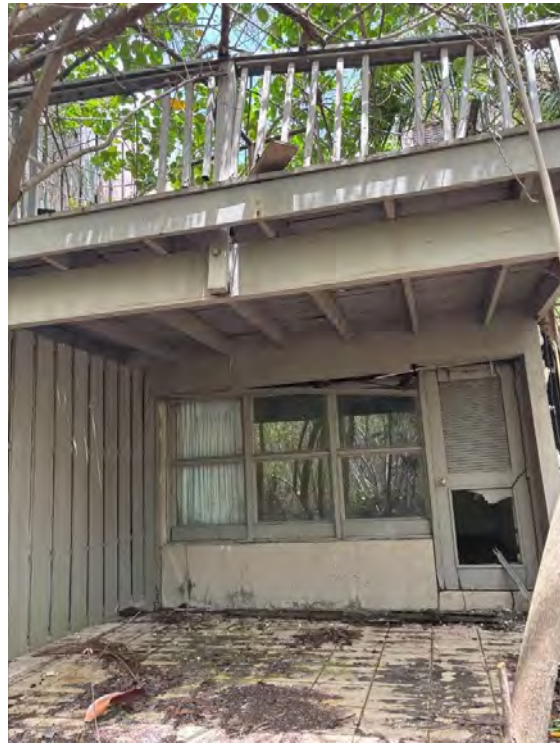
Building: 53 Courthouse Units 143-152

| Component | Material | Notes |
|---|---|--|
| Walls (Non-Structural) | Wood | Severe deterioration. Most of the exterior north facing walls have completely failed on the 2 nd floor and severely damaged on the 1 st floor. |
| Roof | Wood | Severe failure. A significant percentage of the wood roof has collapsed. Termite tubes noted throughout the structure. |
| Stairs/Railings | Stairs – Concrete Railings - Wood | Wood railings are damaged and rotten. |
| Exterior Deck | Wood | Severe deterioration of all exterior decks. Unsafe to walk on. |

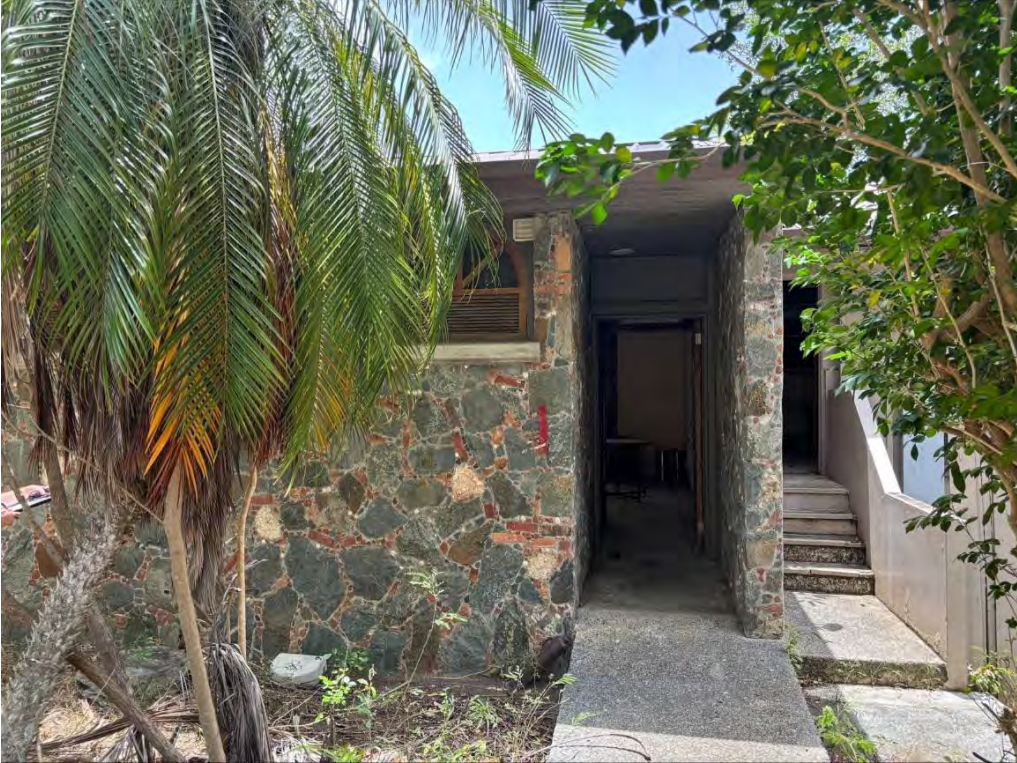
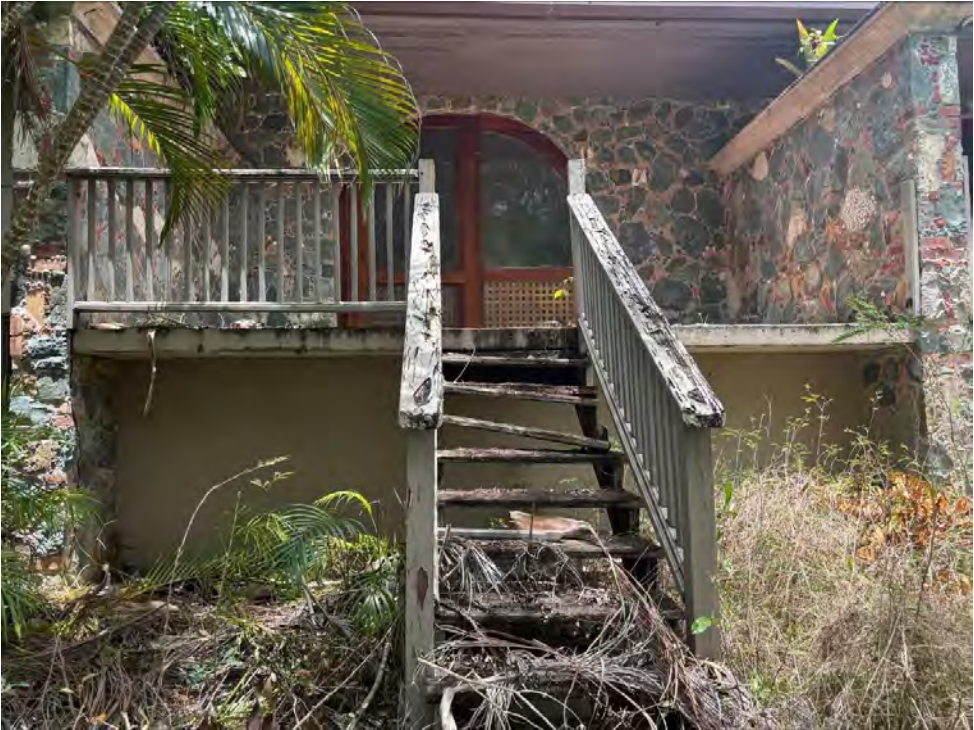
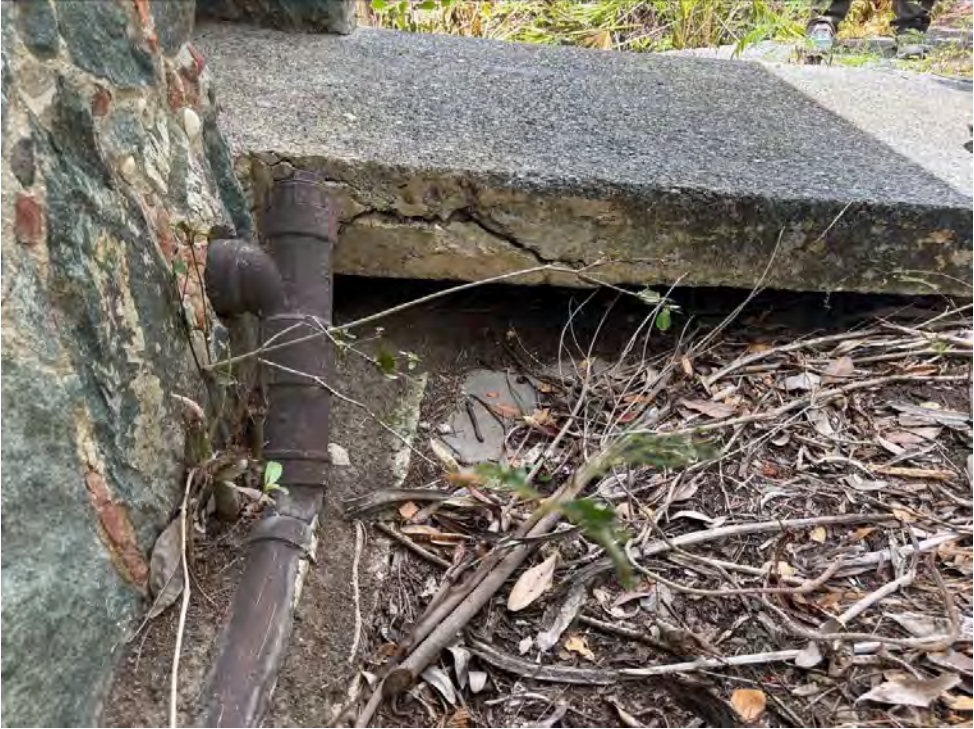
Building: 54 Garden View Unit 153

| Component | Material | Notes |
|---|---|---|
| Walls (Structural) | Stone | Termite tubes observed. |
| Roof | Wood Framed / Metal Roof | Vegetation growing in gutter. Potential termite damage. |
| Stairs/Railings | Wood | Severely deteriorated. |
| Sidewalk | Concrete | Cracked and spalled concrete at elevated slab portion. |

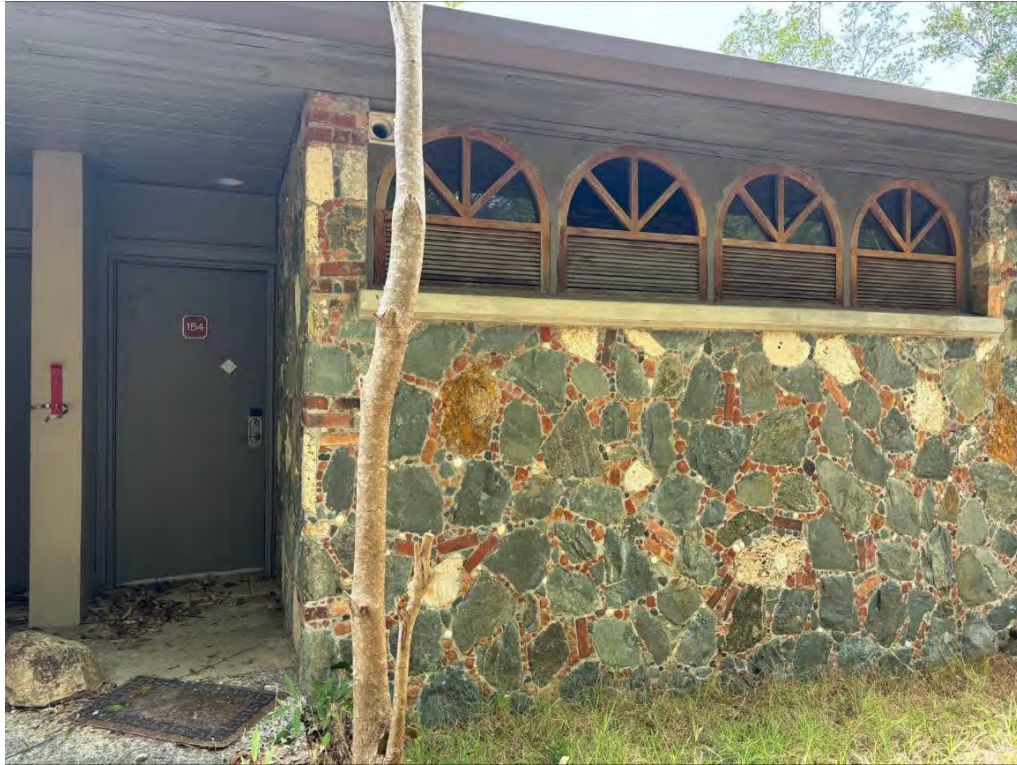
Building: 54 Garden View Unit 154

| Component | Material | Notes |
|---|---|---|
| Walls (Non-Structural) | Stone | Exterior concrete cap is spalling. |
| Roof | Wood Framed / Metal Roof | Vegetation growing in gutter. Potential termite damage. |
| Stairs/Railings | Wood | Severely deteriorated. |

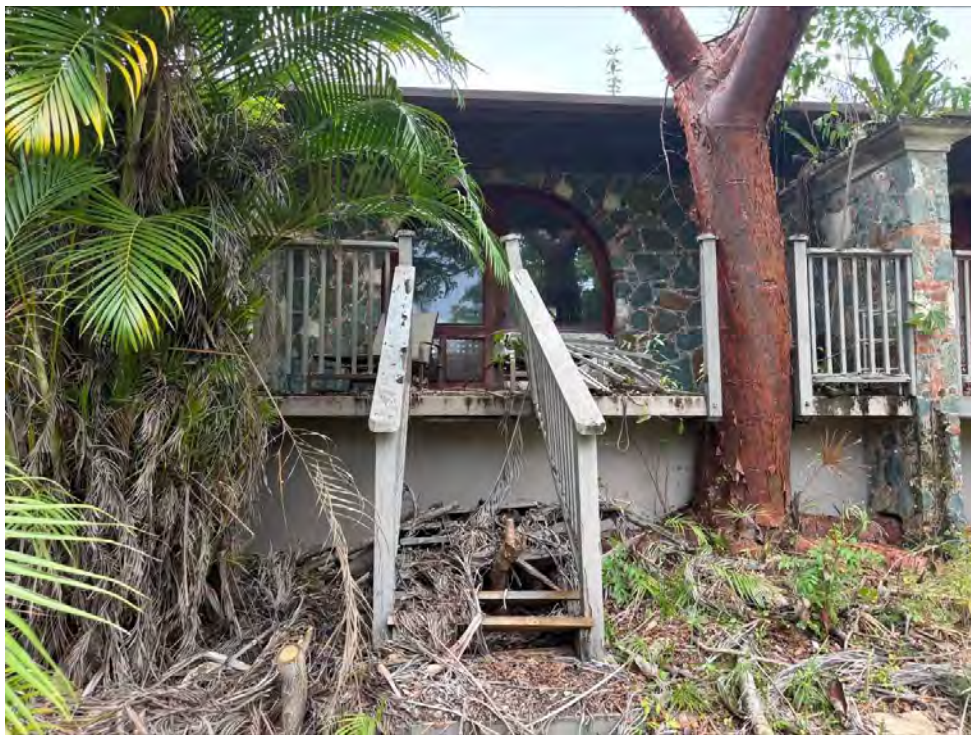
Building: 54 Garden View Unit 155

| Component | Material | Notes |
|---|---|---|
| Walls (Structural) | Stone | Termite tubes observed. |
| Roof | Wood Framed / Metal Roof | Vegetation growing in gutter. Potential termite damage. |
| Stairs/Railings | Wood | Severely deteriorated. |

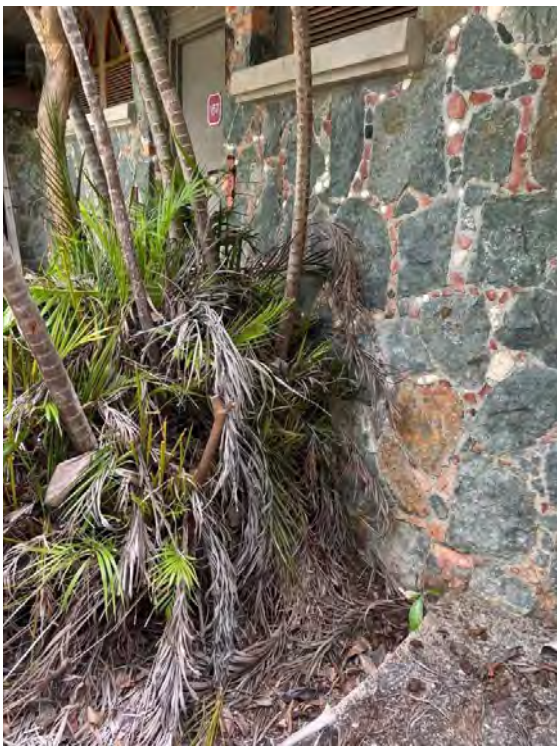
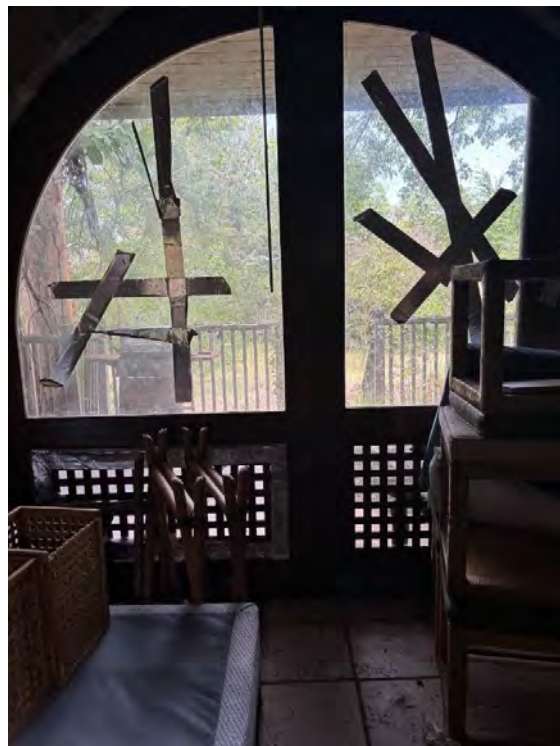
Building: 54 Garden View Unit 156

| Component | Material | Notes |
|---|---|---|
| Walls (Structural) | Stone | Termite tubes observed. |
| Walls (Non-Structural) | Stone | Exterior concrete cap is spalling. |
| Roof | Wood Framed / Metal Roof | Vegetation growing in gutter. Potential termite damage. |
| Stairs/Railings | Wood | Severely deteriorated. |

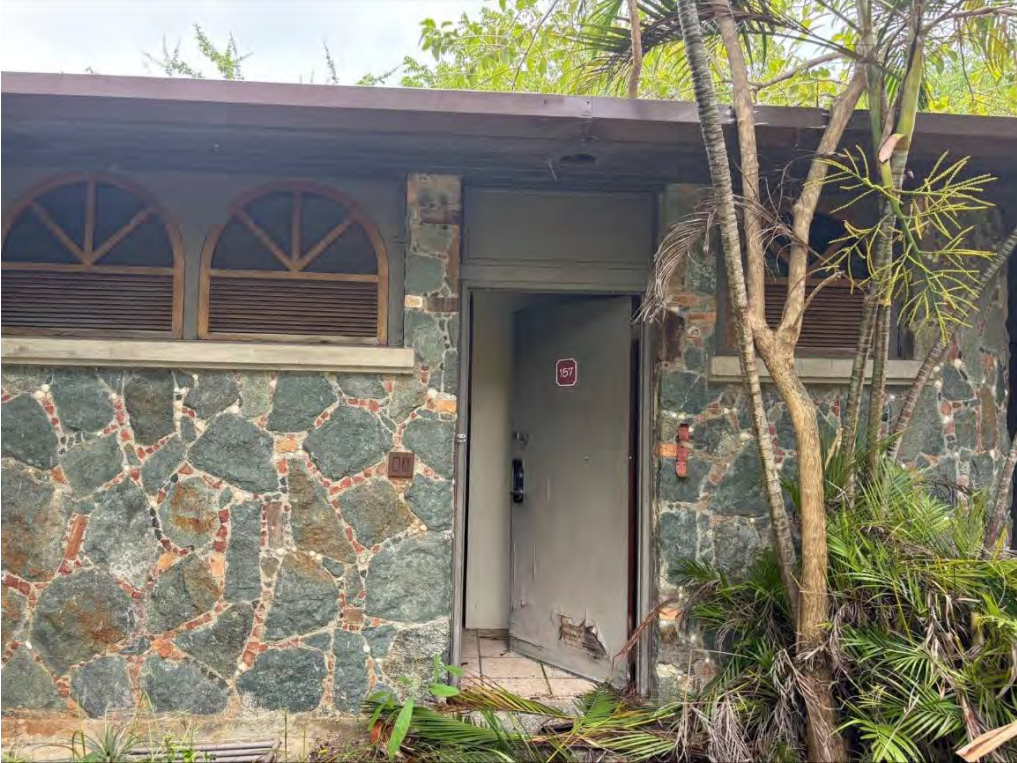
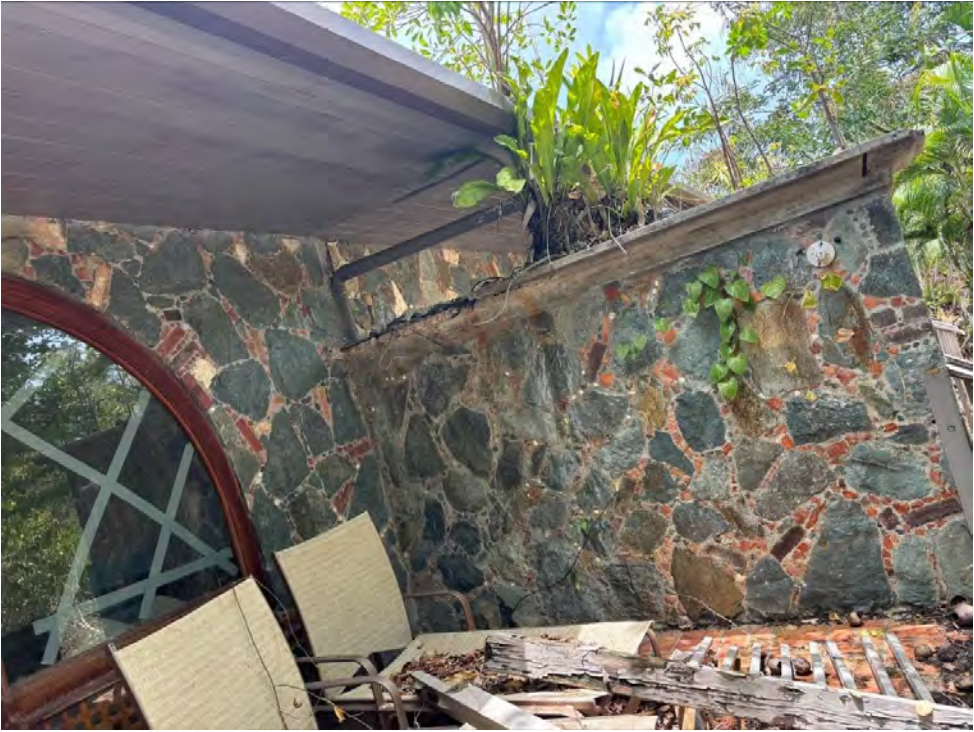
Building: 54 Garden View Unit 157

| Component | Material | Notes |
|---|---|---|
| Walls (Structural) | Stone | Termite tubes observed. |
| Walls (Non-Structural) | Stone | Exterior concrete cap is spalling. |
| Roof | Wood Framed / Metal Roof | Vegetation growing in gutter. Potential termite damage. |
| Stairs/Railings | Wood | Severely deteriorated. |

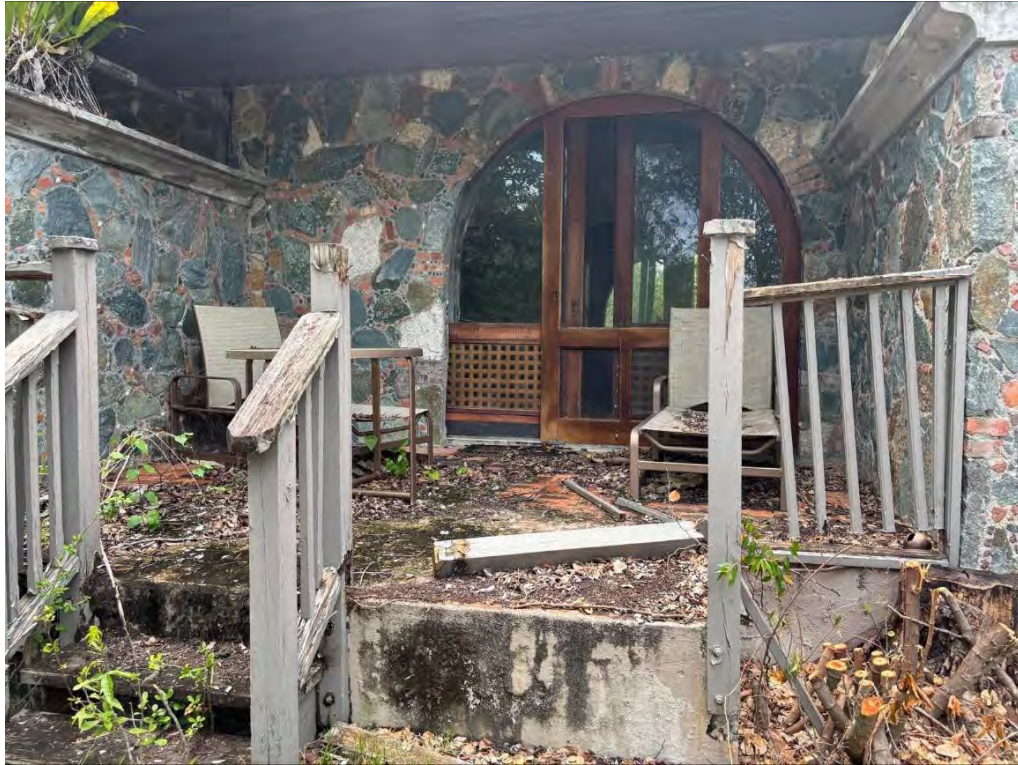
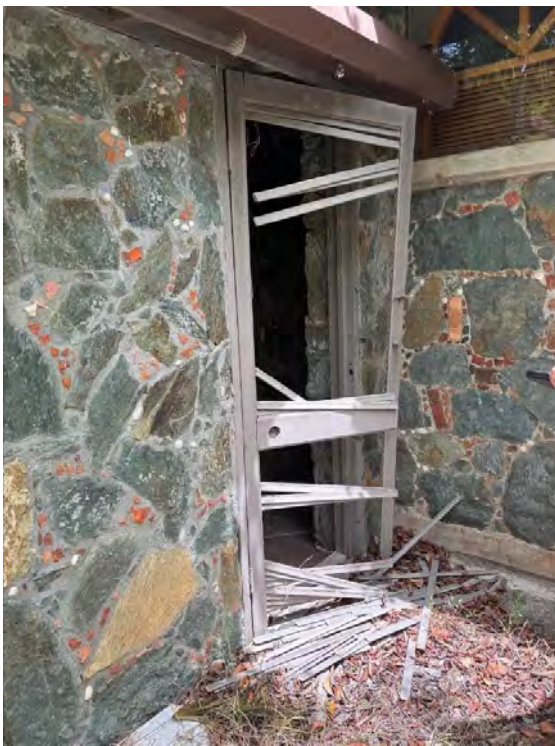
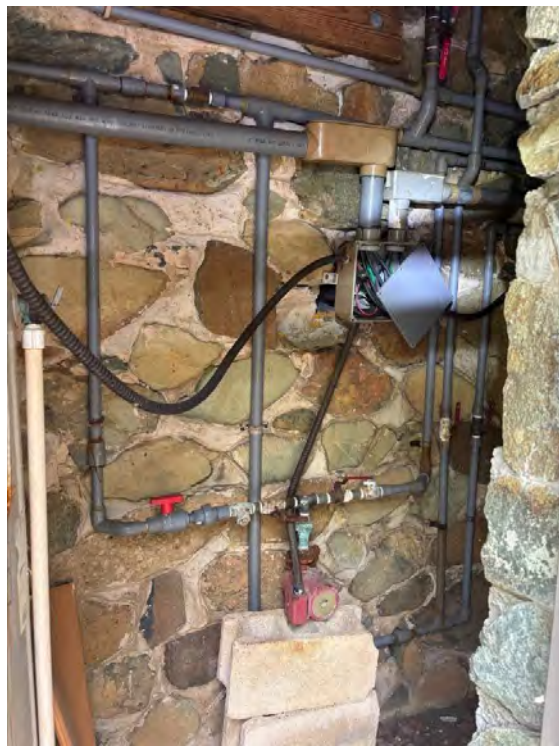
Building: 54 Garden View Unit 158 and Attached Utility Room

| Component | Material | Notes |
|---|---|---|
| Walls (Non-Structural) | Stone | Exterior concrete cap is spalling. |
| Roof | Wood Framed / Metal Roof | Vegetation growing in gutter. Potential termite damage. |
| Stairs/Railings | Wood | Severely deteriorated. |

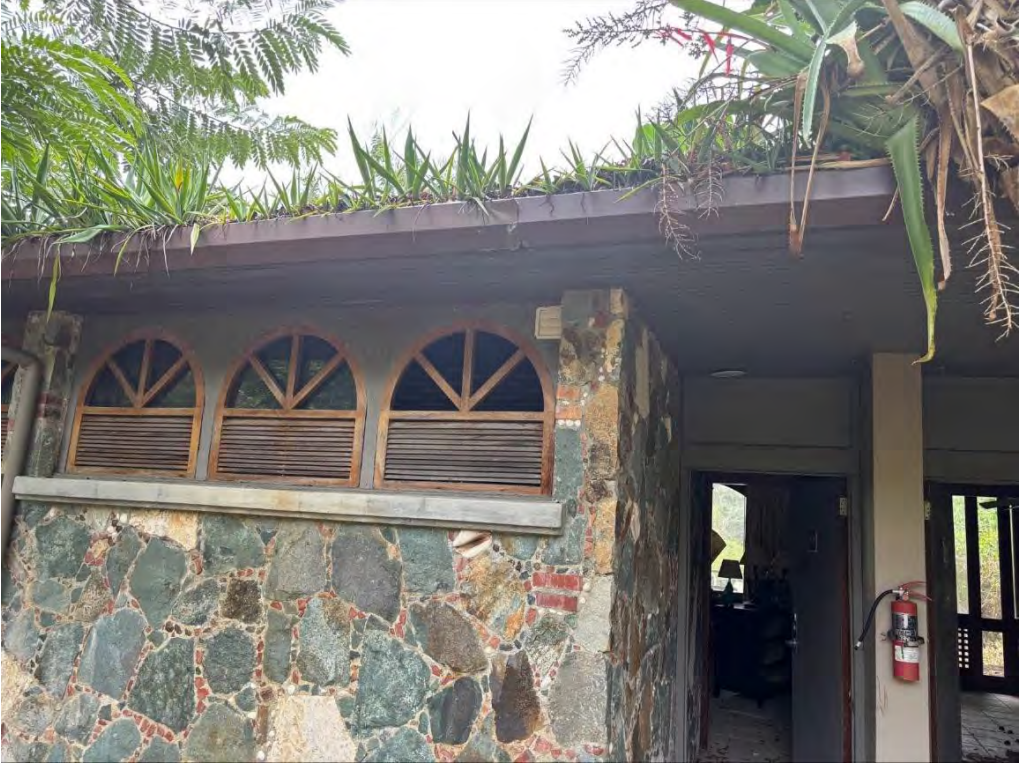
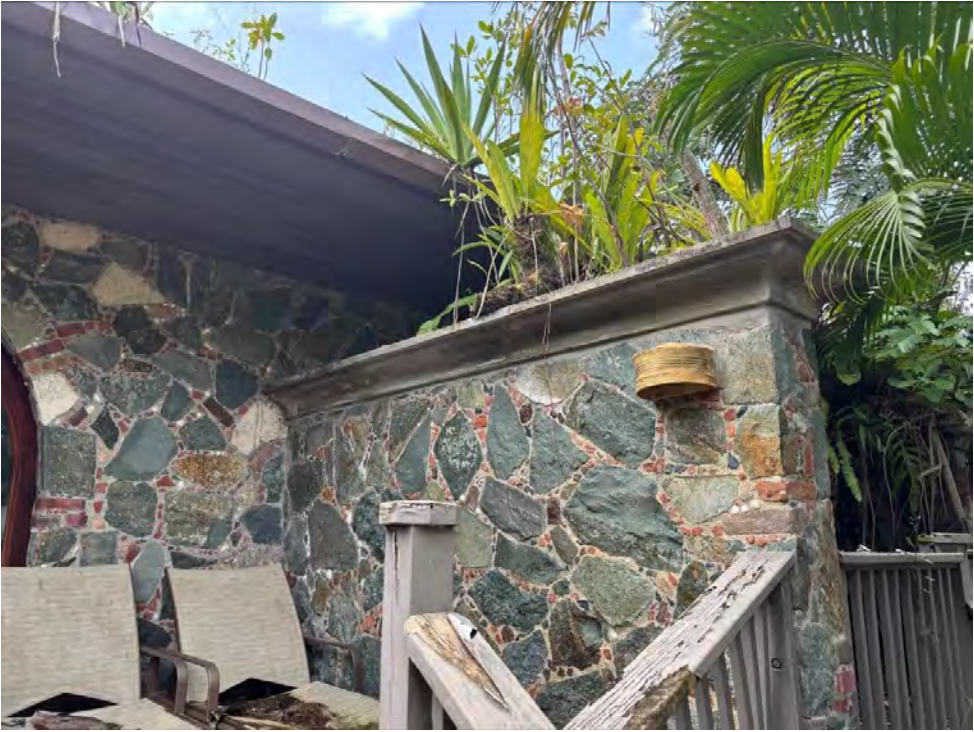
Building: 54 Garden View Unit 159

| Component | Material | Notes |
|---|---|---|
| Roof | Wood Framed / Metal Roof | Vegetation growing in gutter. Potential termite damage. |
| Stairs/Railings | Wood | Severely deteriorated. |
