VIRGIN ISLANDS NATIONAL PARK
Cruz Bay, St. John, U.S. Virgin Islands

CANEEL BAY
STRUCTURAL ASSESSMENT REPORT

NATIONAL PARK SERVICE (NPS)
SOUTH EAST REGION (SER)

July 2025

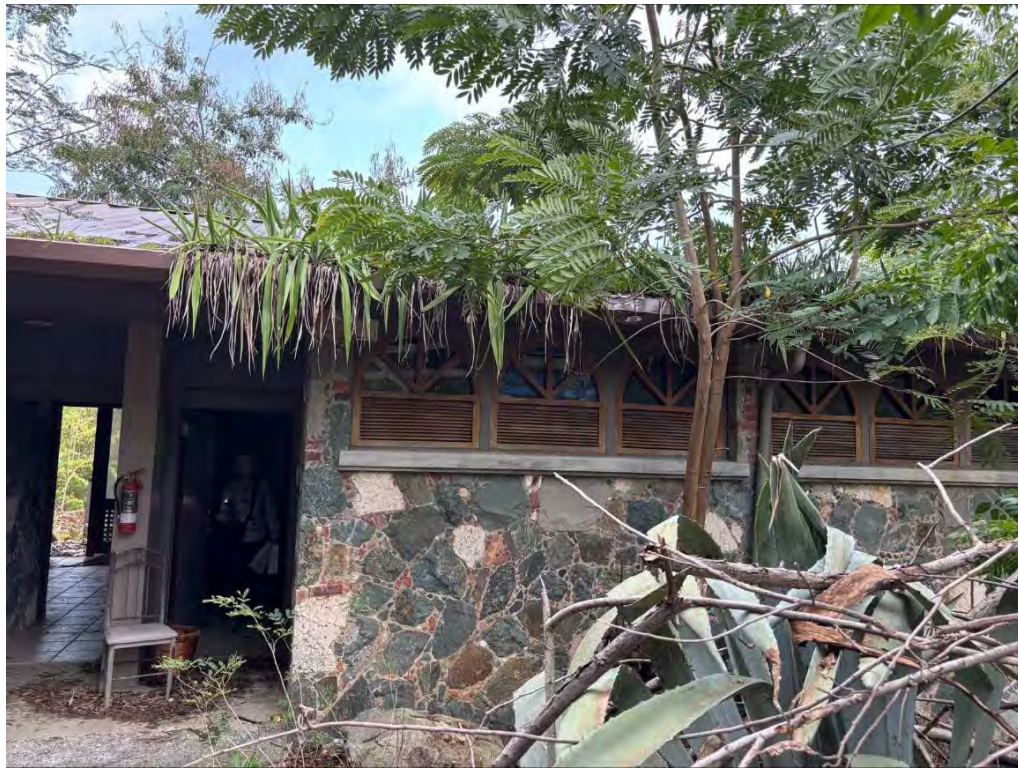
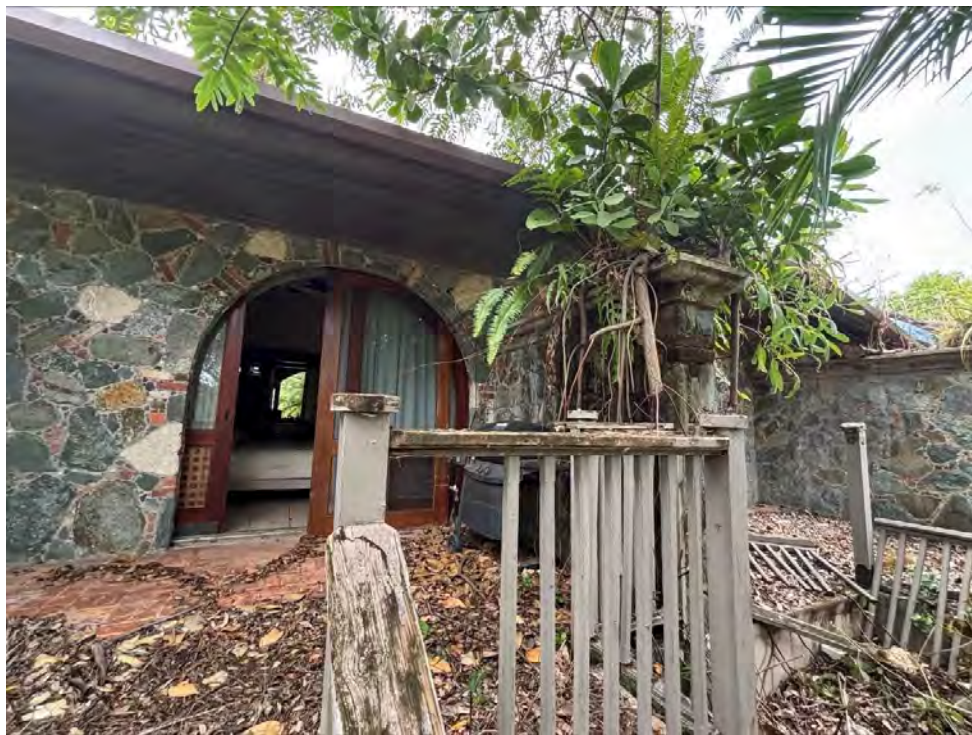
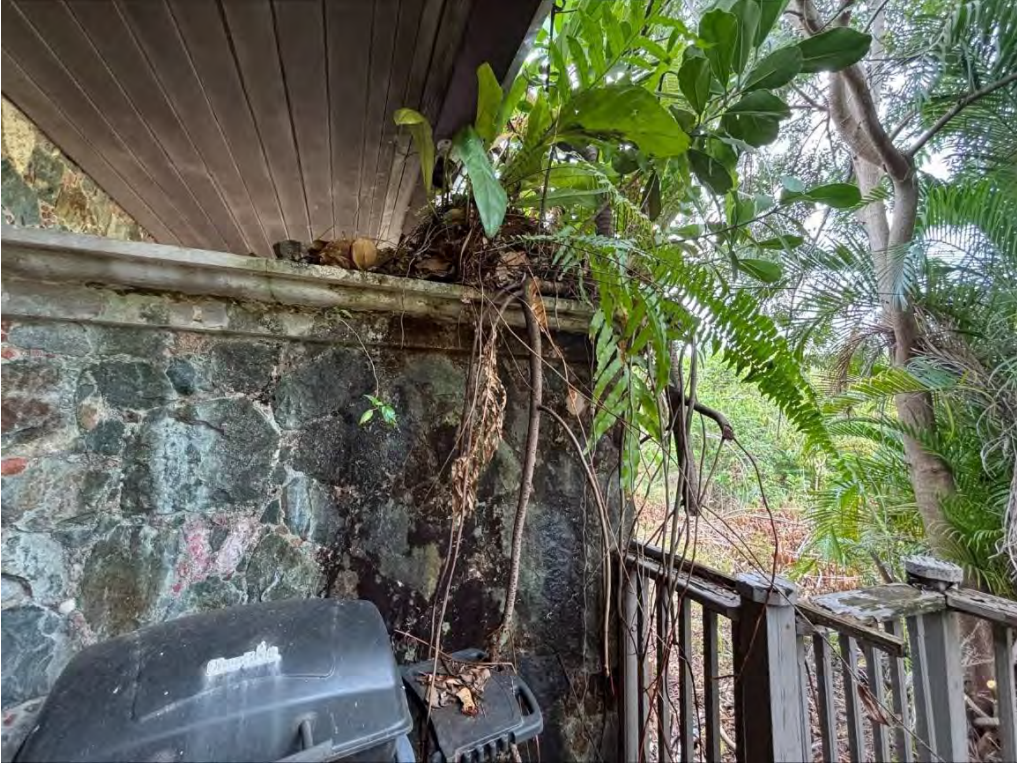
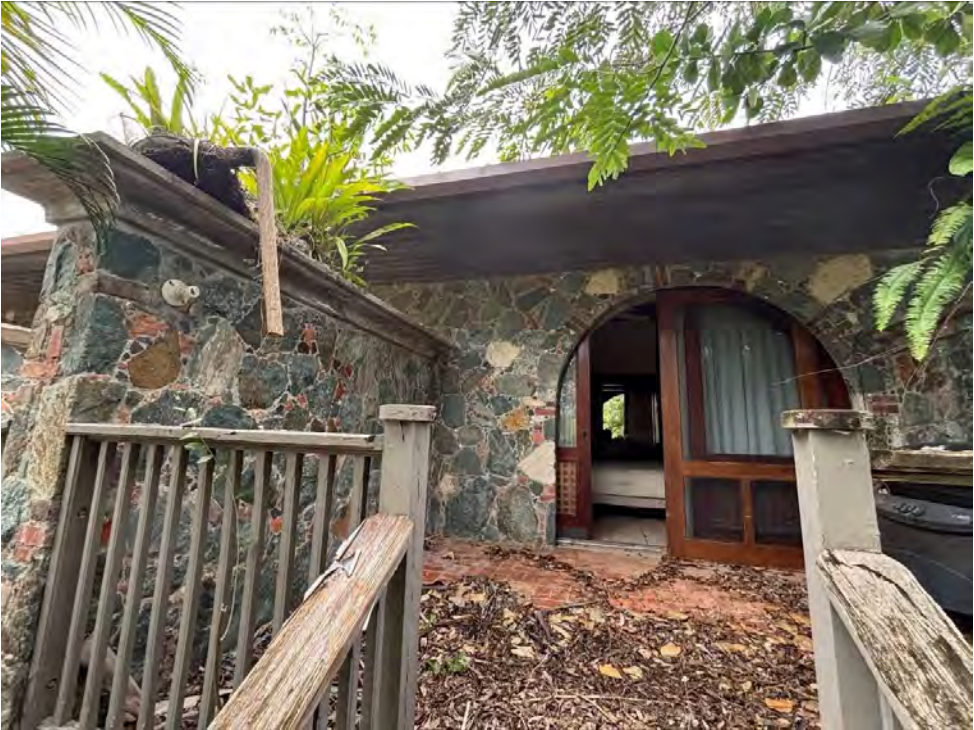
Building: 54 Garden View Unit 160

| Component | Material | Notes |
|---|---|---|
| Walls (Structural) | Stone | Vertical cracks near rear exterior wall joint. |
| Walls (Non-Structural) | Stone | Exterior concrete cap is spalling. |
| Roof | Wood Framed / Metal Roof | Vegetation growing in gutter. Potential termite damage. |
| Stairs/Railings | Wood | Severely deteriorated. |

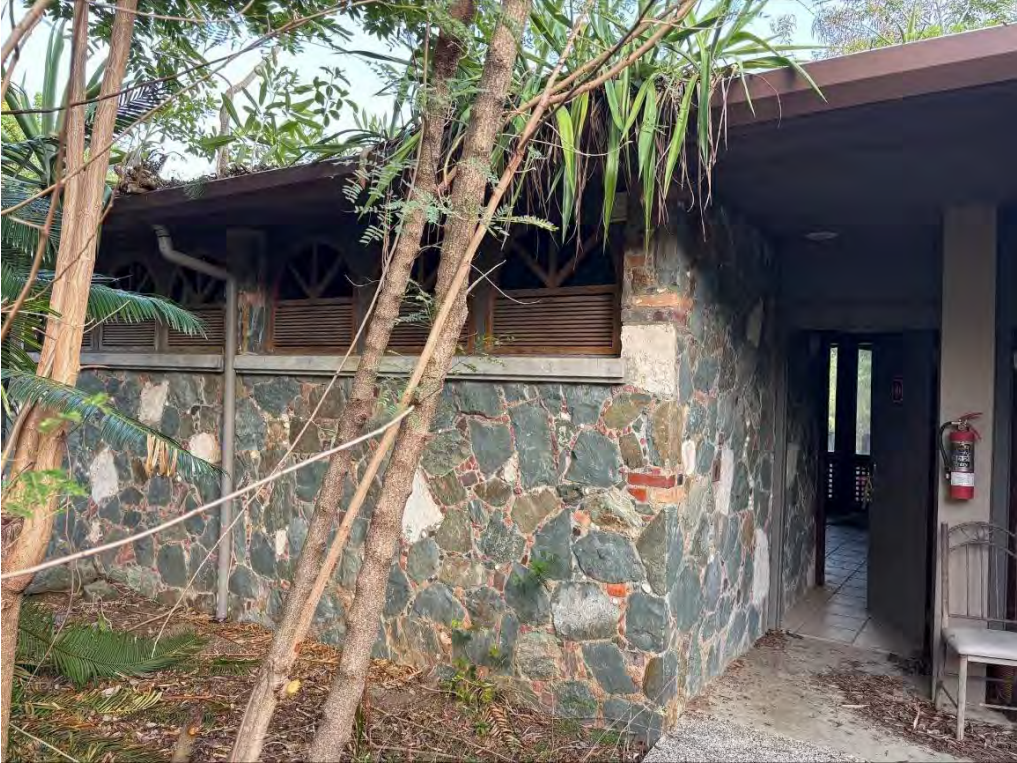
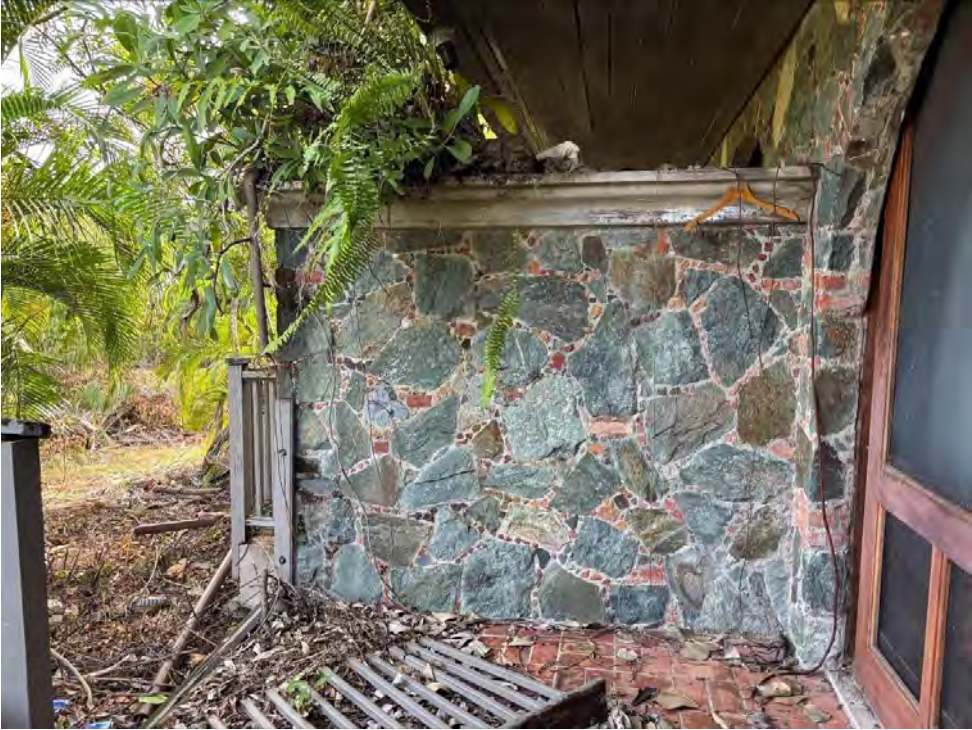
Building: 54 Garden View Unit 161

| Component | Material | Notes |
|---|---|---|
| Walls (Non-Structural) | Stone | Exterior concrete cap is spalling. |
| Roof | Wood Framed / Metal Roof | Partially collapsed roof at rear of building. Vegetation growing in gutter. Potential termite damage. |
| Stairs/Railings | Wood | Severely deteriorated. |

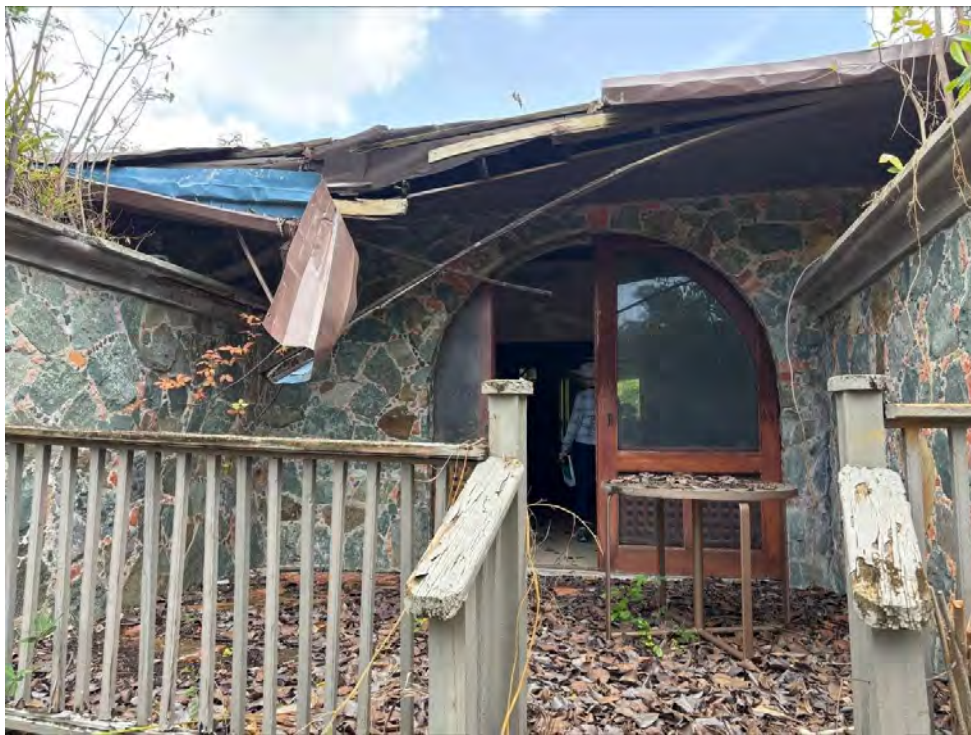
Building: 54 Garden View Unit 162

| Component | Material | Notes |
|---|---|---|
| Walls (Non-Structural) | Stone | Exterior concrete cap is spalling. |
| Roof | Wood Framed / Metal Roof | Vegetation growing in gutter. Potential termite damage. |
| Stairs/Railings | Wood | Severely deteriorated. |

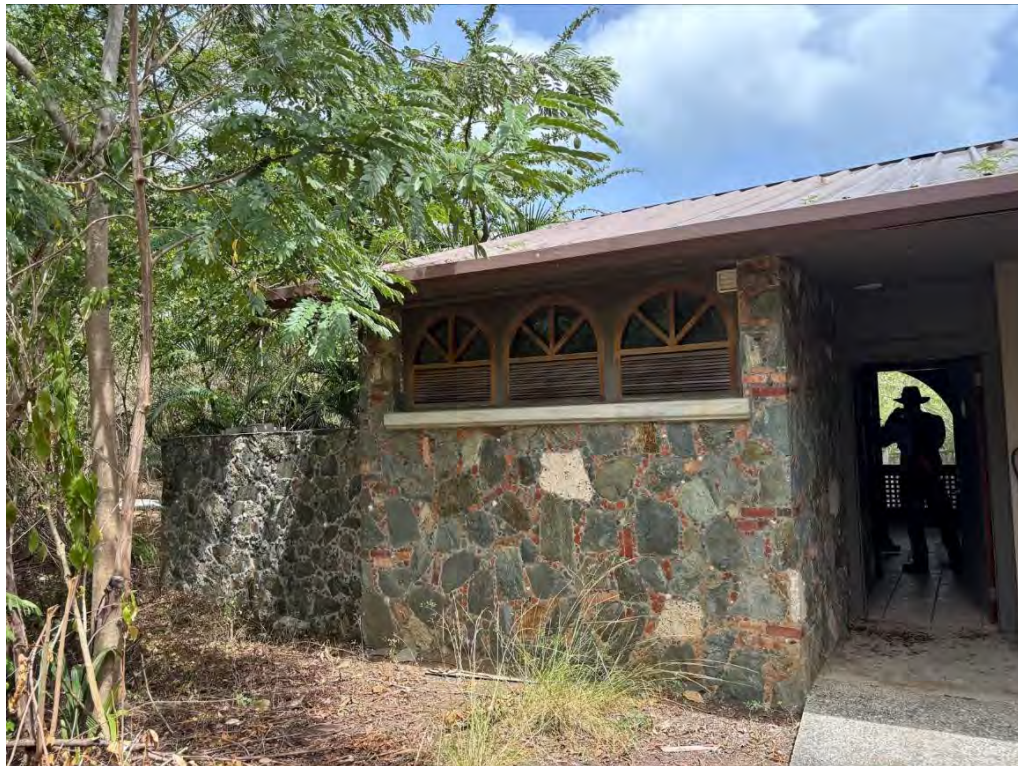
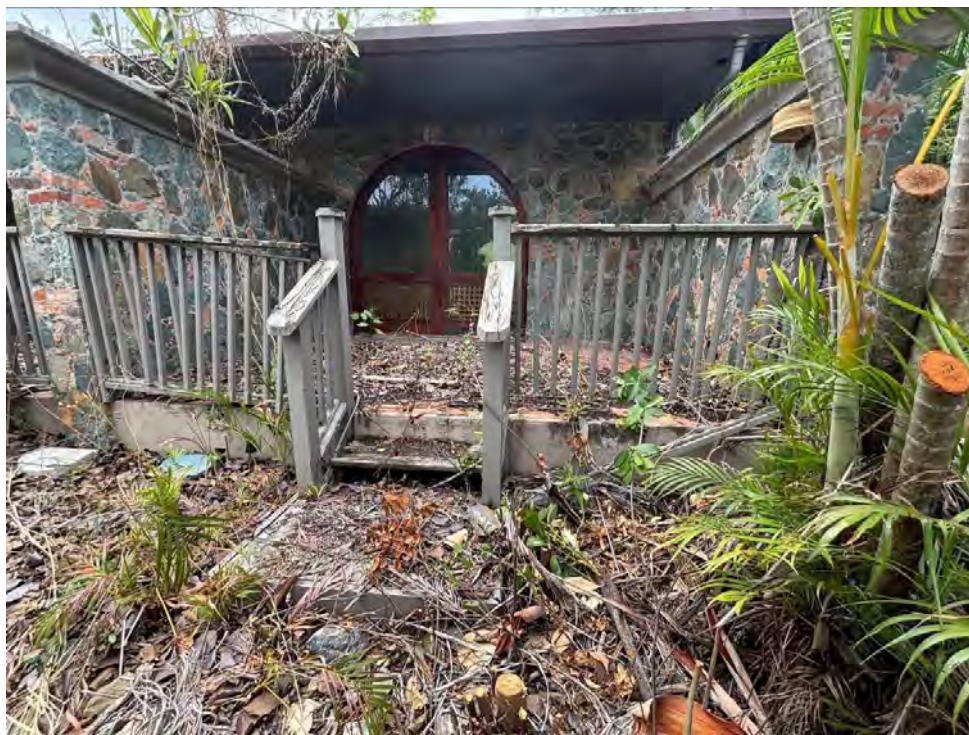
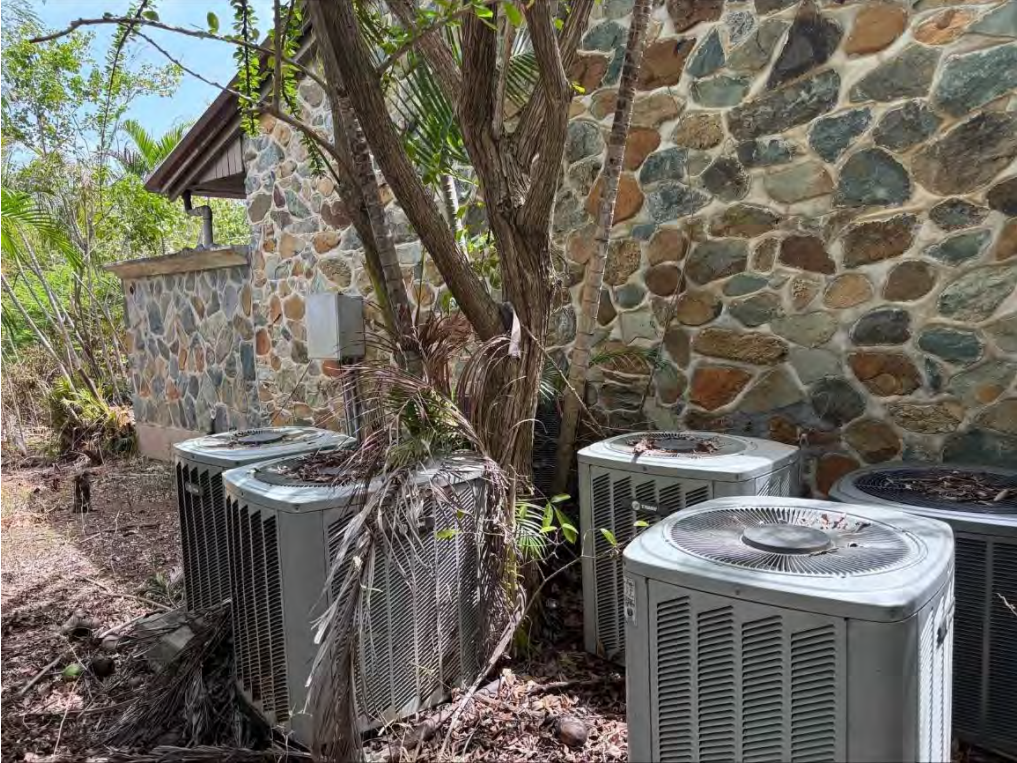
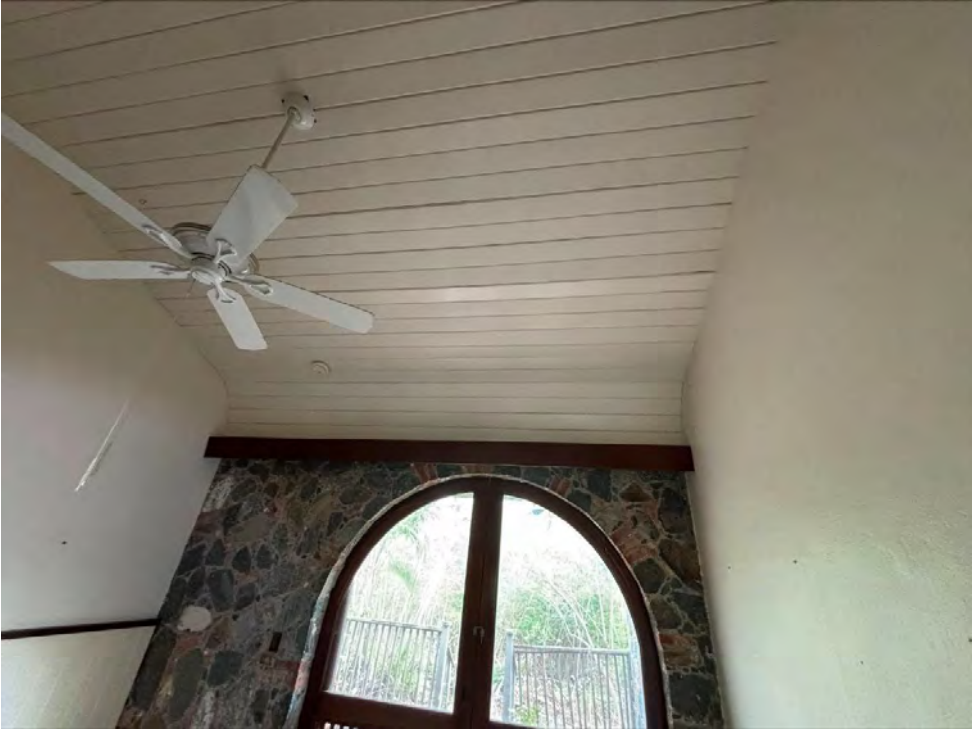
Building: 54 Garden View Unit 163

| Component | Material | Notes |
|---|---|--|
| Walls (Non-Structural) | Stone | Exterior concrete cap is spalling. |
| Roof | Wood Framed / Metal Roof | Vegetation growing in gutter. Interior cladding at underside of roof is buckling. Potential termite damage. |
| Stairs/Railings | Wood | Severely deteriorated. |

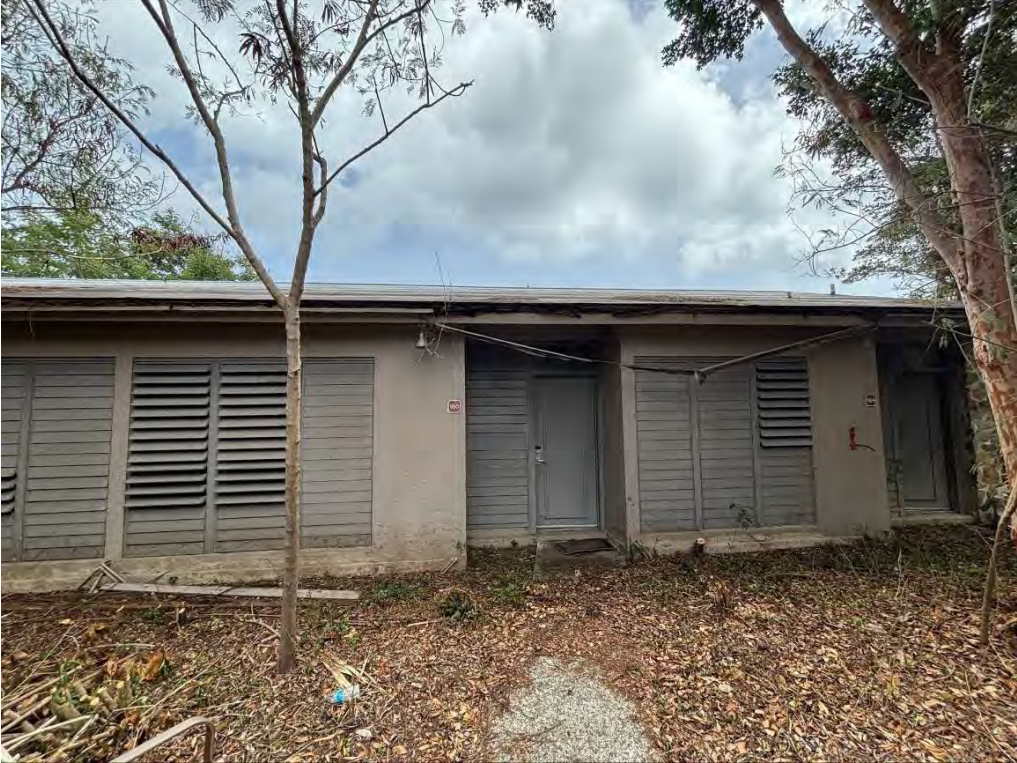
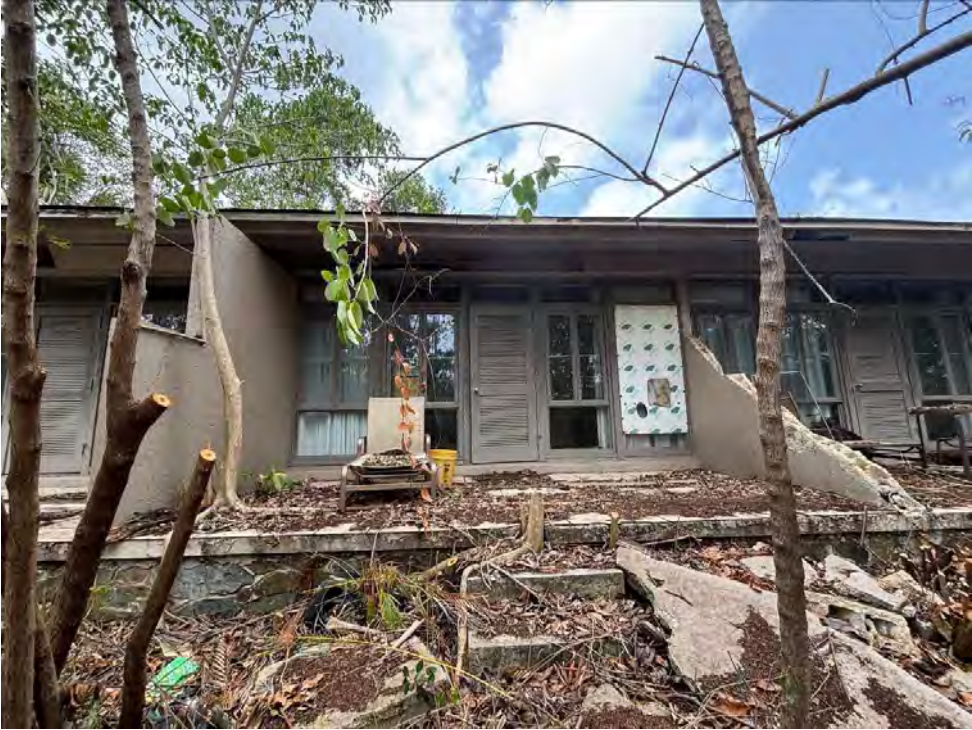
Building: 55 Garden View Unit 165

| Component | Material | Notes |
|---|---|---|
| Walls (Non-Structural) | Masonry (CMU) | Severely damaged exterior partition wall between 165 and 166. |
| Roof | Wood Framed / Metal Roof | Vegetation growing in gutter. Potential termite damage. |
| Stairs/Railings | Wood | Severely deteriorated. |

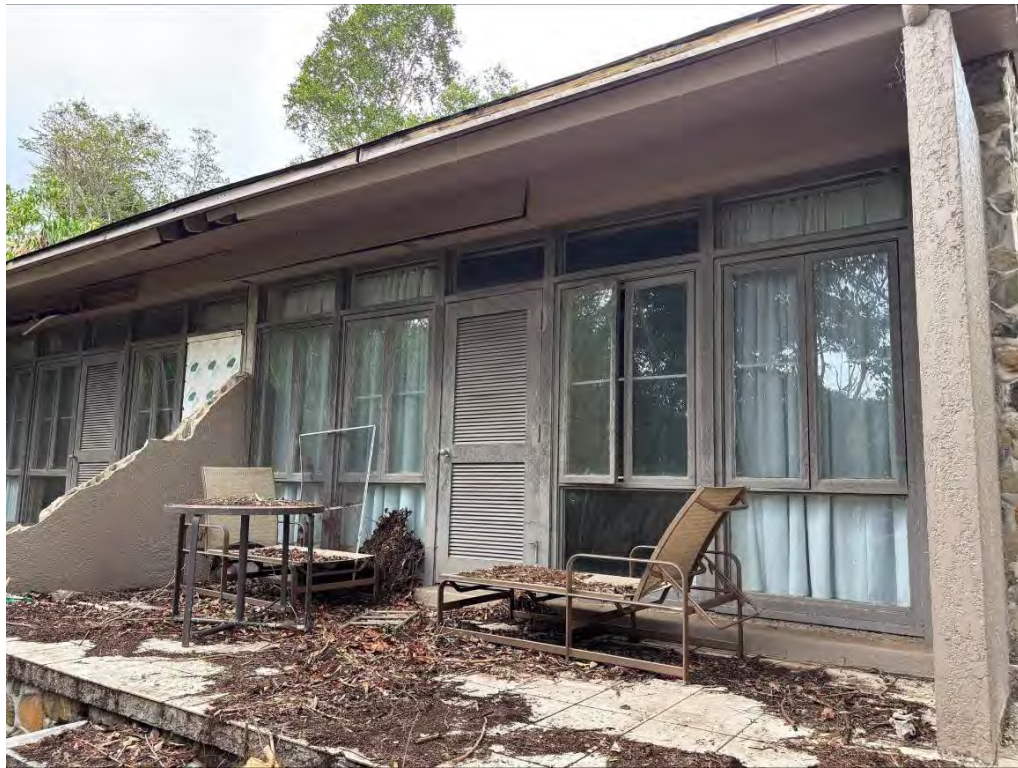
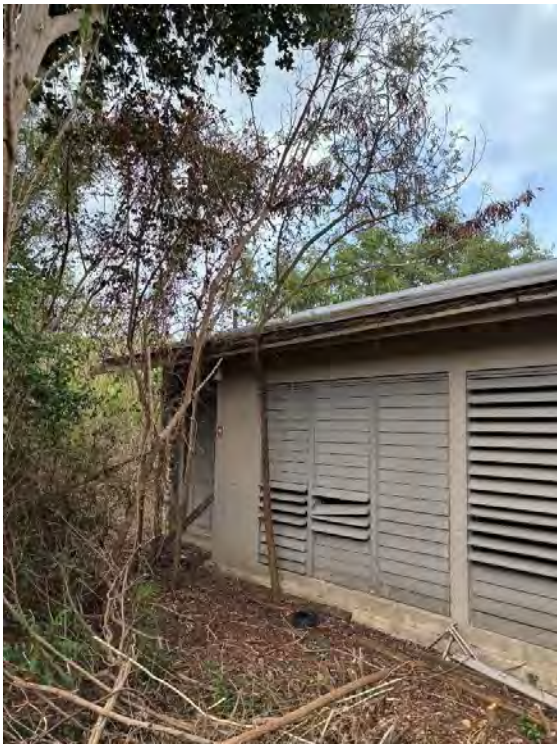
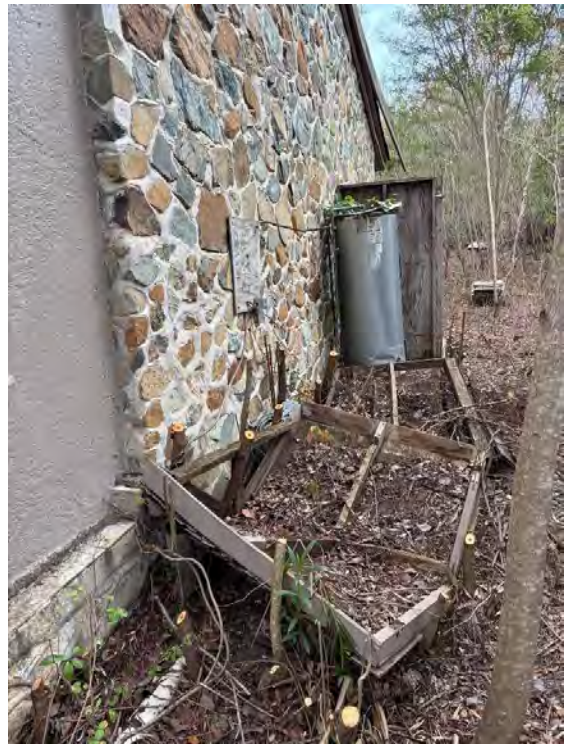
Building: 55 Garden View Unit 166

| Component | Material | Notes |
|---|---|---|
| Walls (Structural) | Stone | Interior water damage. |
| Walls (Non-Structural) | Masonry (CMU) | Severely damaged exterior partition wall between 165 and 166. |
| Roof | Wood Framed / Metal Roof | Vegetation growing in gutter. Potential termite and water damage. |
| Stairs/Railings | Wood | Severely deteriorated. |
