Building: 56 Fitness Center

Structural Assessment: Structurally Sound

National Park Service
Virgin Islands National Park | Caneel Bay
Structural Assessment Report

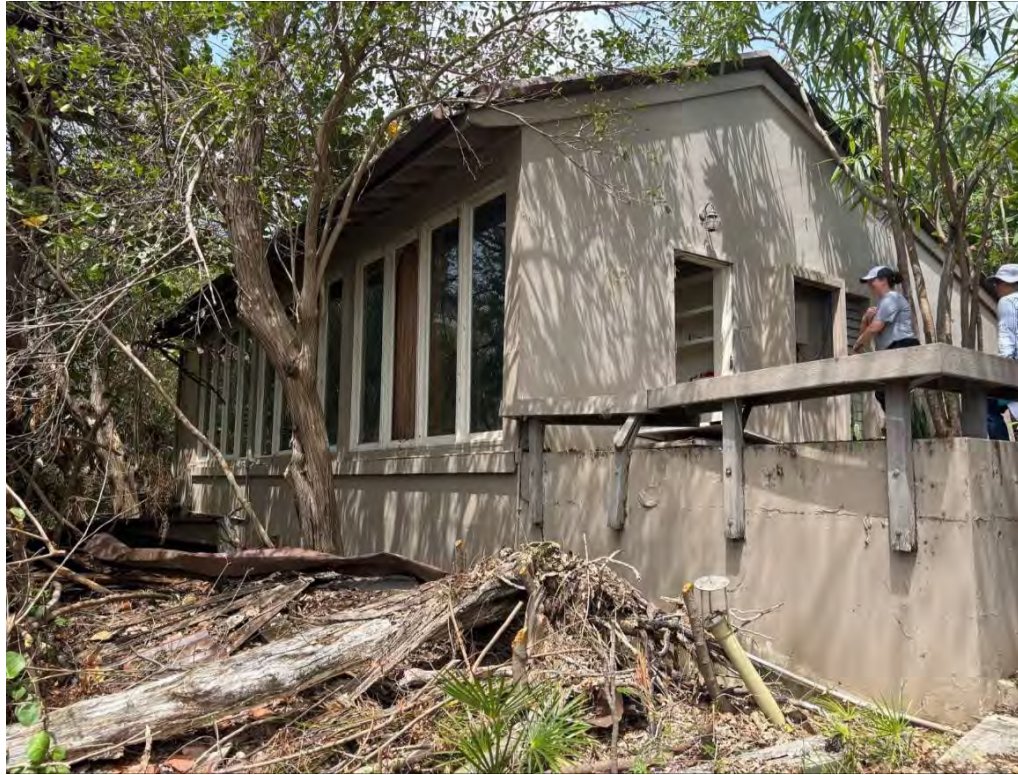
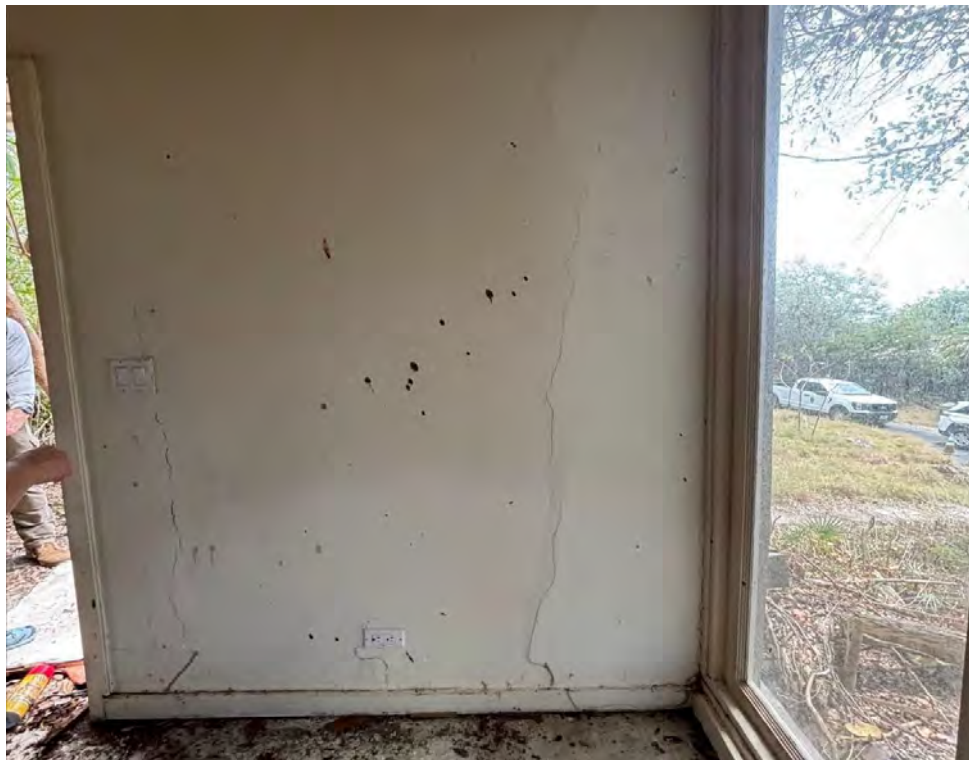
Component	Material	Notes
Floor	Concrete	
Walls (Structural)	Concrete	Small, vertical cracks observed in three corners. No signs of settlement or out of plane movement was observed.
Walls (Non-Structural)	N/A	Rot observed at some fascia boards and window frames.
Roof	Wood Framed / Metal Roof	Potential termite damage.
Stairs/Railings	Wood	Benches, which were serving as railings, are damaged.
Sidewalk

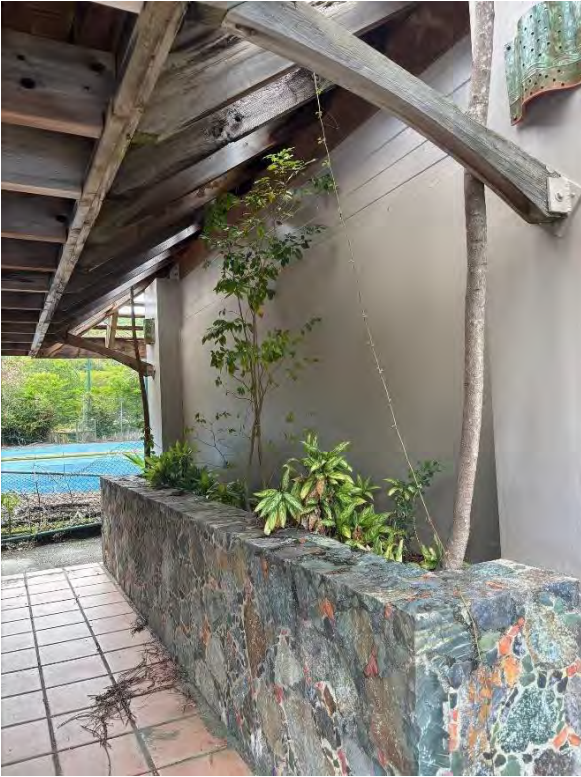
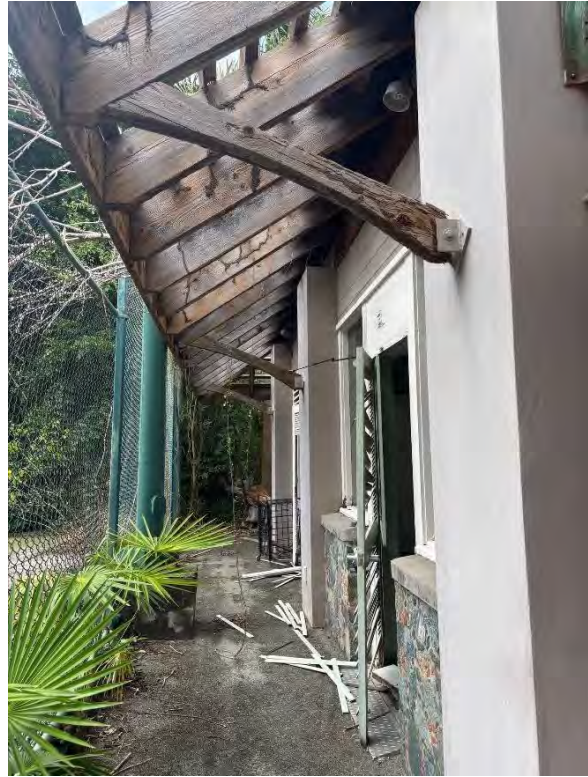
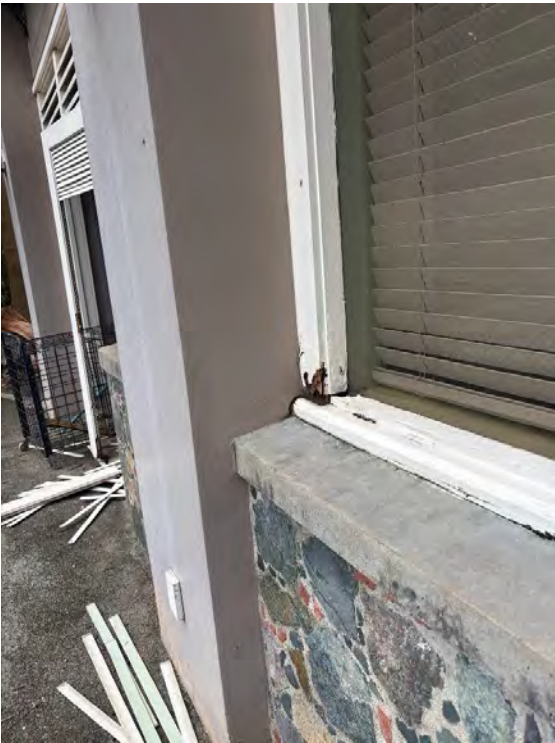
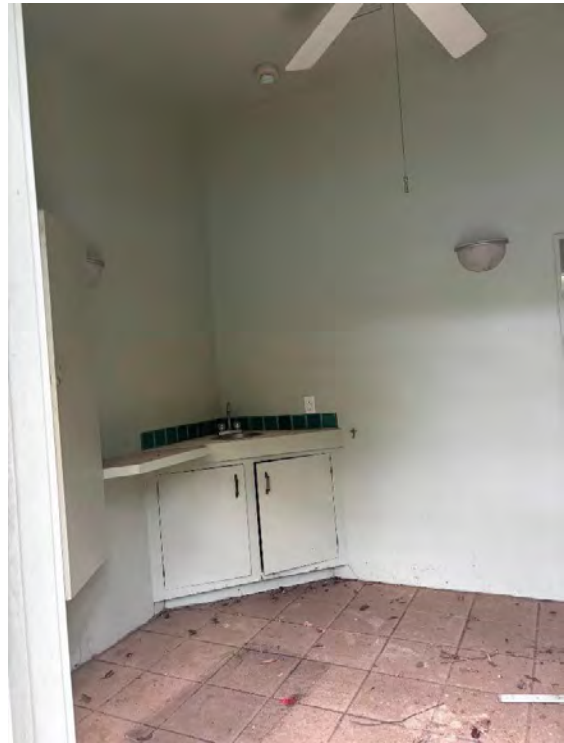
Building: 71 Massage Center

Structural Assessment: Potentially

Repair or Rebuild

Component	Material	Notes
Floor	Concrete	
Walls (Structural)	Concrete	
Walls (Non-Structural)	Stone / wood infill	Wood section of walls is deteriorated. Potential termite damage.
Roof	Wood framed / wood shingles	Roof failed. Wooden bracing is rotted/termite damaged. Potential termite damage.
Stairs/Railings	N/A	
Sidewalk	Concrete

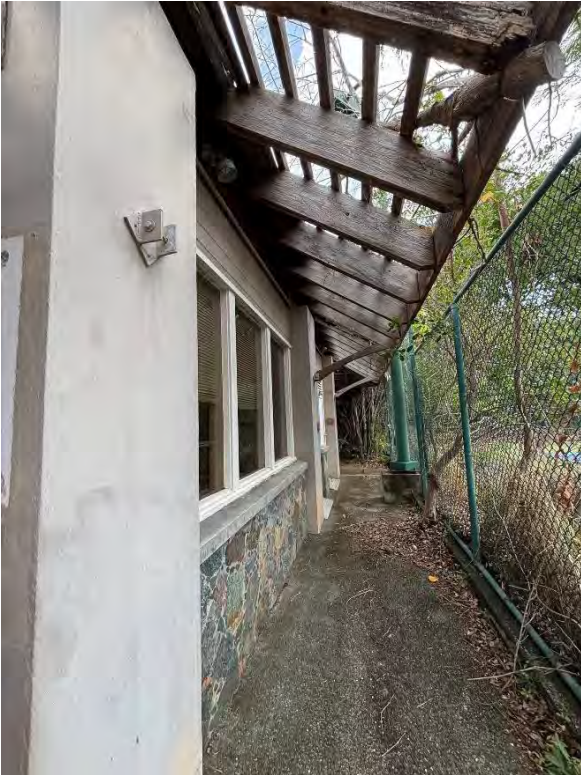
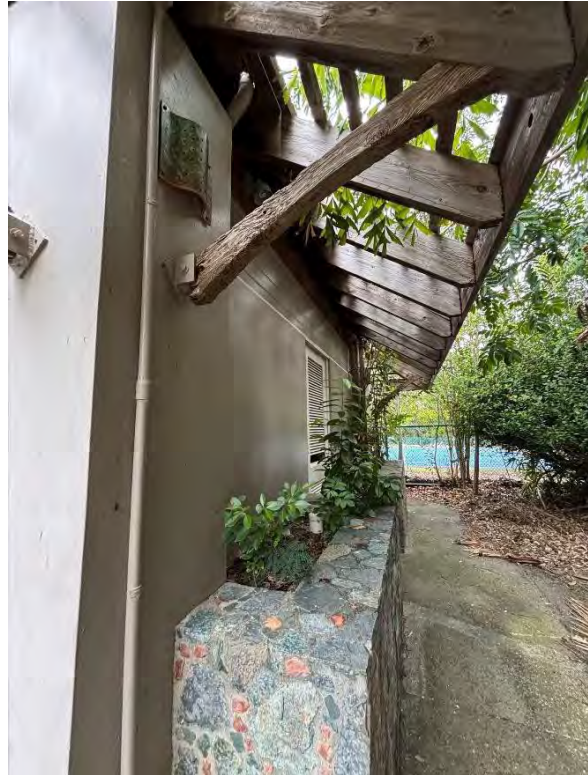
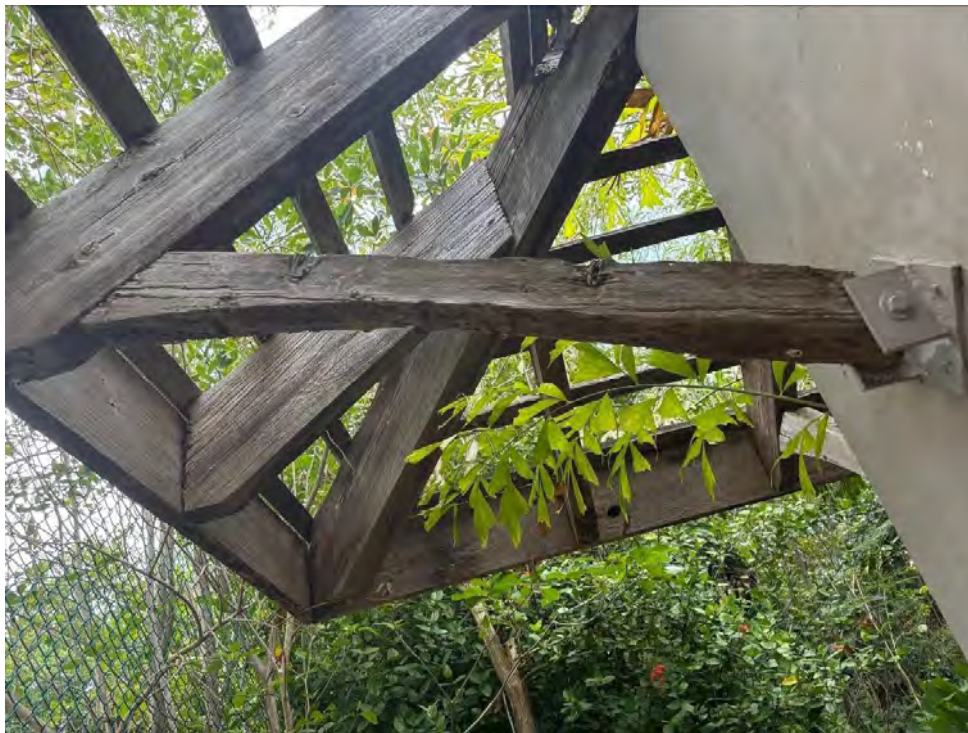
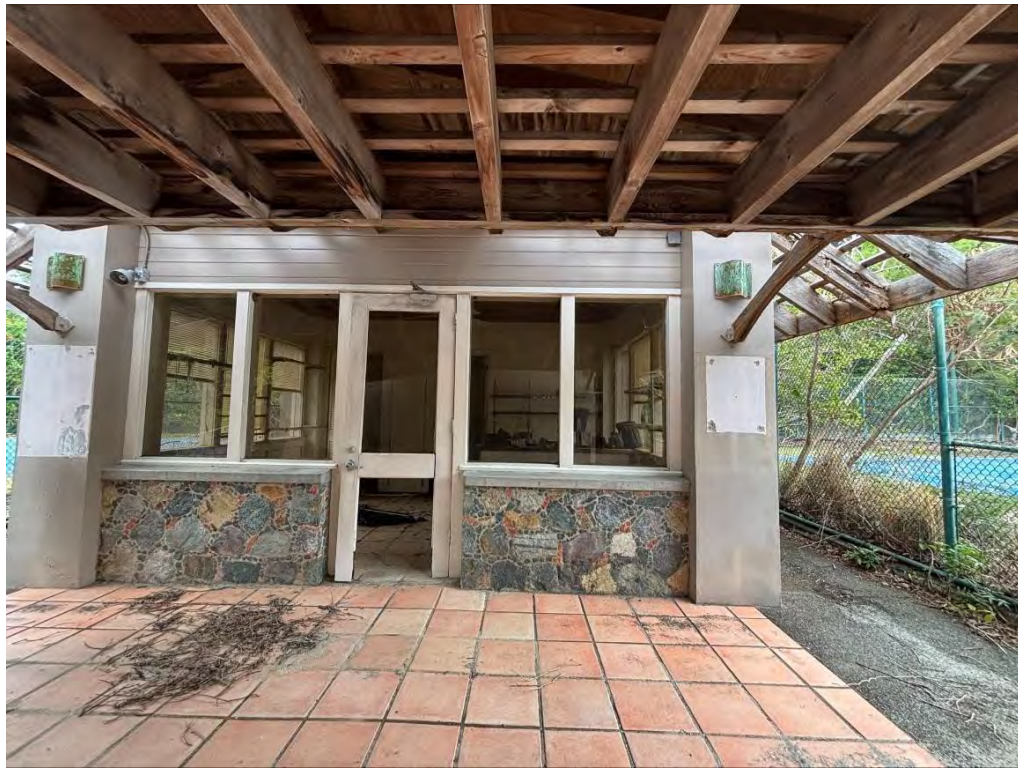
Building: 92 Tennis Pro Shop and Breezeway

**Structural Assessment: Potentially Repair or
Rebuild**

Component	Material	Notes
Floor	Concrete	
Walls (Structural)	Concrete	
Walls (Non-Structural)	Stone / wood infill	Wood section of walls is deteriorated. Potential termite damage.
Roof	Wood framed / wood shingles	Roof failed. Wooden bracing is rotted/termite damaged. Potential termite damage.
Stairs/Railings	N/A	
Sidewalk	Concrete

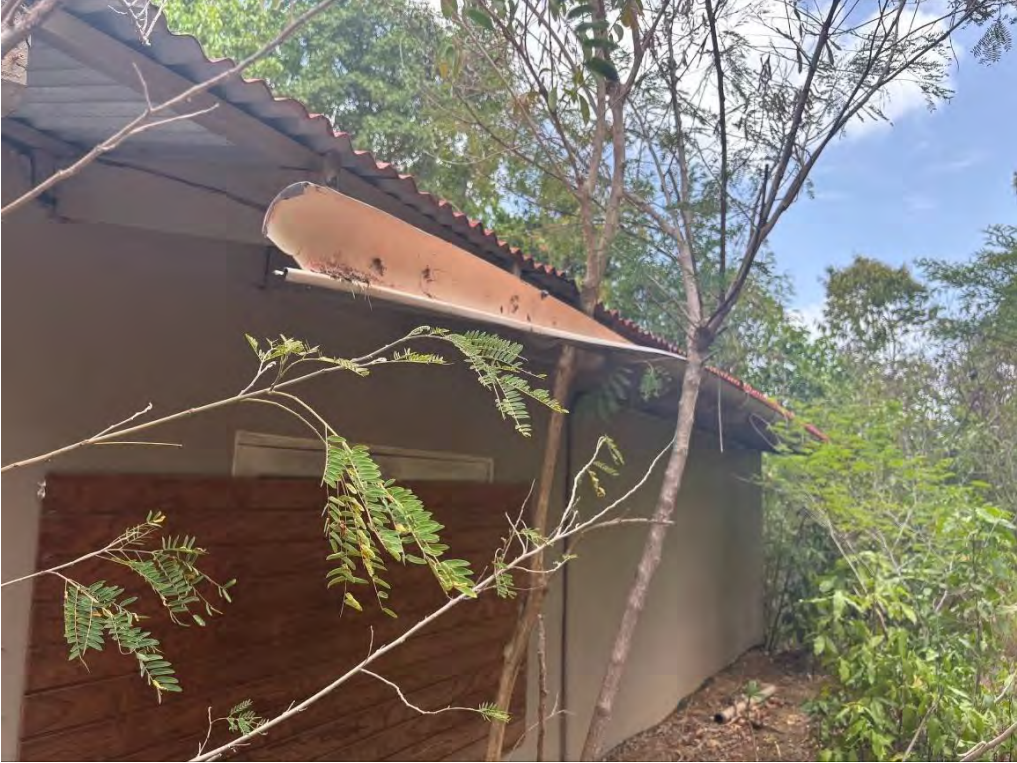
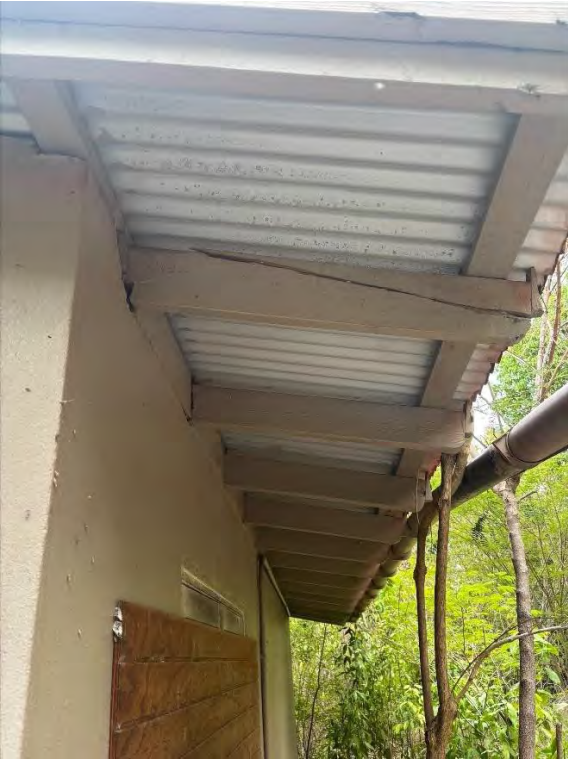
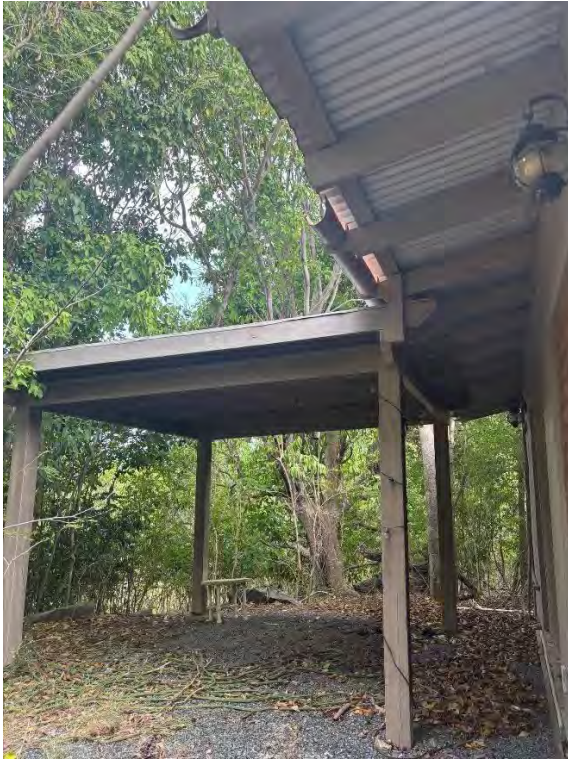
Building: 58 Managing Director's Guest House

Component	Material	Notes
Floor	Concrete	
Walls (Structural)	Concrete	Minor spalling at exterior walls.
Walls (Non-Structural)	Concrete	
Roof	Wood / Metal Roof	Two rafter tails cracked at eaves. Metal roof attached directly to rafters (no plywood sheathing).
Stairs/Railings	N/A	
Sidewalk	Concrete

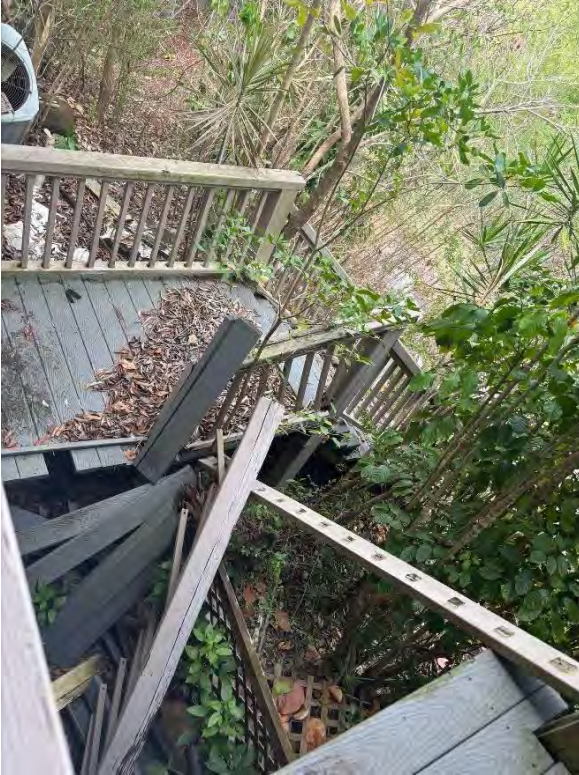
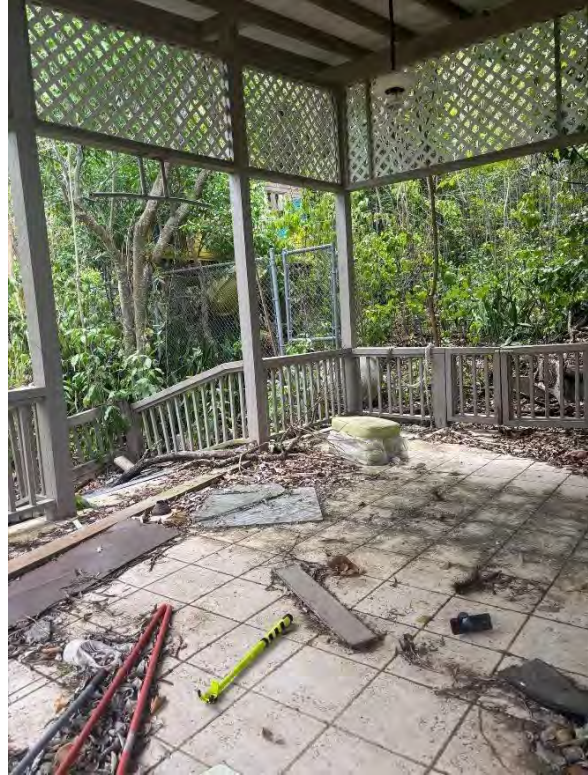
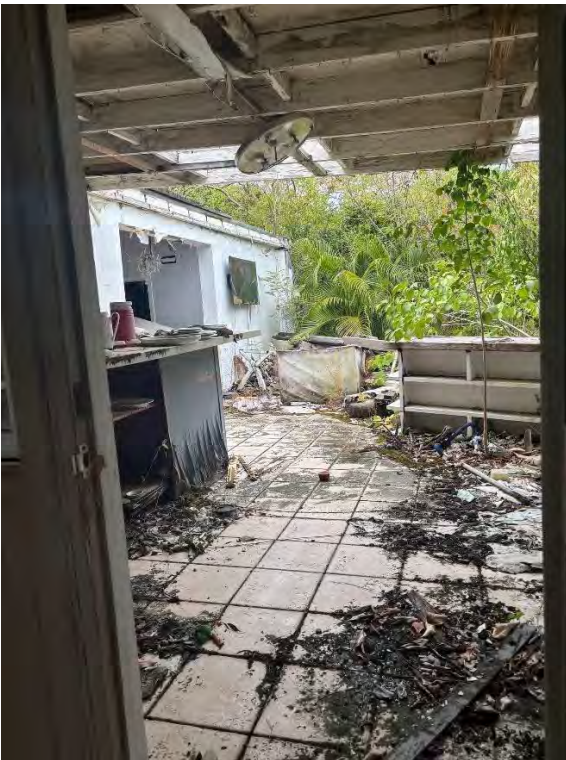
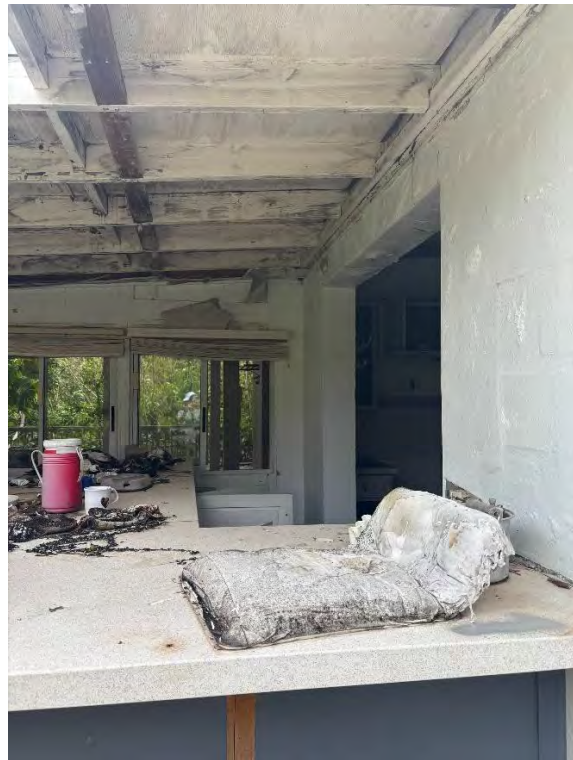
Building: 59 Managing Director’s House

Structural Assessment: Structurally Unsound

NOTE: Unable to safely access full extent of property. Notes are limited to what could be safely reviewed. Further investigation required.

Component	Material	Notes
Floor	Concrete / Wood	Approximately half the building is concrete slab on grade and the other half is wood framed floors. Concrete appeared to be stable. Wood floors were still standing, but not accessed from below. Further investigation of wood framing required.
Walls (Structural)	Concrete / Wood	Approximately half the building is concrete walls and the other half is wood framed walls. Concrete walls appeared to be stable. Wood walls had completely failed.
Walls (Non-Structural)	Wood	It appears all non-structural wood walls had completely failed.
Roof	Wood framed / metal roof	Wood framed roof had partially collapsed over both the wood and concrete portion of the buildings.
Stairs/Railings	Wood	Severely rotted and failed throughout the building.
Sidewalk		Not visible through vegetation.

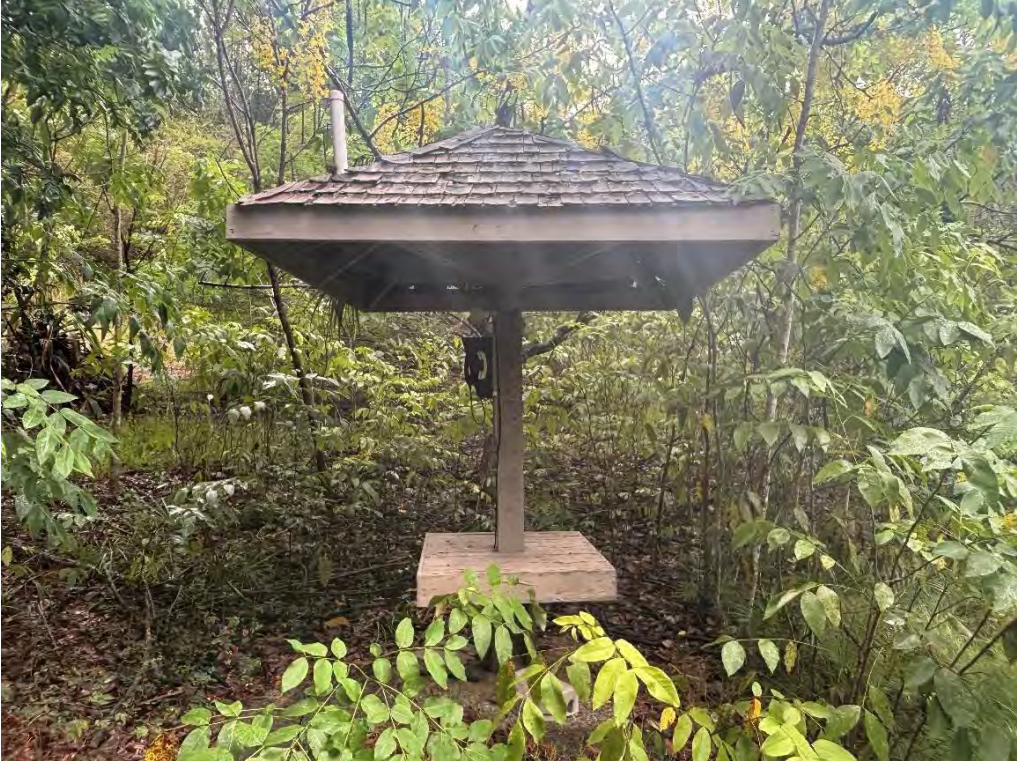
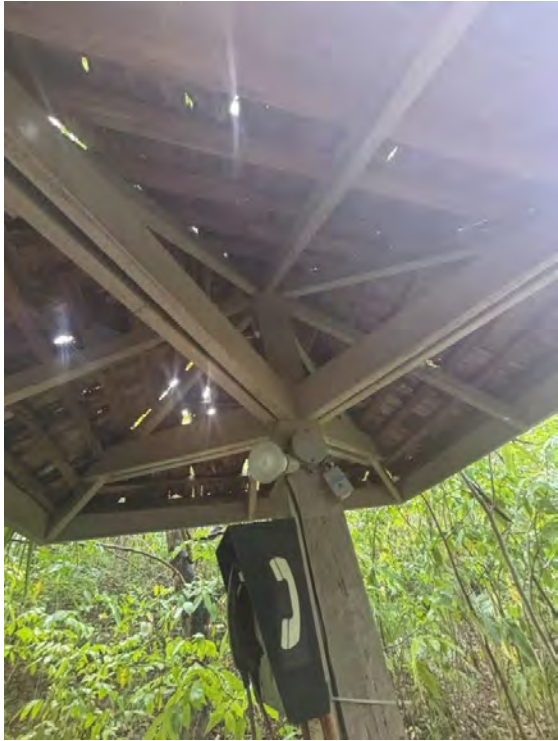
Building: Garden View Bus Stop

Component	Material	Notes
Floor	Concrete	Concrete pad previously trenched for utilities.
Walls (Structural)	Wood	
Walls (Non-Structural)	N/A	
Roof	Wood framed/ Wood shingles	Shingles deteriorated.

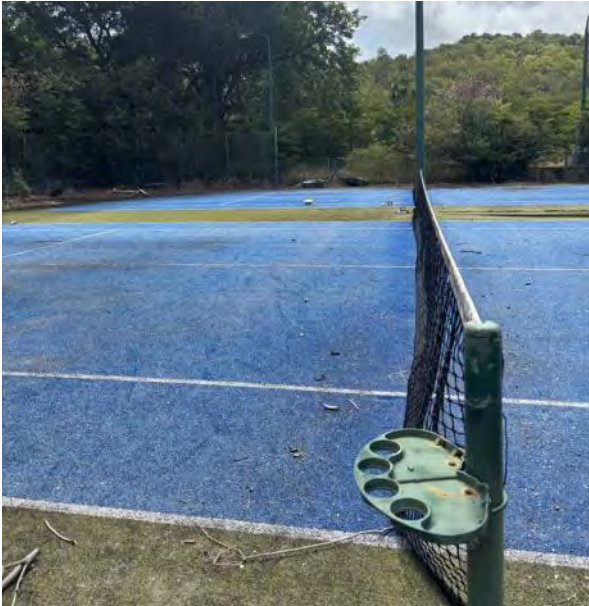
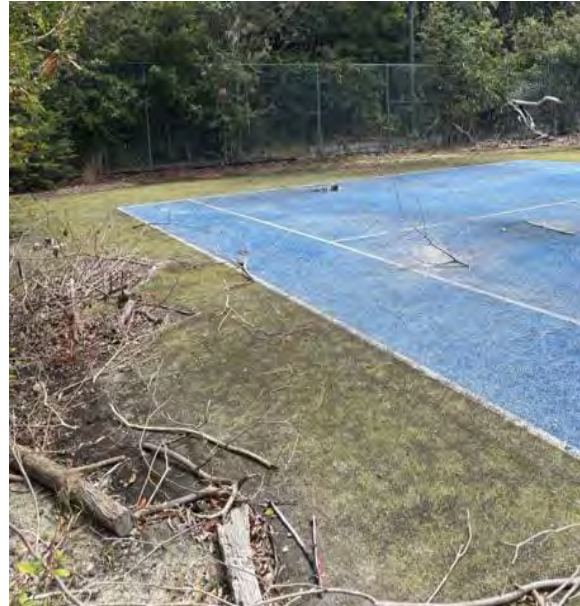
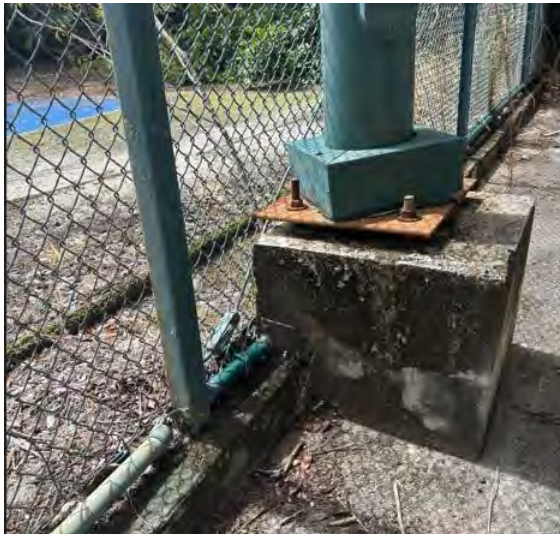
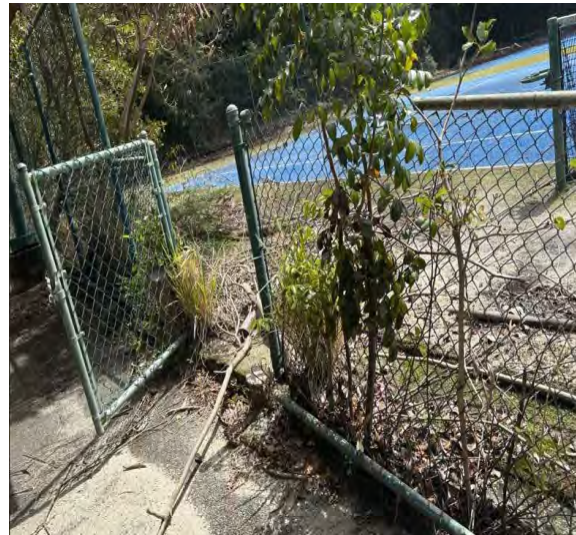
Tennis Courts

Component	Material	Notes
Floor	Turf	Tennis court turf has shifted, wrinkled, ripped, and is damaged.

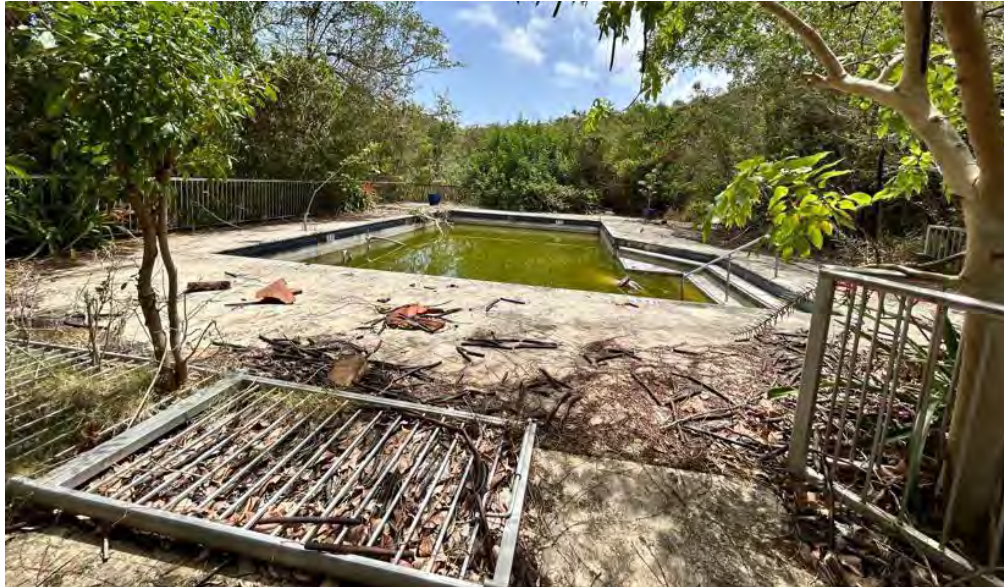
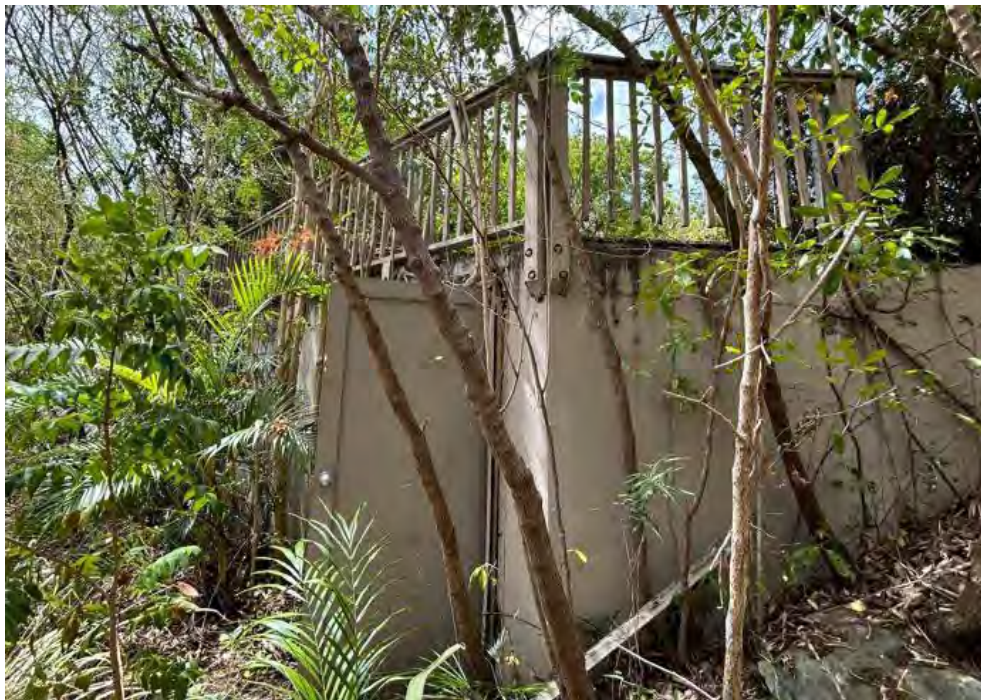
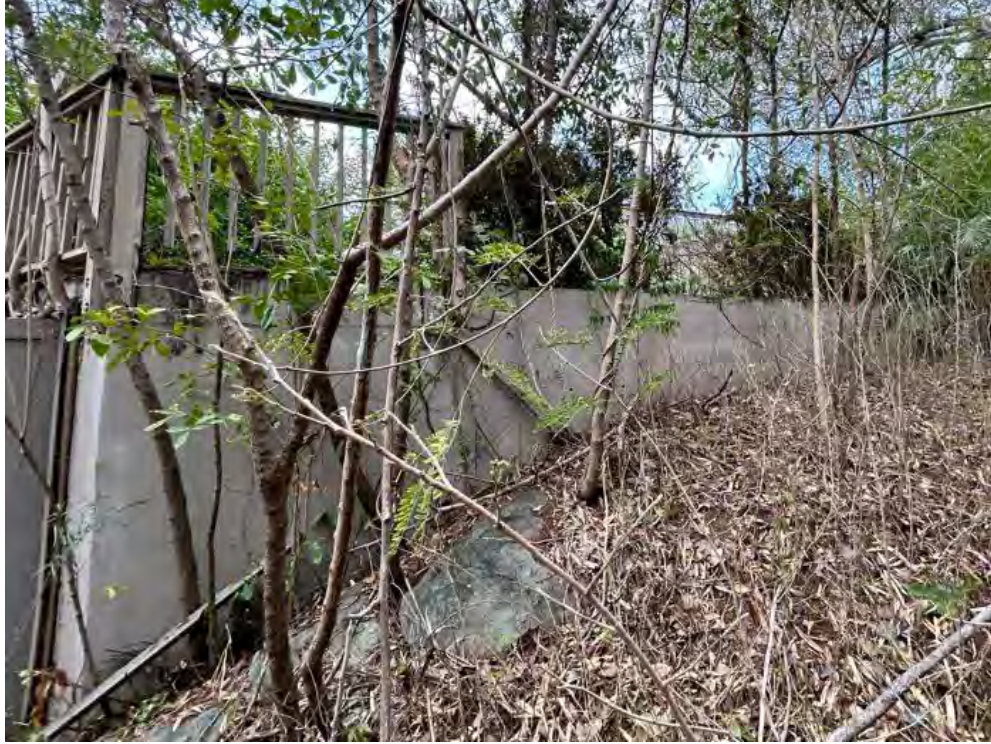
Component	Material	Notes
Structure	Concrete	Pool is holding water and appears to be in good condition.
Railings	Aluminum	Some railings have shifted / failed.

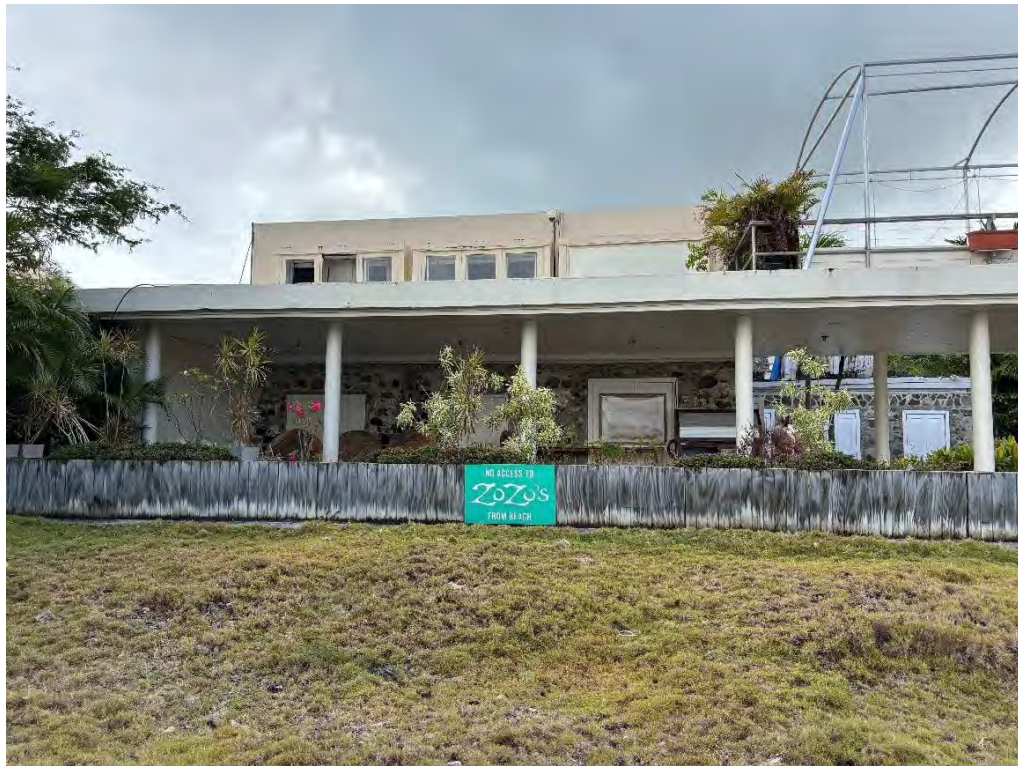
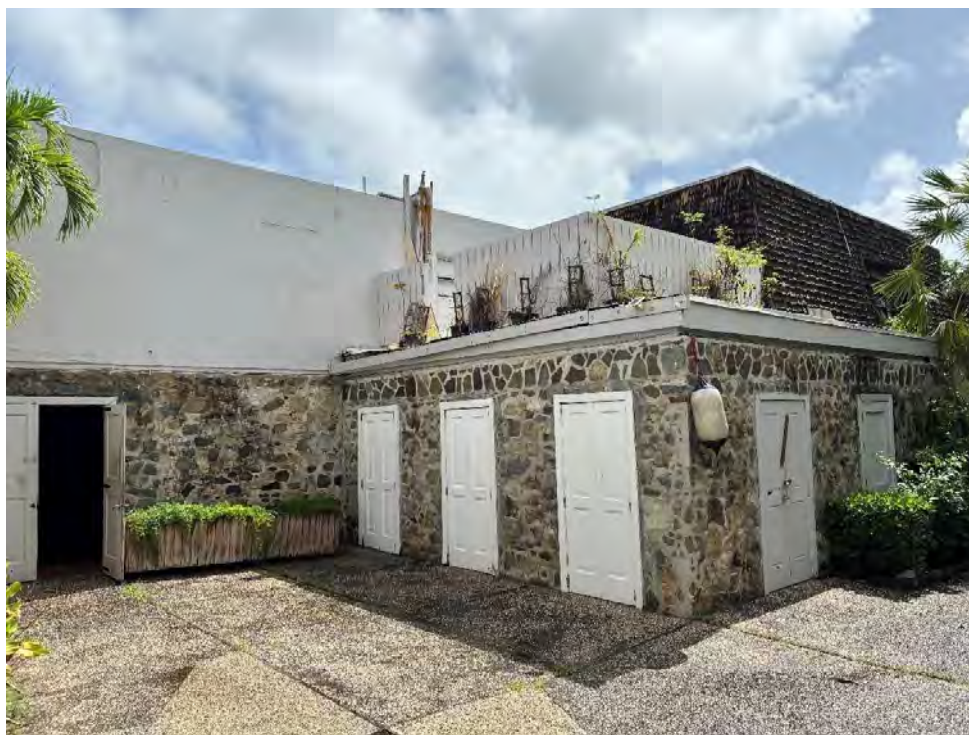
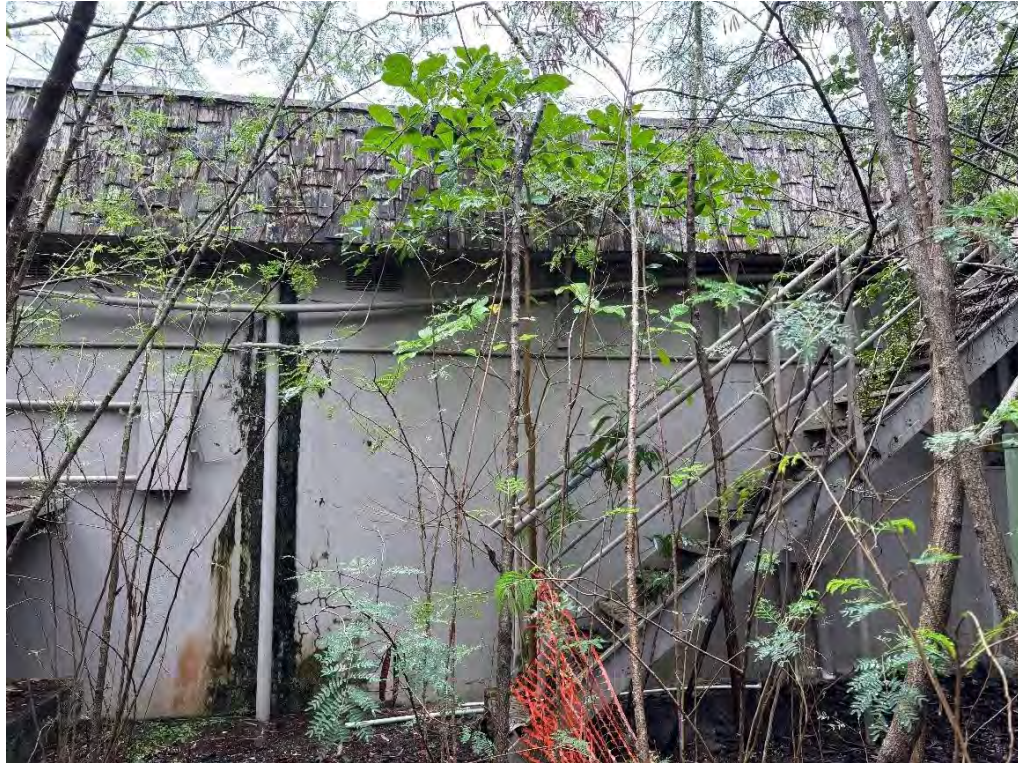
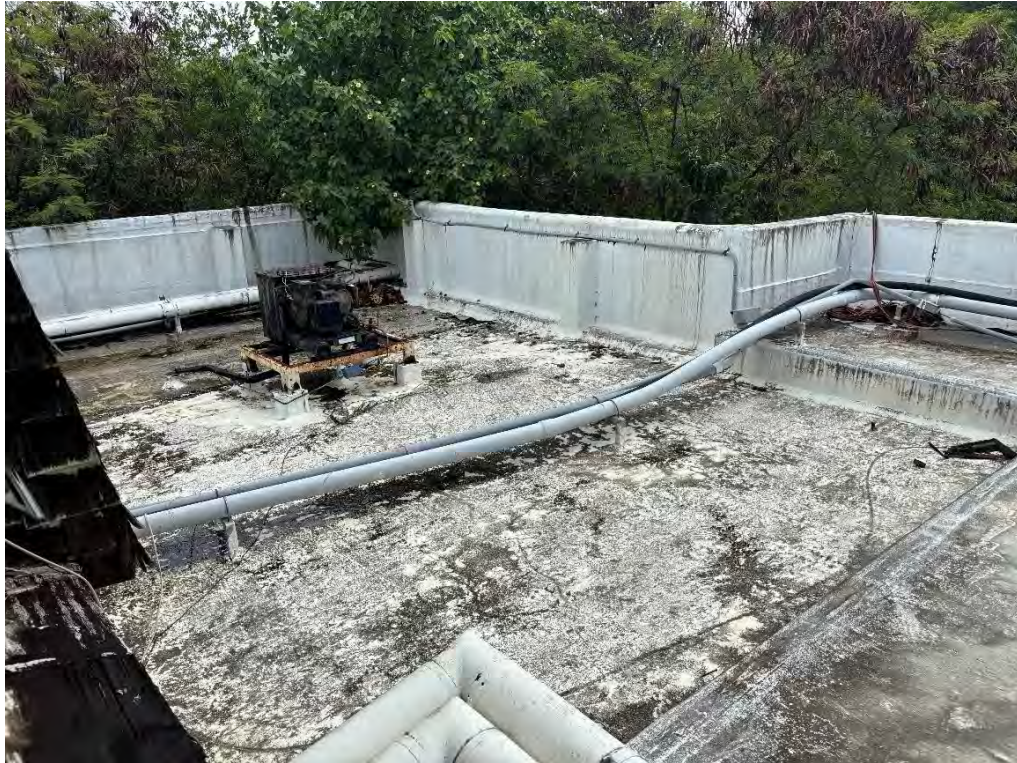
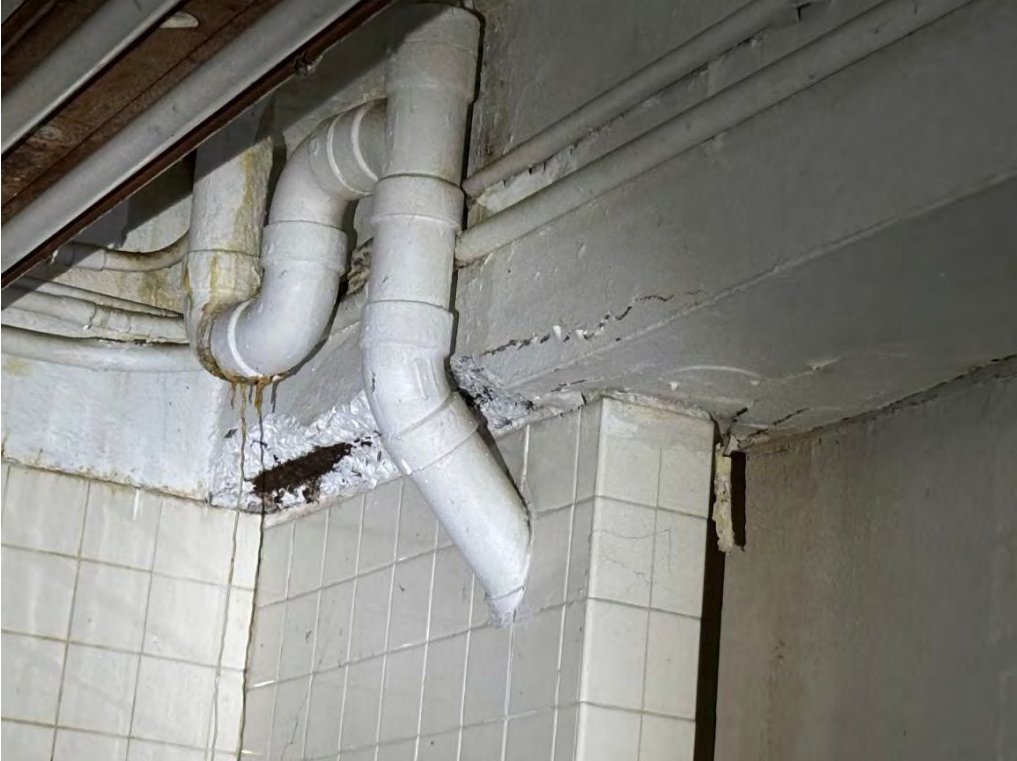
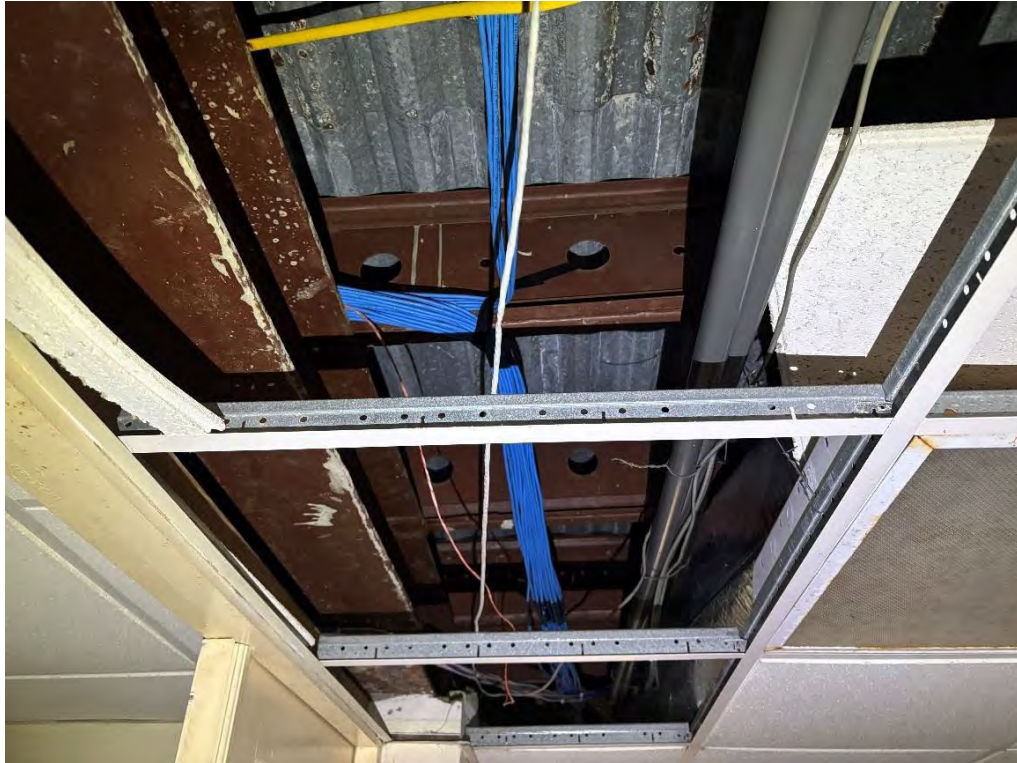
Building: 22 Main Building

Structural Assessment: Potentially

Repair or Rebuild

Component	Material	Notes
Floor	Concrete	
Walls (Structural)	First Floor: Stone/Concrete Second Floor: Concrete on west side, steel framing on east side, and wood framed shed addition further east.	Concrete beams supporting second floor cracked in kitchen area. Spalled beam to column connection with exposed, corroded rebar. Tile finishes in kitchen area covered most walls and ceilings, so some structural conditions may be hidden. Questionable construction design second floor.
Walls (Non-Structural)	Concrete/Wood	Potential termite damage.
Roof	Membrane on Concrete/Metal Decking Mansard wood shingle roof on second floor admin offices	First floor roof is functionally failed, numerous areas of water infiltration and large hole in south east corner. Wood shingles deteriorated and visible biological growth.
Stairs/Railings	Metal Stairs to Roof	Wood planks on roof catwalk deteriorated. Possibly an egress pathway due to occupancy on second floor.

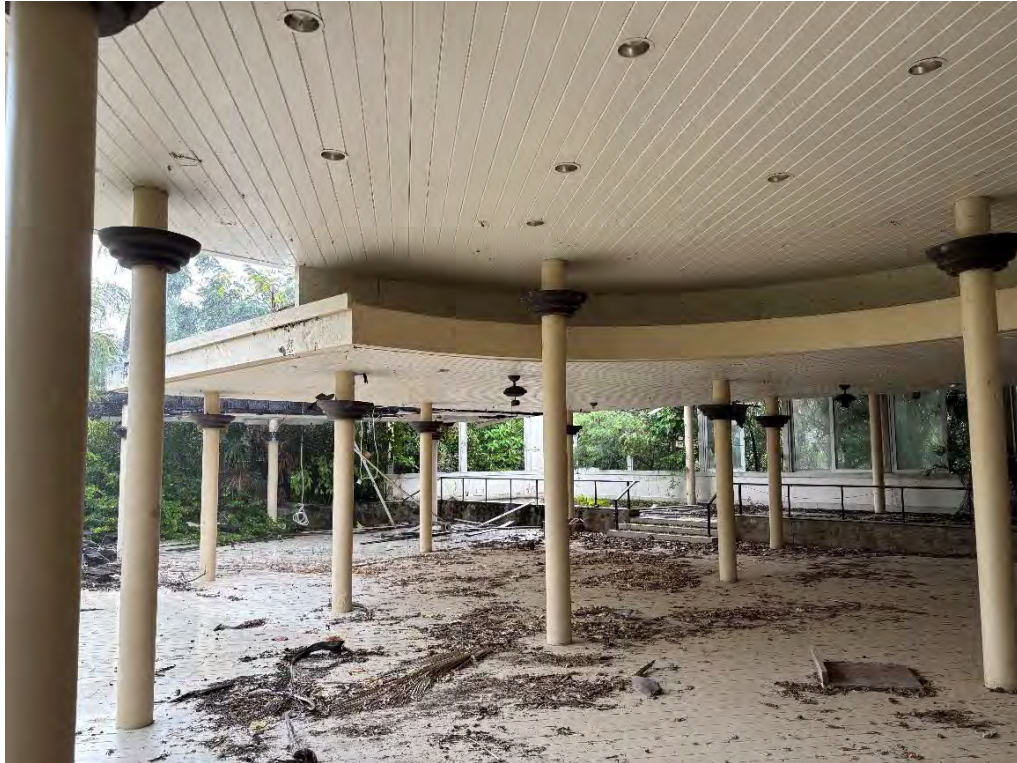
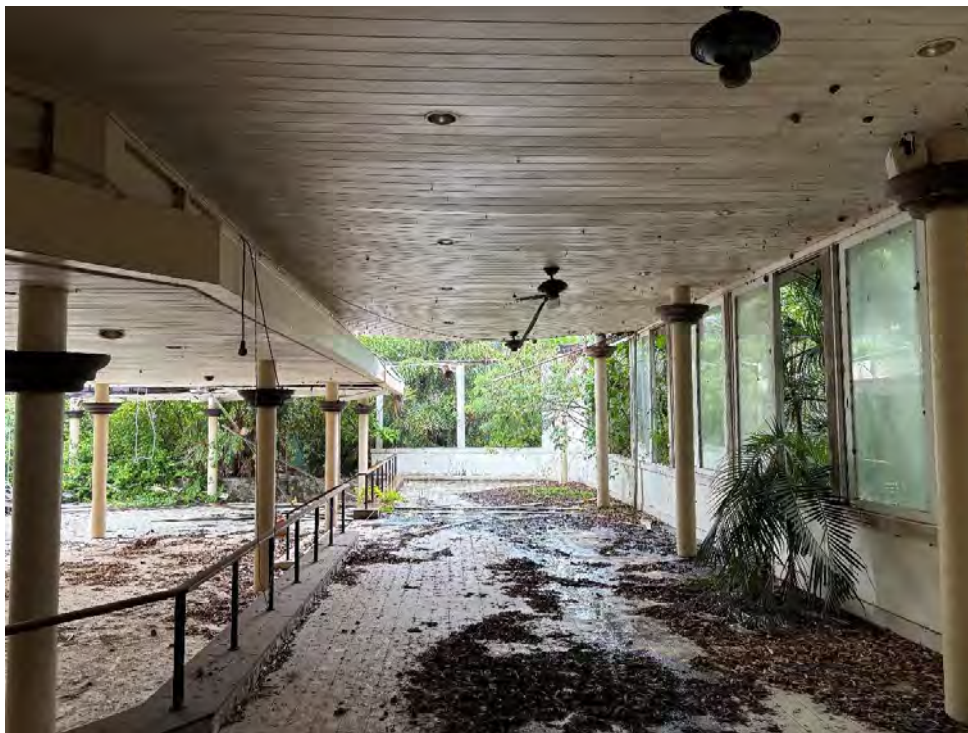
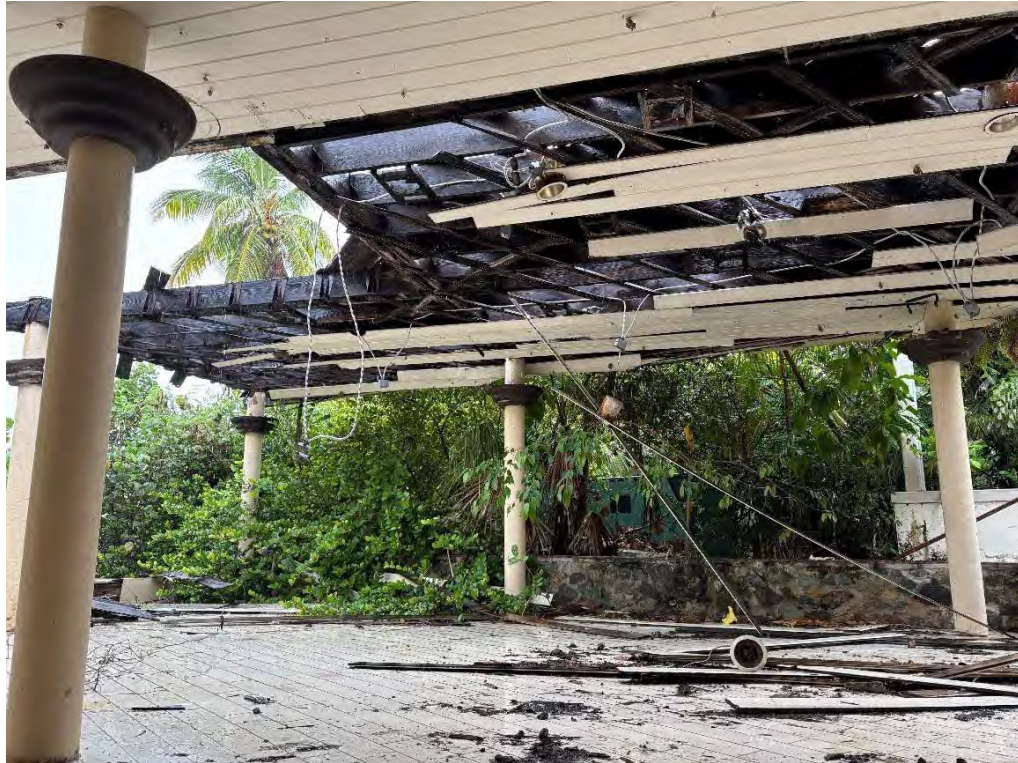
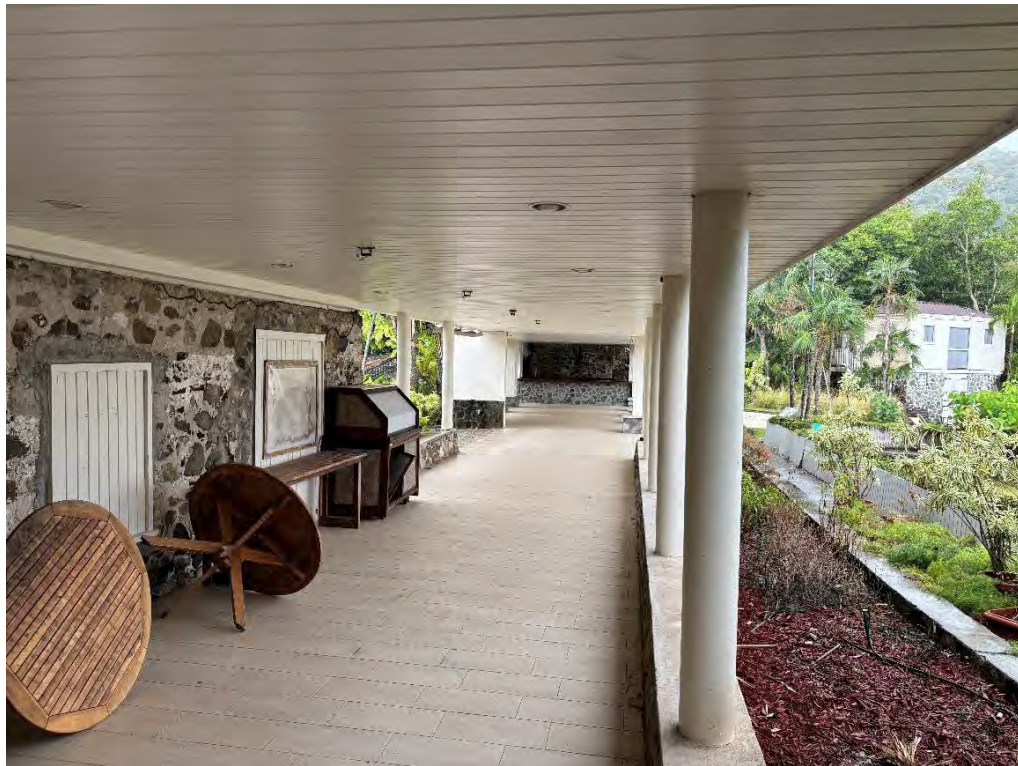
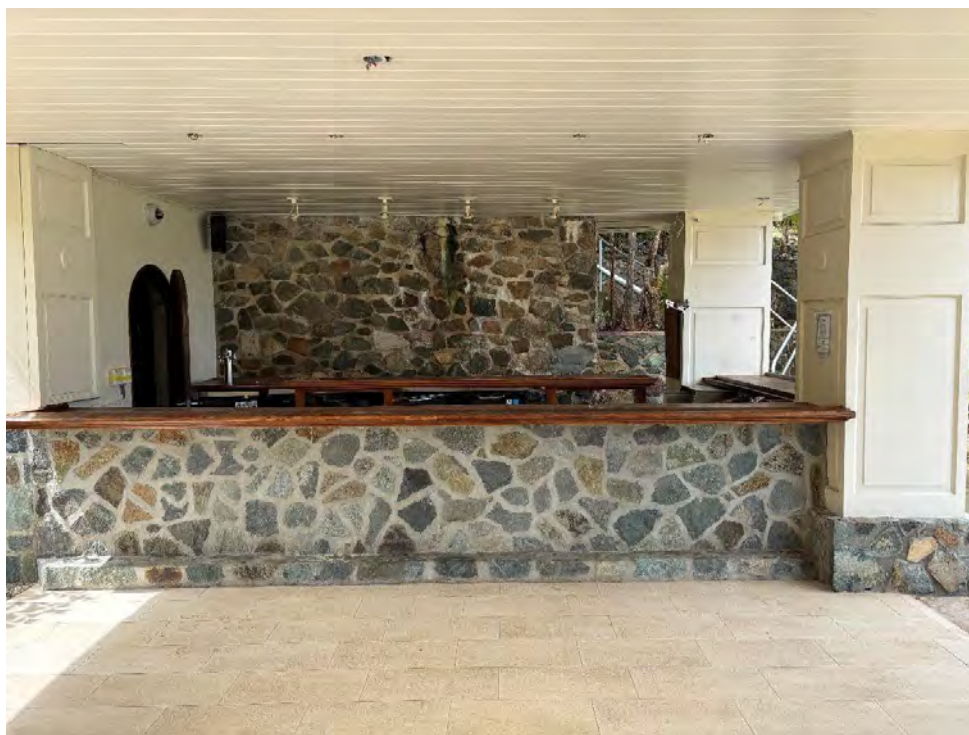
Building: 22 Main Building – Terrace

Component	Material	Notes
Floor	Concrete	
Walls (Structural)	Concrete Piers	Structure is semi-attached to portions of the admin building. The concrete piers are the primary structural system, no pier deterioration was observed.
	Steel/wood-framed addition	Wood-framed additions were hung from the roof at the north end of the structure from a post-installed steel lintel. Questionable construction design of additions.
Walls (Non-Structural)	N/A	
Roof	Concrete	
Stairs/Railings	Metal	
Sidewalk	Concrete
