Building: 56 Fitness Center

Structural Assessment: Structurally Sound

National Park Service
Virgin Islands National Park | Caneel Bay
Structural Assessment Report

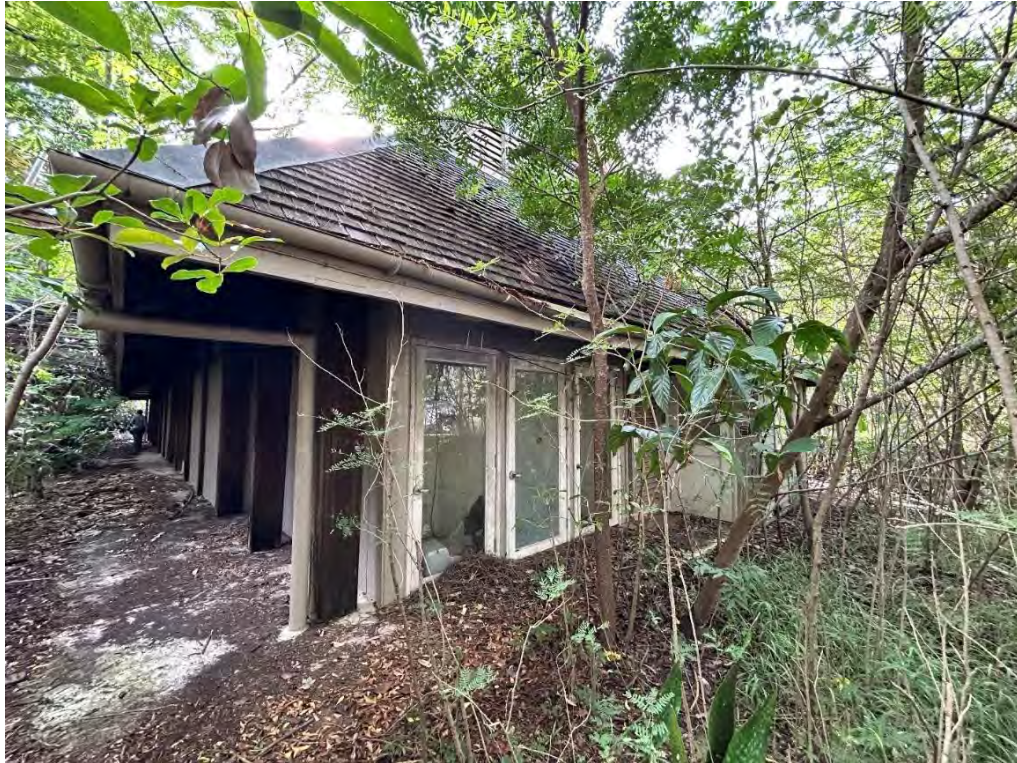
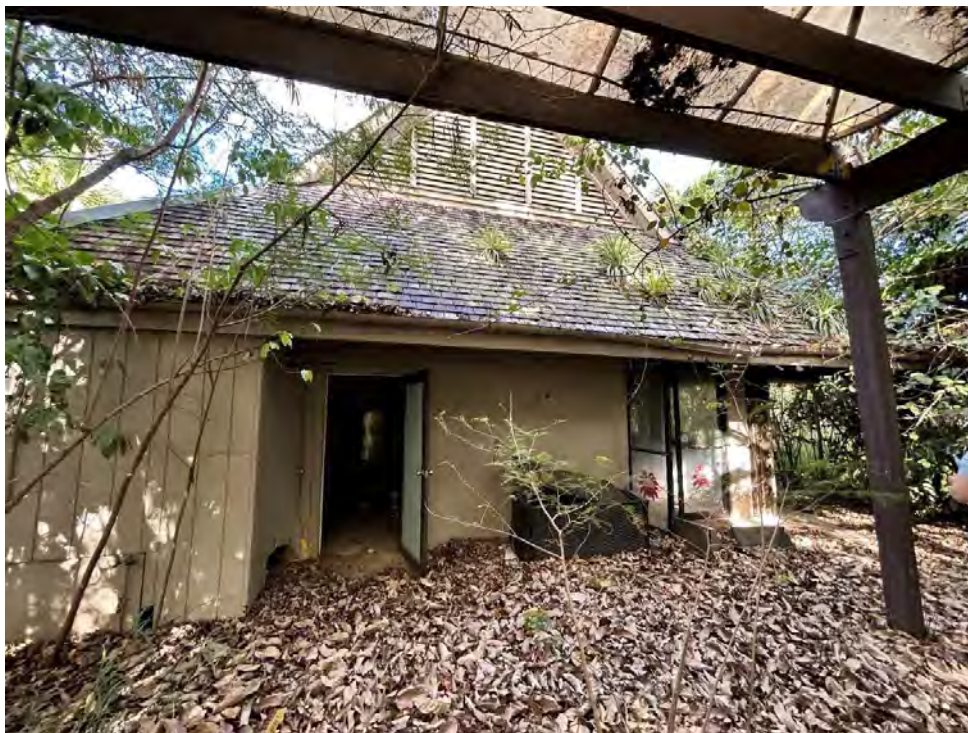
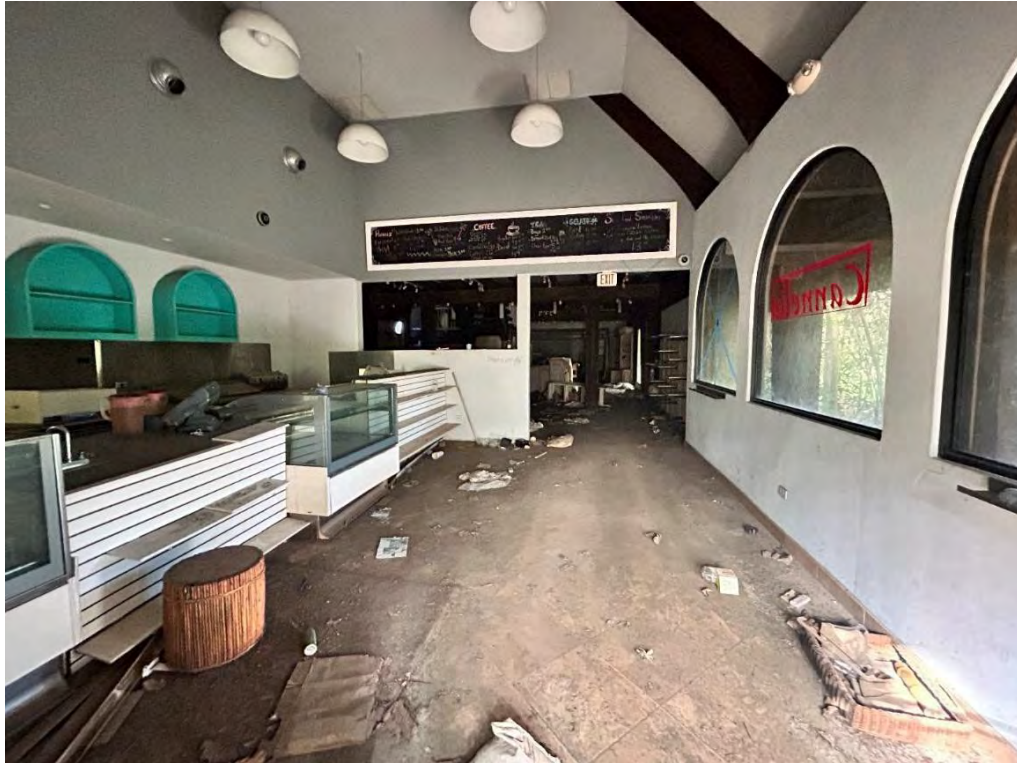
Building: 23 Gift Shop / Car Rental

Component	Material	Notes
1 st Floor	Concrete	
2 nd Floor	Wood Framed	
Framing (Structural)	Laminated Wood / Timber	Bottom of exterior, laminated wood columns have moisture damage.
Walls (Non-Structural)	Wood Framed	Termite activity observed on partition walls by kitchen. Exterior partition walls on south side have sill plate and sheathing damage near base.
Roof	Wood Framed / Wood Shingles	Sporadic sheathing damage and missing wood shingles at roof. Vegetation on roof.
Stairs/Railings	Wood	
Pergolas	Wood Framed	Attached wood pergola on north side with damaged rafters and posts. Detached wood pergola on east side with sever drift and failed connectors.

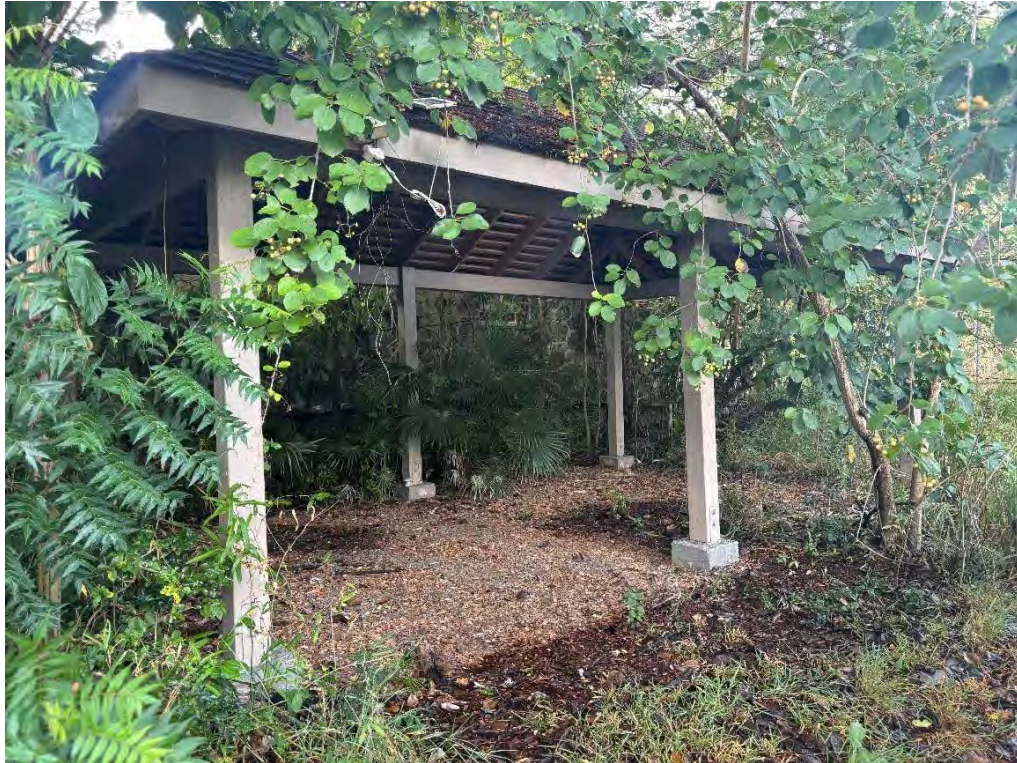
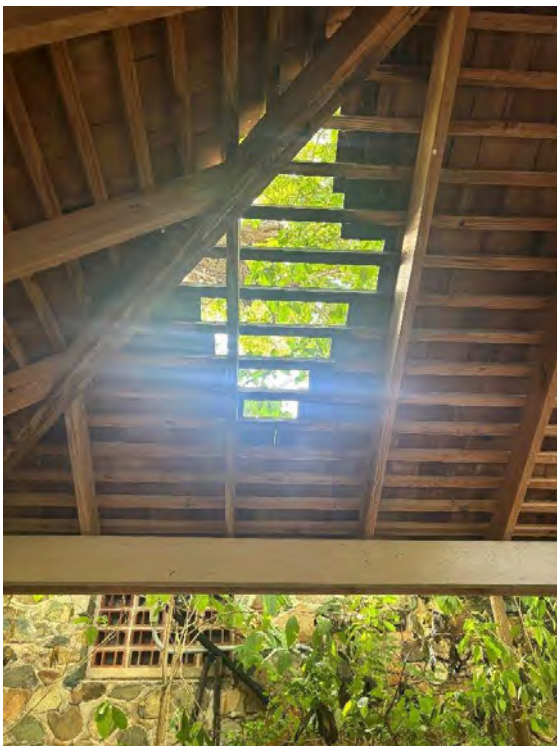
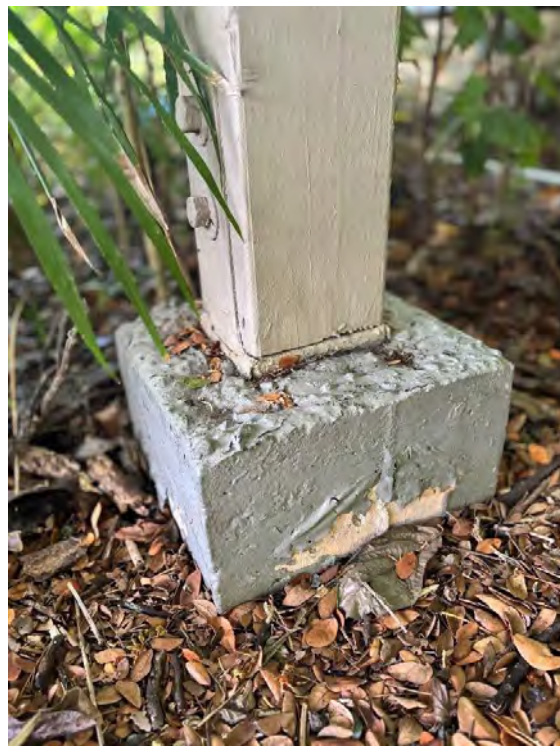
Building: Gift Shop Bus Stop (Adjacent to Gift Shop / Car Rental)

Component	Material	Notes
Roof	Wood Framed / Wood Shingles	Missing roof sections. Potential termite damage.
Posts	Wood	Wood posts supported on concrete foundations.

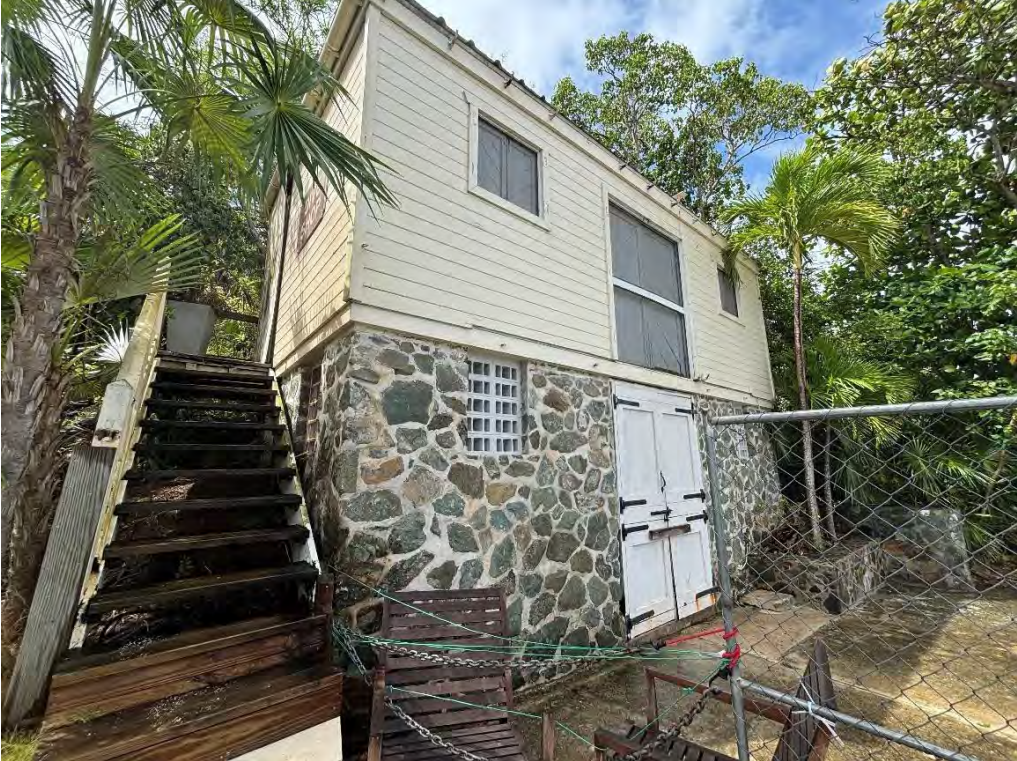
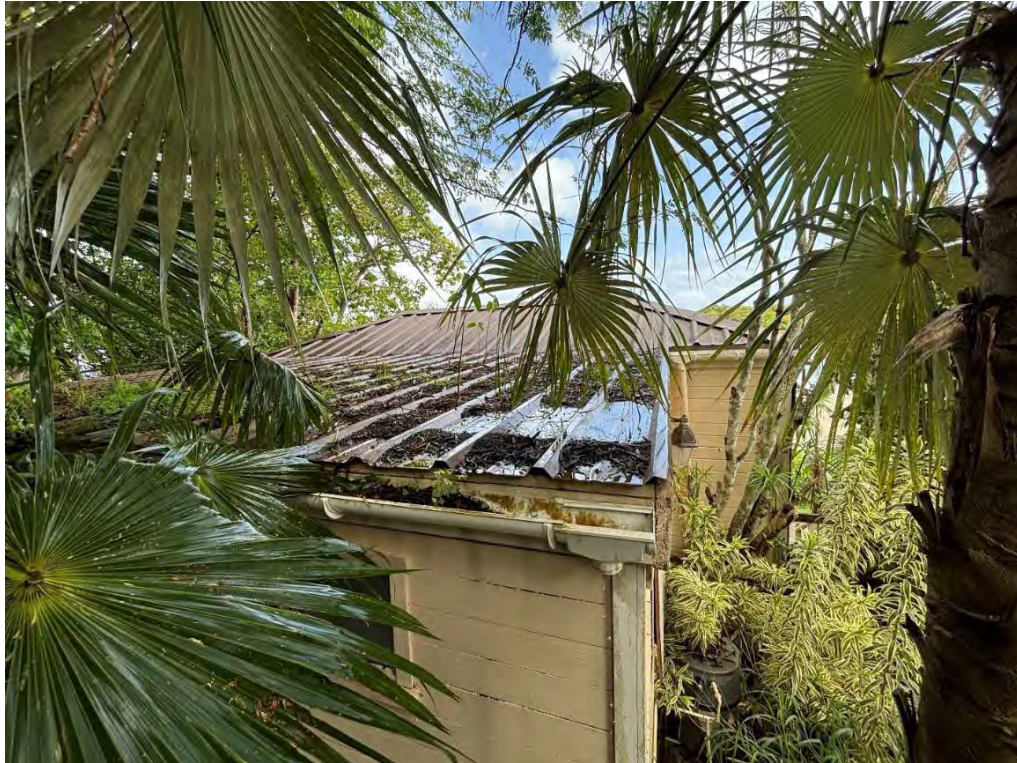
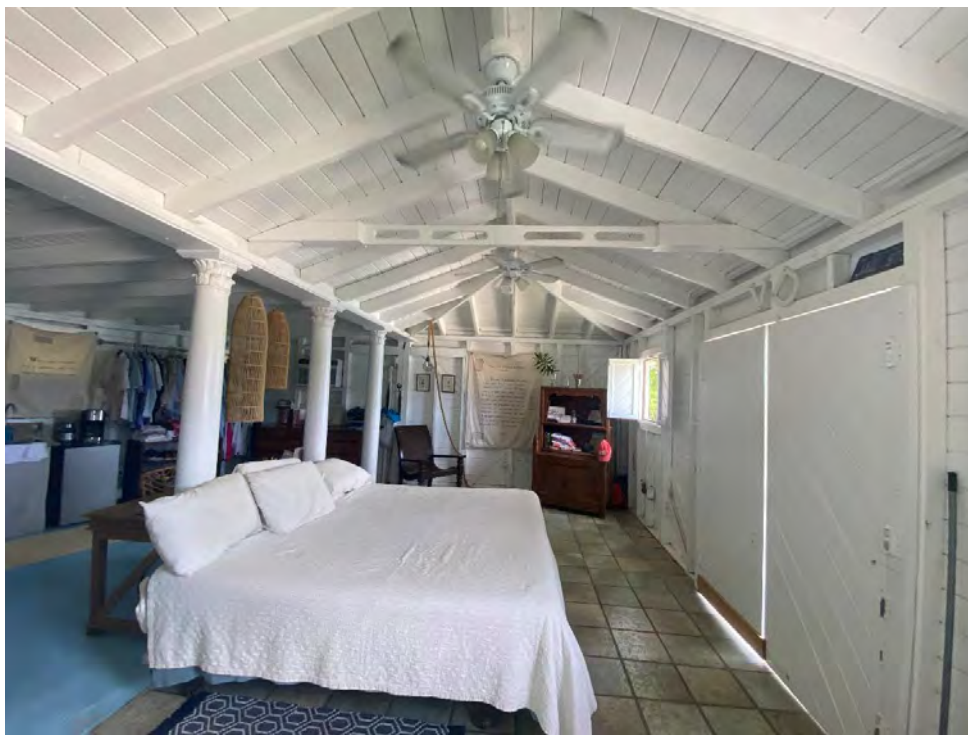
Building: 64 Dive Shop

Component	Material	Notes
Floor	Concrete 1 st Floor / Wood Framed 2 nd Floor	
Walls (Structural)	Stone 1 st Floor / Wood 2 nd Floor	Exterior sheathing on east side of building is showing signs of rot at base of wall.
Roof	Wood Framed / Metal Roof	Vegetation on low roof. Roof at rear building has a very low slope for a metal roof.
Stairs/Railings	Wood	Exterior wood railings have failed.

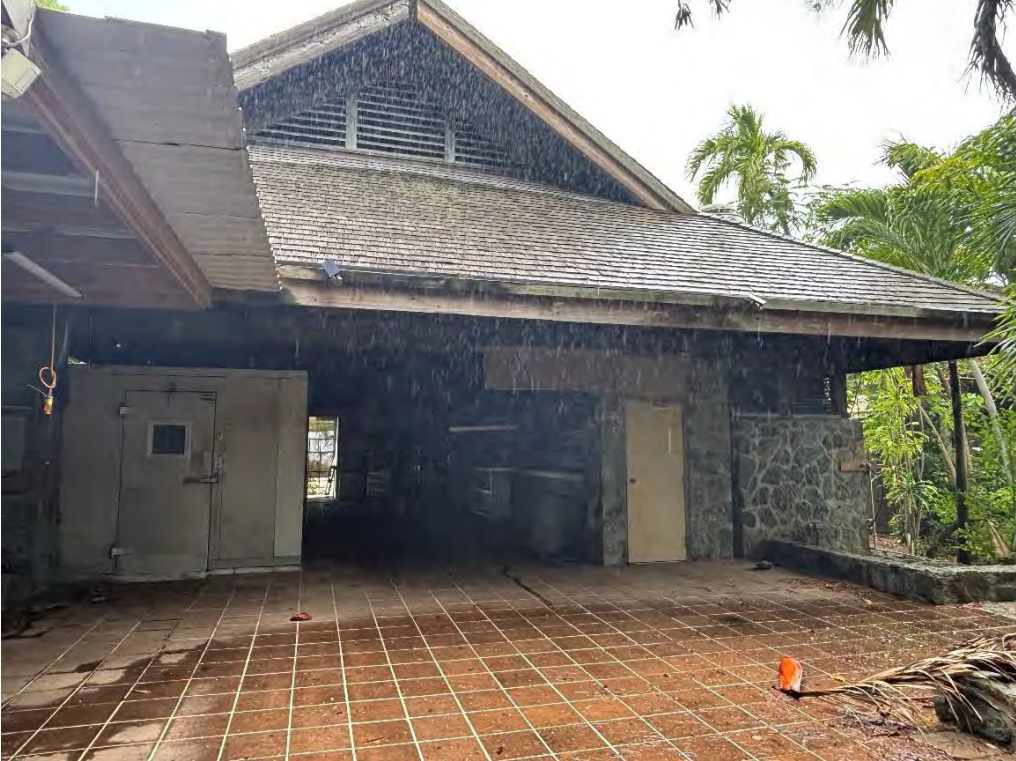
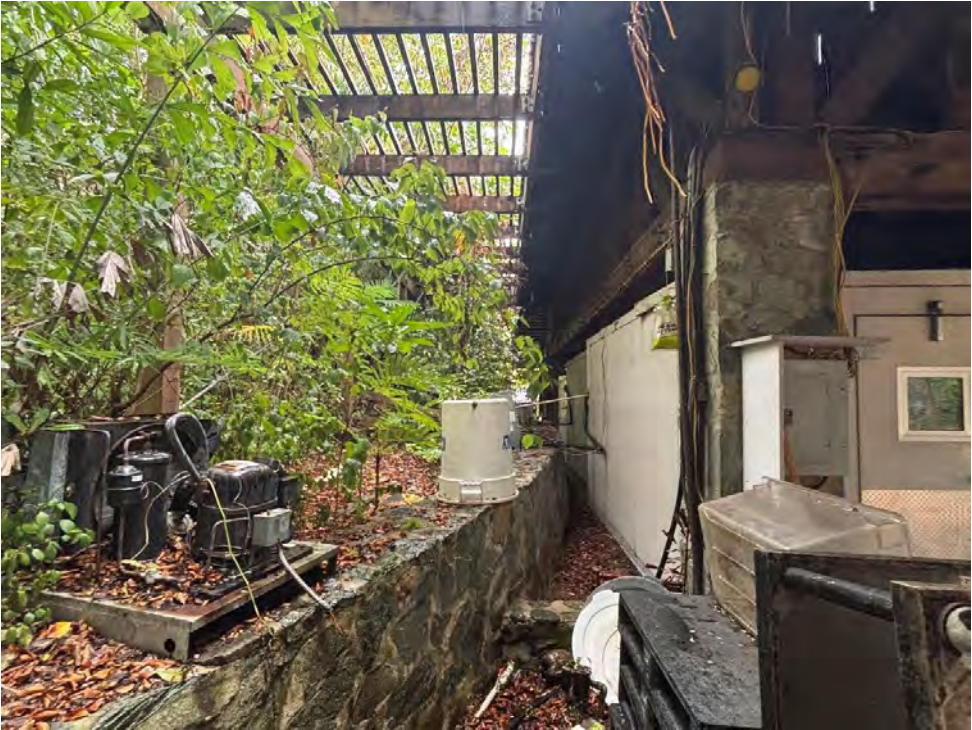
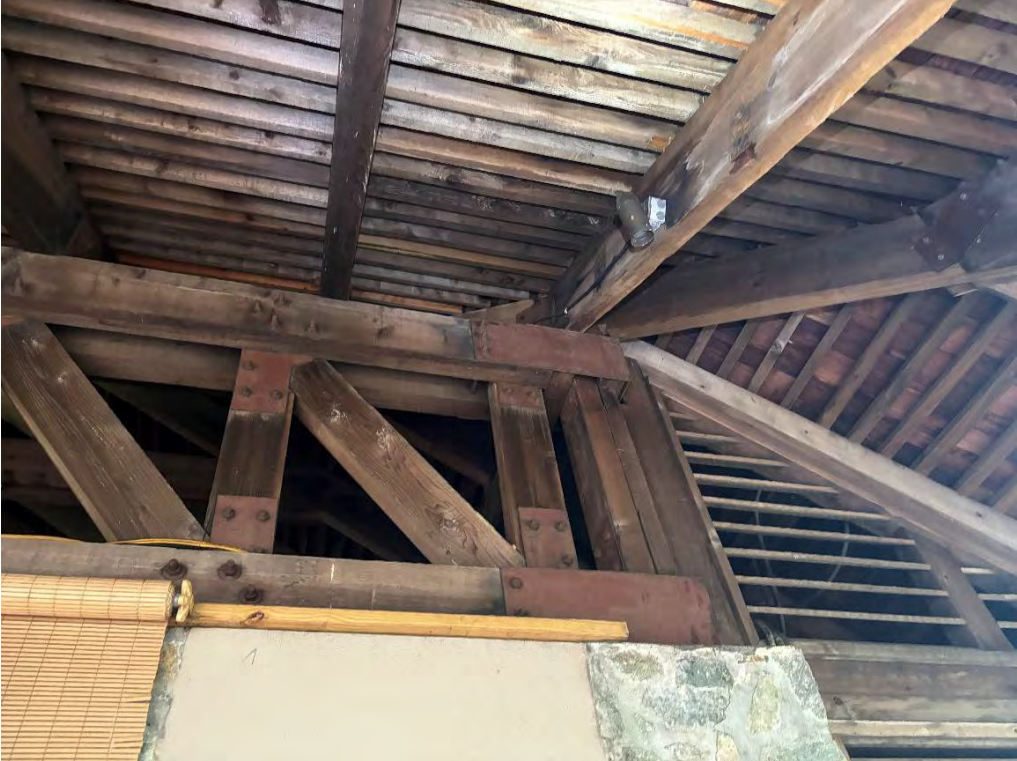
Building: 98 Open Kitchen at ZoZo's

Component	Material	Notes
Floor	Concrete	
Walls (Structural)	Stone	Stone piers support 4 timber trusses.
Roof	Wood Framed / Wood Shingles	Rafters at north-east corner shows signs of termite damage and rotted wood. Minor missing wood shingles throughout roof structure.

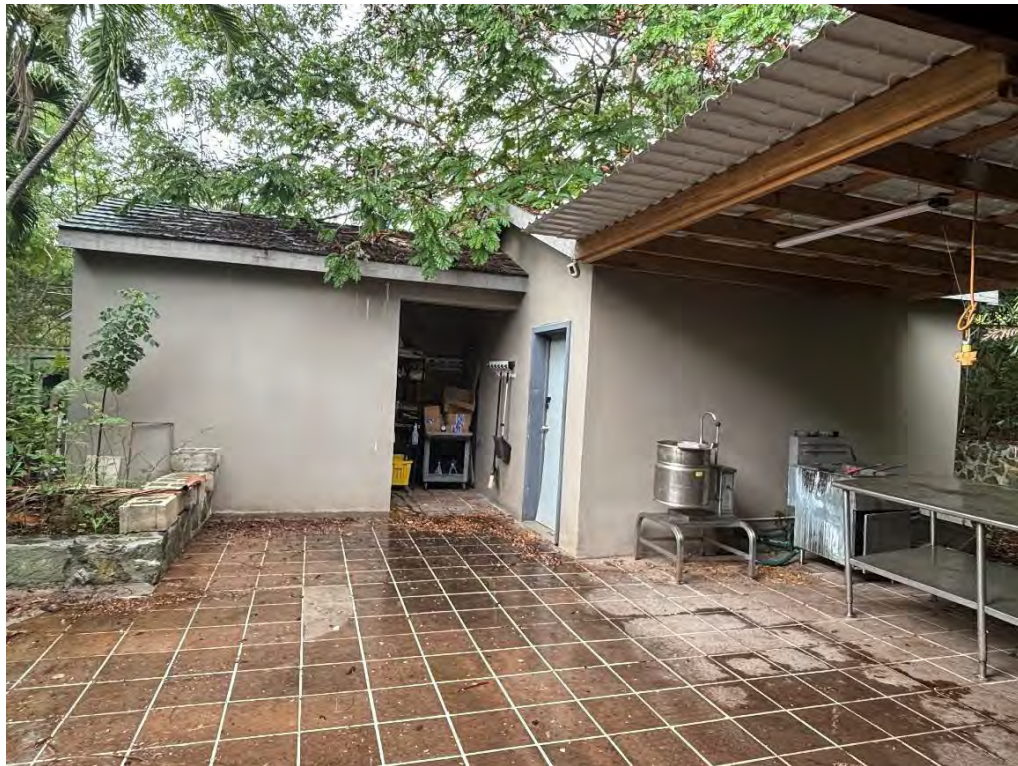
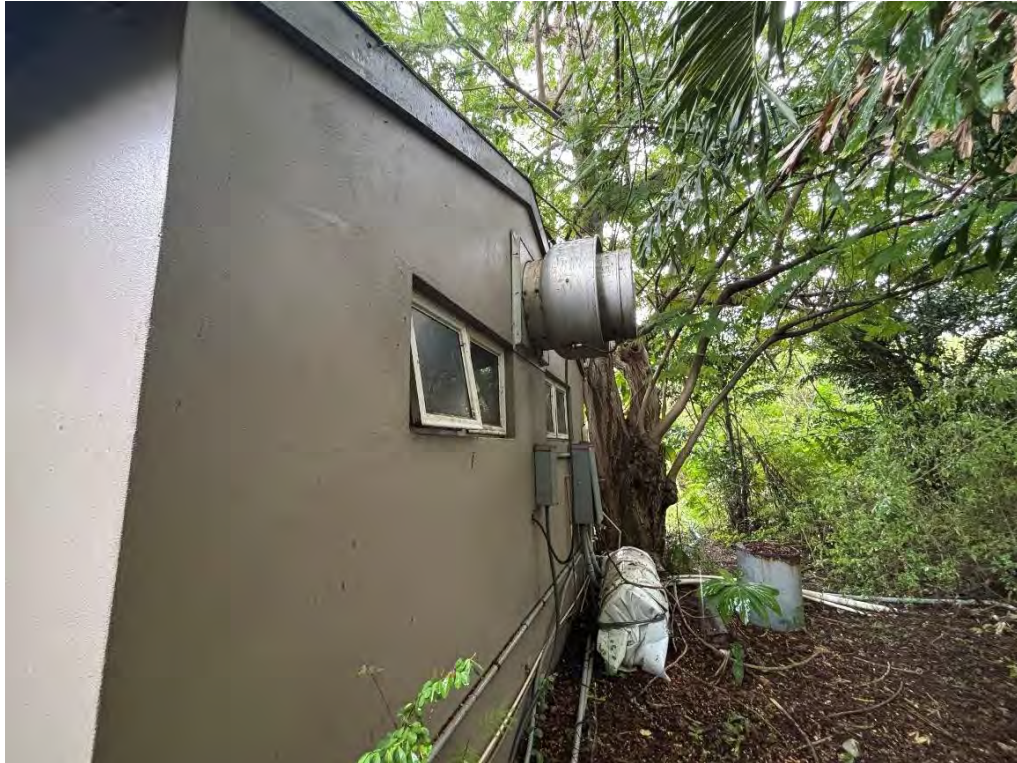
Building: Laundry and Prep Kitchen at ZoZo's

Component	Material	Notes
Floor	Concrete	
Walls (Structural)	Concrete	Minor rot of wood frames around exterior door.
Walls (Non-Structural)	Concrete	
Roof	Wood Framed / Wood Shingles	
Infill Structure	Wood Framed / Plastic Corrugated Roof

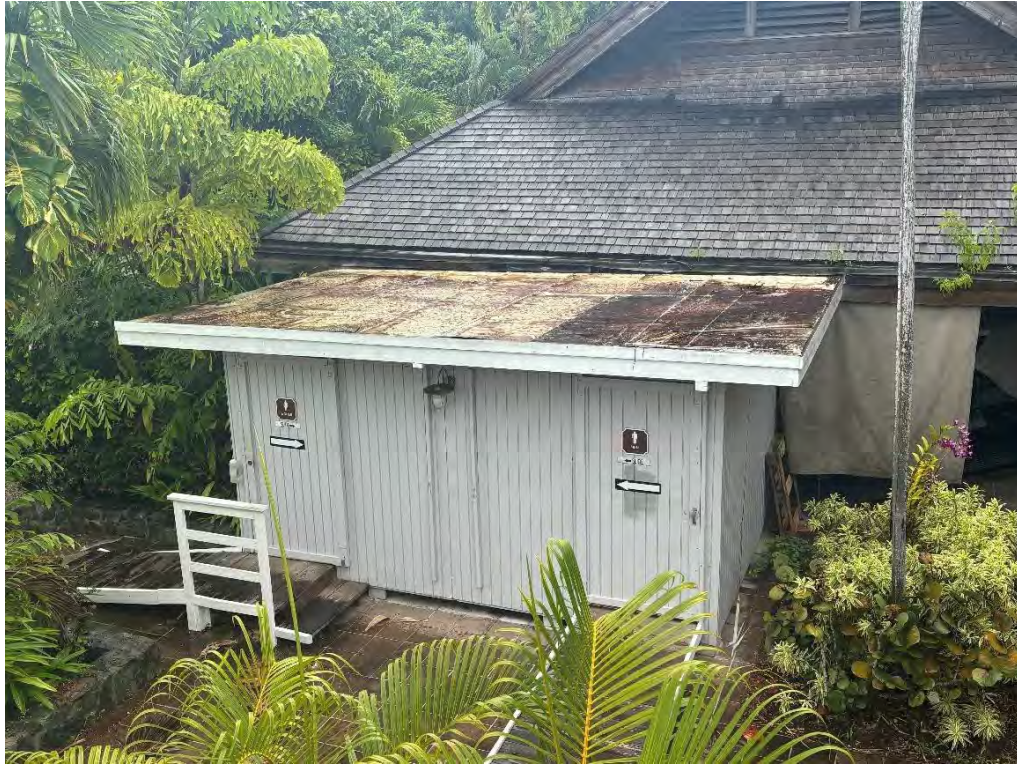
Building: Comfort Station at ZoZo's

Component	Material	Notes
Floor	Wood	
Walls (Structural)	Wood	
Walls (Non-Structural)	Wood	
Roof	Wood Framed / Membrane	Minor damage at flashing edge and membrane roof.
Stairs/Railings	Wood Ramps

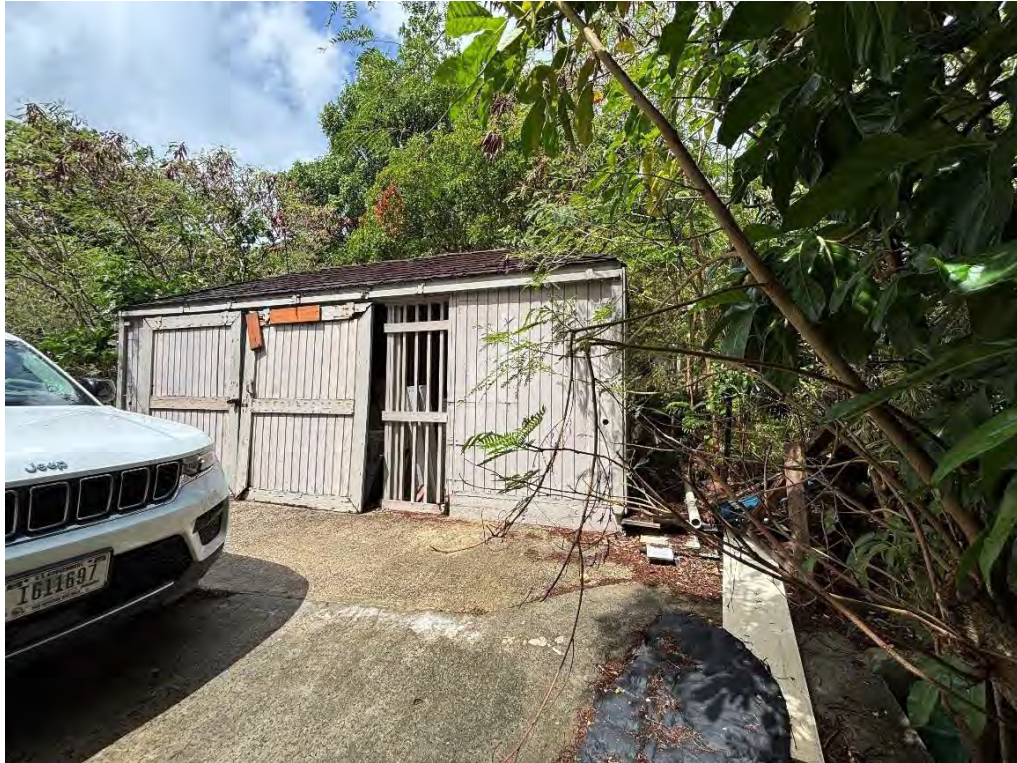
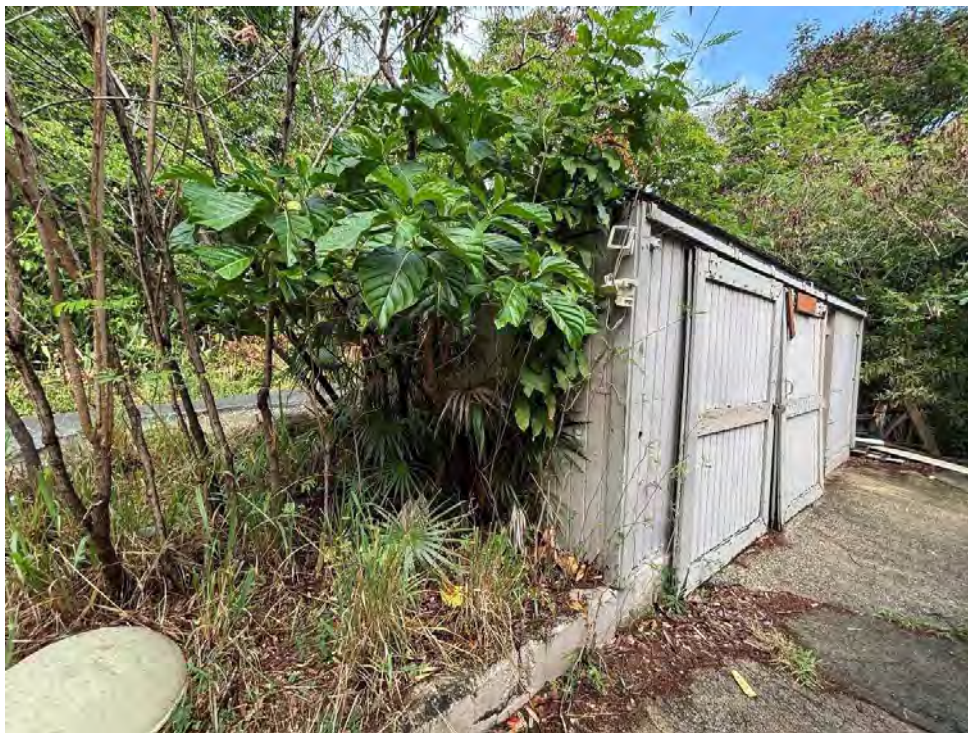
Building: Storage Shed at ZoZo's

Component	Material	Notes
Floor	Concrete	
Walls (Structural)	Wood	Appears to have originally been bus stop with two center posts supporting the roof. Non-bearing wood walls were added at perimeter to create and enclosed structure. Large sliding barn doors on north side of structure have significantly deteriorated.
Roof	Wood Framed / Wood Shingles	Minor damage at flashing edge and membrane roof.

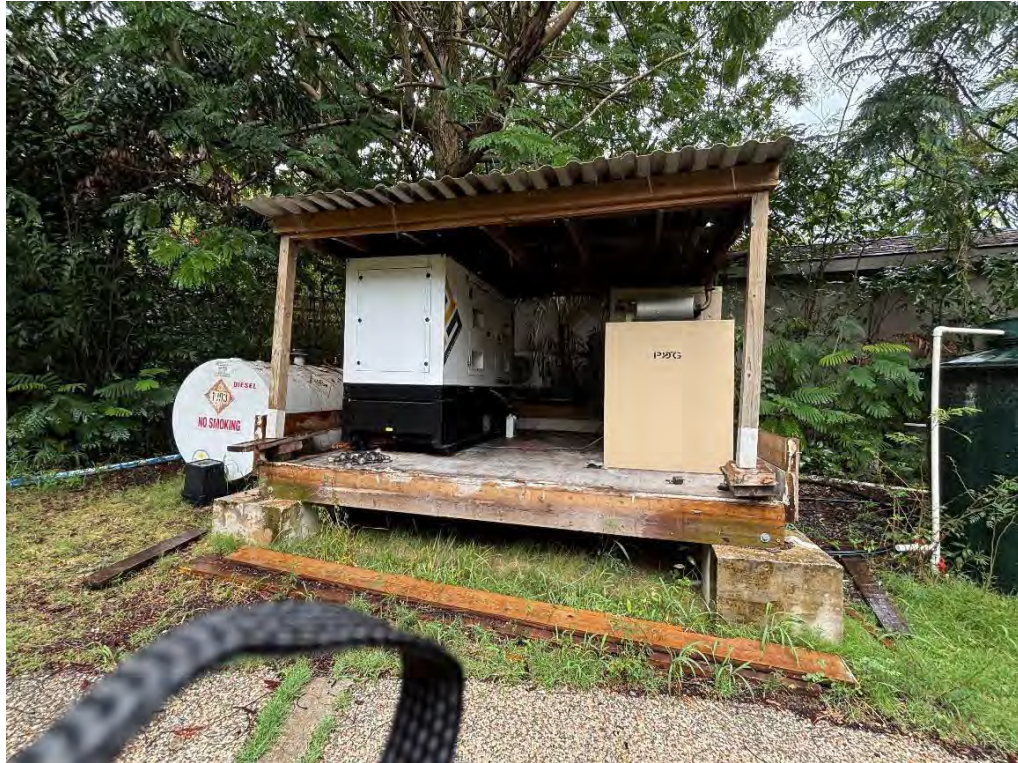
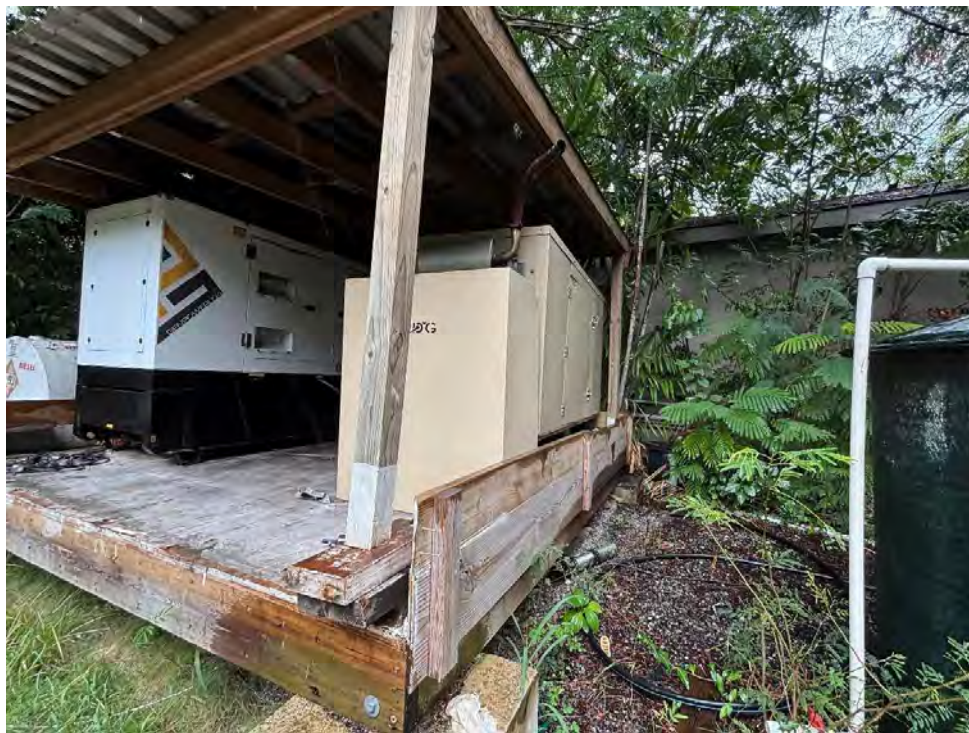
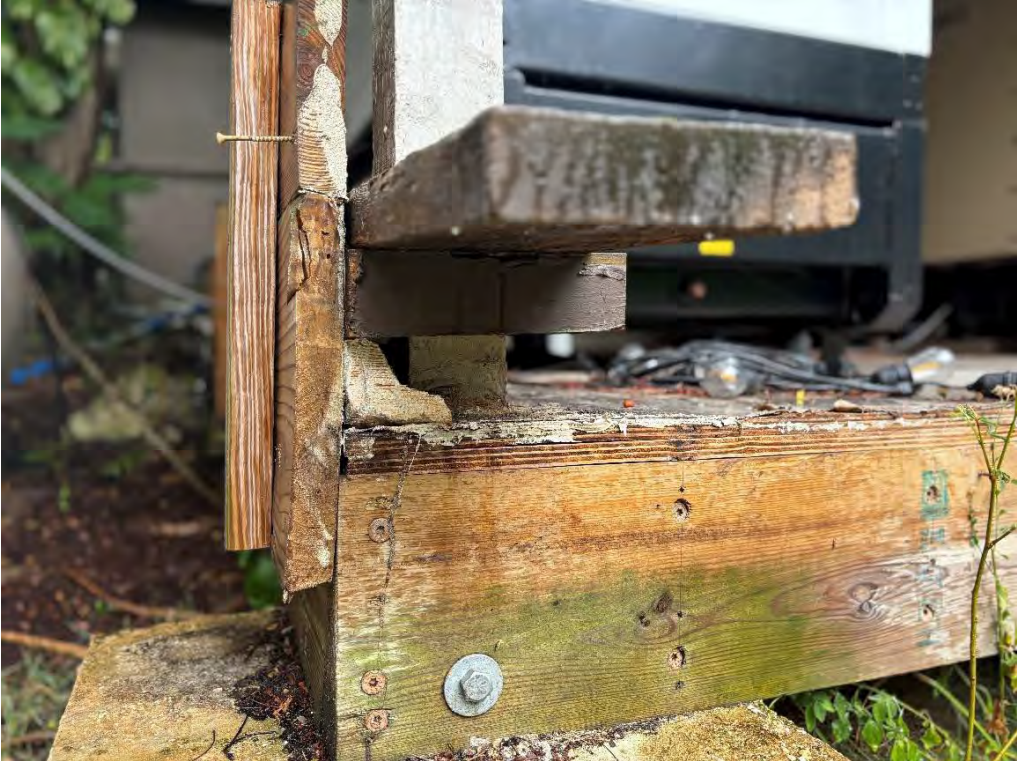
Building: Generator Hut at ZoZo’s

Structural Assessment: Structurally Unsound

Component	Material	Notes
Floor	Wood Framed / Plywood Deck	
Structure	Wood	Open structure with a wood post at each of the 4 corners. The front two posts have been cut and are supported on stacked wood scraps. The posts are leaning and have no positive connection to the blocking or deck below.
Roof	Wood Framed / Plastic Corrugated Deck	Minor damage to roof deck.

- Structure appears to not meet requirements of National Fire Protection Association (NFPA) regarding supporting generators on flammable surfaces and clearance surrounding generators. Further review recommended to assess code compliance for generator structure.

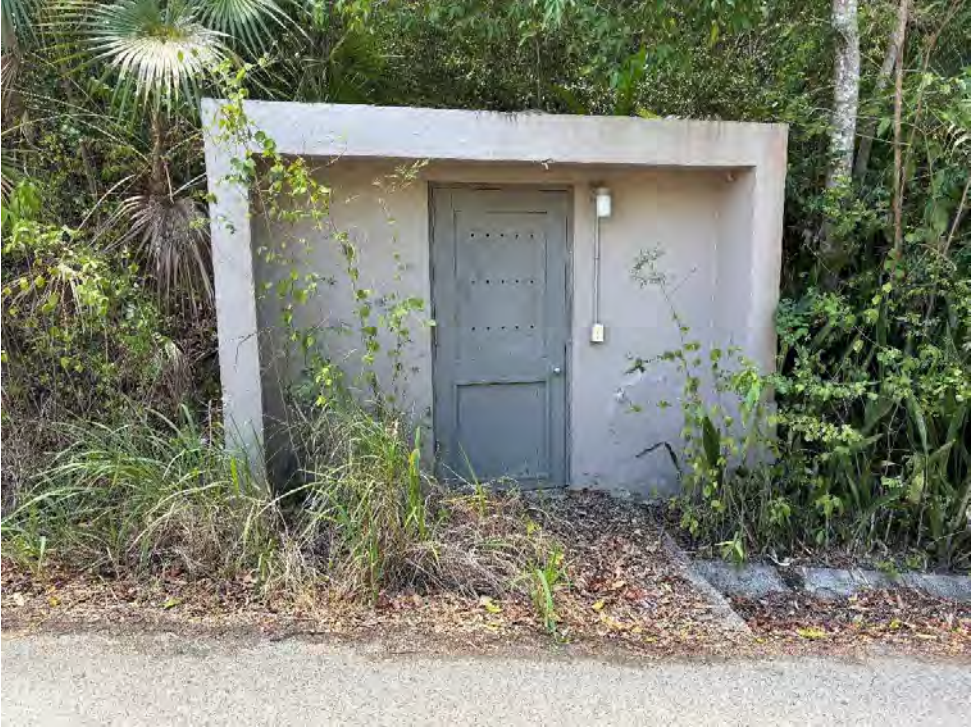
Building: Concrete Shed on Road to Honeymoon Beach

Component	Material	Notes
Floor	Unknown	Door seized shut, unable to access interior.
Walls (Structural)	Concrete	Spall on roadside concrete wall. Note due to vegetation and soil elevation, unable to access three sides of the building.
Roof	Concrete

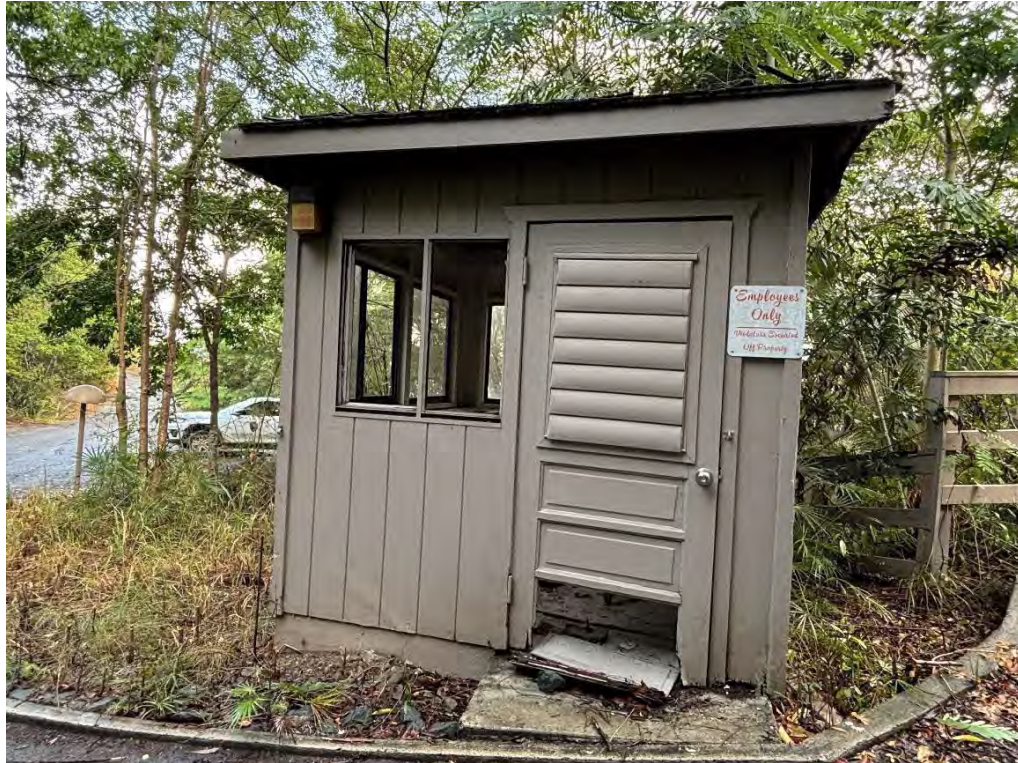
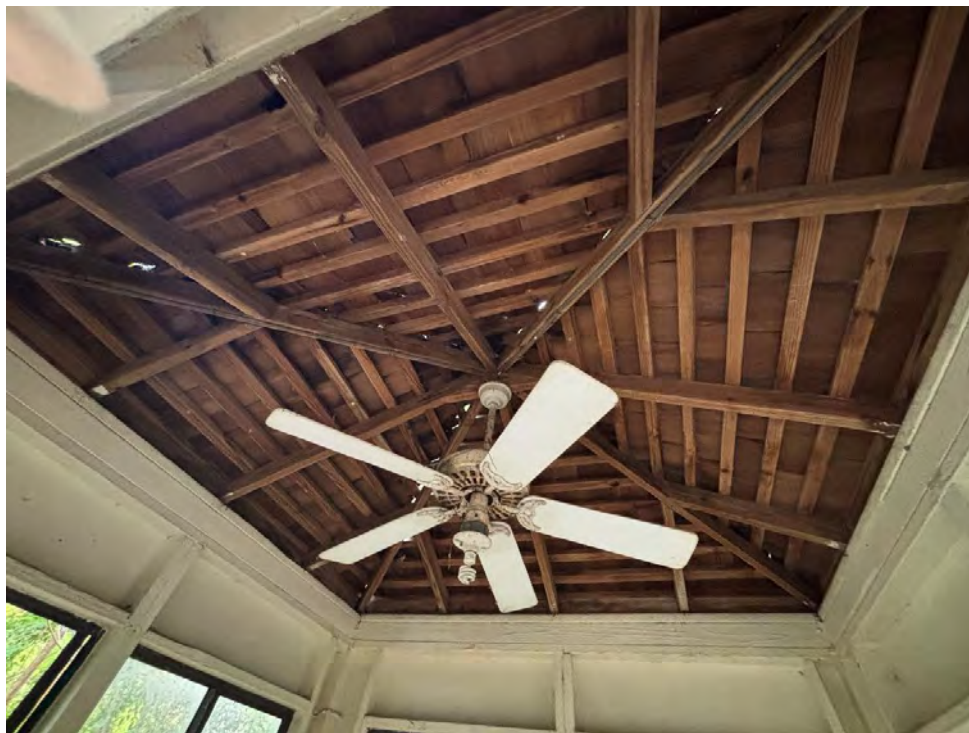
Building: Little Caneel Beach Guard Shack

Component	Material	Notes
Floor	Concrete	
Walls (Structural)	Wood	Minor rot at base of exterior sheathing.
Walls (Non-Structural)	N/A	
Roof	Wood framed/ Wood shingles	Missing some shingles. Missing fascia board at one corner.

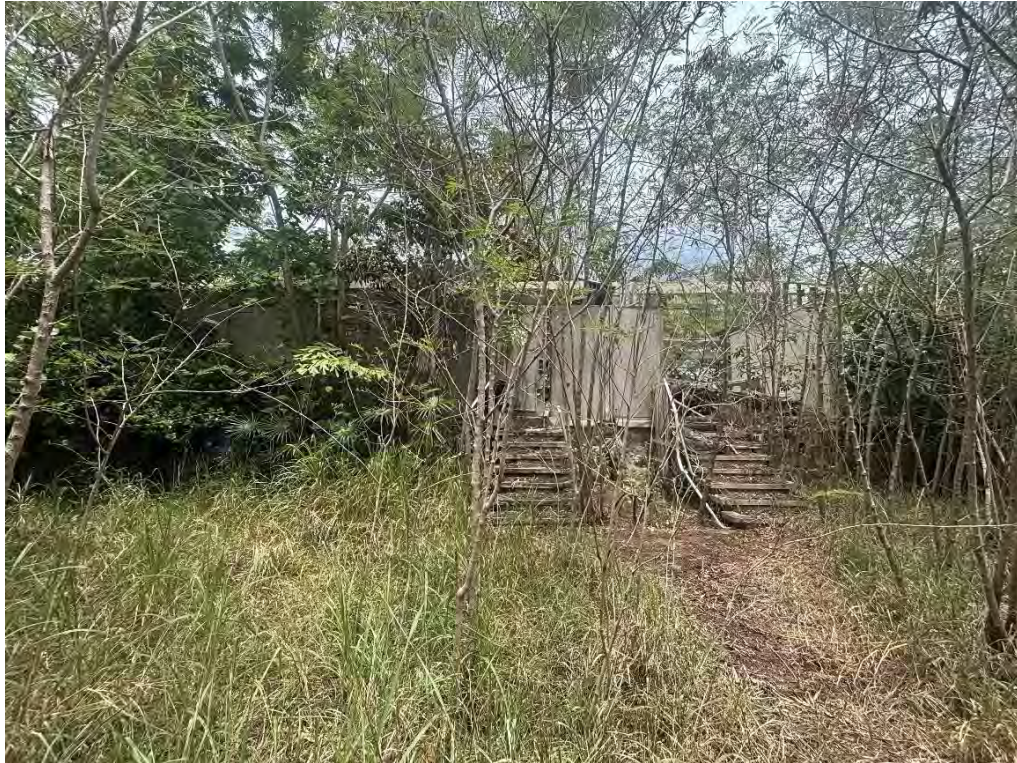
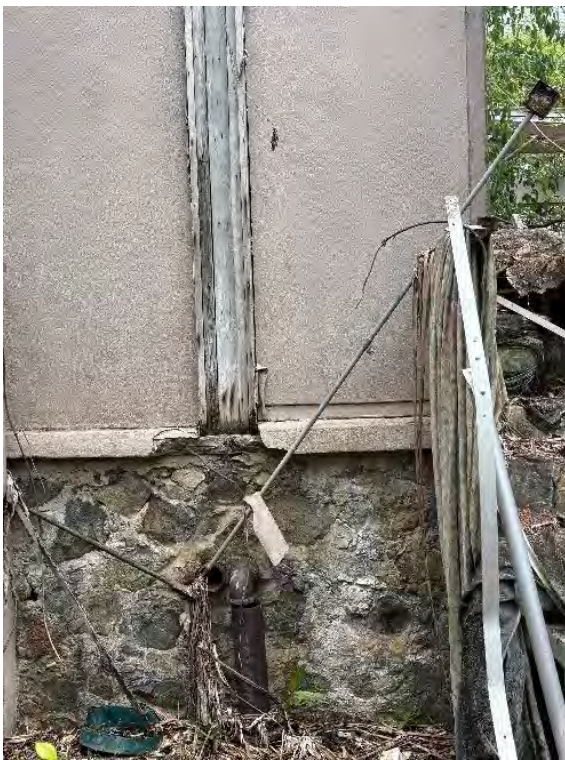
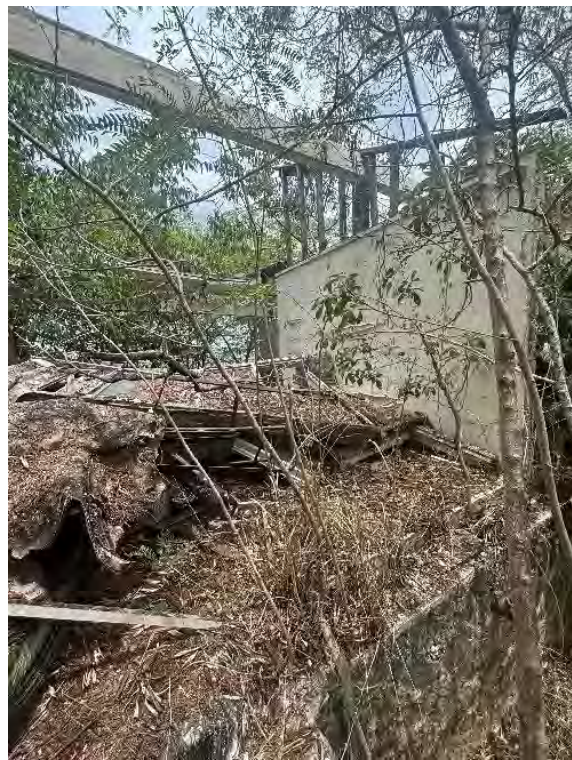
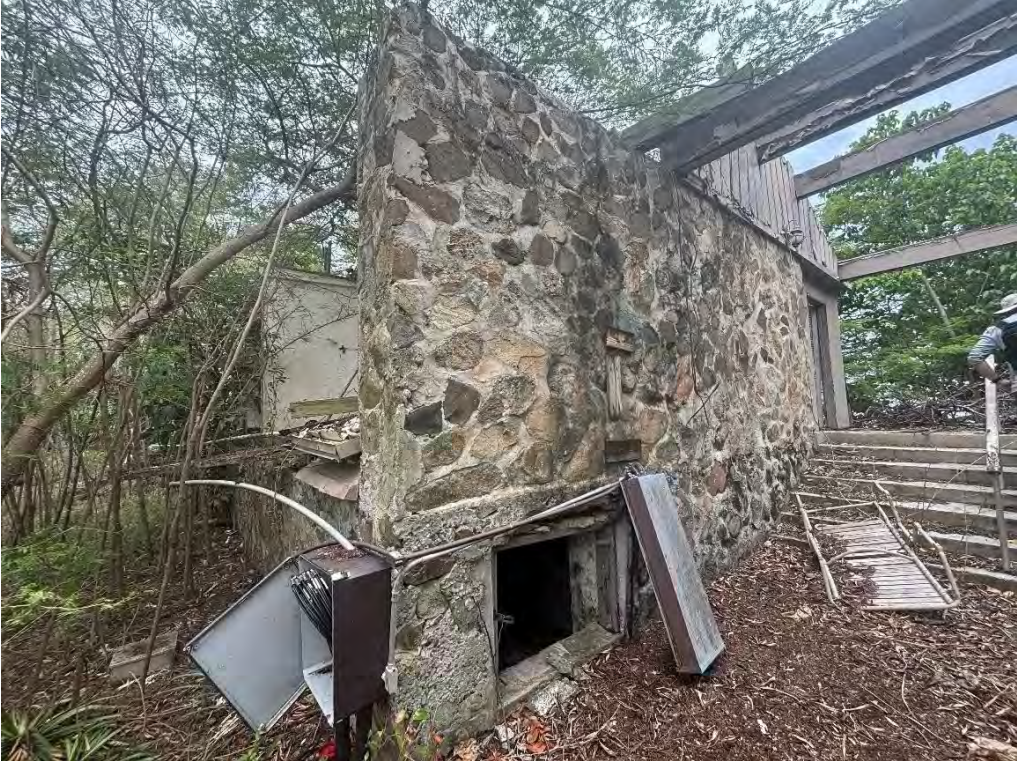
Building: 69 Caneel Beach Units 14-17

Component	Material	Notes
Floor	Concrete / Hollow Core Concrete	Concrete damage and exposed rebar east side of slab in Unit 15.
Walls (Structural)	Stone / Concrete / Steel Columns	Concrete cracking at door to Unit 17. Steel columns corroded at base.
Walls (Non-Structural)	Wood	Collapsed.
Roof	Wood	Roof collapsed.
Stairs/Railings	Concrete / Aluminum	Railings damaged.

- This building has significant corrosion of the embedded steel structure and corrosion of the concrete encased steel piers and rebar within the concrete bearing walls.

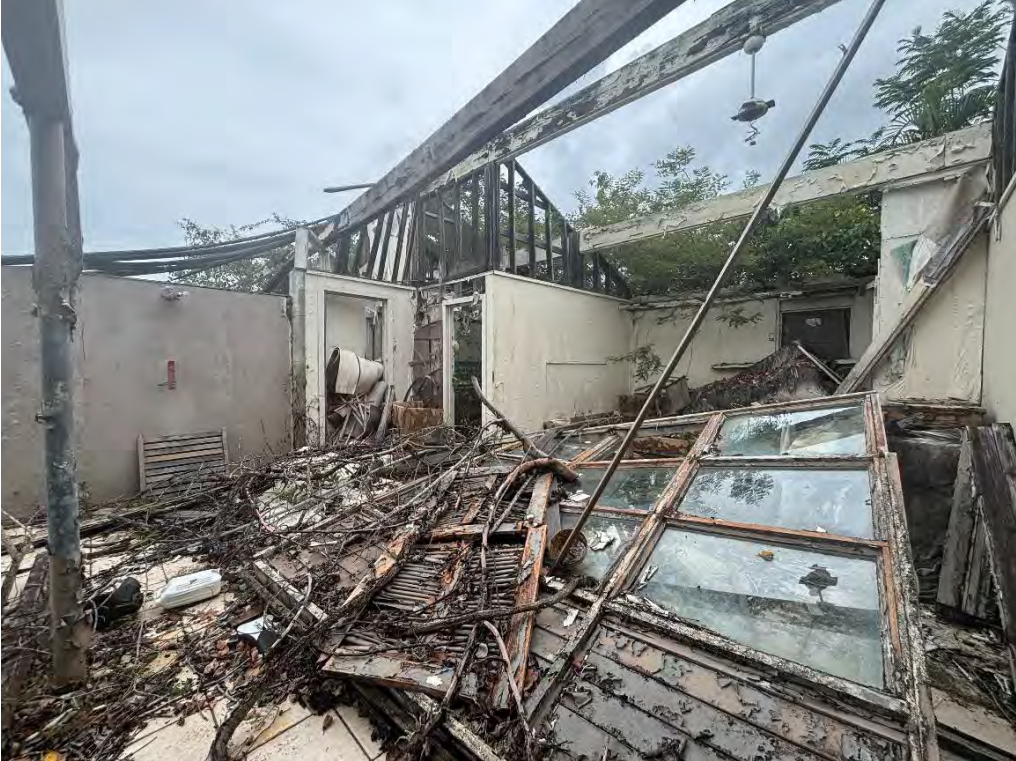
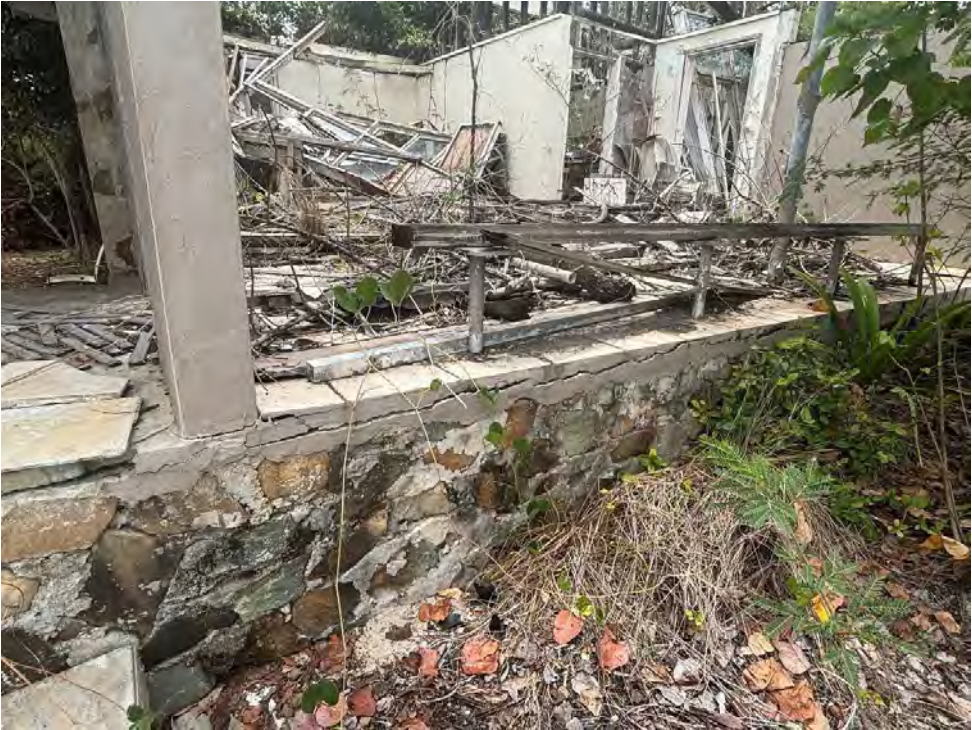
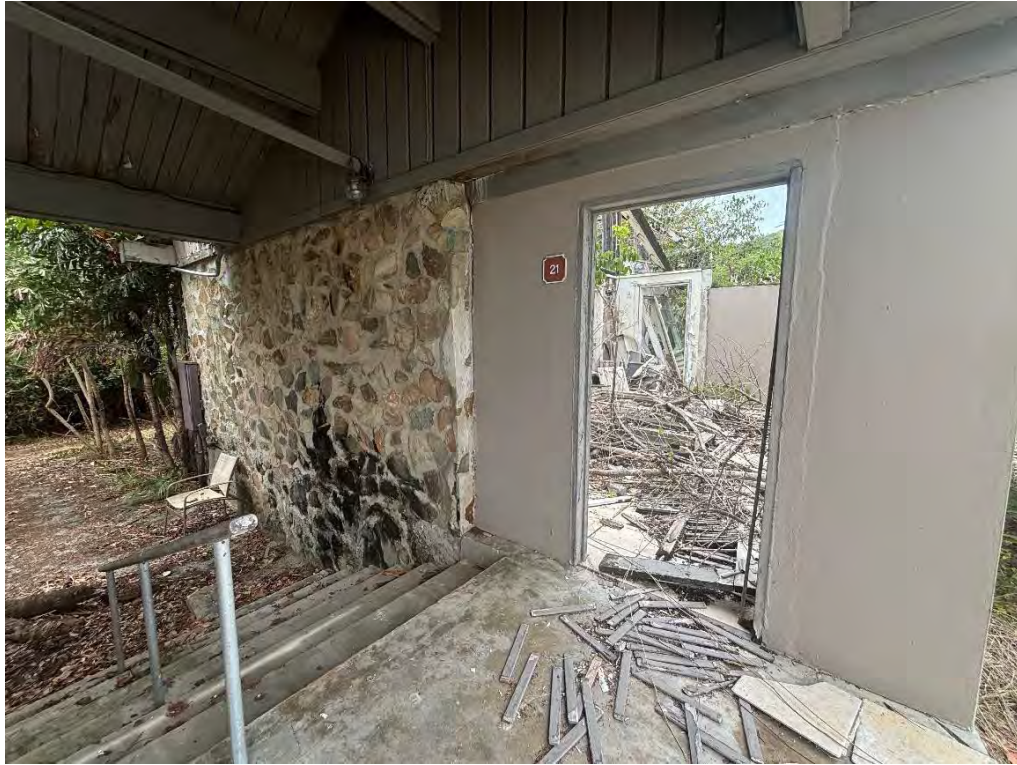
Building: 68 Caneel Beach Units 18-21

Structural Assessment: Structurally Unsound

Component	Material	Notes
Floor	Concrete / Hollow Core Concrete	Hollow core concrete plank in Units 19 and 20 collapsed.
Walls (Structural)	Stone / Concrete / Steel Columns	Concrete wall collapsed between Units 19 and 20. Foundation walls on west side have mortar deterioration. Steel columns corroded at base.
Walls (Non-Structural)	Wood	Collapsed.
Roof	Wood	Roof collapsed.
Stairs/Railings	Concrete / Aluminum

- Severely corroded steel columns at base, collapse of exterior slabs, and collapsed concrete wall.
