Building: 56 Fitness Center

Structural Assessment: Structurally Sound

National Park Service
Virgin Islands National Park | Caneel Bay
Structural Assessment Report

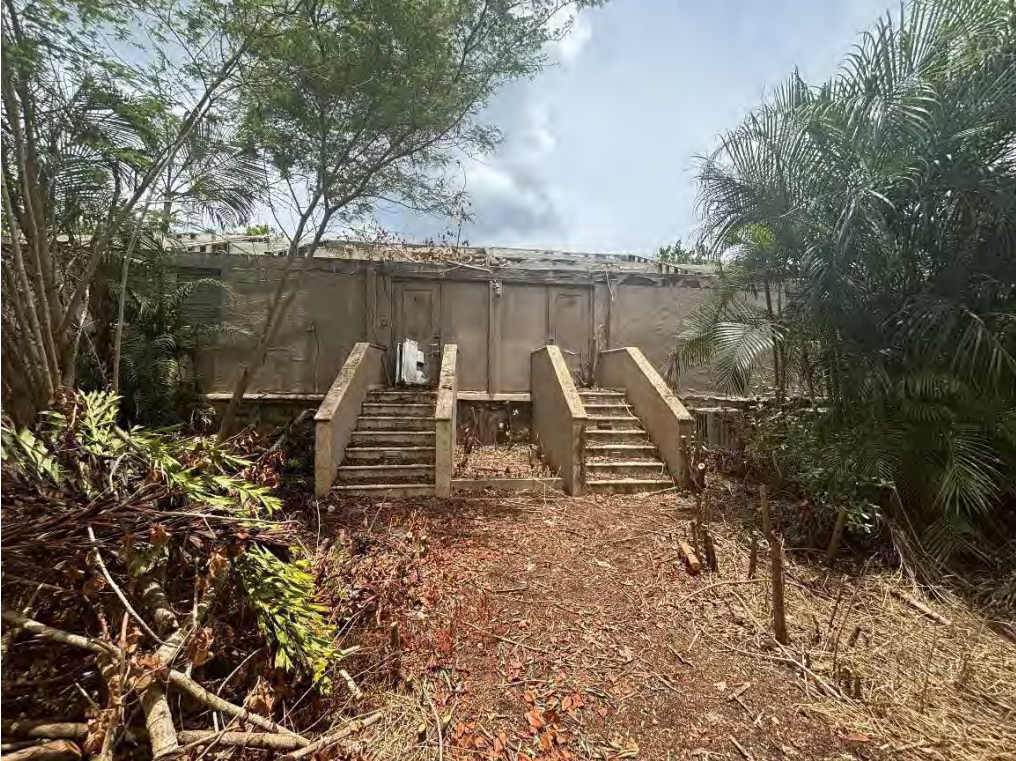
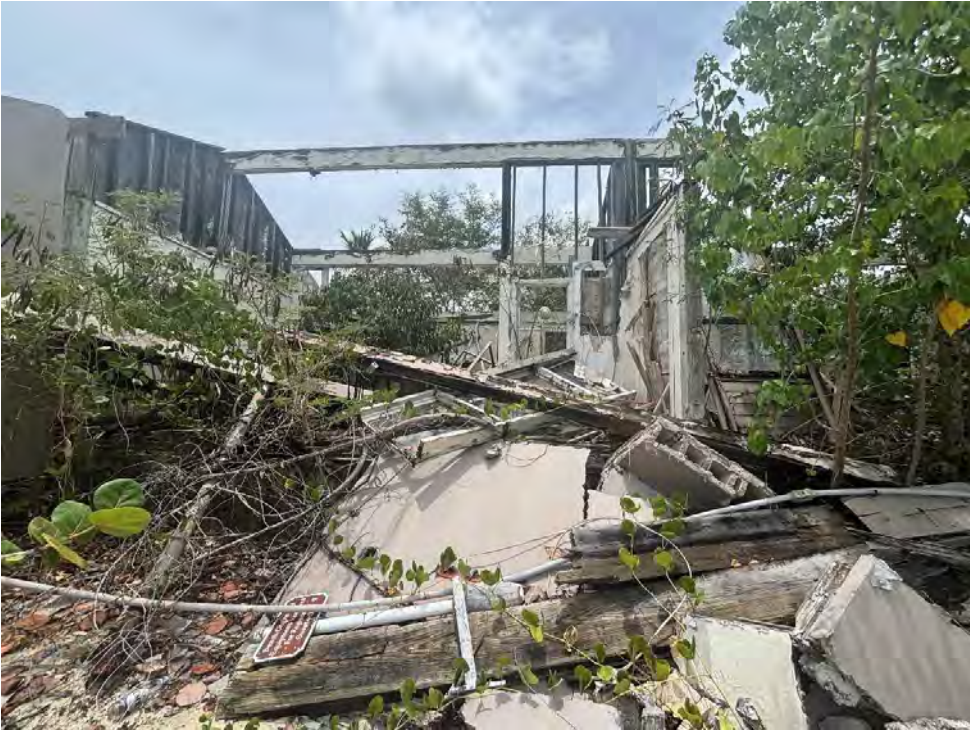
Building: 67 Caneel Beach Units 22-25

Structural Assessment: Structurally Unsound

Component	Material	Notes
Floor	Concrete / Hollow Core Concrete	Hollow core concrete plank in units 22-23 collapsed. 8" topping slab added over hollow core concrete plank creating significant risk of overburdening structure and causing sudden collapse.
Walls (Structural)	Stone / Concrete / Steel Columns	Concrete wall displaced. Shear crack in wall between units 24 and 25. Steel columns corroded at base.
Walls (Non-Structural)	Wood	Collapsed.
Roof	Wood	Roof collapsed.
Stairs/Railings	Concrete / Aluminum

- Severely corroded steel columns at base, collapse of exterior slabs, and collapsed concrete walls.
