**National Park Service**  
Virgin Islands National Park | Caneel Bay  
Structural Assessment Report

**Building: 28 Caneel Beach Units 26-29**

**Structural Assessment: Structurally Sound**

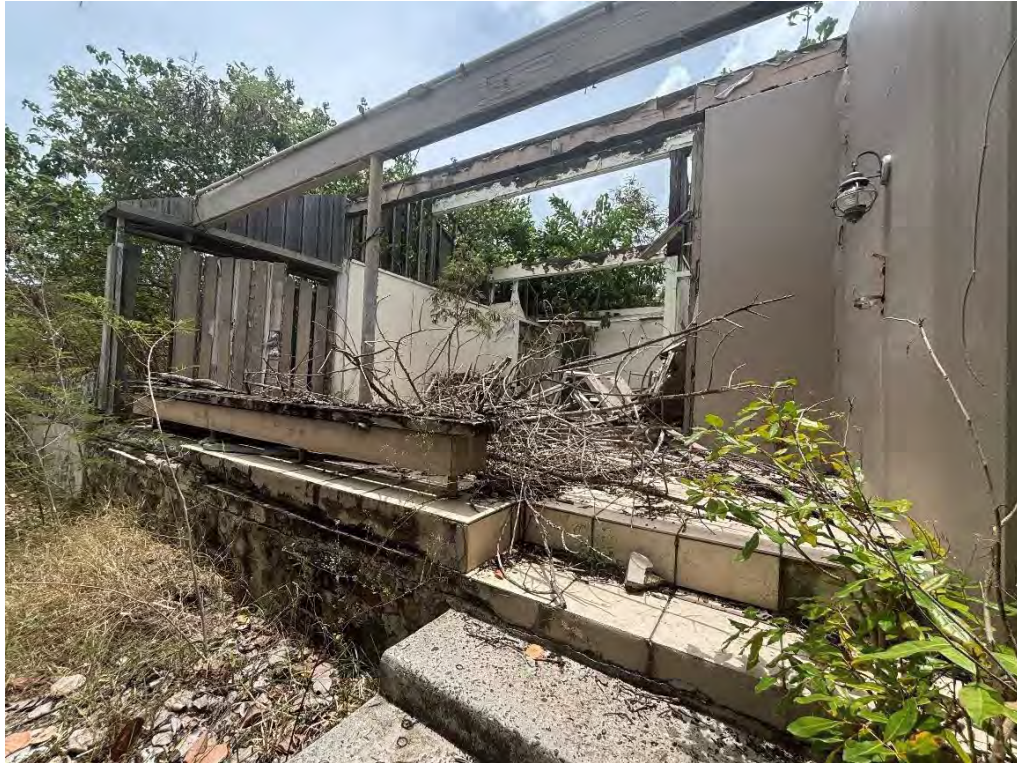
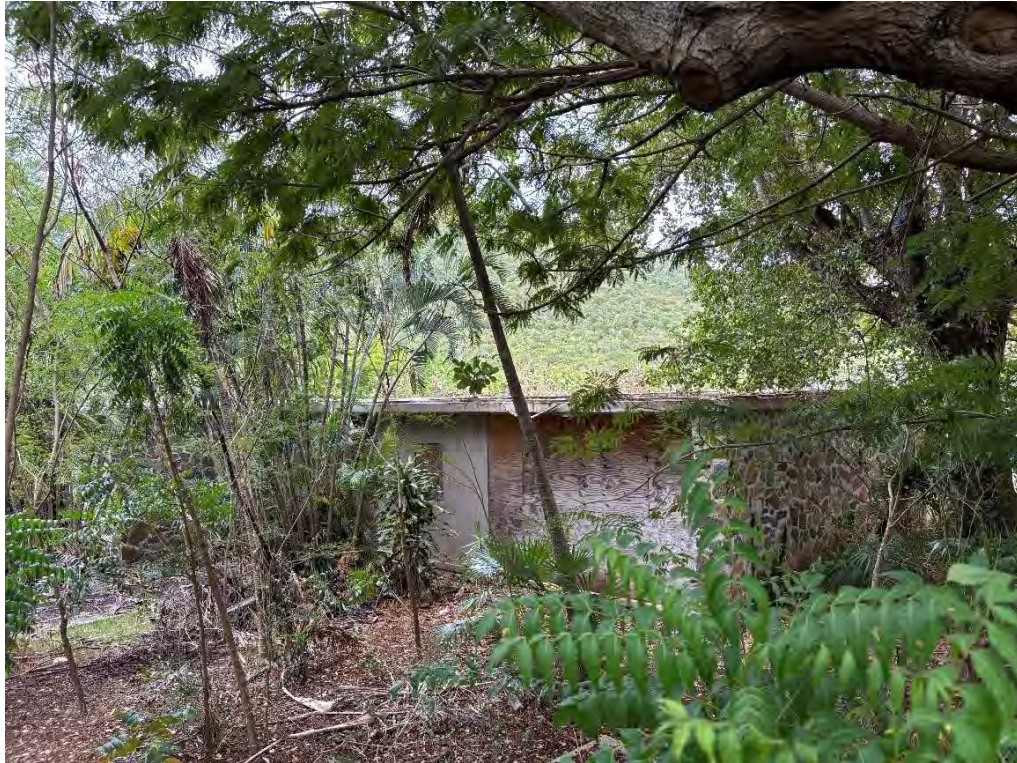
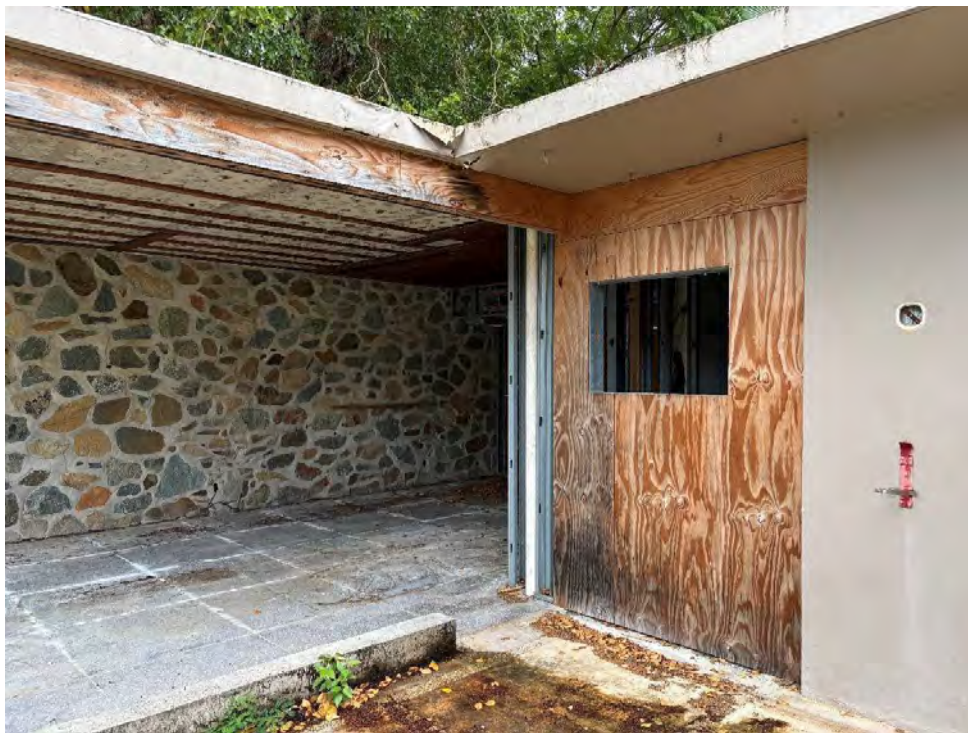
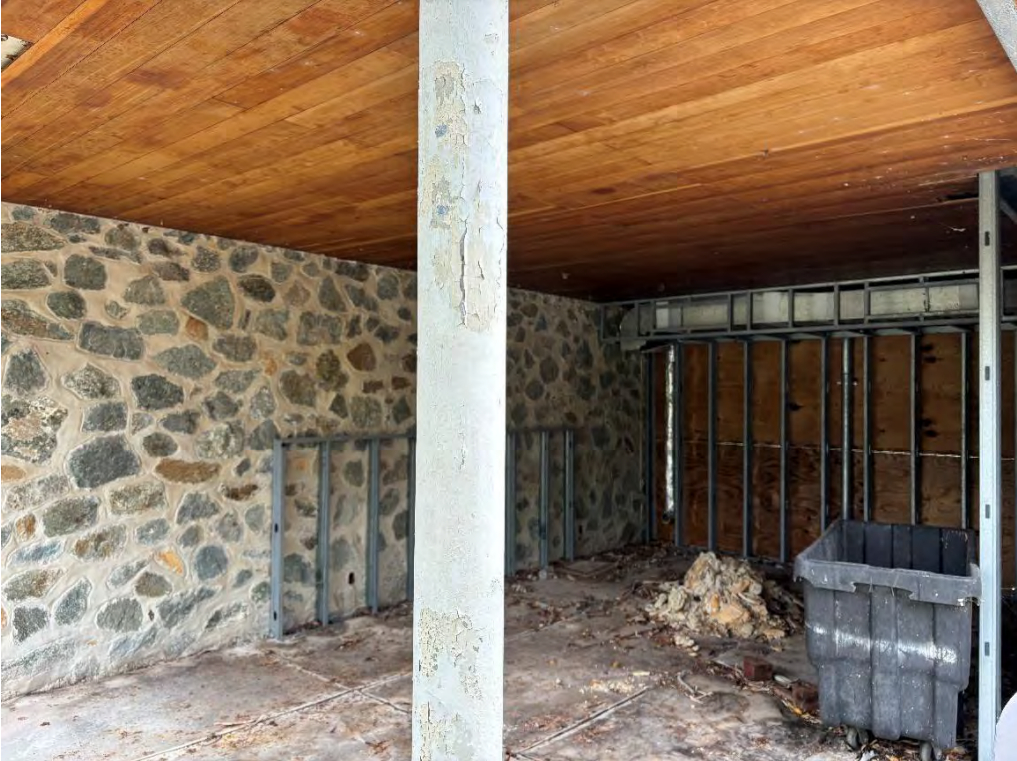
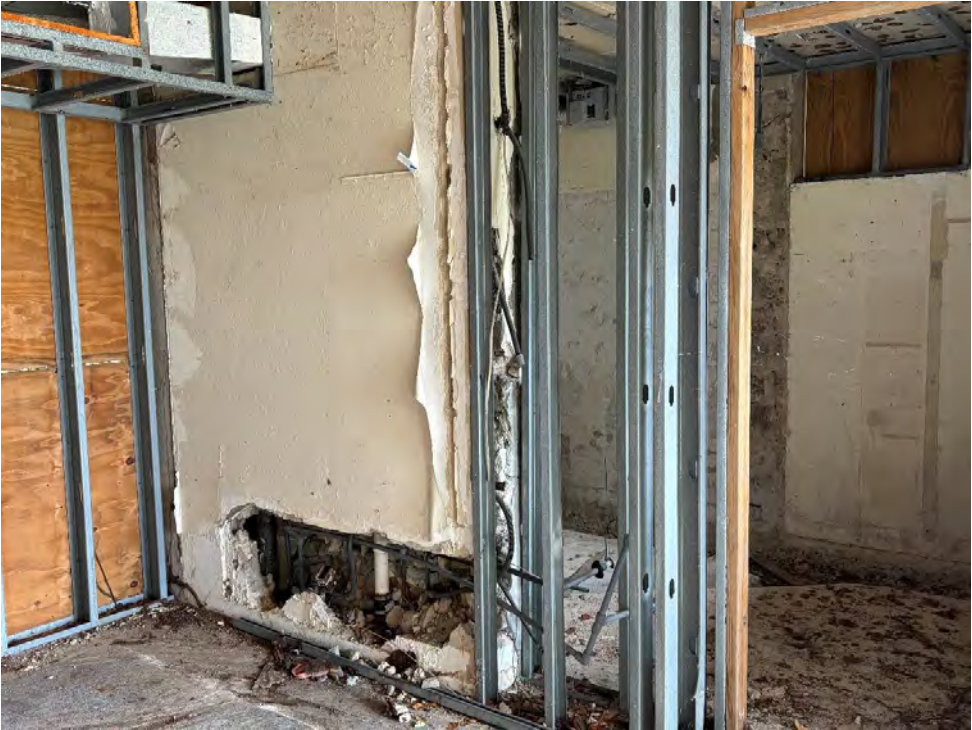
Component	Material	Notes
Floor	Concrete	Slab surface cracking observed in units 28 and 29.
Walls (Structural)	Stone / Concrete / Steel Columns	
Walls (Non-Structural)	Wood/Masonry (CMU)/Concrete	Some infill walls were previously demolished and reframed with steel studs for a prior renovation which was underway and paused. Remaining concrete infill walls had cracks.
Roof	Concrete	Roof intact.
Stairs/Railings	Concrete / Aluminum	Concrete stair nosing cracked/failing.

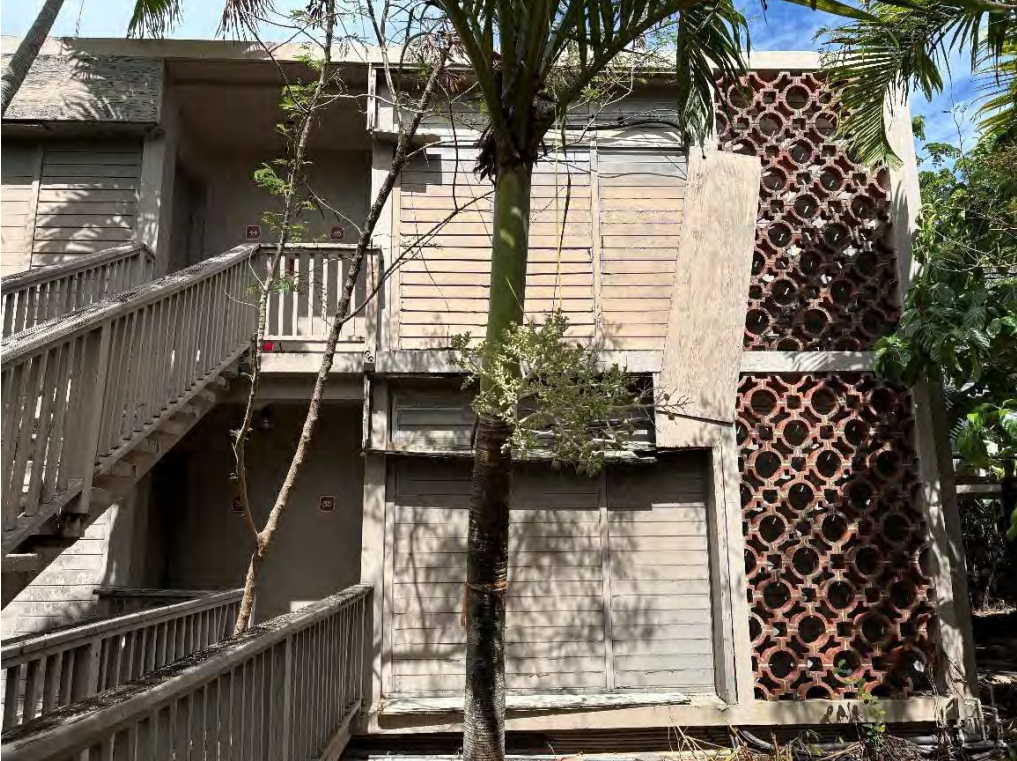
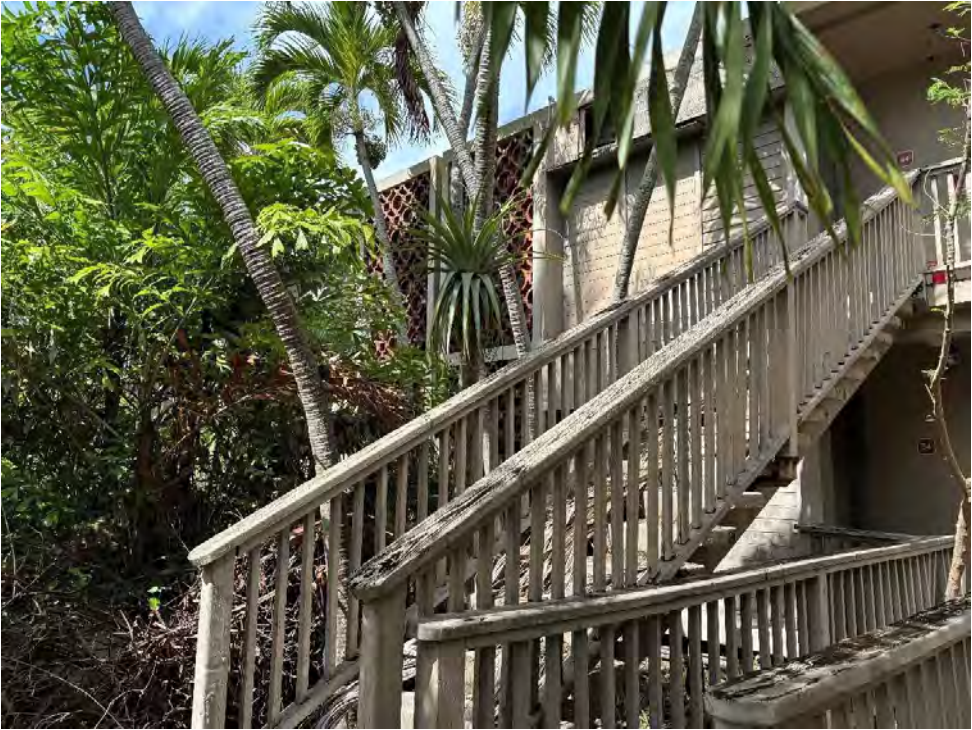
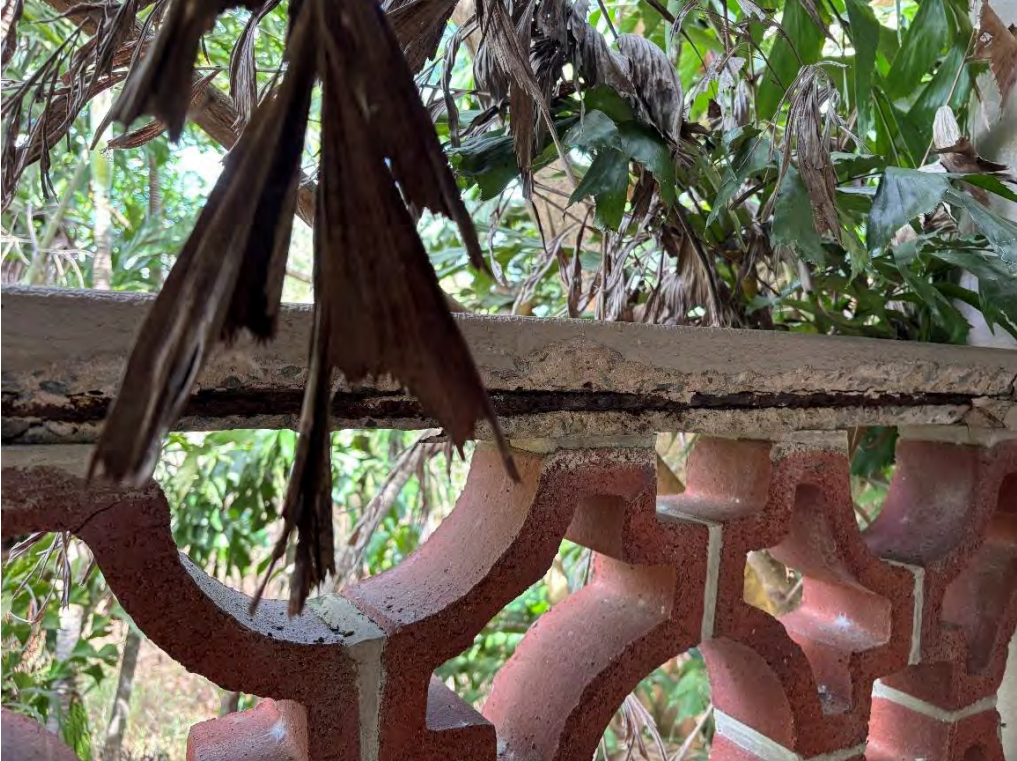
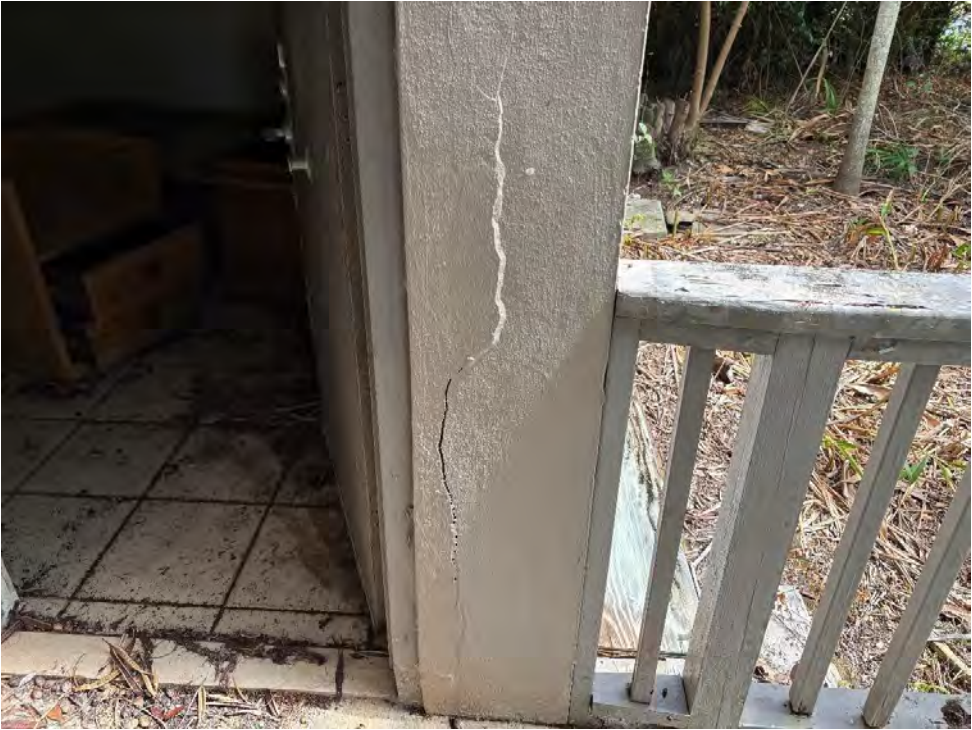
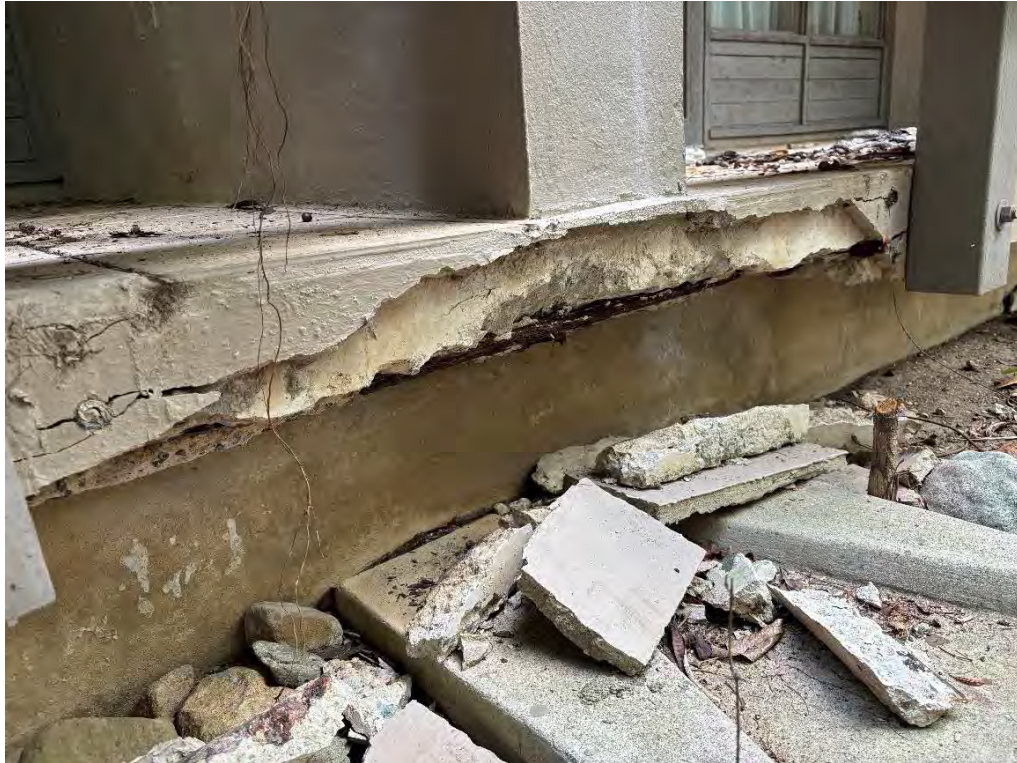
**Building: 26 Caneel Beach Units 30-35, 40-45**

Component	Material	Notes
Floor	Concrete	Slab edges deteriorated between units 31, 31, 32, and 33.
Walls (Structural)	Concrete	Moisture wicking into bottom 2' of each concrete bearing wall. Spalling at embedded electrical outlets from moisture wicking. Column cracked between units 34 and 35 on east side.
Walls (Non-Structural)	Concrete / Wood	Concrete walls at mechanical room over low roof are severely cracked. Steel columns around opening in the low roof have severely corroded and failed. Missing blocks at open CMU partition at north corner, room 39. Exterior plywood mechanical chase failed in multiple locations. Rotten wood noted at wood frames around exterior doors and windows.
Roof	Concrete	
Stairs/Railings	Concrete / Ornamental Masonry Railing	Ornamental masonry railings deteriorated at 41 and 42. Concrete caps on masonry railings deteriorated at all units.

<b>Component</b>	<b>Material</b>	<b>Notes</b>
Pergola	Wood	Wood pergola framed to building on beach (west) side. Pergola has failed along length of building.

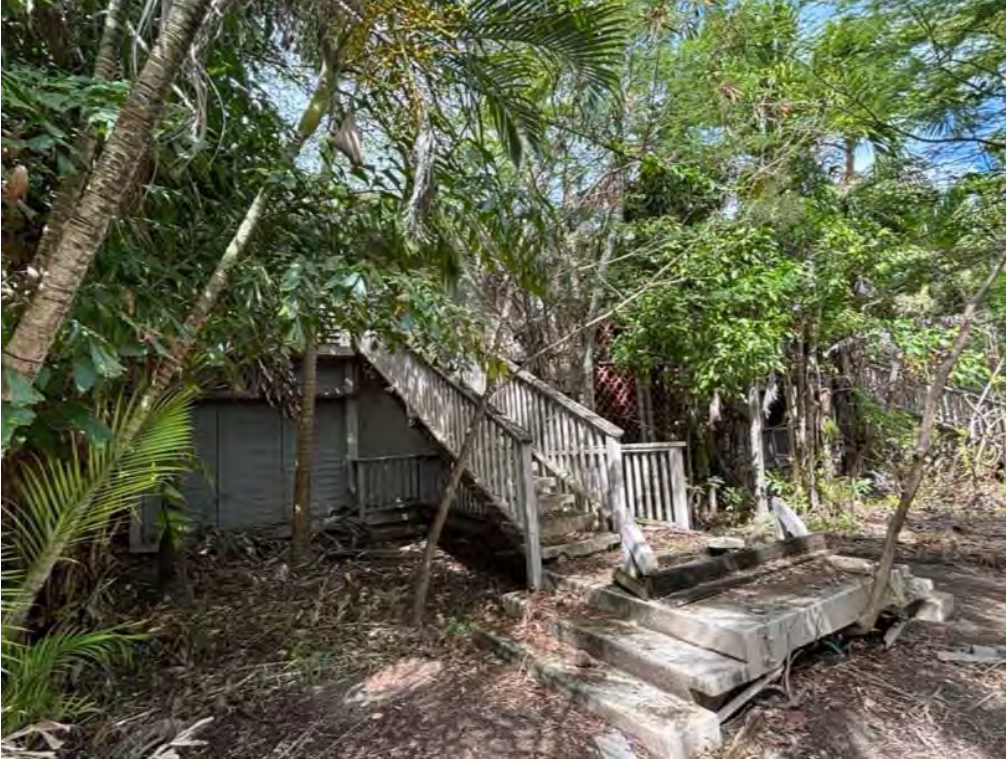
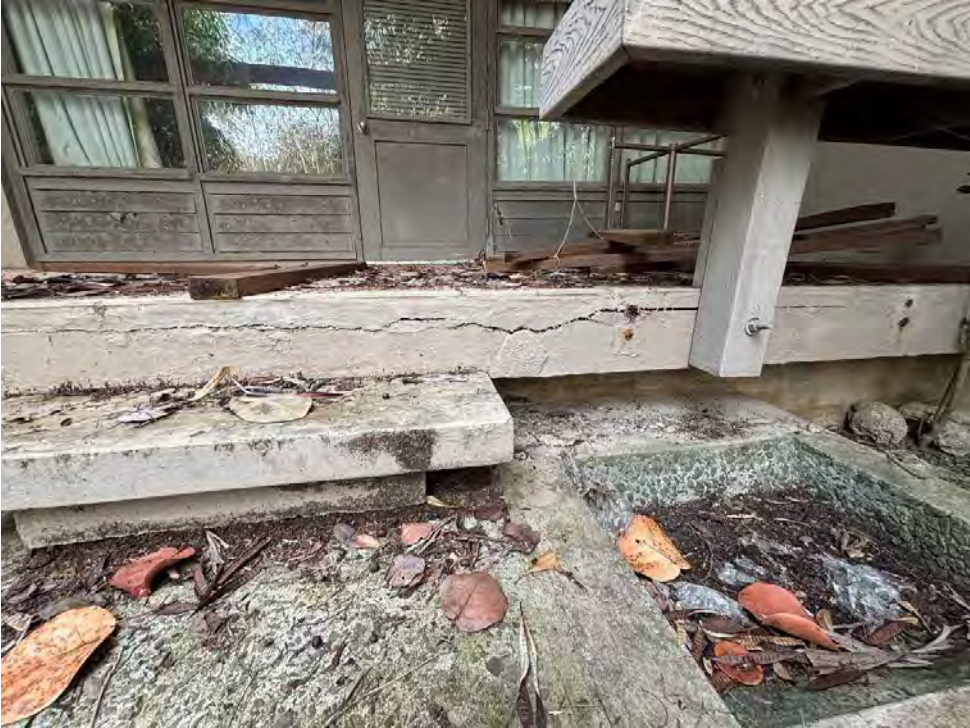
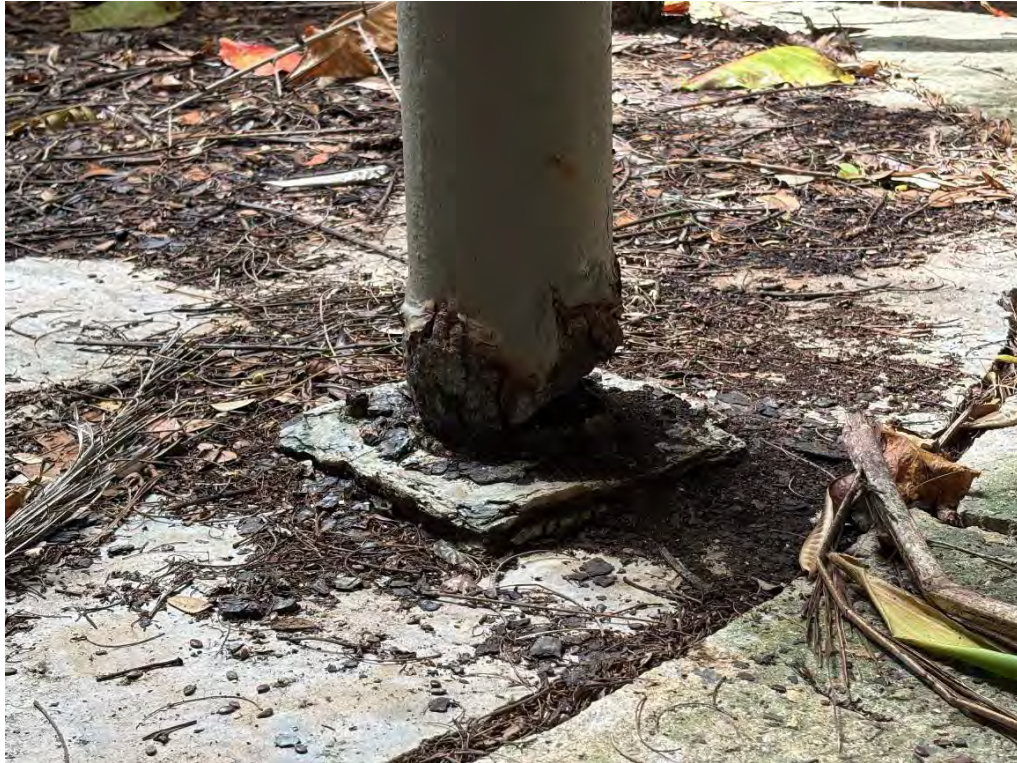
**Building: 27 Caneel Beach Units 36-39, 46-49**

Component	Material	Notes
Floor	Concrete	Exterior slab at unit 46 delaminated on porch.
Walls (Structural)	Concrete	
Walls (Non-Structural)	Concrete / Wood	Concrete walls at mechanical room over low roof are severely cracked. Steel columns around opening in the low roof have severely corroded and failed. Missing blocks at open CMU partition at north corner, room 39. Exterior plywood mechanical chase failed in multiple locations. Rotten wood noted at wood frames around exterior doors and windows.
Roof	Concrete	
Stairs/Railings	Concrete / Wood Railing	2 <sup>nd</sup> floor balconies have open CMU railings with cracked and decaying rebar precast concrete cap. Wood railings at stairs failed.
Pergola	Wood	Wood pergola framed to building on beach side. Pergola has failed along length of building.

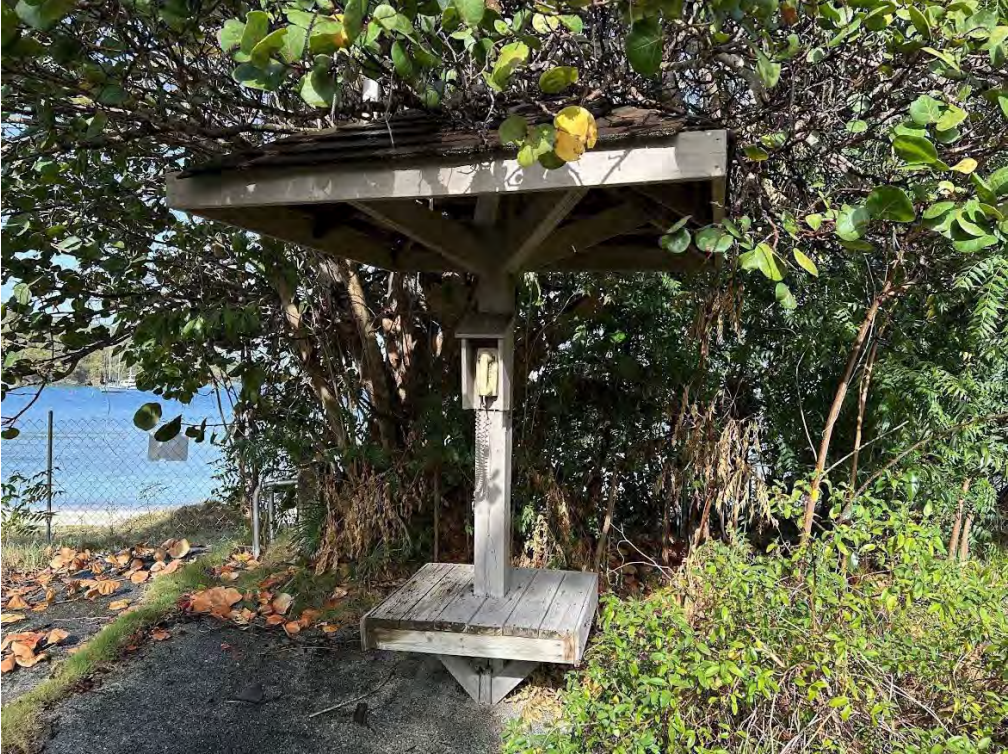
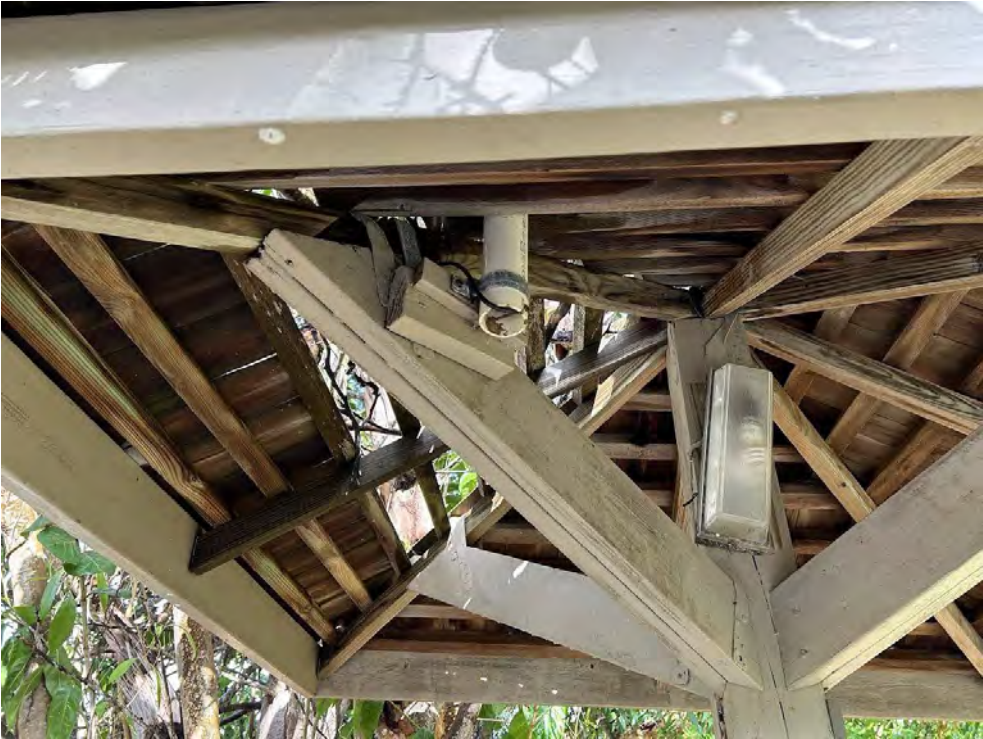
**Building: Caneel Beach Phone Booth**

Component	Material	Notes
Floor	Concrete	
Walls (Structural)	Wood	
Walls (Non-Structural)	N/A	
Roof	Wood framed/ Wood shingles	Roof has deteriorated, causing seat to deteriorate.

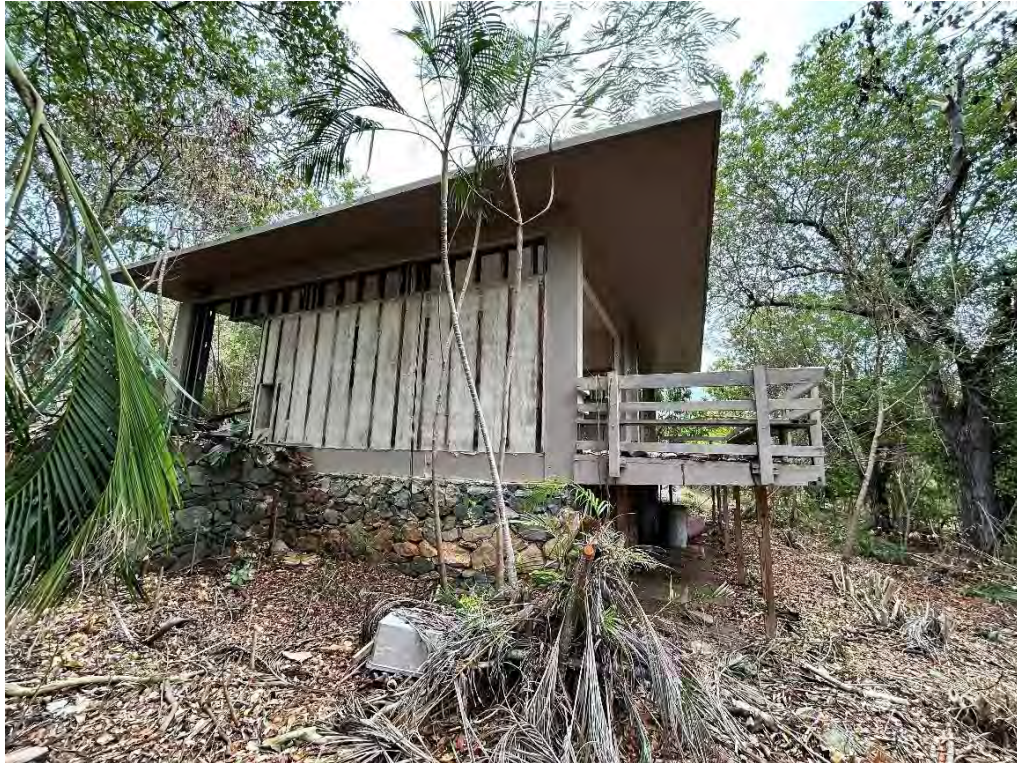
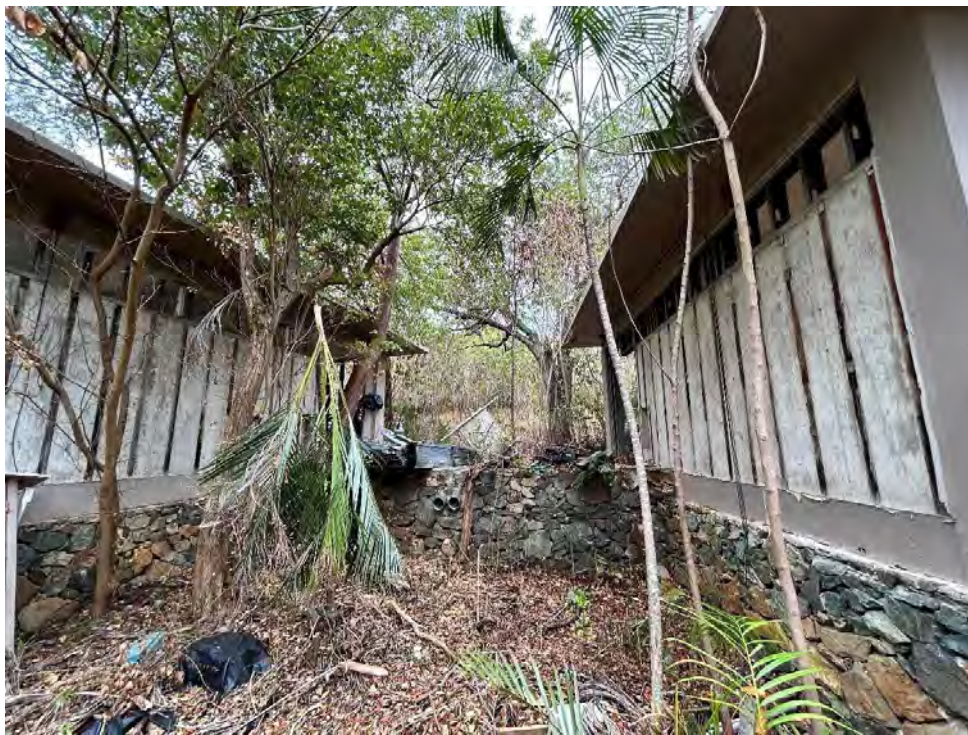
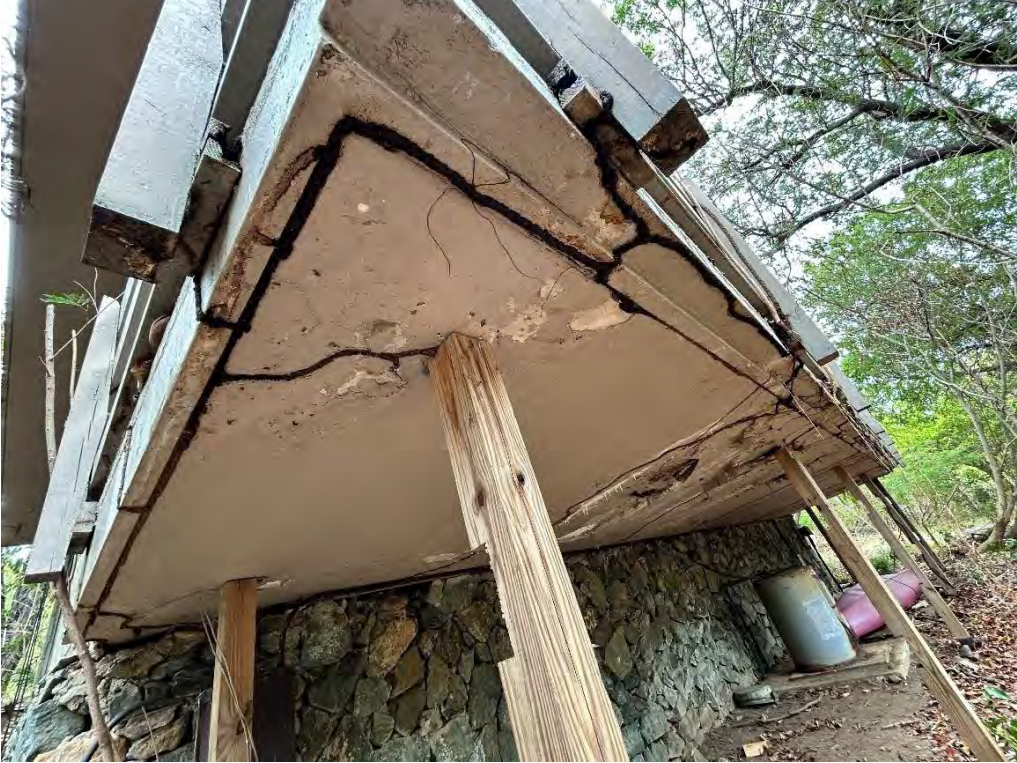
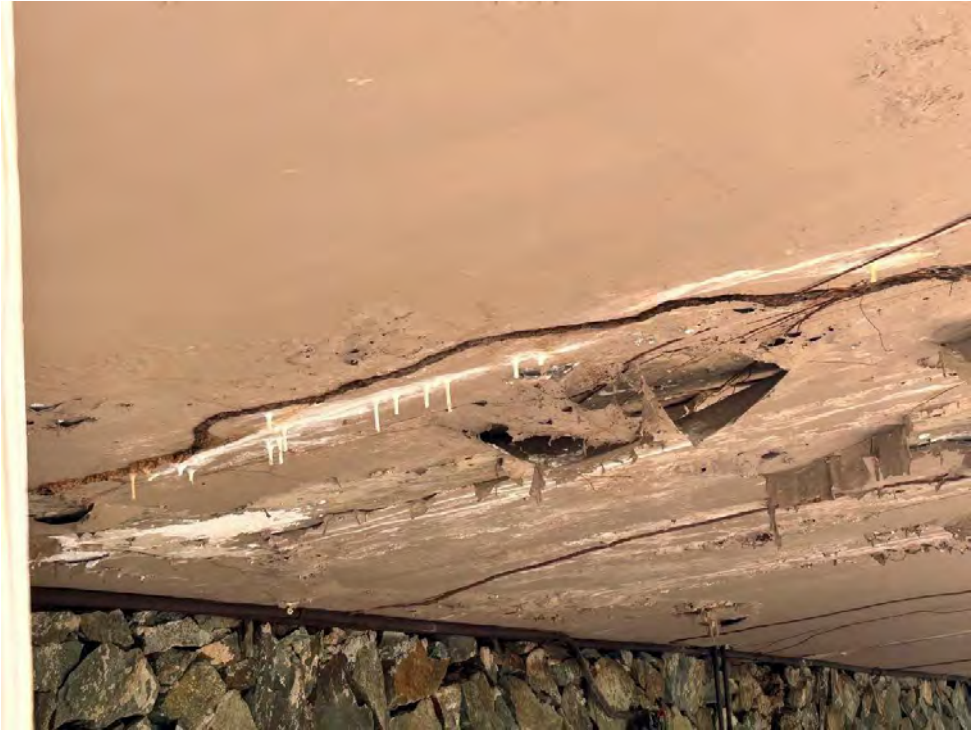
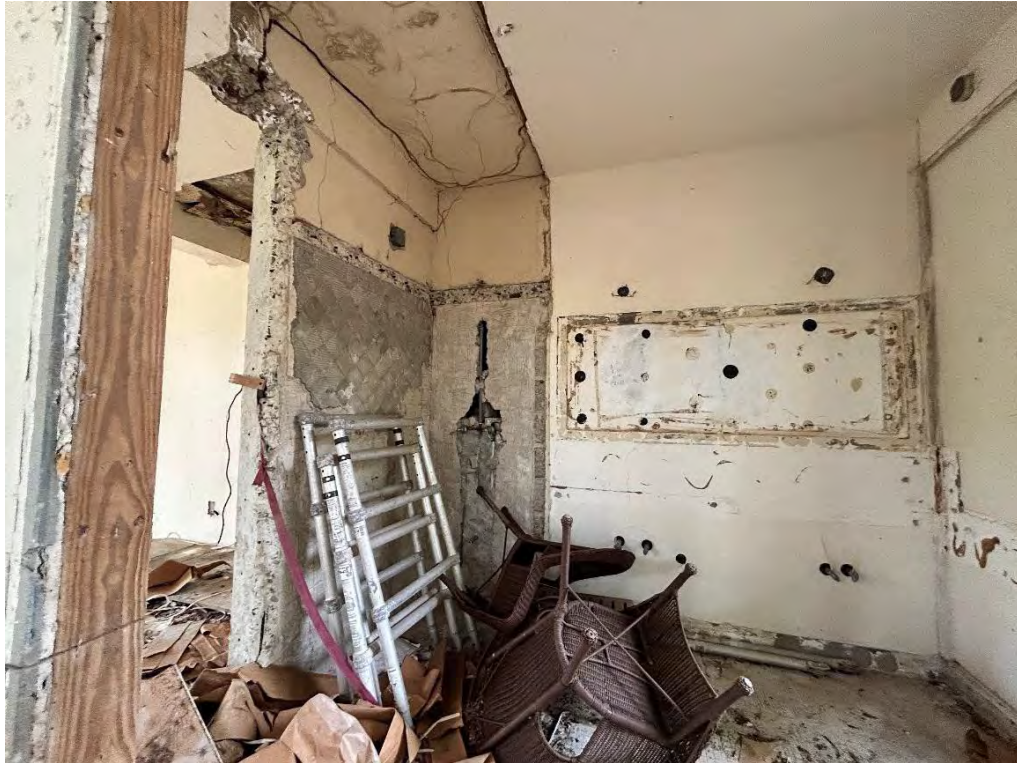
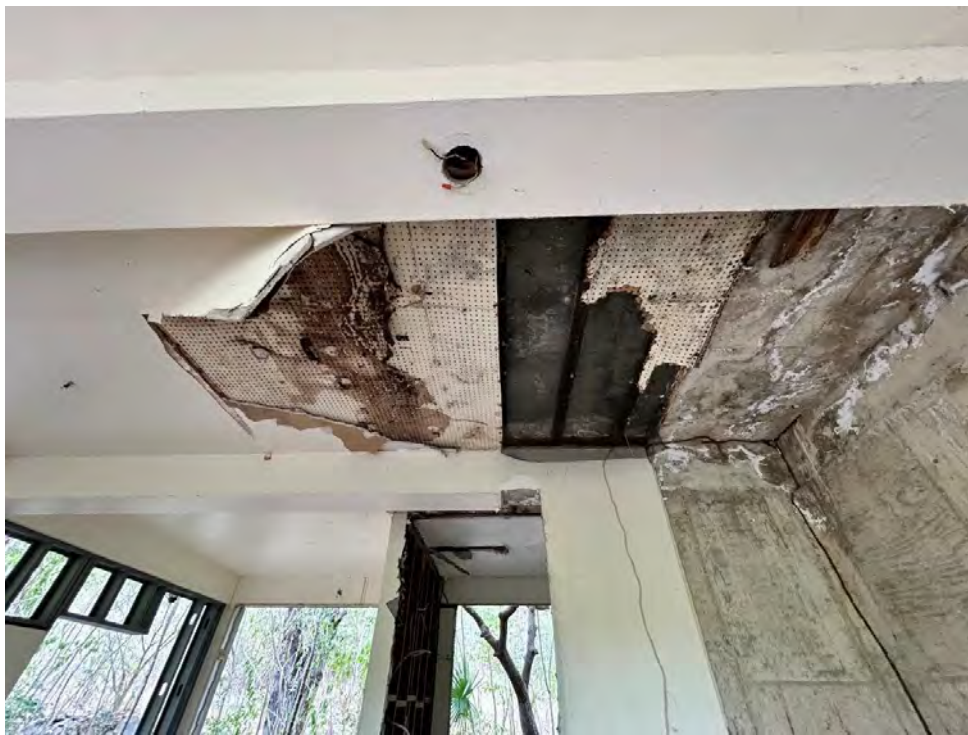
**Building: 29 Cottage Point Units 50-51**

Component	Material	Notes
Floor	Concrete	Signs of efflorescence with stalactites at underside of porch slab.
Walls (Structural)	Concrete / Steel Posts	Unable to verify condition of steel pipes where they framed into wall.
Walls (Non-Structural)	Light Gage Metal Framing	The light gage metal framing appears to be a renovation that started post hurricane damage and was abandoned prior to completion.
Roof	Concrete / Membrane	Spalling at underside of concrete roof where ceiling finishes had been removed. Unable to determine extent of spalls where finishes remained. Signs of previous renovations which cut back the wall creating a longer beam span. It is unknown if this modification with properly designed.
Stairs/Railings	Wood Railings / Benches	Wooden benches and railings on south side have failed. Posts under porch concrete slab are notched.

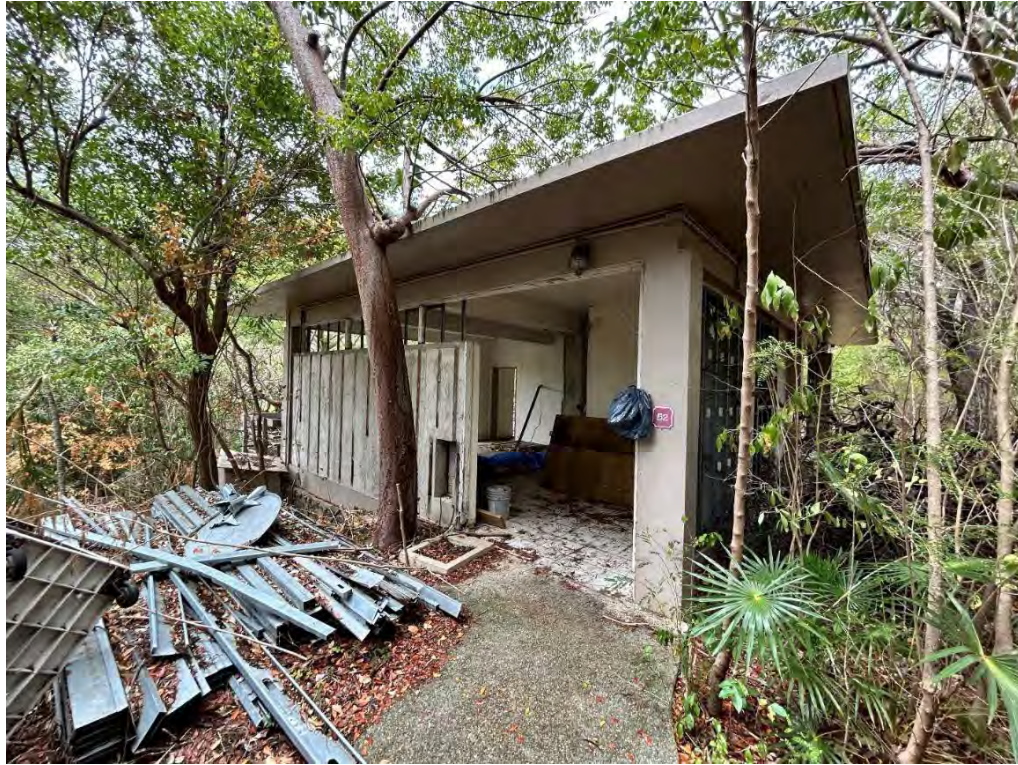
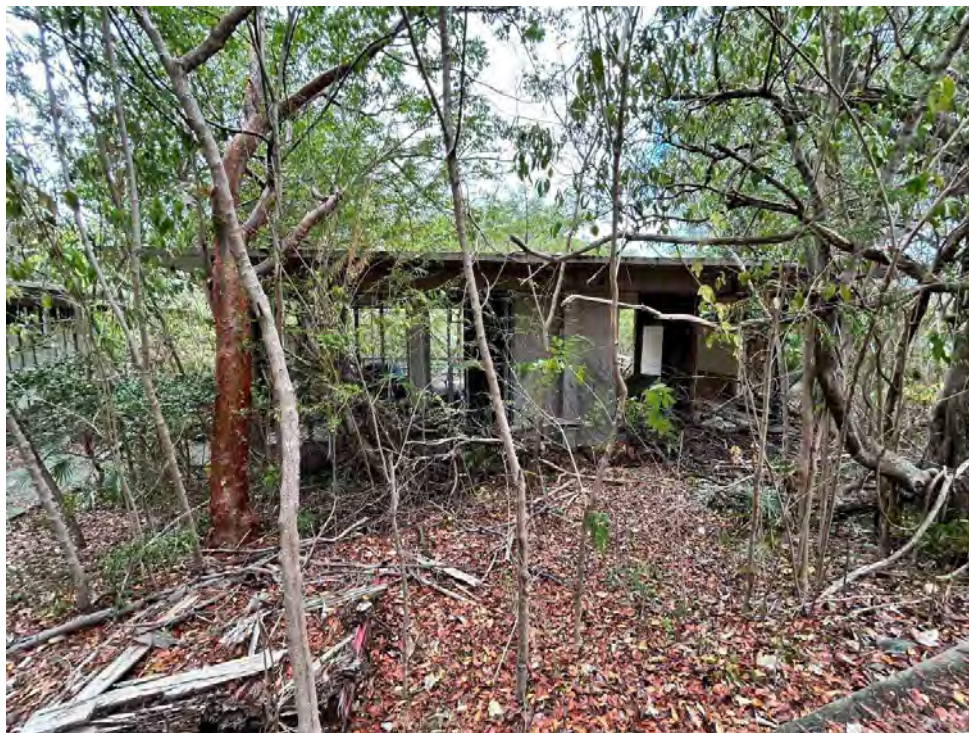
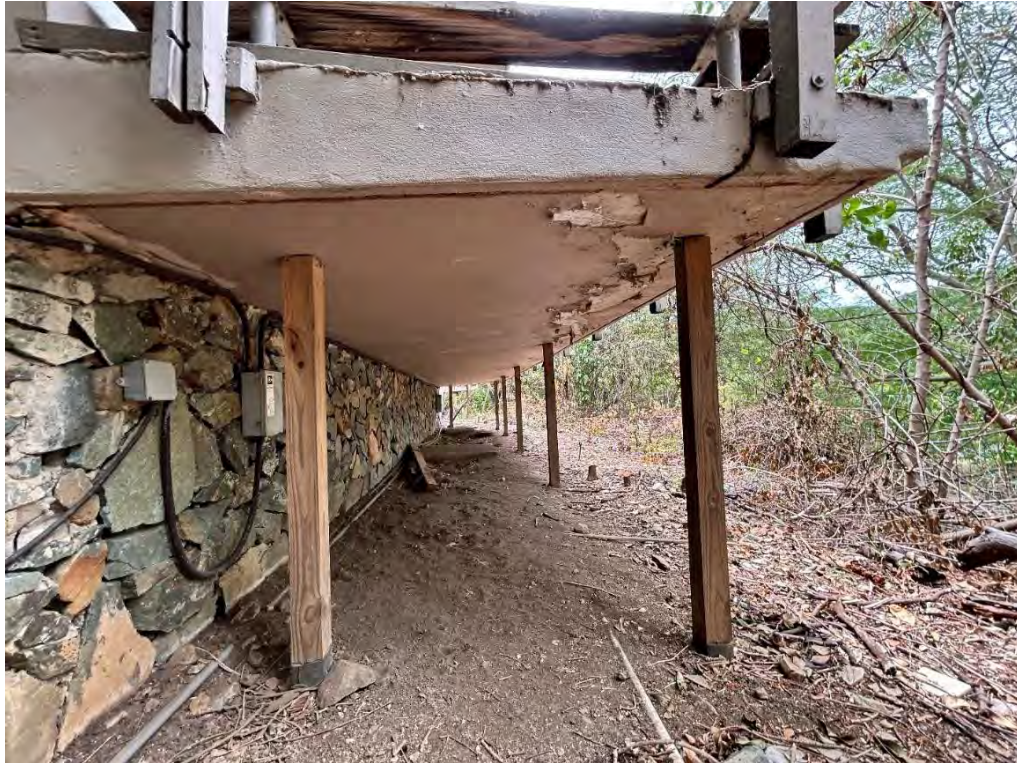
**Building: 30 Cottage Point Units 52-53**

Component	Material	Notes
Floor	Concrete	
Walls (Structural)	Concrete / Steel Posts	Unable to verify condition of steel pipes where they framed into wall.
Walls (Non-Structural)	Light Gage Metal Framing	The light gage metal framing appears to be a renovation that started post hurricane damage and was abandoned prior to completion.
Roof	Concrete / Membrane	Spalling at underside of concrete roof where ceiling finishes had been removed. Unable to determine extent of spalls where finishes remained. Signs of previous renovations which cut back the wall creating a longer beam span. It is unknown if this modification with properly designed.
Stairs/Railings	Wood Railings / Benches	Wooden benches and railings on south side have failed. Posts under porch concrete slab are notched.

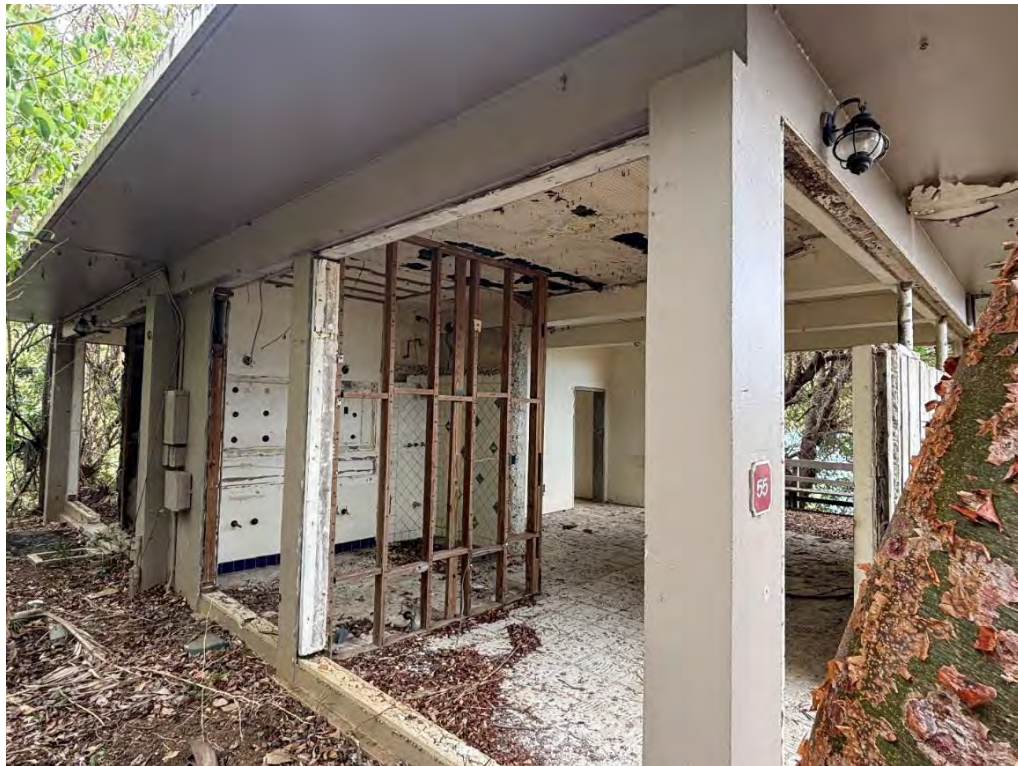
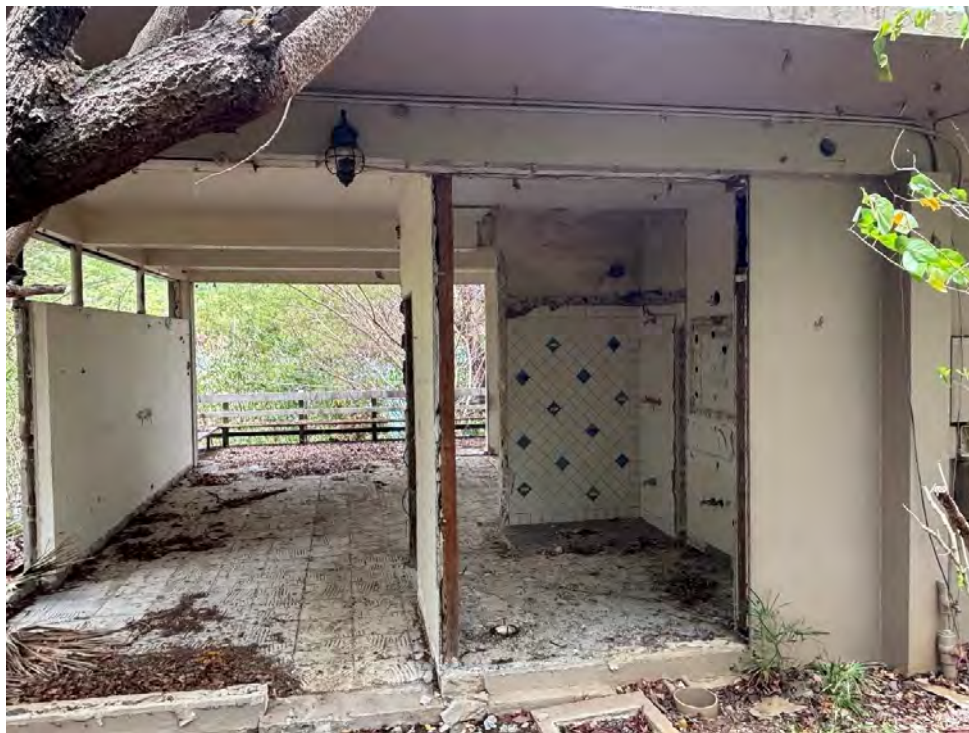
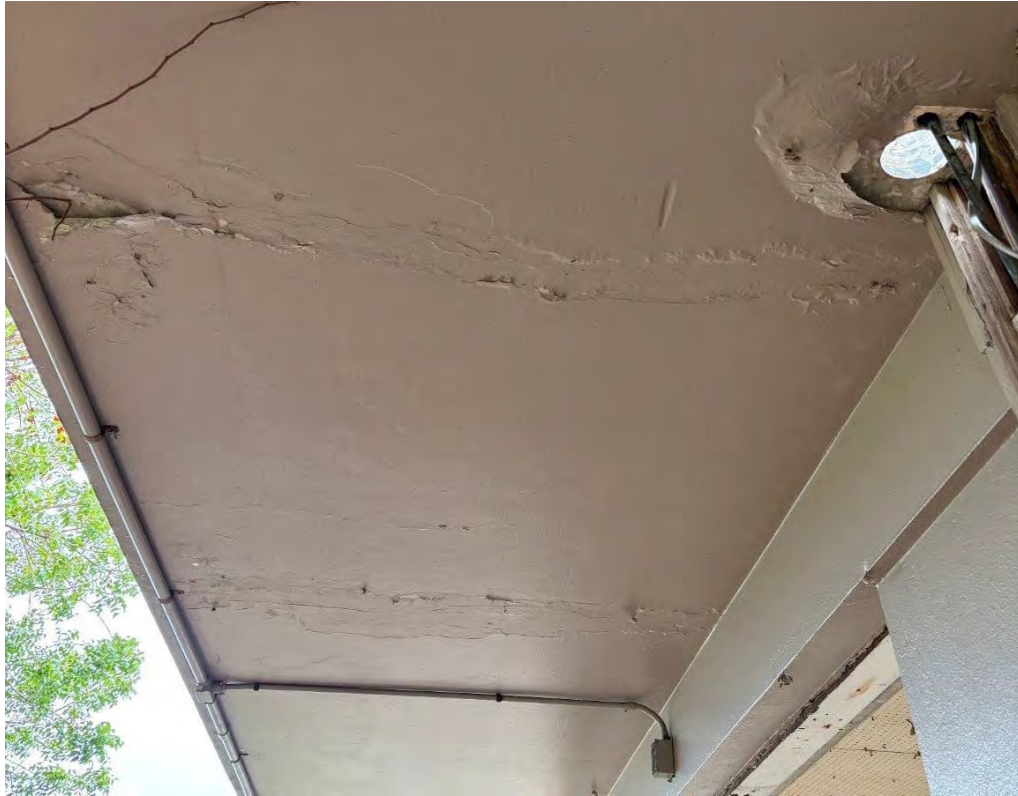
**Building: 31 Cottage Point Units 54-55**

Component	Material	Notes
Floor	Concrete	
Walls (Structural)	Concrete / Steel Posts	Unable to verify condition of steel pipes where they framed into wall.
Walls (Non-Structural)	Wood Framing	Partitions previously demolished.
Roof	Concrete / Membrane	Significant spalling at underside of concrete roof slabs. Multiple beams cracked.  Previous renovations cut back the wall creating a longer beam span. It is unknown if this modification with properly designed.
Stairs/Railings	Wood Railings	Wooden railings deteriorated.
