**National Park Service**  
Virgin Islands National Park | Caneel Bay  
Structural Assessment Report

**Building: 28 Caneel Beach Units 26-29**

**Structural Assessment: Structurally Sound**

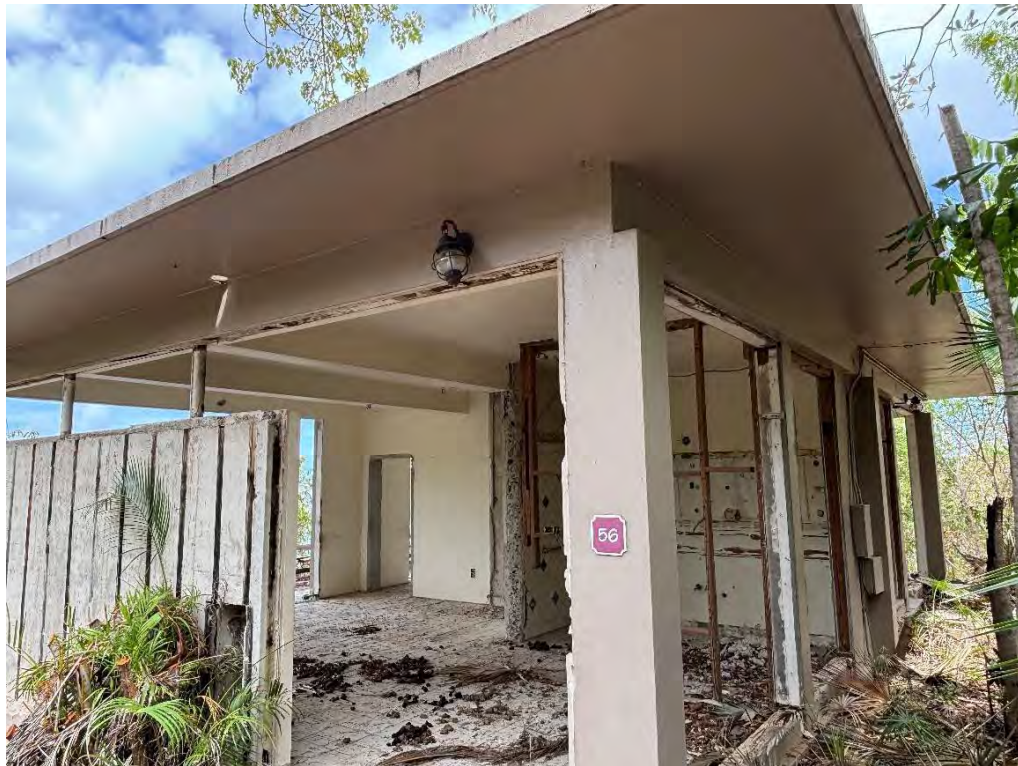
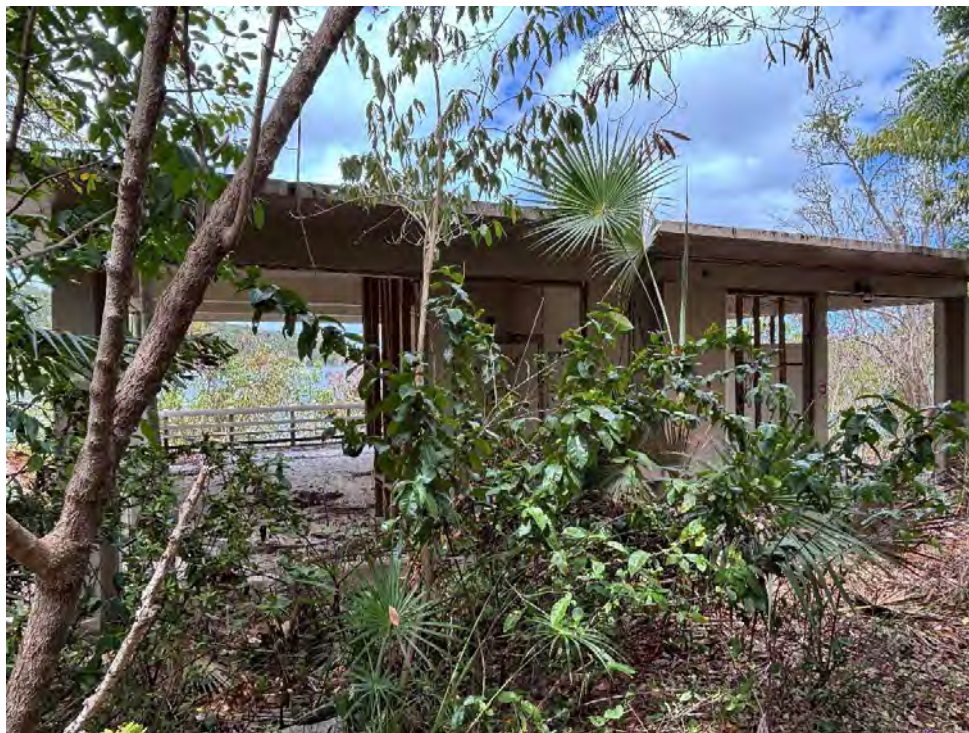
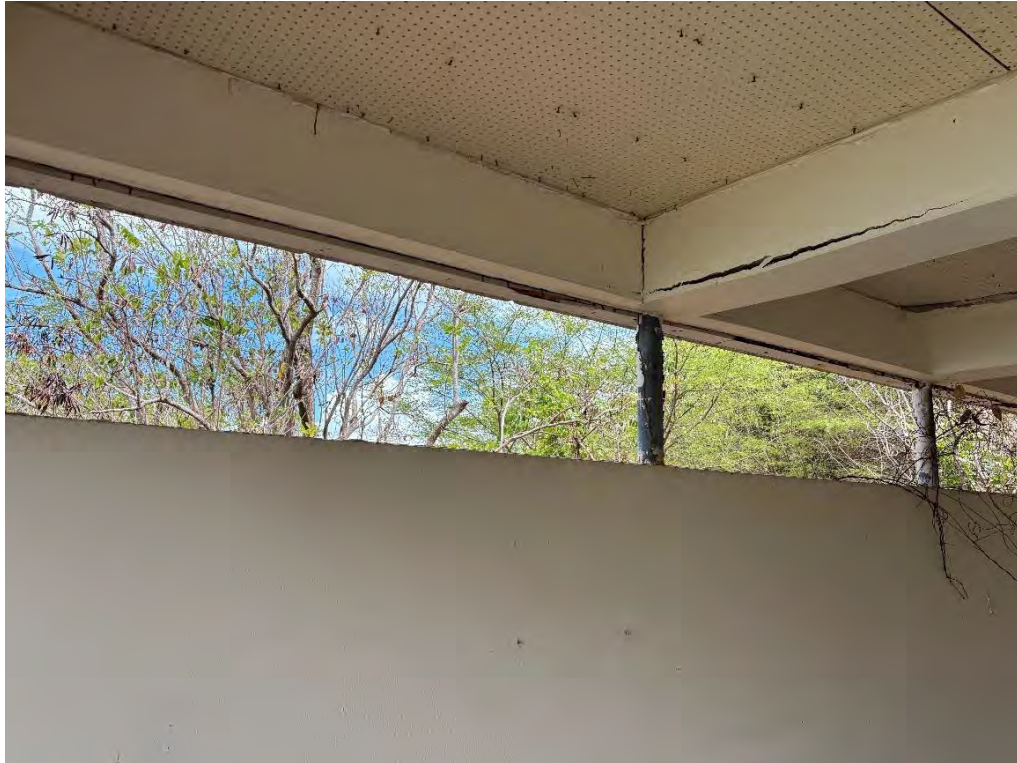
**Building: 32 Cottage Point Units 56-57**

Component	Material	Notes
Floor	Concrete	
Walls (Structural)	Concrete / Steel Posts	Unable to verify condition of steel pipes where they framed into wall.
Walls (Non-Structural)	Wood Framing	Partitions previously demolished.
Roof	Concrete / Membrane	Significant spalling at underside of concrete roof slabs. Beam cracked.  Previous renovations cut back the wall creating a longer beam span. It is unknown if this modification with properly designed.
Stairs/Railings	Wood Railings	Wooden railings deteriorated.

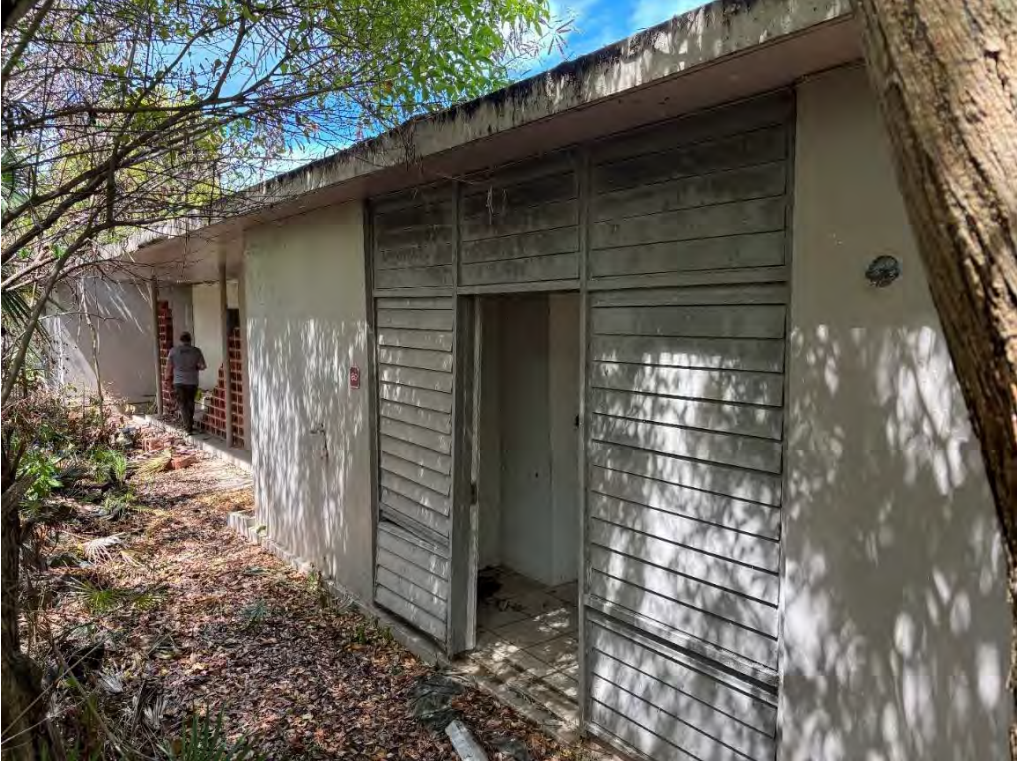
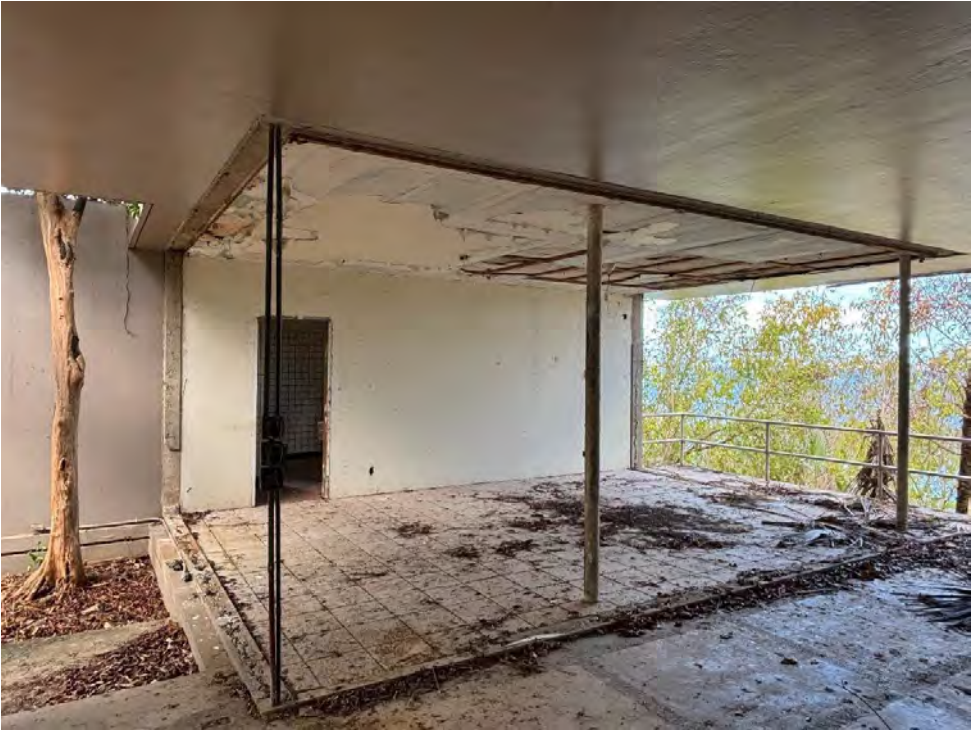
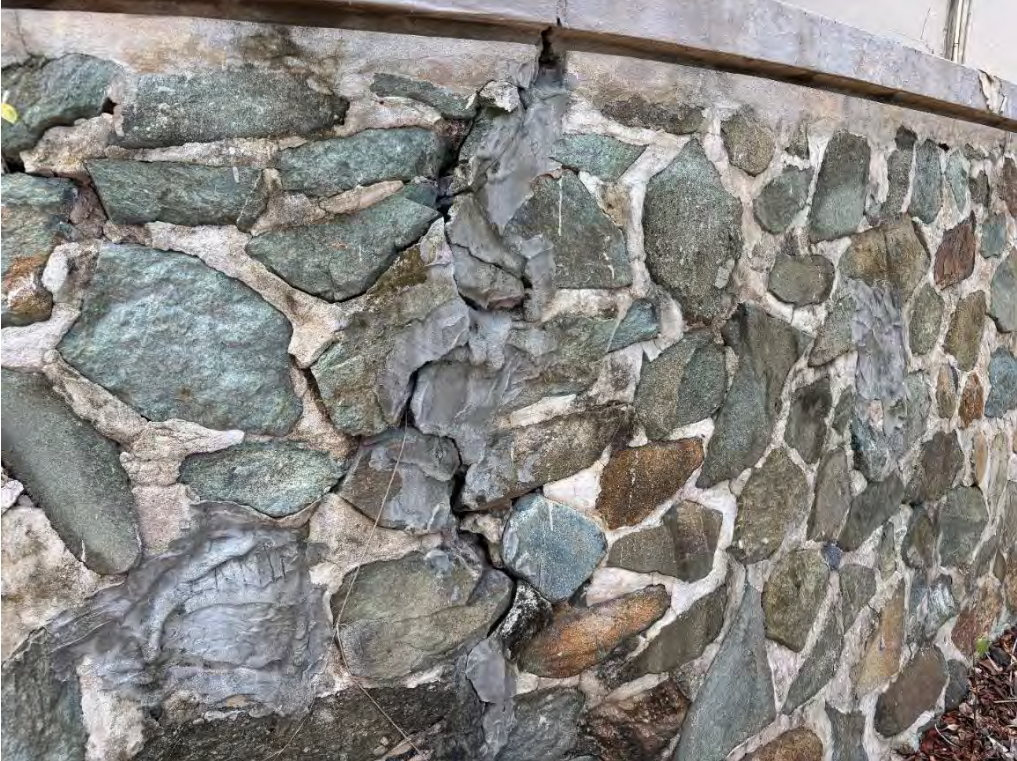
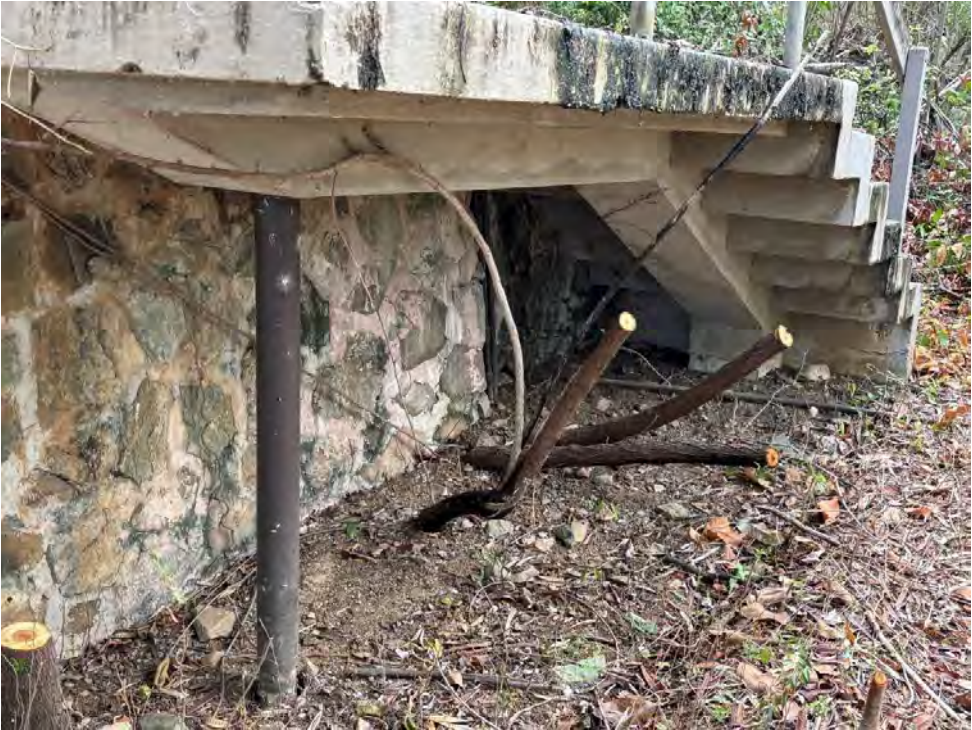
**Building: 33 Cottage Point Units 58-60**

<b>Component</b>	<b>Material</b>	<b>Notes</b>
Floor	Concrete	Balcony slab cracked.
Walls (Structural)	Concrete / Steel Posts	
Walls (Non-Structural)	Wood Framing	Partitions previously demolished.
Roof	Concrete / Membrane	Cracks in roof overhang and ceiling between units.
Stairs/Railings	Aluminum Railings Concrete Steps	Concrete steps leaning due to corrosion of steel post.

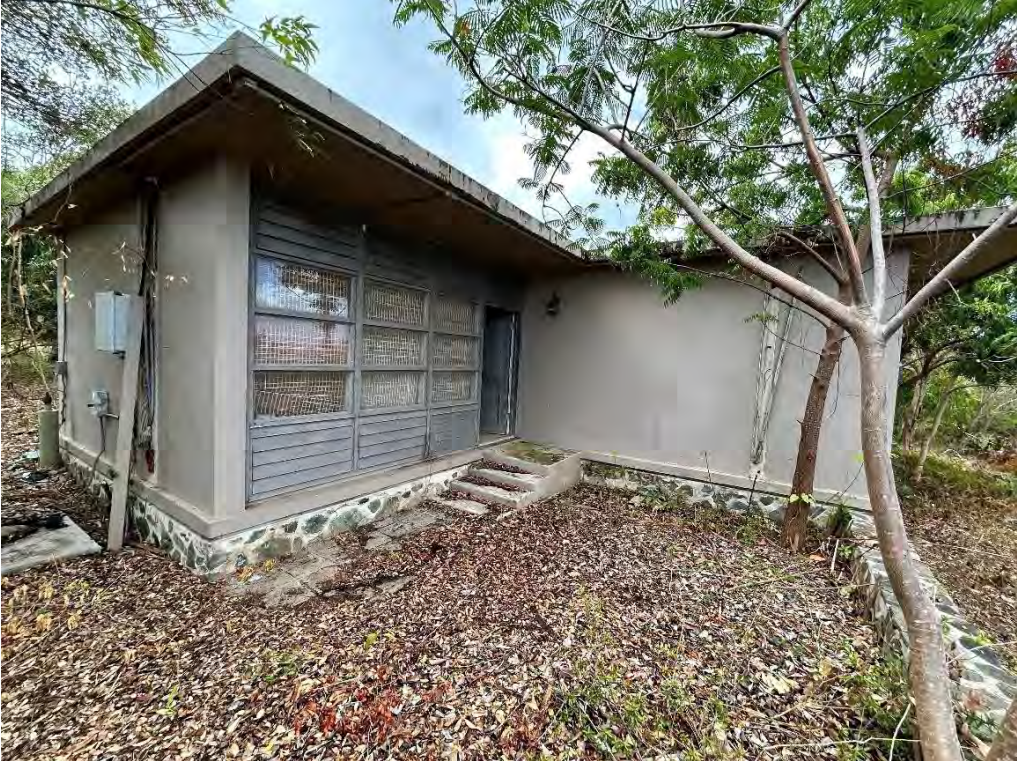
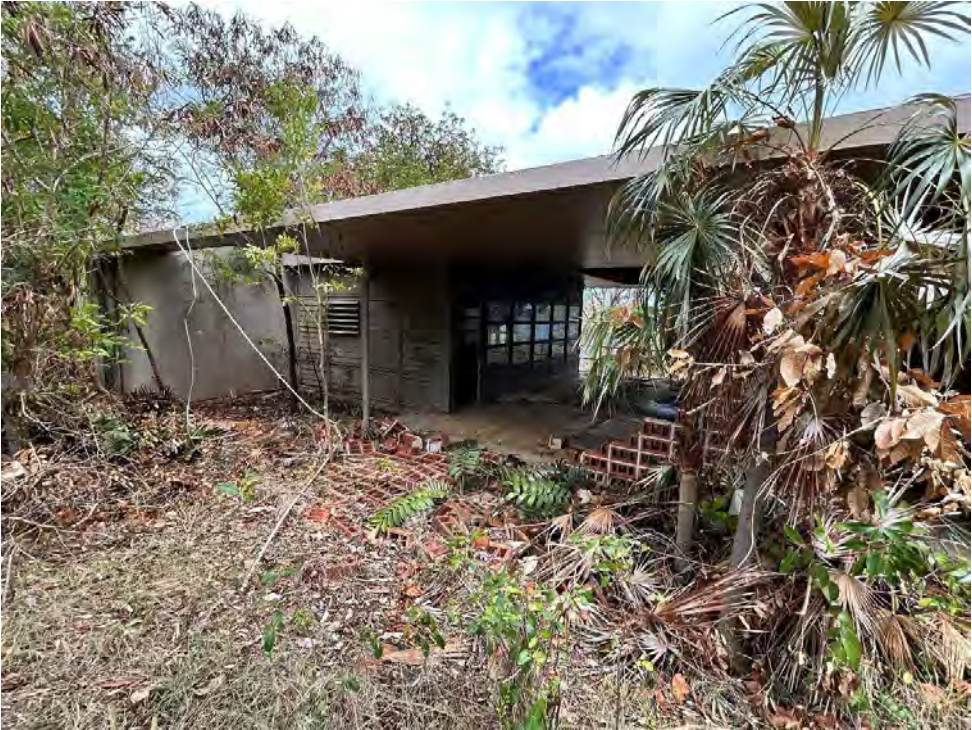
**Building: 34 Cottage Point Units 61-63**

Component	Material	Notes
Floor	Concrete	Exterior cantilevered concrete slab at Unit 61 shows signs of hairline cracks throughout the slab. Unable to access underside of slab for further investigation.
Walls (Structural)	Concrete	Minor concrete cracking with signs of previous repairs observed. Spalled concrete at breezeway. Moisture pockets observed.
Walls (Non-Structural)	Wood Framed / Open CMU Walls	CMU wall collapsed.
Roof	Concrete with Wood Infill / Membrane	2x wood infill with plywood sheathing at breezeway roof. Elsewhere is concrete roof. Moisture pockets observed.
Stairs/Railings	Concrete	Concrete steps from Unit 63 to north porch is damaged. Deck missing from Unit 62 creating large drop from north door.
Retaining Wall	Stone	Stones missing at stone retaining wall.

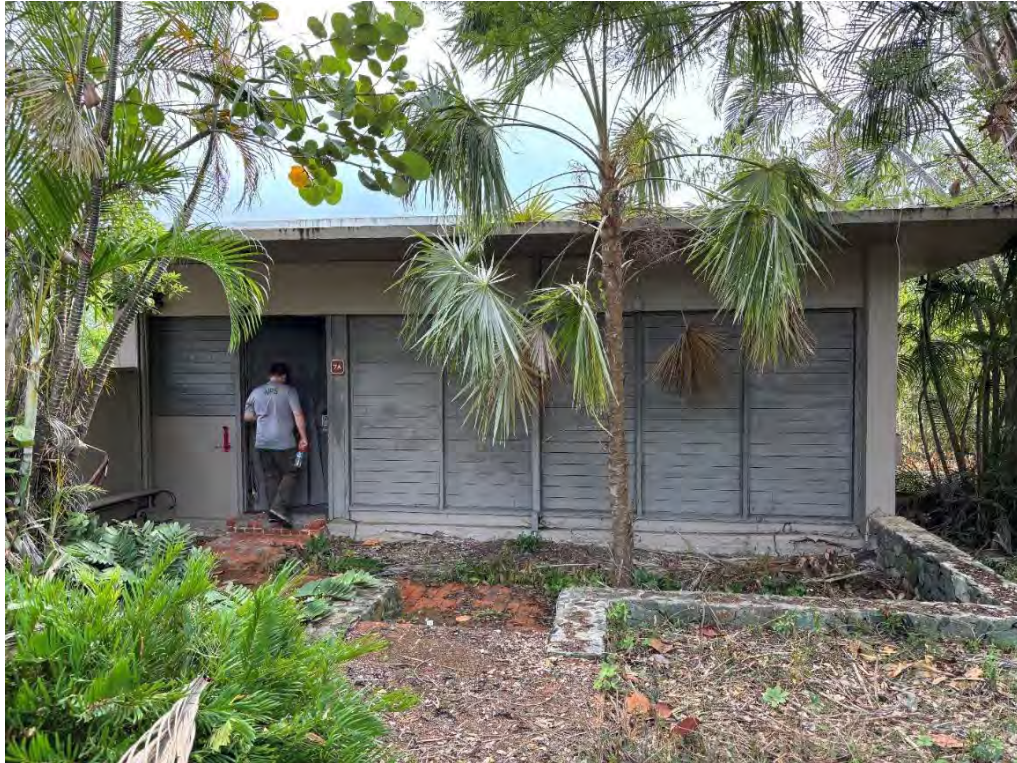
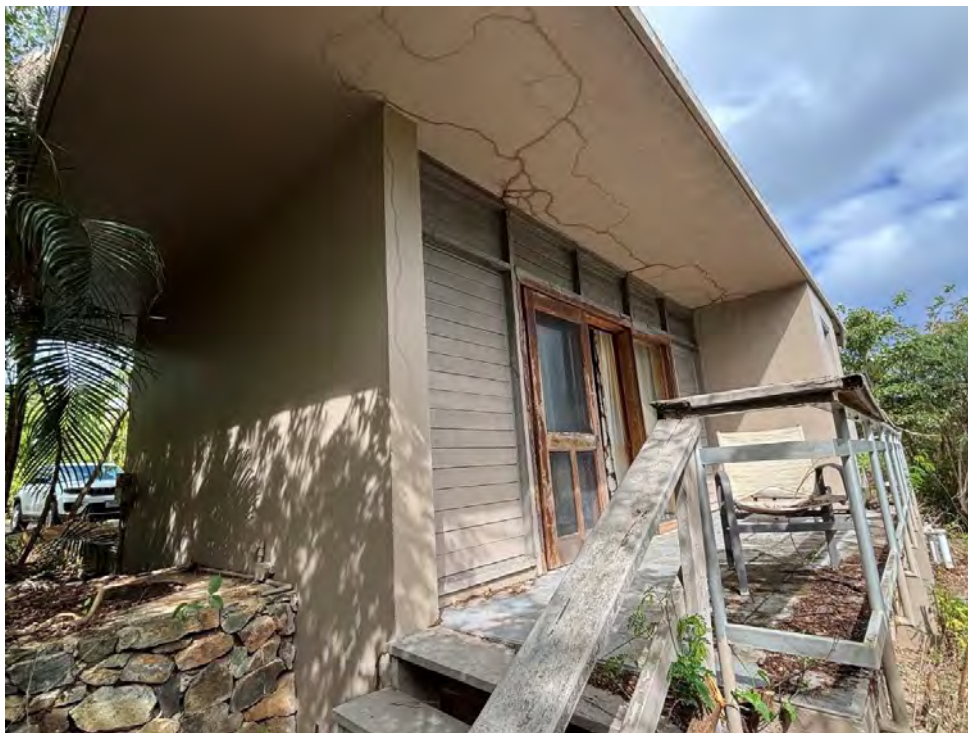
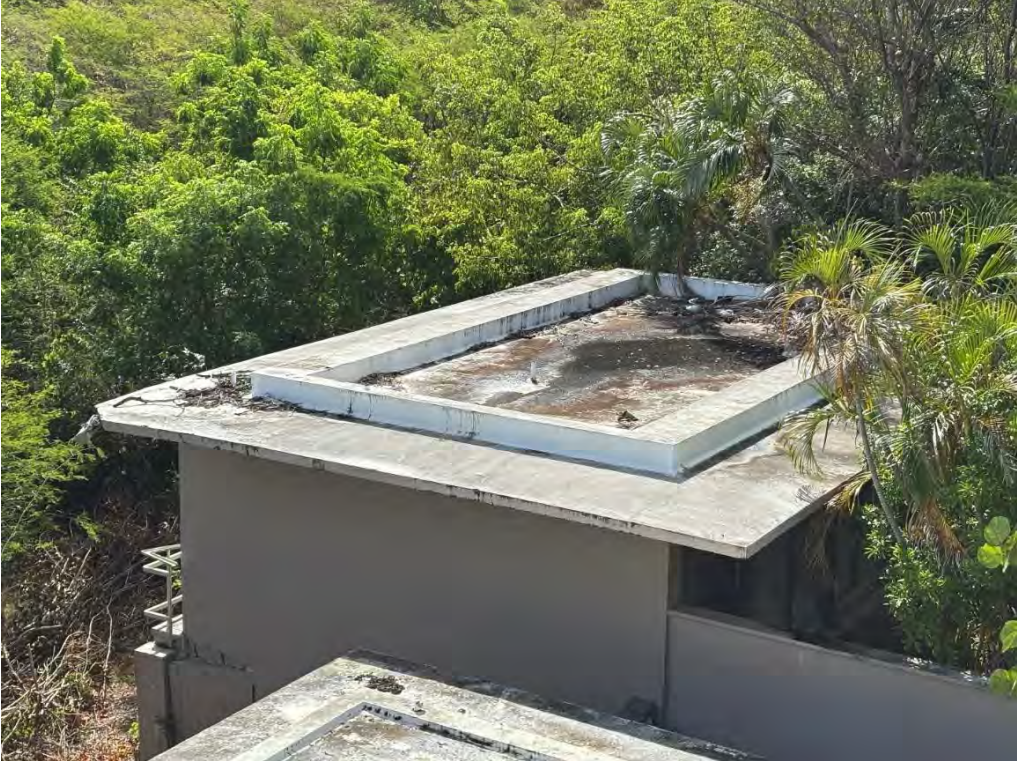
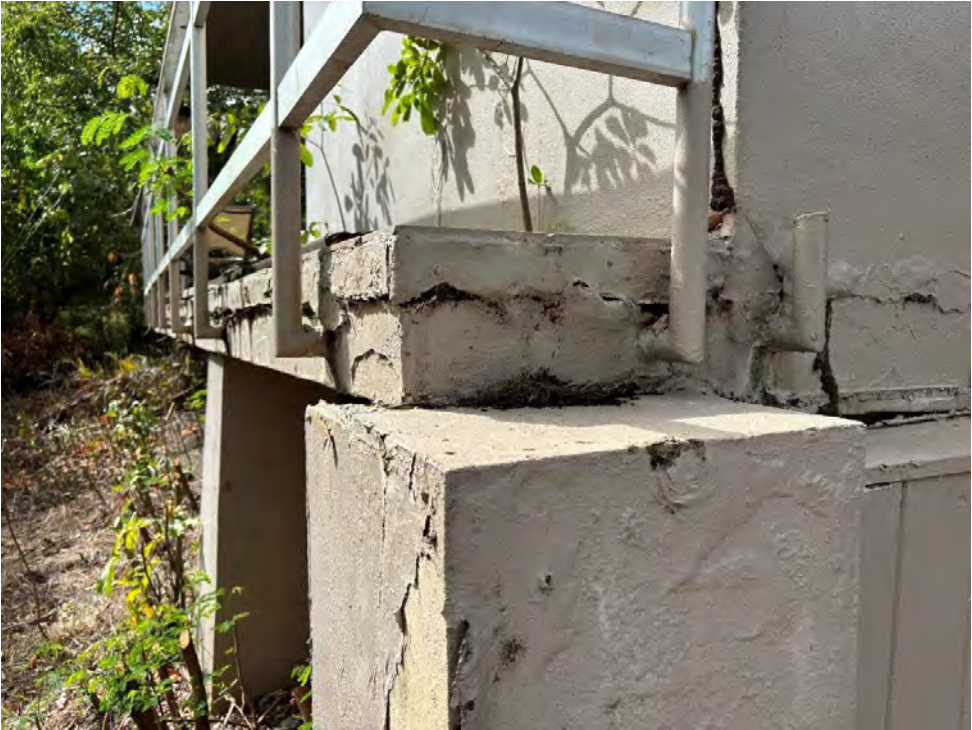
**Building: 96 Cottage 7 Unit 7A**

Component	Material	Notes
Floor	Concrete	Slab separation/cracking along entire north side.
Walls (Structural)	Concrete	Concrete cracks around north window.
Walls (Non-Structural)	Wood	
Roof	Concrete	
Stairs/Railings	Wooden Steps / Aluminum Railing	Wooden steps deteriorated and leaning.
Sidewalk	Concrete

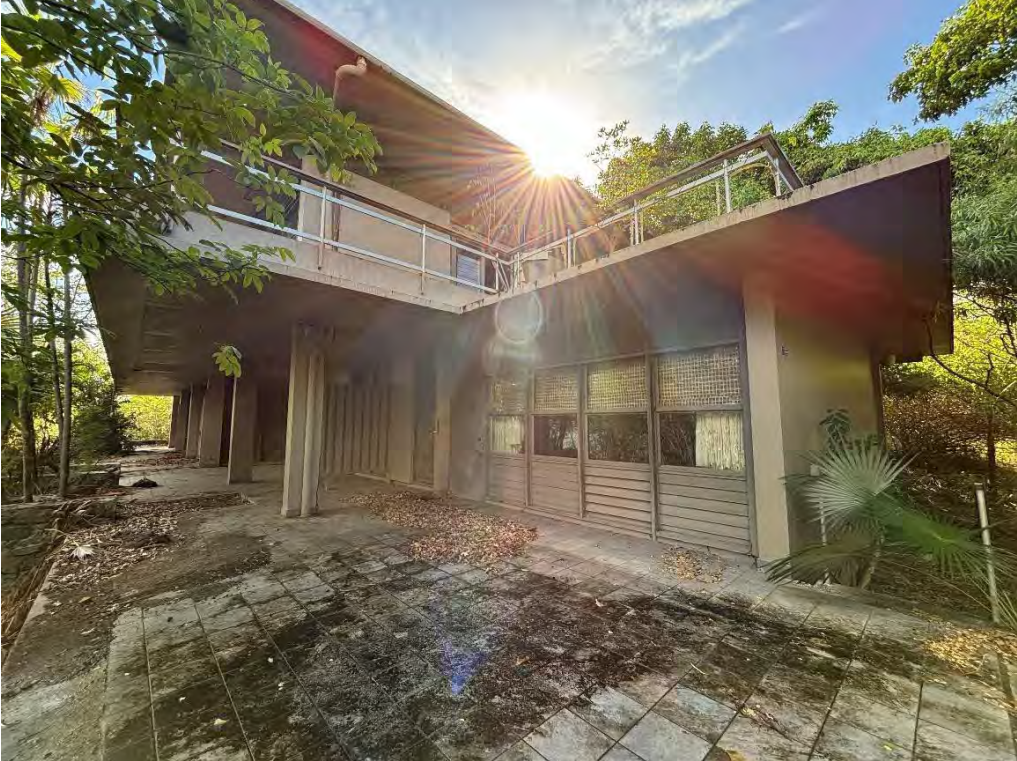
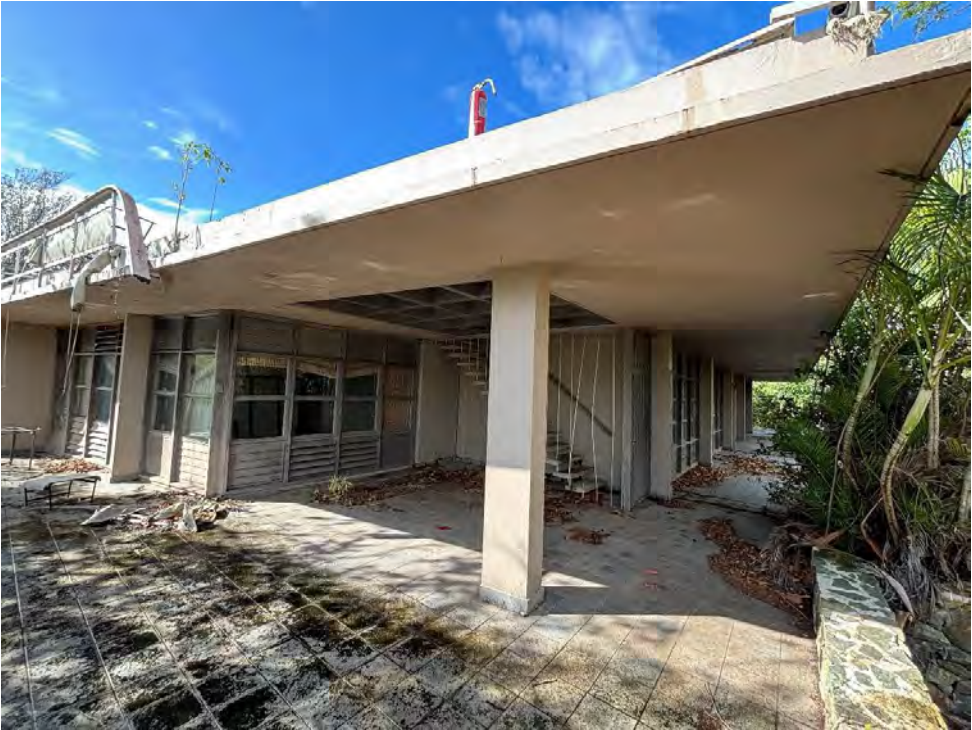
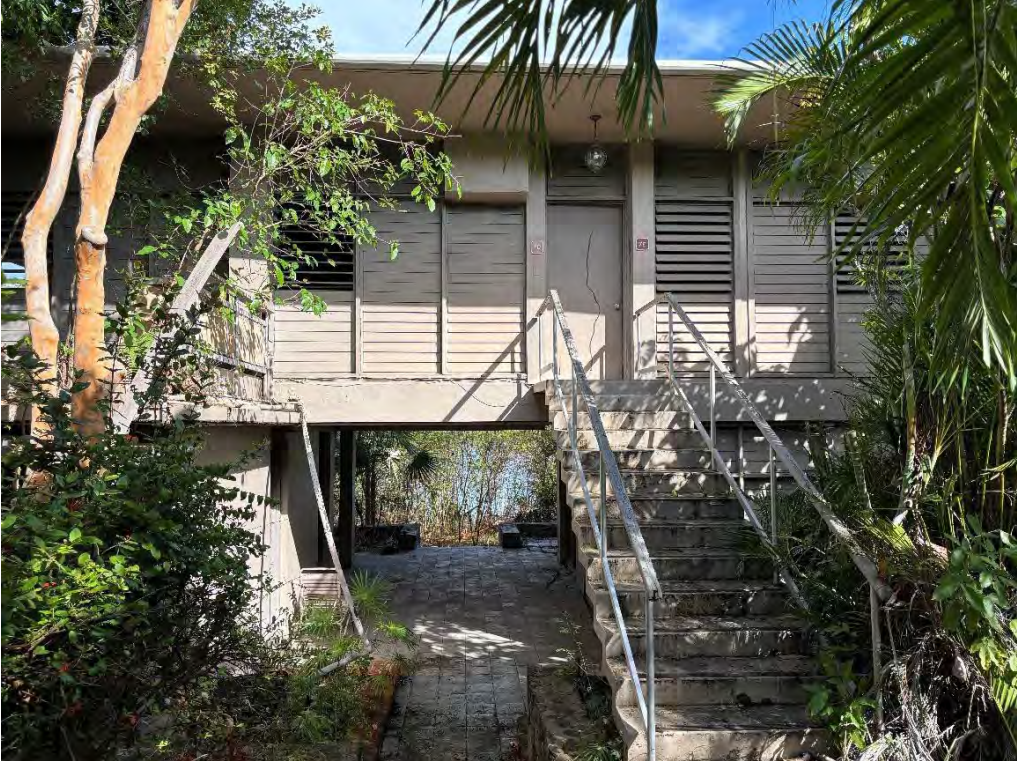
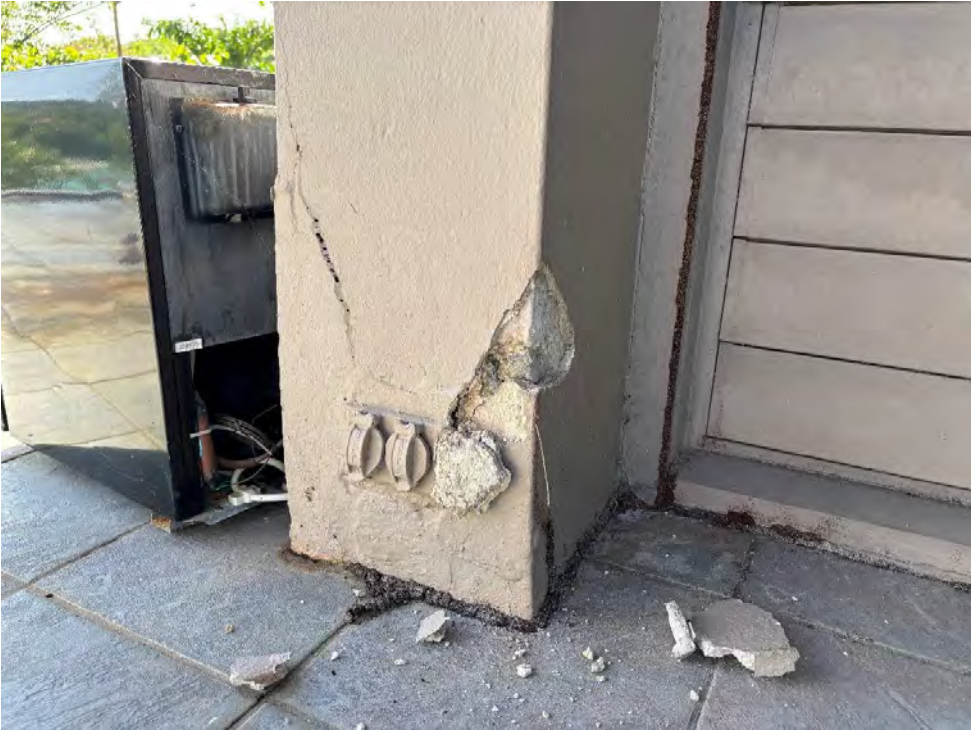
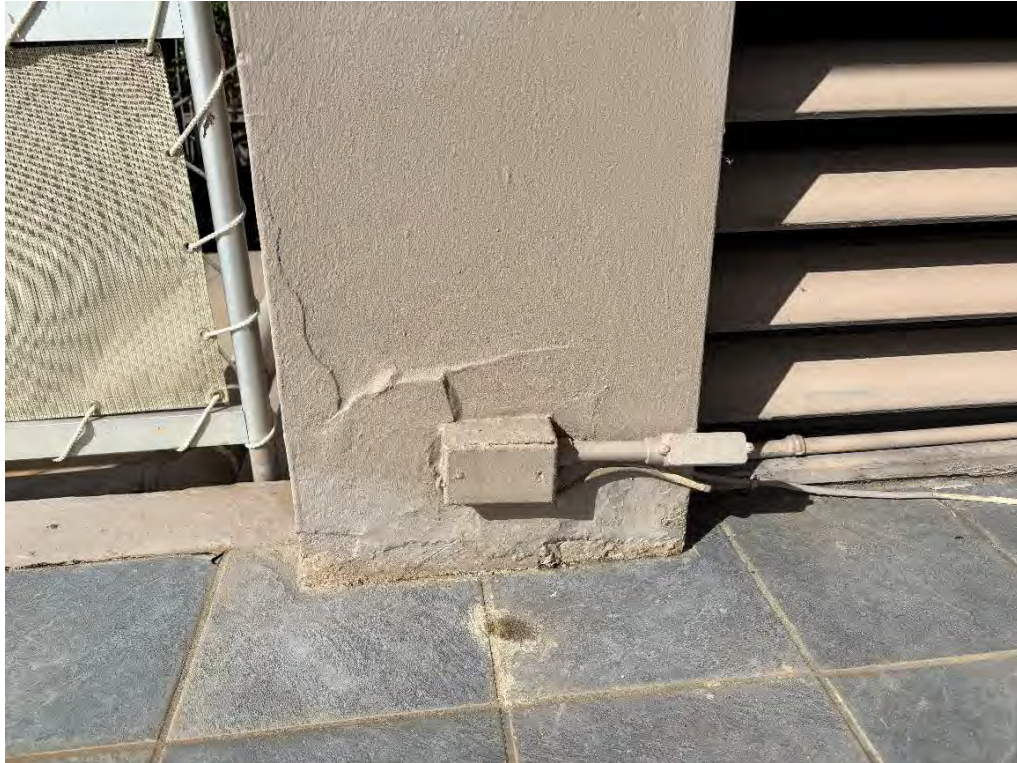
**Building: 36 Cottage 7 Units 7B-7F**

Component	Material	Notes
Floor	Concrete	
Walls (Structural)	Concrete	Concrete columns on beach side (NW) of building show signs of minor cracking and spalling on the 1 <sup>st</sup> and 2 <sup>nd</sup> floor. Cracks at exterior concrete wall of unit 7D and 7B.
Walls (Non-Structural)	Wood	Wood finishes show signs of severe termite activity.
Roof	Concrete	Minor cracks in concrete roof overhang
Stairs/Railings	Concrete / Aluminum Railing	Exterior floating stairs near units 7F and 7B show signs of damage to the treads and hanging support rods. Aluminum railings at perimeter of second floor are damaged and missing. The railings relied on canvas infill within the aluminum frame to provide fall protection. Most of the canvas panels are gone.
Sidewalk	Concrete	
Basement	Concrete	Standing water in basement. Potential wall cracks (unable to access due to water).

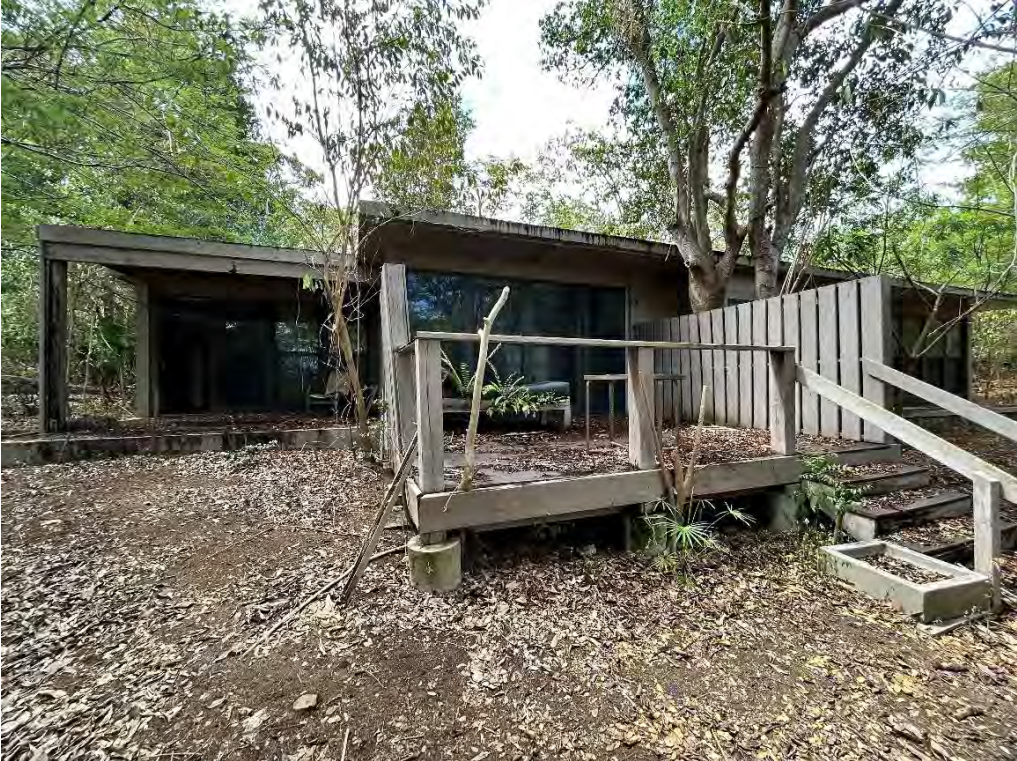
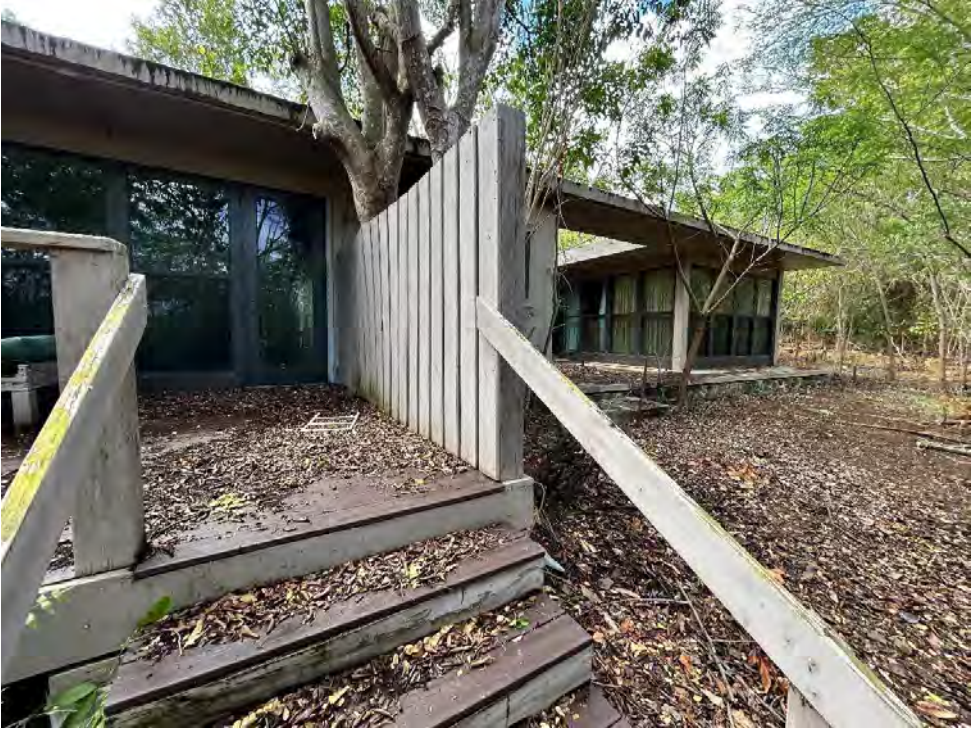
**Building: 35 Paradise Beach Units 64-66**

Component	Material	Notes
Floor	Concrete	
Walls (Structural)	Concrete	Minor concrete cracking, some cracks show signs of previous repairs. Spalled concrete at breezeway. Potential soil loss at foundation support for Unit 65 NW wall.
Walls (Non-Structural)	Wood Framed / Open CMU Walls	Open CMU wall at breezeway.
Roof	Concrete and Wood/ Membrane	Wood framed roof over Unit 66 porch. Roots growing from ceiling in Unit 65 (unable to access interior of unit) Vegetation on roof. Moisture pockets in paint at underside of roof overhang. Roof cracks.
Stairs/Railings	Wood	
Deck	Wood	Wood framed deck north side of Unit 65.

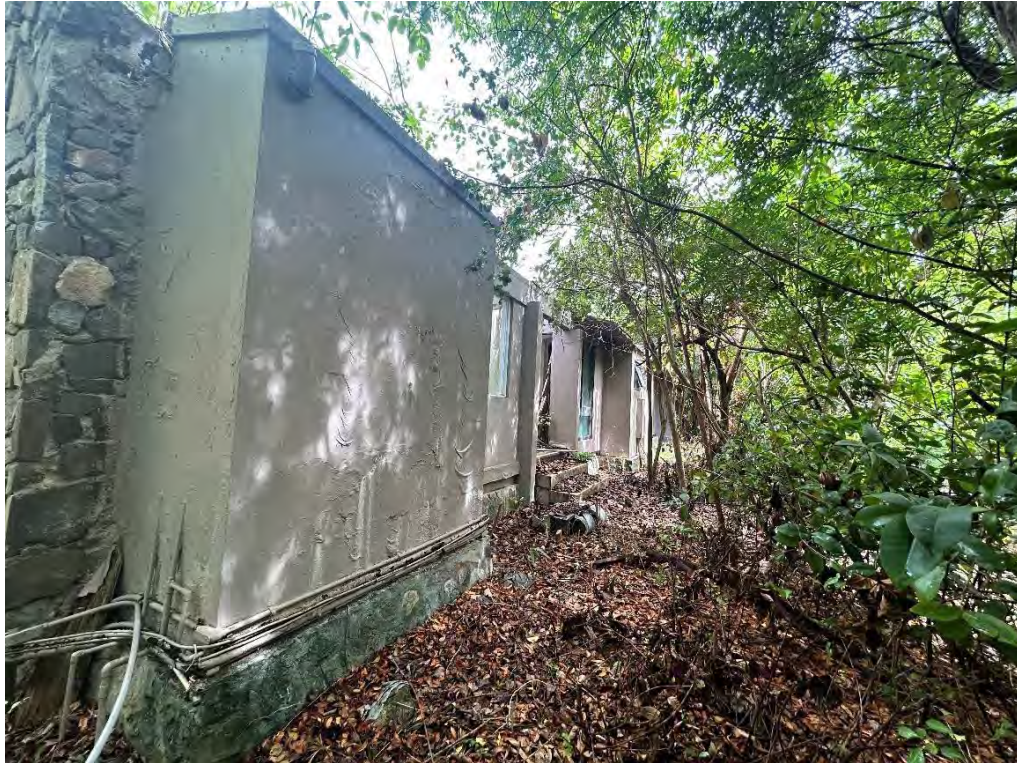
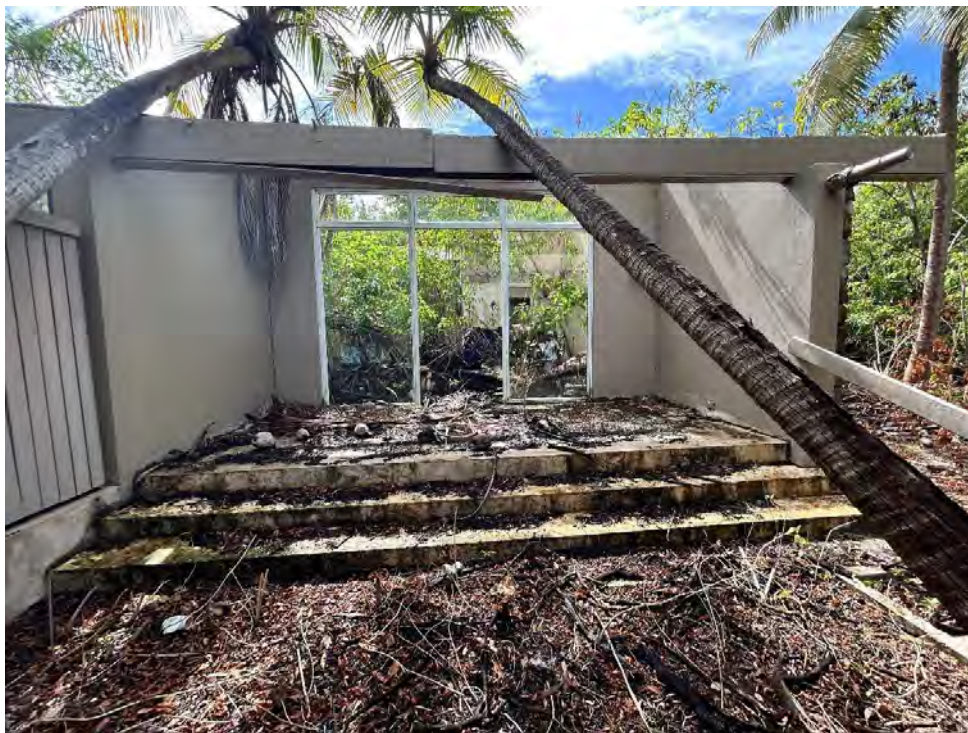
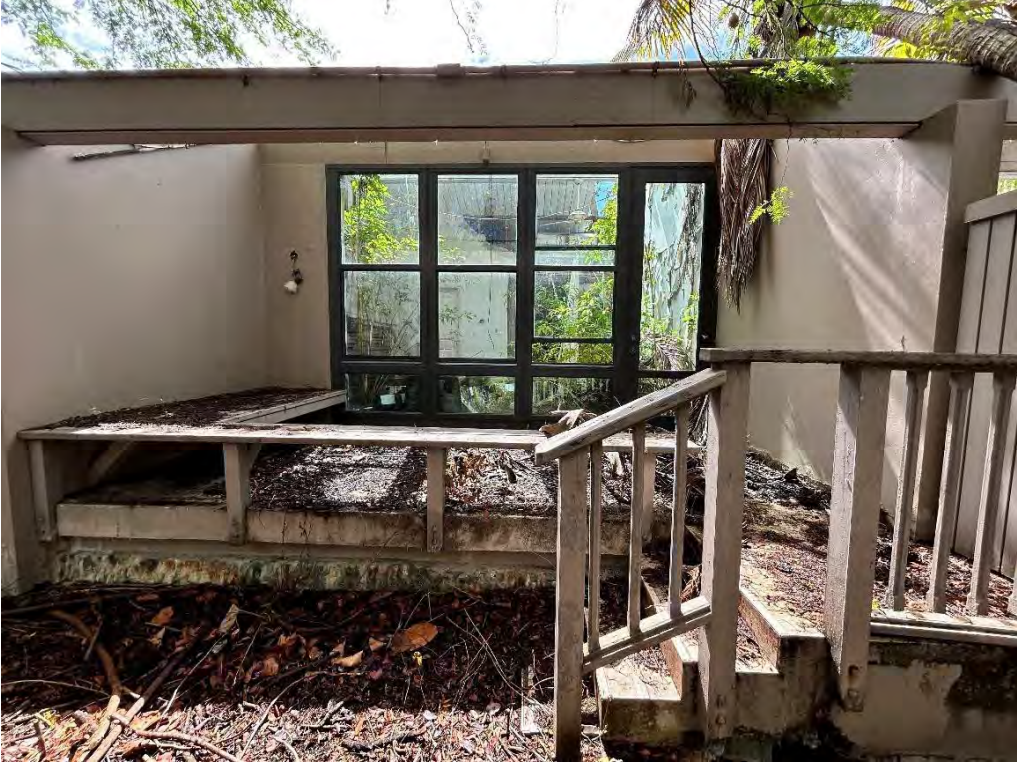
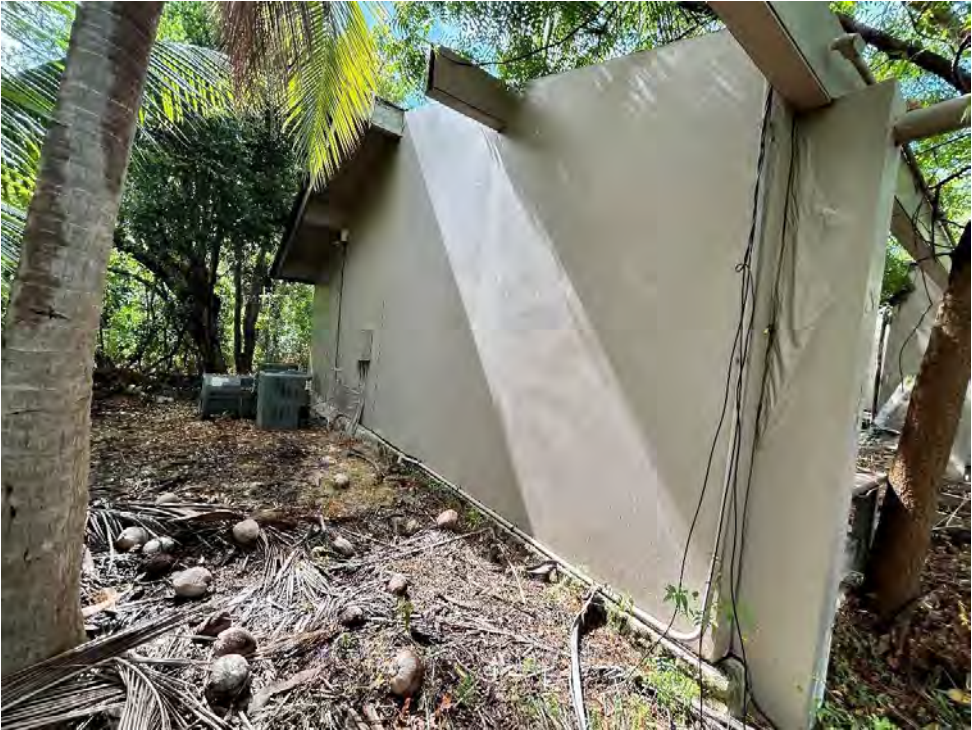
**Building: 37 Scott Beach Units 67-70**

Component	Material	Notes
Floor	Concrete	Efflorescence with stalactites forming at bottom of west concrete porch edge. Vegetation growth.
Walls (Structural)	Concrete	Concrete spalled at exterior wall between units 69 and 70. Signs of termite activity. Efflorescence with stalactites forming at bottom of east walls.
Walls (Non-Structural)	Metal Framed Window Wall / Stone Veneer End Wall	Vegetation grown on stone veneer wall.
Roof	Wood Framed / Metal Sheathing	Roof collapsed completely at Unit 67. Partial roof collapse for Units 68, 69, and 70.
Stairs/Railings	Concrete

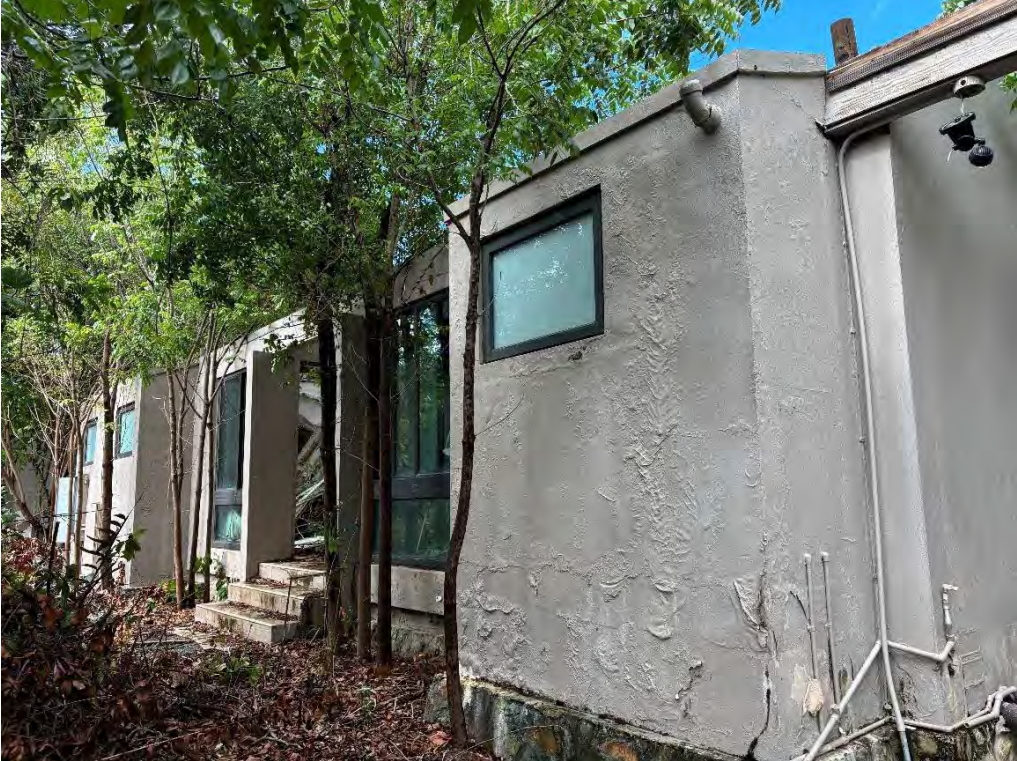
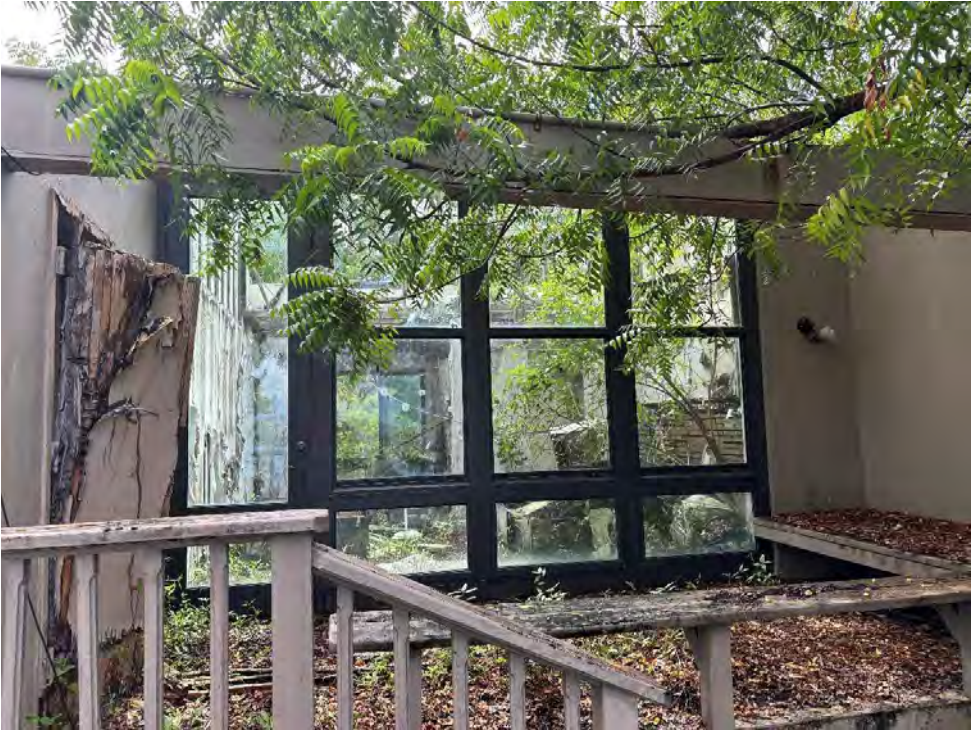
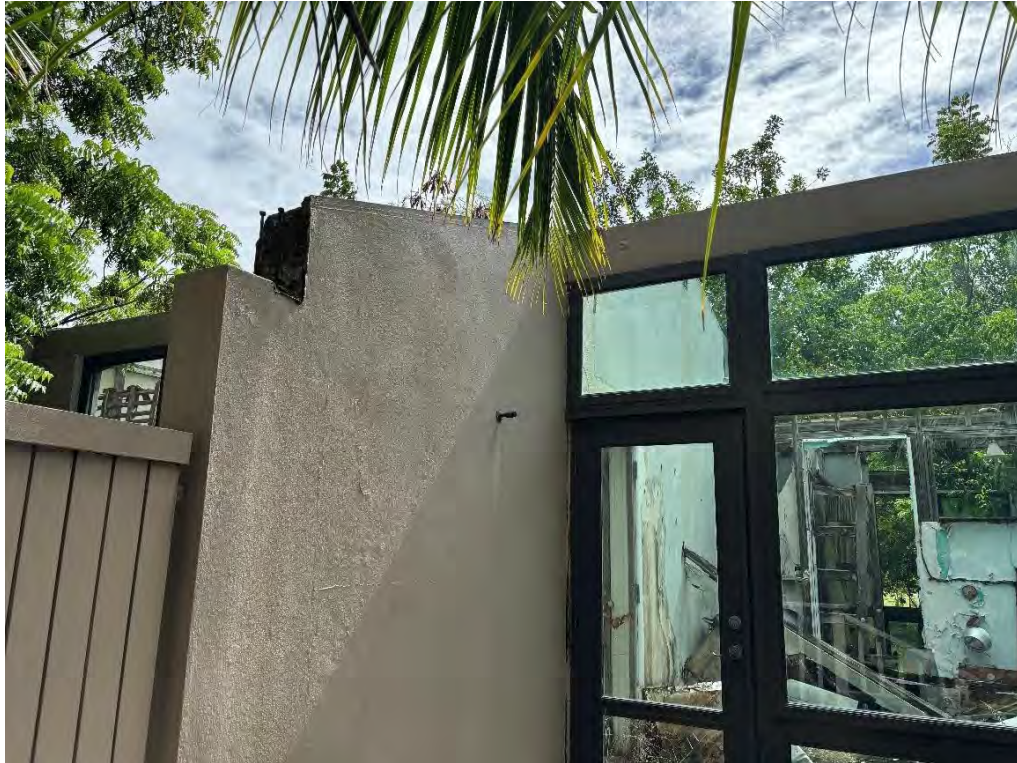
**Building: 38 Scott Beach Units 71-74**

Component	Material	Notes
Floor	Concrete	Vegetation growth.
Walls (Structural)	Concrete	Beam pocket damage at rear wall of unit 74. Signs of termite activity. Efflorescence with stalactites forming at bottom of east walls.
Walls (Non-Structural)	Metal Framed Window Wall	
Roof	Wood Framed / Metal Sheathing	Roofs collapsed.
Stairs/Railings	Concrete
