**National Park Service**  
Virgin Islands National Park | Caneel Bay  
Structural Assessment Report

**Building: 28 Caneel Beach Units 26-29**

**Structural Assessment: Structurally Sound**

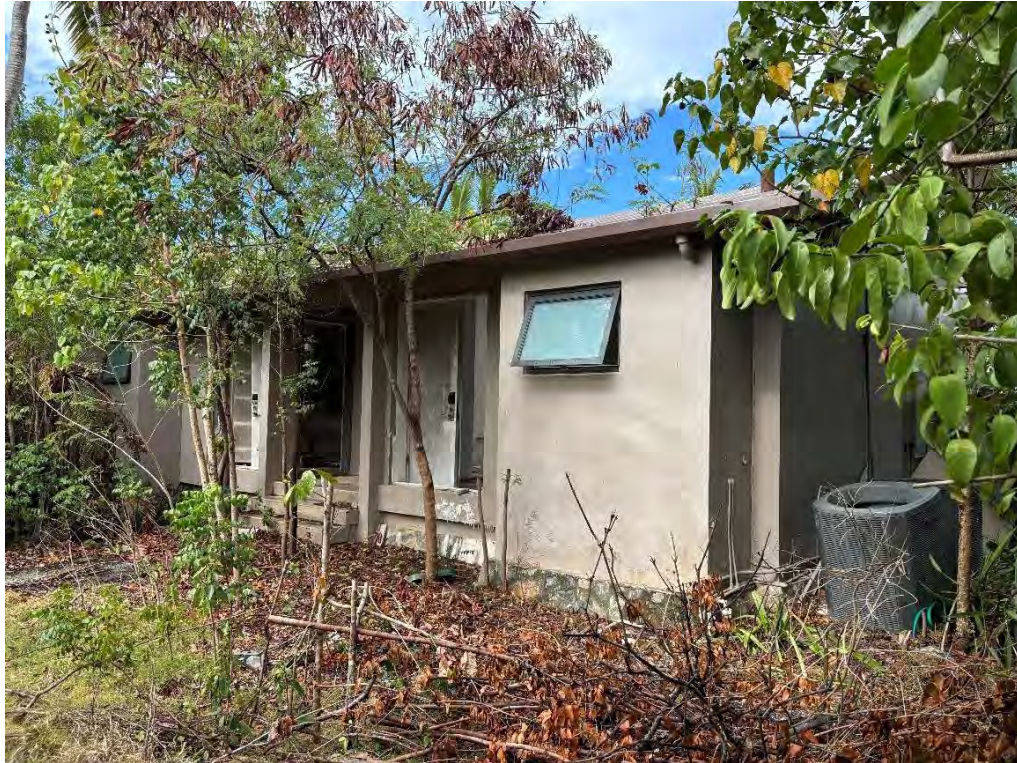
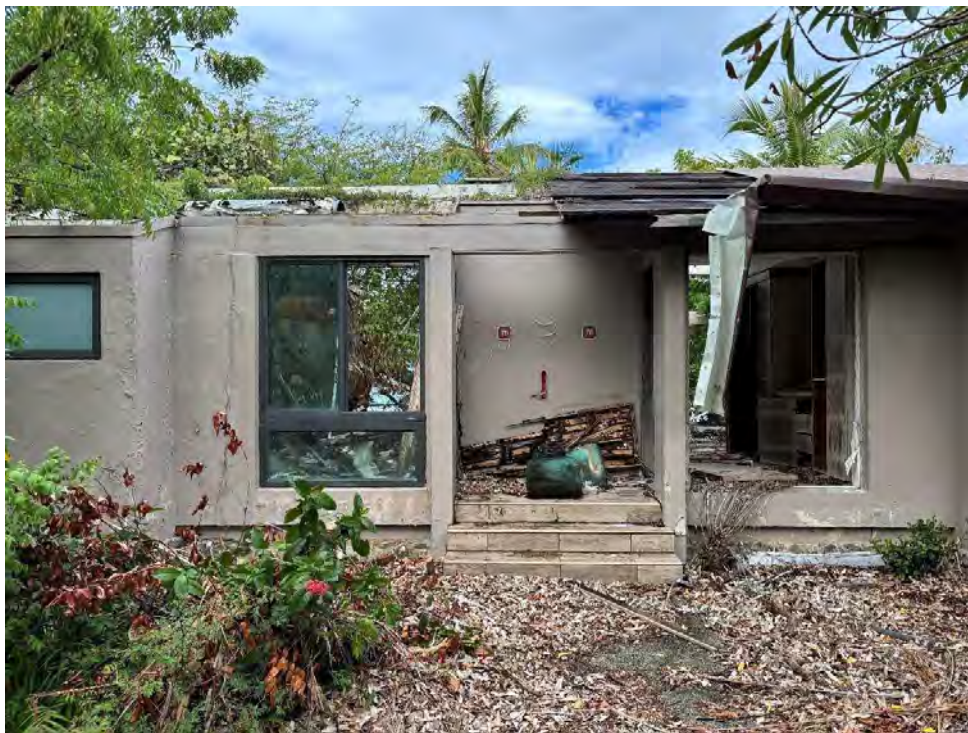
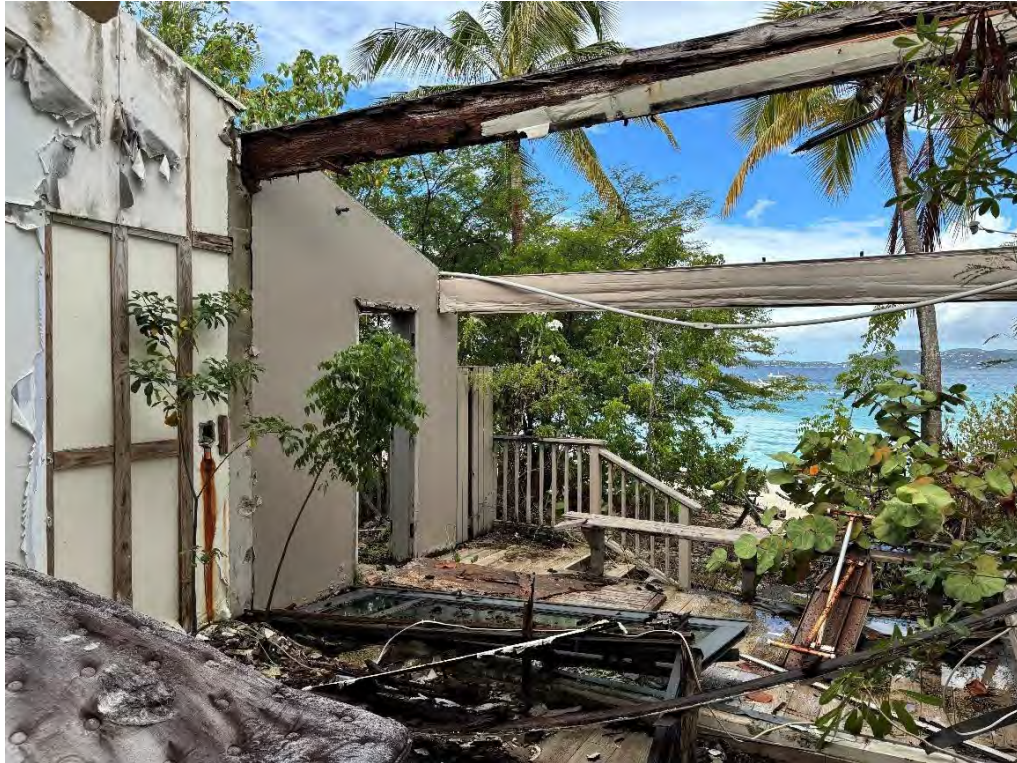
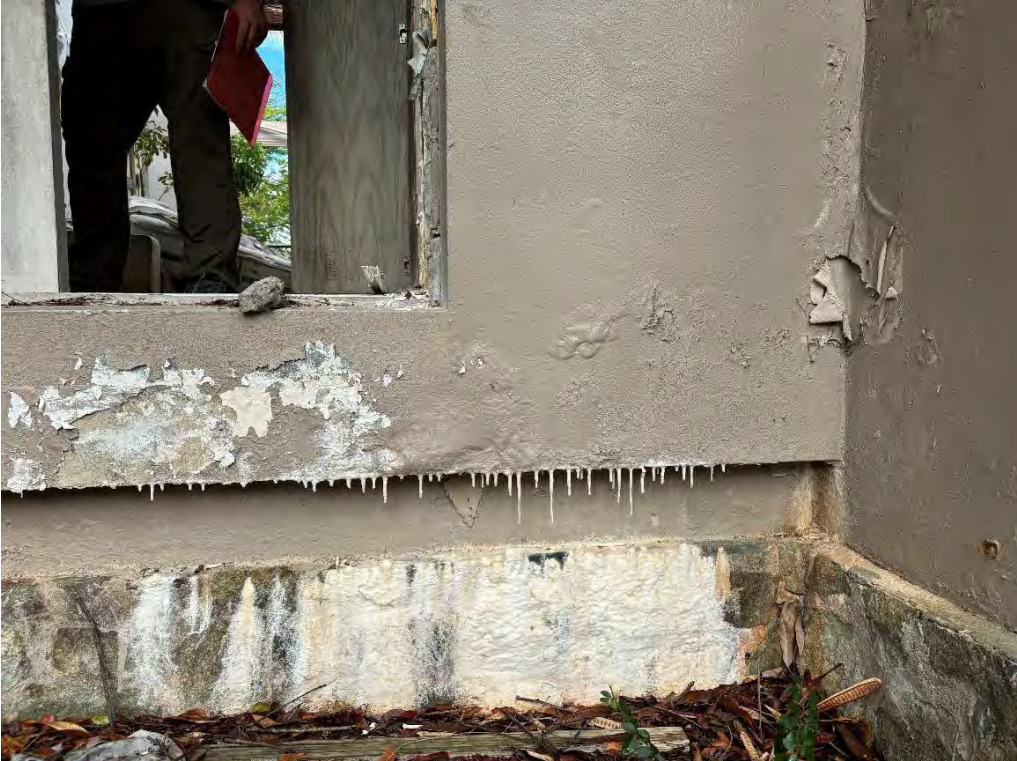
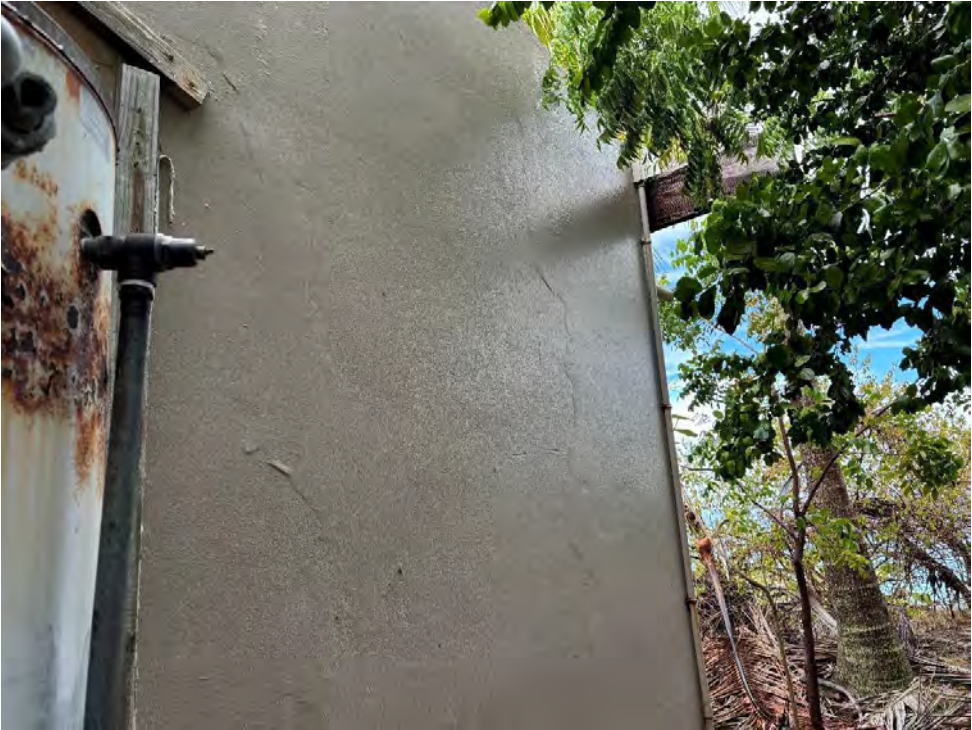
**Building: 39 Scott Beach Units 75-78**

Component	Material	Notes
Floor	Concrete	Vegetation growth.
Walls (Structural)	Concrete	Beam pocket damage at front wall of unit 75. Signs of termite activity. Efflorescence with stalactites forming at bottom of east walls. Concrete bearing walls were covered with drywall for architectural cladding.
Walls (Non-Structural)	Metal Framed Window Wall	
Roof	Wood Framed / Metal Sheathing	Roof collapsed completely at Unit 75. Partial roof collapse for Units 76, 77, and 78.
Stairs/Railings	Concrete	Railings deteriorated.

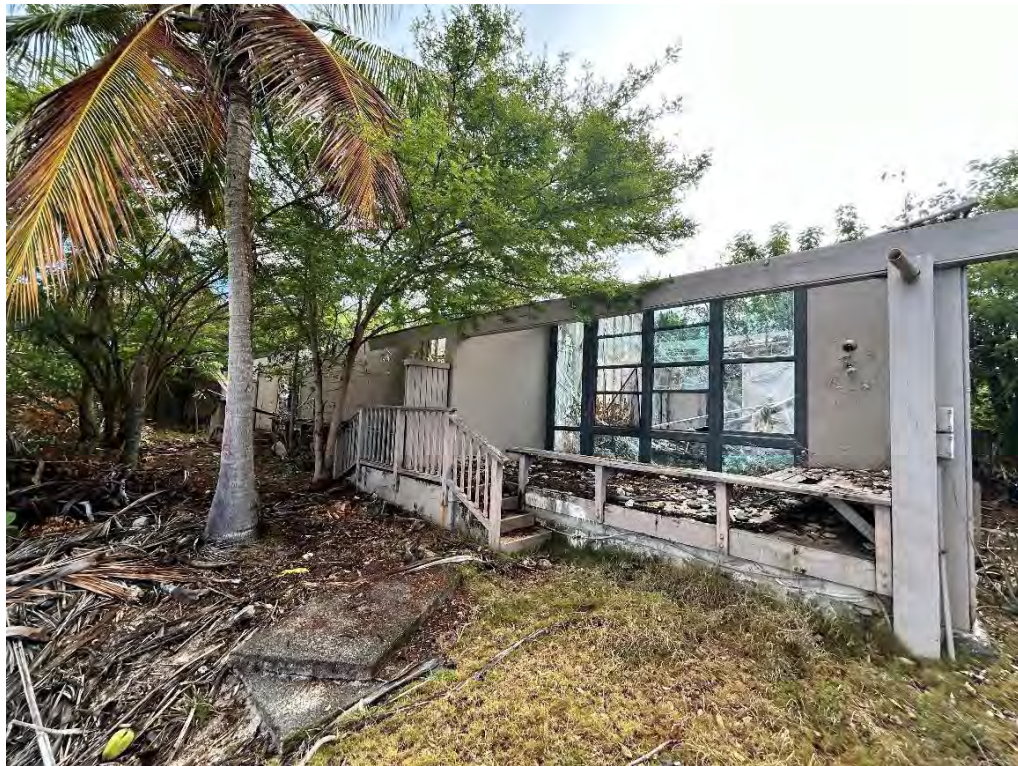
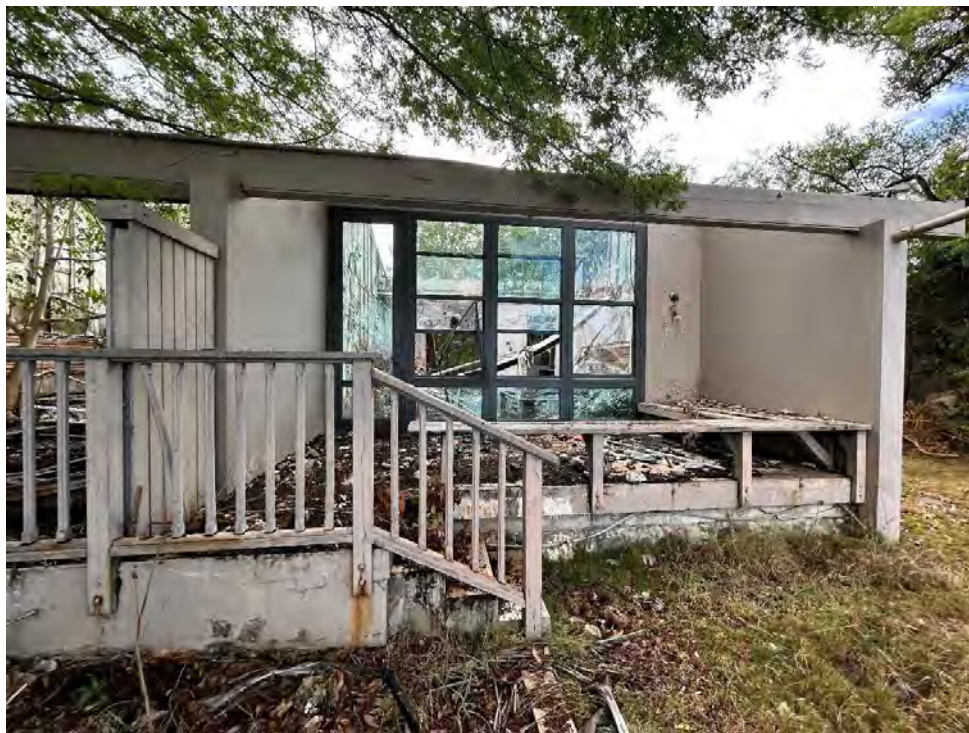
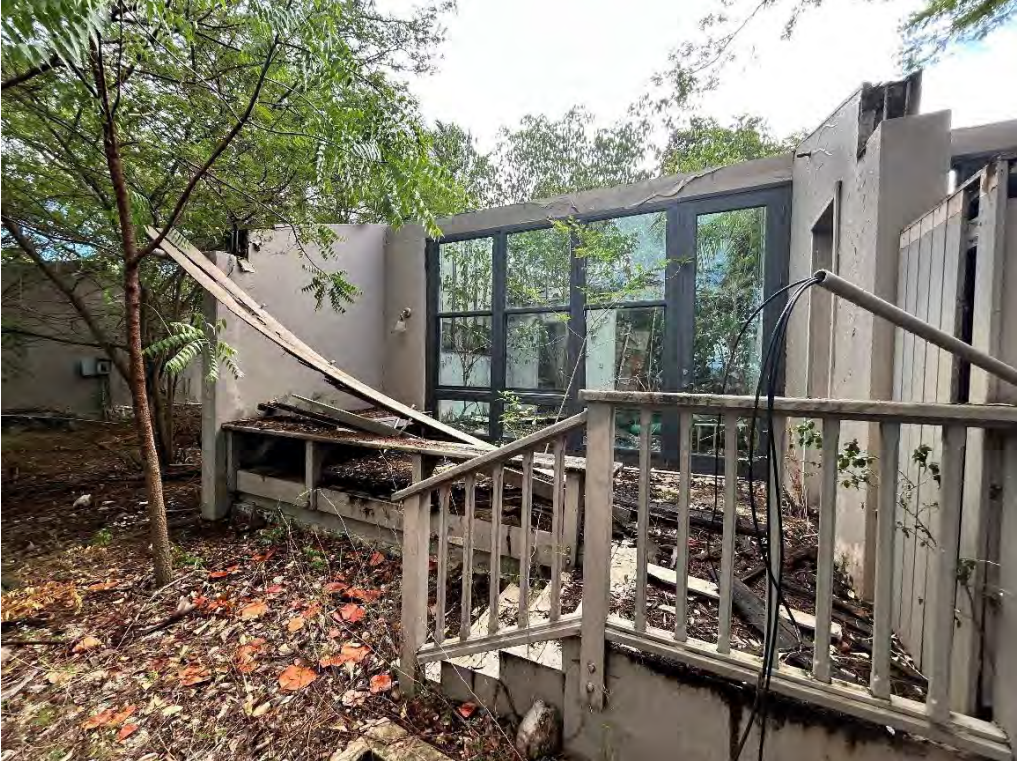
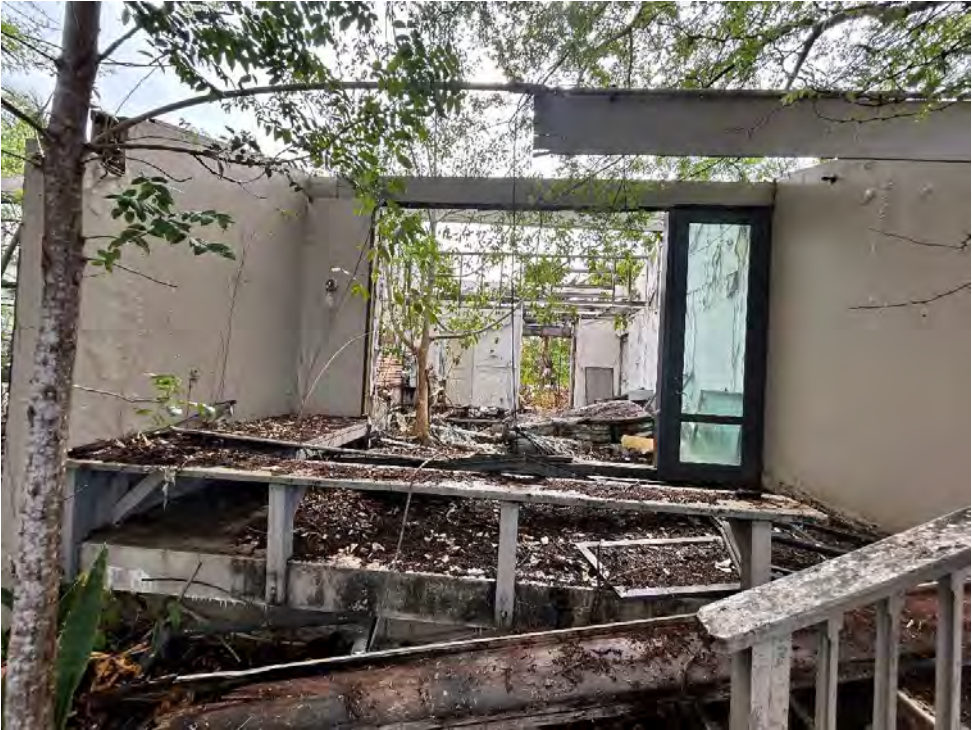
**Building: 40 Scott Beach Units 79-82**

Component	Material	Notes
Floor	Concrete	
Walls (Structural)	Concrete	Concrete spall at end walls (exterior walls of units of 79 and 82). Signs of termite activity.
Walls (Non-Structural)	Metal Framed Window Wall	Blown out exterior partition wall at Unit 81, west side.
Roof	Wood Framed / Metal Sheathing	Roof collapsed for all units.
Stairs/Railings	Concrete

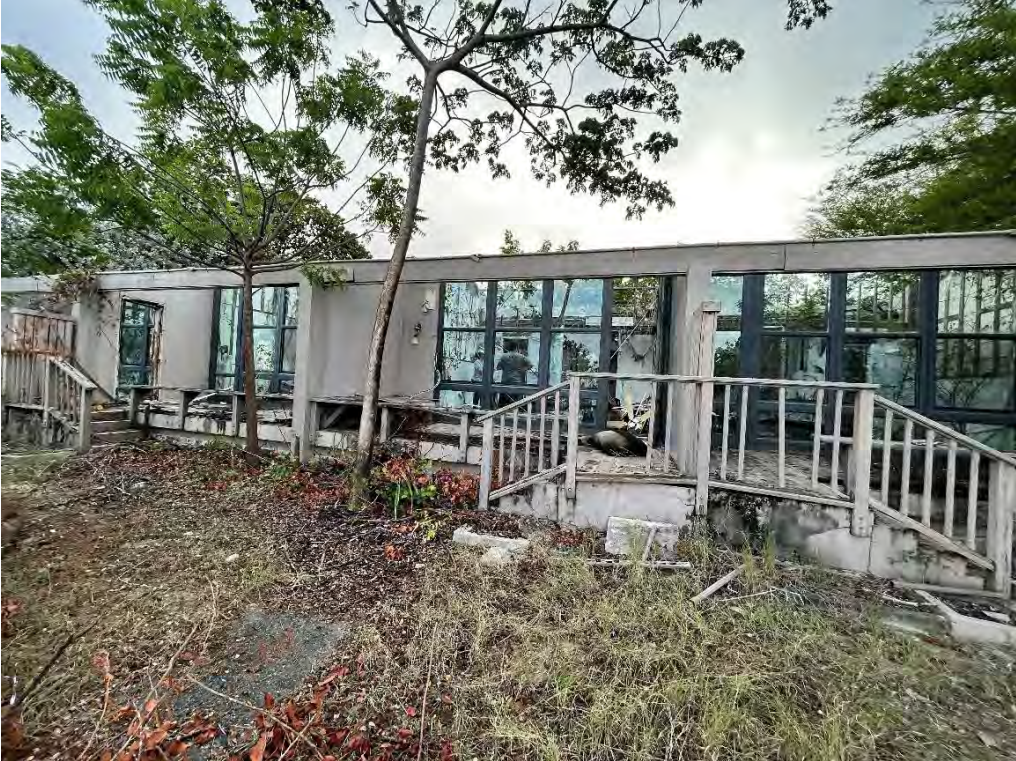
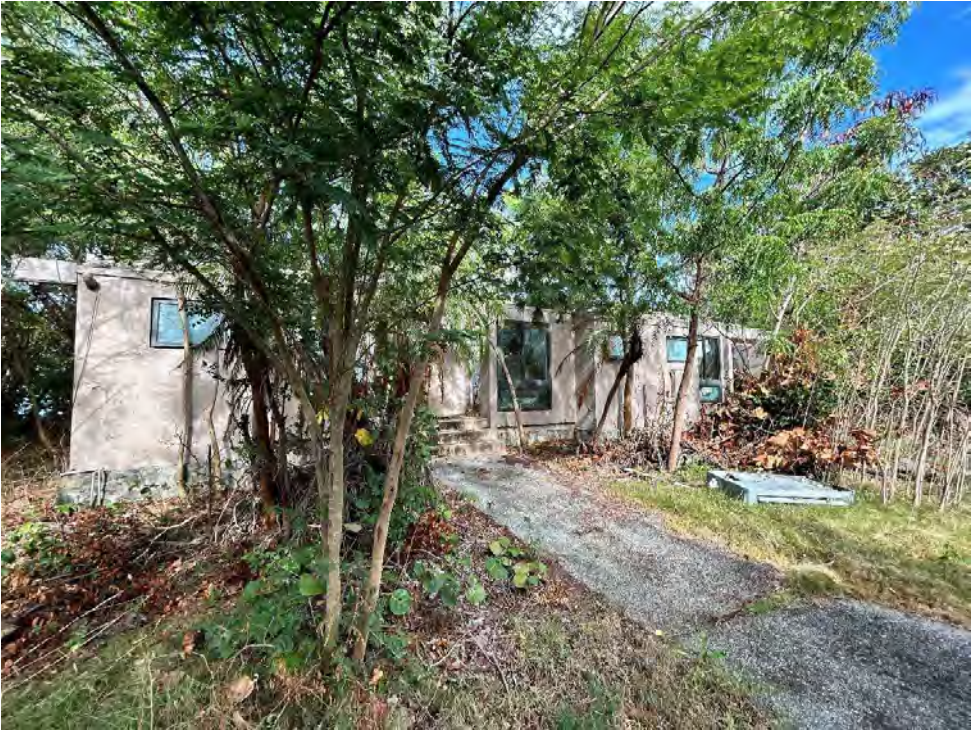
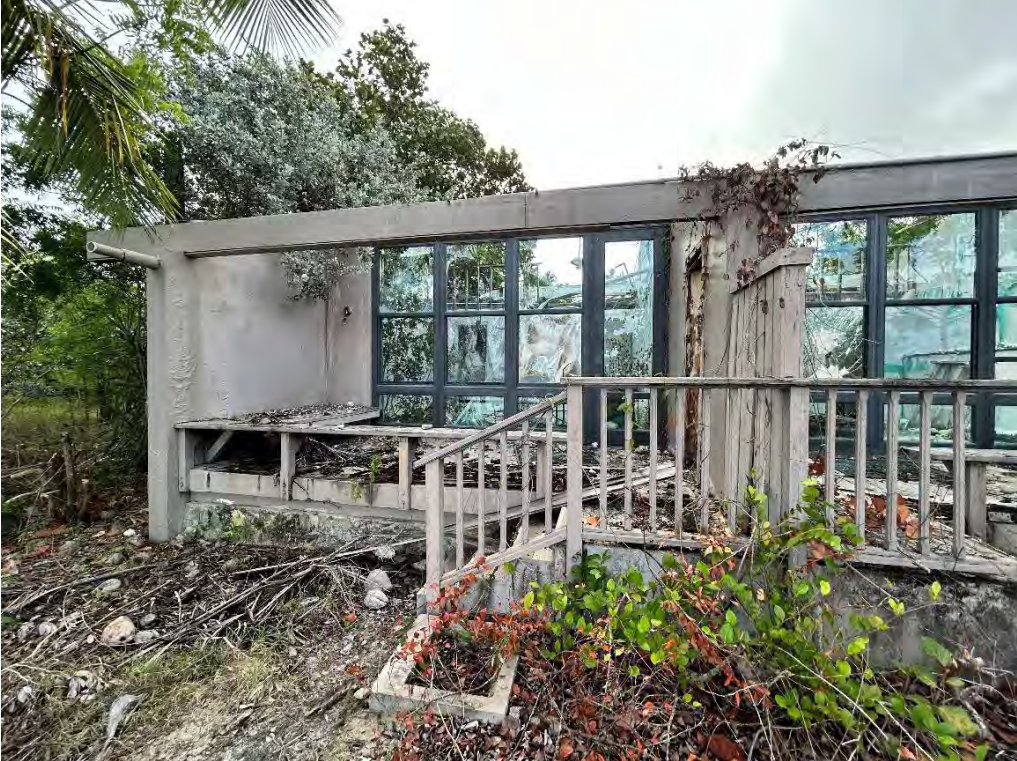
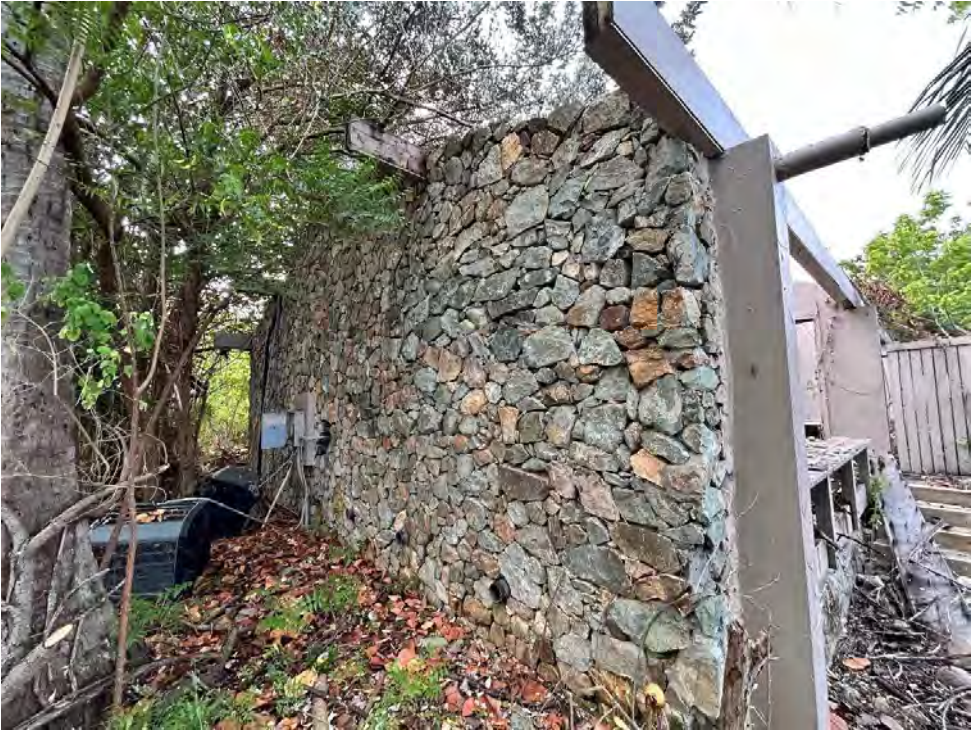
**Building: 41 Scott Beach Units 83-86**

Component	Material	Notes
Floor	Concrete	Standing water observed in crawl space below building.
Walls (Structural)	Concrete	Concrete spall at exterior wall between units 83-84. Signs of termite activity. Efflorescence with stalactites forming at bottom of east walls.
Walls (Non-Structural)	Metal Framed Window Wall	Missing stones at stone veneer wall on exterior side of Unit 86.
Roof	Wood Framed / Metal Sheathing	Roof collapsed for all units.
Stairs/Railings	Concrete

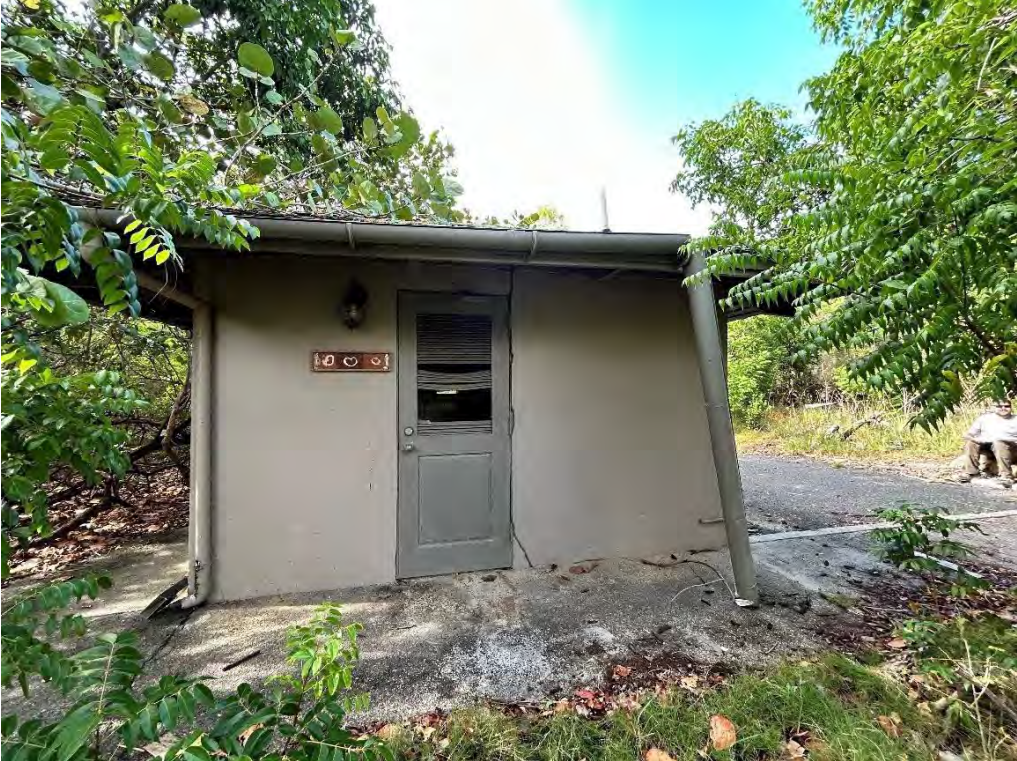
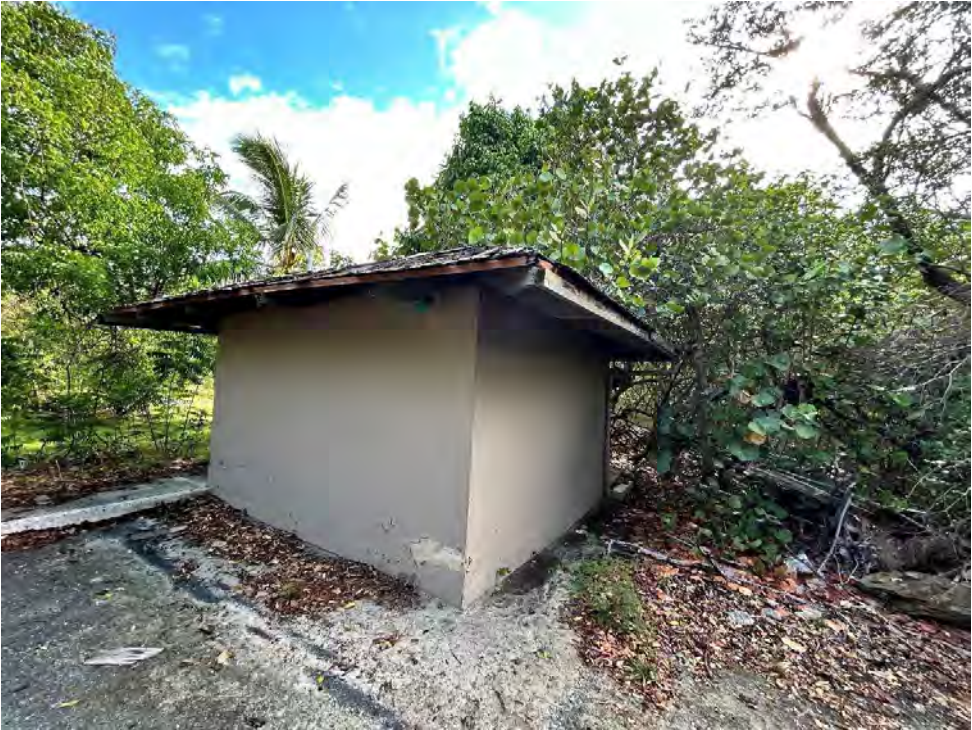
**Building: 101 Scott Beach Restroom**

Component	Material	Notes
Floor	Concrete	
Walls (Structural)	Concrete	Concrete spall adjacent to door on east side.
Roof	Wood Framed / Wood Shingles	Rafter Deterioration at exterior overhang at NW corner.
