National Park Service
Virgin Islands National Park | Caneel Bay
Structural Assessment Report

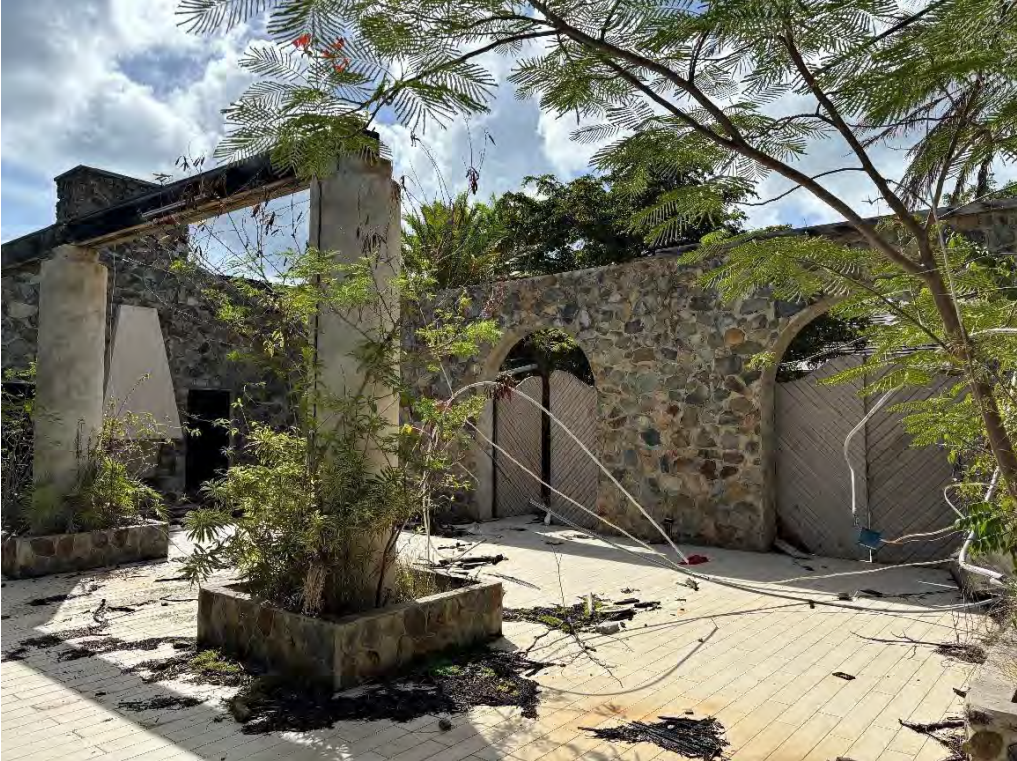
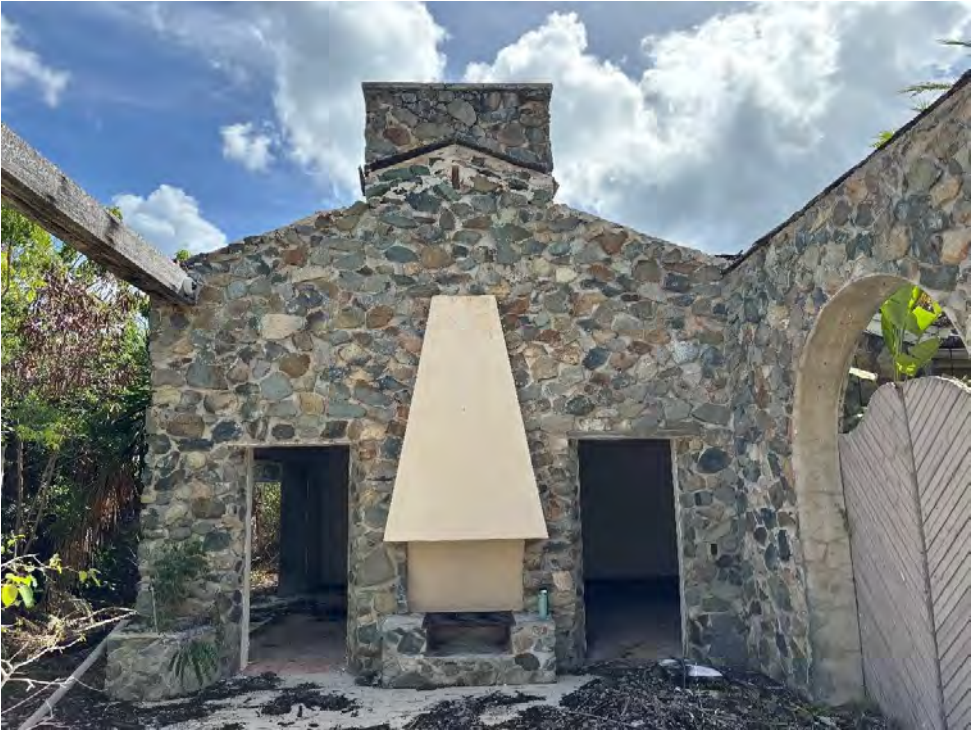
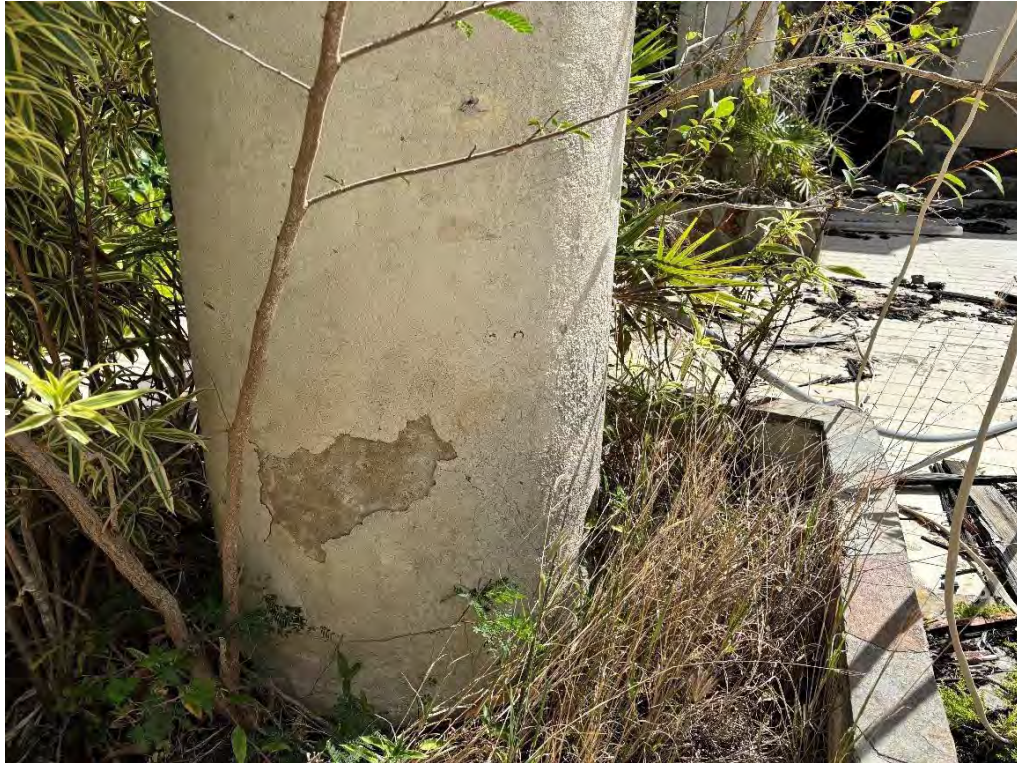
Building: 95 Turtle Bay Estate House Veranda

Structural Assessment: Structurally Sound

Component	Material	Notes
Floor	Concrete	Standing water in restroom/hallway area.
Walls (Structural)	Concrete / Stone	Missing stones in stone walls. Spalling concrete with corroded rebar at south wall. Mortar missing, loose, and cracked at south wall. Rusted lintel at exterior stairs.
Walls (Non-structural)	Wood / Doors	Rotten wood at base of infill walls between doors.
Roof	Wood Framed / Wood Singles	Some missing wood shingles. Signs of water intrusion and moisture damage on interior finishes. Signs of termite activity. Wood shed roof over exterior stairs is missing major support beam and has failed.
Stairs/Railings	Concrete / Wood Railings

- Wood framing at roof was not visible. Given water damage and signs of termite activity, it is likely there is additional wood damage not observed at this time. Future renovations should evaluate the structure further.

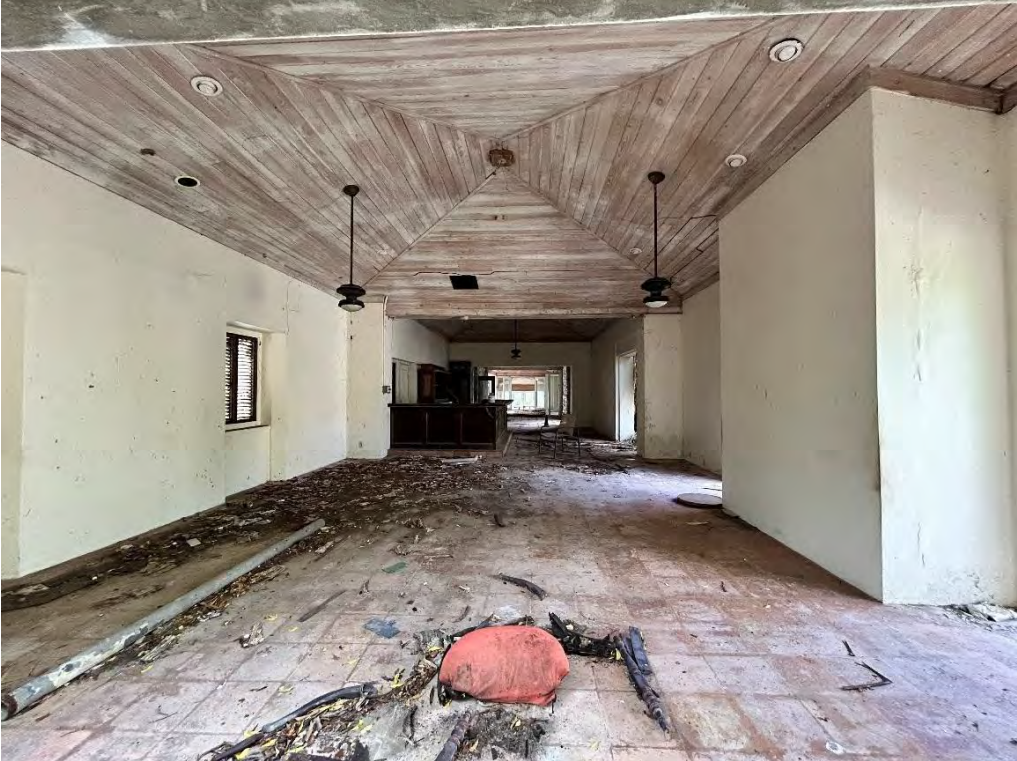
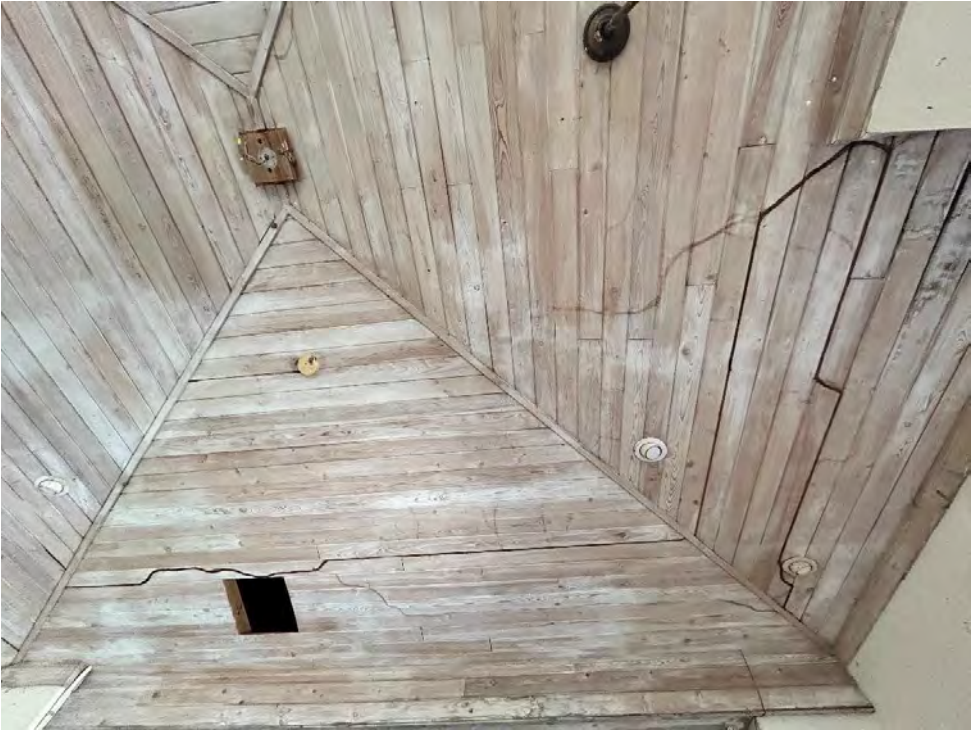
Building: 95 Turtle Bay Kitchen & Nail Salon

Structural Assessment: Potentially Repair or Rebuild

Component	Material	Notes
Floor	Concrete	
Walls (Structural)	Concrete	Vertical crack in concrete end wall at Nail Salon. (Nail salon shares roofline and structural walls with kitchen area).
Walls (Non-Structural)	Wood framed	Wood frame infill walls above concrete knee walls. Water and termite damage.
Roof	Wood framed/ Wood shingles	Roof damaged, not watertight. Water and termite damage.
Sidewalk	Concrete	Rear concrete loading area.

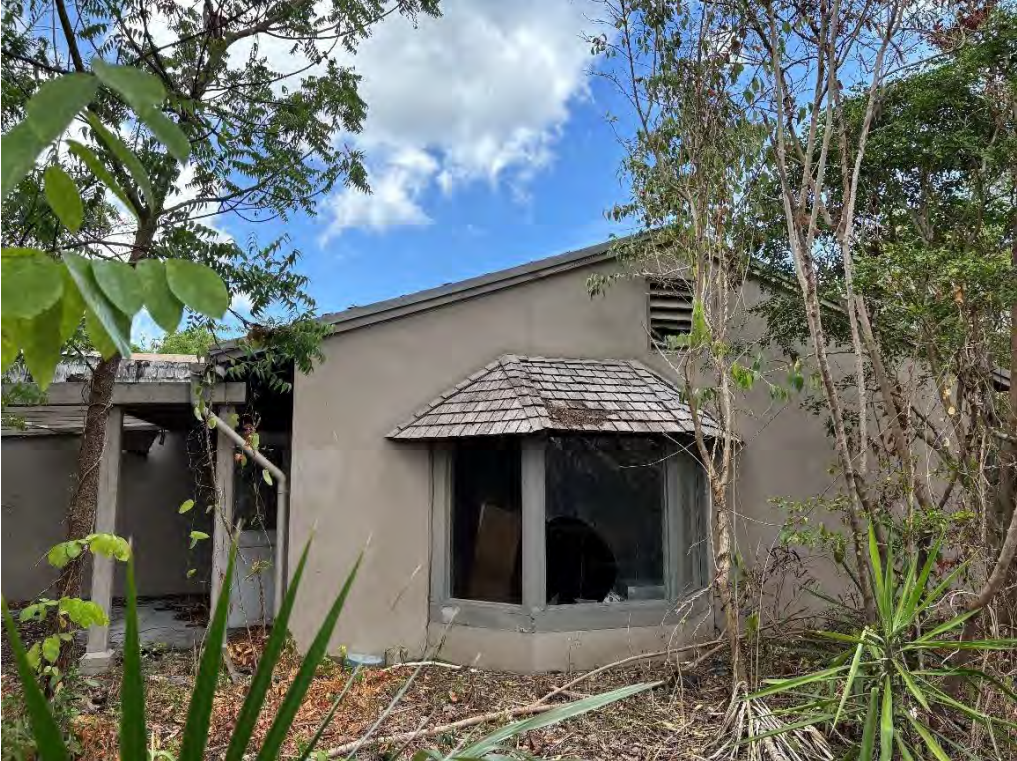
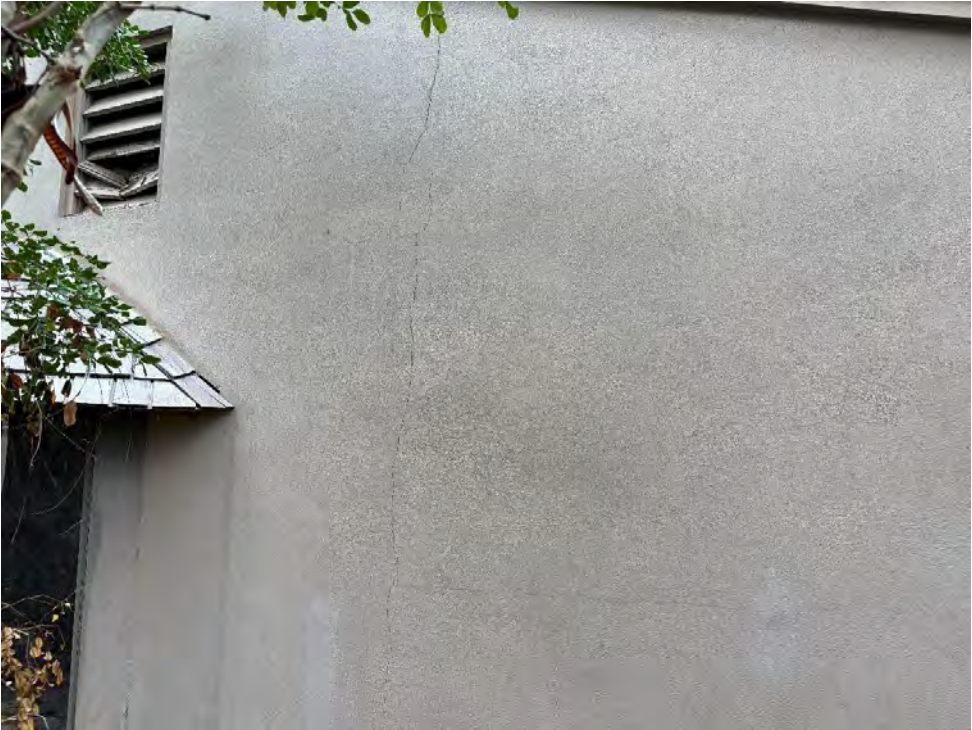
Building: 95 Turtle Bay Activity Room

Structural Assessment: Potentially

Component	Material	Notes
Floor	Concrete	Horizontal cracks in concrete wall may be signs of potential foundation rotation or differential movement.
Walls (Structural)	Concrete / Stone Retaining Walls	Missing stones in retaining walls. Horizontal cracks on north wall.
Walls (Non-structural)	Wood / Doors	Rotten wood at base of infill walls between doors.
Roof	Wood Framed / Wood Singles	Some missing wood shingles. Signs of water intrusion on interior finishes.
Stairs/Railings	Concrete / Aluminum Railings

Wood framing at roof was not visible. Given water damage and signs of termite activity, it is likely there is additional wood damage not observed at this time.

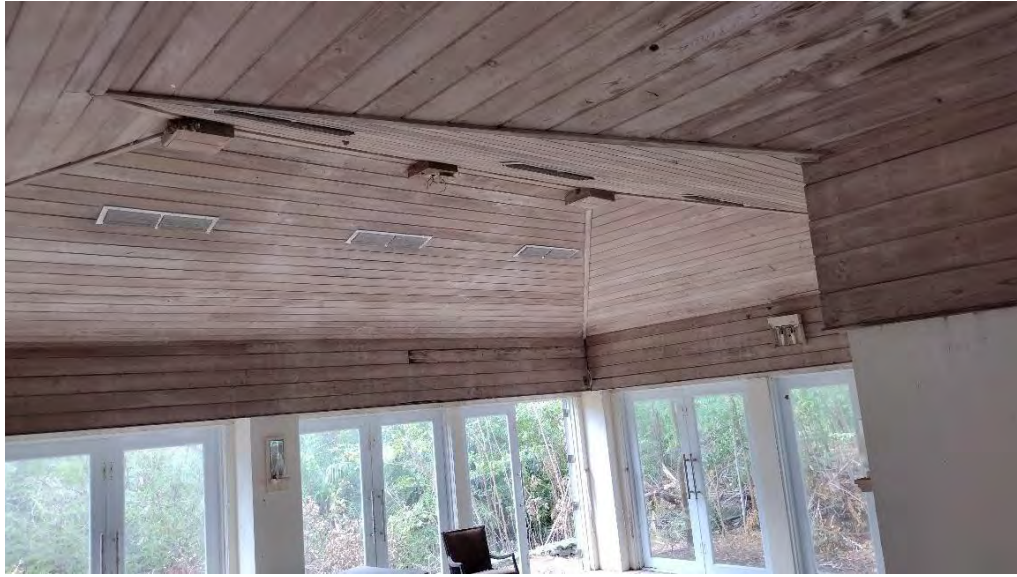
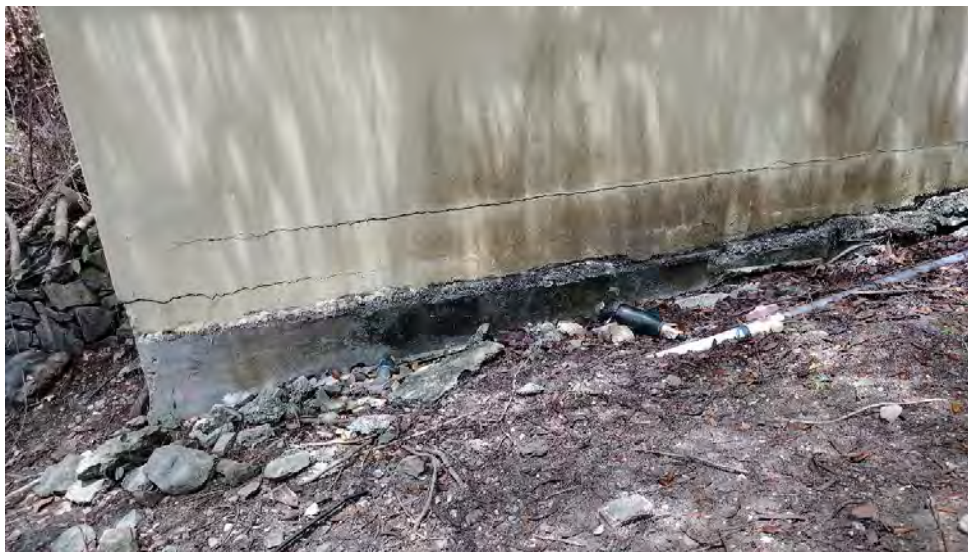
Building: Turtle Bay Units 99-100 & Multi-Purpose Room

Structural Assessment: Potentially Repair or Rebuild

Component	Material	Notes
Floor	Concrete	
Walls (Structural)	Stone/Concrete	Door lintels cracked and displaced in 99. Window lintels cracked in 100. Wall and lintel cracks in Multi Purpose Room.
Walls (Non-Structural)	Wood framed	Demolish partitions due to termite activity. Potential termite damage.
Roof	Wood framed/ unknown	Roof collapsed. Potential termite damage.
Stairs	Stone	
Deck / Railings	Wood	Decks and railings have failed.

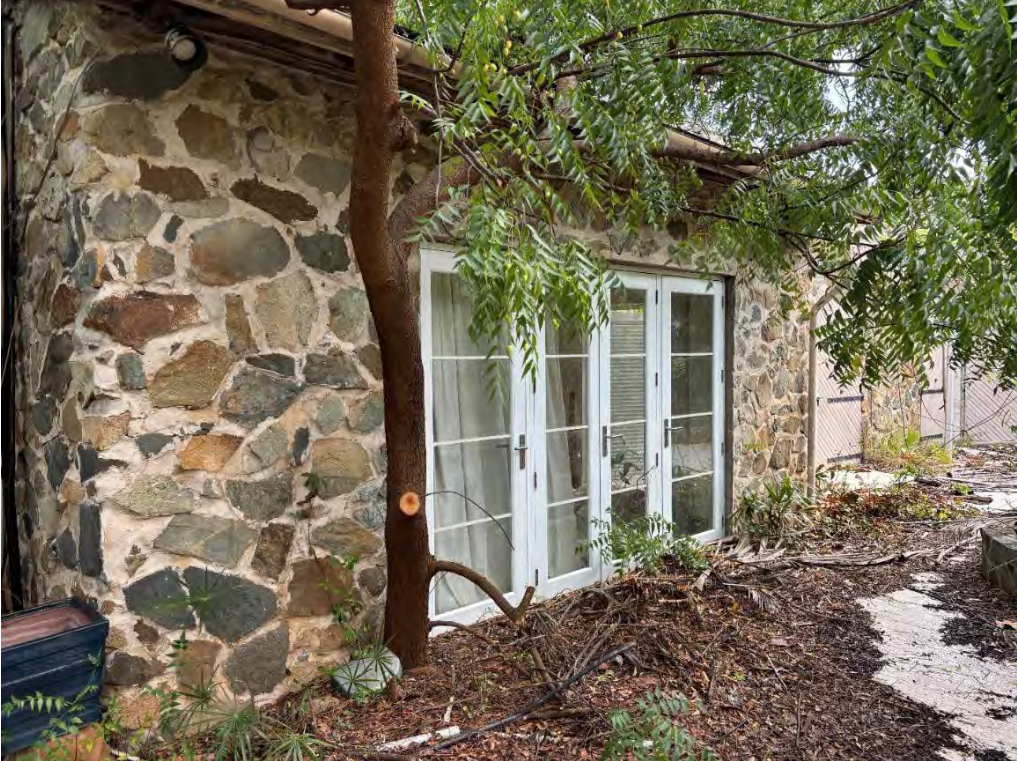
Building: 95 Turtle Bay Storage Shed (North)

Structural Assessment: Structurally Sound

Component	Material	Notes
Floor	Concrete	
Walls (Structural)	Concrete	Some moisture staining and cracking in skim coat on front concrete wall.
Walls (Non-Structural)	Concrete	Wood frame infill walls above concrete knee walls on right shed addition.
Roof	Wood framed/ Metal	
Sidewalk	Concrete

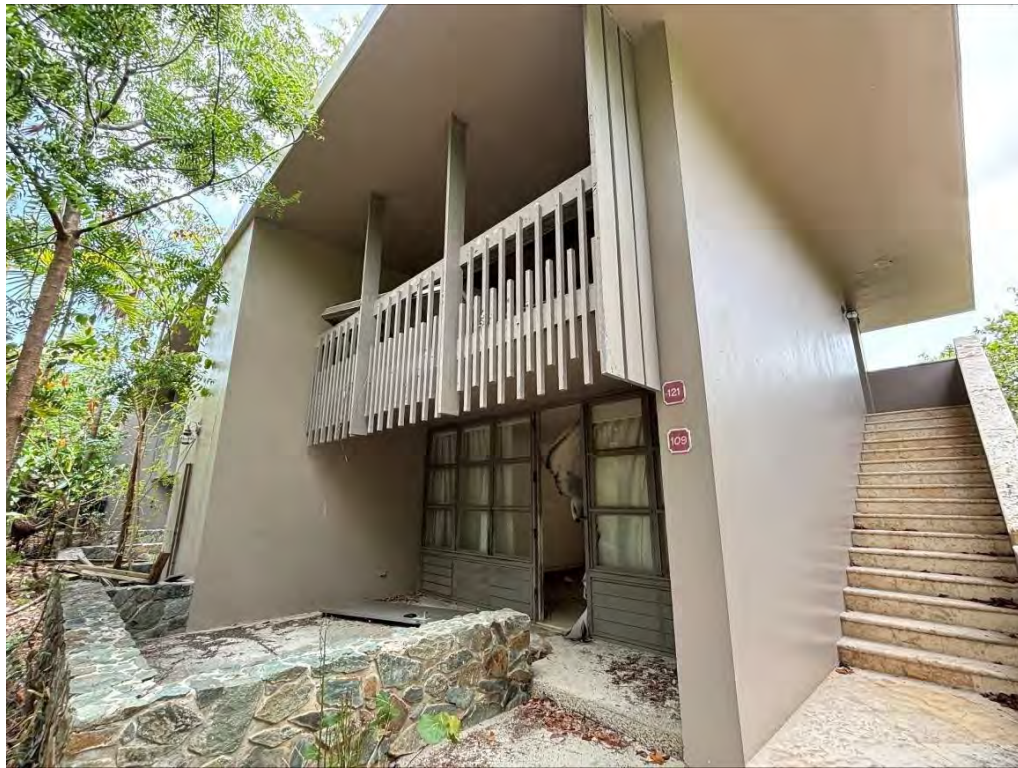
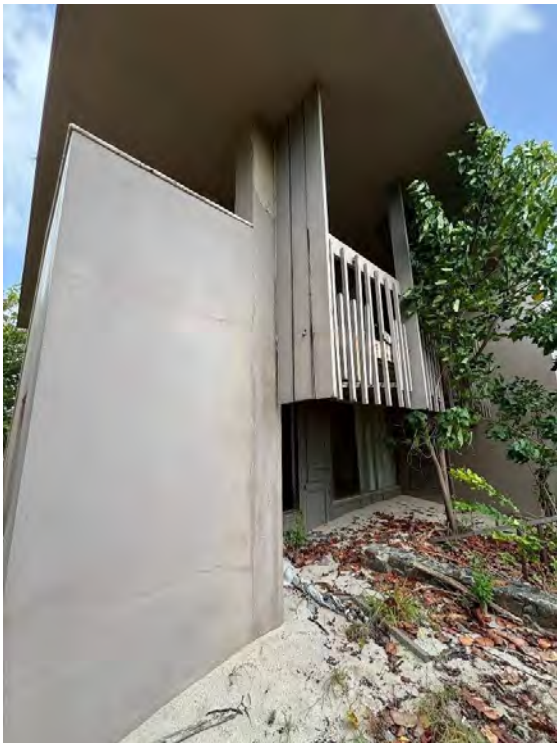
Building: 46 Hawksnest Beach Units 106-109, 118-121

Structural Assessment: Potentially Repair or Rebuild

Component	Material	Notes
Floor	Concrete	First floor has significant sand blown into the rooms.
Walls (Structural)	Concrete	Spalling on concrete columns with exposed rebar at east side between rooms 107 and 108. Vertical cracks at geometry changes typical east and west side of second floor rooms (118, 119, 120, 121).
Walls (Non-Structural)	Wood and Windows	Windows blown out (106 east, 107 west, 108 east, 109 east, 121 east). Walls collapsed (106 west, 107 east).
2nd Floor	Concrete	Spalling and exposed rebar at edge of concrete slab where railing attached (120 east & west, 121 east). Localized spalling at underside of slab throughout the building. At some locations rusted rebar is visible.
Roof	Concrete & Wood Framed / Membrane	Spalling on underside of slabs with exposed rebar in some locations. Localized spalling at underside of slab throughout the building. At some locations rusted rebar is visible.

Stairs/Railings	Concrete / Wood Railings	Railing connections to slabs have failed.
Sidewalk	Concrete

- Concrete walls and slabs, including underside of slabs, should be fully sounded to detect all areas of spalling and delamination.
- Remove existing railings and fully review edge of concrete slabs for damage.
- Repairs may consist of replacing damaged rebar with new rebar, cleaning and coating rebar with zinc rich paint, and repairing concrete.

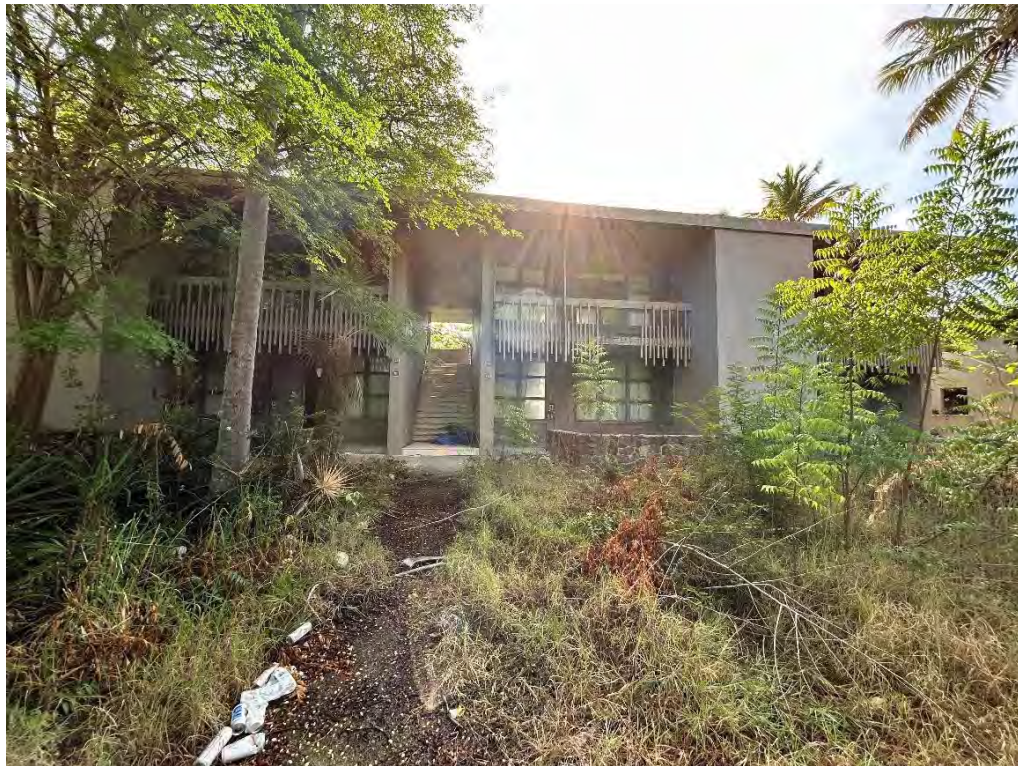
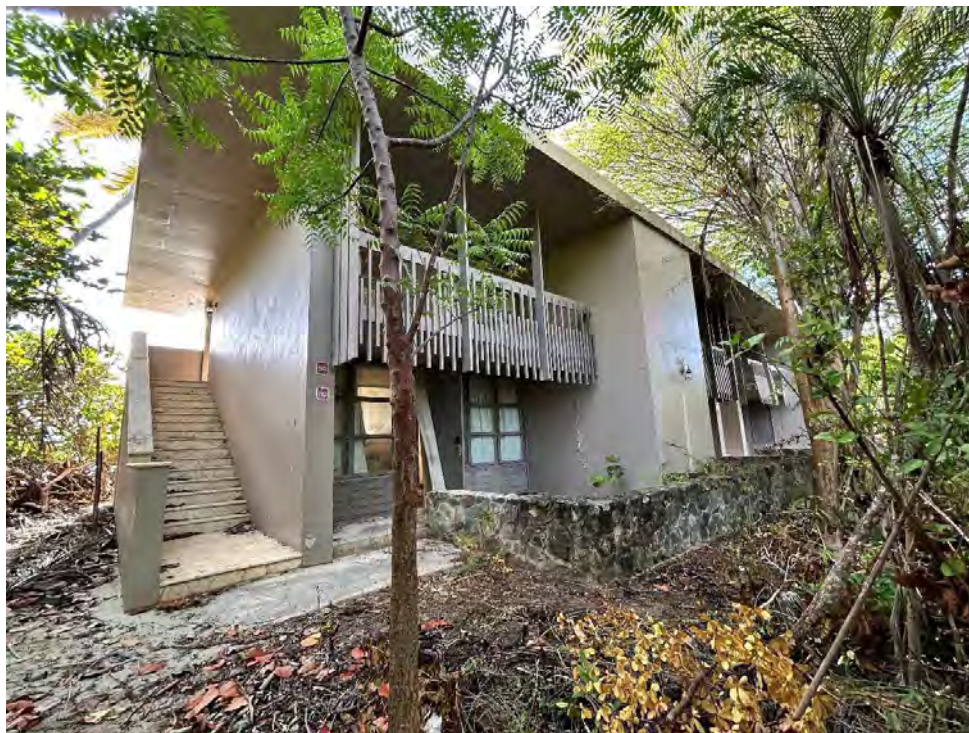
Building: 47 Hawksnest Beach Units 110-113, 122-125

Structural Assessment: Potentially Repair or Rebuild

Component	Material	Notes
Floor	Concrete	First floor has significant sand blown into the rooms.
Walls (Structural)	Concrete	Spalling on concrete columns with exposed rebar at east side between room 111 and the stairwell. Vertical cracks at geometry changes typical east and west side of second floor rooms (122, 123, 124, 125). Hairline crack in wall at second floor slab elevation between room 125 and stairwell wall. Spalled concrete noted at base of all stairwells.
Walls (Non-Structural)	Wood and Windows	Windows blown out (112 east, 113 east, 123 east). Walls collapsed (110 east).
2nd Floor	Concrete	Spalling and exposed rebar at edge of concrete slab where railing attached (122 east, 123 east, 124 east). Localized spalling at underside of slab throughout the building. At some locations rusted rebar is visible.
Roof	Concrete & Wood Framed / Membrane	Spalling on underside of slabs with exposed rebar in some locations. Localized spalling at underside of slab throughout the building. At some locations rusted rebar is visible.

Component	Material	Notes
Stairs/Railings	Concrete / Wood Railings	Railing connections to slabs have failed, predominantly on beach side. Stair walls have vertical crack at geometry change.
Sidewalk	Concrete

- Concrete walls and slabs, including underside of slabs, should be fully sounded to detect all areas of spalling and delamination.
- Remove existing railings and fully review edge of concrete slabs for damage.
- Repairs may consist of replacing damaged rebar with new rebar, cleaning and coating rebar with zinc rich paint, and repairing concrete.

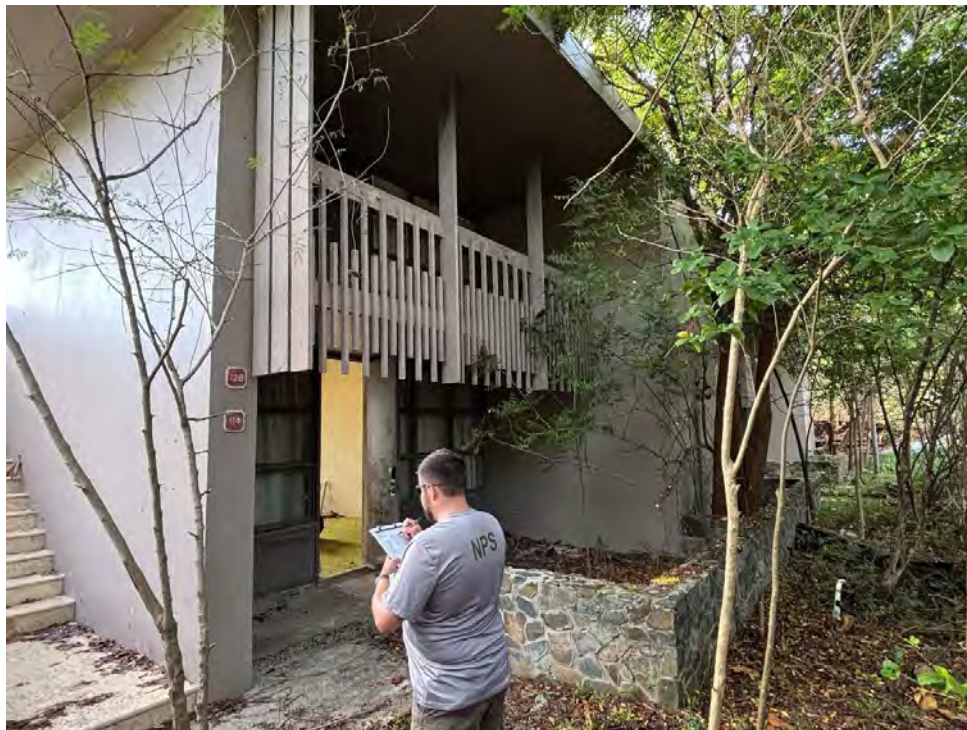
Building: 48 Hawksnest Beach Units 114-117, 126-129

Structural Assessment: Potentially Repair or Rebuild

Component	Material	Notes
Floor	Concrete	First floor has significant sand blown into the rooms.
Walls (Structural)	Concrete	Spalling on concrete columns with exposed rebar at east side between rooms 127 and 128. Vertical cracks at geometry changes typical east and west side of concrete balconies.
Walls (Non-Structural)	Wood and Windows	Windows blown out (114 east, 126 east, 127 east, 128 east). Walls collapsed (117 east).
2nd Floor	Concrete	Spalling and exposed rebar at edge of concrete slab where railing attached (126 east, 127 east, 128 east, 129 east). Localized spalling at underside of slab throughout the building. At some locations rusted rebar is visible.
Roof	Concrete & Wood Framed / Membrane	Spalling on underside of slabs with exposed rebar in some locations. Significant spalling at top of middle stairs to second floor, between units 127 and 128.
Stairs/Railings	Concrete / Wood Railings	Railing connections to slabs have failed.

- Concrete walls and slabs, including underside of slabs, should be fully sounded to detect all areas of spalling and delamination.
- Remove existing railings and fully review edge of concrete slabs for damage.
- Repairs may consist of replacing damaged rebar with new rebar, cleaning and coating rebar with zinc rich paint, and repairing concrete.

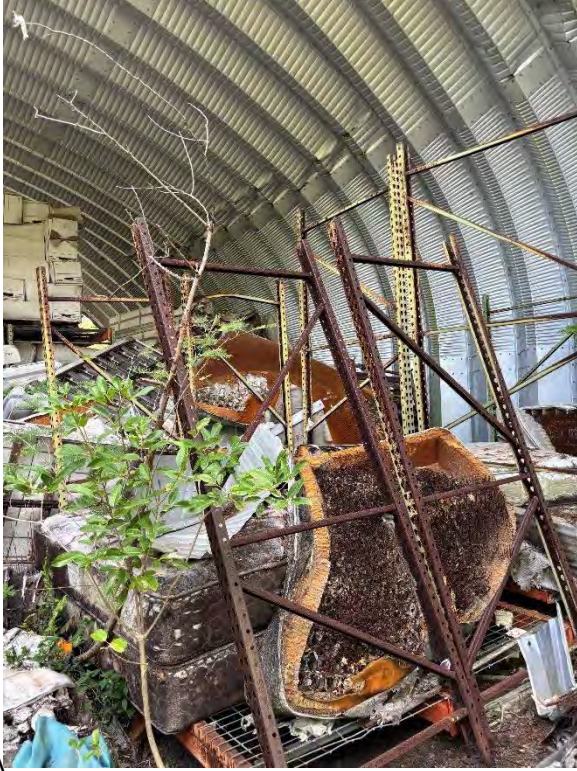
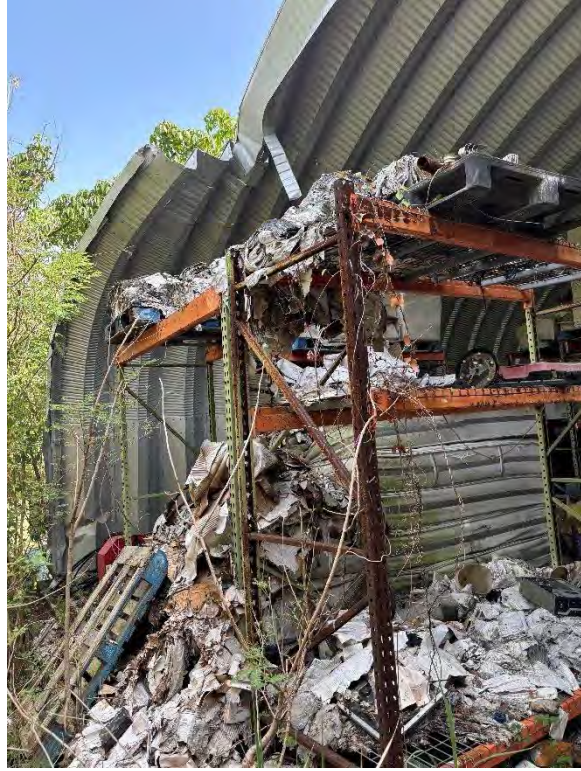
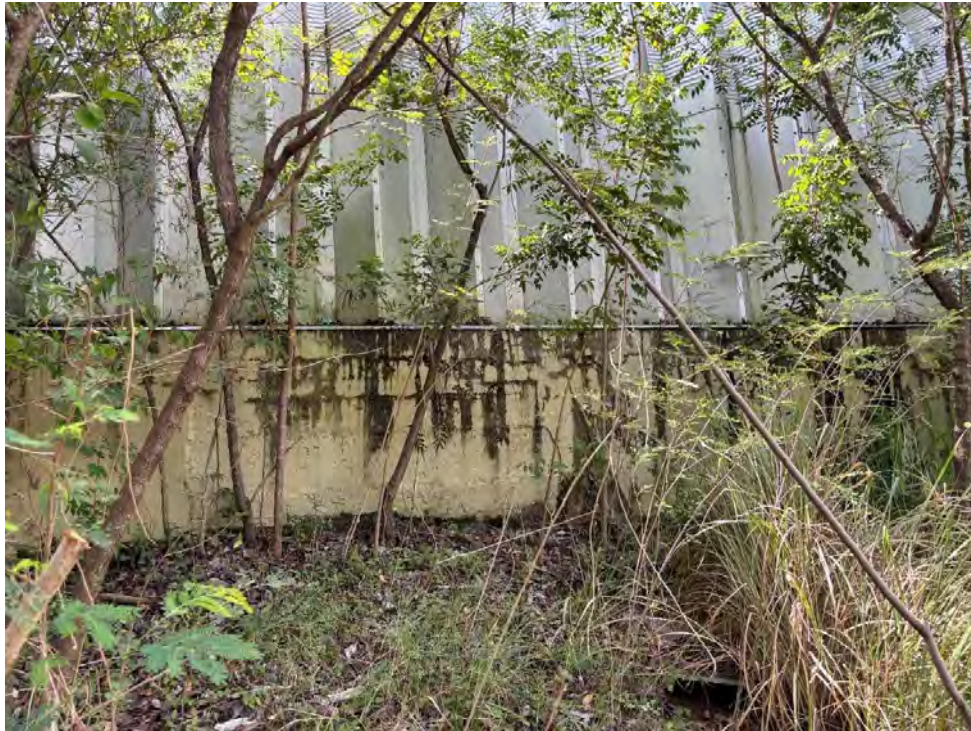
Building: 11 Laundry

Structural Assessment: Potentially Repair or Rebuild

Component	Material	Notes
Floor	Concrete	
Walls (Structural)	Steel	Corroded bracing and metal framing members.
Roof	Steel Framed / Metal Roof	Vegetation on roof.
Stand Alone Bathroom	Concrete	No roof.

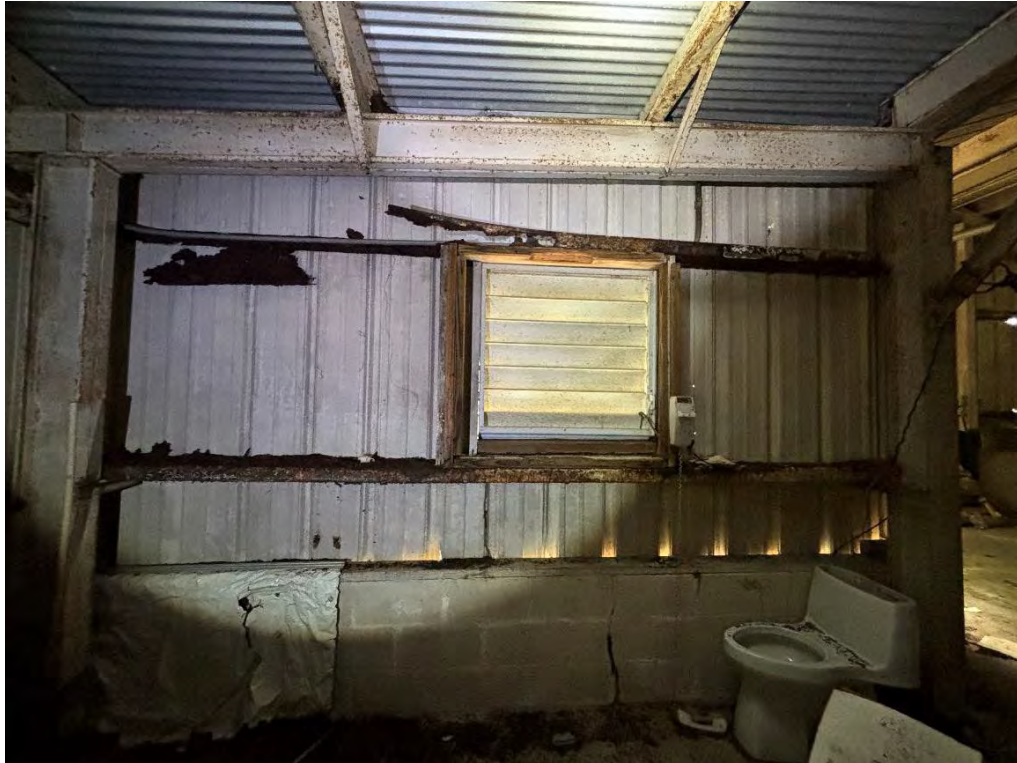
Building: 12 Ice Plant

Structural Assessment: Structurally Unsound

Component	Material	Notes
Floor	Concrete	
Walls (Structural)	Masonry (CMU)	Collapsed.
Walls (Non-Structural)	N/A	
Roof	Unknown	Collapsed.
Stairs/Railings	Concrete	
Sidewalk	Concrete

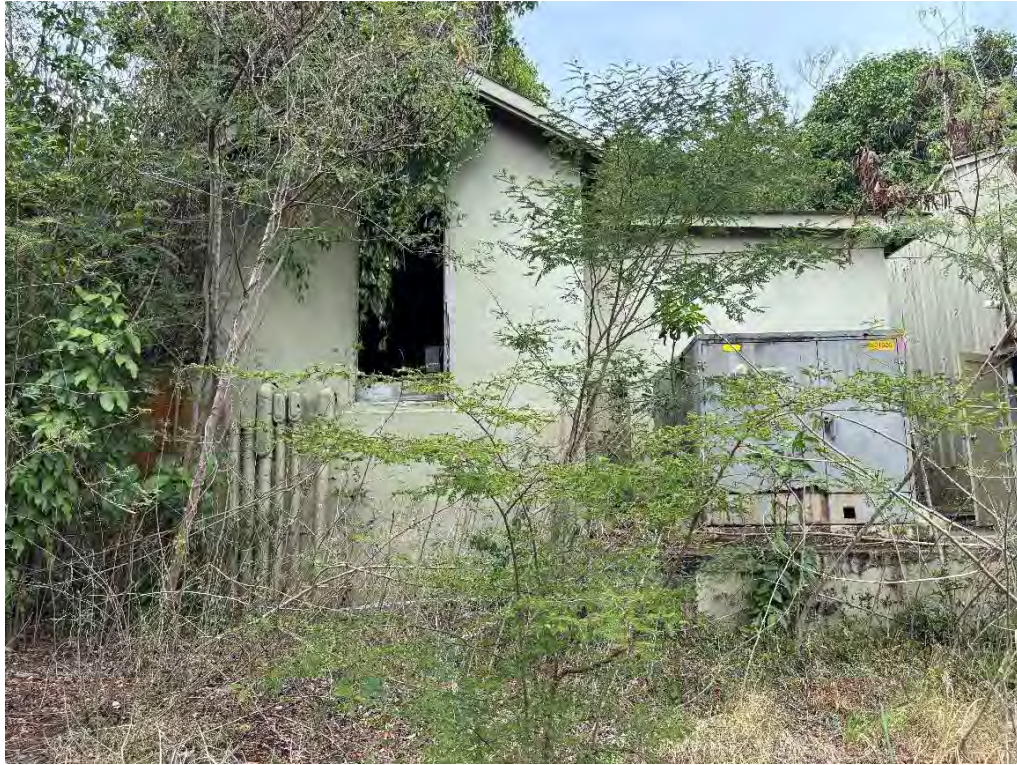
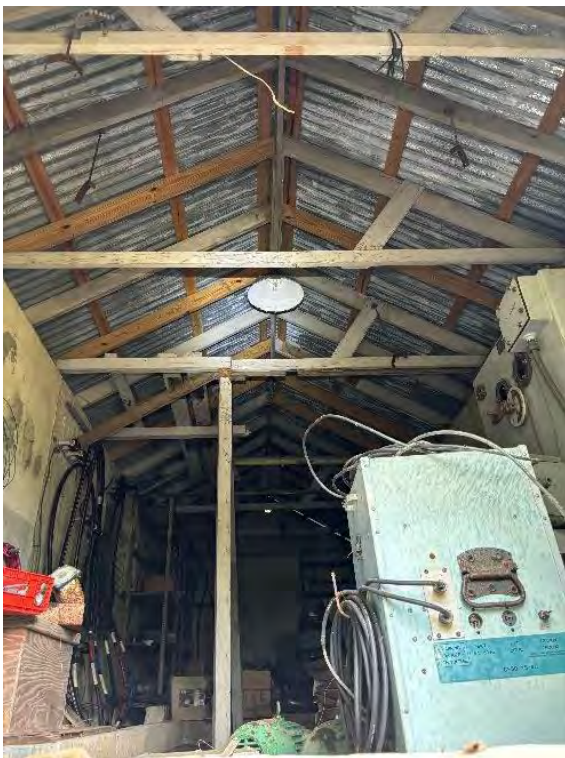
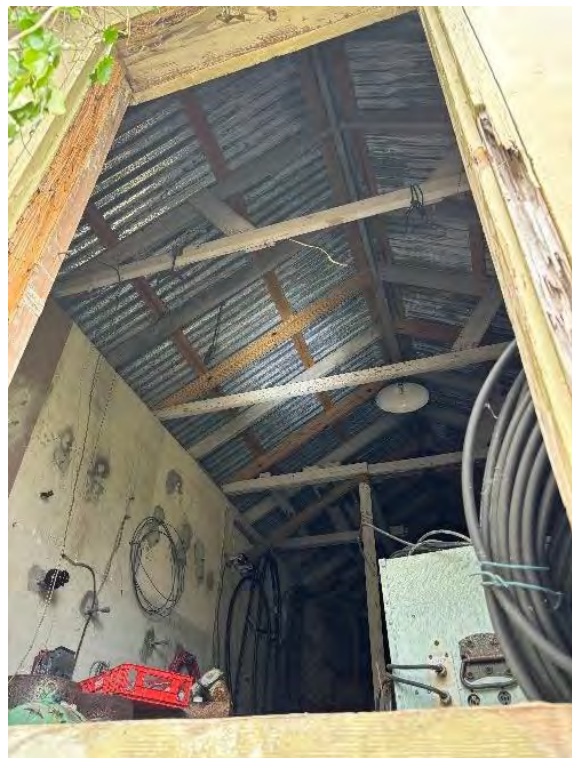
Building: 13A Electrical Complex

Structural Assessment: Structurally Sound

Component	Material	Notes
Floor	Concrete	
Walls (Structural)	Concrete	No cracks were noted from the outside.
Roof	Wood Framed / Metal Roof	Vegetation on roof. Unable to gain access to inspect roof from the interior.
