Building: 13B Generator Building

Structural Assessment: Potentially

National Park Service
Virgin Islands National Park | Caneel Bay
Structural Assessment Report

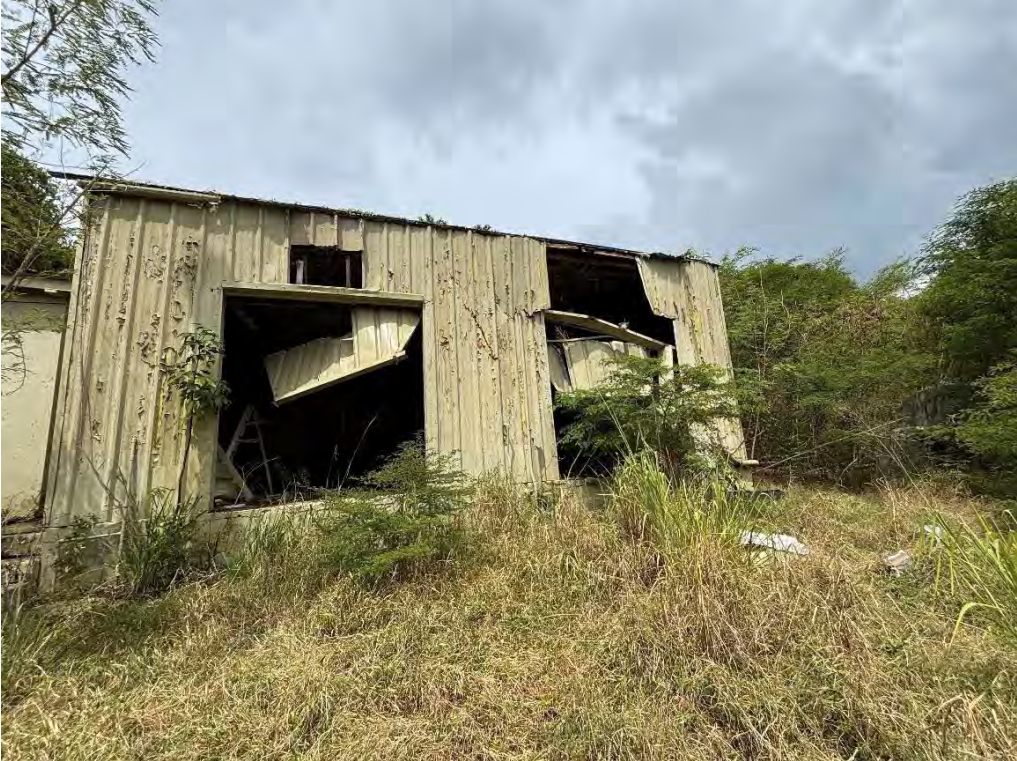
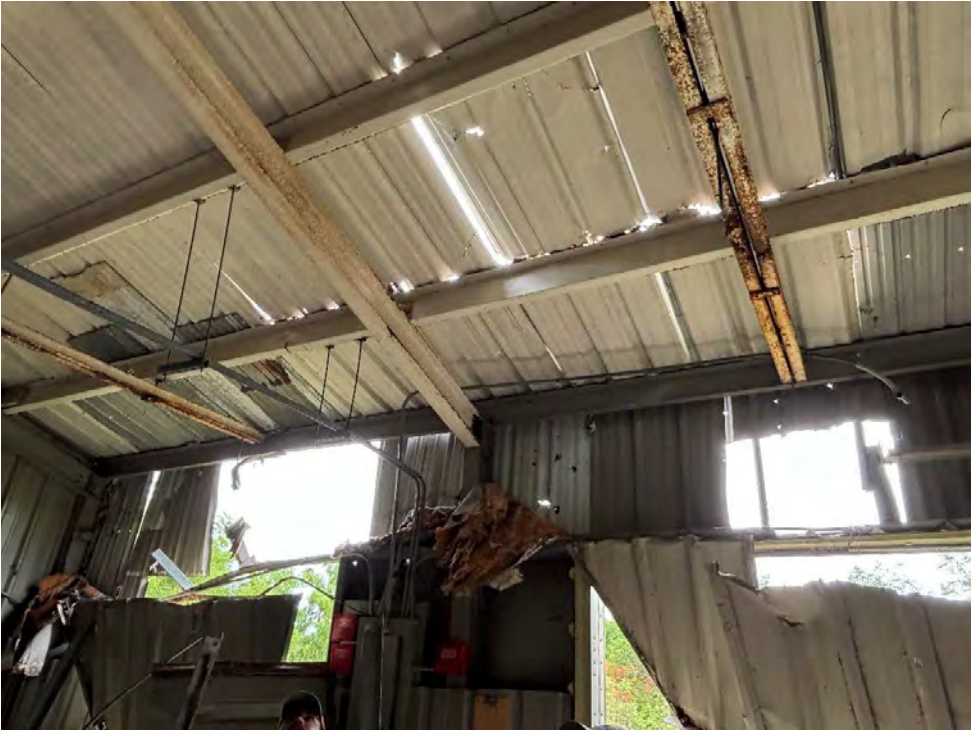
Component	Material	Notes
Floor	Concrete	Slab contains in slab conduit, trenches, and equipment pads. Concrete slab has been heavily modified in the past.
Walls (Structural)	Steel	Two bay, steel framed structural building. Severe corrosion of structural members (noticeable section loss) and base plates, especially at building columns.
Roof	Steel Framed / Metal Roof	Main roof members appeared in acceptable condition. Secondary steel members showed signs of localized corrosion.

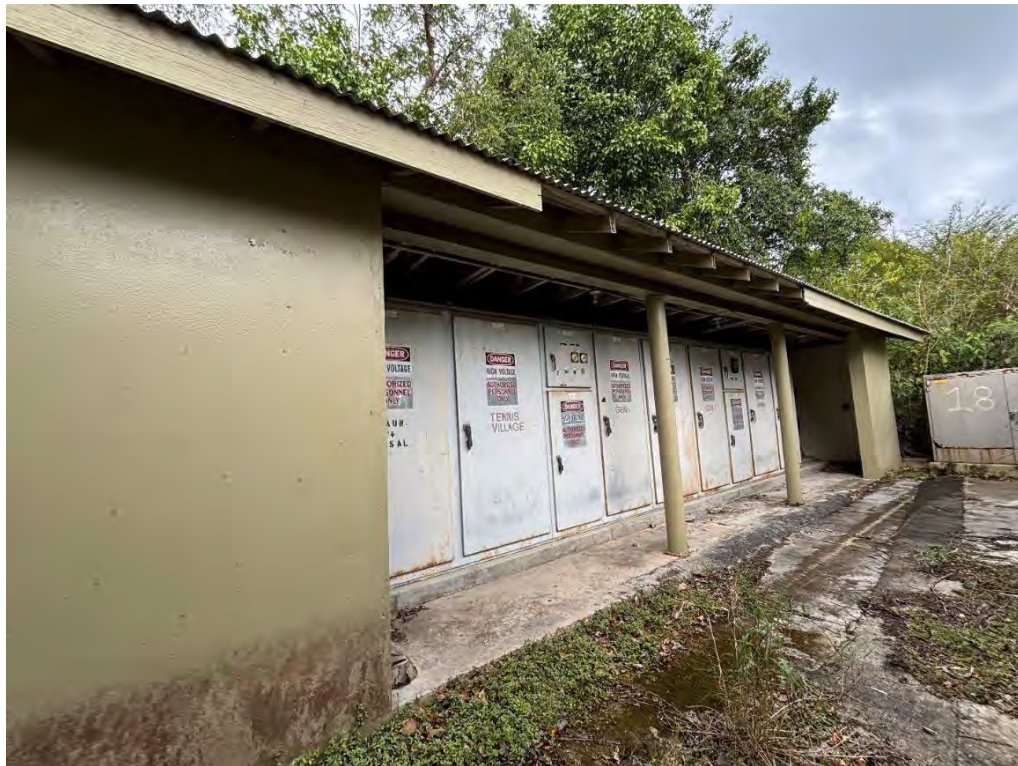
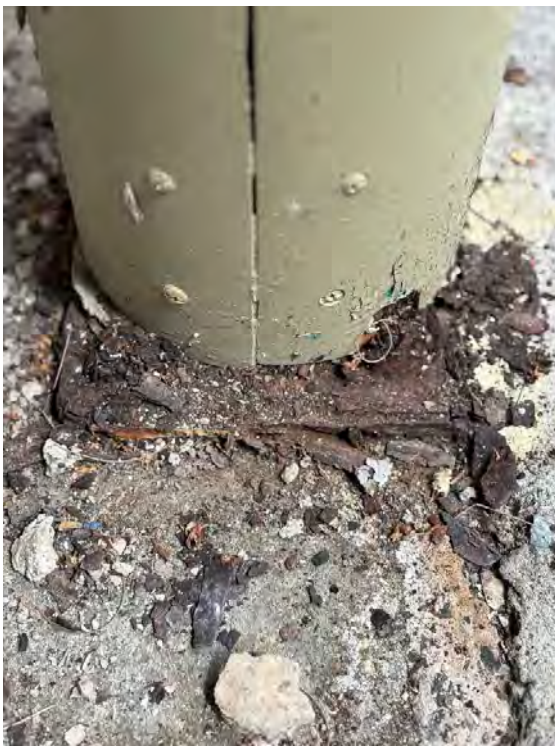
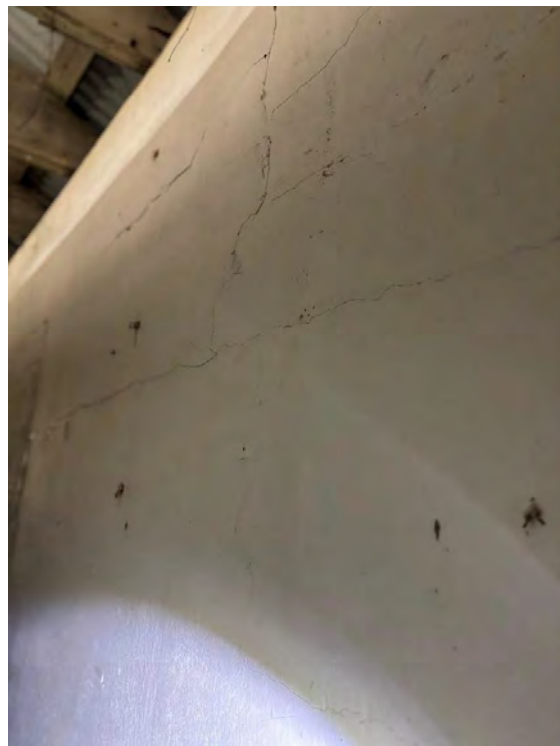
Building: 13C Electrical Distribution

Component	Material	Notes
Floor	Concrete	
Walls (Structural)	Concrete on 3 Sides / Steel Columns and Beams 1 Side	Base of steel columns corroded. Minor concrete cracking on rear wall.
Roof	Wood Framed / Metal Roof	End of one wood truss deteriorated.

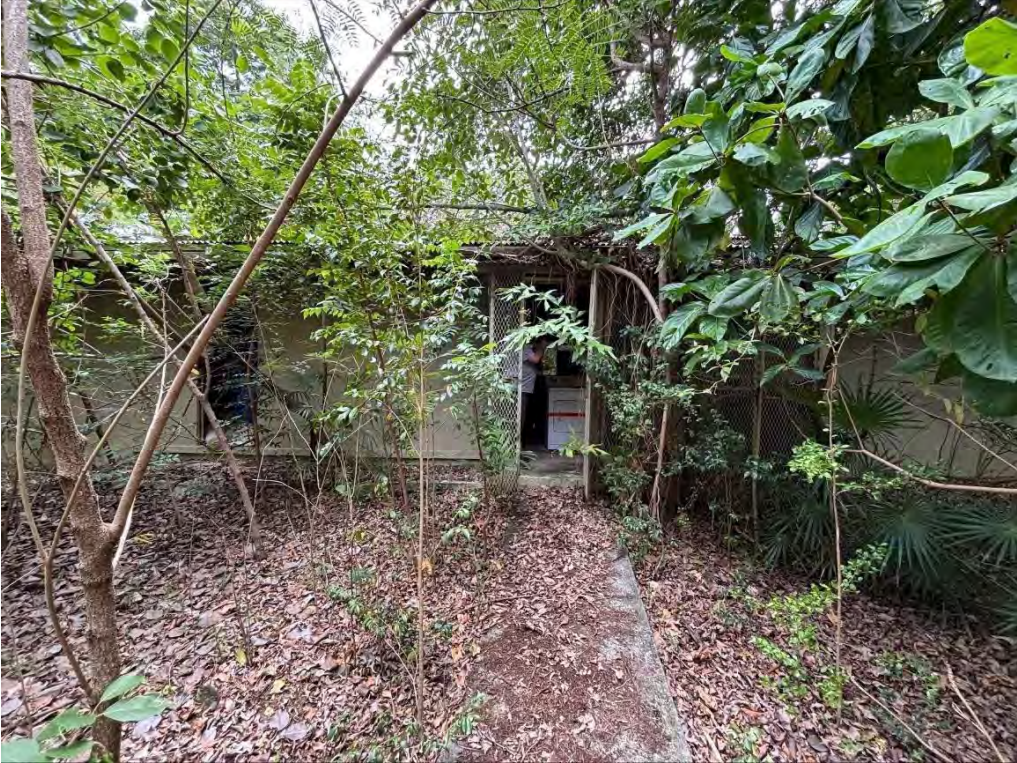
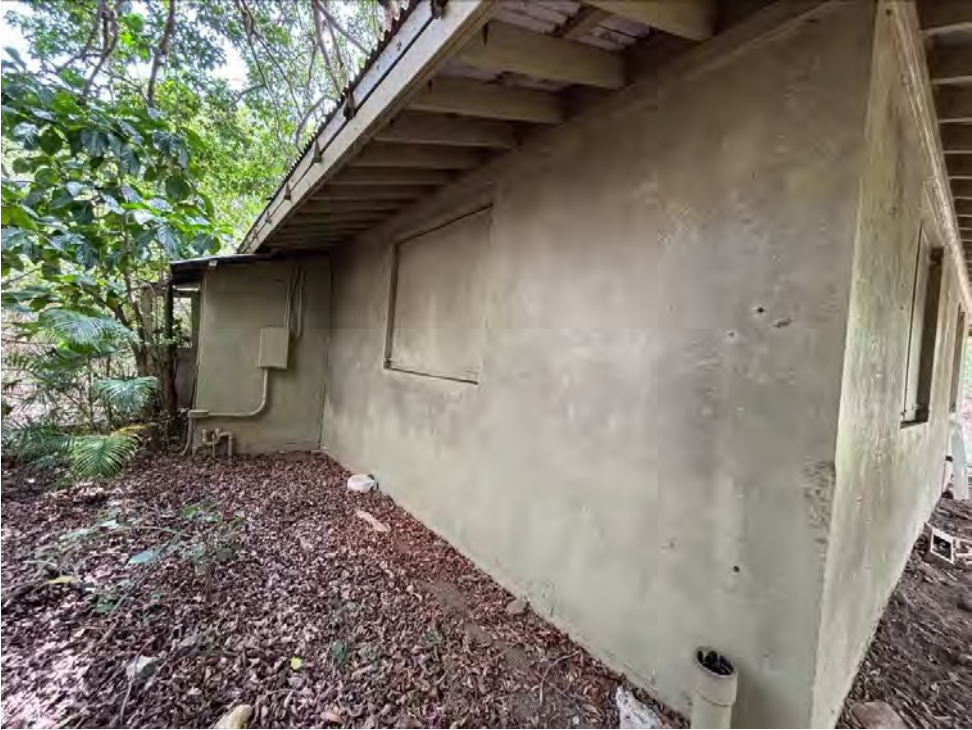
Building: 15 Uniform and Room Service

Component	Material	Notes
Floor	Concrete	
Walls (Structural)	Concrete	Minor concrete cracking above windows on north side.
Walls (Non-Structural)	Wood	
Roof	Wood framed / metal deck	
Stairs/Railings	N/A	
Sidewalk	Concrete

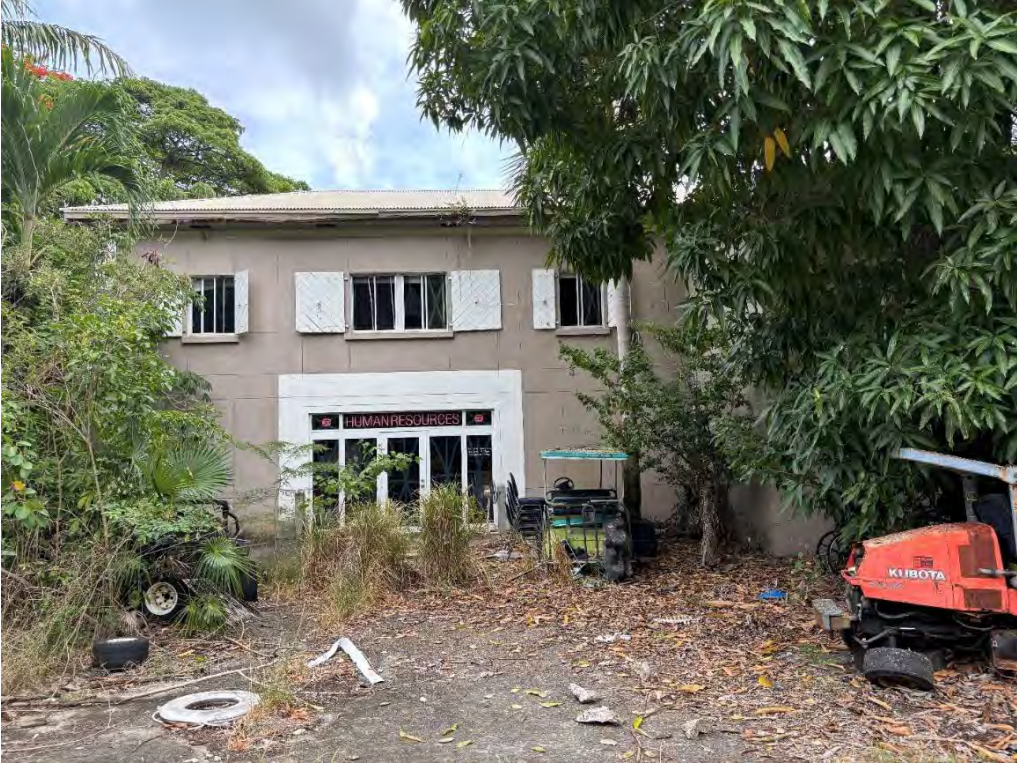
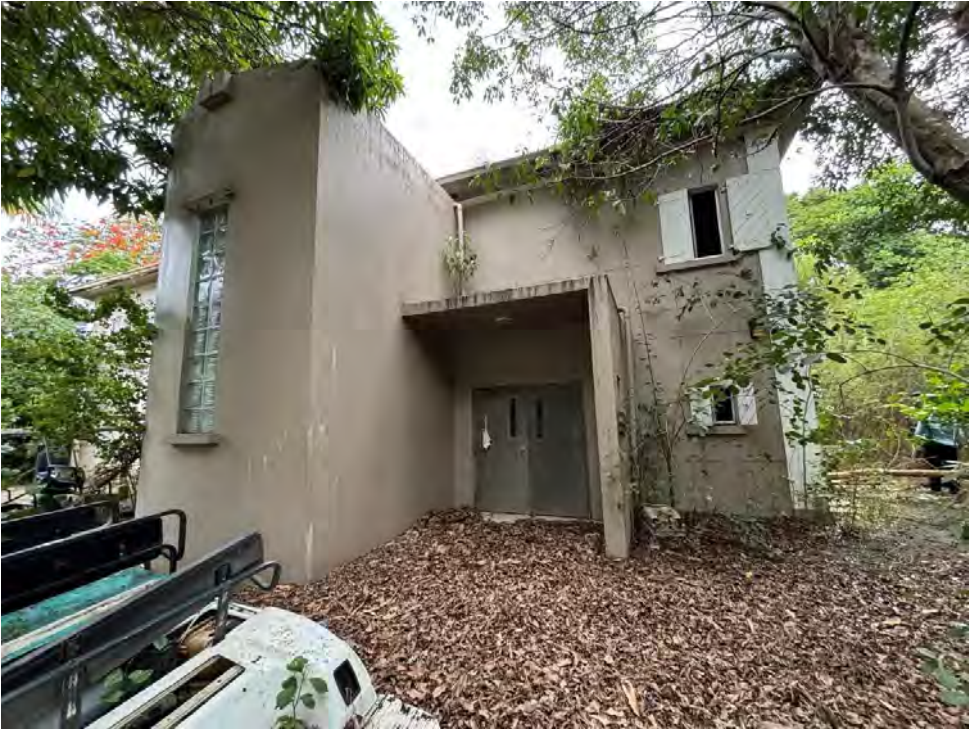
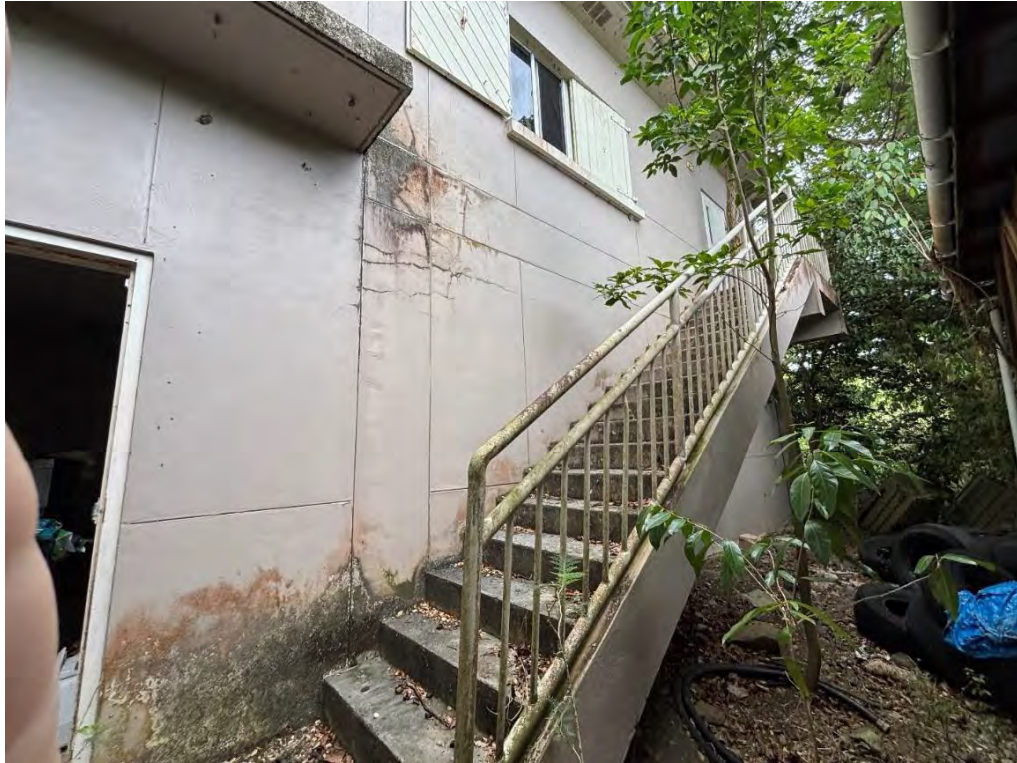
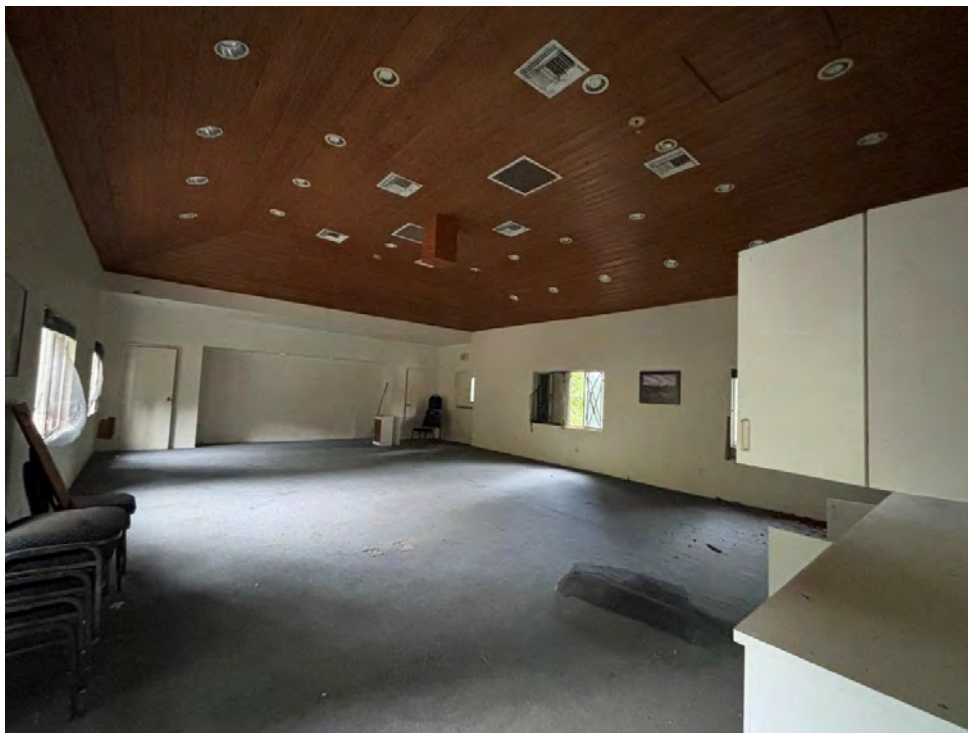
Building: 16 Housekeeping Building (Human Resources 2)

Component	Material	Notes
Floor	Concrete	
Walls (Structural)	Concrete	Minor concrete cracking.
Walls (Non-Structural)	Concrete	Minor termite tubes observed.
Roof	Unknown w/ Metal Deck	Roof is sloped. Unable to verify construction. Vegetation on roof. Low concrete roof over exterior entrance has standing water.
Stairs/Railings	Concrete / Aluminum Rail	
Elevator		Elevator not inspected.

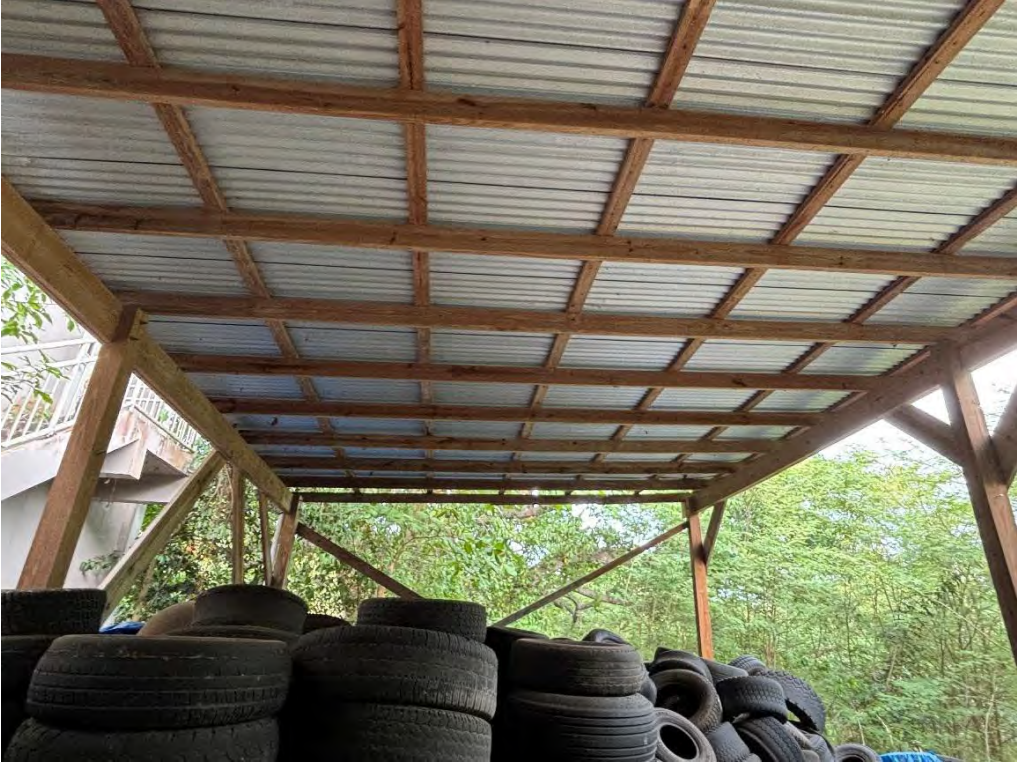
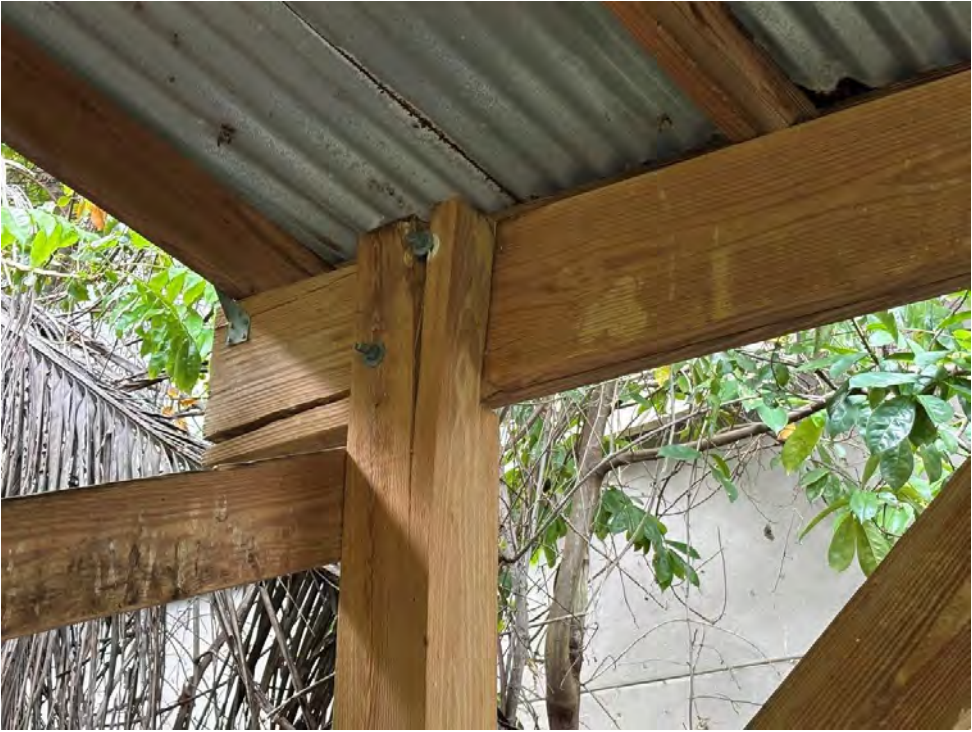
Building: Housekeeping HR2 Pole Barn

Component	Material	Notes
Floor	Dirt	
Framing	Wood	Wood framed pole barn. Bolted connections at top of 4 of the 6 posts failed. Top bolt split the post and bottom bolt split the rafter tail.
Roof	Wood Framed / Metal Roof

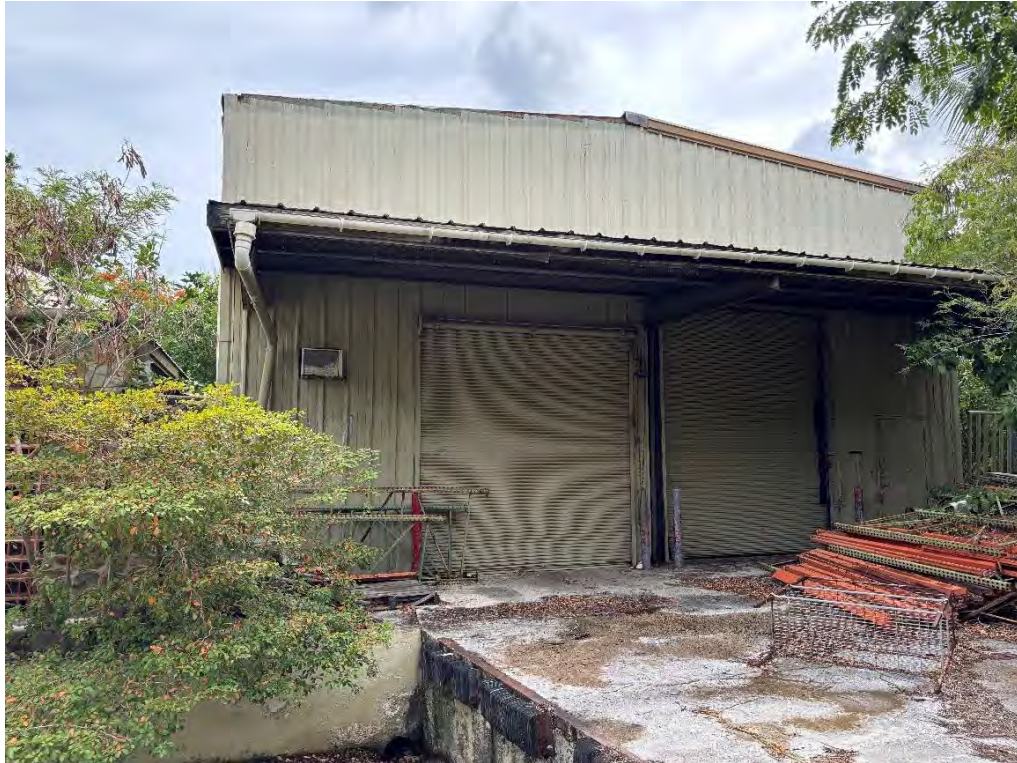
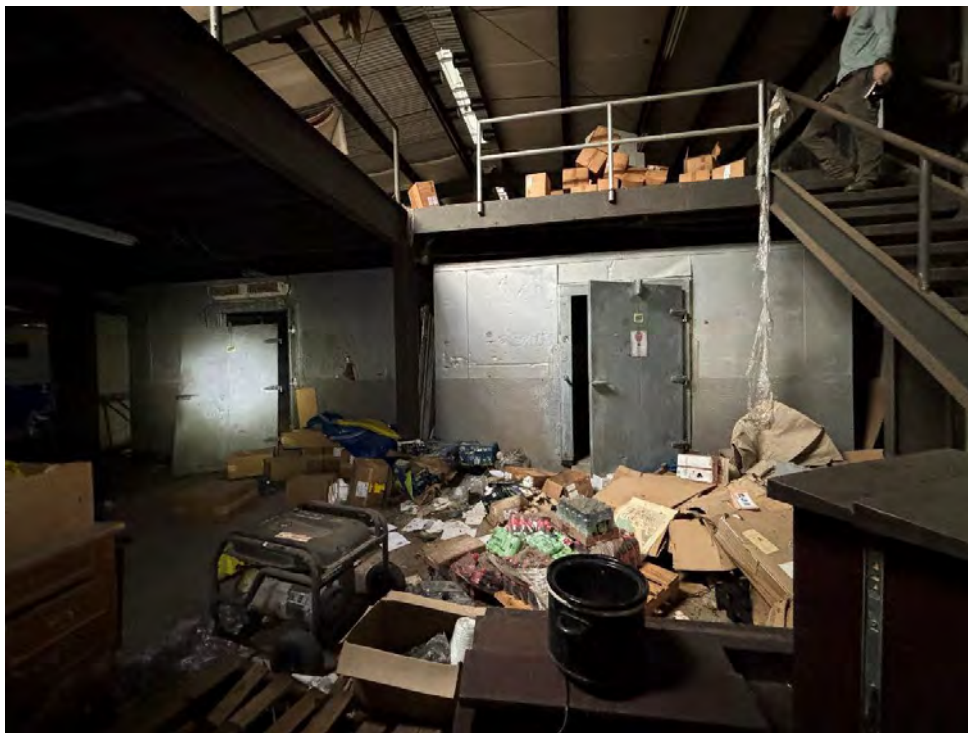
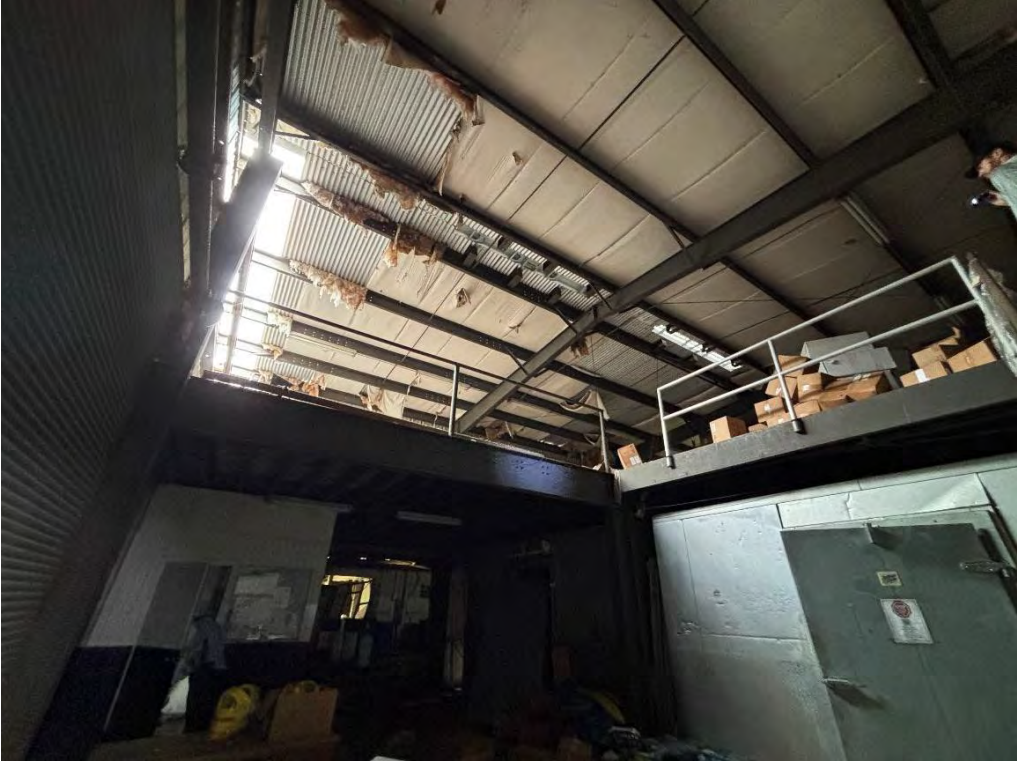
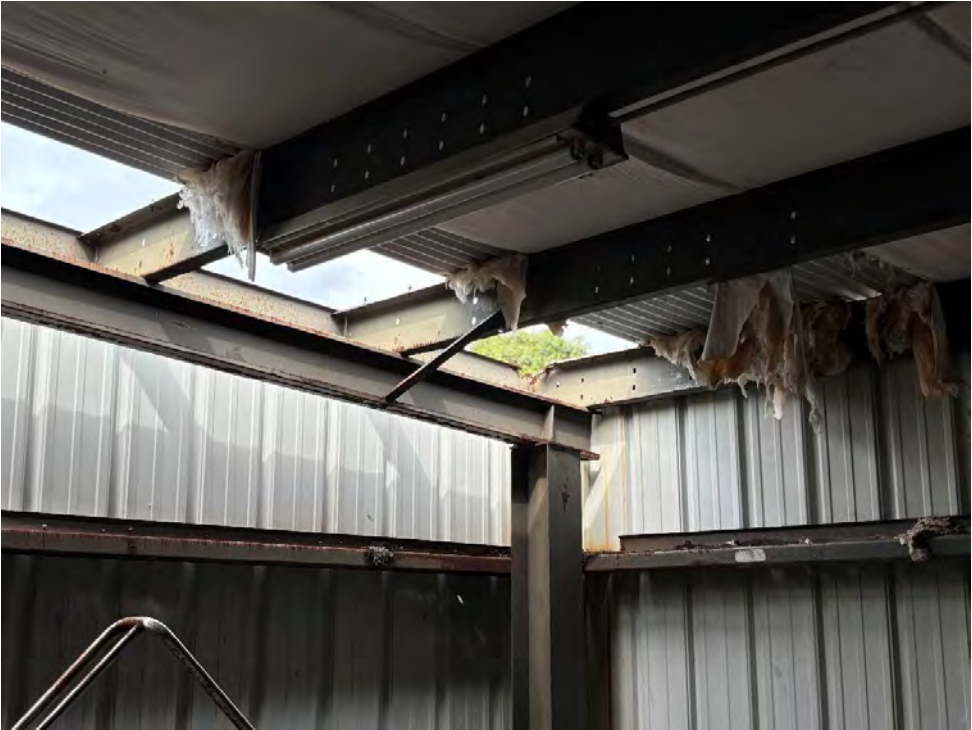
Building: 17E Central Storage

Component	Material	Notes
Floor	Concrete SOG / Steel Framed with Concrete Slab	
Structure	Steel Framed	Minor exterior cladding missing.
Roof	Steel Framed / Metal Deck	Minor roof deck missing exposing steel frame to elements. Exterior tie-rod at overhang damaged.
Stairs/Railings	Steel

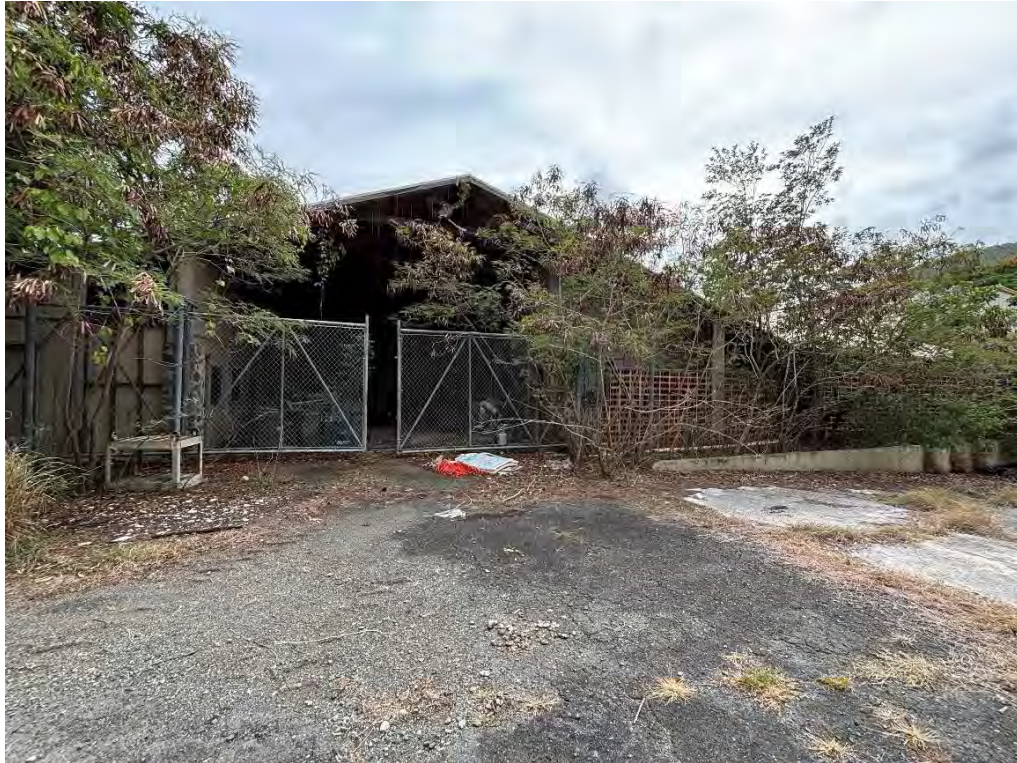
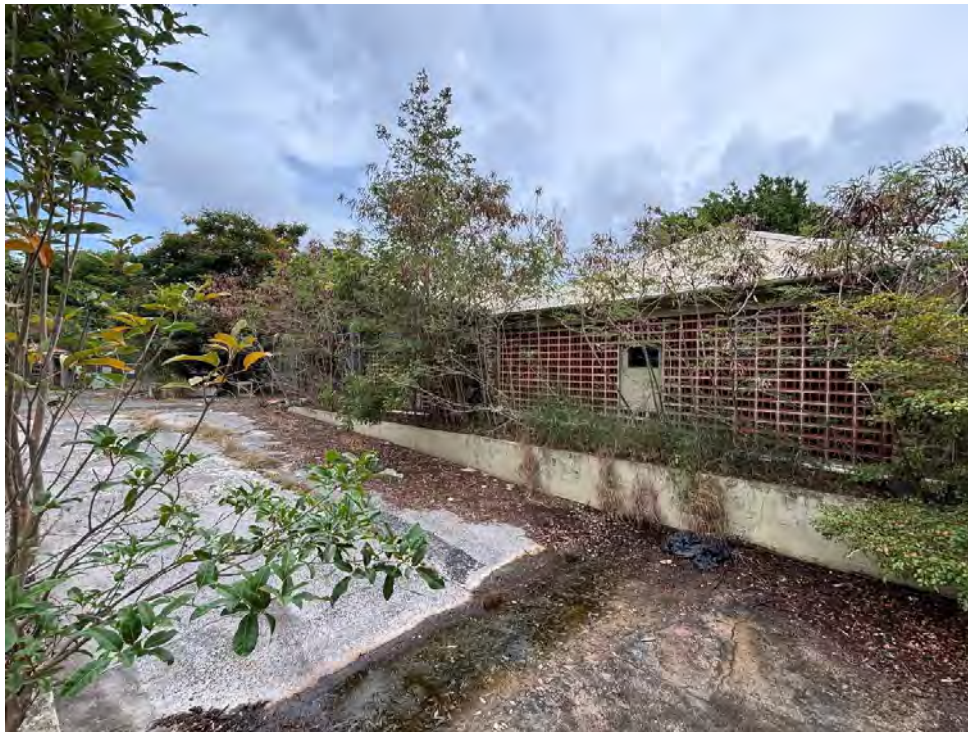
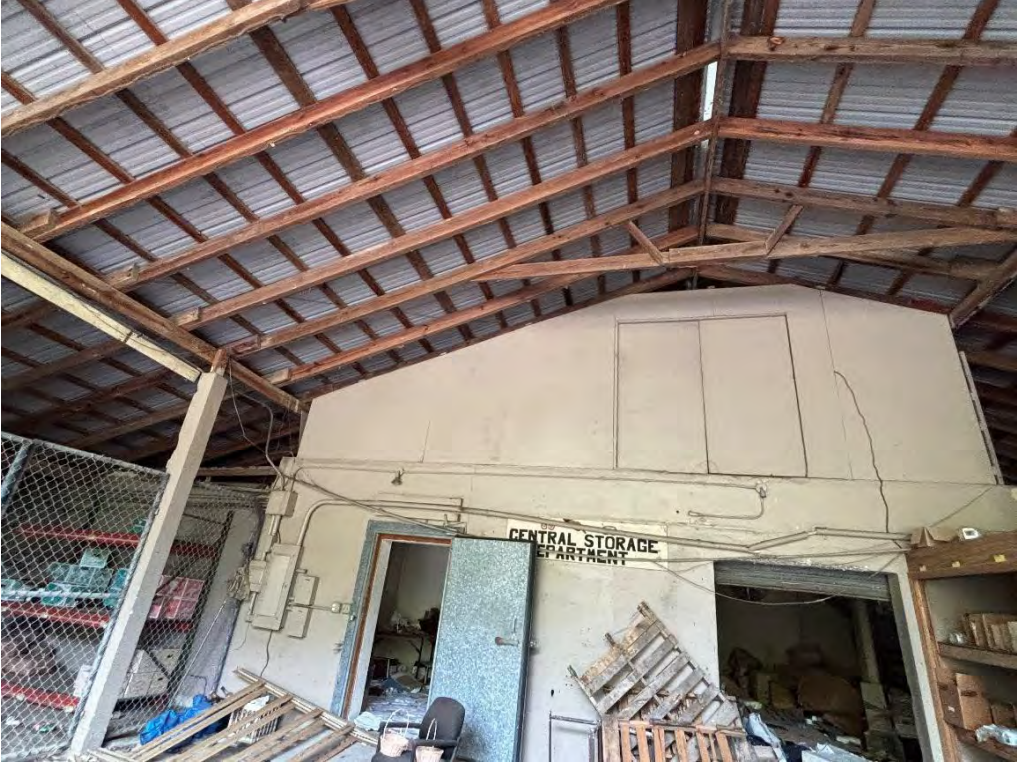
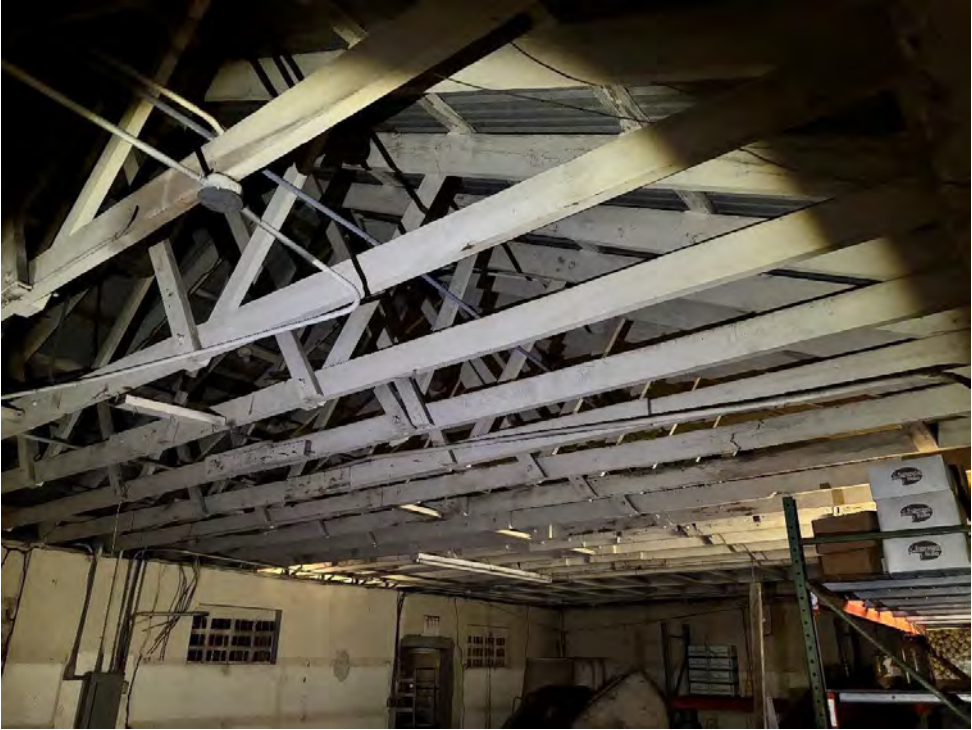
Building: 17W Central Storage

Component	Material	Notes
Floor	Concrete SOG / Wood Framed with Wood Deck	
Walls (Structural)	Stone / Interior Concrete Columns with Wood Posts	Impact damage to concrete column base with exposed, rusted rebar.
Walls (Non-Structural)	Wood / Masonry	
Roof	Wood / Metal Deck	Isolated wood beam and truss member failures. Significant termite activity. Some displaced cladding allowing moisture intrusion.
Stairs/Railings	Wood	Support posts appear to have shifted.

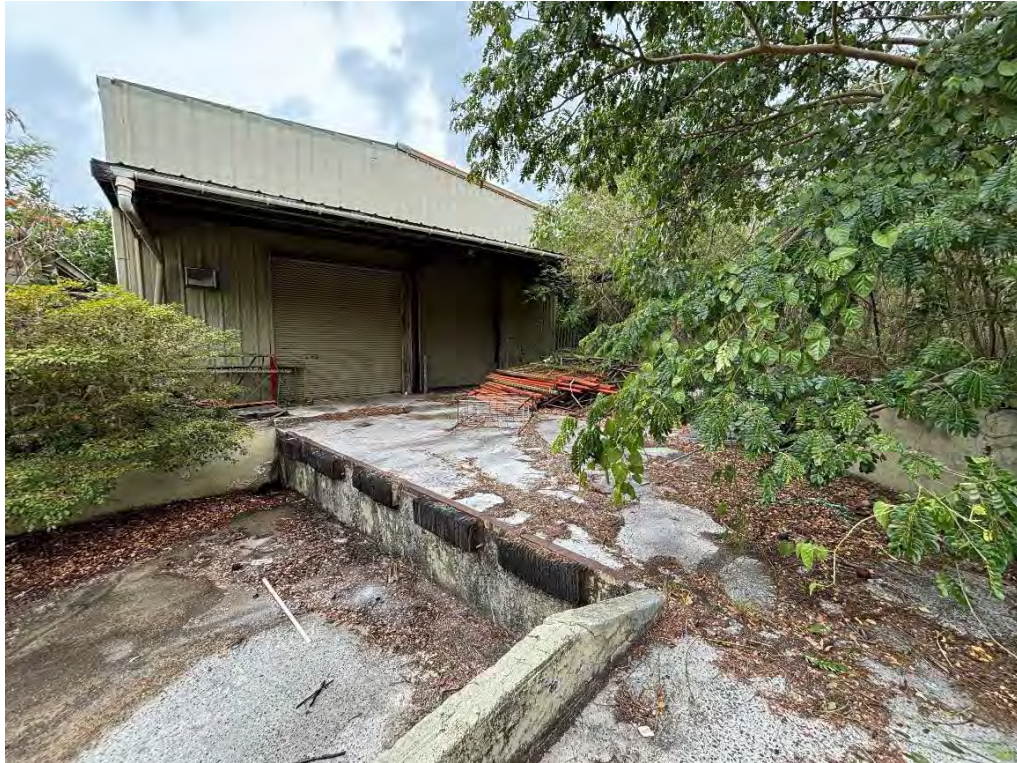
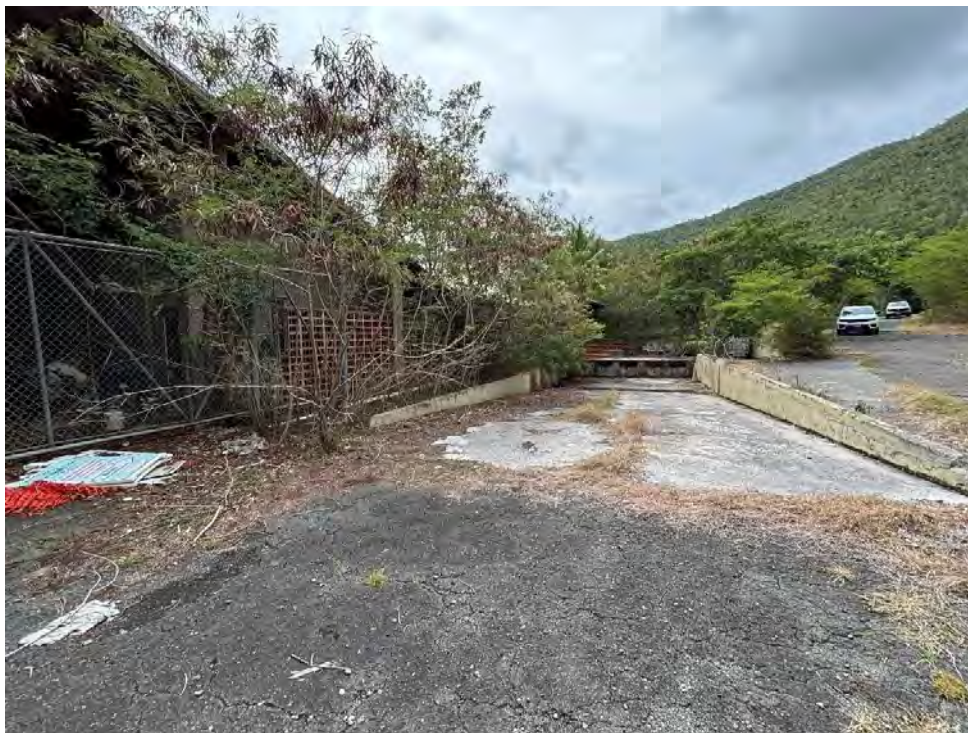
Building: 97 Loading Dock

Component	Material	Notes
Floor	Concrete	Concrete slab on grade at ramp and sidewalk around ramp.
Walls (Structural)	Concrete Retaining Walls	Concrete retaining walls around ramp are in relatively good condition with minor damage at top of wall curb. Retaining wall to sidewalk has vertical crack at curve.

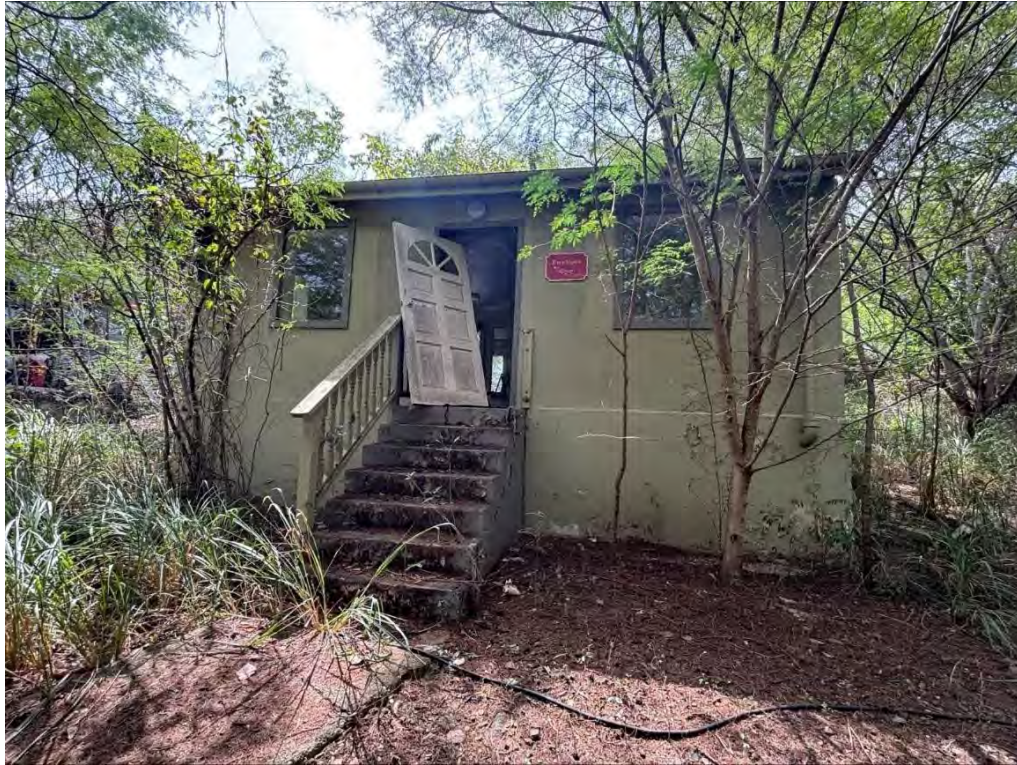
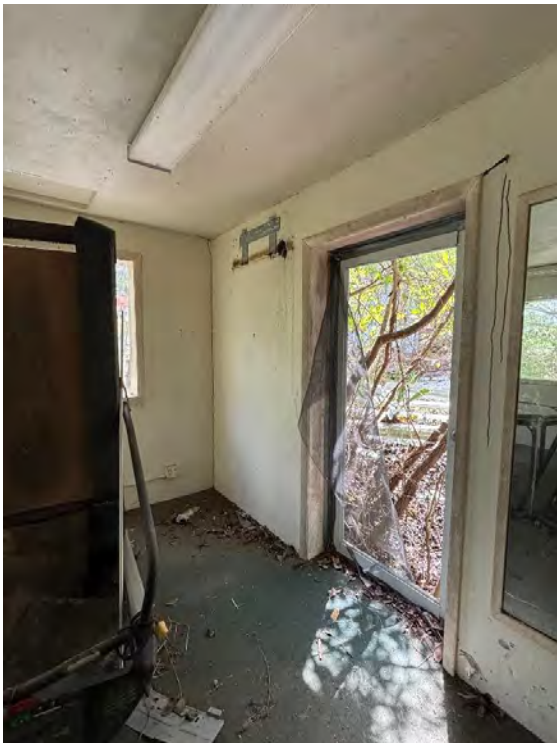
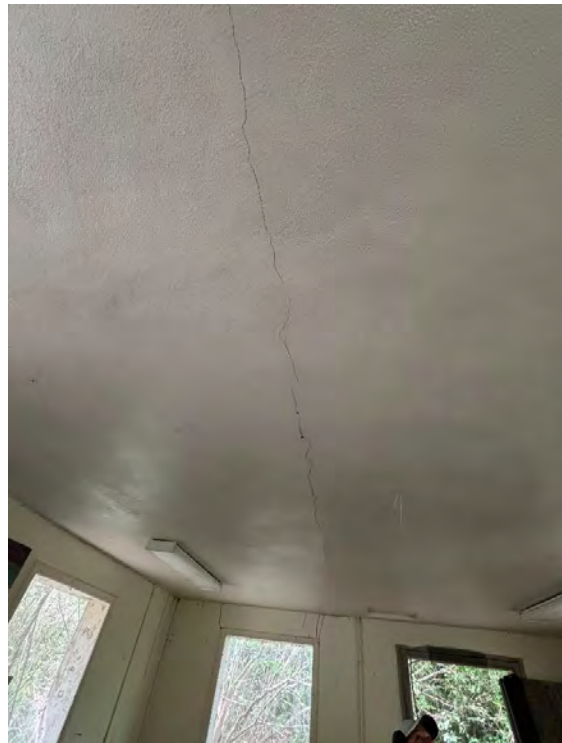
Building: 60 Employee Gym

Component	Material	Notes
Floor	Concrete	
Walls (Structural)	Concrete	Minor, hairline cracks observed on two faces on exterior concrete walls. Termite tubes observed.
Walls (Non-Structural)	N/A	
Roof	Wood framed / metal deck	Crack in interior ceiling plaster.
Stairs/Railings	Concrete / Wood	Right railing on stairs missing.
Sidewalk	Concrete

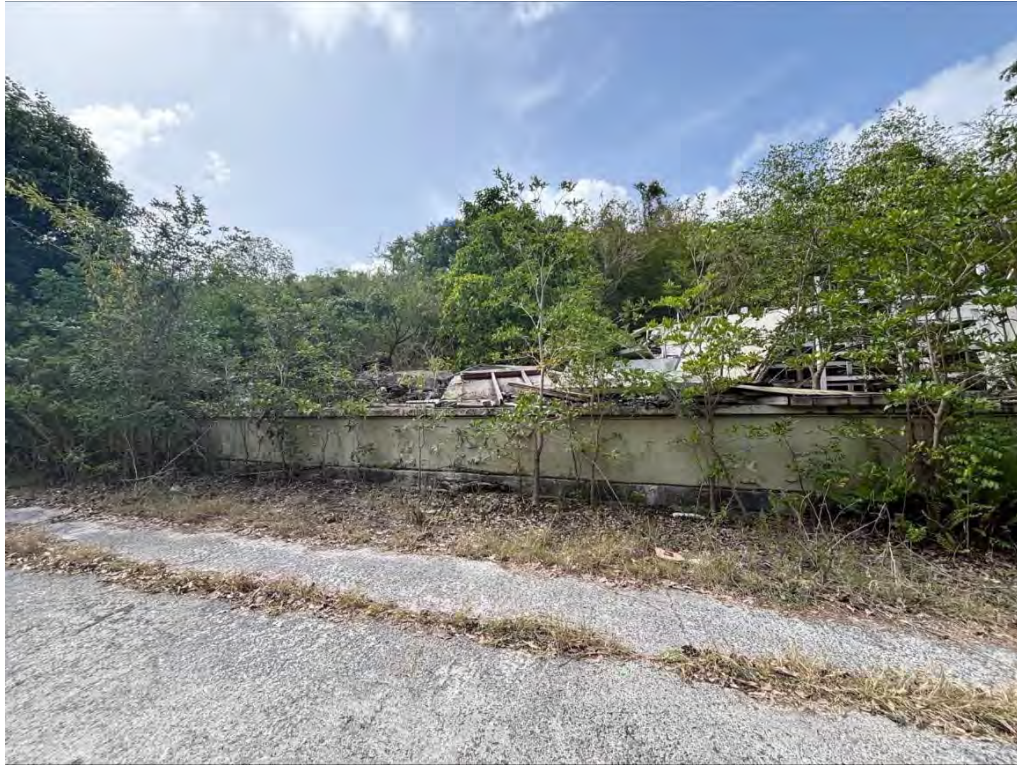
Building: 77 Gift Shop Warehouse

Component	Material	Notes
Floor	Concrete	
Walls (Structural)	Wood Framed	Building collapsed, walls not standing.
Walls (Non-Structural)	N/A	
Roof	Unknown	Roof collapsed.
Stairs/Railings	Concrete	
Sidewalk	Concrete

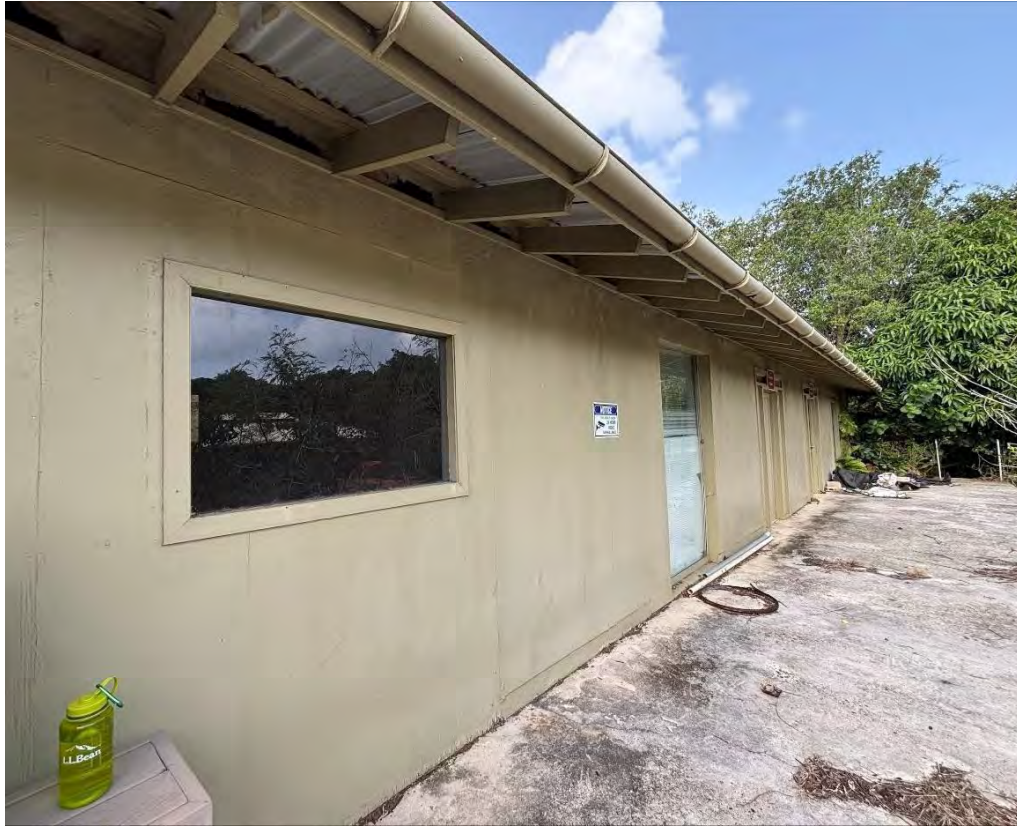
Building: 78 Facilities Office

Component	Material	Notes
Floor	Concrete	
Walls (Structural)	Wood	Rotted sill plate noted in select locations.
Walls (Non-Structural)	Wood	
Roof	Wood Framed / Metal Deck	
Stairs/Railings	Concrete	
Sidewalk	Concrete

- Potential mold in building.

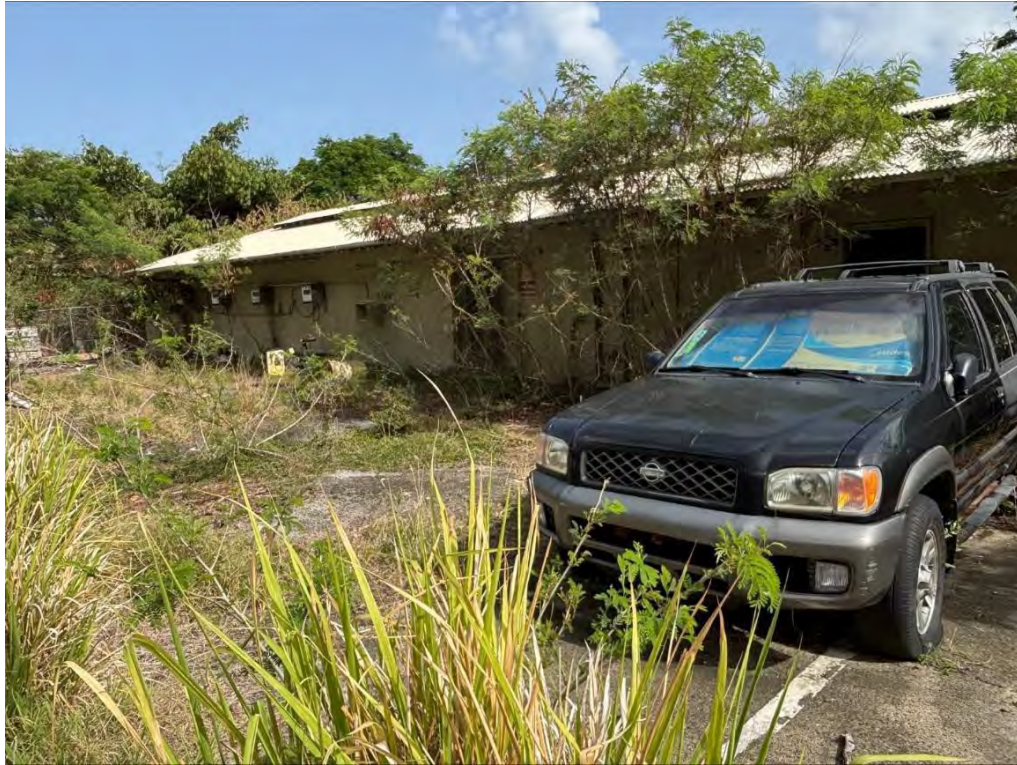
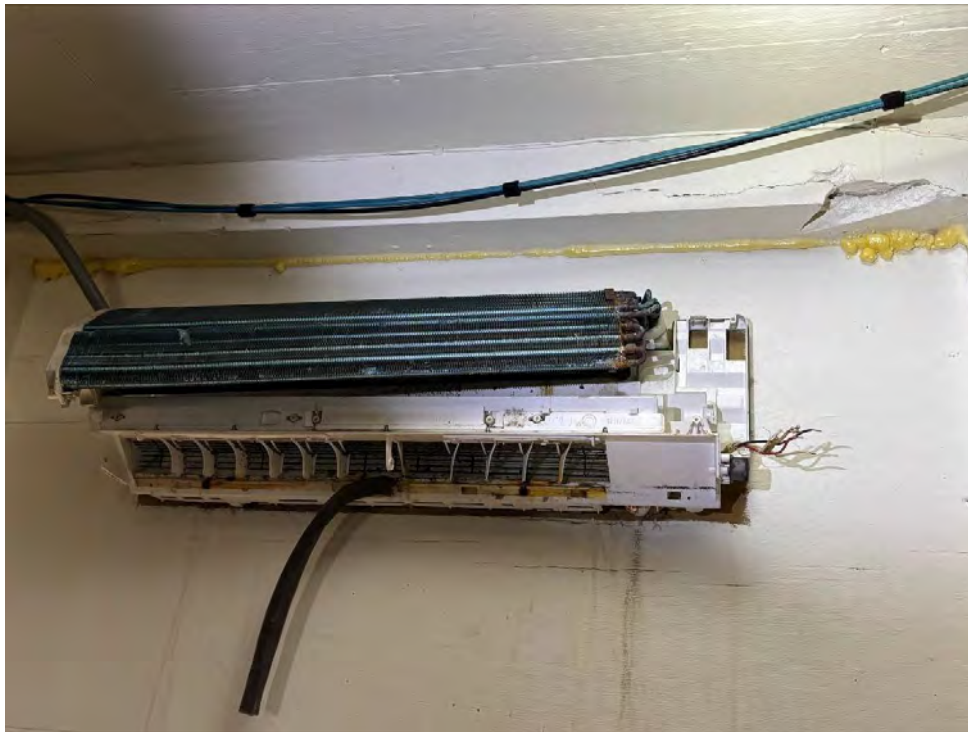
Building: 79 Engineering Warehouse

Component	Material	Notes
Floor	Concrete	
Walls (Structural)	Concrete	Horizontal crack in lintel. Cracks at joint between dive storage addition and main building. Failed walls at small shed addition to west of dive storage room.
Walls (Non-Structural)	Wood	
Roof	Wood Framed / Metal Deck	Roof collapsed at small shed addition to west of dive storage room.
Stairs/Railings	N/A	
Sidewalk	Concrete
