Building: 13B Generator Building

Structural Assessment: Potentially

National Park Service
Virgin Islands National Park | Caneel Bay
Structural Assessment Report

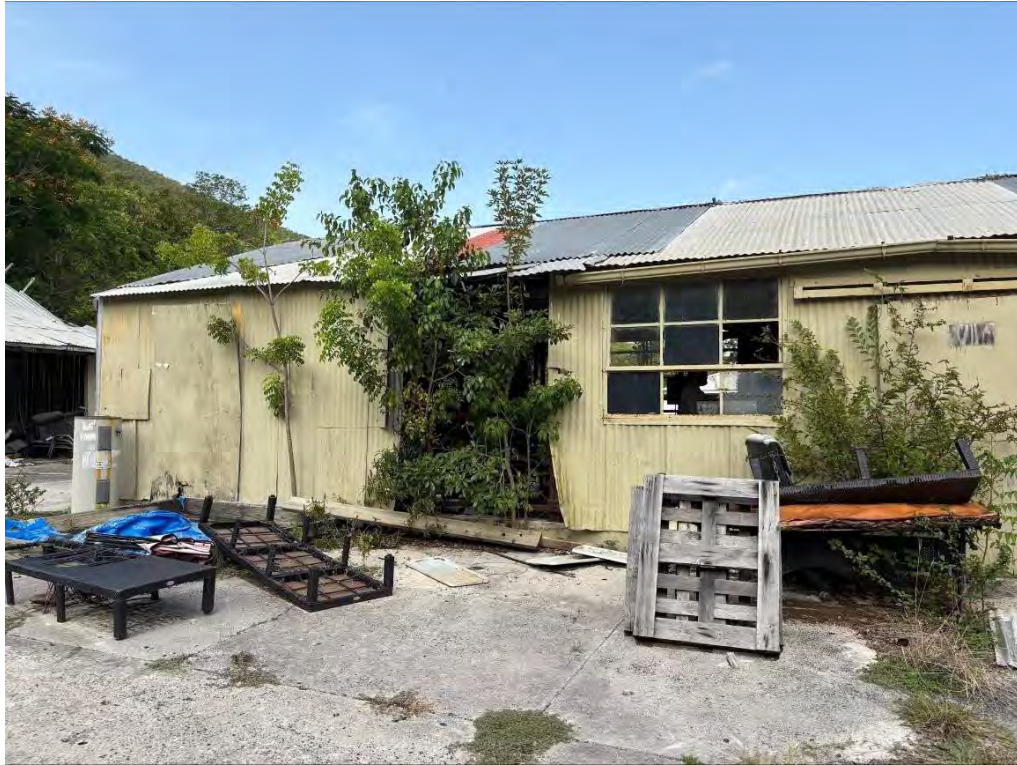
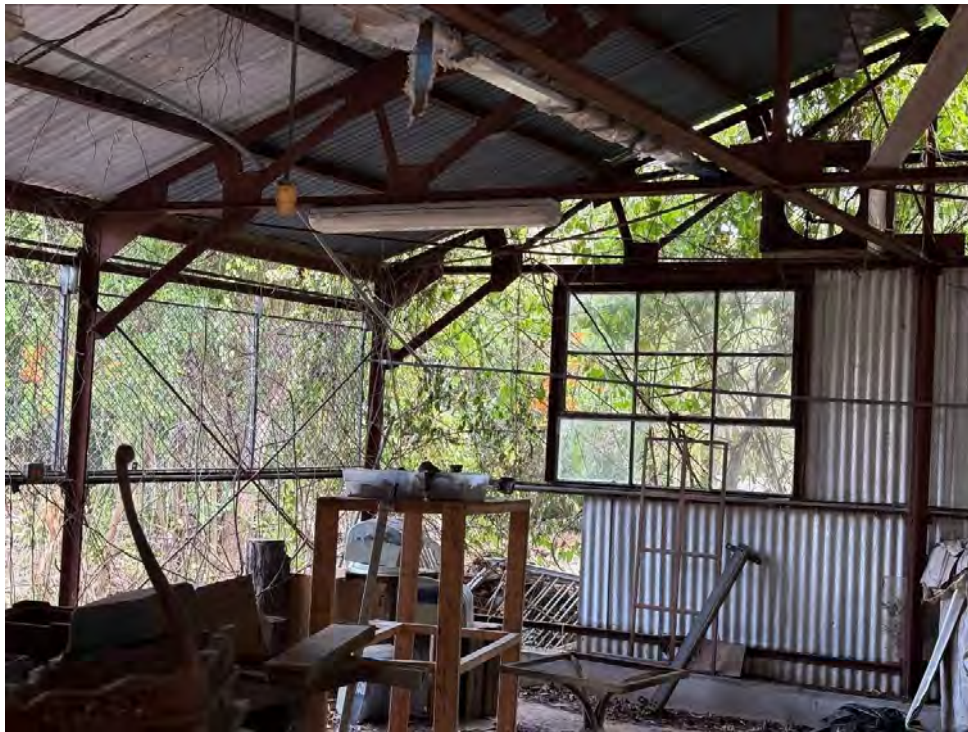
Building: 80 Carpenter Shop

Component	Material	Notes
Floor	Concrete	Minor cracking.
Walls (Structural)	Steel	Rusted base plates, rust jacking between steel framing members.
Walls (Non-Structural)	Metal Cladding	Missing non-structural cladding. Section loss from rust in some horizontal bracing elements.
Roof	Metal Framed/ Metal Roof	Missing metal roof cladding.

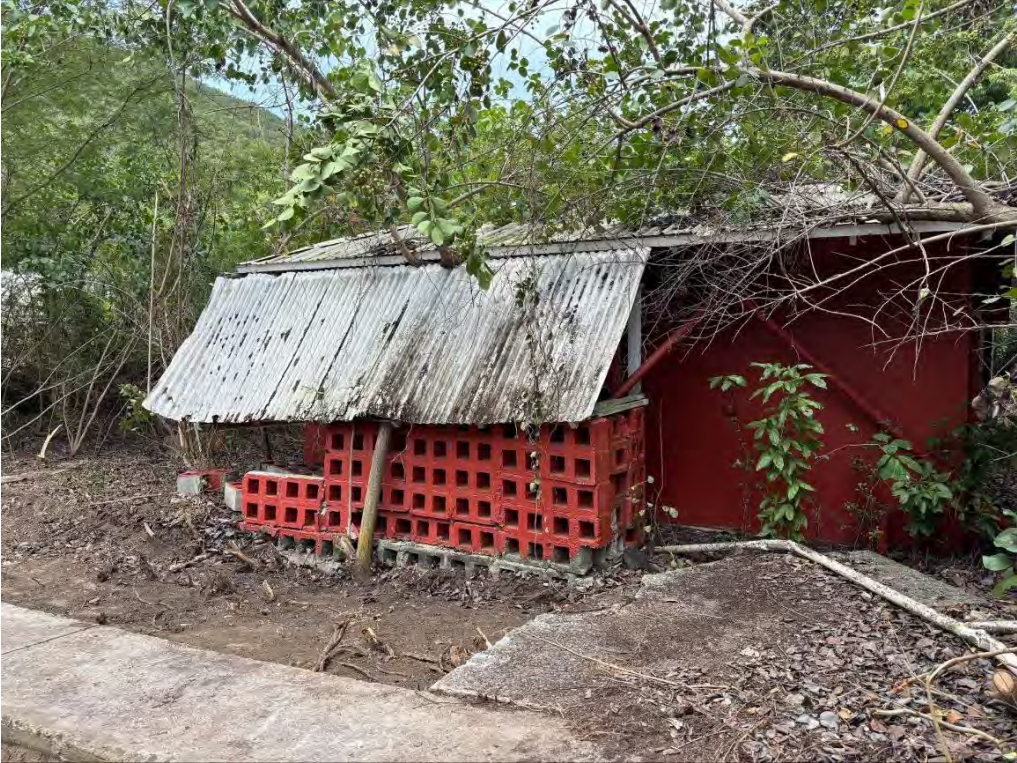
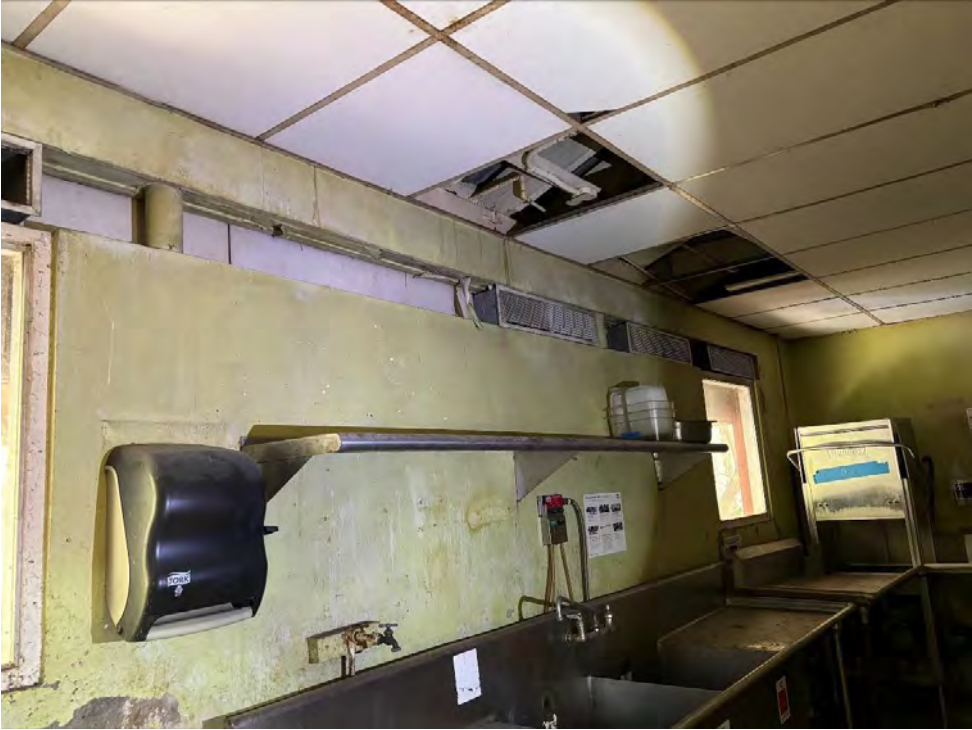
Building: 81 Staff Dining Facility

Component	Material	Notes
Floor	Concrete	
Walls (Structural)	Masonry (CMU) on south, steel columns on north	Steel columns severely corroded and failed.
Walls (Non-Structural)	Masonry (CMU) infill in vicinity steel columns	
Roof	Metal Framed/ Metal Roof

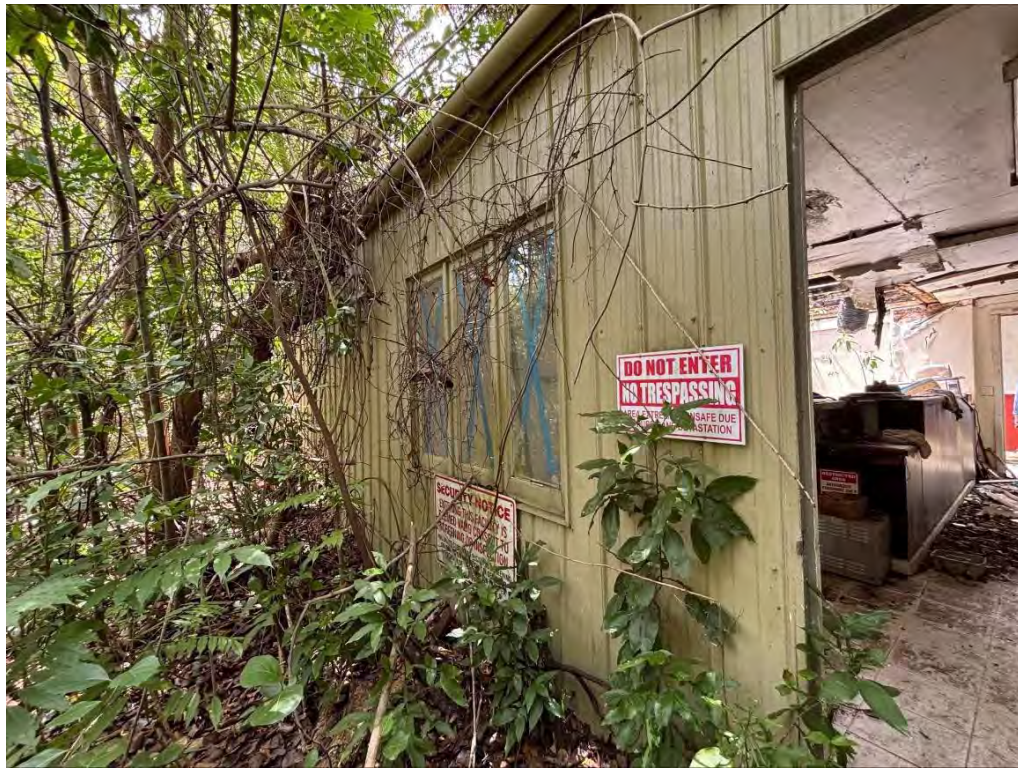
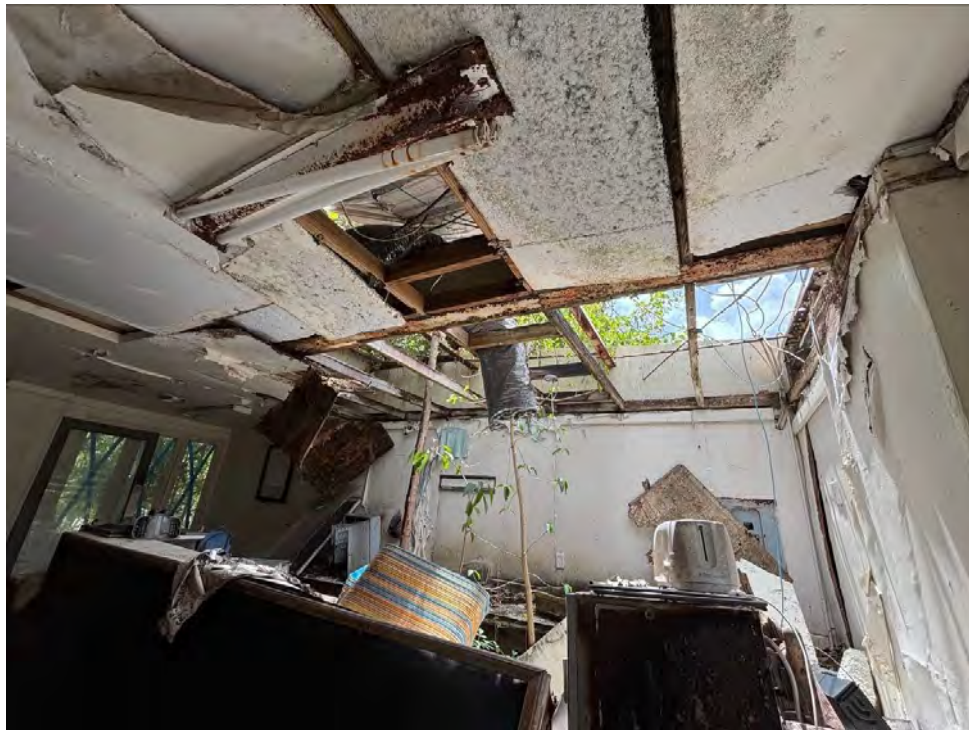
Building: 82 Security Office

Component	Material	Notes
Floor	Concrete	
Walls (Structural)	Steel	Major section loss in structural steel.
Walls (Non-Structural)	Wood	
Roof	Metal Framed/ Metal Roof	Failed/collapsed.

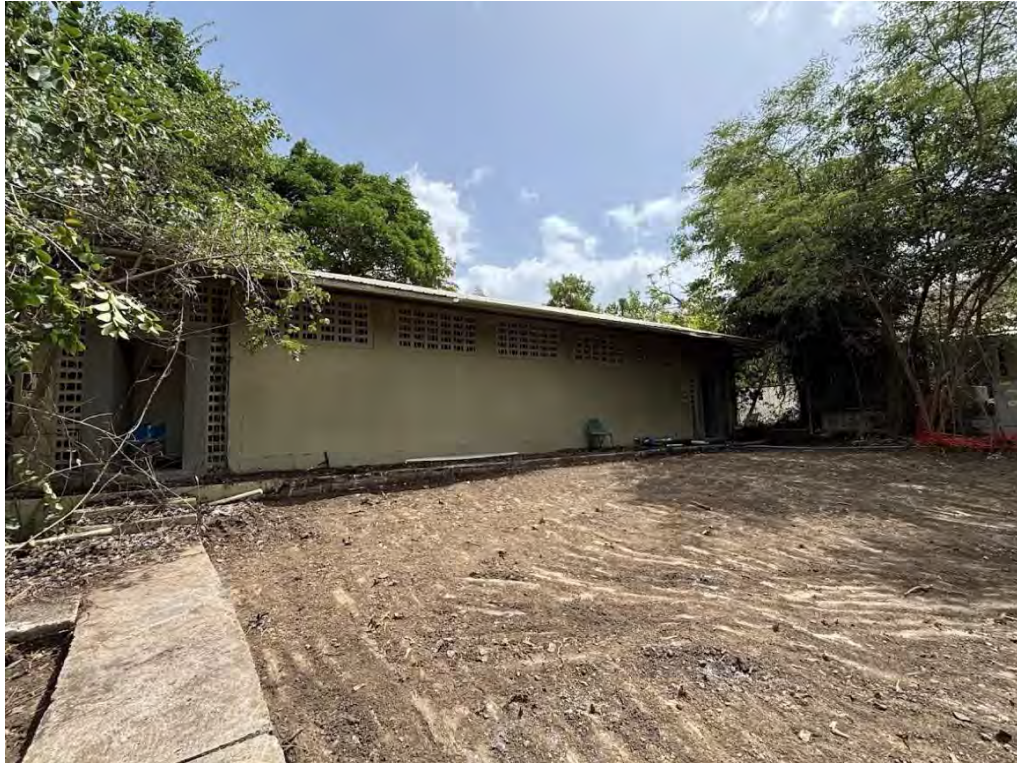
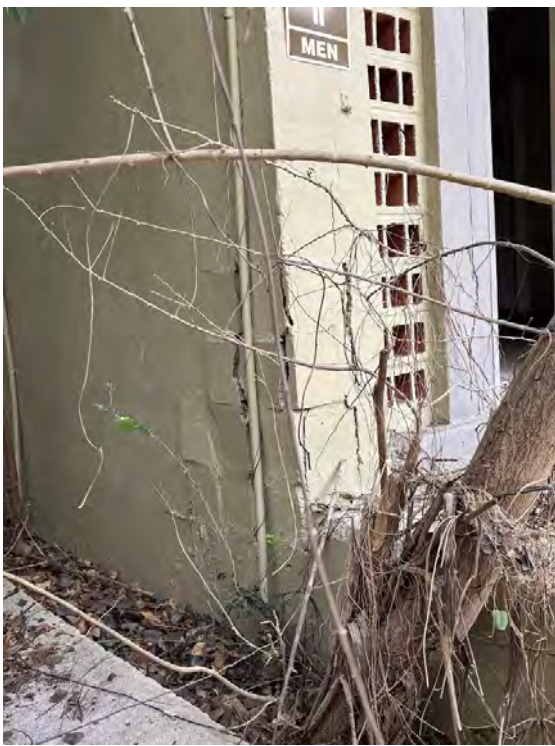
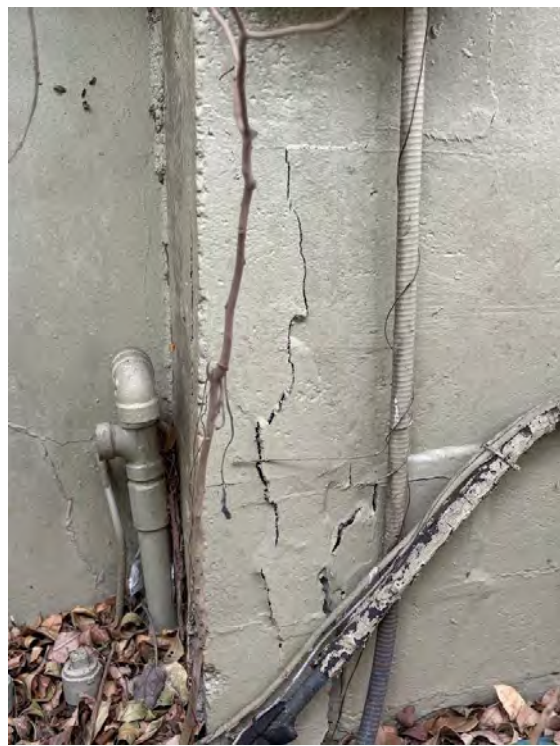
Building: 83 Staff Locker Rooms

Component	Material	Notes
Floor	Concrete	
Walls (Structural)	Masonry (CMU)	CMU cracking due to potential differential settlement.
Walls (Non-Structural)	Masonry (CMU)	
Roof	Metal Framed/ Metal Roof

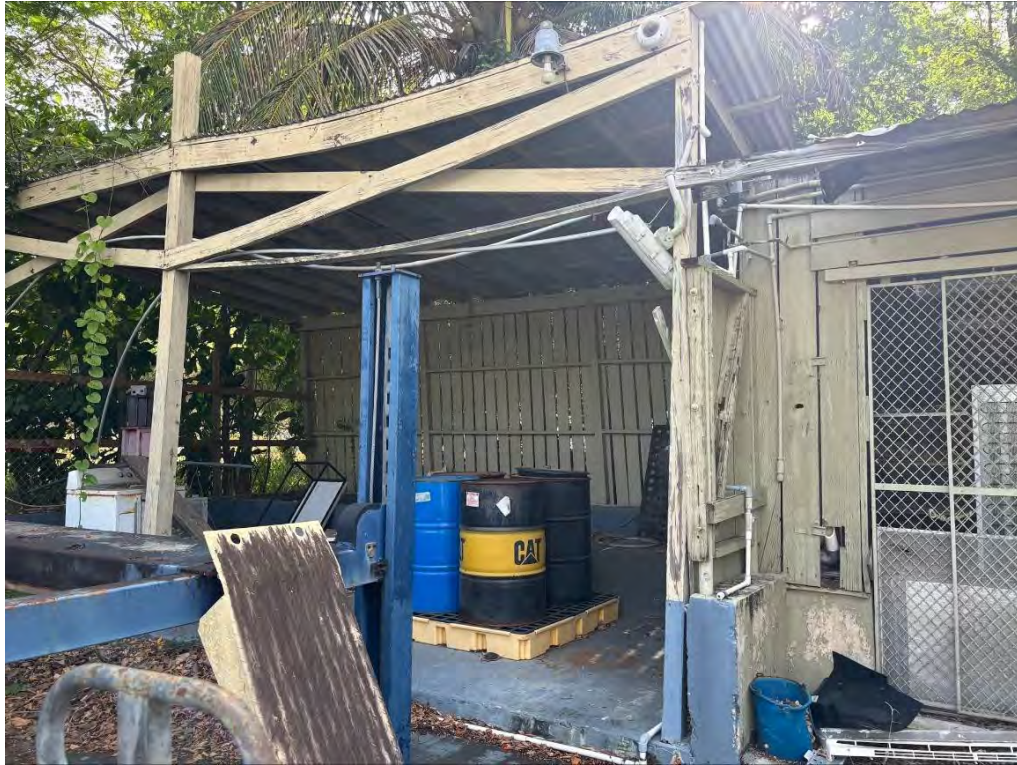
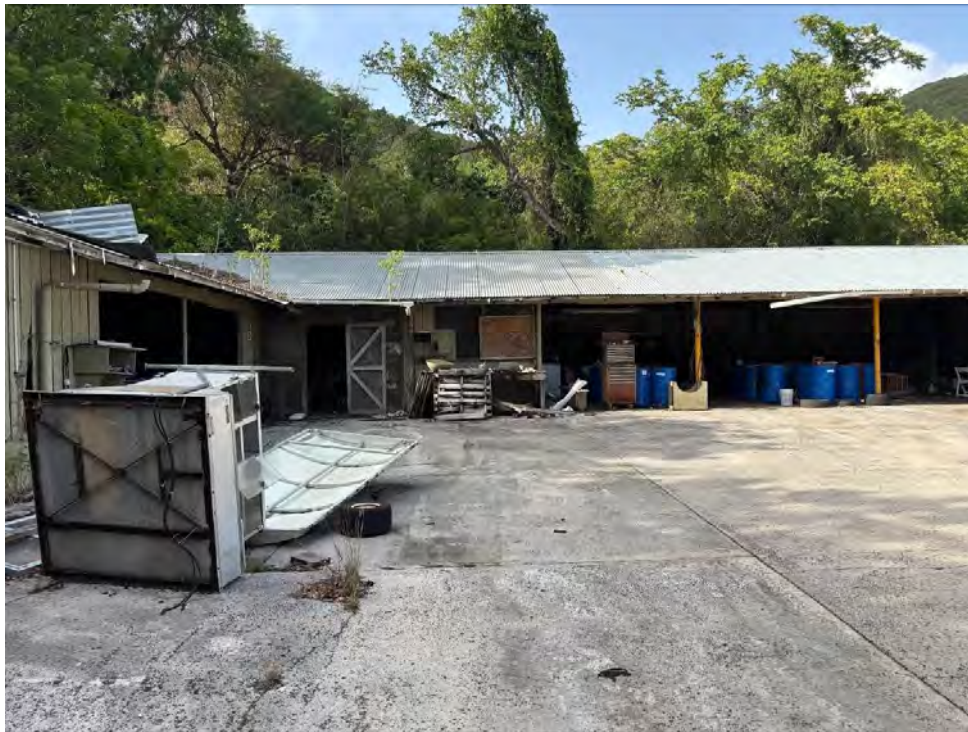
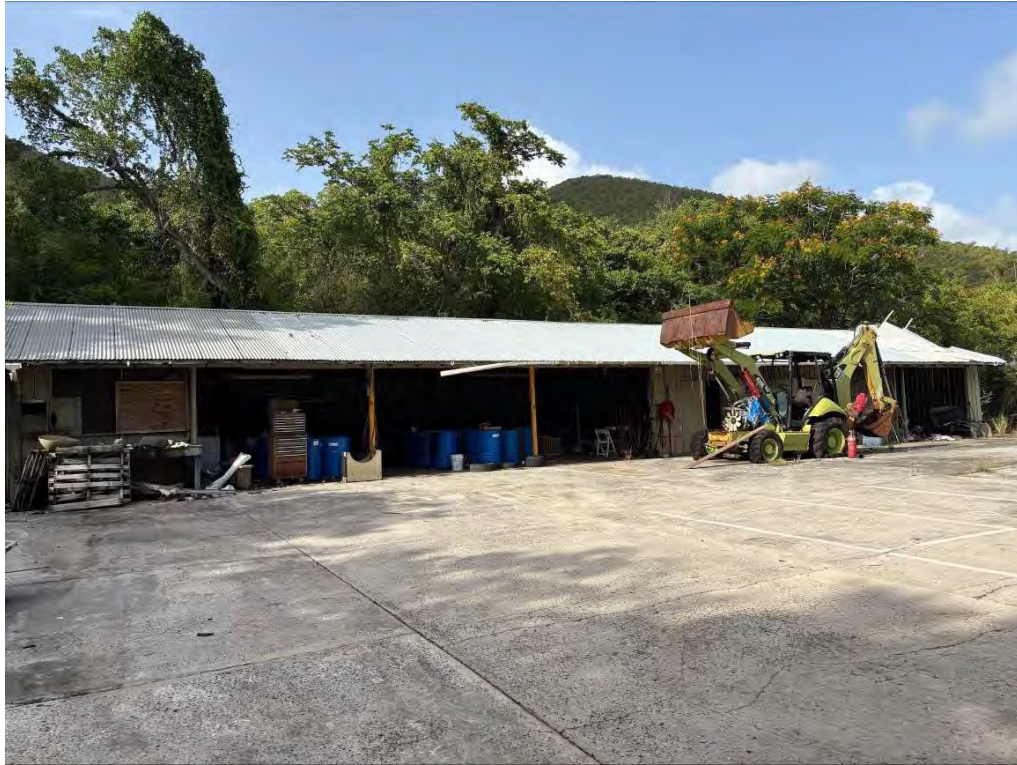
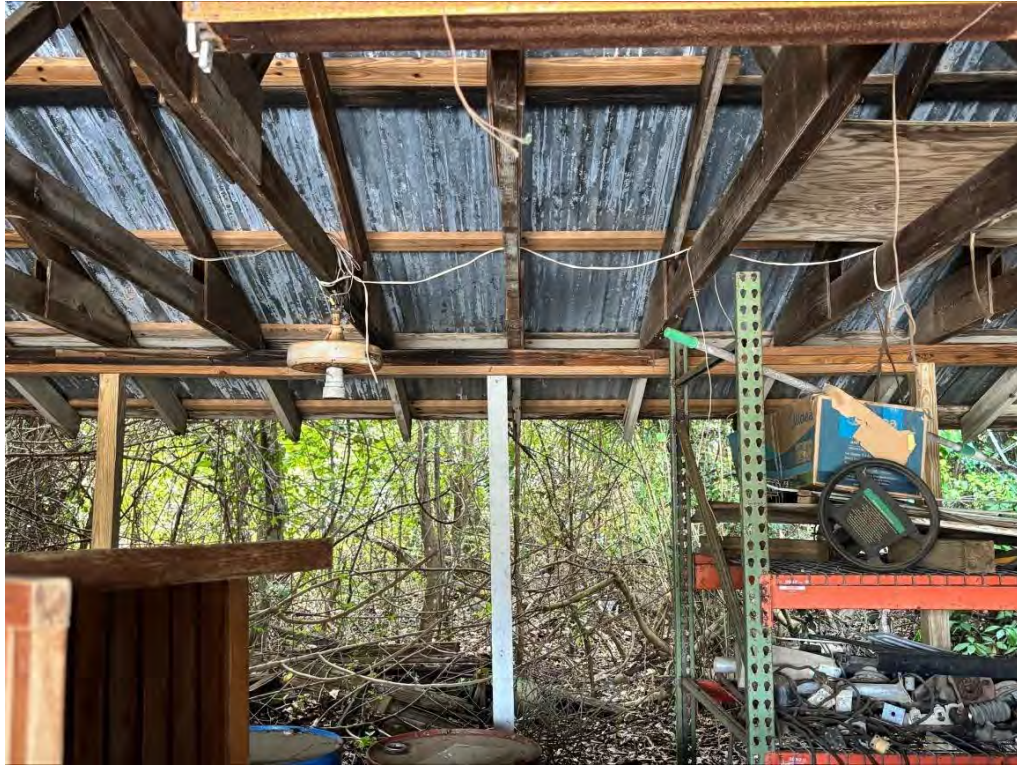
Building: 84 Motor Pool

Component	Material	Notes
Floor	Concrete	
Walls (Structural)	Wood	Deteriorated rafter tails, deteriorated sill plates, trusses cut in south wing, truss end bearing deteriorated in 2 locations, portion of east wall inadequately framed.
Walls (Non-Structural)	Wood Framed/ Metal Cladding	
Roof	Metal Framed/ Metal Roof

- Note the east wall between the north and south wings of the building where the wall framing was previously removed was reframed improperly. Current framing does not provide adequate support for the rafters.

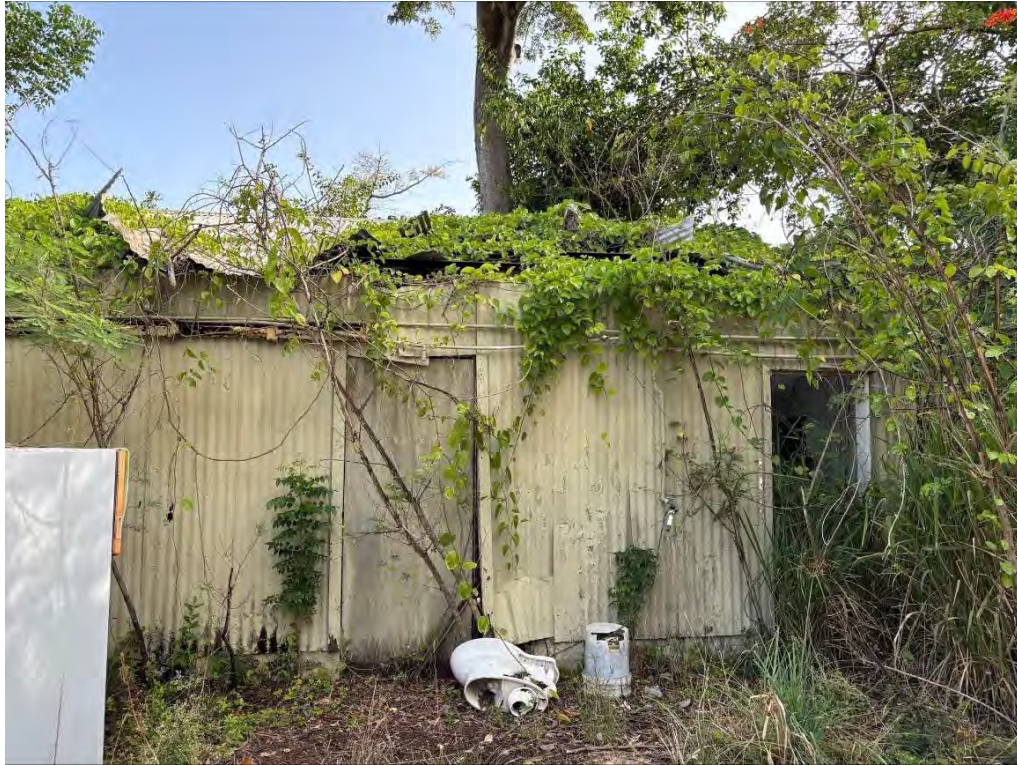
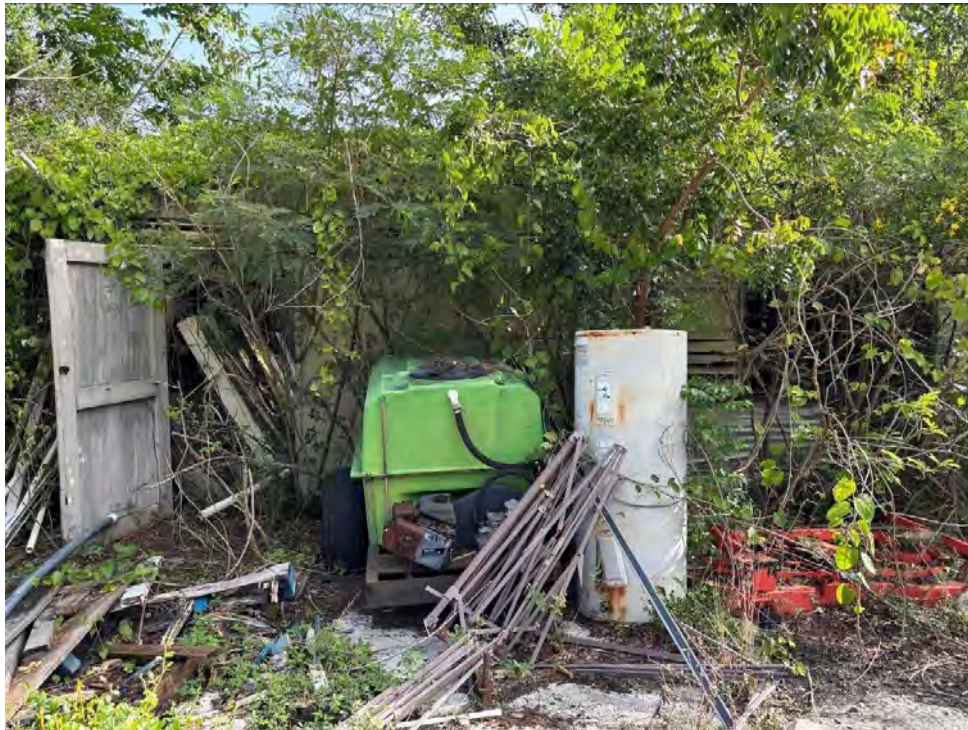
Building: 85 Engineering Storage

Component	Material	Notes
Floor	Concrete	
Walls (Structural)	Steel	Appears to have rust on structural elements, unable to fully verify due to vegetation and material preventing access.
Walls (Non-Structural)	Metal Cladding	Missing non-structural cladding. Section loss from rust in some horizontal bracing elements.
Roof	Metal Framed/ Metal Roof	Roof finishes severely damaged/missing. Building is exposed to elements due to failed roof. This may lead to increased deterioration of steel.

- Unable to access interior due to excessive growth and stored materials.
- Appears to be similar condition to Building 80 Carpenter Shop.

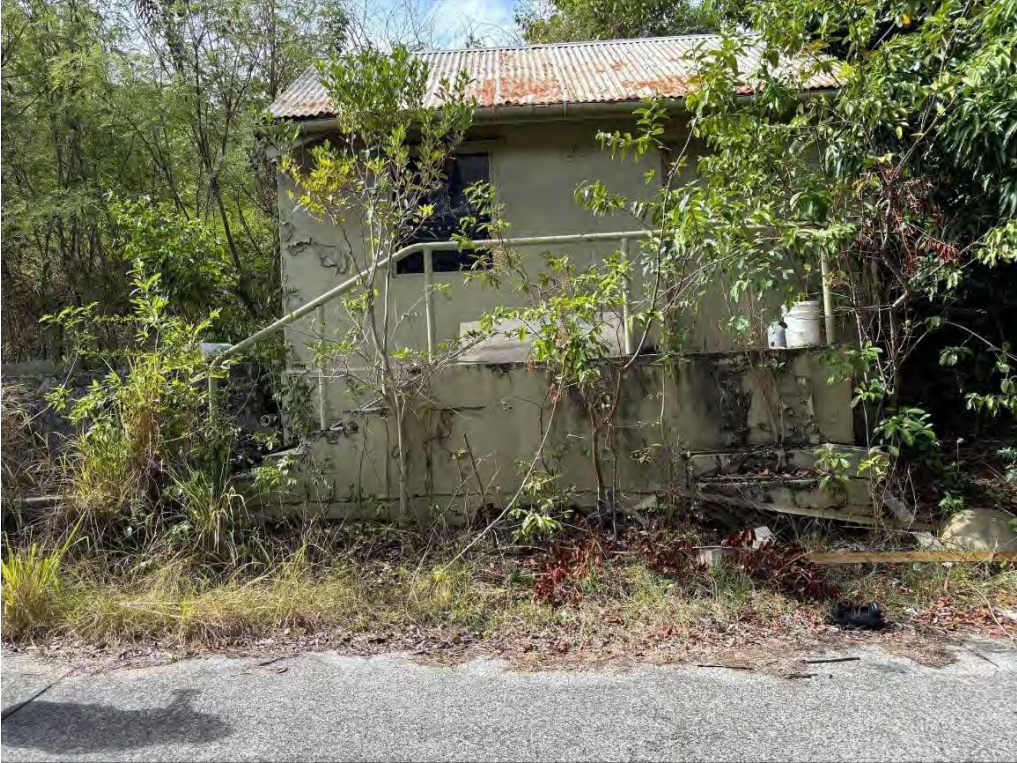
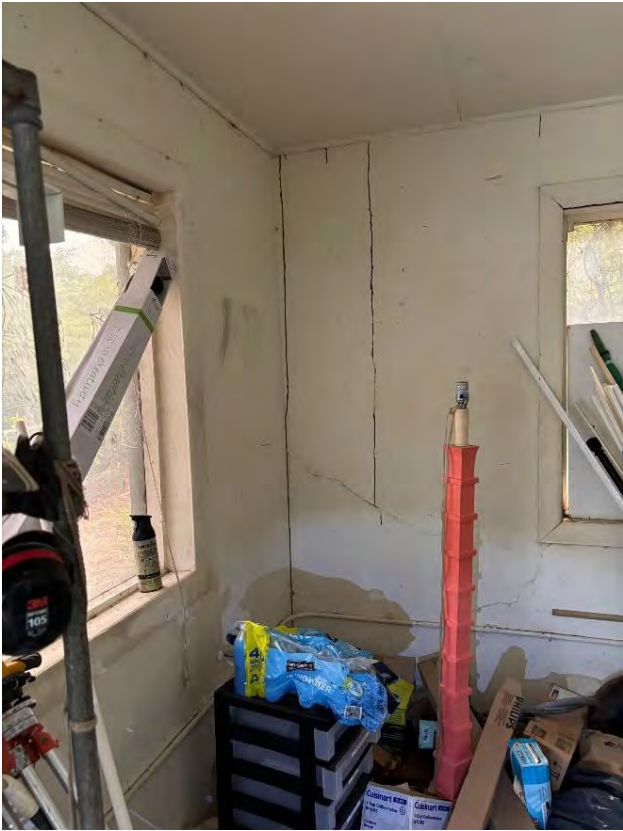
Building: 86 Employee Lounge

Component	Material	Notes
Floor	Concrete	
Walls (Structural)	Concrete / wood framed addition	Small horizontal crack between windows on north and east wall.
Roof	Wood framed / metal deck	Adjacent Quonset hut wall fell on addition roof.
Stairs/Railings	Concrete w/ aluminum rail

- Unable to access the rear shed addition to evaluate for roof damage. Further investigation required to determine condition of the roof.

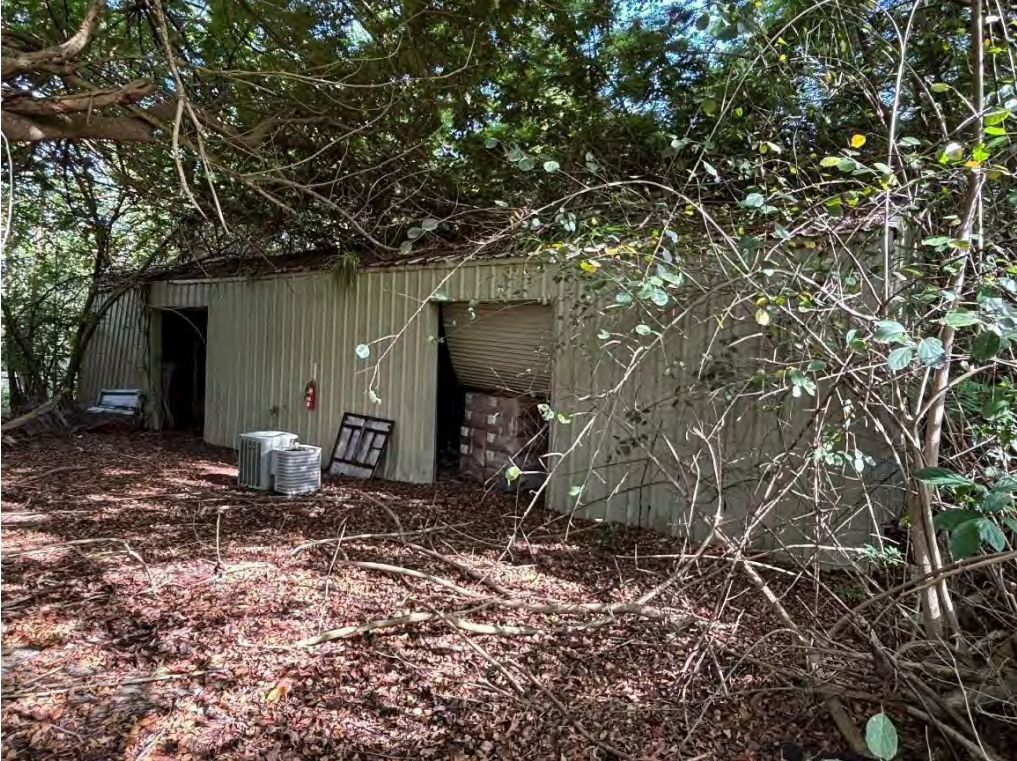
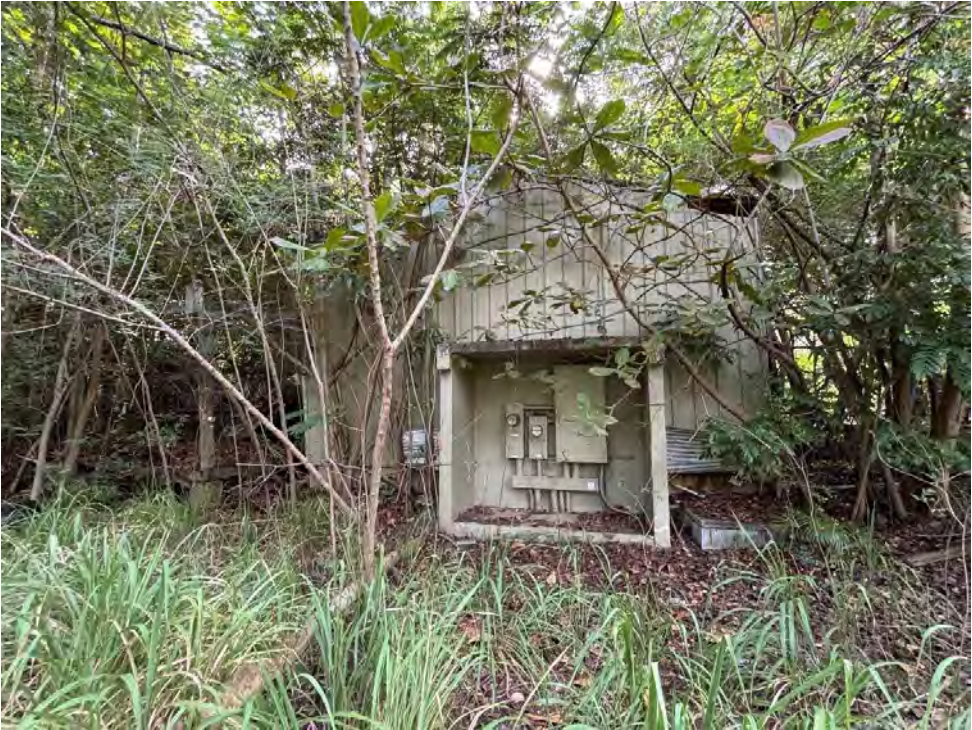
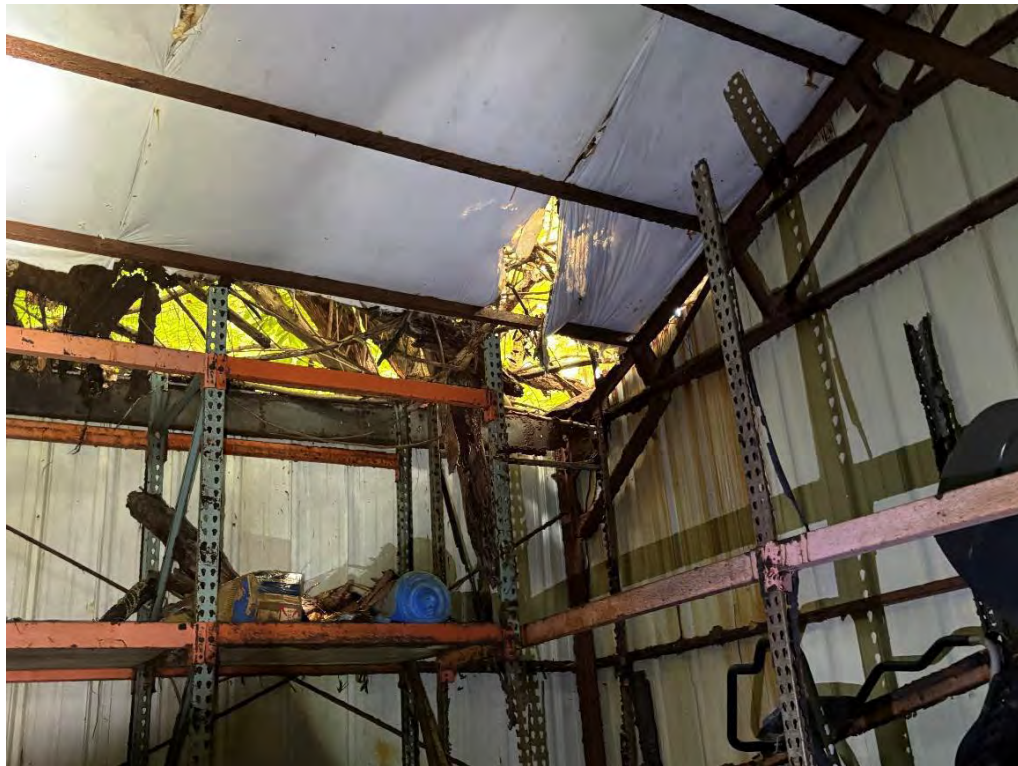
Building: 90 Carpenter Shop 2

Component	Material	Notes
Floor	Concrete	
Walls (Structural)	Steel	SW corner of building failed. Steel columns corroded and have significant section loss. Some columns have completely rusted at base plate.
Roof	Steel Framed / Metal Deck	Failed/collapsed.

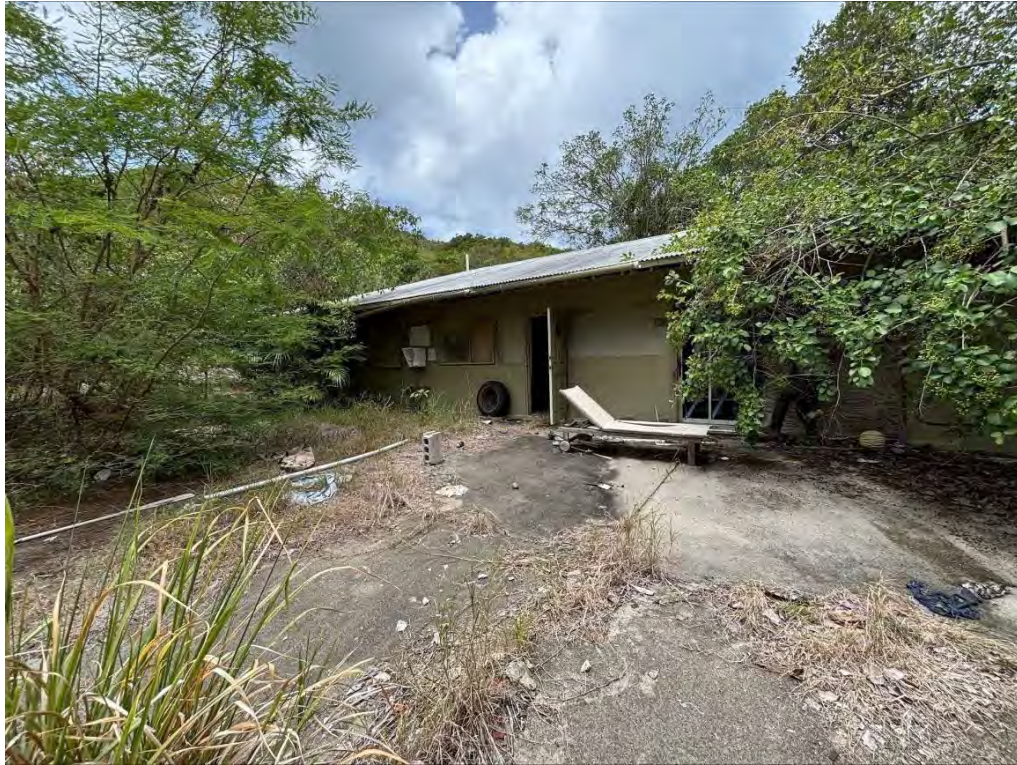
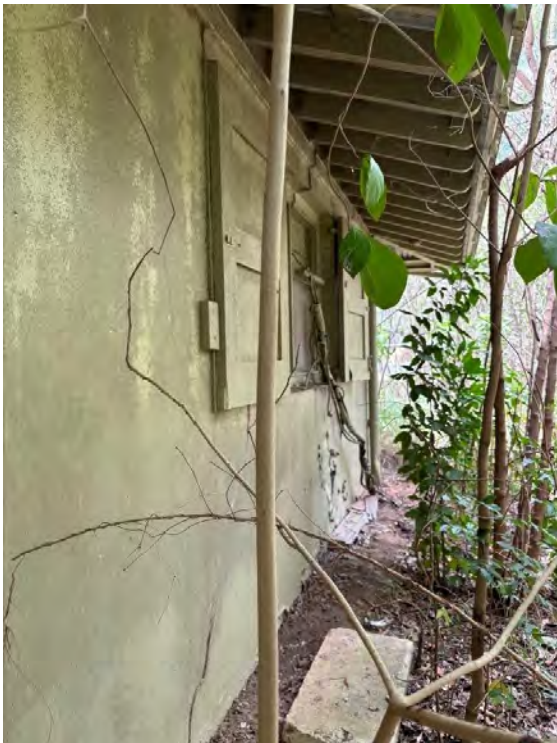
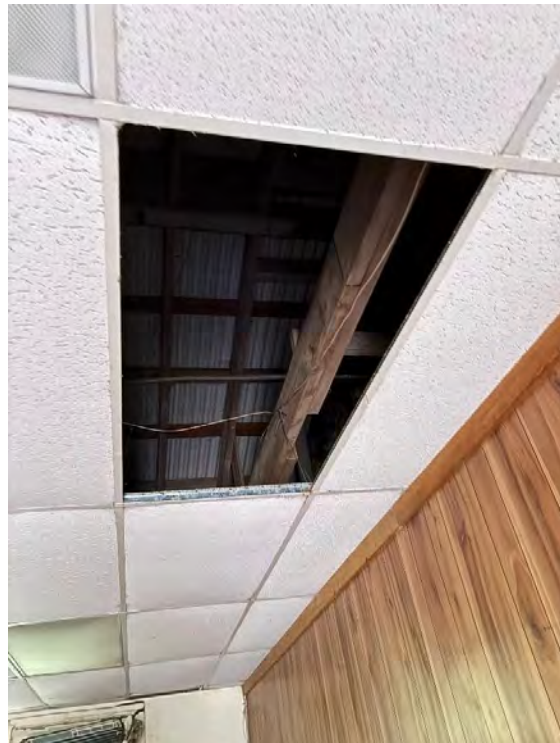
Building: 91 Human Resources

Component	Material	Notes
Floor	Concrete	
Walls (Structural)	Concrete	Signs of termites observed.
Walls (Non-Structural)	Concrete	
Roof	Wood framed / metal deck

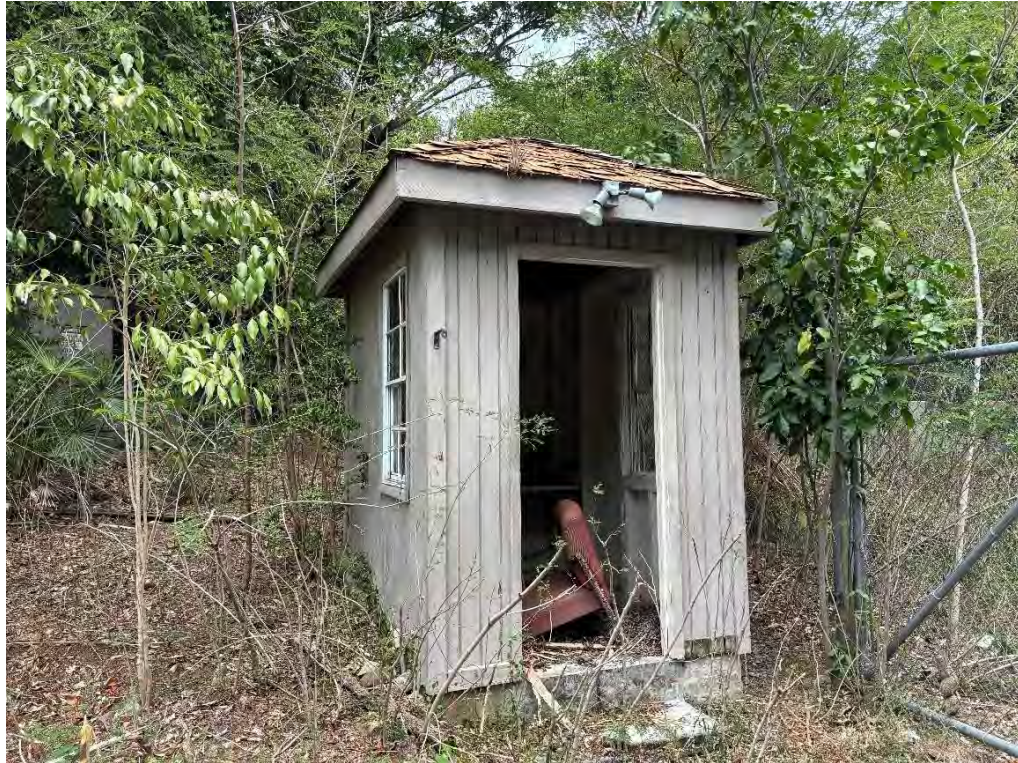
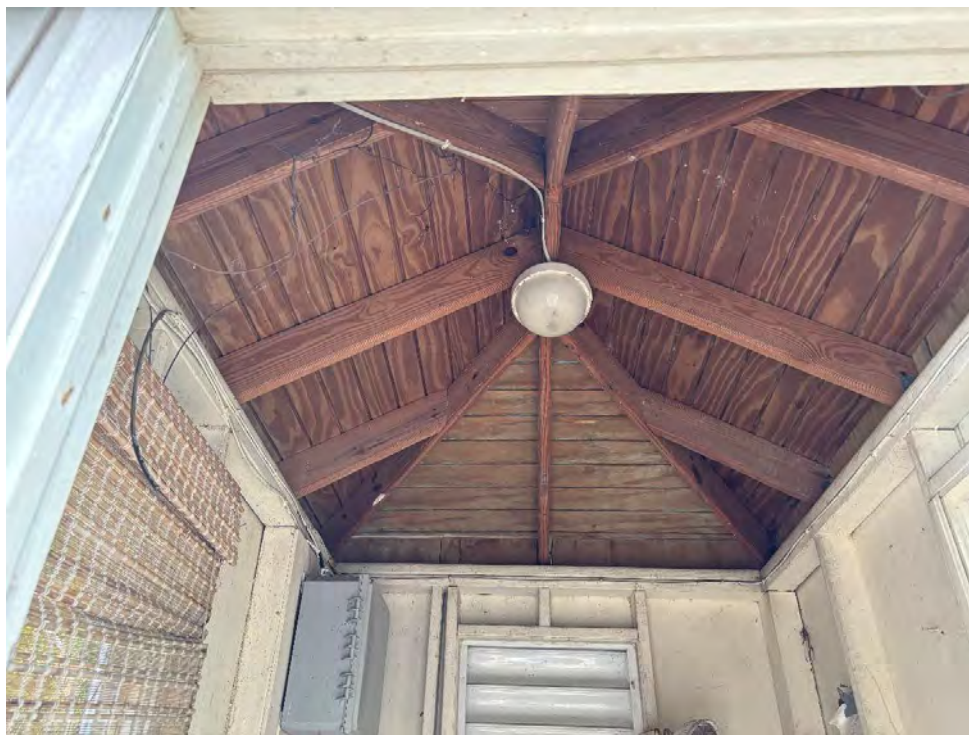
Building: Maintenance Area Guard Shack

Component	Material	Notes
Floor	Concrete	
Walls (Structural)	Wood	Potential termite damage.
Walls (Non-Structural)	Wood	Potential termite damage.
Roof	Wood Framed/ Wood Shingles	Potential termite damage.

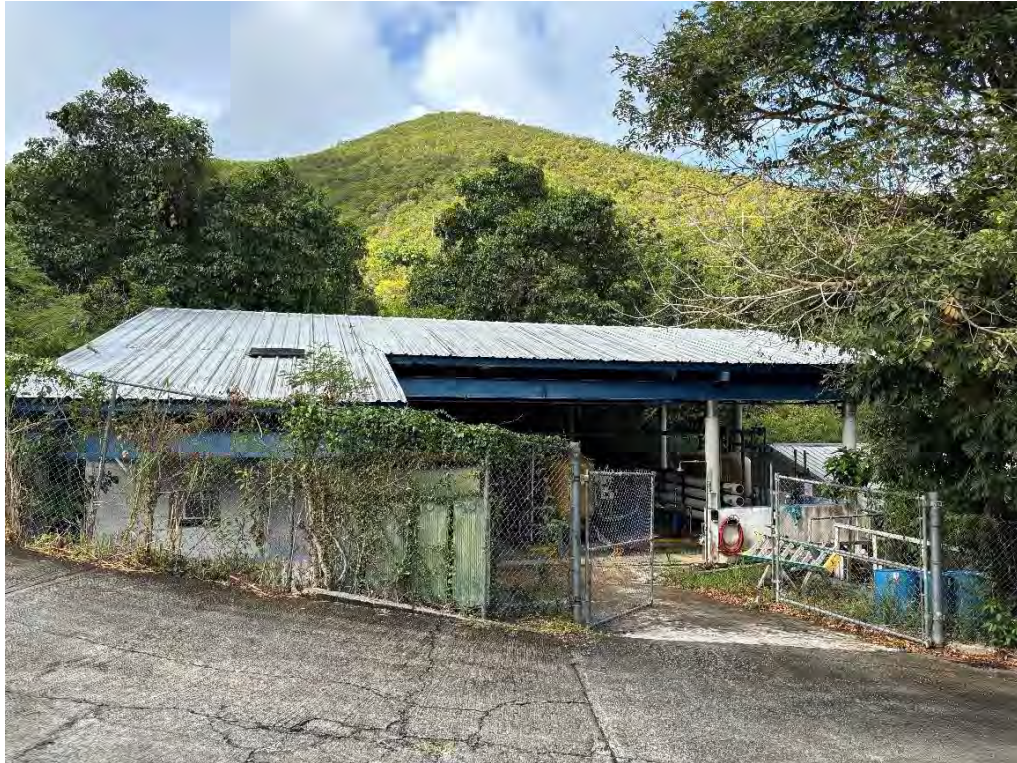
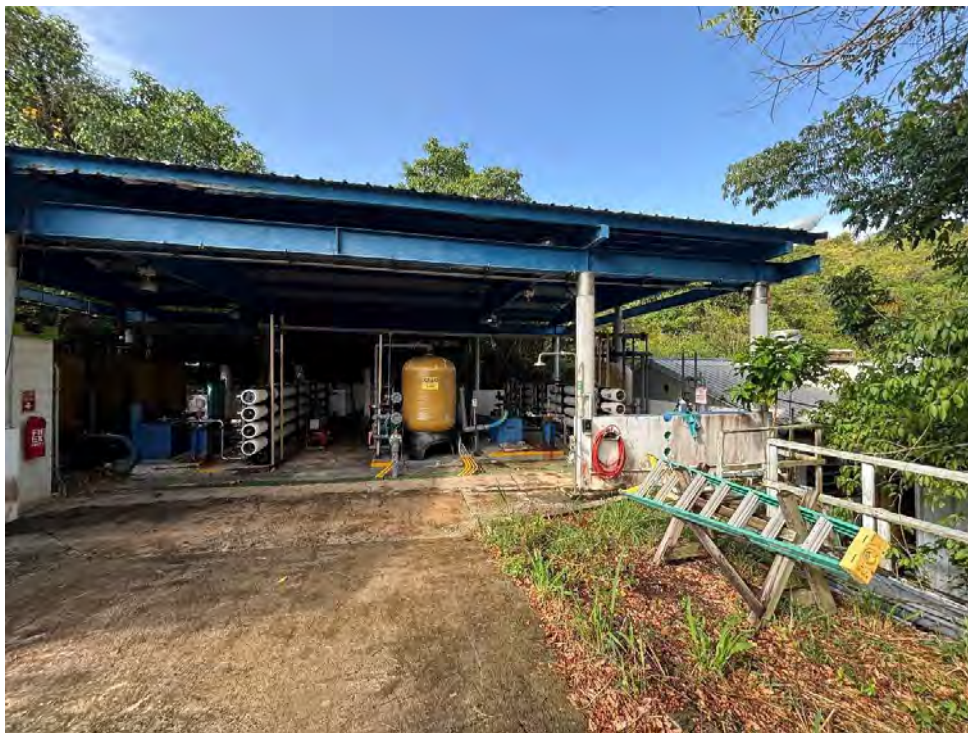
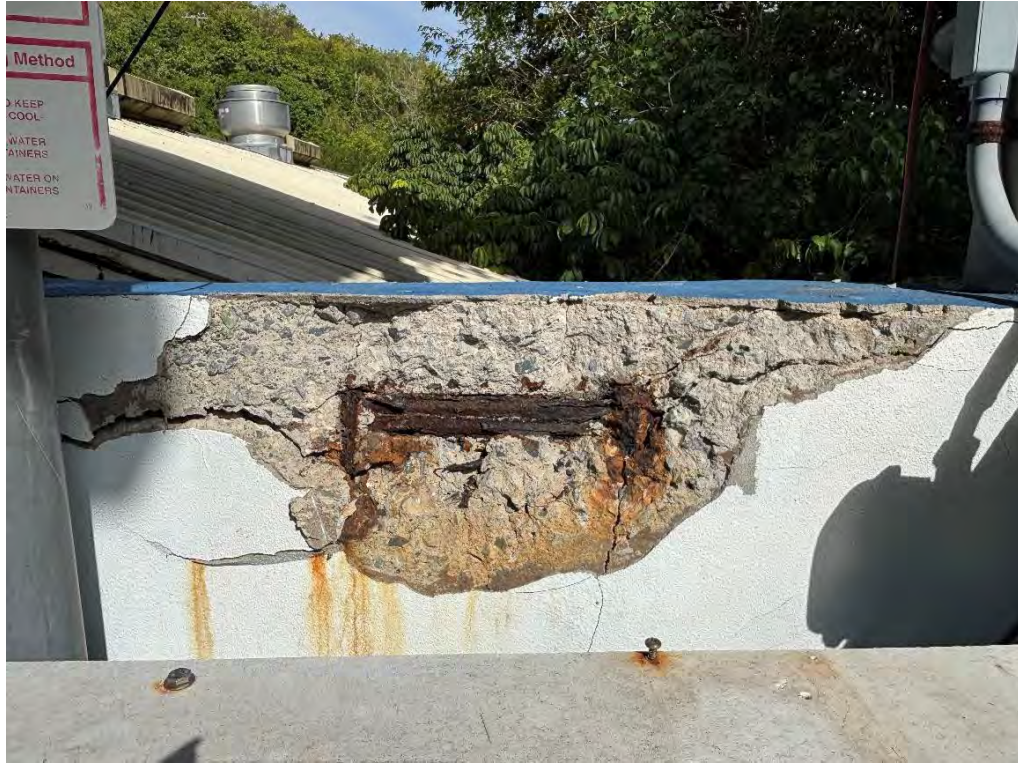
Building: R.O. Plant

Component	Material	Notes
Floor	Concrete	Concrete slab with concrete pads for equipment.
Office Walls (Structural)	CMU	
Office Roof	Wood Framed / Wood	
Plant Walls (Structural)	Concrete Knee Walls / Steel Columns Encased in Concrete	Concrete walls on north side are cracked, spalled and have severely rusted rebar. Concrete around steel columns has spalled. CMU wall on south side is acting as a retaining wall and has horizontal cracks along the length of the wall.
Roof	Steel / Metal Roof	Roof has severely corroded in one location and rusted completely through. Bottom flange of "Z" purlins have various degrees of corrosion on the bottom flange throughout the structure.
West Roof	Wood Framed / Metal Roof	Wood structure attached to the west side of the RO plant appears to be in good condition.

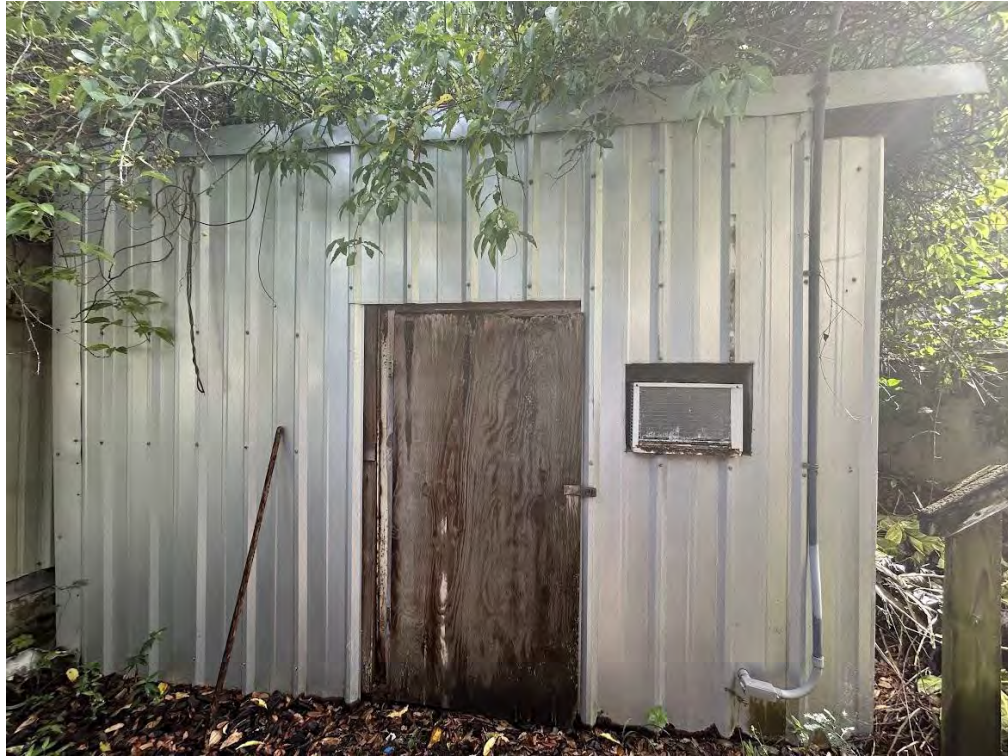
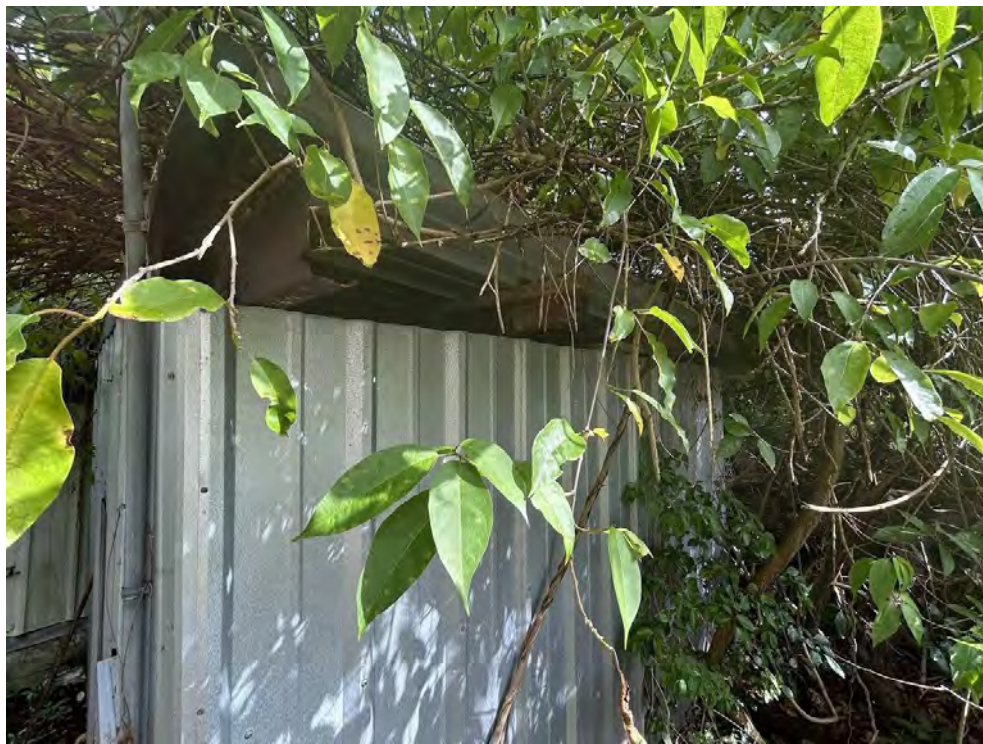
Building: R.O. Storage Shed

Component	Material	Notes
Floor	Concrete	
Walls (Structural)	Steel	Corrosion visible on steel framing.
Walls (Non-Structural)	Wood / Metal Cladding	
Roof	Metal framed / Metal roof
