Building: 13B Generator Building

Structural Assessment: Potentially

National Park Service
Virgin Islands National Park | Caneel Bay
Structural Assessment Report

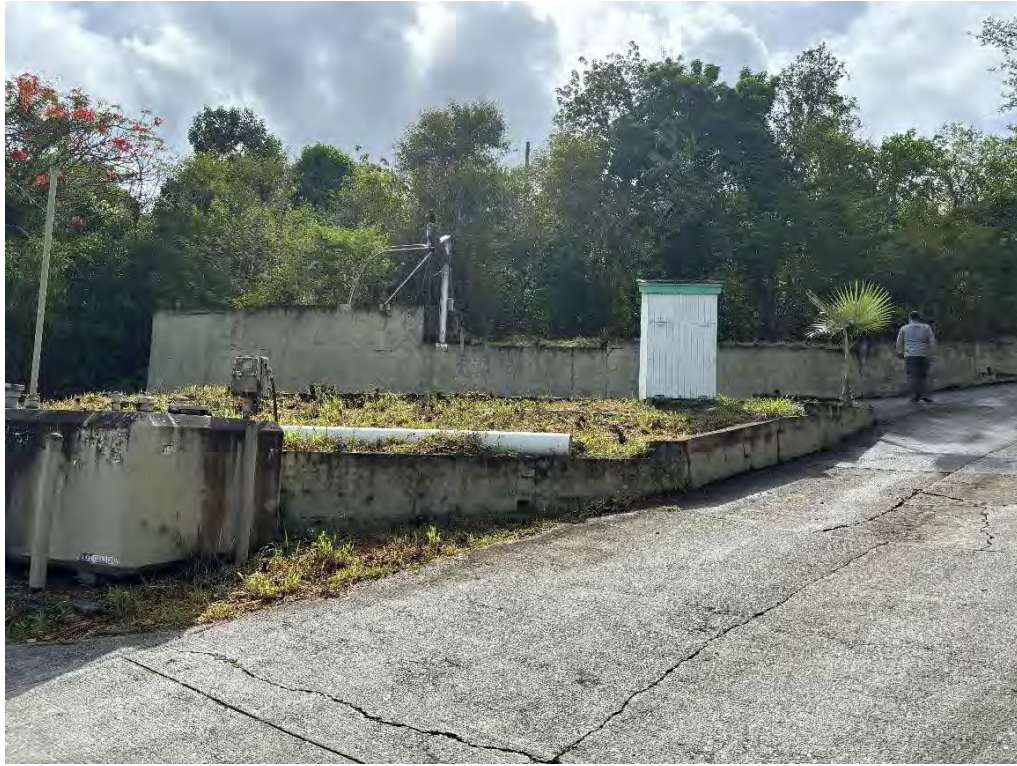
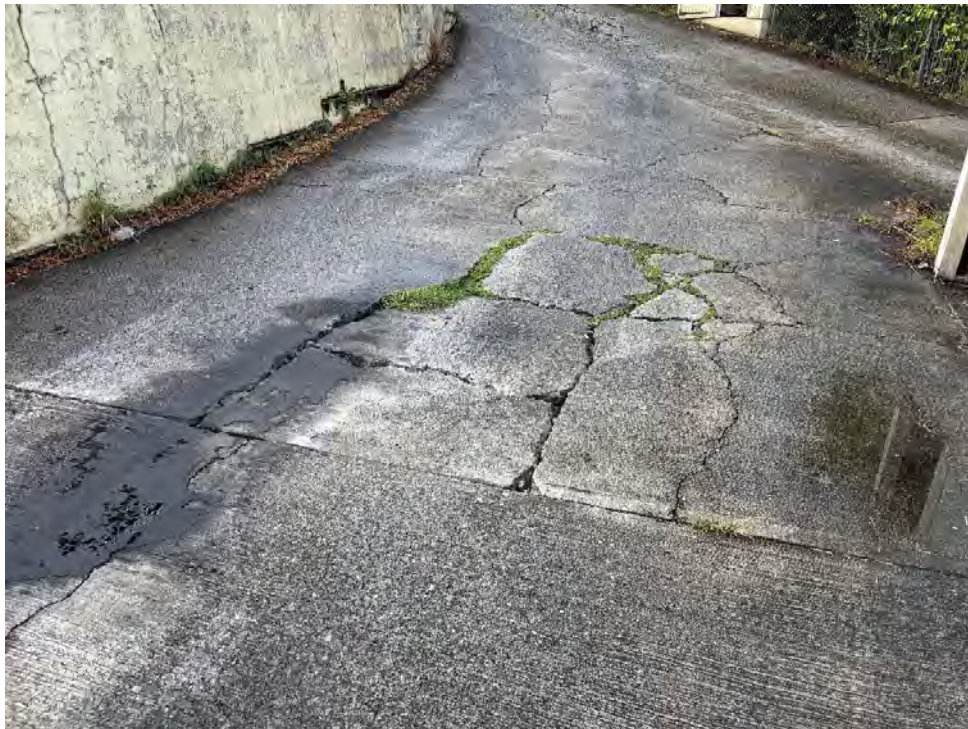
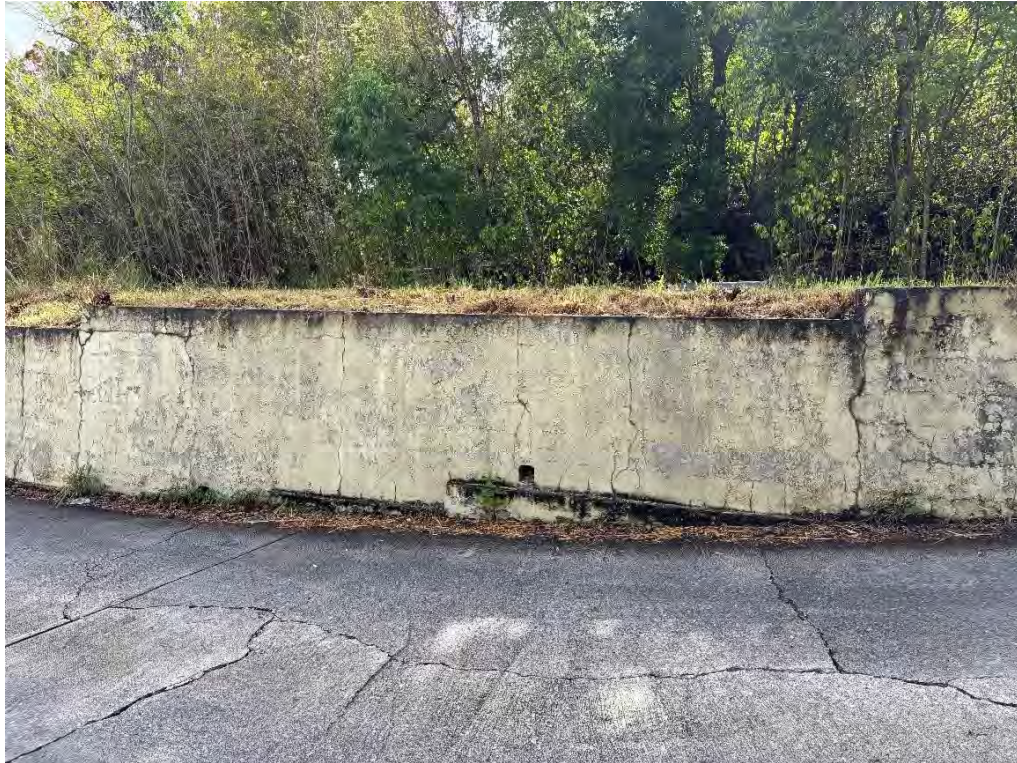
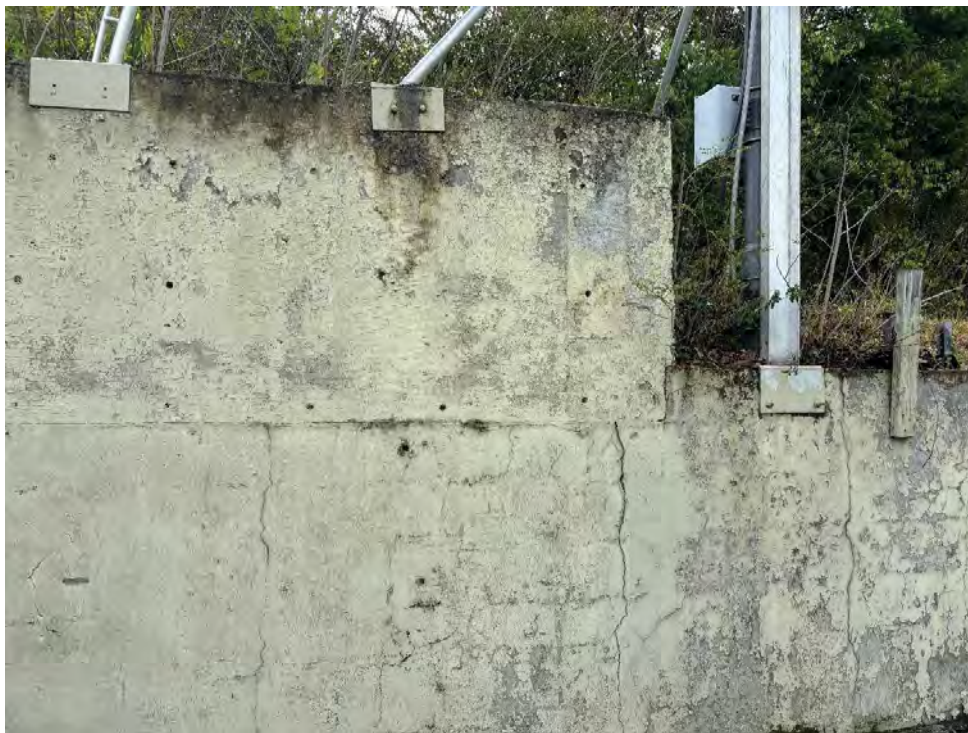
Building: R.O. Filling Station

Component	Material	Notes
Floor	Concrete	Roadway cracked and deteriorated from truck traffic.
Walls (Structural)	Masonry (CMU)	No leaning or displacement observed but retaining wall cracked.
Walls (Non-Structural)	Scale structure wood framed	
Roof	Wood framed / Wood shingles

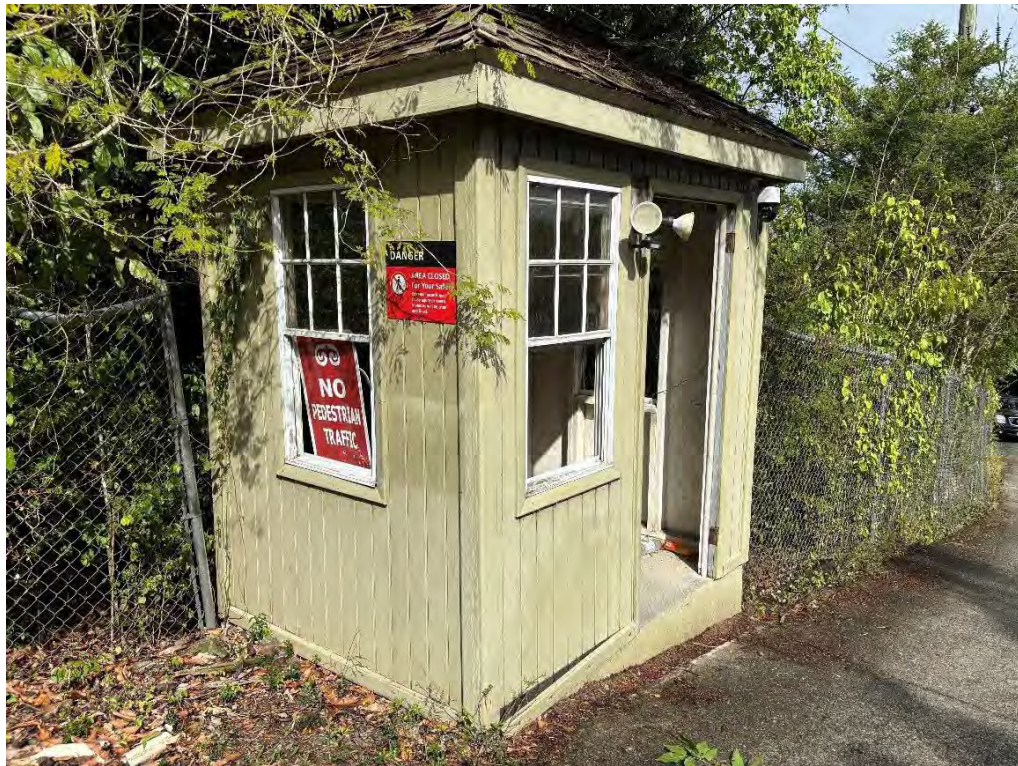
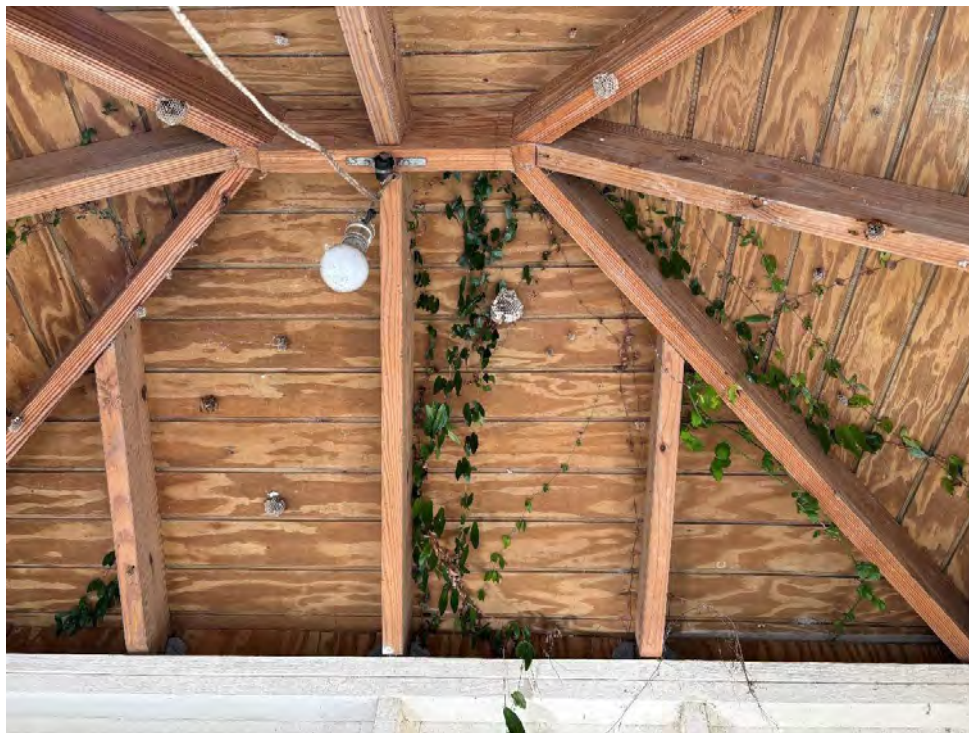
Building: R.O. Guard Shack

Component	Material	Notes
Floor	Concrete	
Walls (Structural)	Wood	Minor rot at base of exterior sheathing.
Walls (Non-Structural)	N/A	
Roof	Wood framed/ Wood shingles	Vegetation growing on roof.

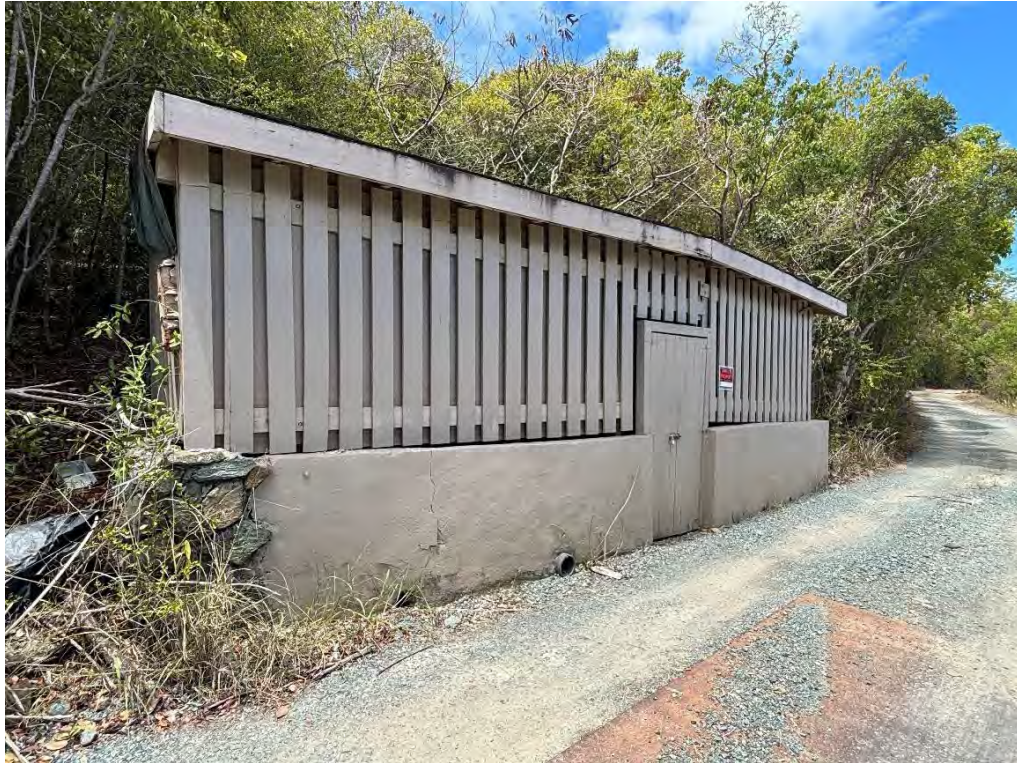
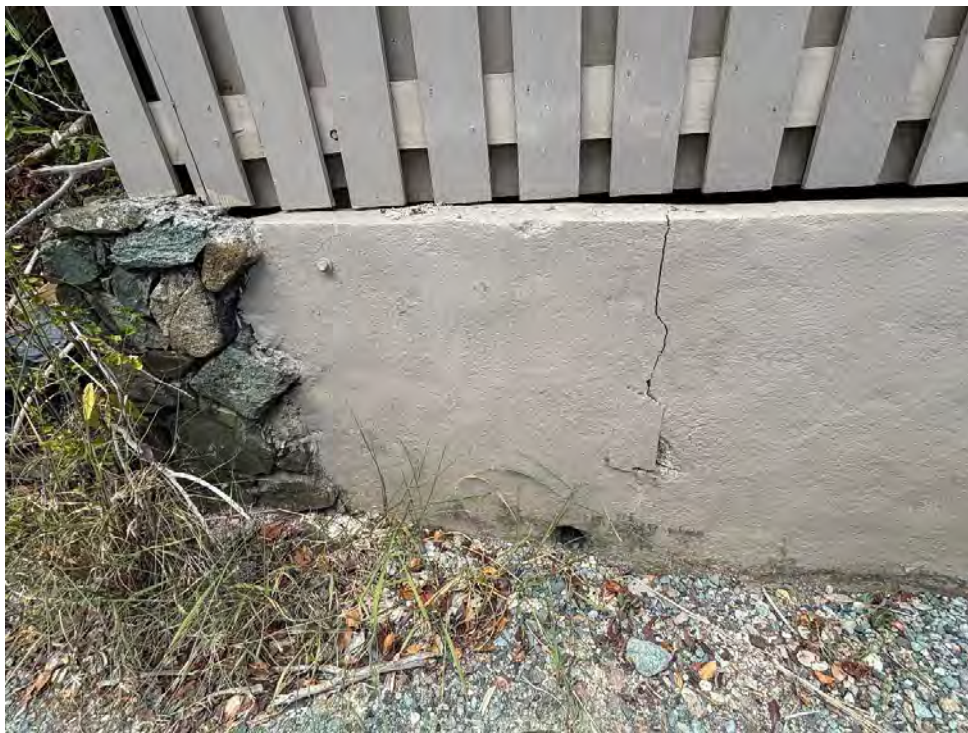
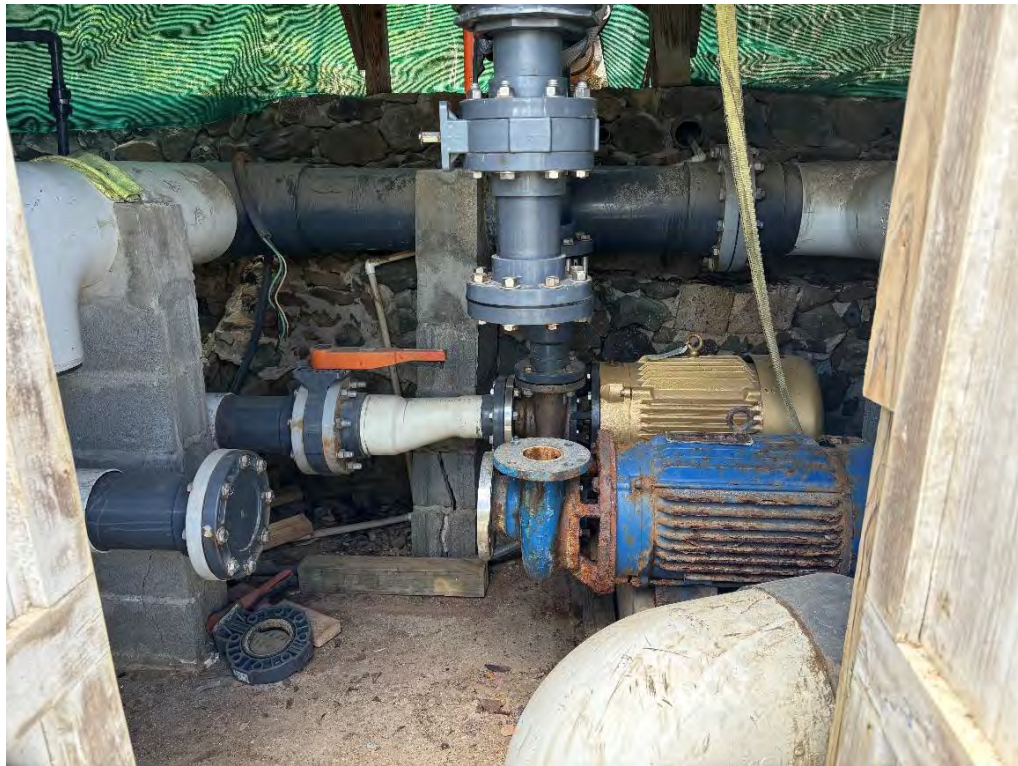
Building: R.O. Pump House by Honeymoon Beach

Component	Material	Notes
Floor	Concrete	Concrete maintenance pads for equipment currently in use.
Walls (Structural)	Stone / CMU / Wood	The structure consists of a CMU wall parallel to the road and 3 stone walls. The wall extend up partial height and have a wood framed shed structure for the top half. Wood posts partially supported on unstable rocks / wood scraps. Beas have insufficient bracing and are leaning/rotating. Wood posts are leaning. CMU at wall has a crack either side.
Roof		Wood beams framed into posts are unstable.
