National Park Service
Virgin Islands National Park | Caneel Bay
Structural Assessment Report

CANEEL BAY
PARK RETAINED STRUCTURES
STRUCTURAL ASSESSMENT REPORT

July 2025

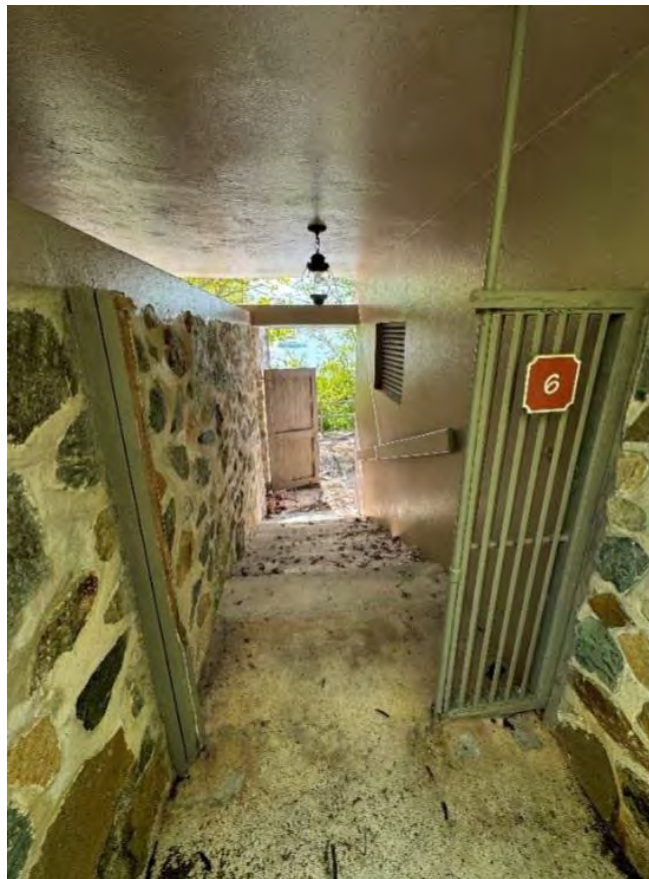
Figure 1 - Breezeway Stair to Cottage Entrance

The units have flat roofs with stepped sections at the breeze ways. The roofs are supported at the concrete and stone masonry walls that run north and south. Where there are non load bearing walls, there are steel posts that support the roof. The north edge of the roof cantilevers out beyond the bearing walls.

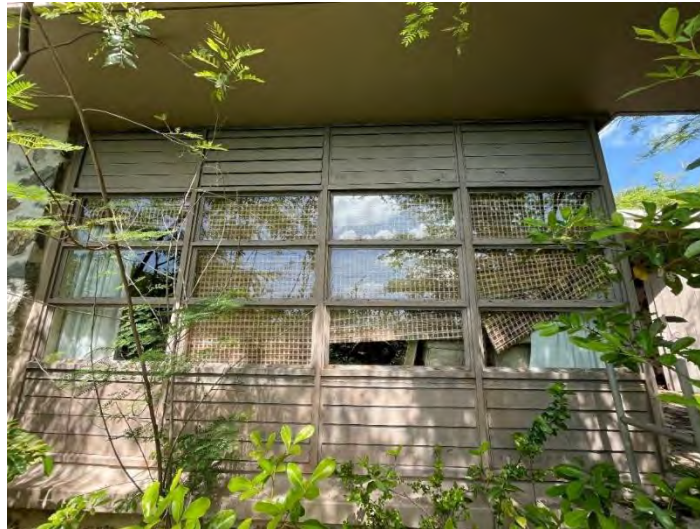
Figure 6 – North Facing Non-Load Bearing Walls

The wood exterior framing walls are non-load bearing. The north facing walls consist of wood framed glass, and louvered walls. The return walls consist of the entrance door and wood framed glass and louvered walls. The wood framing of the return walls show signs or significant damage including complete failure and extensive insect damage. The condition of these walls is important for maintaining the building envelope system.

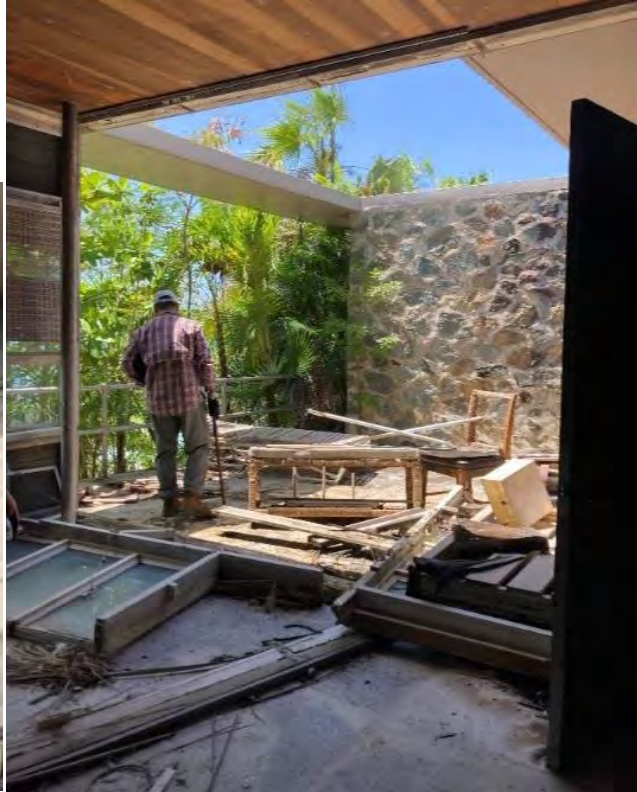
Figure 8 - Failed Return Wall

Cottage #	Observations
5	Rotten sill plate on return wall, rotted mullion by door, louver repair, 1 broken windowpane. North facing window wall in good condition.
6	Return wall has collapsed. North facing window wall in good condition.
8	Rotten sill plate on return wall, rotted mullion by door. North facing window wall in good condition.
9	Rotten sill plate on return wall, rotted mullion North facing window wall in good condition.
10	Rotten sill plate on return wall, rotted mullions. North facing window wall in good condition.

Cottages 5-13 are in generally good structural condition, however the building envelope is not secure. The non-structural return walls as indicated above are in poor condition or have completely failed. Standard maintenance including painting and roofing have been neglected which has led to interior damage of finishes.
