**VIRGIN ISLANDS NATIONAL PARK
Cruz Bay, St. John, U.S. Virgin Islands**

**CANEEL BAY
ADDITIONAL STRUCTURES
STRUCTURAL ASSESSMENT REPORT**

**NATIONAL PARK SERVICE (NPS)
SOUTH EAST REGION (SER)**

July 2025

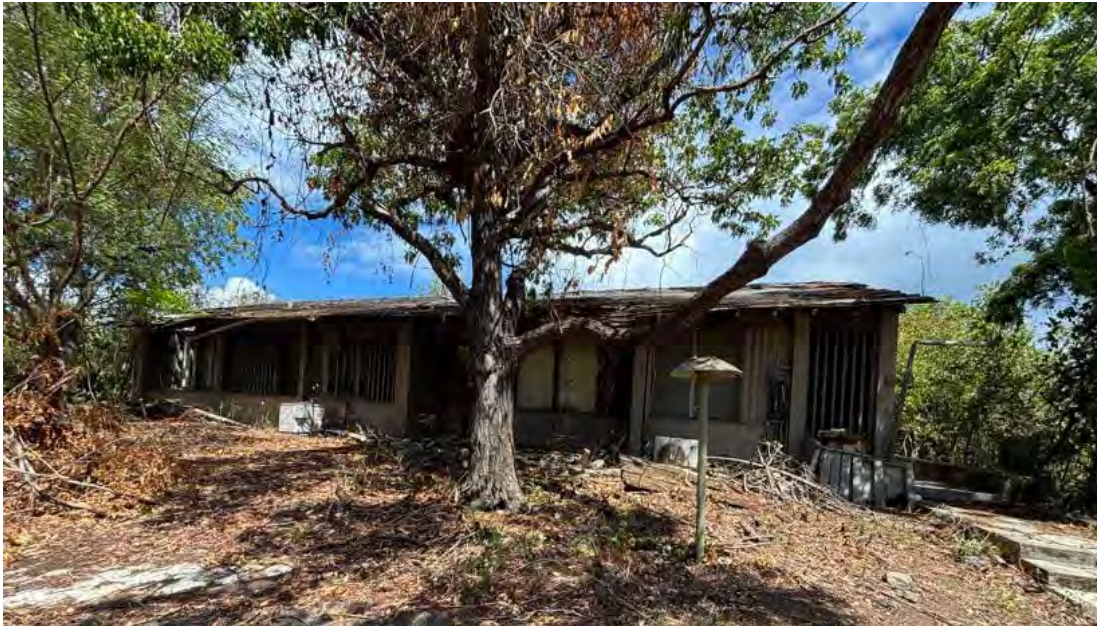
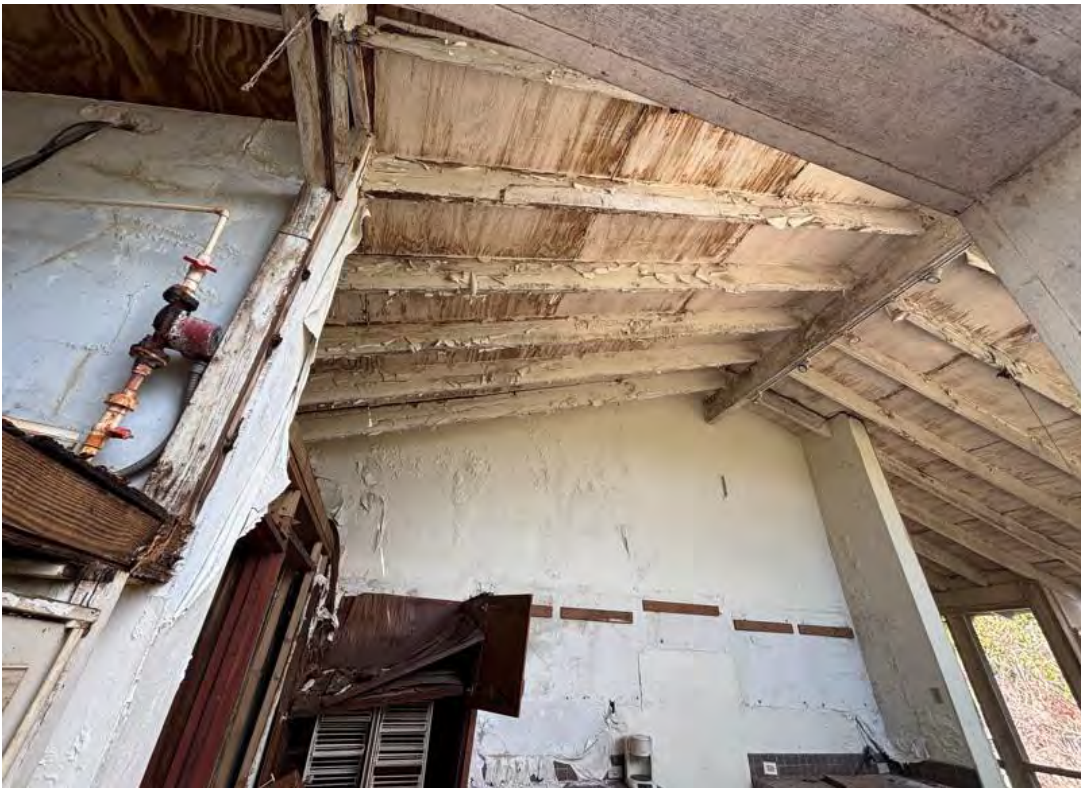
Component	Material	Notes
Floor	Concrete	
Walls (Structural)	Wood	Exterior walls are wood framed with wood lintels over windows / doors and wood posts. Wood showed significant signs of water and insect damage throughout the building.
Walls (Non-Structural)	Concrete / Wood	Concrete walls at interior of building were non-load bearing.
Roof	Wood Framed / Wood Shingles	Wood rafters and roof sheathing was significantly deteriorated with rot, insect damage, cracks, and rotation. Roof is partially missing on west side.
Sidewalks	Concrete

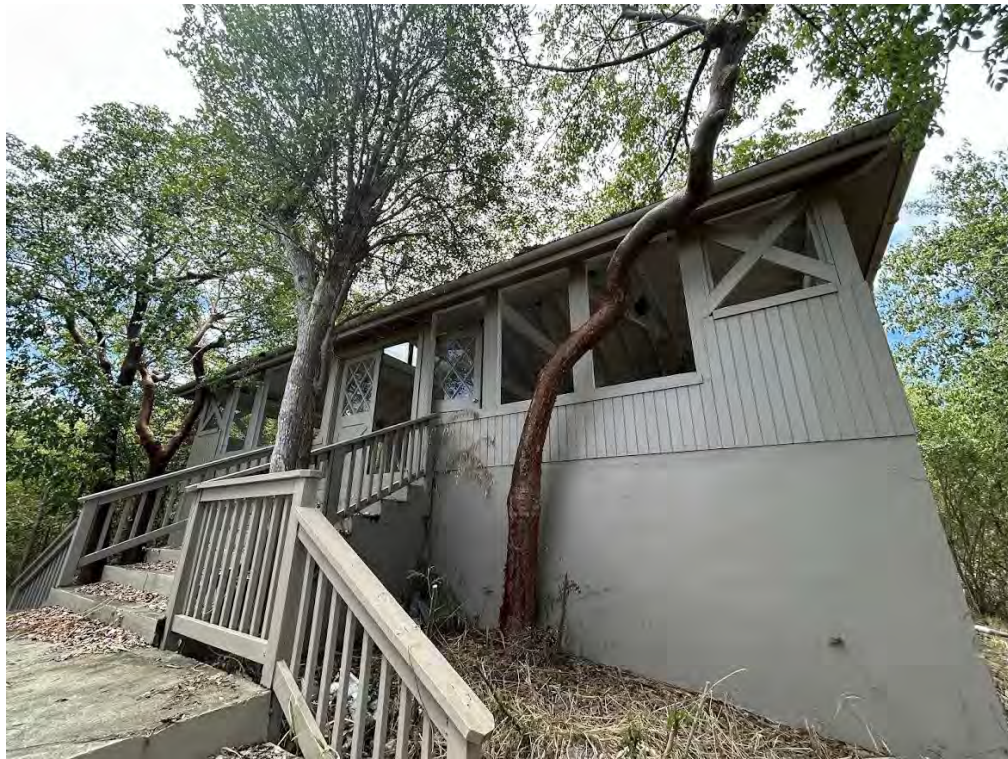
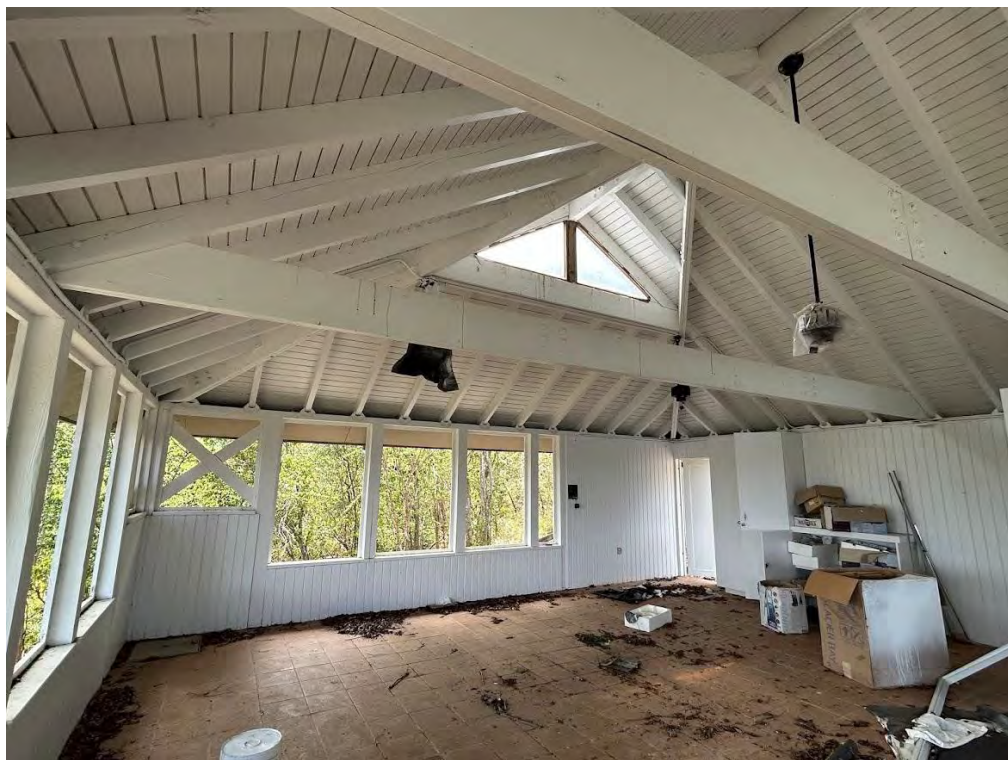
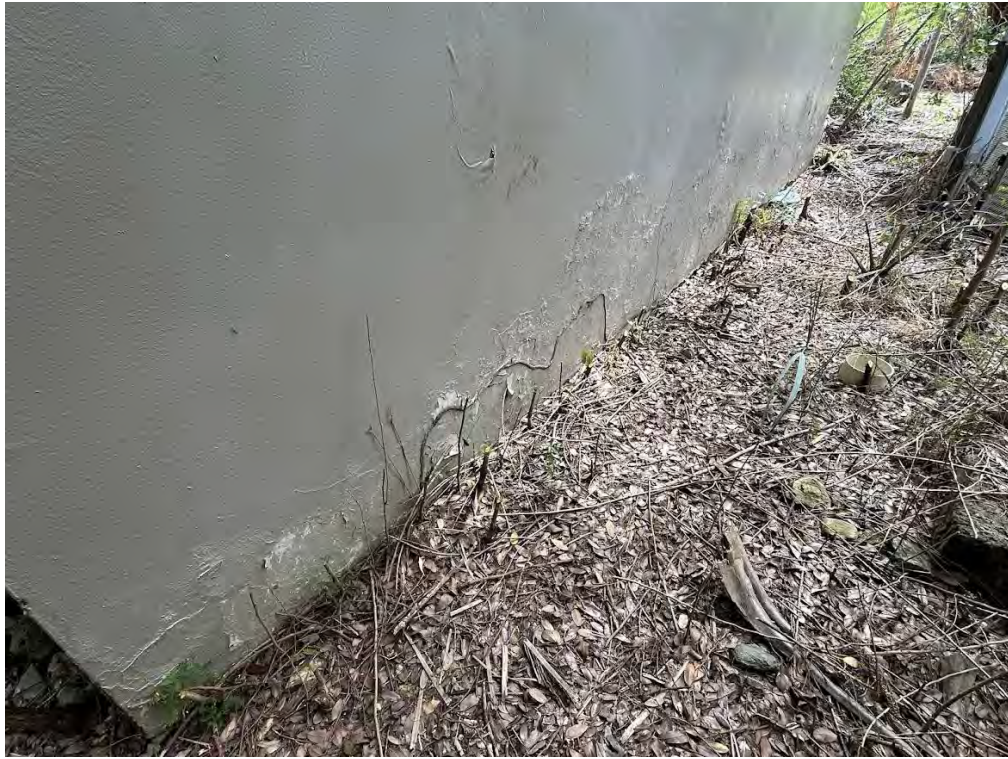
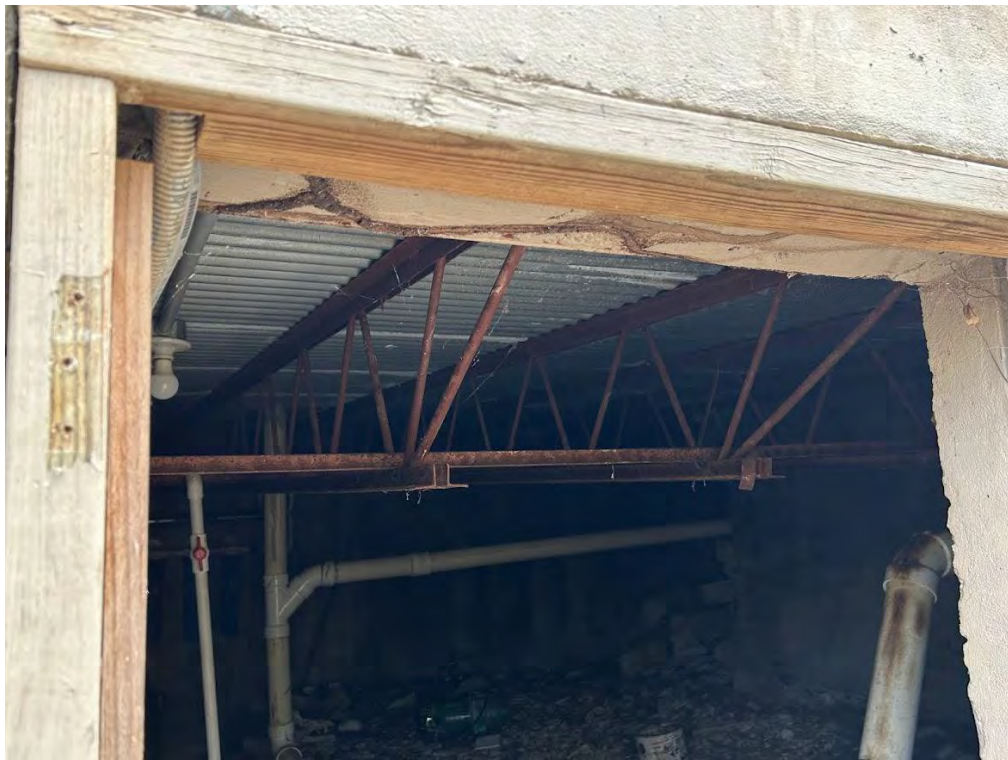
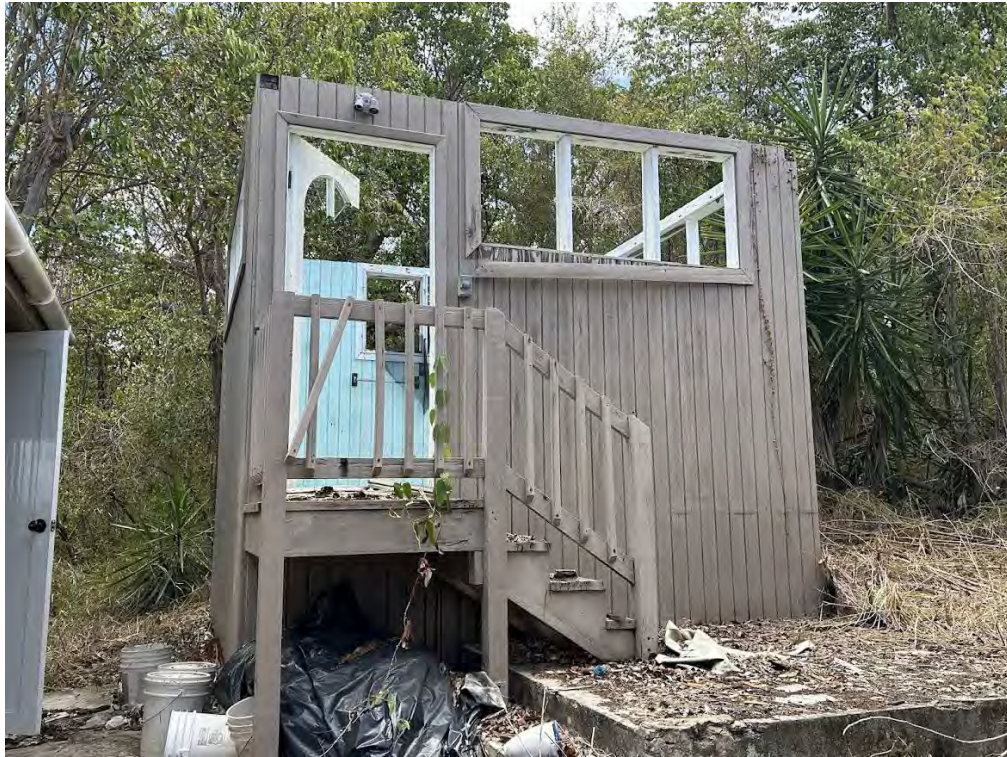
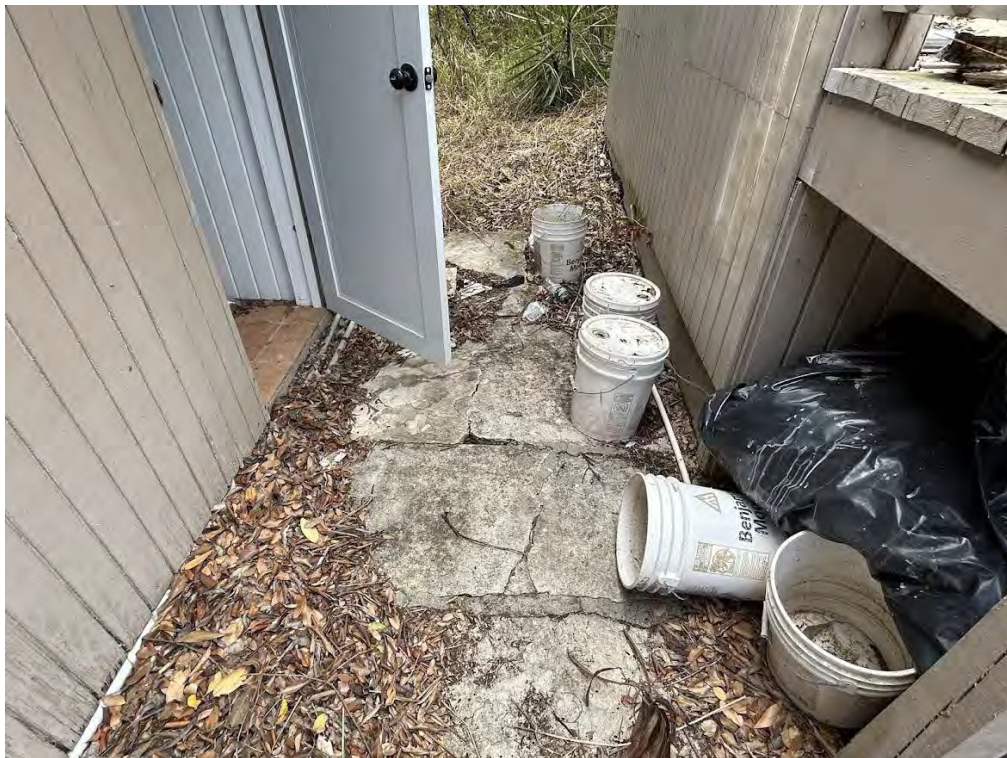
Component	Material	Notes
Floor	Concrete Slab on Steel Bar Joists	Corrosion on steel joists.
Walls (Structural)	Wood framed	
Walls (Non-Structural)	N/A	
Roof		
Stairs/Railings		
Sidewalk	Concrete	The concrete at the south exit between the main structure and the accessory structure

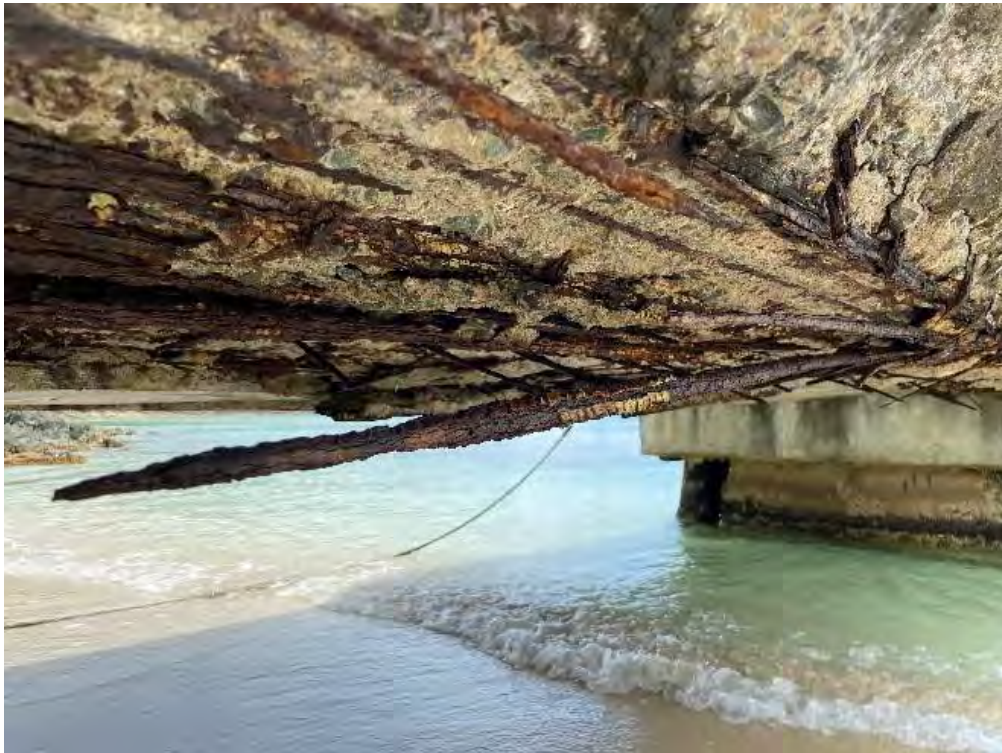
The topping slab on the planks is cracked and not bonded to the planks in some locations. The planks appear to be in generally good condition when viewed from the pier. However, inspection from the underside shows there is some significant damage to the underside of the planks. The concrete planks of the first full bay are in the worst condition. The bottom concrete has completely spalled off, the epoxy coating on most of the exposed rebar is completely gone and the rebar is severely corroded. The next bay of planks shows signs of delaminated concrete and rusting rebar but is less severe than the first bay. Conditions for the remainder of the pier range from good condition to severely corroded.

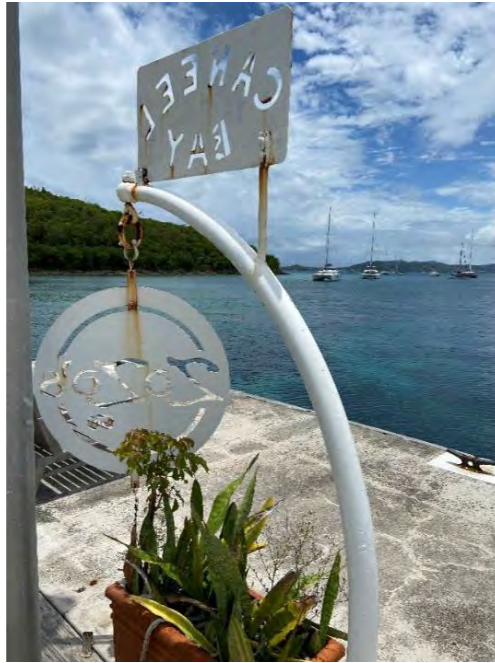
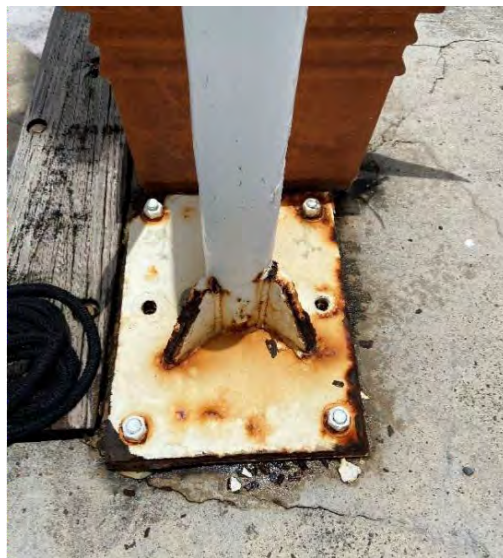
The dock supports a metal sign supported on a curved pipe post. The post base plate is surface mounted with post-installed anchors to the deck top. The post also supports a ZoZo's sign for the nearby restaurant. The steel base plate of the sign is significantly rusted.

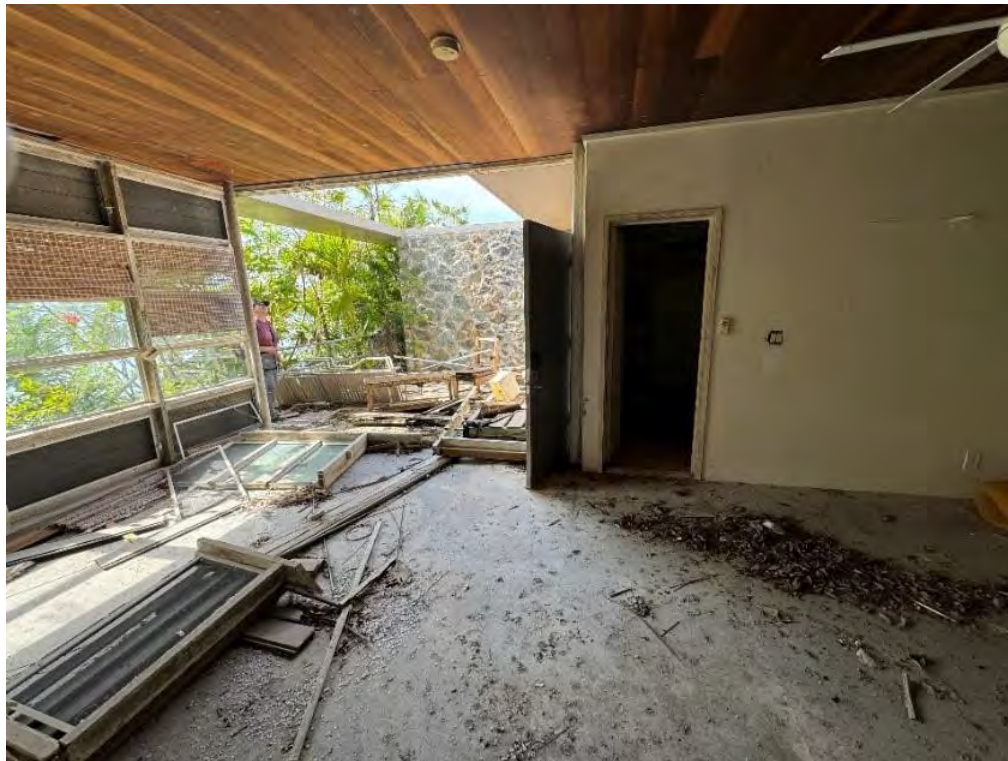
Figure 2 - Failed Return Wall

Cottages 5-13 are in generally good structural condition, however the building envelope is not secure. The non-structural return walls as indicated above are in poor condition or have completely failed. Standard maintenance including painting and roofing have been neglected which has led to interior damage of finishes.

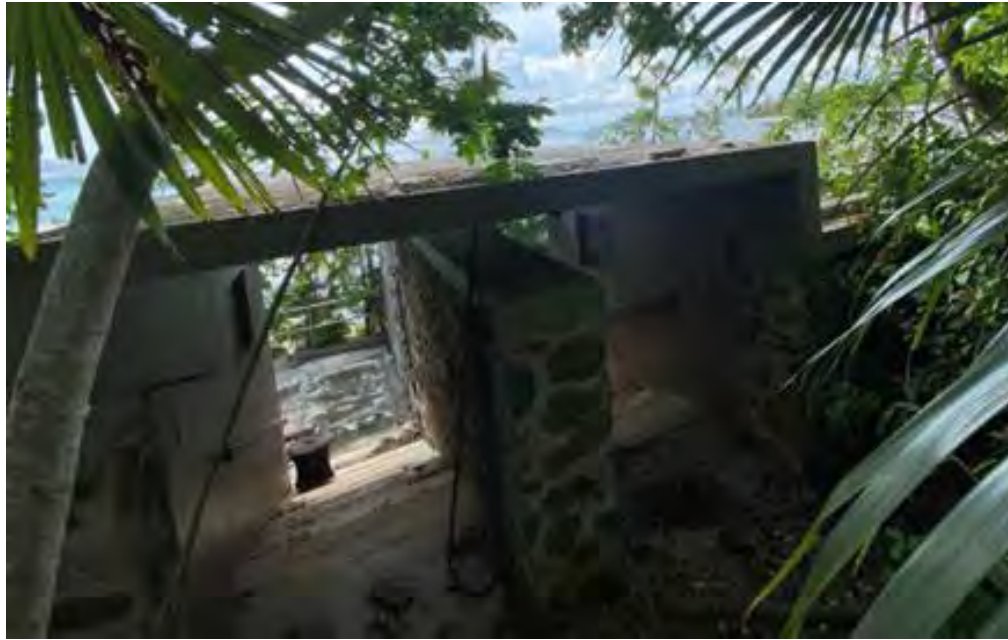
Figure 5 – Flat Roof over Breezeway Stairs

The roof was not accessible for examination. The exact age and type of the existing roof coating material is unknown. Based on existing documentation the roof is thought to have waterproof elastomeric paint system with approximately a 10 year life span. Standing water on some roofs indicate clogged drains. Water damage on the interior ceiling finishes indicate the roof system is failing in some locations.

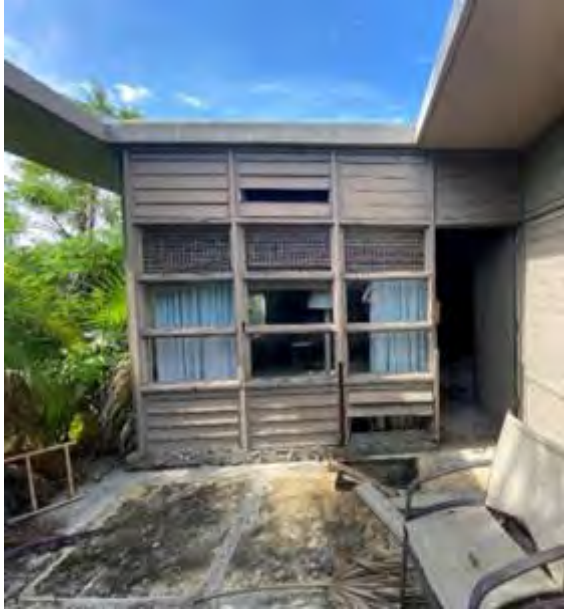
Figure 7 - Return Wall in Poor Condition

Cottage #	Observations
11	Rotten sill plate on return wall, rotted mullions. North facing window wall in good condition.
12	Rotten sill plate on return wall. Return wall moves and is not stable North facing window wall in good condition.
13	Rotten sill plate on return wall, rotted mullions. North facing window wall in good condition.
