**VIRGIN ISLANDS NATIONAL PARK**  
**Cruz Bay, St. John, U.S. Virgin Islands**

**CANEEL BAY**  
**STRUCTURAL ASSESSMENT REPORT**

NATIONAL PARK SERVICE (NPS)  
SOUTH EAST REGION (SER)

July 2025

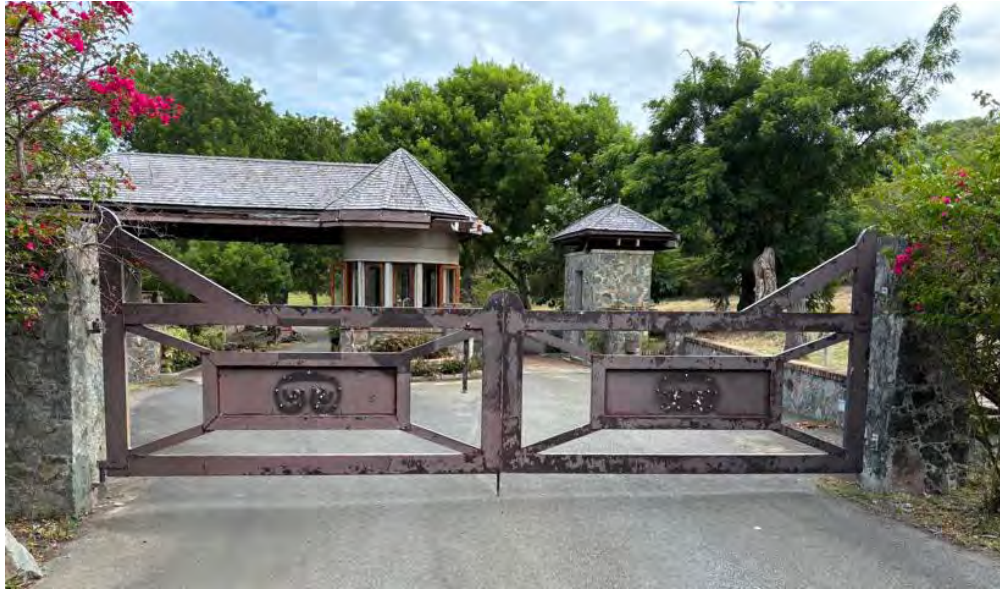
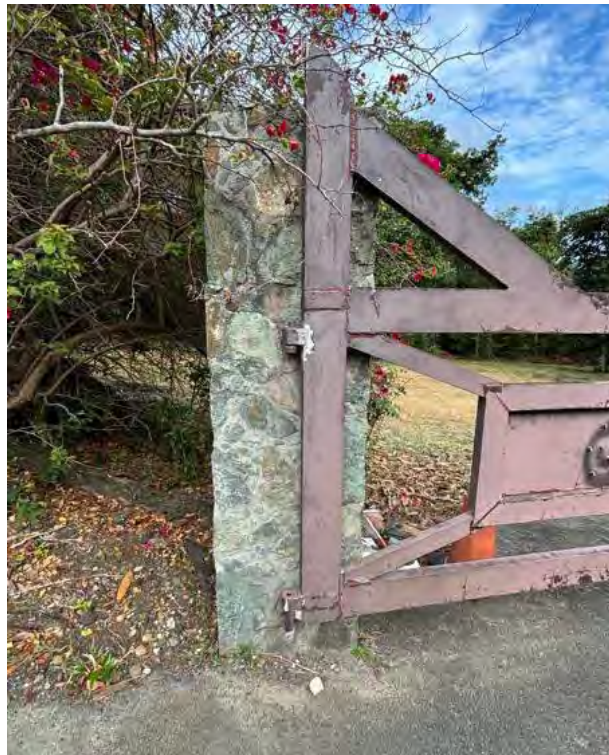
**Building: 88 Welcome Center Gate**

| Component | Material | Notes |
|---|---|---|
| Gate | Aluminum | Each gate leaf is approximately 116" wide by 78" tall and constructed with 2" deep painted aluminum tubes.<br>The east gate has damage to one of the vertical leaf sections |

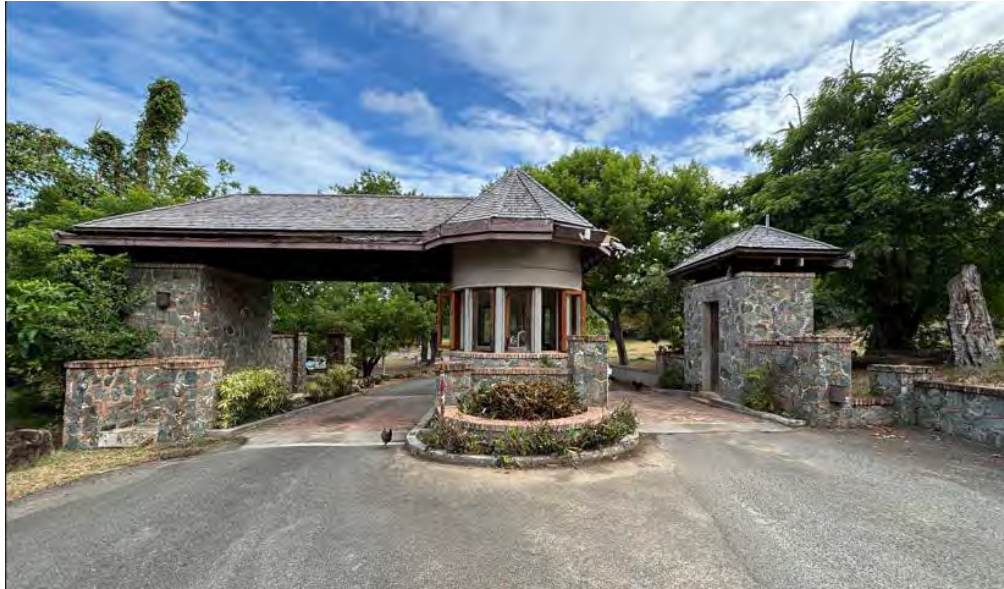
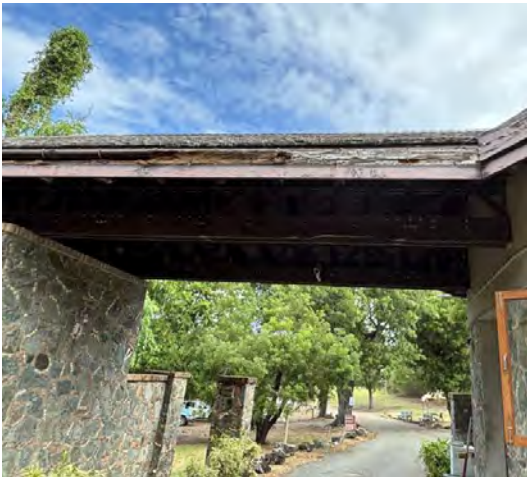
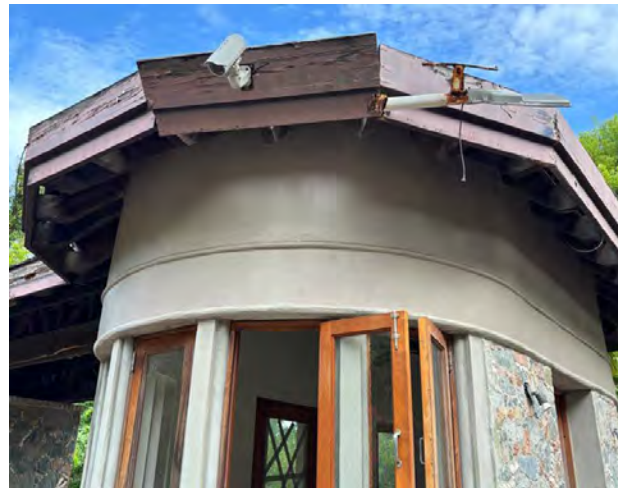
**Building: 88 Welcome Center**

| Component | Material | Notes |
|---|---|---|
| Roof | Timber Truss /<br>Timber Rafters<br>/ Wood<br>Shingles | Signs of termite activity.<br>Impact damage bottom chord of truss.<br>The secondary framing rafters showed<br>signs of excessive termite and water<br>damage in select areas. Damage was<br>especially prevalent at the hip rafter over<br>the storage room and comfort station. |

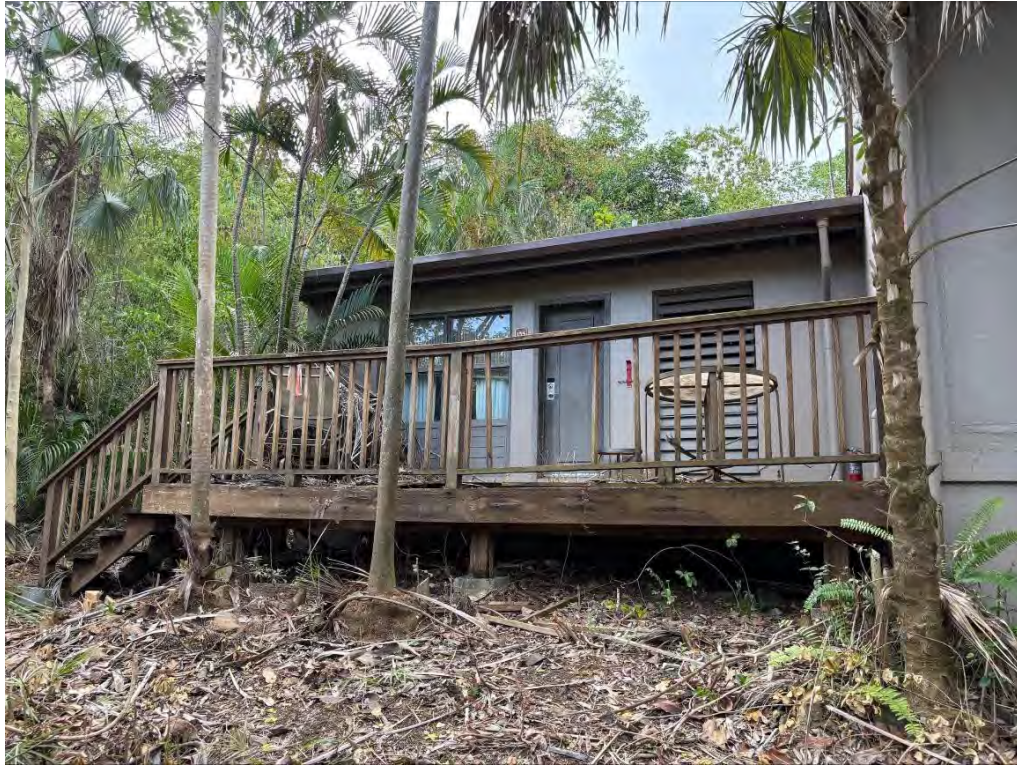
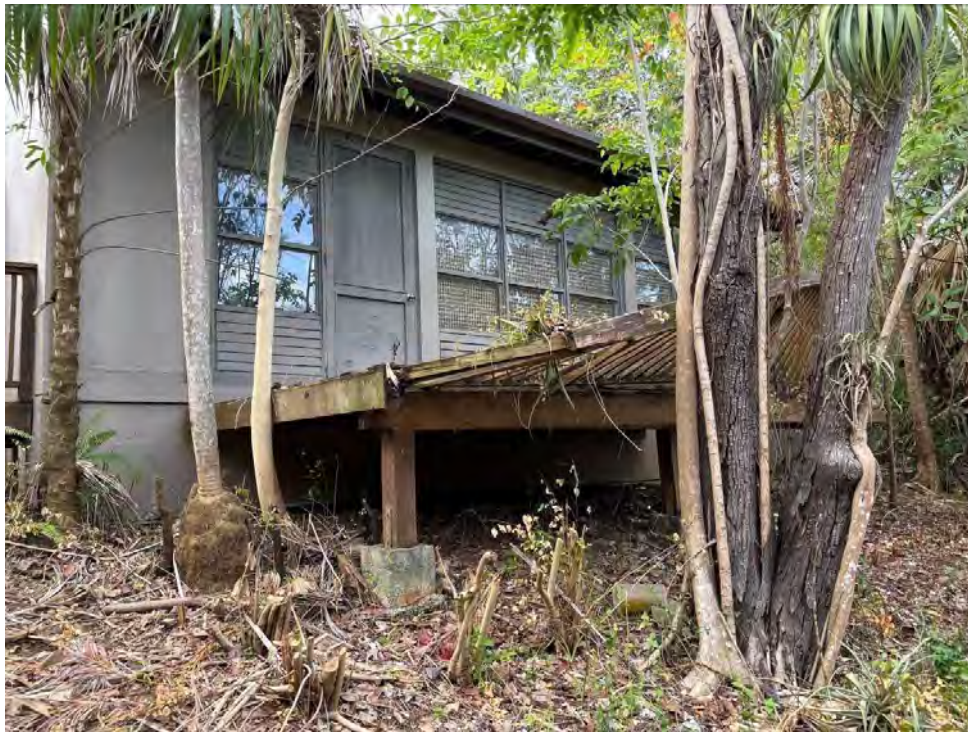
**Building: 57 Garden View Units 132-133**

| Component | Material | Notes |
|---|---|---|
| Walls (Structural) | Concrete | Cracks at NE wall corner, NW foundation of 132, and vertical crack in dividing wall between 131 and 132. |
| Roof | Wood framed/<br>Metal Roof | Vegetation growing in gutter, termite damage potential |
| Deck / Railings | Wood | Decks and railings have failed. |

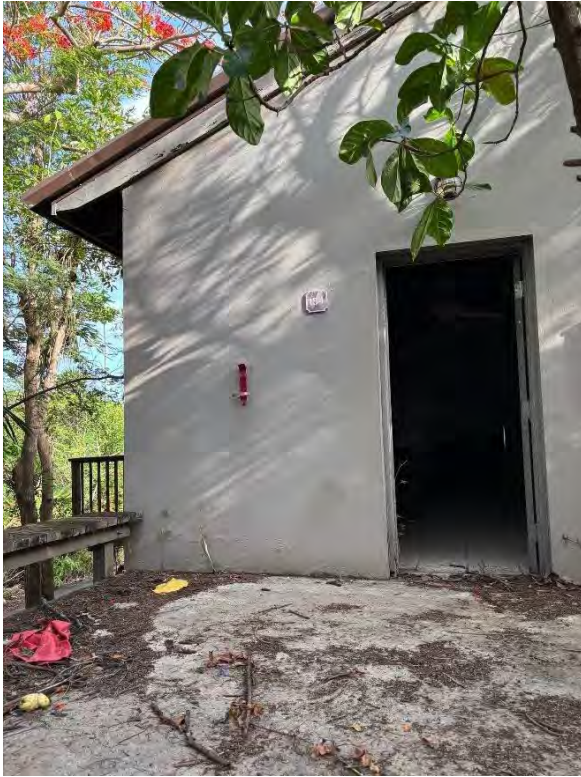
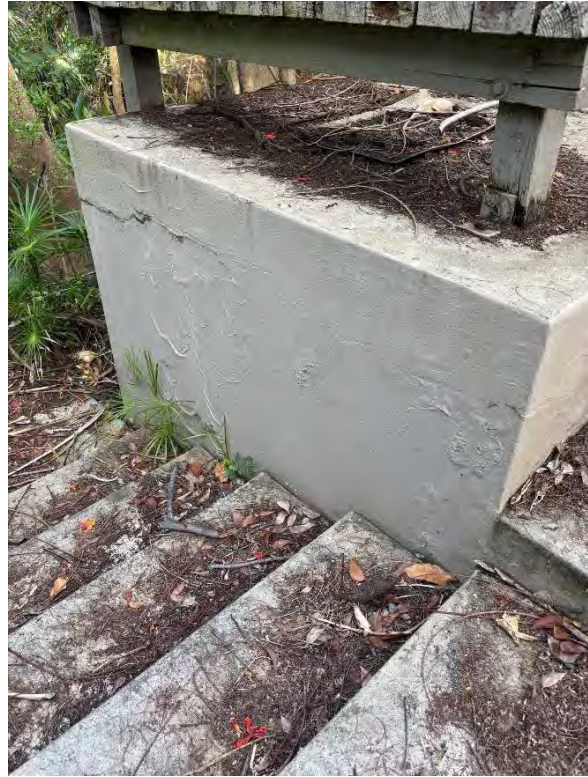
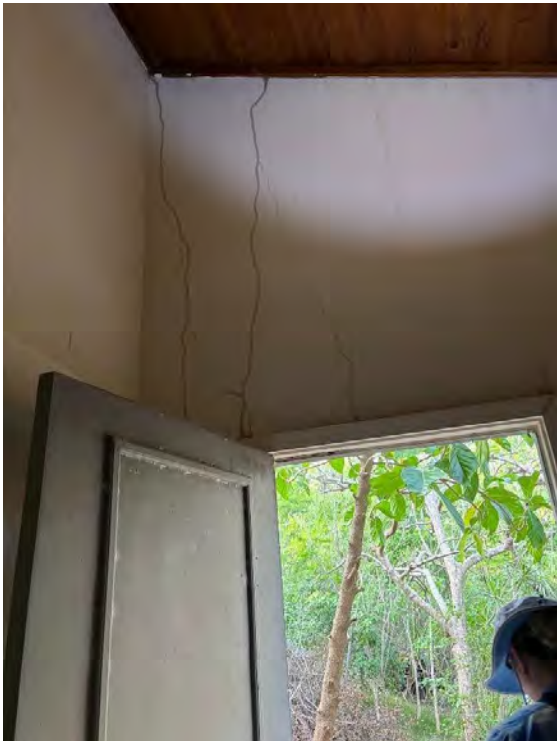
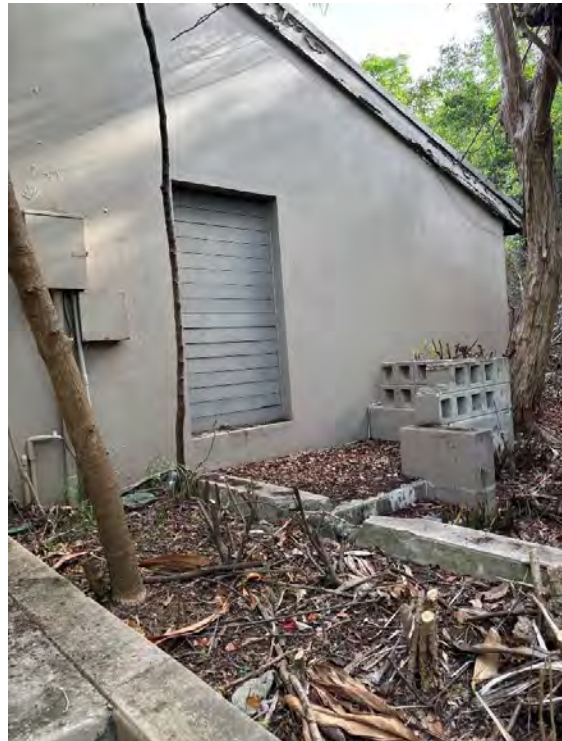
**Building: 50 Garden View Units 134-135**

| Component | Material | Notes |
|---|---|---|
| Walls (Structural) | Concrete | Moisture infiltration at north side of 135. |
| Roof | Wood<br>framed/<br>Metal Roof | Vegetation growing in gutter. Potential<br>termite damage. |
| Deck / Railings | Wood | Decks and railings have failed. |

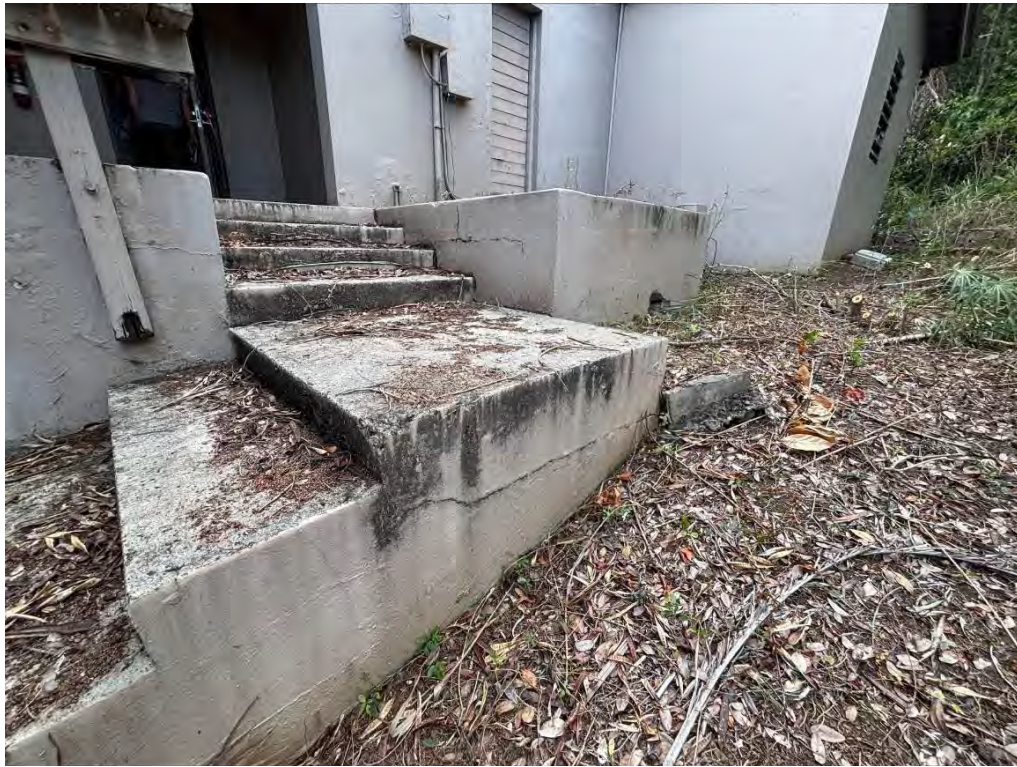
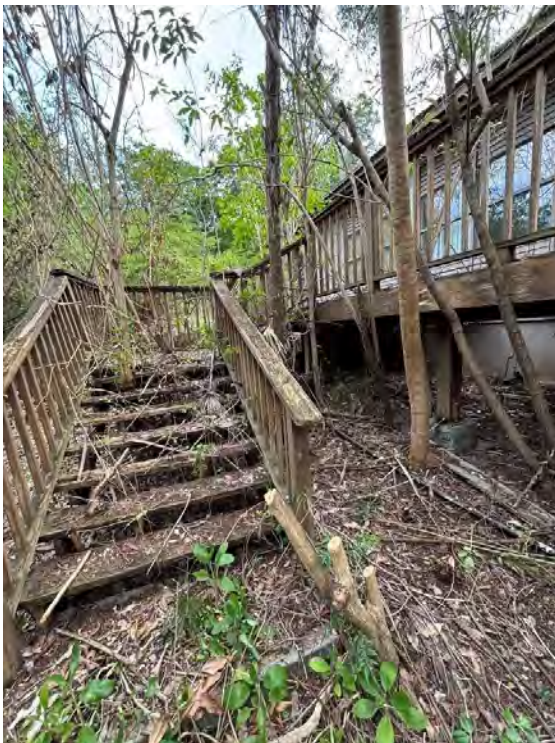
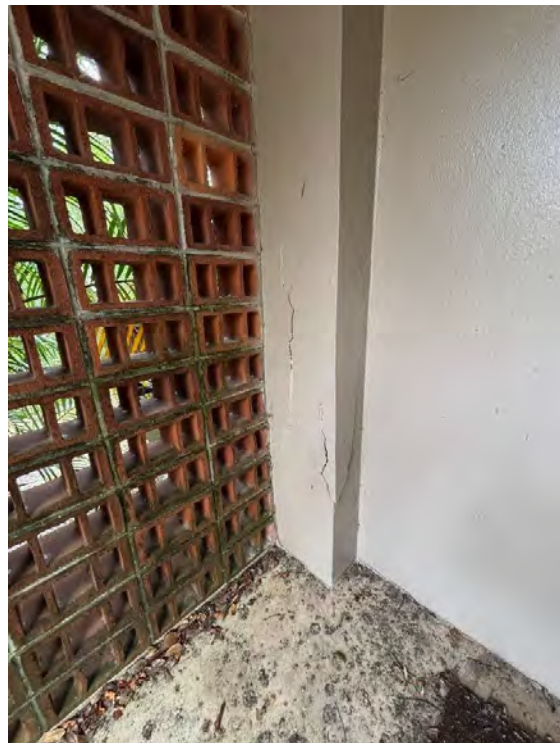
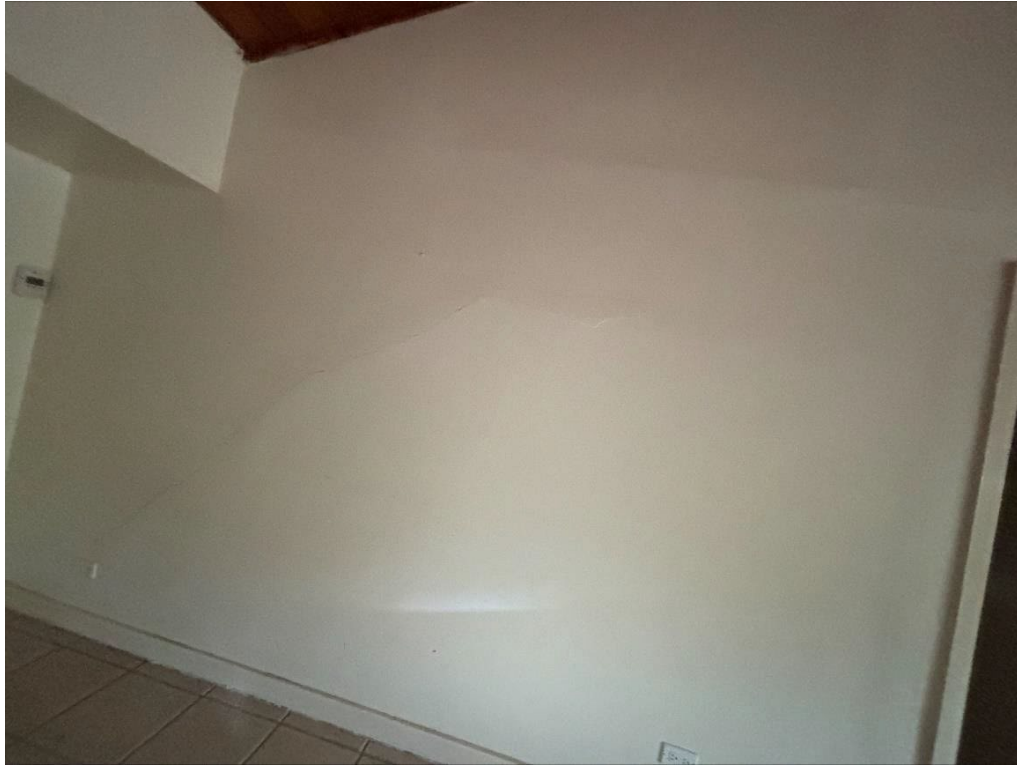
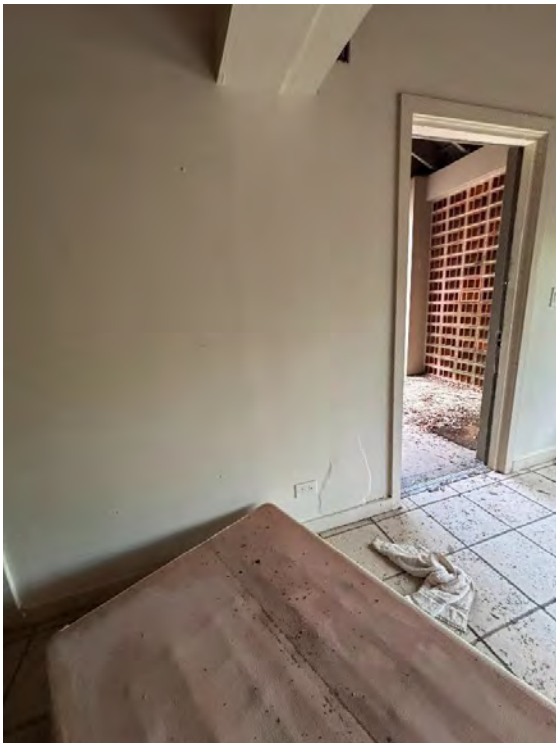
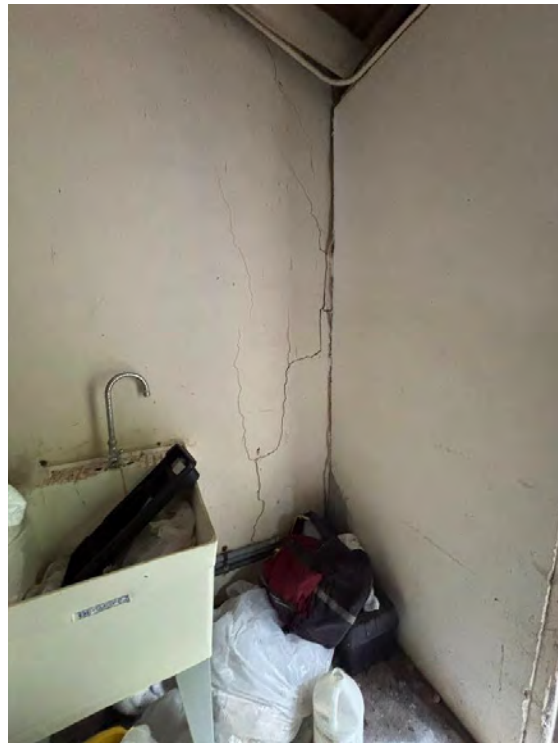
**Building: 49 Garden View Units 136-138**

| Component | Material | Notes |
|---|---|---|
| Walls (Structural) | Concrete | Cracks observed in walls running north-south.<br>Crack in north wall of custodial closet.<br>Widening gap between custodial closet and main building.<br>Cracks observed in concrete column and concrete wall near entrance of 136. |
| Walls (Non-Structural) | Concrete / Wood | Cracks observed in concrete partition walls running north-south. |
| Roof | Wood framed / Metal Roof | Vegetation growing in gutter. Potential termite damage. |
| Deck / Railings | Wood | Decks and railings have failed. |

- Recommend further investigation to identify underlying problems causing wall cracking. There is evidence of previous repairs at cracks that have failed. Wall cracks indicate that there may be differential foundation movement.

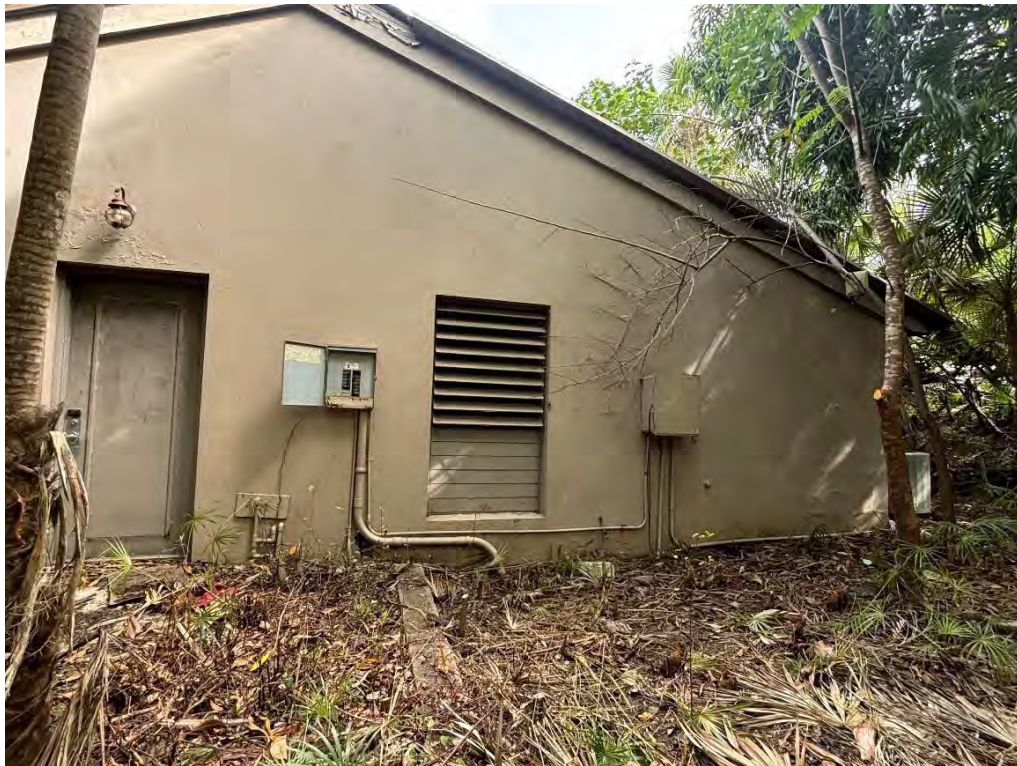
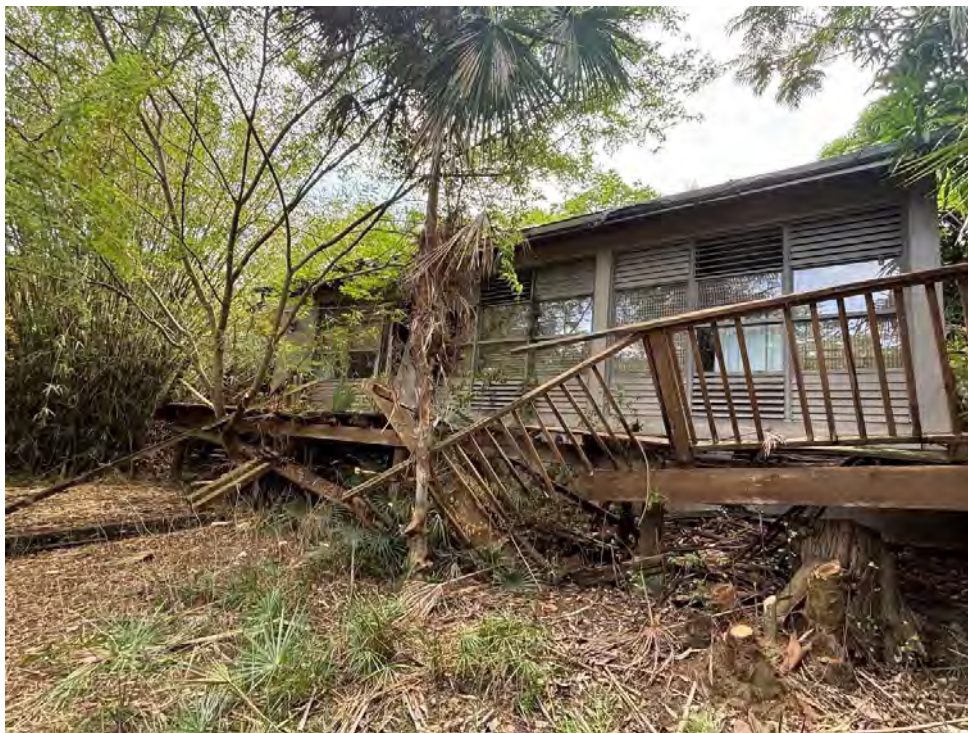
**Building: 51 Garden View Units 139-140**

| Component | Material | Notes |
|---|---|---|
| Walls (Structural) | Concrete | Vertical crack in south wall of 140. Vertical crack with signs of previous repair on north wall of 139, water infiltration and spalling of parging on interior face of wall. |
| Roof | Wood<br>framed/<br>Metal Roof | Vegetation growing in gutter. Potential termite damage. |
| Deck / Railings | Wood | Decks and railings have failed. |

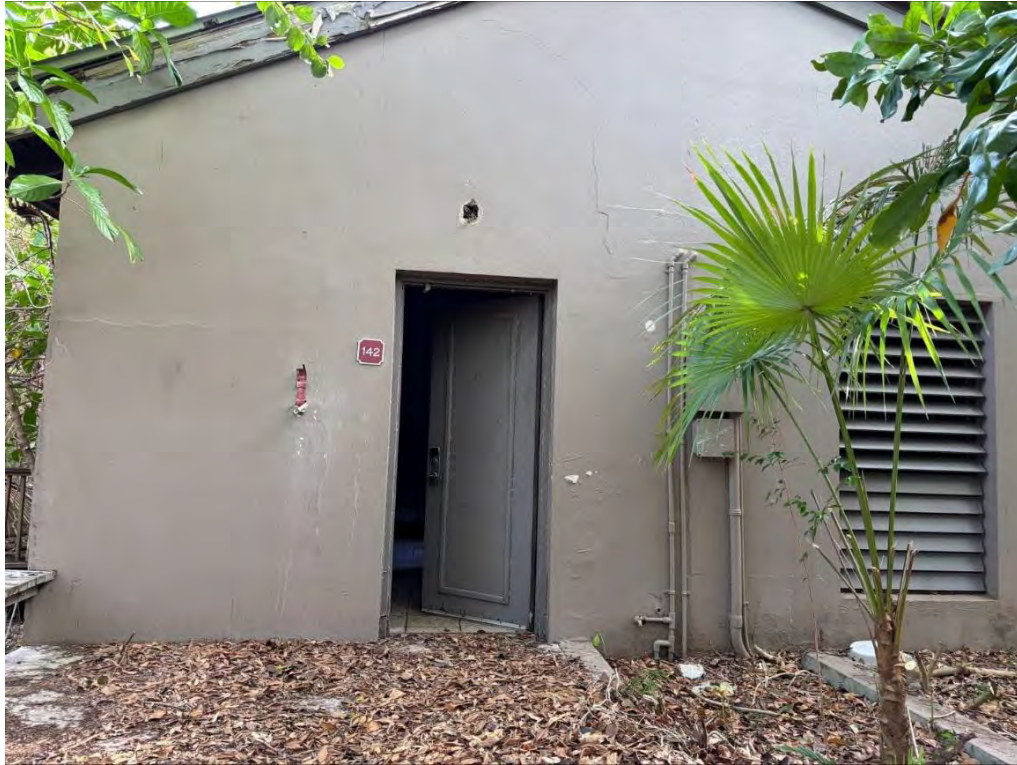
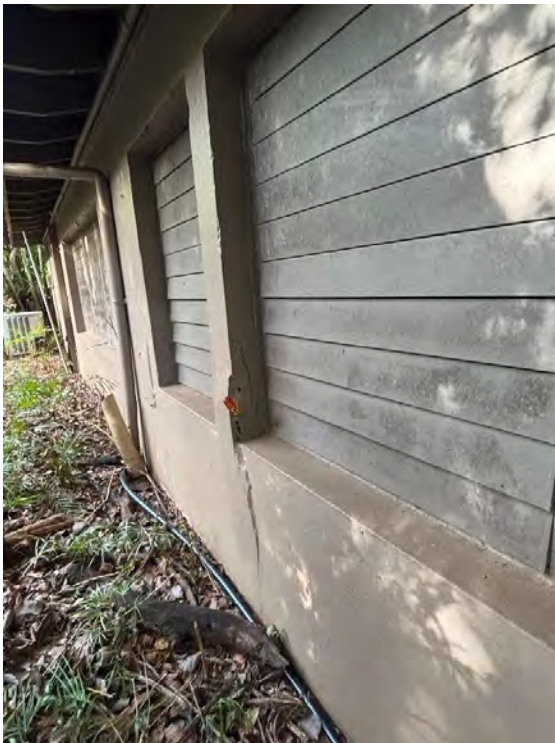
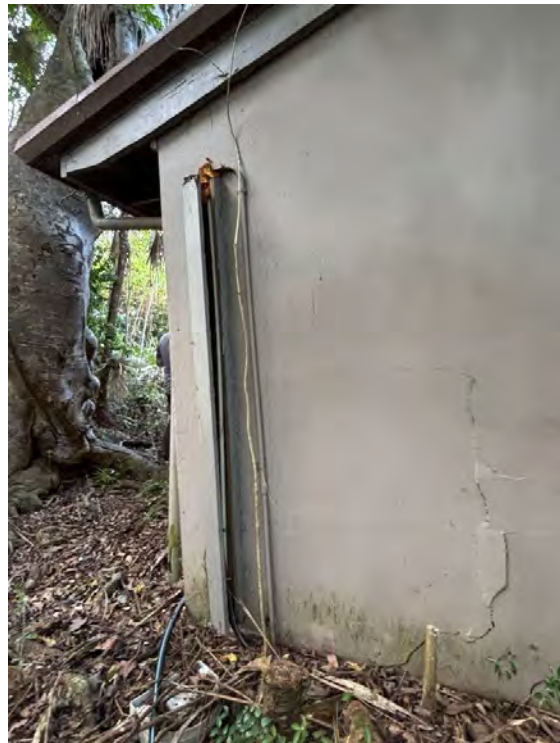
**Building: 52 Garden View Units 141-142**

| Component | Material | Notes |
|---|---|---|
| Walls (Structural) | Concrete | Cracked column on east side of building. |
| Roof | Wood<br>framed/<br>Metal Roof | Vegetation growing in gutter. Potential termite damage. |
| Deck / Railings | Wood | Decks and railings have failed. |

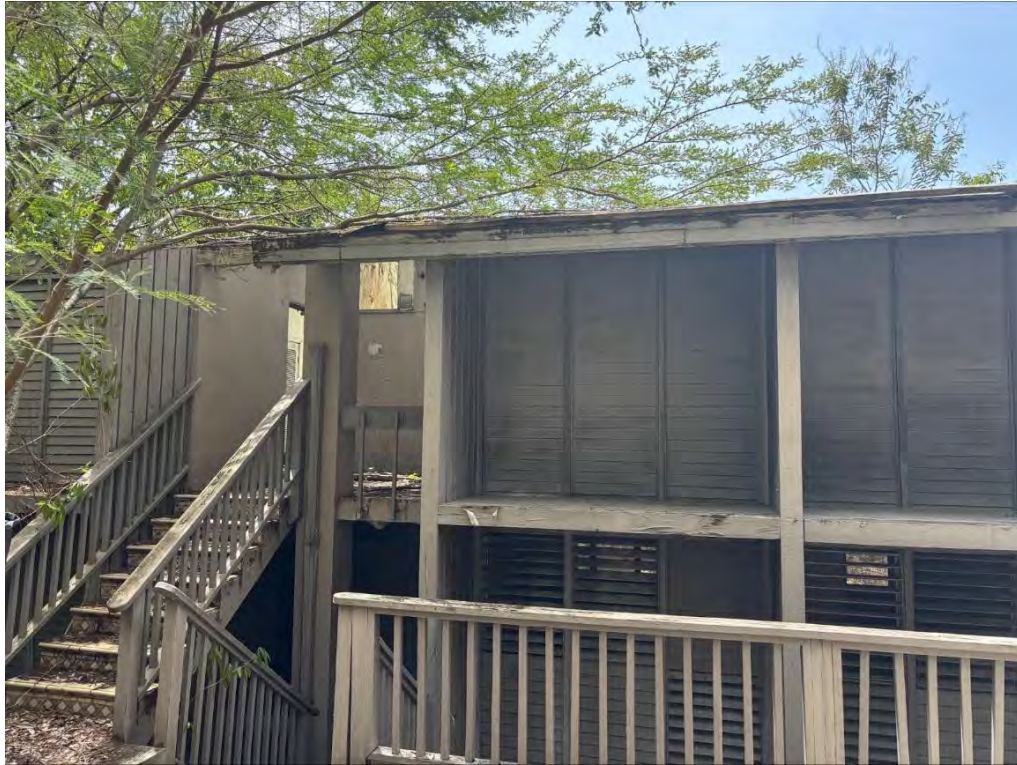
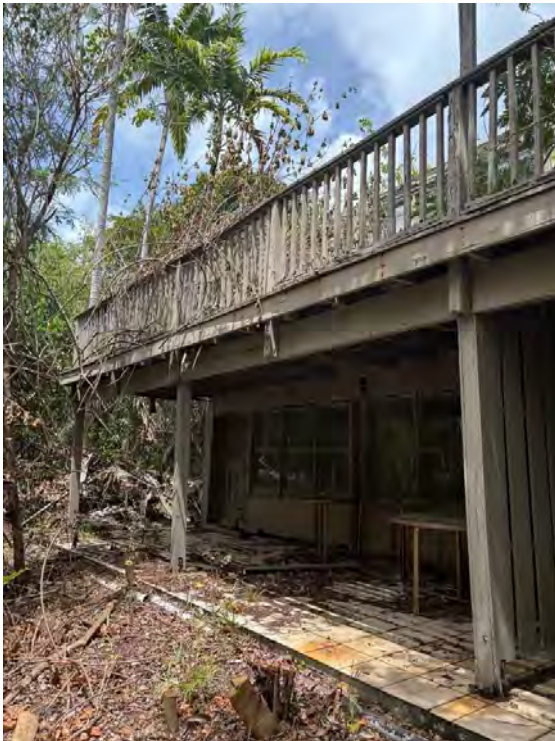
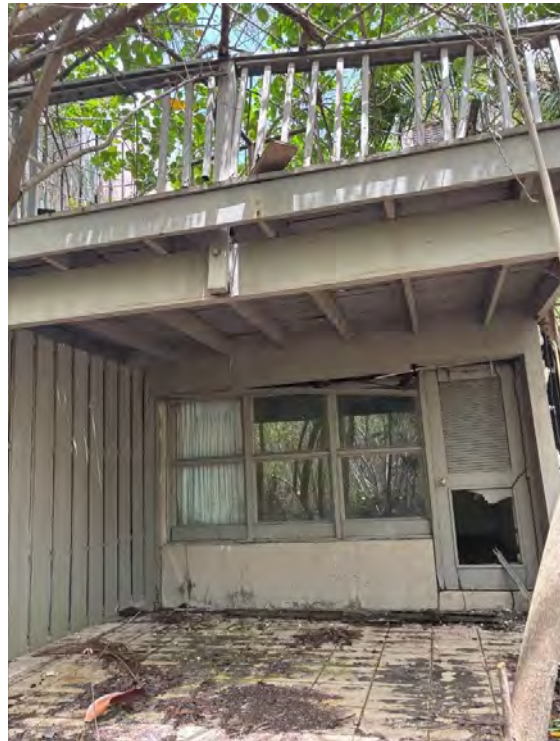
**Building: 53 Courtside Units 143-152**

| Component | Material | Notes |
|---|---|---|
| Walls (Non-Structural) | Wood | Severe deterioration. Most of the exterior north facing walls have completely failed on the 2 <sup>nd</sup> floor and severely damaged on the 1 <sup>st</sup> floor. |
| Roof | Wood | Severe failure. A significant percentage of the wood roof has collapsed. Termite tubes noted throughout the structure. |
| Stairs/Railings | Stairs – Concrete<br>Railings - Wood | Wood railings are damaged and rotten. |
| Exterior Deck | Wood | Severe deterioration of all exterior decks. Unsafe to walk on. |

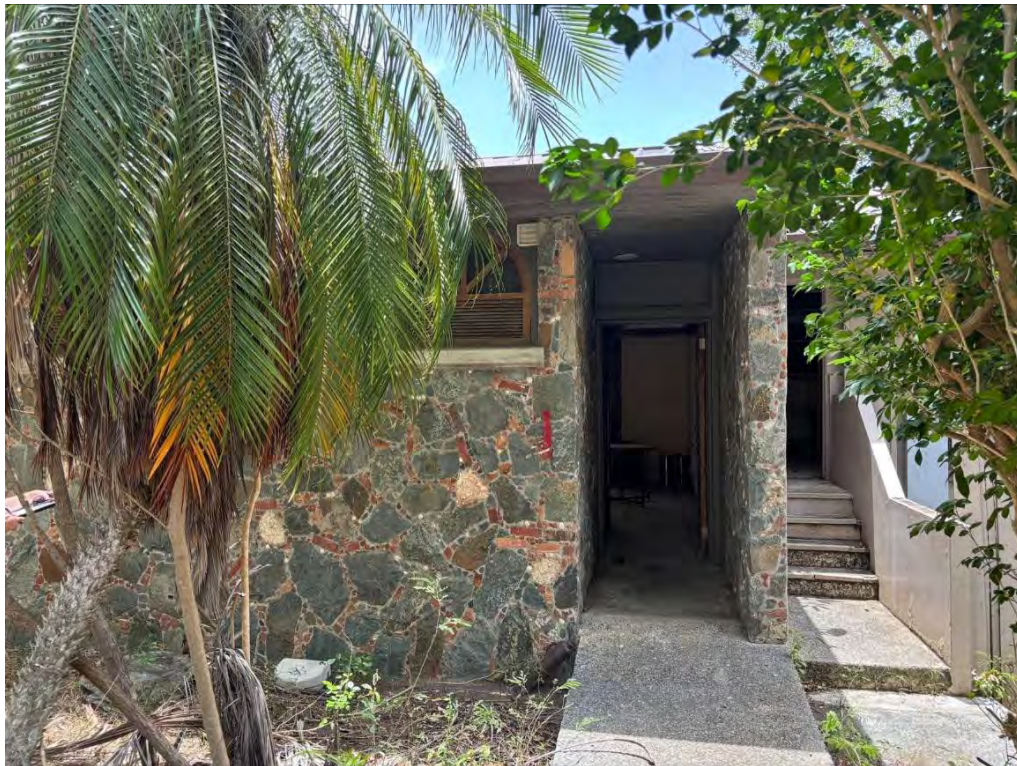
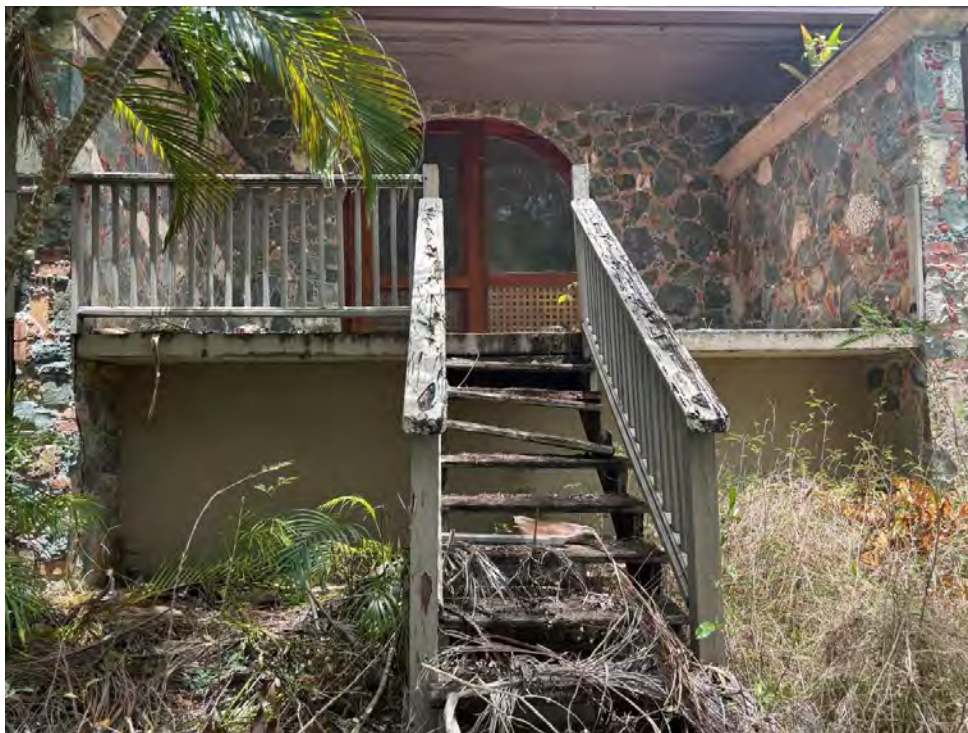
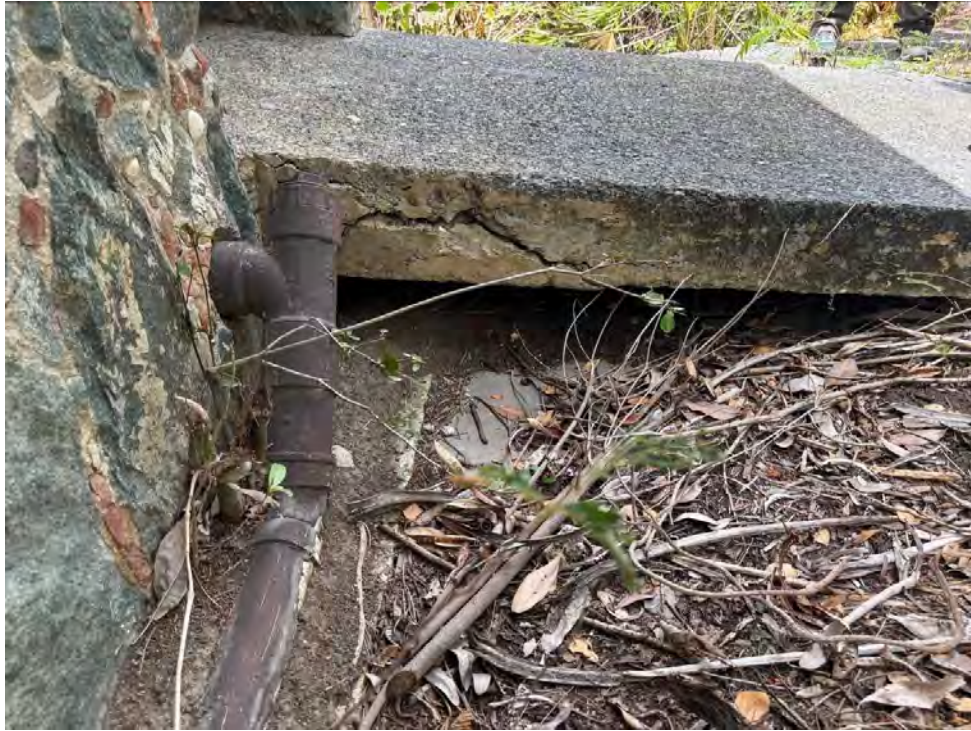
**Building: 54 Garden View Unit 153**

| Component | Material | Notes |
|---|---|---|
| Walls (Structural) | Stone | Termite tubes observed. |
| Roof | Wood Framed /<br>Metal Roof | Vegetation growing in gutter. Potential termite damage. |
| Stairs/Railings | Wood | Severely deteriorated. |
| Sidewalk | Concrete | Cracked and spalled concrete at elevated slab portion. |

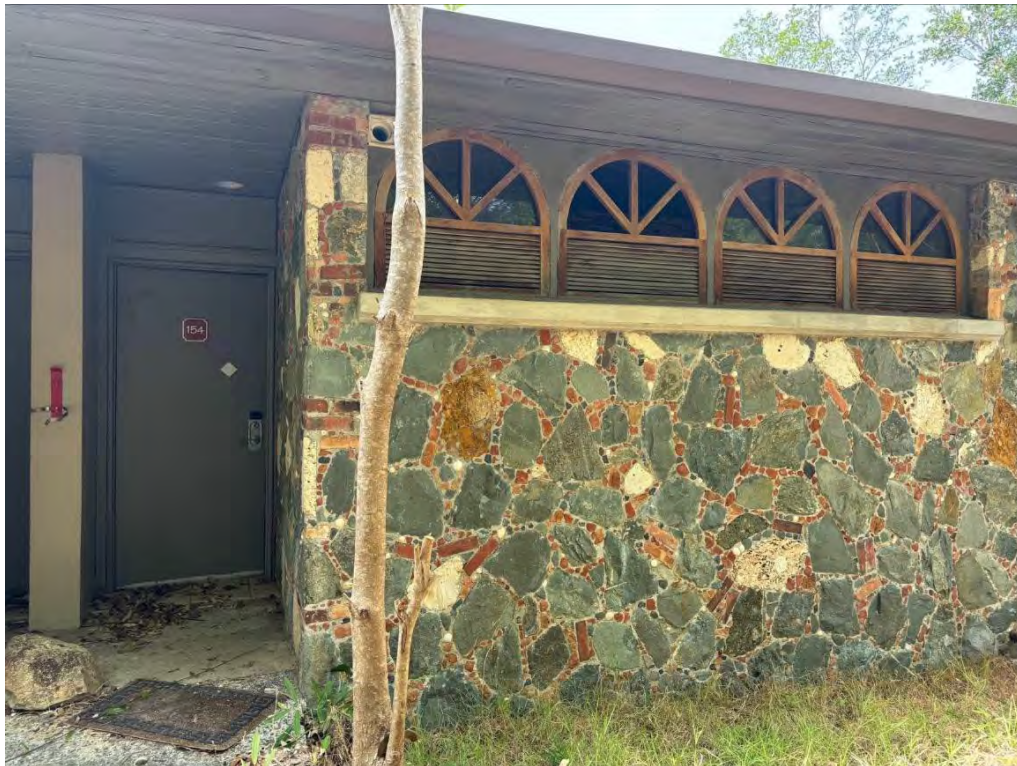
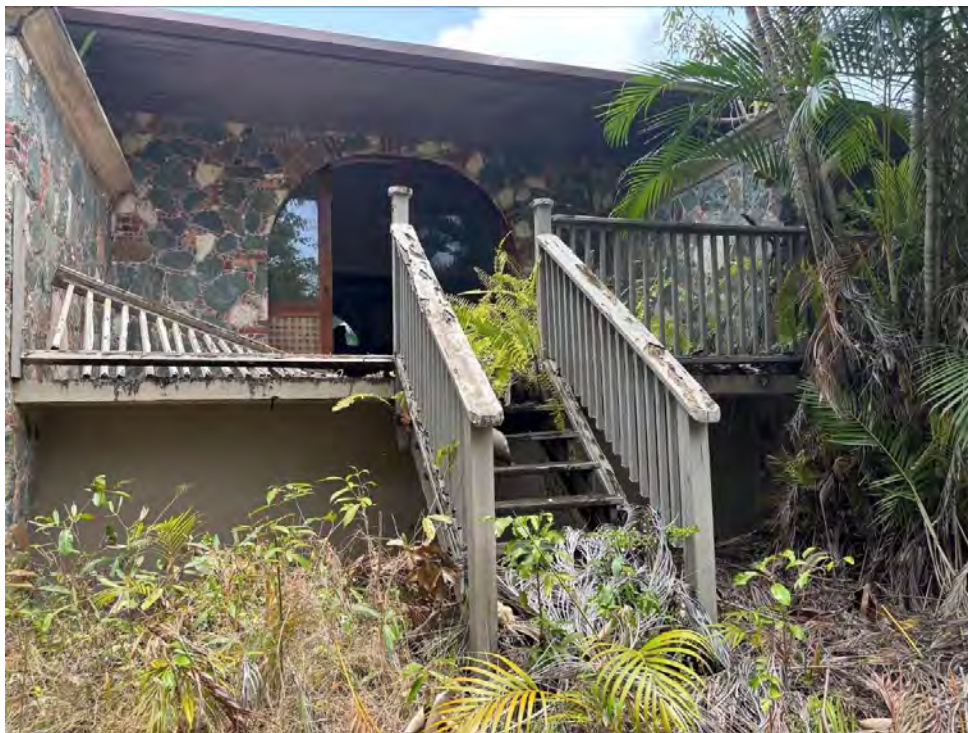
**Building: 54 Garden View Unit 154**

| Component | Material | Notes |
|---|---|---|
| Walls (Non-Structural) | Stone | Exterior concrete cap is spalling. |
| Roof | Wood Framed /<br>Metal Roof | Vegetation growing in gutter. Potential termite damage. |
| Stairs/Railings | Wood | Severely deteriorated. |

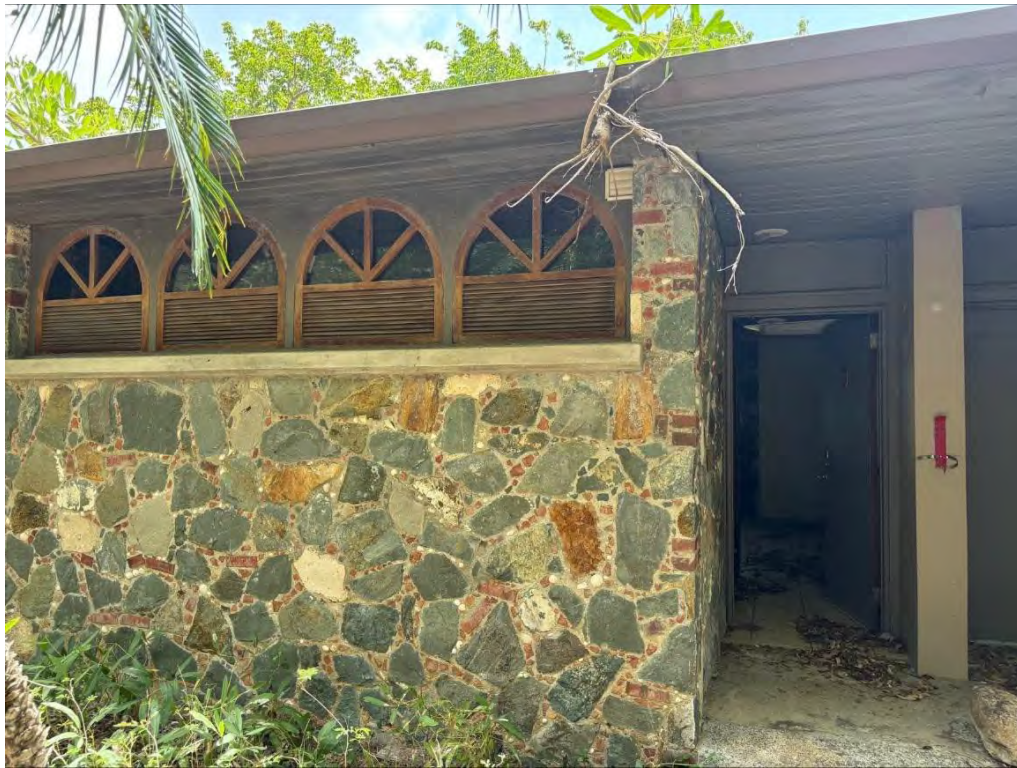
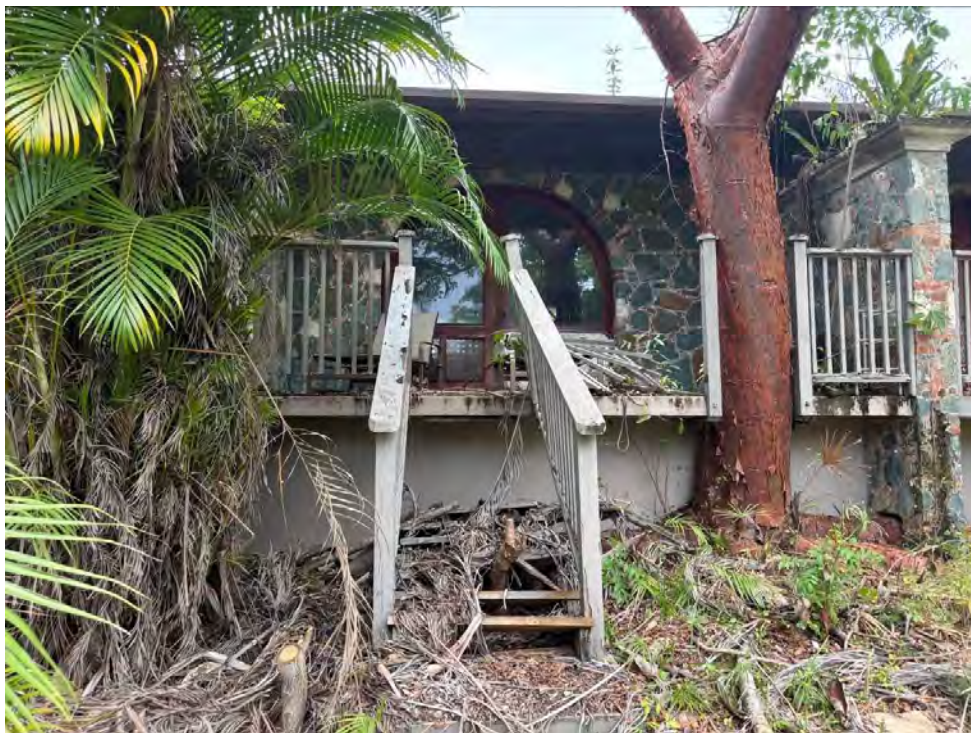
**Building: 54 Garden View Unit 155**

| Component | Material | Notes |
|---|---|---|
| Walls (Structural) | Stone | Termite tubes observed. |
| Roof | Wood Framed /<br>Metal Roof | Vegetation growing in gutter. Potential termite damage. |
| Stairs/Railings | Wood | Severely deteriorated. |

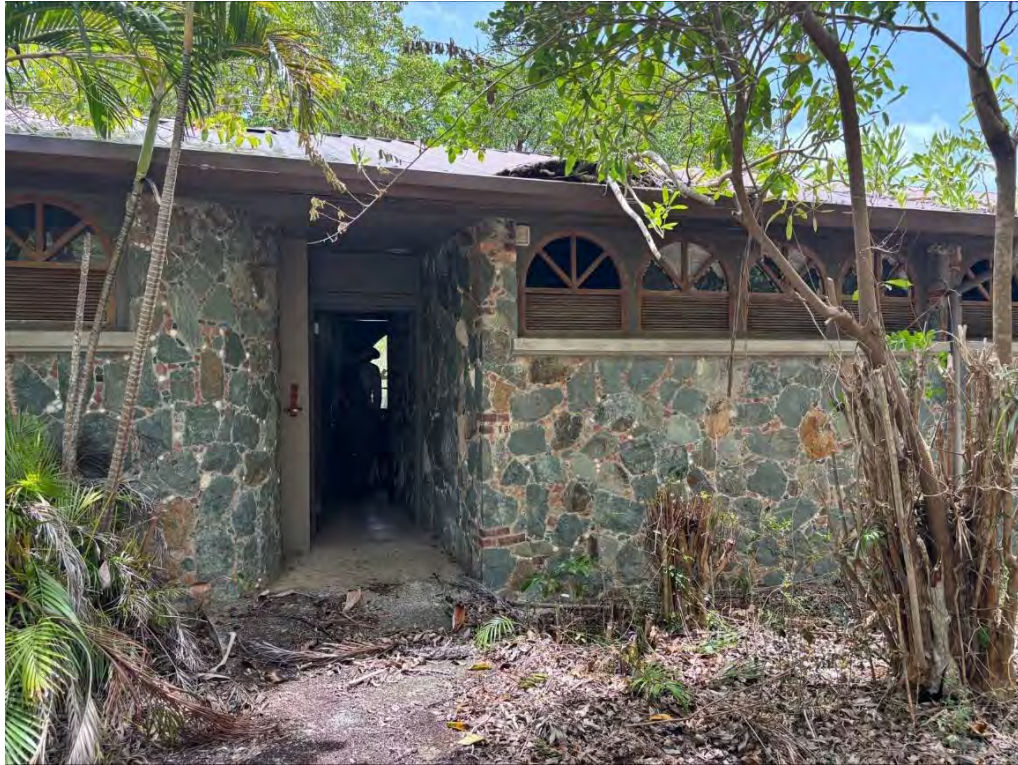
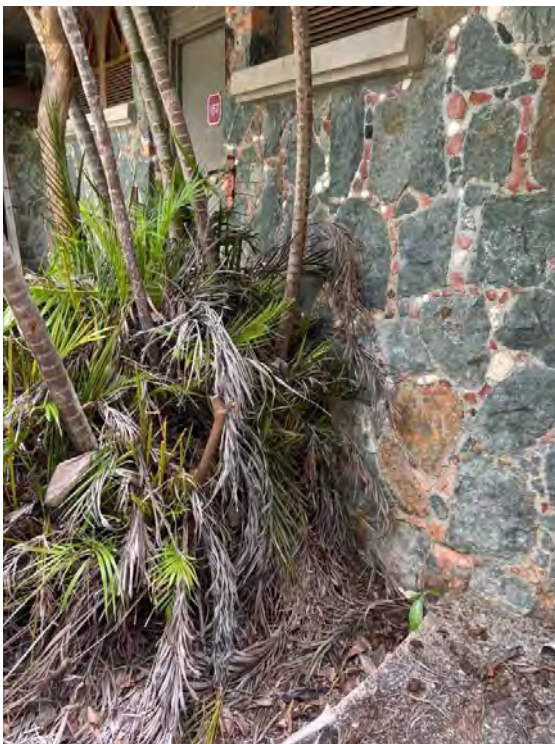
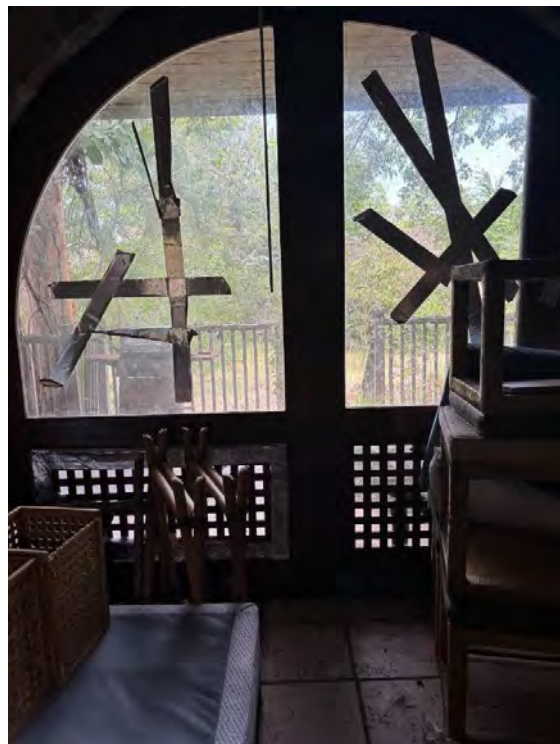
**Building: 54 Garden View Unit 156**

| Component | Material | Notes |
|---|---|---|
| Walls (Structural) | Stone | Termite tubes observed. |
| Walls (Non-Structural) | Stone | Exterior concrete cap is spalling. |
| Roof | Wood Framed /<br>Metal Roof | Vegetation growing in gutter. Potential termite damage. |
| Stairs/Railings | Wood | Severely deteriorated. |

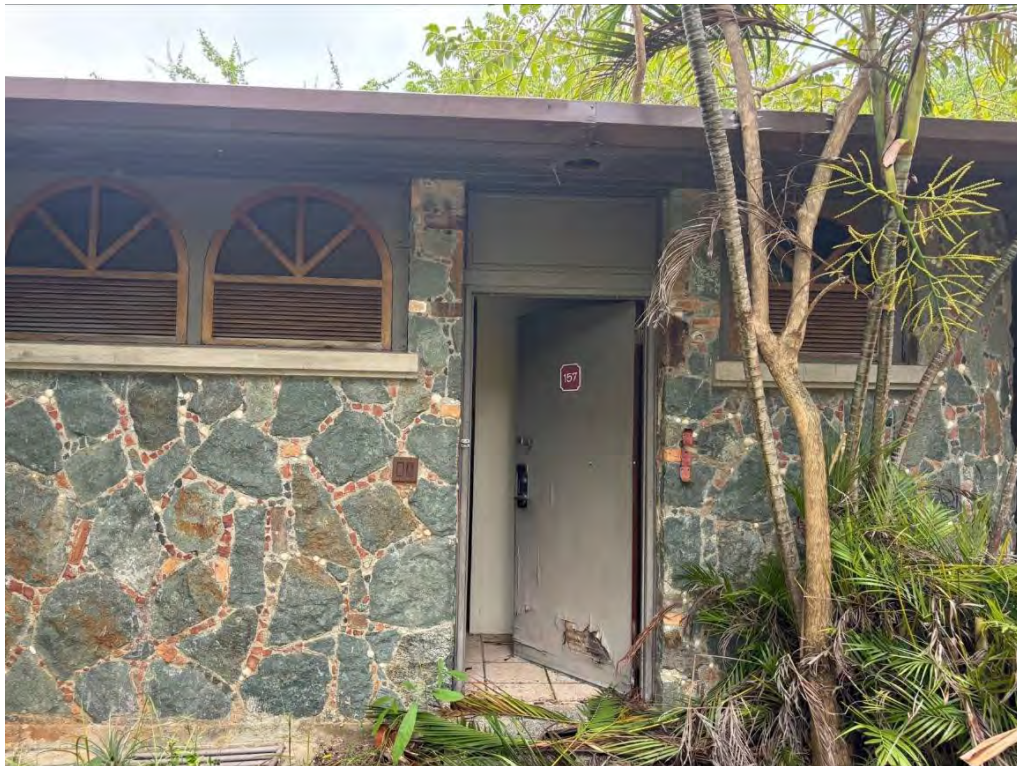
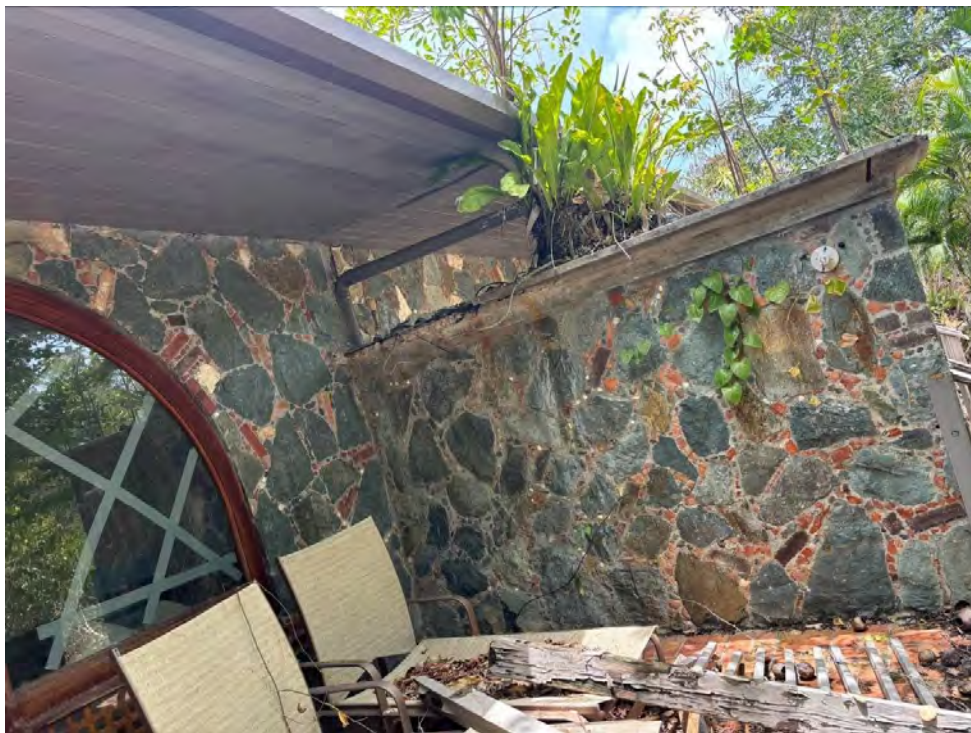
**Building: 54 Garden View Unit 157**

| Component | Material | Notes |
|---|---|---|
| Walls (Structural) | Stone | Termite tubes observed. |
| Walls (Non-Structural) | Stone | Exterior concrete cap is spalling. |
| Roof | Wood Framed /<br>Metal Roof | Vegetation growing in gutter. Potential termite damage. |
| Stairs/Railings | Wood | Severely deteriorated. |
